## Mechanical Group Chairman's Factual Report

## Oxnard, California

## HWY 15MH006

# F. GROUP EXAMINATION OF THE FRONT PILOT ASSEMBLY FROM CAR SCAX 645 (10/28/2015)

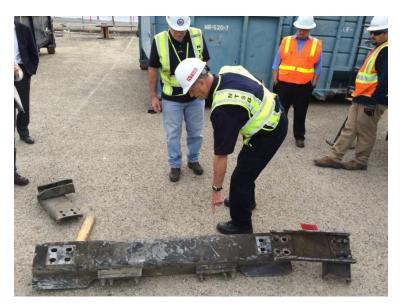
Figure 1 Investigators examining the pilot assembly.

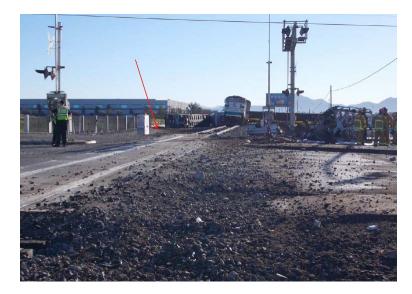
Figure 2 View of the pilot assembly from the crossing.

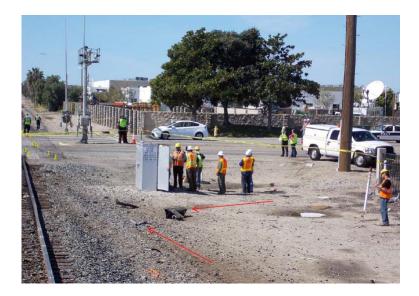
Figure 3 View of pilot assembly from the rear locomotive.

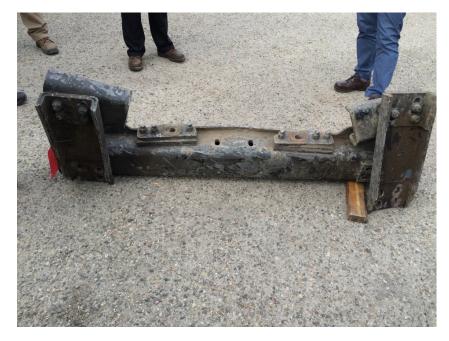
On October 28, 2015, the investigative group met at Metrolinks Moorpark storage yard to examine the pilot assembly of Cab Car SCAX 645. All portions of the pilot assembly and its attachments were examined for signs of wheel contact that may have incurred during the incident. No such strike marks were observed. The assembly's brackets and welds showed signs of impact and weld failure due to the collision with the highway vehicle.

Figure 8 Rear view of pilot assembly.

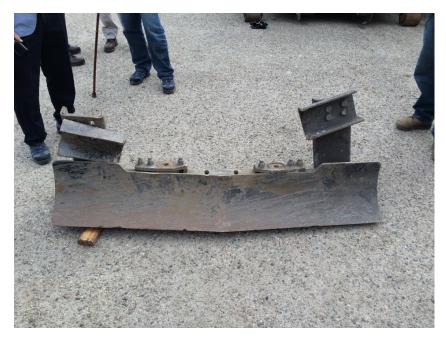
Figure 9 Front view of pilot assembly.

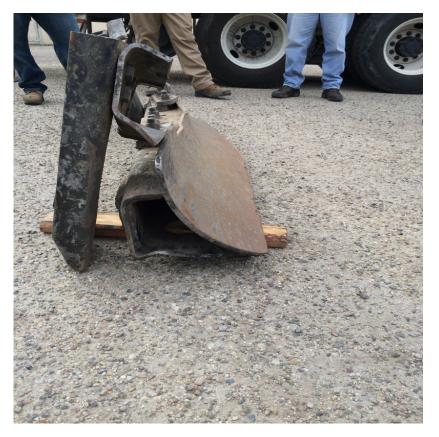
Figure 10 Right view of pilot assembly.

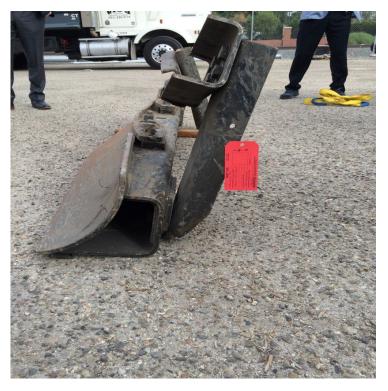
Figure 11 Left view of pilot assembly.

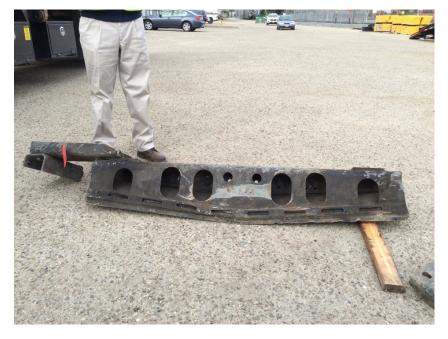
Figure 12 Bottom view of pilot assembly.

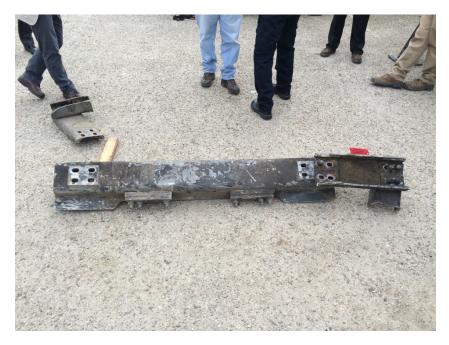
Figure 13 Top view of pilot assembly.
