Derailment of FC4230
Conrail Hazardous Materials Train
Paulsboro, New Jersey
November 30, 2012

Mechanical Group Factual Report

DCA 13 MR 002

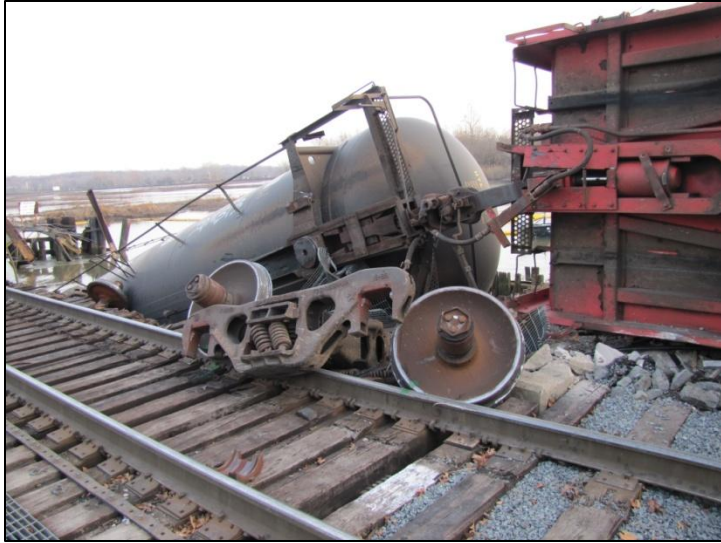
Figure 2-Photograph of UTLX 207938 Coupled to SGLR 6298

The locomotives and the first five cars behind the locomotive did not derail. These cars were on the south side of the bridge. The next seven cars, the 6th through the 12th, in the line derailed. Car numbers six and seven were derailed and laying on their sides to the east side of the main. The next car in the line was a tank car (UTLX 207938) loaded with ethanol. This car was still coupled to the A-End of the 7th car (SGLR 6298). See figure 2.

This car was lying on its side on the east side of the main partially submerged on the shoreline of Mantua Creek.

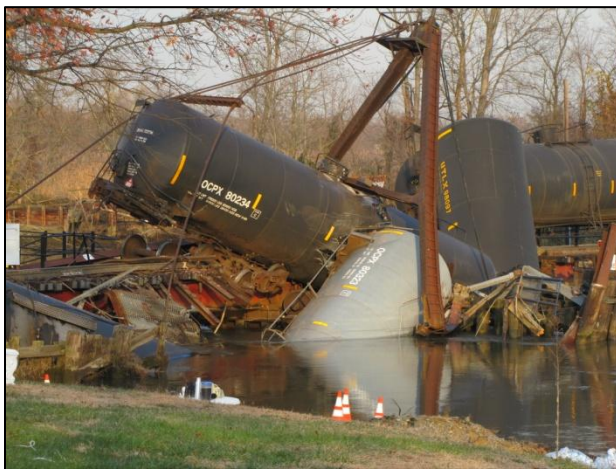
Figure 3-OCPX 80234

The 10th car (OCPX 80234) was derailed to the east side of the bridge. The tank car was resting on its right side (right side is defined by looking from the B-End) against the 9th car's A-End body bolster. OCPX 80234 sustained a breach at this contact area, releasing part of its product; vinyl chloride. See figure 3. And figure 4. The 13th car was left in place as an anchor and the trailing 70 cars were moved to Pavonia Yard in Camden, NJ.

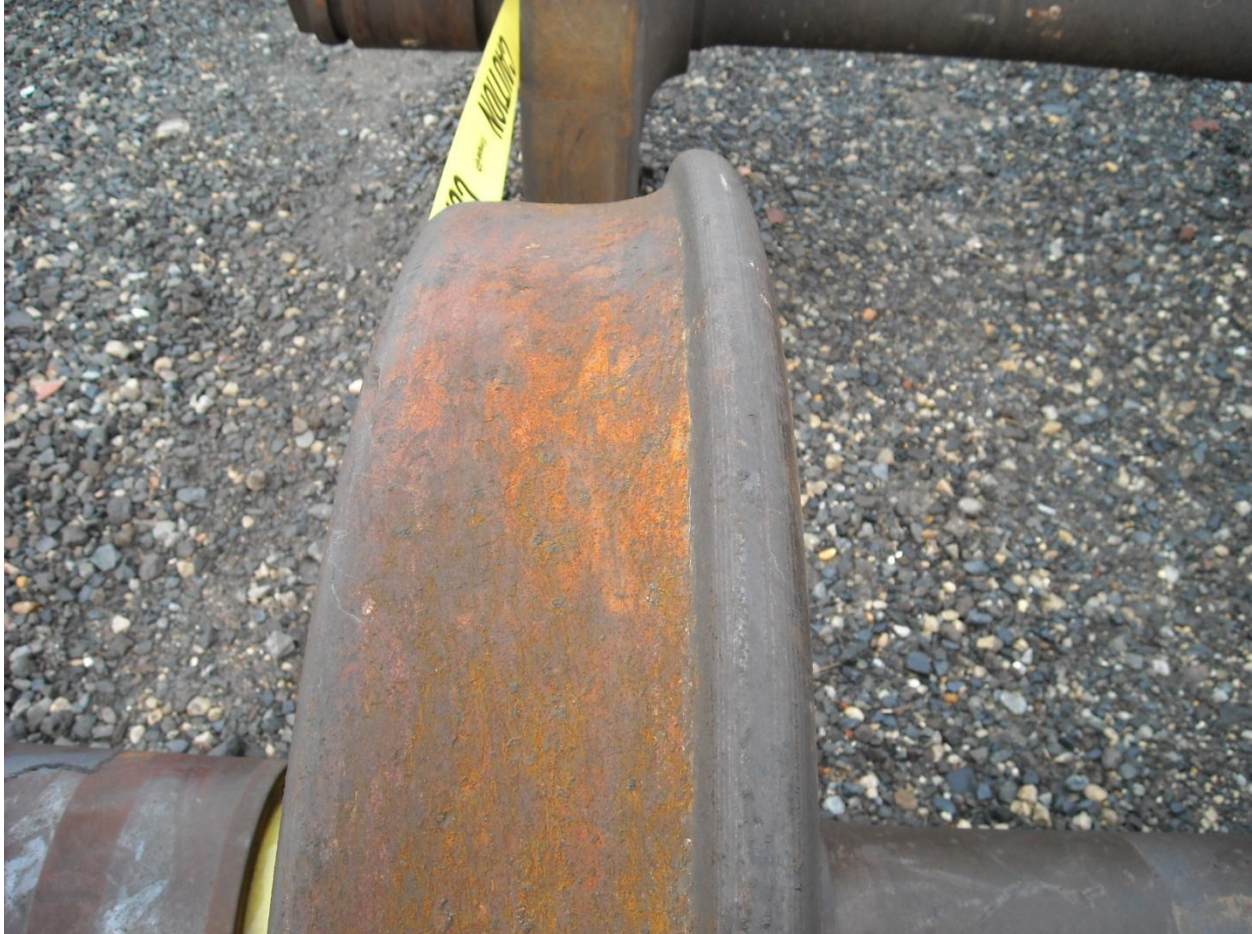
Figure 8 Typical recovered wheel profile.

None of the wheels on any of the 12 sets had any type of flange profile defect. Each wheel set had 100-ton axles and 6 ½ by 12 roller bearings. Several roller bearings were broken but strike marks were evident at each broken location. One axle was bent with back-to-back readings of 50 inches and 57 7/8 inches.
