National Transportation Safety Board  
Office of Railroad, Pipeline and Hazardous Materials Investigations  
Washington, D.C. 20594

BNSF – Head on Collision  
Panhandle, TX  
June 28, 2016  
Mechanical Group Factual

NTSB Accident Number: DCA16FR008  
Date of Accident: June 28, 2016  
Time of Accident: 8:21 a.m. (CDT)  
Type of Trains: Freight  
Railroad Owner: BNSF  
Train Operator: BNSF  
Fatalities: 3  
Injuries: 1  
Location of Accident: Panhandle, TX

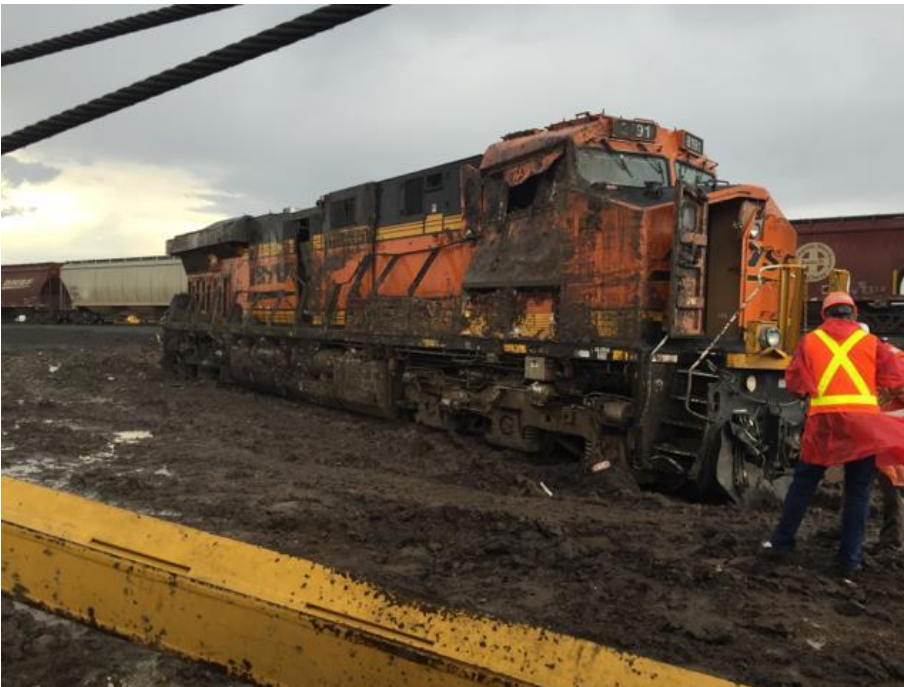
Figure 1 Photo of locomotive BNSF 8191 after being cleared from collision area.

BNSF 8191 derailed upright with moderate structural and truck damages.
