ERA12LA535

Millville, New Jersey

Beech Aircraft Corporation 95-A55 – N71BM

NTSB ENGINE EXAMINATION NOTES

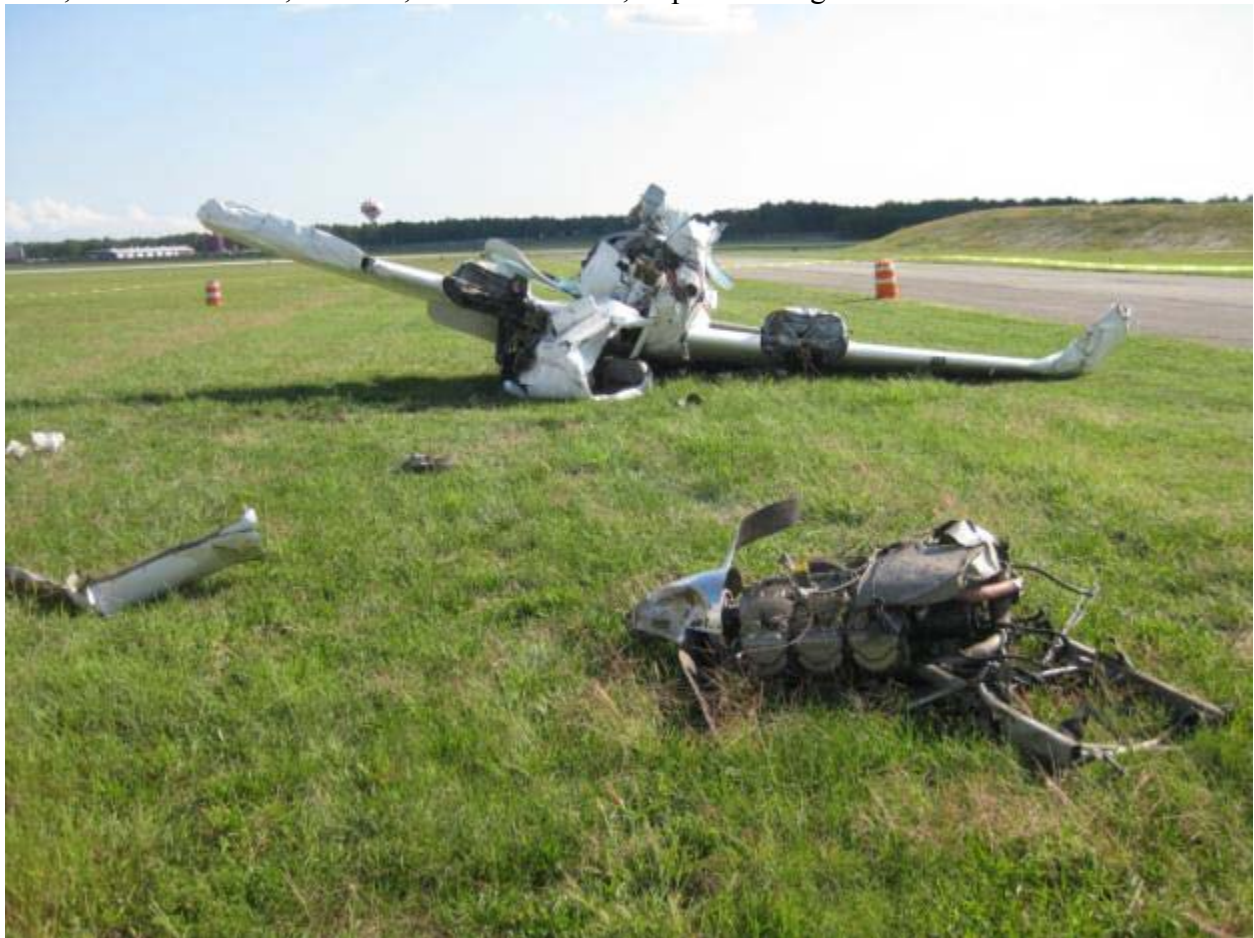
Photo 1: Airplane at Rest (Courtesy of the FAA)

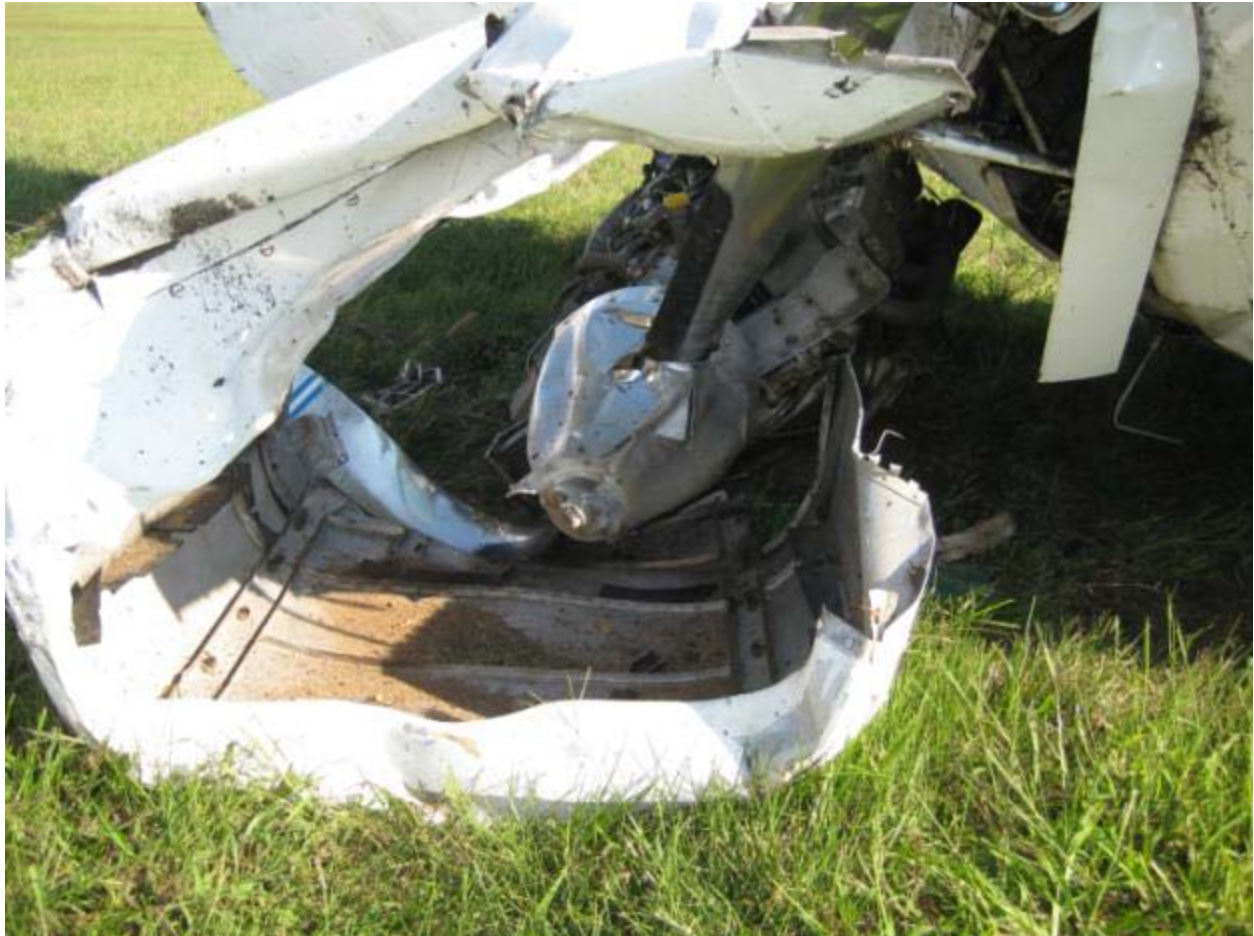
Photo 2: Right Engine at Rest (Courtesy of the FAA)

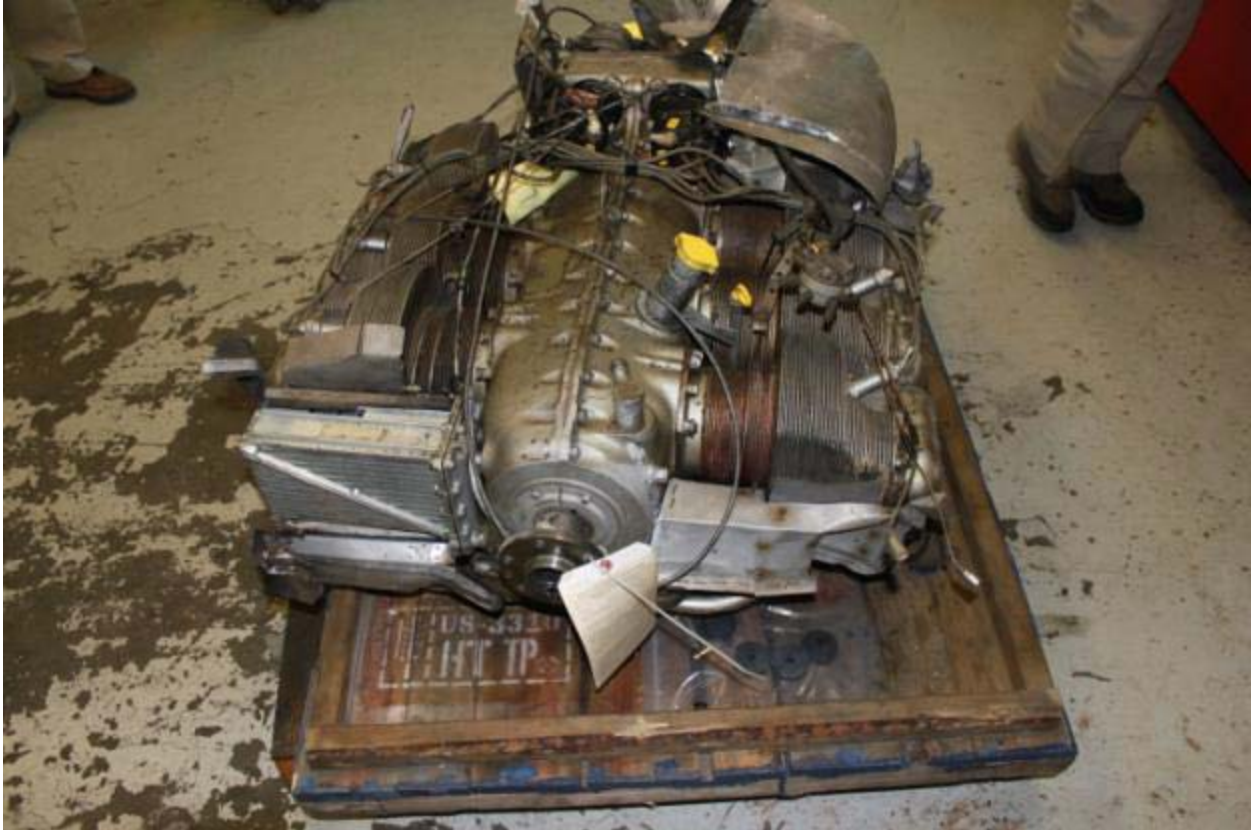
The engine was shipped from the accident airport to CMI's facilities in Mobile, Alabama via crate and bonded shipment. Upon receipt the engine was immediately logged and placed in bonded/secure storage and was not opened. The crate was viewed by the IIC as unopened; it was photographed and opened for examination. The examination revealed that four (4) mounting legs were impact separated and will need to be replaced in order to facilitate examination. The oil sump exhibited a breach of the structure which resulted in a loss of engine oil. The left side exhaust exhibited compression damage near the No. 1 Cylinder area. The right side exhaust exhibited slight compression damage on the aft side of the engine which resulted in a breach of the tubing. The generator pulley rim exhibited impact damage; however, the generator remained attached to the rear accessory drive. The starter was impact separated; however, was found placed on the right side of the engine's exhaust. Induction tubes exhibited impact damage at the coupling near cylinders No.s 1 and 2.

Photo 6: Right Engine Before Exam

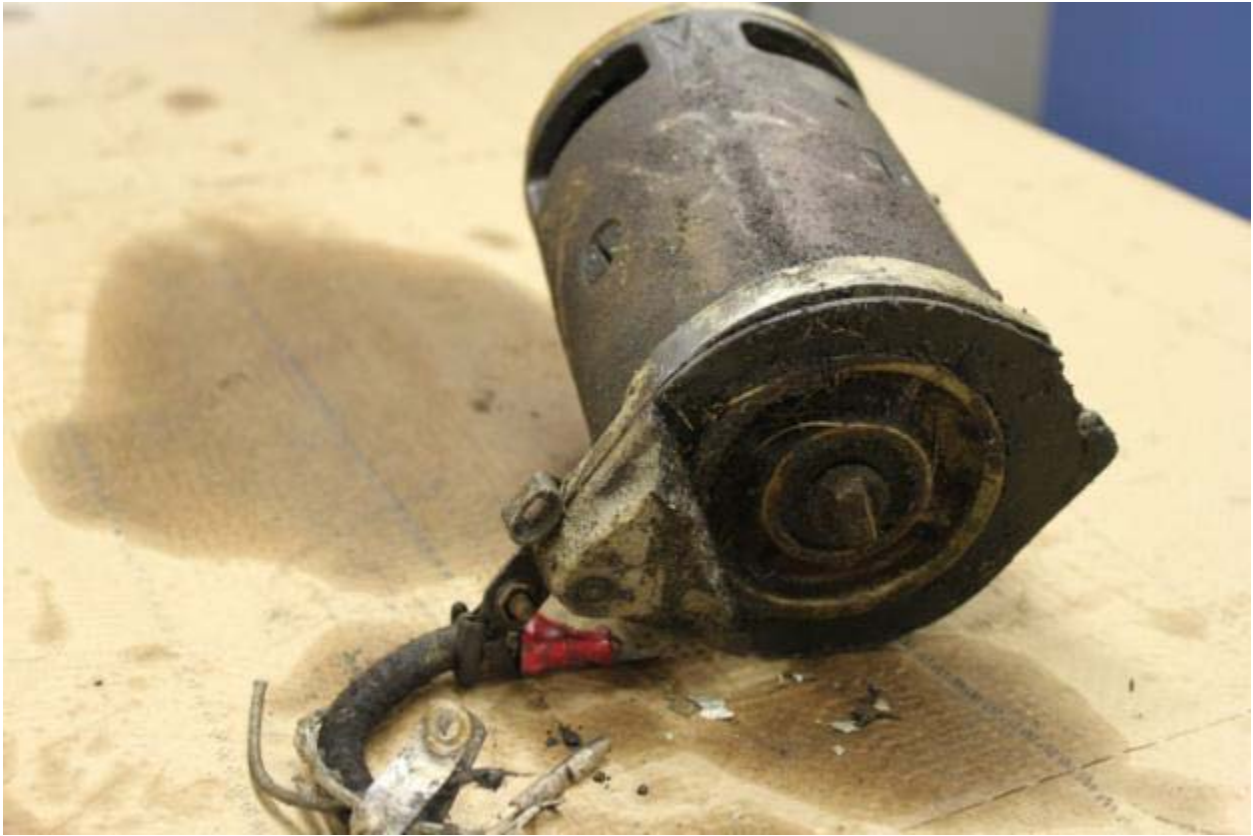
Photo 7: Starter

Part number 1108234. Serial number 29041R. Impact damage was located at mounting points. Rotation was smooth and no anomalies were noted.

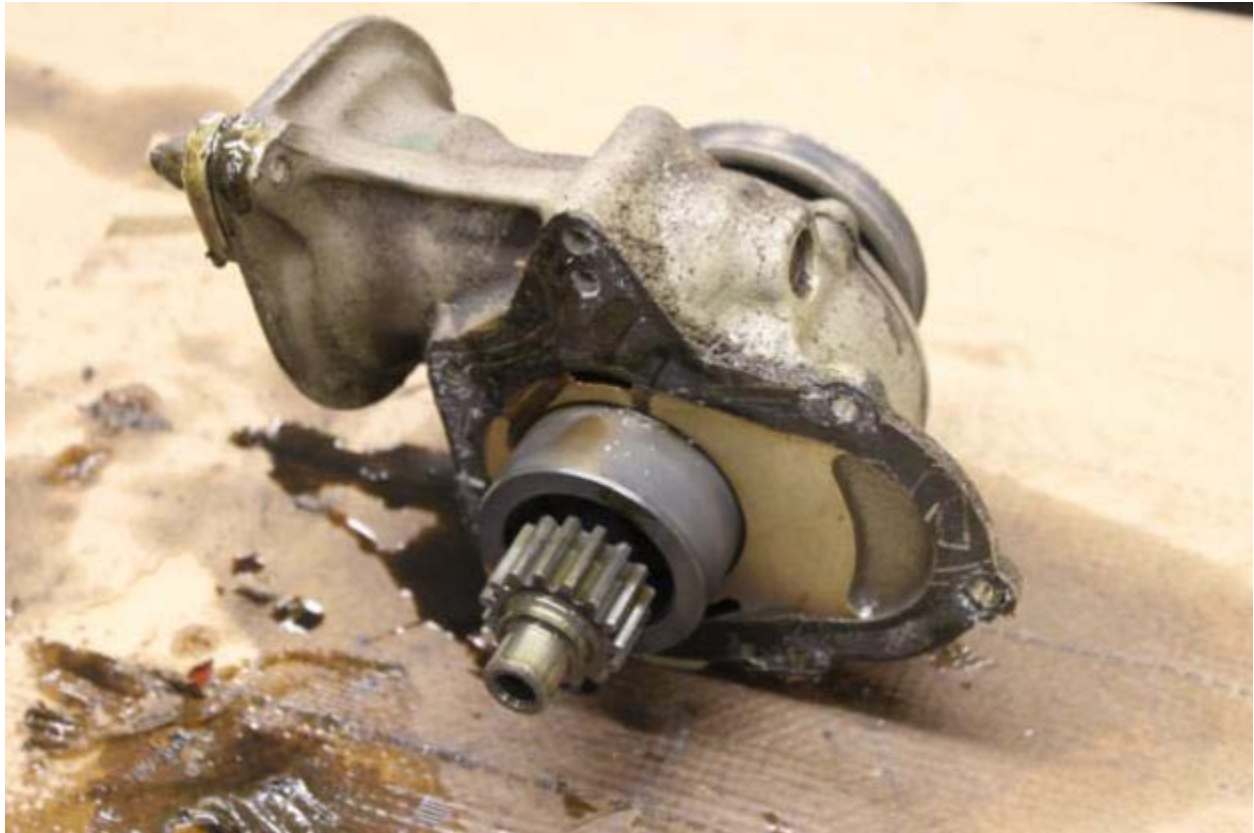
Photo 8: Starter Drive Adapter

Casting number 534957. The adapter was impact fractured at the mounting surface. There was impact damage to 30 percent of starter adapter flange. Looking at the face of the flange, the damage was noted from 12 o'clock to 3 o'clock. A small portion of starter flange was still attached at bolt to starter adapter flange. Attach point to starter rotated freely with slight resistance, was rotated for one turn and rotated back. The timing plate remained in place, although not required and should have been removed. Rotation of the gears was smooth and no anomalies were noted.

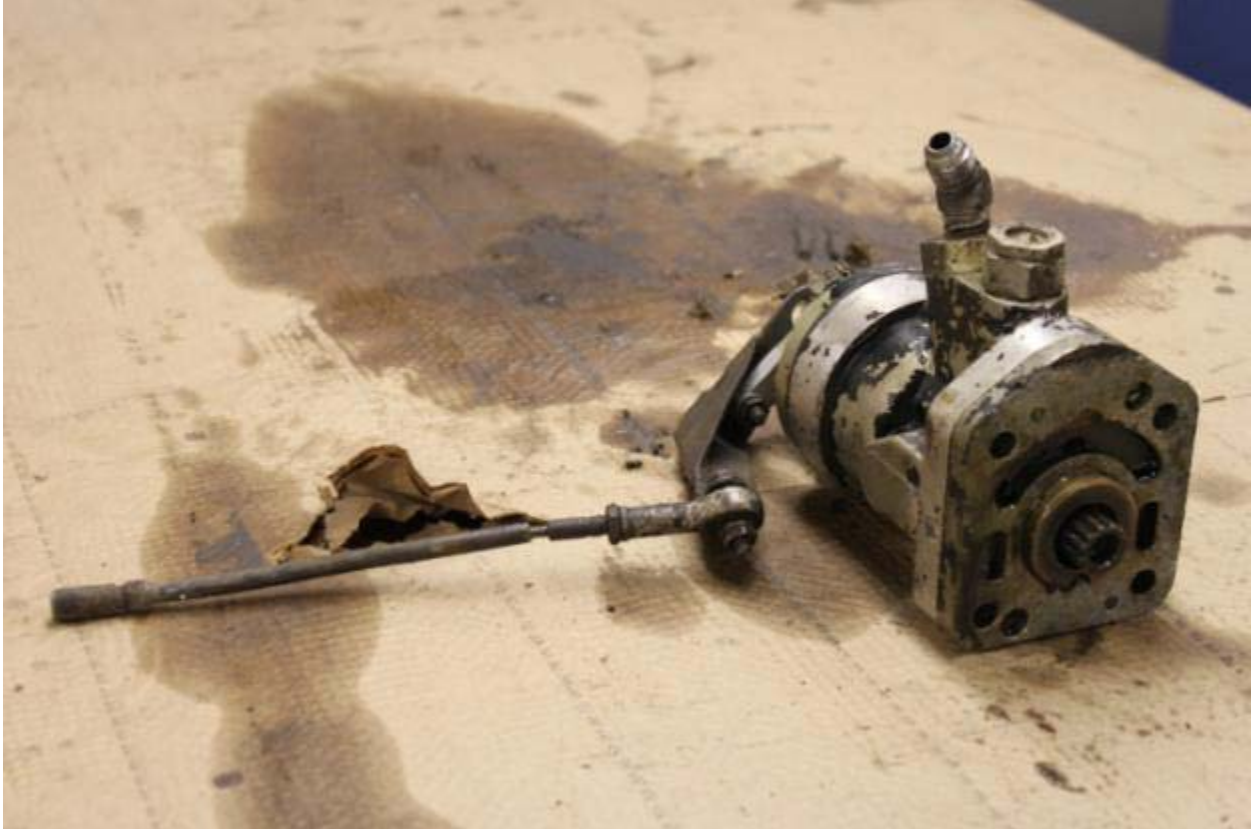
Photo 9: Propeller Governor

Woodward propeller governor, type 210355K, serial number 600122, and part number was unable to be determined. The screen was free and clear of debris and rotation was smooth and unremarkable. There was impact damage to the propeller control arm that caused it to bend 30 degrees. Propeller control arm was free of binding and rotated smoothly to stops.

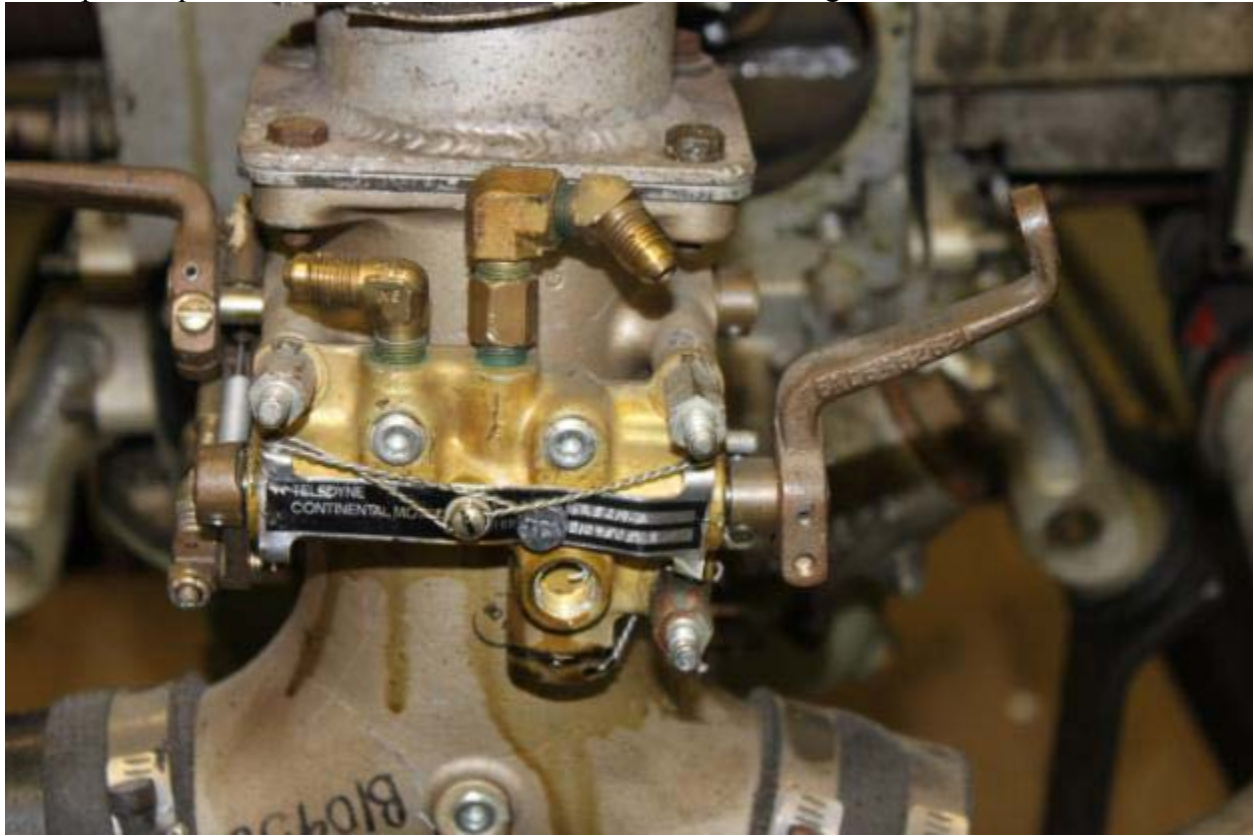
Photo 10: Fuel Metering Unit

Part number 625219-2 and serial number B109505AR. Metering unit remained attached during the impact sequence. No anomalies were noted. Unit used for engine test.

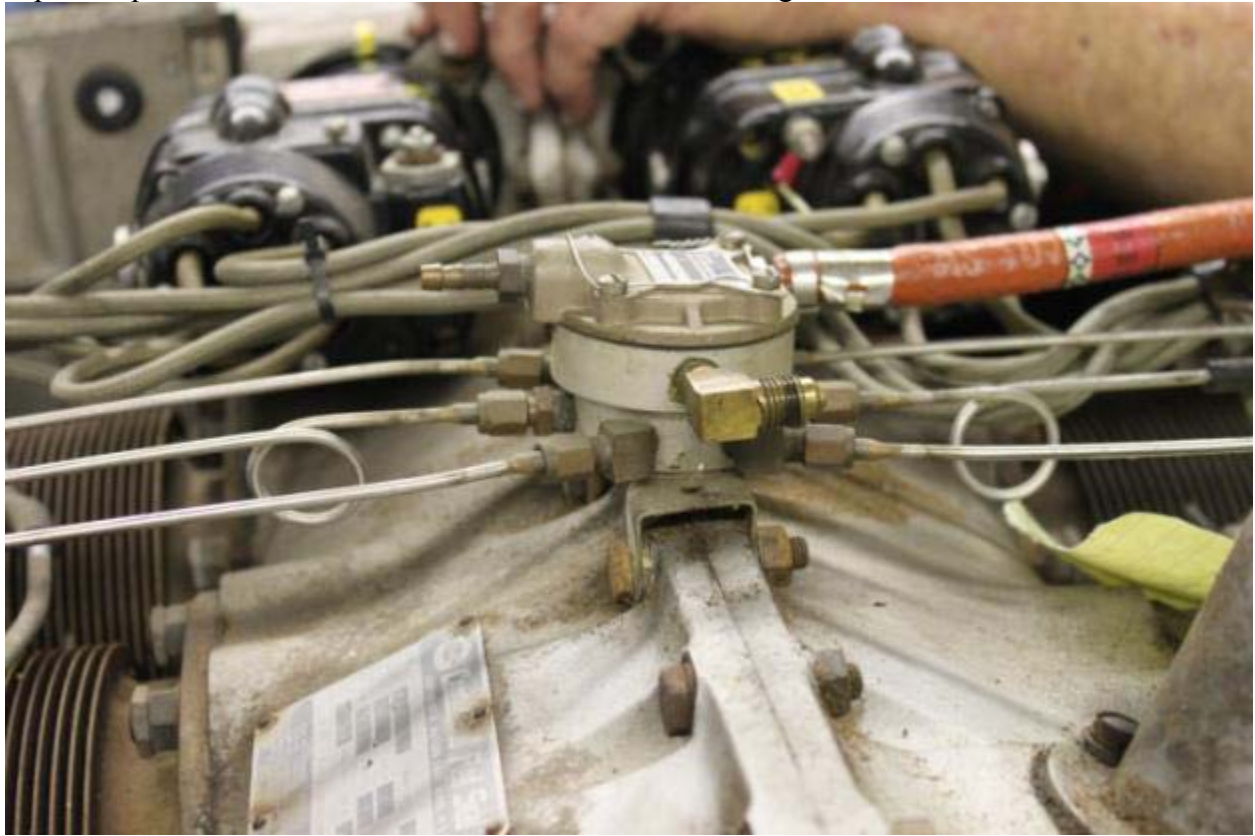
Photo 11: Fuel Manifold

Part number 631427-348 and serial number B109505CR. Manifold remained attached during the impact sequence. No anomalies were noted. Unit used for engine test.

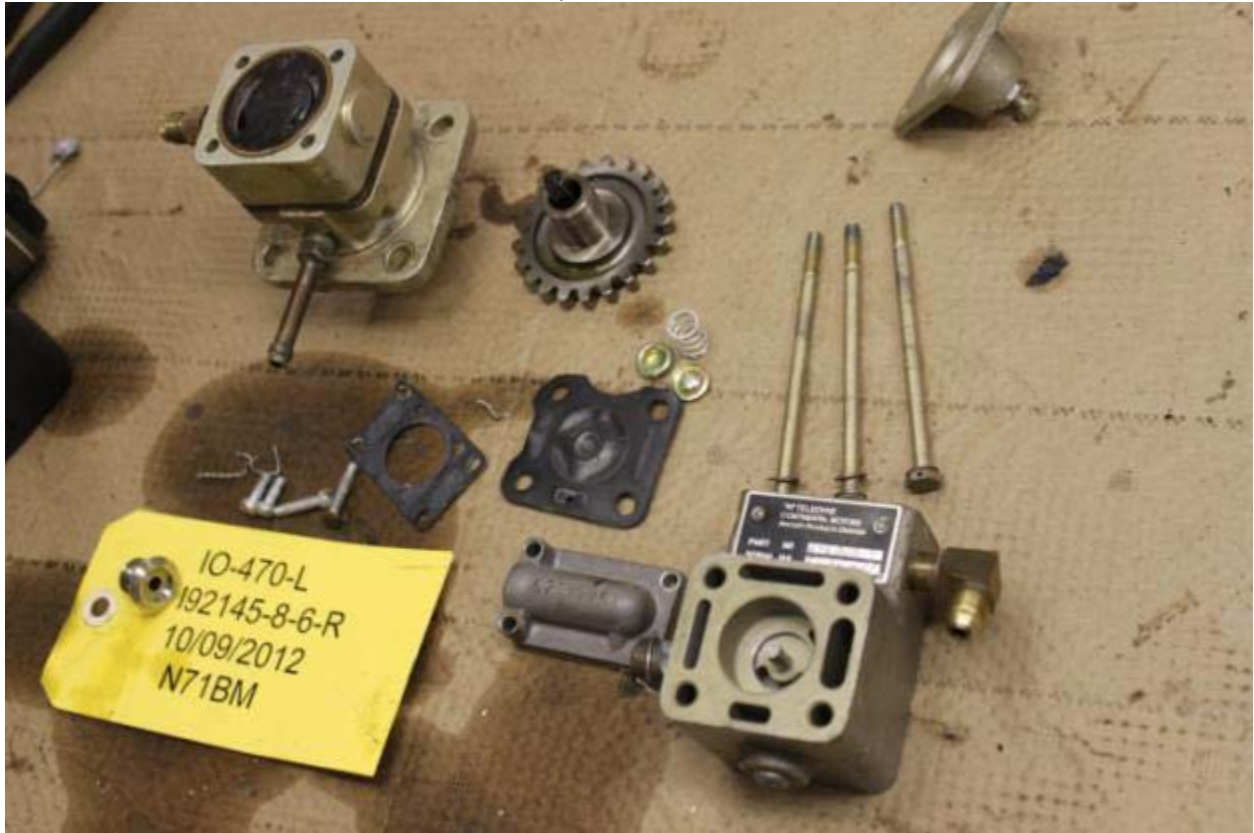
Photo 12: Fuel Pump

Part number 646212-9 and serial number B109515BR. The unit rotated smoothly and freely by hand and no anomalies were noted. There was impact damage to the fuel inlet fitting and vapor return fitting. The drive coupling was intact. The low end adjustment on the rear housing was replaced due to a circumferential crack. Needle valve was also replaced.

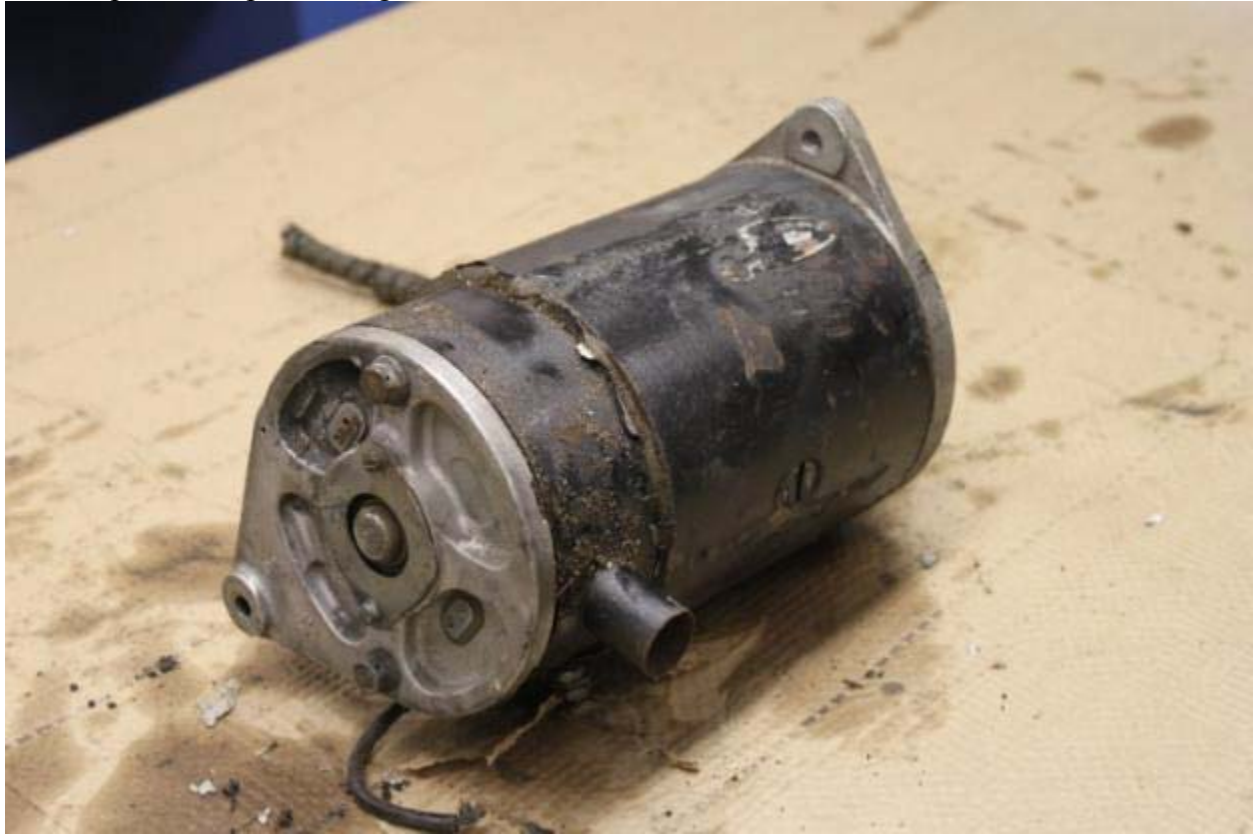
Photo 13: Generator

Part number and serial number were unable to be determined due to impact damage to the data plate. The unit was removed and rotated freely by hand that the pulley. Both forward and aft rim were 50 percent impact damaged around the circumference of the face.

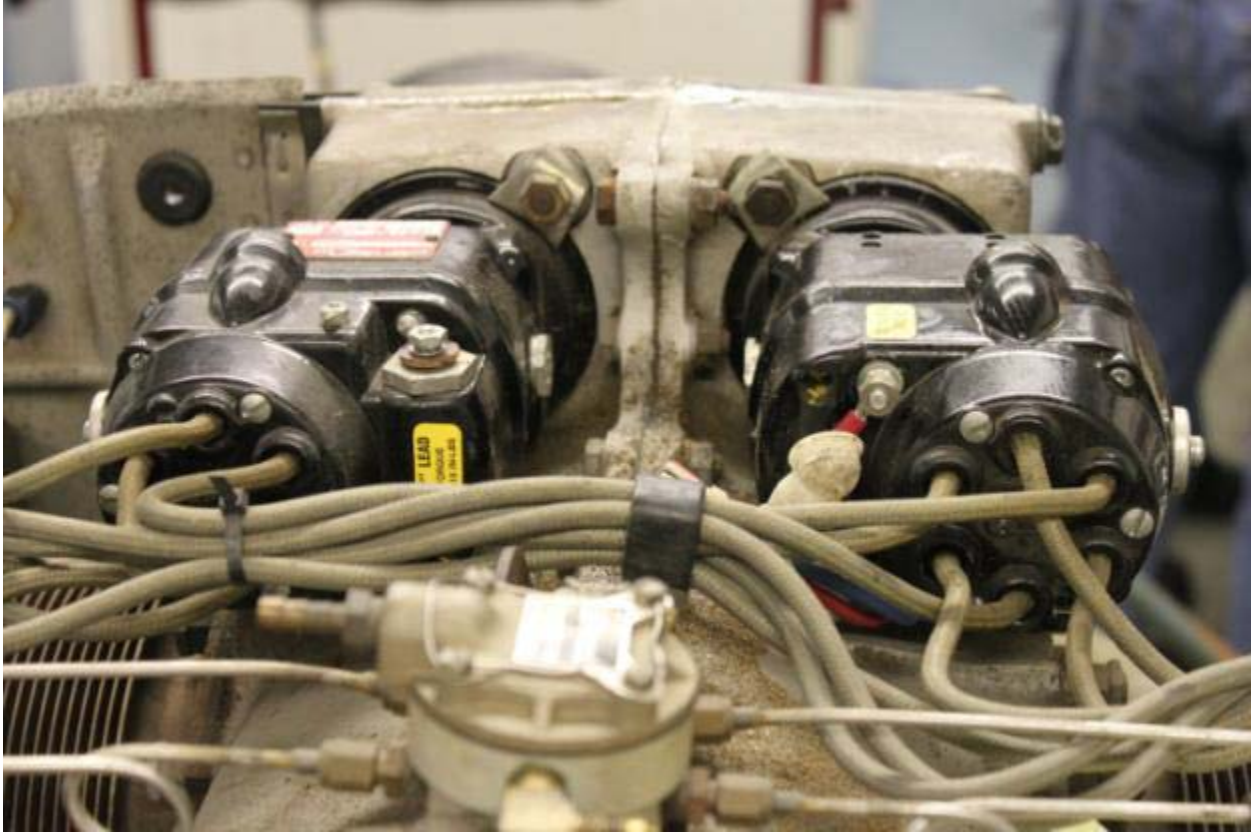
Photo 14: Magnetos

22 degrees from top dead center.

The left magneto remained attached to the engine case. It was a Slick Magneto, M-6309.

Serial number 95060004. Slick Aircraft Company Magneto, Model 6313. Magneto remained attached during the impact sequence. Unit used for engine test.

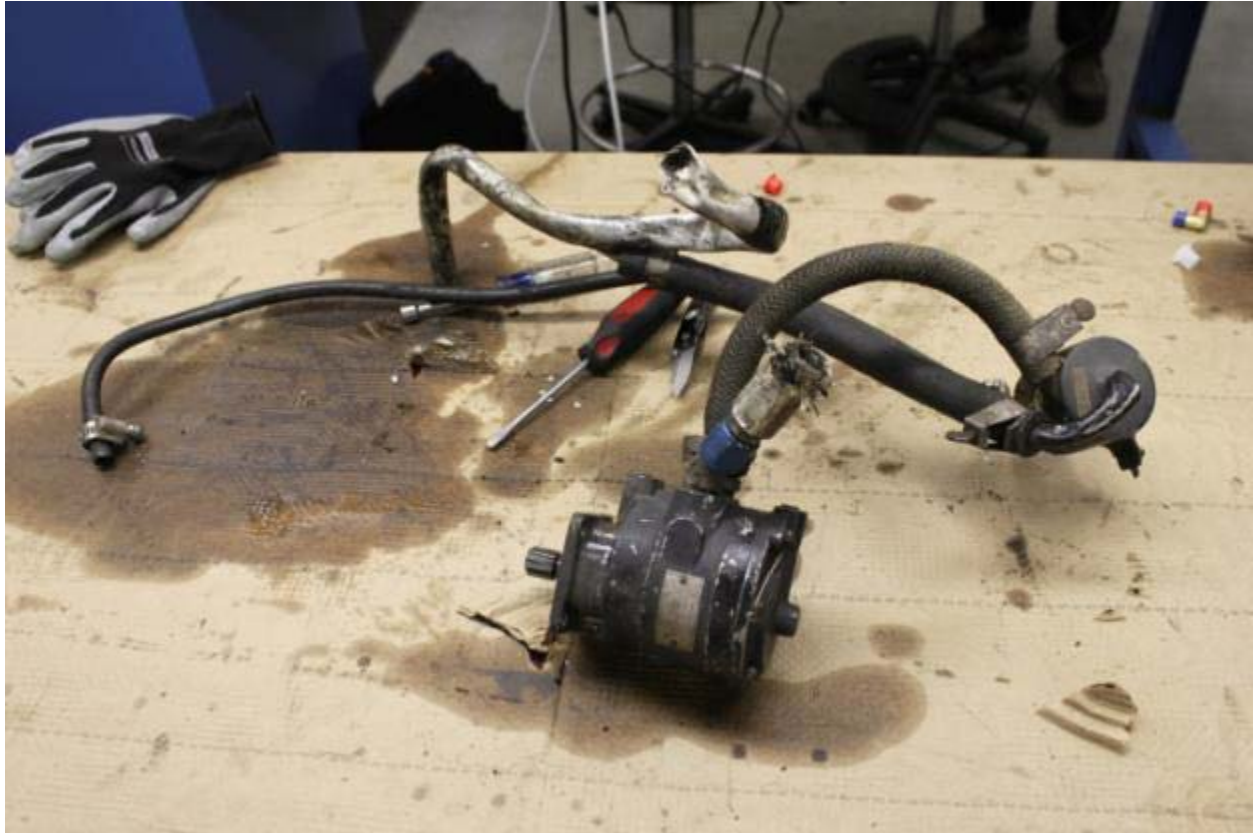
Photo 15: Vacuum Pump

Part number G455 and serial number 15982. Wet vacuum pump system. Unit remained attached to rear accessory pad. The unit rotated smoothly at spline; no mechanical malfunctions or anomalies were noted.
