Pacific Gas and Electric Company  
Metallurgical Lab Test Report  
3400 Crow Canyon Road  
San Ramon, CA 94583

**SUBJECT: METALLURGICAL ANALYSIS OF LEAKING GAS TRANSMISSION  
PIPE, LINE 402, ADOBE ROAD**

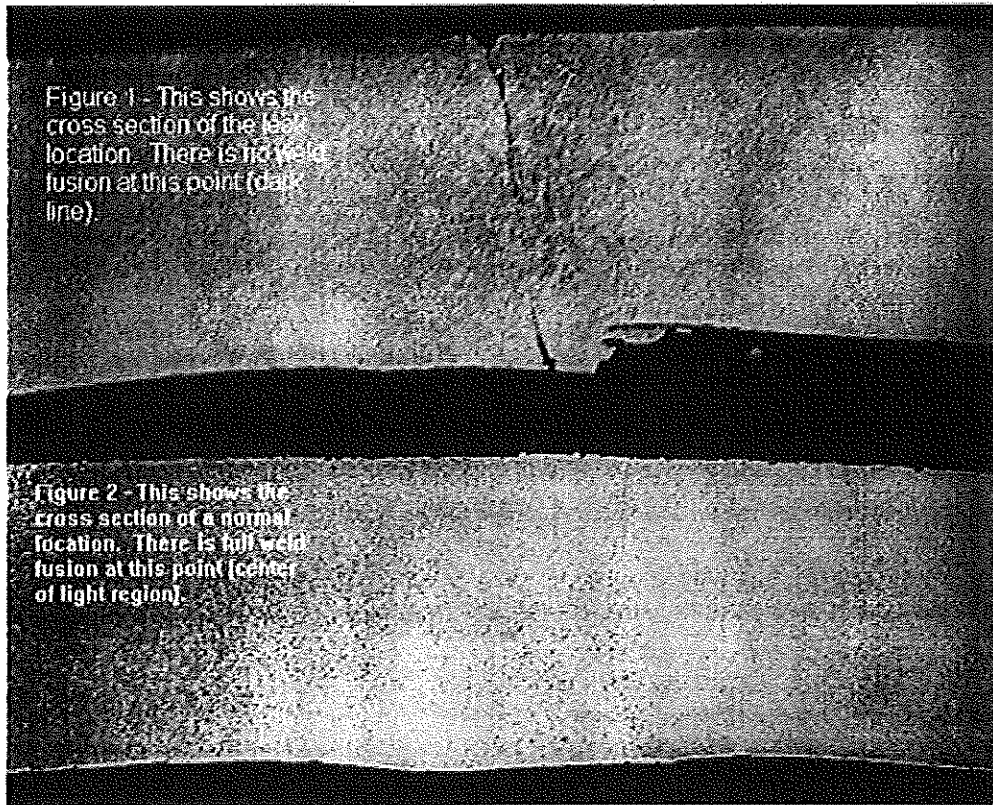
The segment containing the leak, and another cross section from about 3 inches away, had defective welds (see Figure 1). There was a wide heat affected zone that showed that some heat had been applied in the area of the intended weld. There was some slight deformation on the inner surface of the pipe at the intended weld location. But there was little or no fusion at the points where the plate edges were in contact, and the deformation and grain flow normal to ERW welds were not present. It was probably caused by insufficient welding current. This defect was extremely tight and depending on the exact extent of it along the pipe might have held pressure or at least had a very slow leak rate. It appeared similar to normal pipe surface marks.

Based on these results, it appears that only the pipe segment that leaked had an original manufacturing flaw that was not detected, but eventually leaked in service. The other pieces that were tested had no similar defect at the locations sampled.
