Pacific Gas and Electric Company  
Metallurgical Laboratory Test Report  
Technical and Ecological Services  
3400 Crow Canyon Road  
San Ramon, CA 94583

**SUBJECT: METALLURGICAL EVALUATION OF CRACKING IN LINE 109 SEAM WELDS**

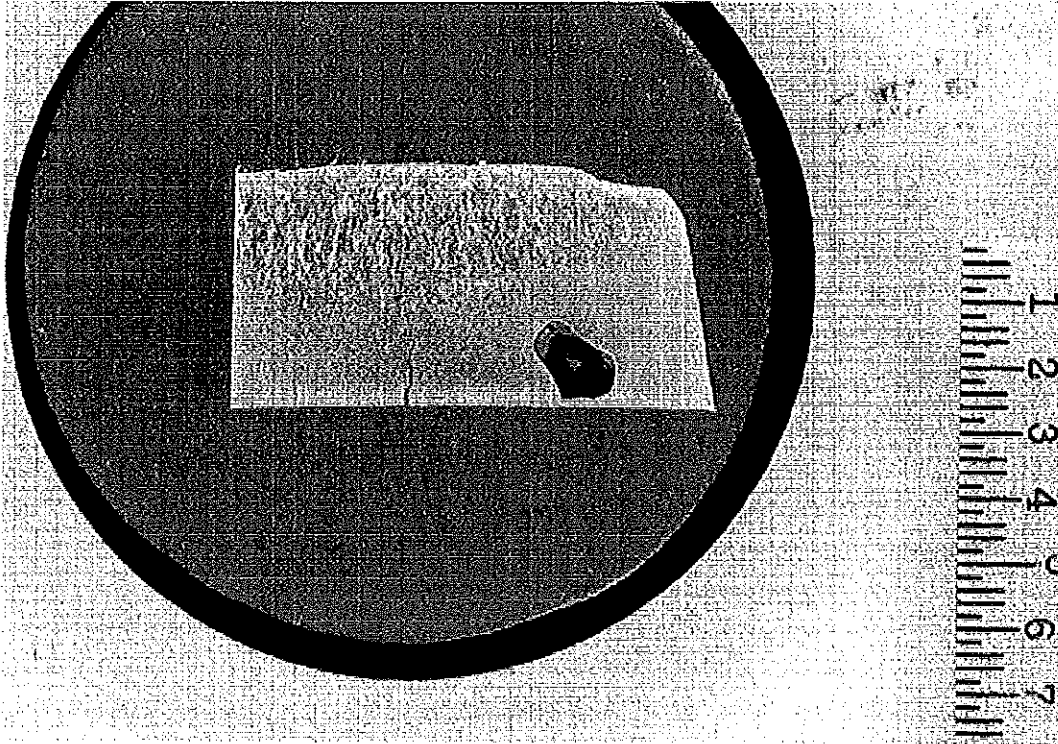
Macroscopic views of the seam weld cracking in Spool #1 is shown in Figure 2 and in Figure 3. The crack in Figure 2 is a cross section through the middle of one of the 0.30-inch long cracks. The section plane was about 0.75-inch from the fusion line of the girth weld, as measured from the root. The crack in Figure 3 is a cross section through the 1.6-inch long crack. This section plane was about 2.25-inches from the fusion line of the girth weld, as measured from the root. Microscopic examination of the cracking revealed that these seam welds were made with two layers deposited from the outside, and that the cracking was confined to the first (root) layer only. The microstructure of the first layer was renormalized, apparently by the heat from deposition of the second layer. The crack propagated in a transgranular manner, and the crack tip was relatively blunt. The crack that was closest to the girth weld (shown in Figure 2) followed a trail of oxides/inclusions in the weld metal, as shown in Figure 4. A sample of the larger crack was broken open at liquid nitrogen temperature to examine the crack surfaces. There was no evidence of beach marks or other indicators of progressive crack growth on the fracture surface. The fracture surfaces were covered with a uniform layer of corrosion products, as shown in Figure 5. No evidence of high temperature oxide scale was found inside any of these cracks, nor did we find any evidence of repair welds made from the inside surface.

**Figure 2** - Cross section through a 0.30-inch long crack in Spool #1. The depth was 0.150-inch or 44.1% of the 0.340-inch local wall thickness. Magnification is 4.0X.

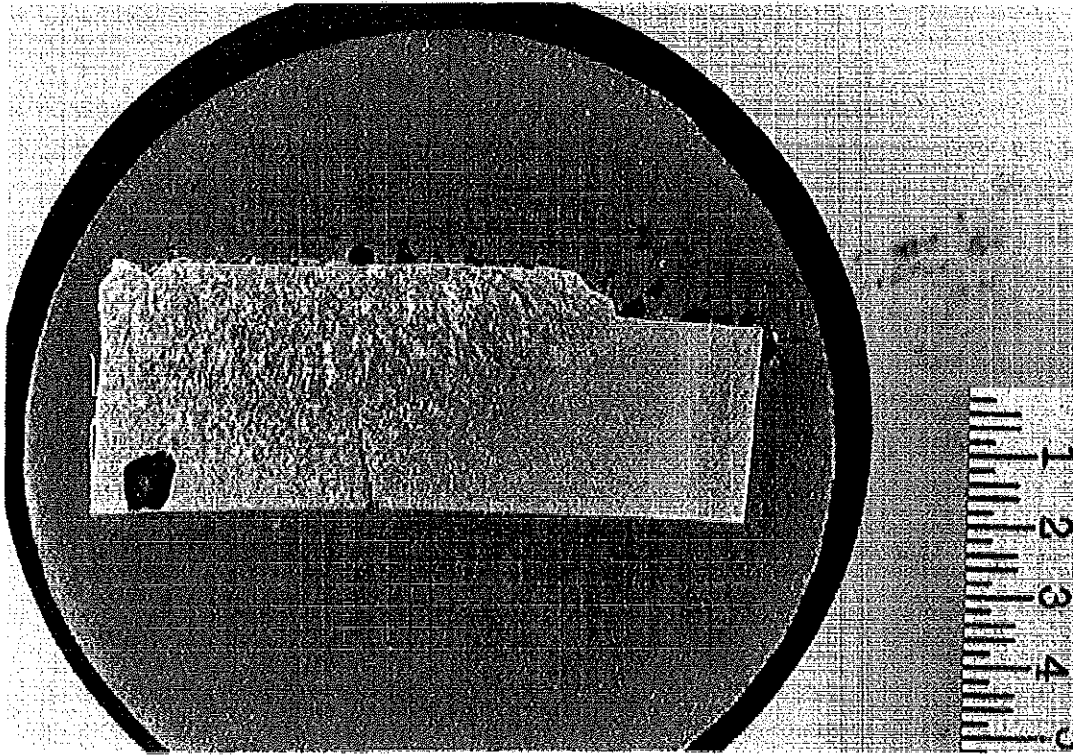
**Figure 3** - Cross section through the 1.6-inch long crack in Spool #1. The depth was 0.148-inch or 40.0% of the 0.370-inch local wall thickness. Magnification is 4.3X.

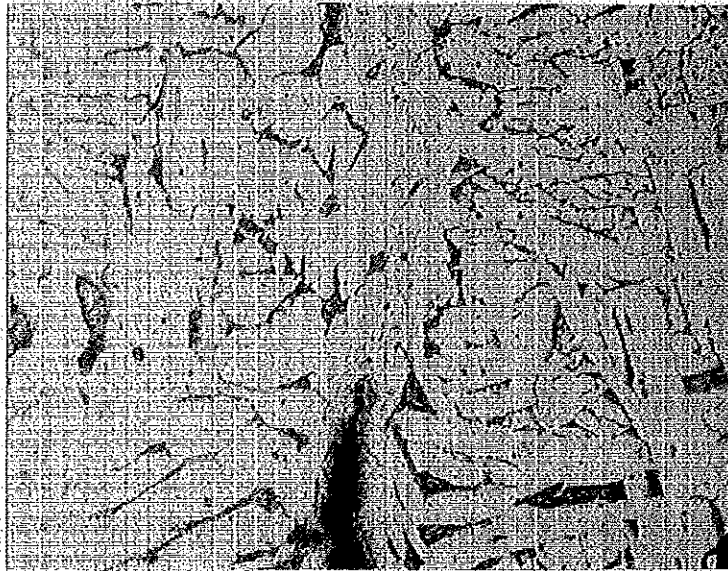
The cracking in spool #1 was located in a manual SMAW repair weld made to the original SAW seam. The original seam weld likely cracked during the cold expansion process. We believe the cracking in the repair weld was caused by the fabrication process, meaning the crack has been present since original construction in 1935. The cause of the cracking is believed to be related to

the solidification of the first layer of the repair weld metal, wherein impurities such as oxides and inclusions were concentrated along the last region to solidify. This created a weak local area which cracked probably after deposition of the second layer.

**Figure 4** - Photomicrograph of the crack tip in Spool #1 showing that the crack followed a trail of oxides/inclusions in the renormalized weld metal. Magnification is 500X.

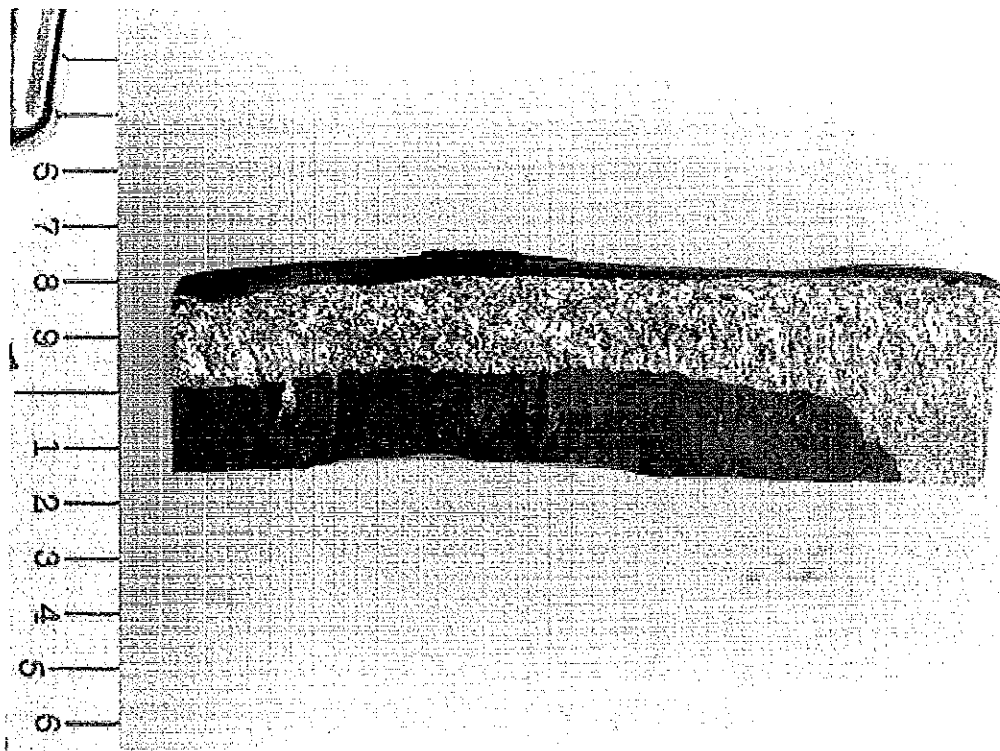
The repairs in Spool #1 were made from the outside surface. The lack of slag or high temperature oxide scale inside the crack indicates the crack was not exposed to elevated temperature for very long, if at all. The absence of beach marks, striations, or other indicators of cyclic crack growth such as progressive oxidation rules out fatigue as the cause. The fact that the cracking followed a trail of oxides/inclusions in the weld metal indicates the crack was related to the solidification of the first layer of the weld metal repair. This trail of oxides/inclusions could then act as a weak path in the material. The absence of slag inside the crack indicates the crack was probably not present before the second weld layer was deposited. One scenario that accounts for all the evidence is that the crack was formed shortly after the second layer of the repair weld was solidified but still hot. We believe the cracks in the spool are fabrication defects that have been present since the line was installed in 1935. The reason for repair of the original submerged arc weld is unknown, but likely to be because of cracking during the cold expansion or "belling" process.

Figure 5 - Fracture surface of the 1.6-inch long crack shown in Figure 3. No evidence of in service progression was detected. Magnification is 3.4X.

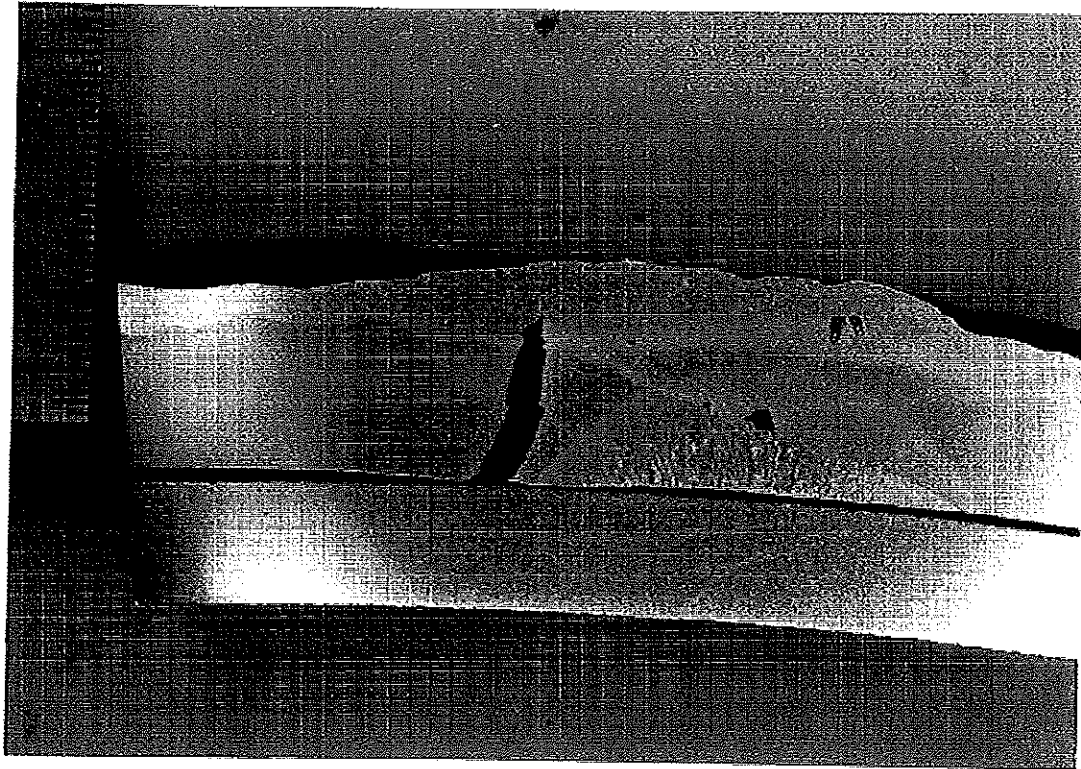
Macroscopic views of the cracks found in Spool #2 are shown in Figure 6 and Figure 7. Figure 6 shows the deepest crack found in the sample. As reported in Table 1 it was 76.5% of the local wall thickness. The section plane was approximately 0.50-inch from the fusion line of the girth weld, as measured from the root. The macro shows a repair weld was made from the inside surface, and that there are defects associated with the repair. Although when we received the sample the seam weld crown was ground off and was smooth, the bead placement and shape appears to indicate repair welding was also done from the outside surface. Figure 7 is a cross section of the same crack shown in Figure 6 except at a location farther from the girth weld (about 1.8-inch from the girth weld). The macros in Figure 6 and Figure 7 show that the cracks are not in the repair weld metal but are in the original SAW weld metal, which is now the heat affected zone of the repair weld at the inside surface. The cracks propagated in a transgranular path, and the crack tips were very blunt. No evidence of high temperature oxide scale was found inside any of these cracks. There was no evidence of beach marks or other indicators of cyclic crack growth on the fracture surface.

We believe the cracking in Spool #2 was located in the original SAW weld metal and was caused by the cold expansion or belling process during fabrication. This conclusion was arrived at primarily by the presence of large crack opening displacements in the belled area, and the absence of consistent evidence to support any other low temperature failure mechanism. Before the pipe was placed into service an attempt to repair the cracking was made but not all the original weld metal cracks were removed. The reason for this is unknown.

**Figure 6** - Cross section through the deepest crack found in Spool #2. It was 0.309-inch deep, or 76.5% of the 0.404-inch local wall thickness. Note the large crack opening displacement. The girth weld can be seen at the OD surface. A weld repair was made from the inside surface. Magnification is 3.3X

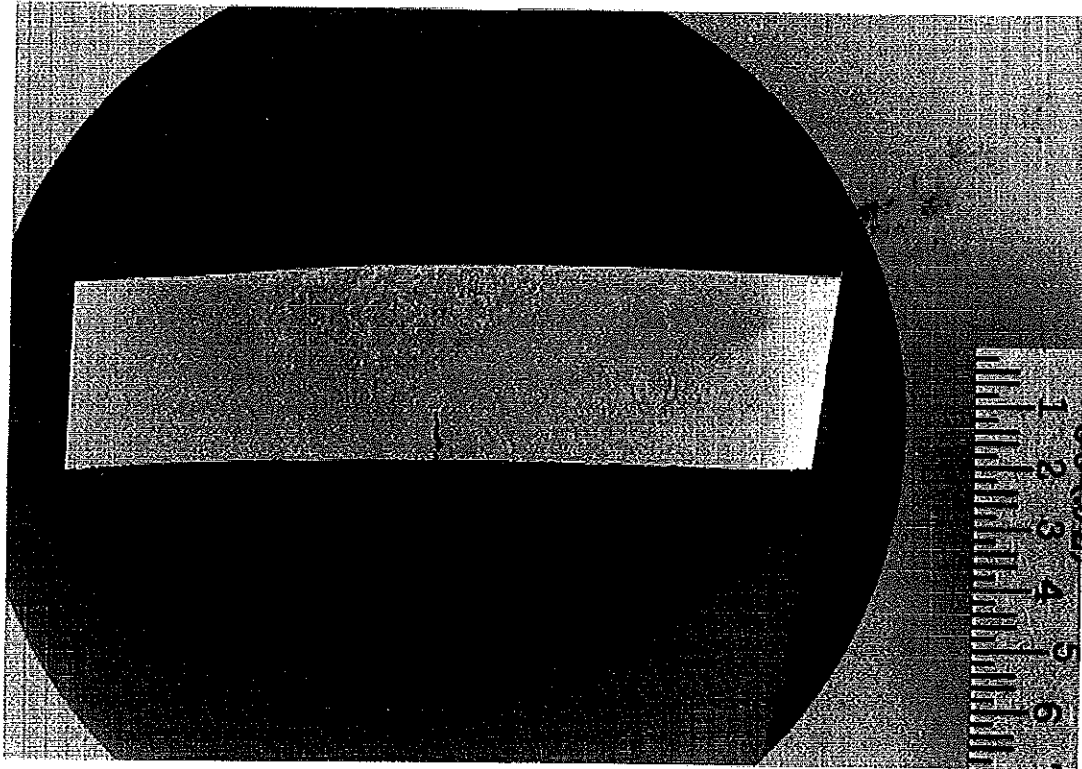
Figure 7 - Same crack as shown in Figure 6, except in the transition region of the belled area. The COD is noticeably smaller than that shown in Figure 6. Magnification is 3.7X.

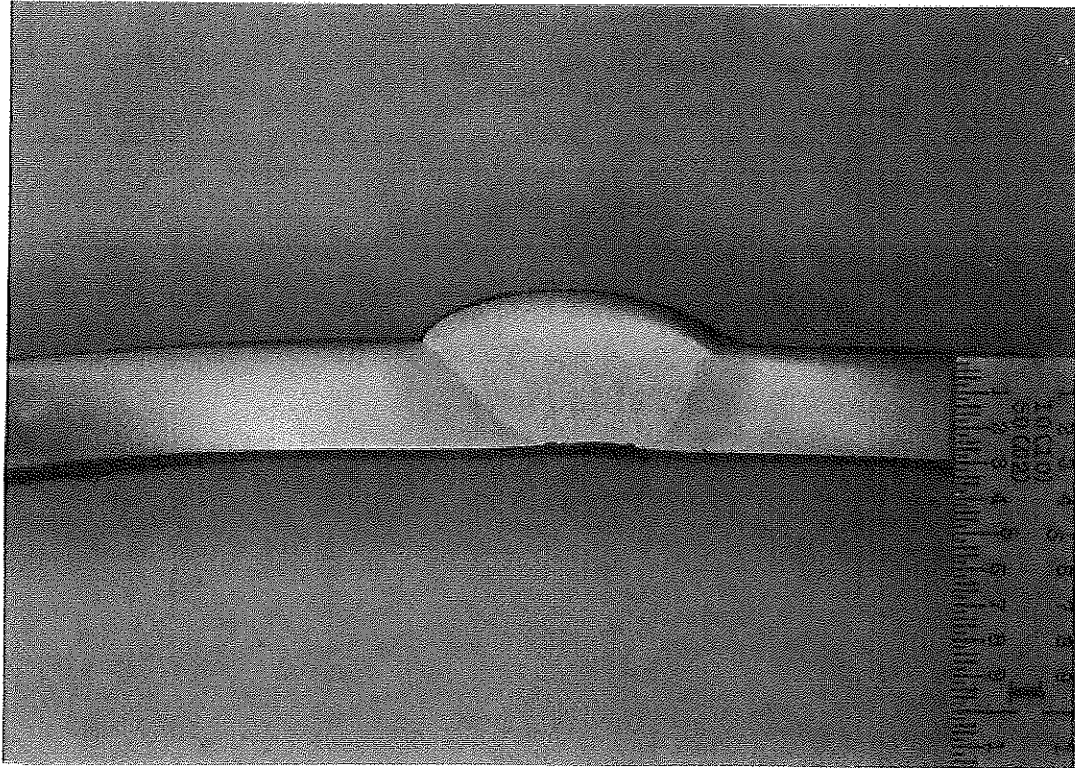
A typical unrepaired seam weld is shown in Figure 8. Note that this seam was made with a single pass submerged arc weld. Based on our experience this is typical construction practice. The photomicrographs in Figure 2 through Figure 7 show that both of these seam welds differ from this configuration indicating they were repaired. The repairs were done with the manual shielded metal arc process, as evidenced by the coarse ripple structure on the outside surface, and the limited penetration compared to the submerged arc process. The seam weld repairs were completed before the girth weld was made because the repairs at the inside surface were found to be ground smooth to accommodate the backing ring. In considering the cost of manufacturing, it is also likely that the belled regions were made by cold expansion rather than at elevated temperature.

**Figure 8** - Typical Line 109 seam weld. The seam is usually made with a single pass submerged arc weld. Magnification is 2.1X.
