NATIONAL TRANSPORTATION SAFETY BOARD

Metallurgical Group Chairman
Factual Report

MATERIALS LABORATORY FACTUAL REPORT

Place : San Bruno, CA
Date : September 9, 2010
Vehicle : Natural Gas Transmission Pipeline
NTSB No. : DCA10MP008
Investigator : Ravi Chhatre, RPH-20

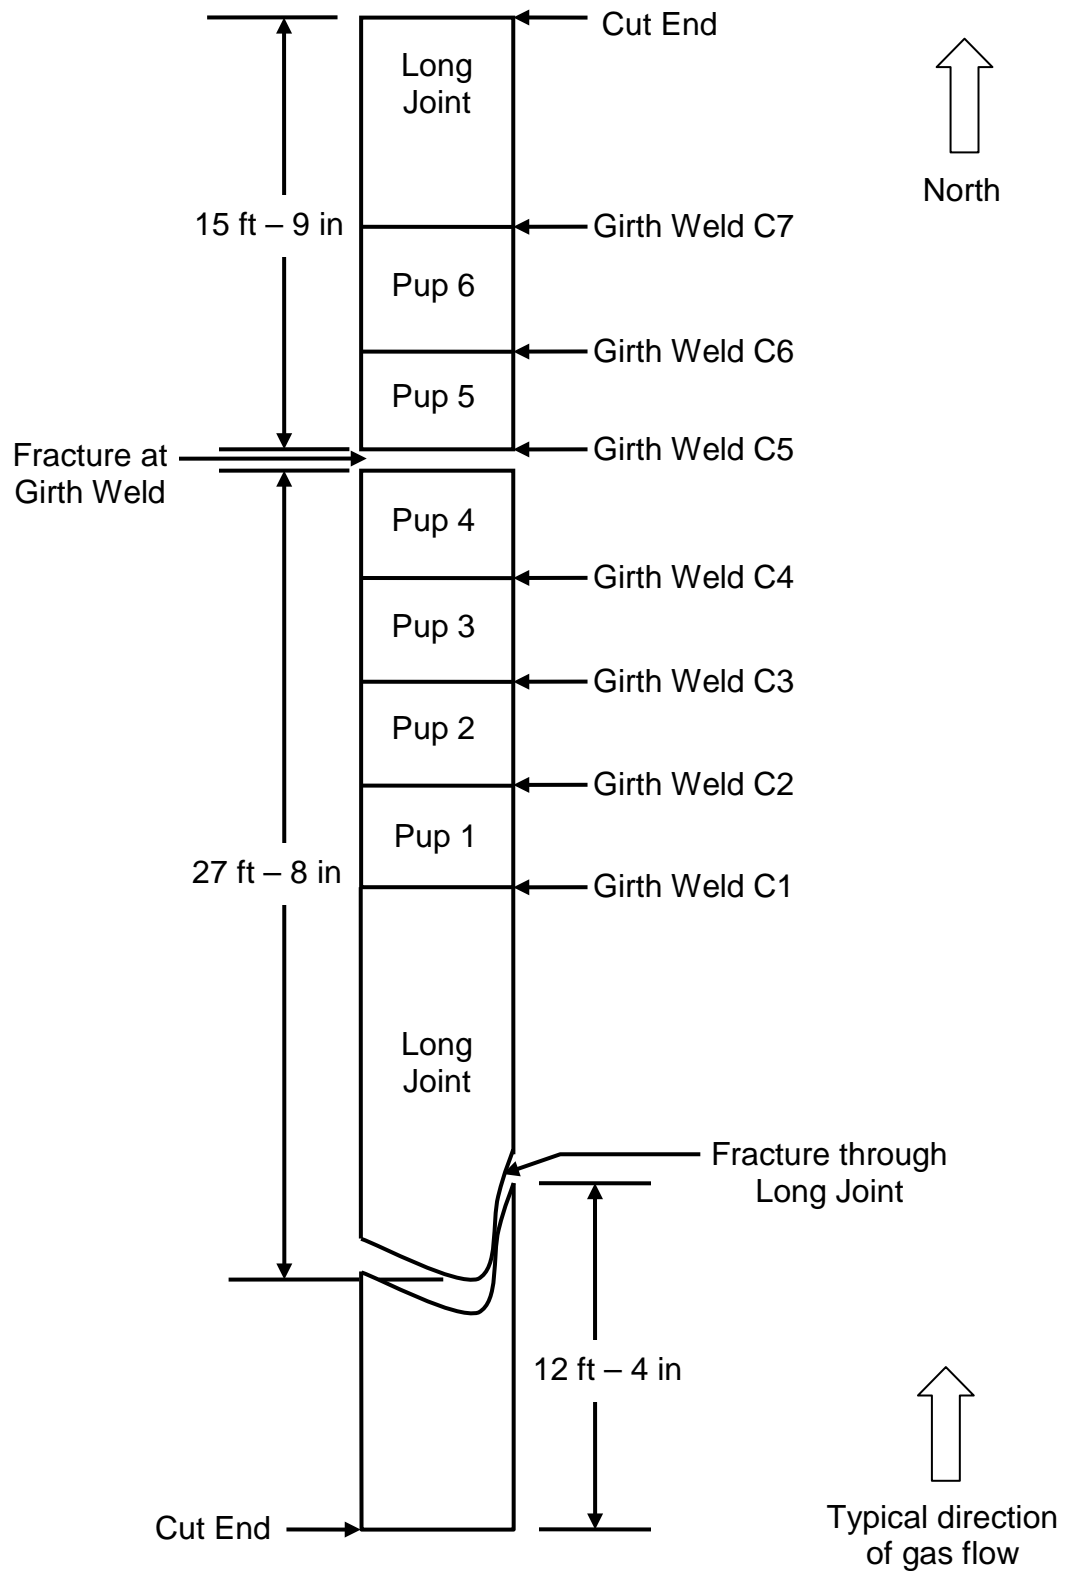
The center section had circumferential fractures at both ends. One fracture was through the long joint to the south of pup 1 as shown in figure 4. The other fracture was at the girth weld between pup 4 and pup 5 (girth weld C5 in figure 1) as shown in figures 3 and 6. There was a longitudinal fracture in pup 1 that continued in the long joint south of pup 1 to the circumferential fracture at the south end of the center section, visible in figure 3. There were circumferential fractures in girth weld C2 between pup 1 and pup 2 on both sides of the pup 1 longitudinal fracture as shown in figures 7a and b. In the counterclockwise direction, the circumferential fracture measured 27 inch (Note: Clockwise and counterclockwise directions are assigned as a rotation about the longitudinal axis of the pipeline looking north). At the end of the fracture there was a 10 inch diameter circular depression in the pipe. In the clockwise direction, the circumferential fracture measured 6.25 inch, at which point it intersected with a longitudinal fracture in pup 2 as shown in figure 7b. The longitudinal fracture in pup 2 extended 29.25 inch from girth weld C2 at which point it branched in two, visible in figure 7a and 7c. One branch continued in the longitudinal direction to within 3 inch of girth weld C3 (Note: This was only visible after removal of the coating as shown in figure 7c). The other branch was angled 66° to the longitudinal direction and measured 18 inch. The circumferential fracture at the north end of the center section deviated from girth weld C5 along a 3.5 inch circumferential length up to 1 inch longitudinally in pup 4 at the location shown in figure 6.

Figure 1: Schematic of pipe showing location of girth welds and fractures. Longitudinal fracture not depicted.

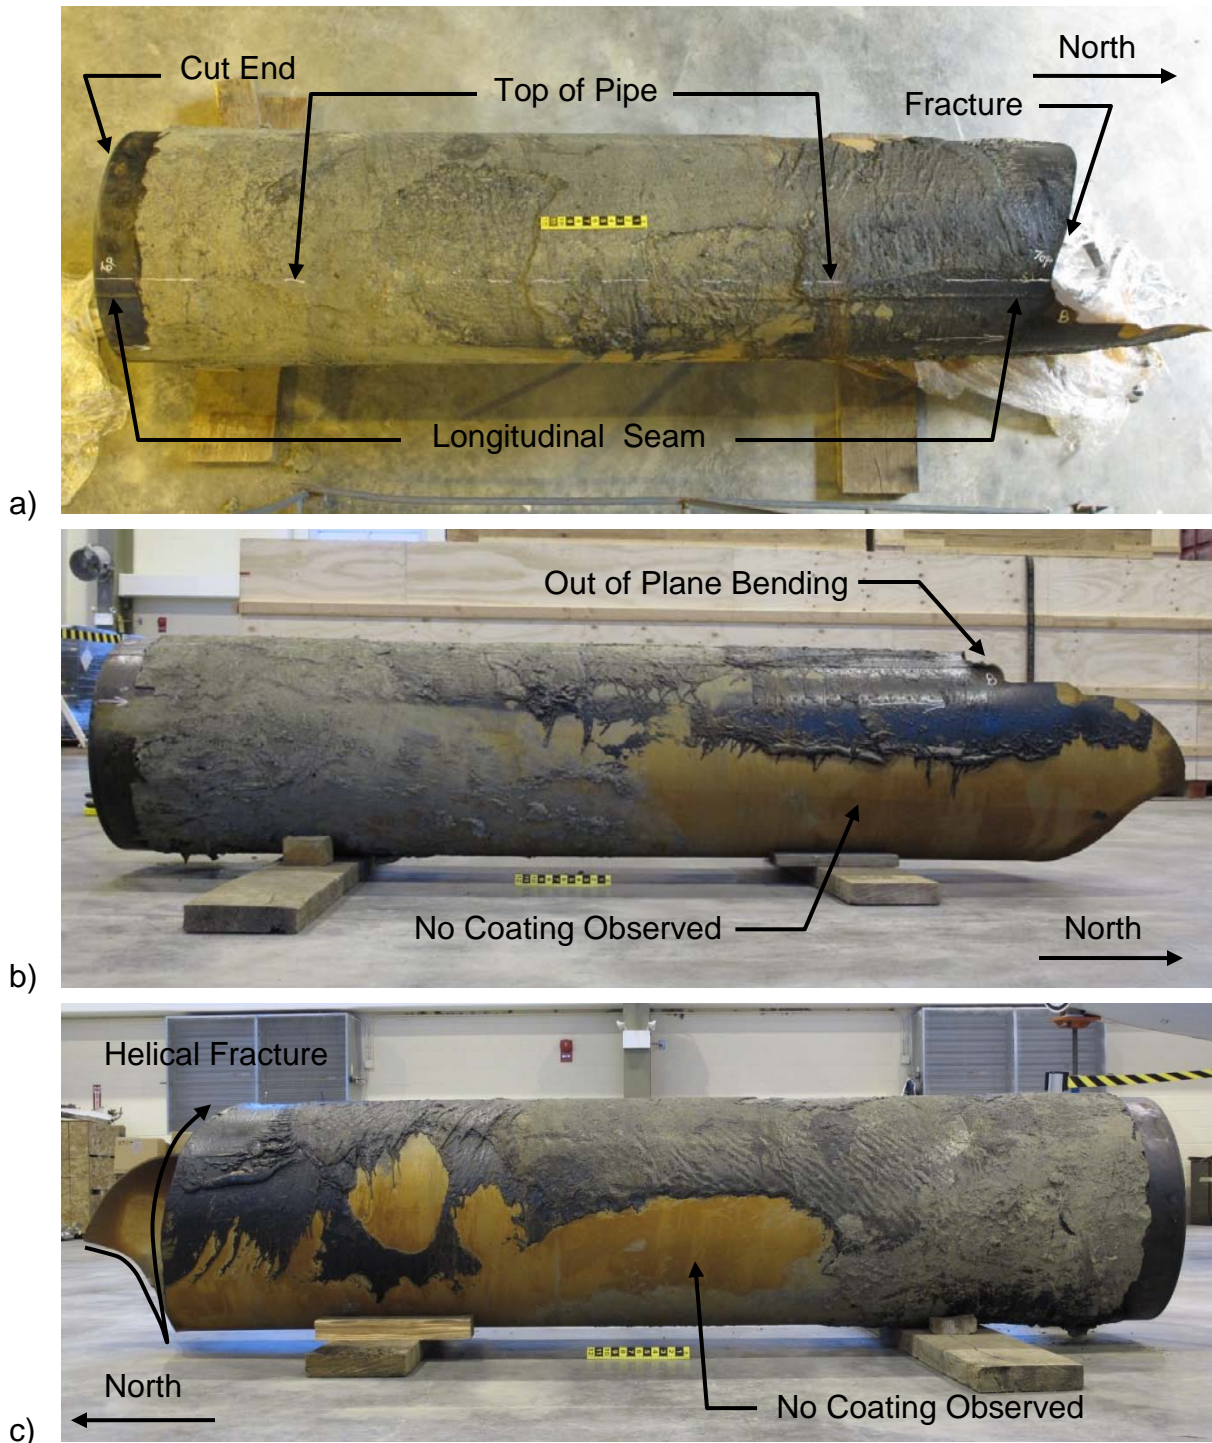
The southern section had a helical fracture at its north end as shown in figure 2c. Out of plane bending was observed along a 5 inch length along the top of the pipe, consistent with the point of final fracture. The bending deformation started at the longitudinal seam as shown in figures 2b and 8 and continued north and clockwise from this point. The fracture ran along the west side of the seam for approximately 1.5 inch, transitioned across the seam and continued on the east side of the seam. A circumferential crack was observed from the inside of the pipe where the main fracture intersected the seam. The crack propagated through the seam and continued for approximately 1.25 inch along the east side of the seam.

Figure 2: Southern section of pipe as received; a) Top side of pipe; b) East side of pipe; c) West side of pipe.

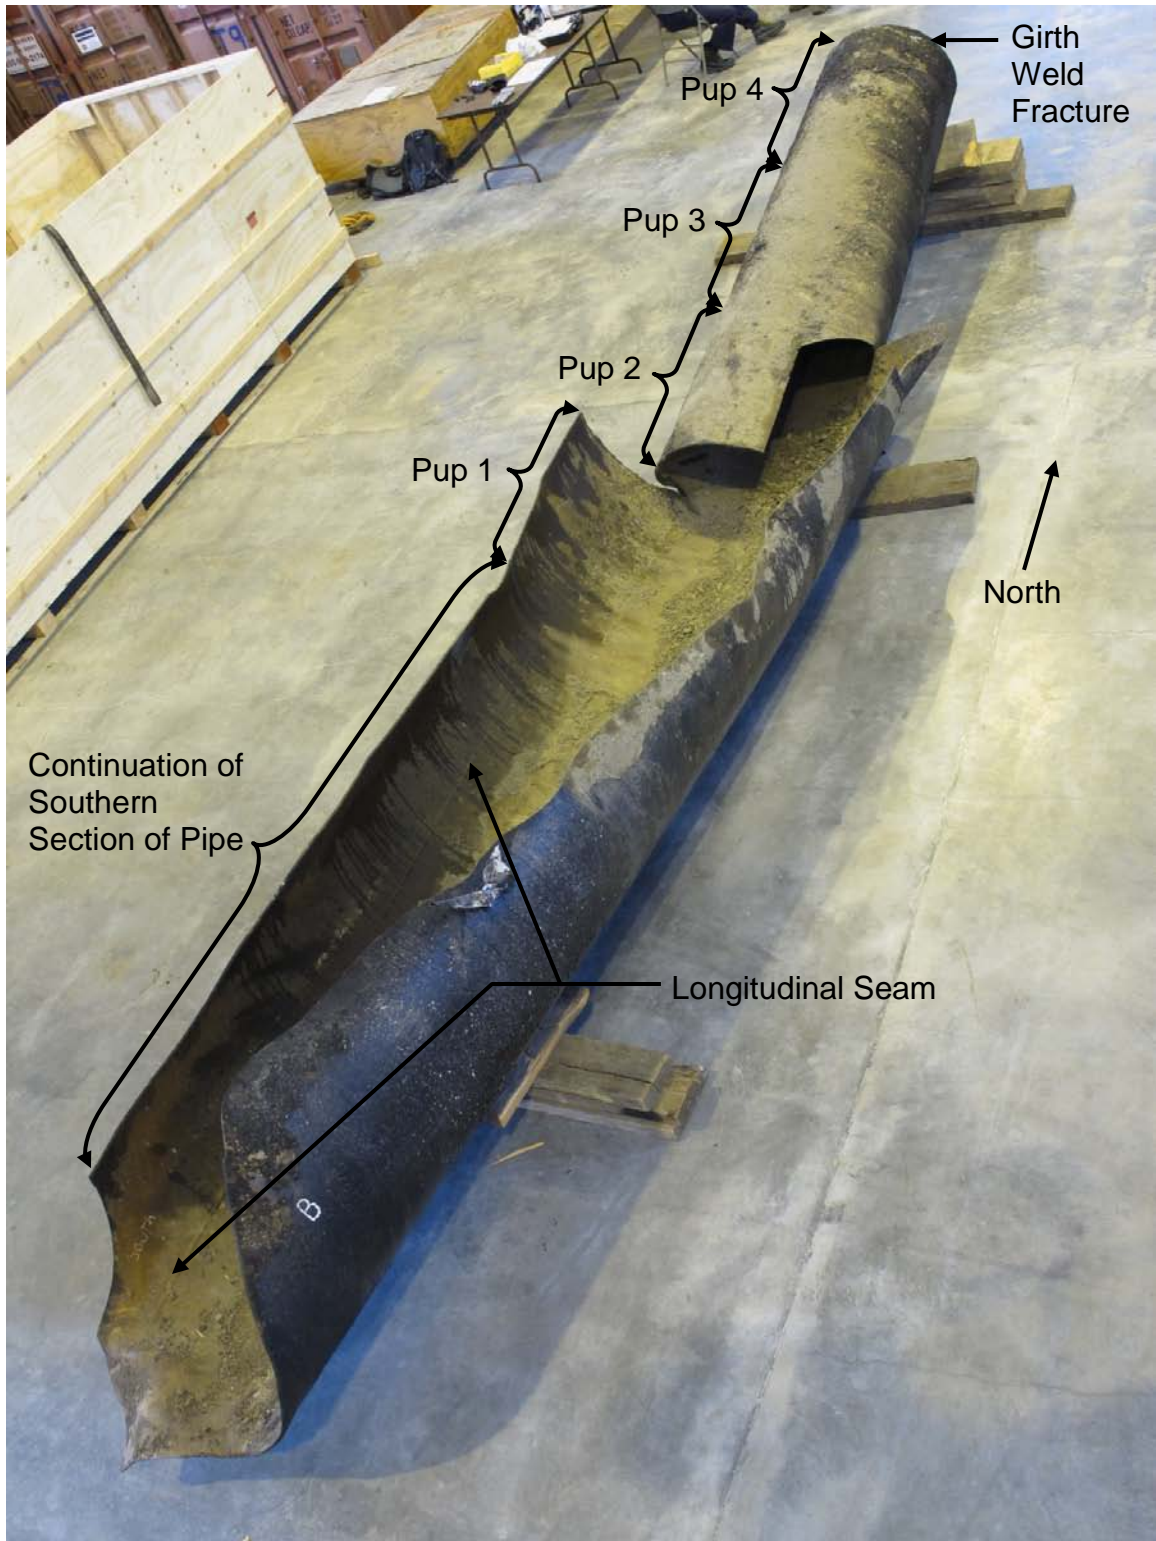
Figure 3: Center section of pipe.

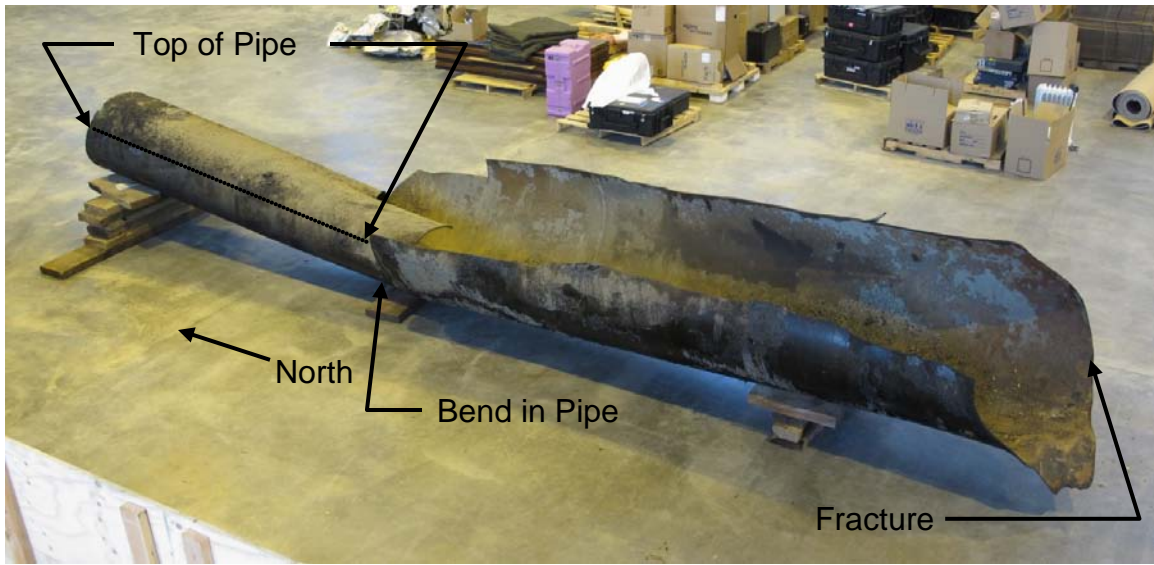
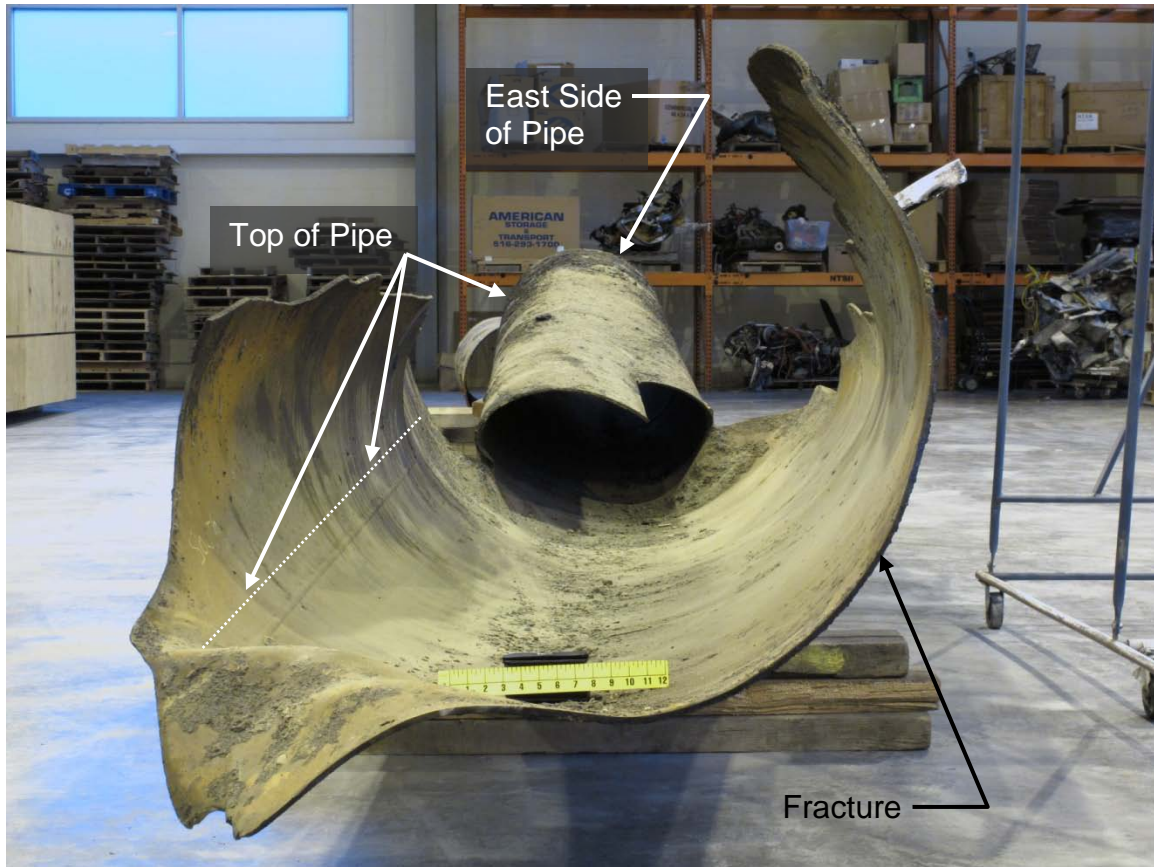
There was a 10° deformation bend in the pipe in the vicinity of pup 2 that caused the section to lie partly on its western side as shown in figure 4. The pipe showed continuously varying ovalization from pup 2 through pup 4, visible in figure 6. The minor radius, measured from inner wall to inner wall varied from 16.0 inch at the south end of pup 2 to 26.2 inch at the north end of pup 4. By comparison, the inner radius of an undeformed nominal 30 inch diameter 0.375 inch wall pipe is 29.2 inch. The southern and northern sections each had a fractured end that mated with one of the fractures on the center section. The true top of the center section was located by mating fracture features and

Figure 4: Center section of pipe; a) Orientation of the “true” top of the pipe at the north end; b) Orientation of the true top of the pipe and the east side of the pipe viewed along an axial direction.

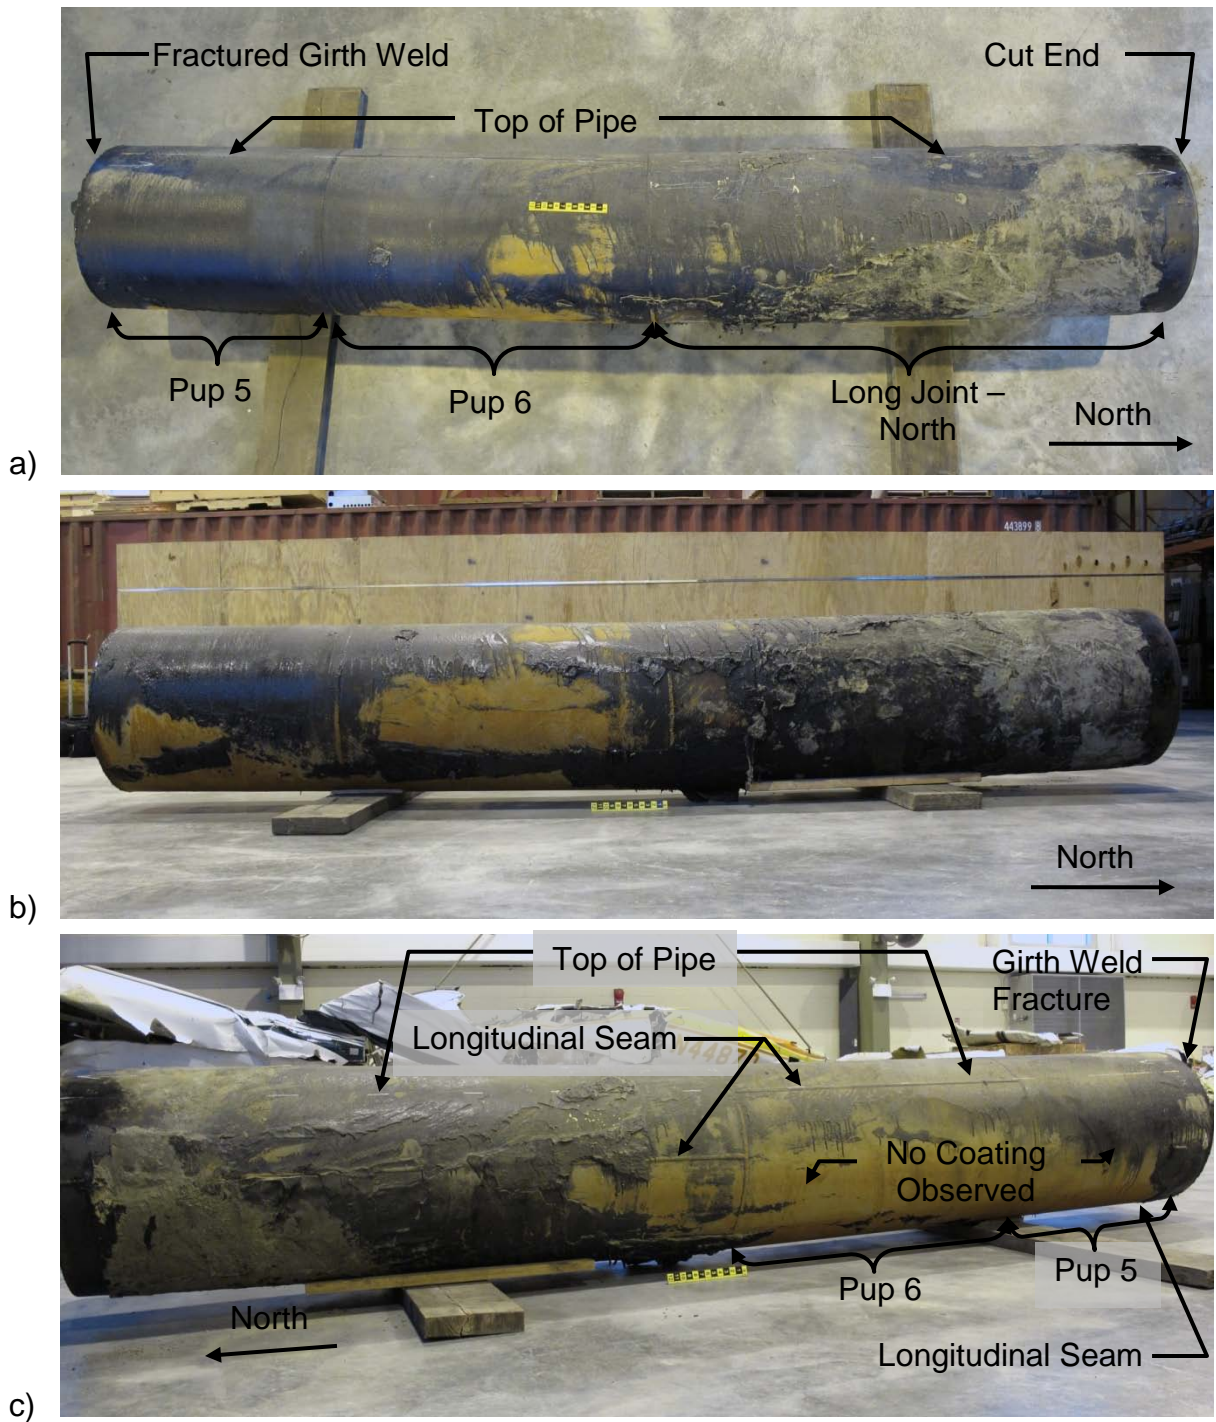
Figure 5: Northern section of pipe as received; a) Top side of pipe; b) East side of pipe; c) West side of pipe.

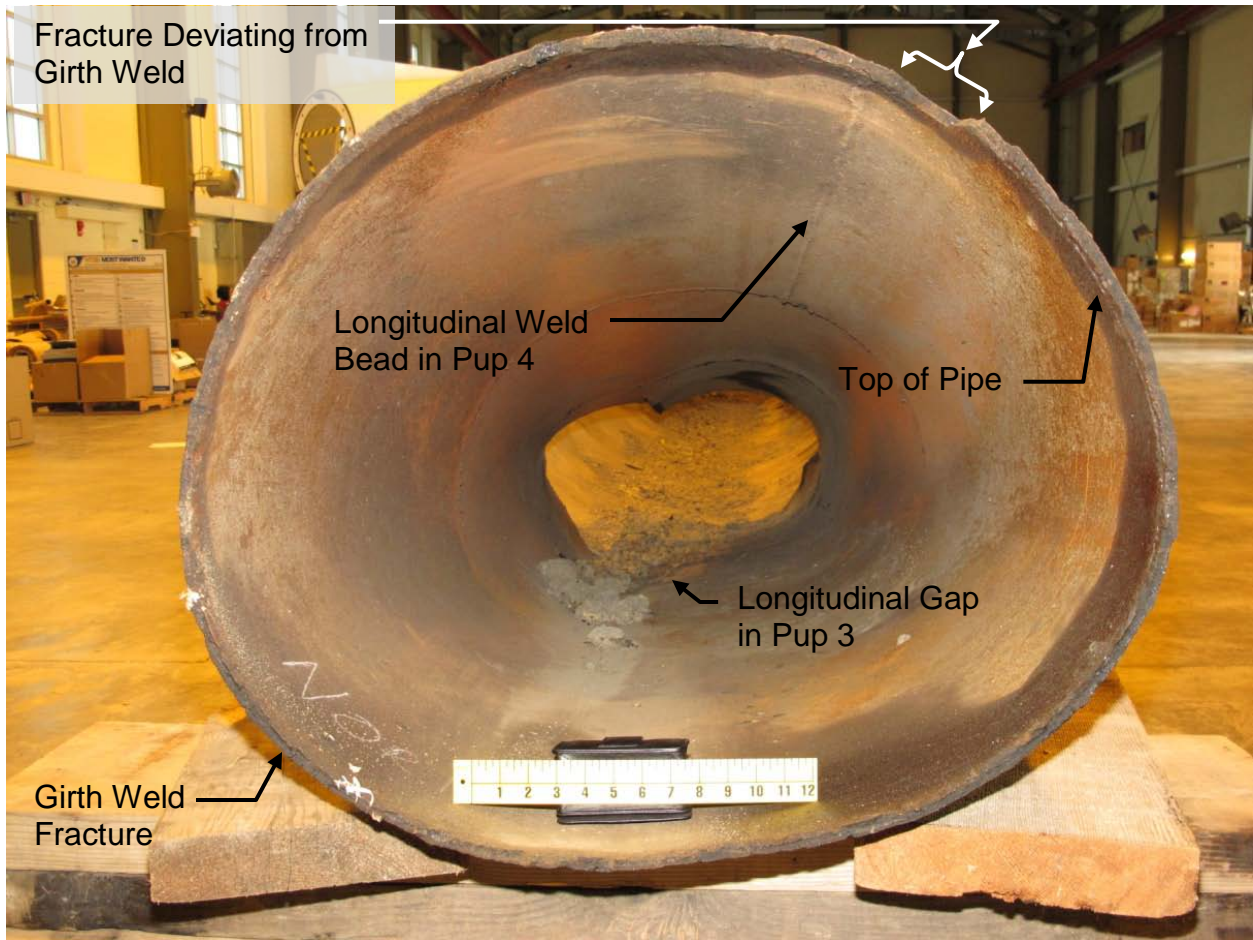
Figure 6: Fracture through the girth weld between pup 4 and pup 5 at the north end of the center section. The view is looking south. Pup 3 and pup 2 are also visible.

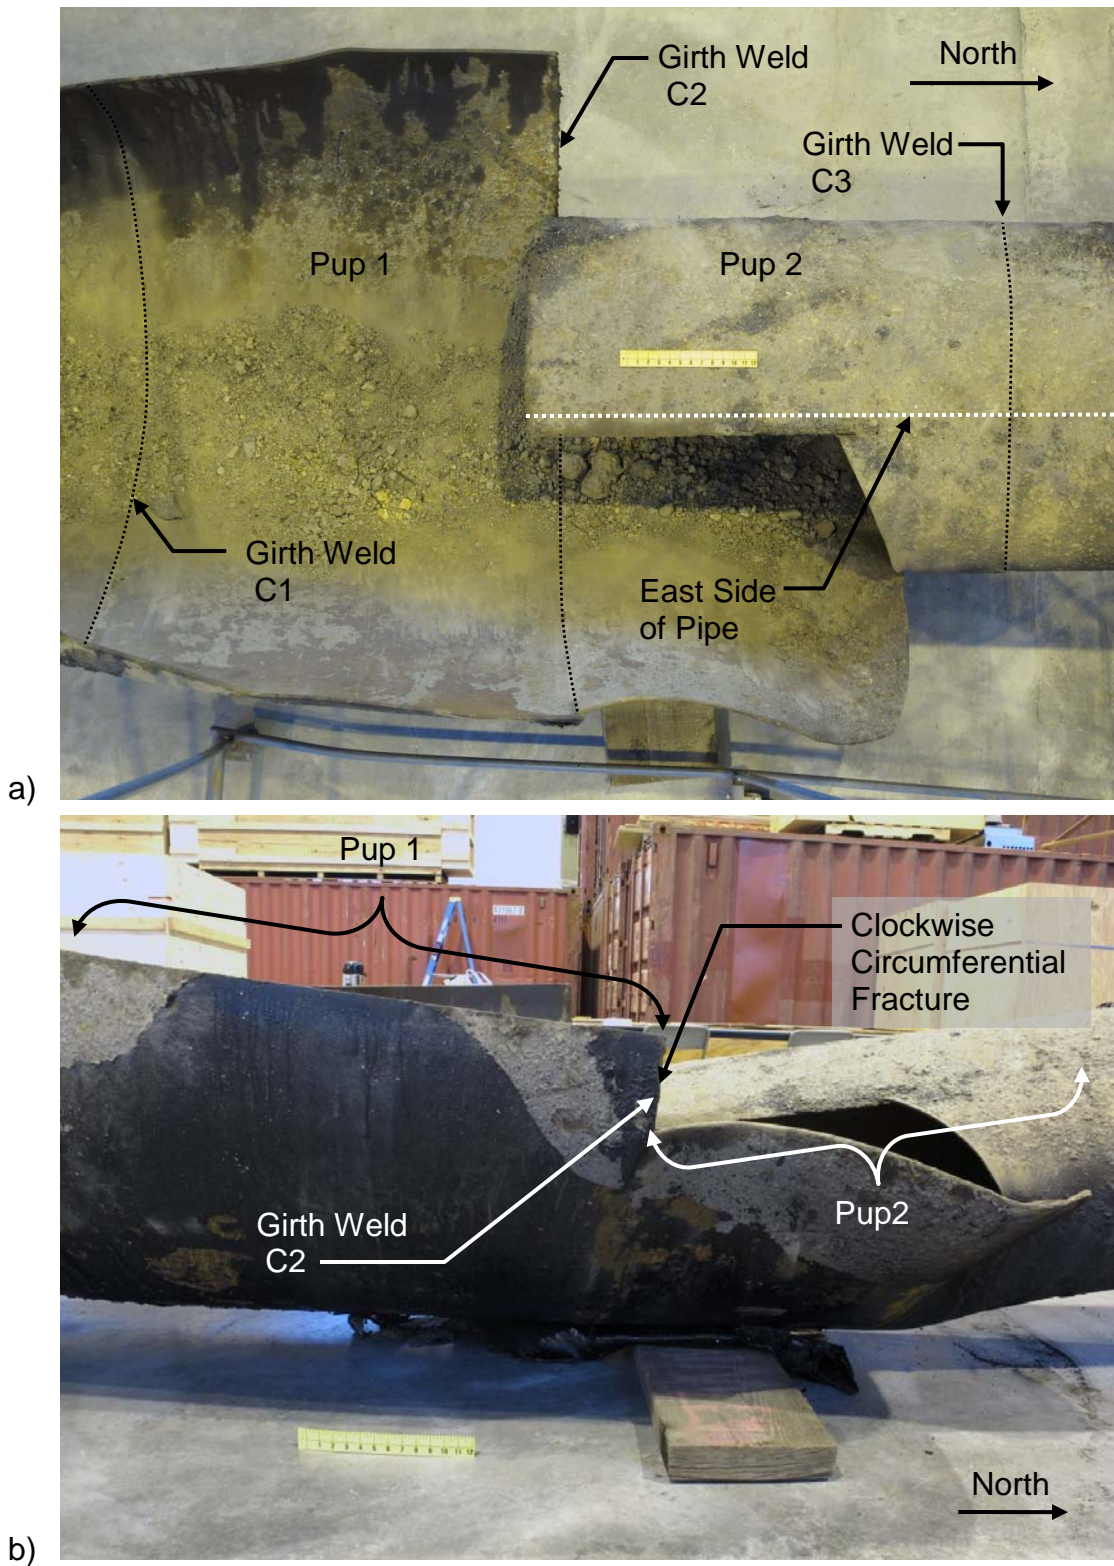
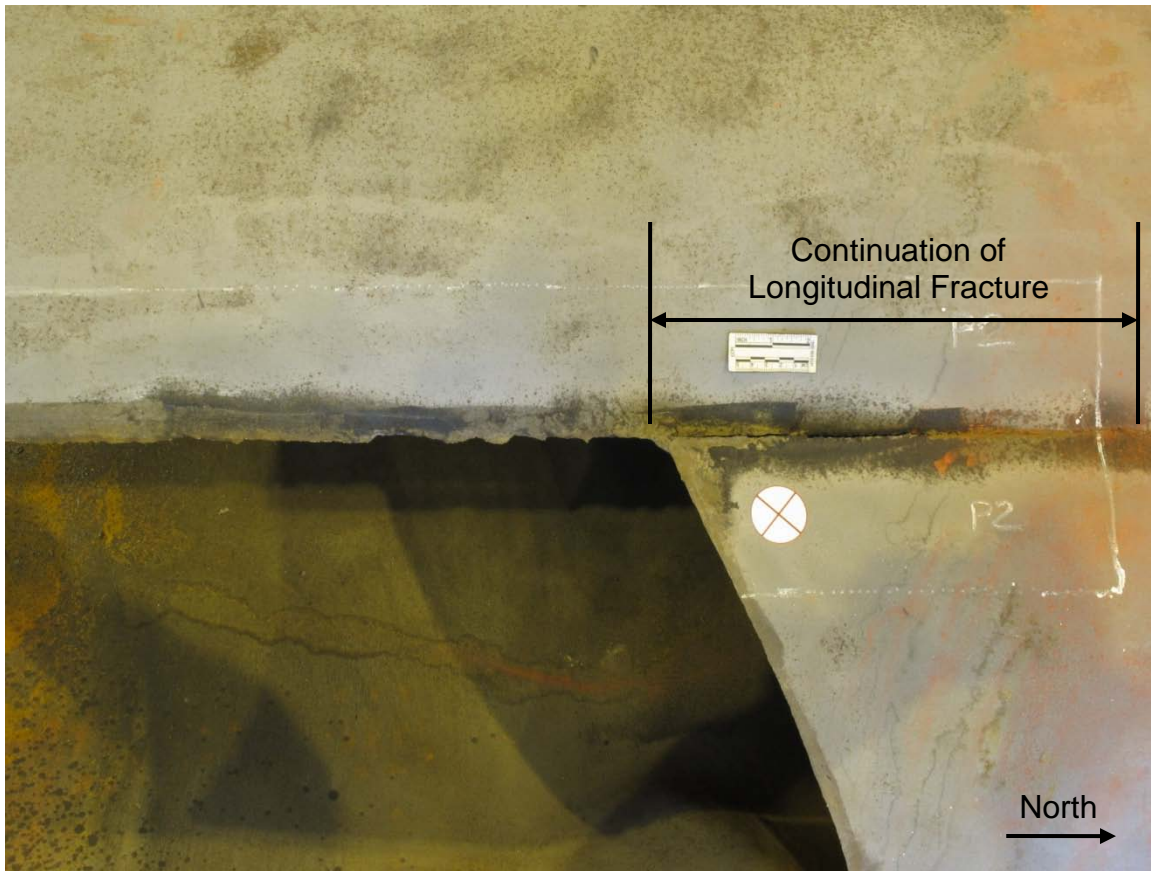
Figure 7: The longitudinal and circumferential fractures in pup 1 and pup 2; a) overhead view of the east side of the pipe; b) side view of east and bottom sides of the pipe.

Figure 7 (cont.): c) Continuation of the longitudinal fracture in pup 2 past the branching point was visible after removal of the coating.

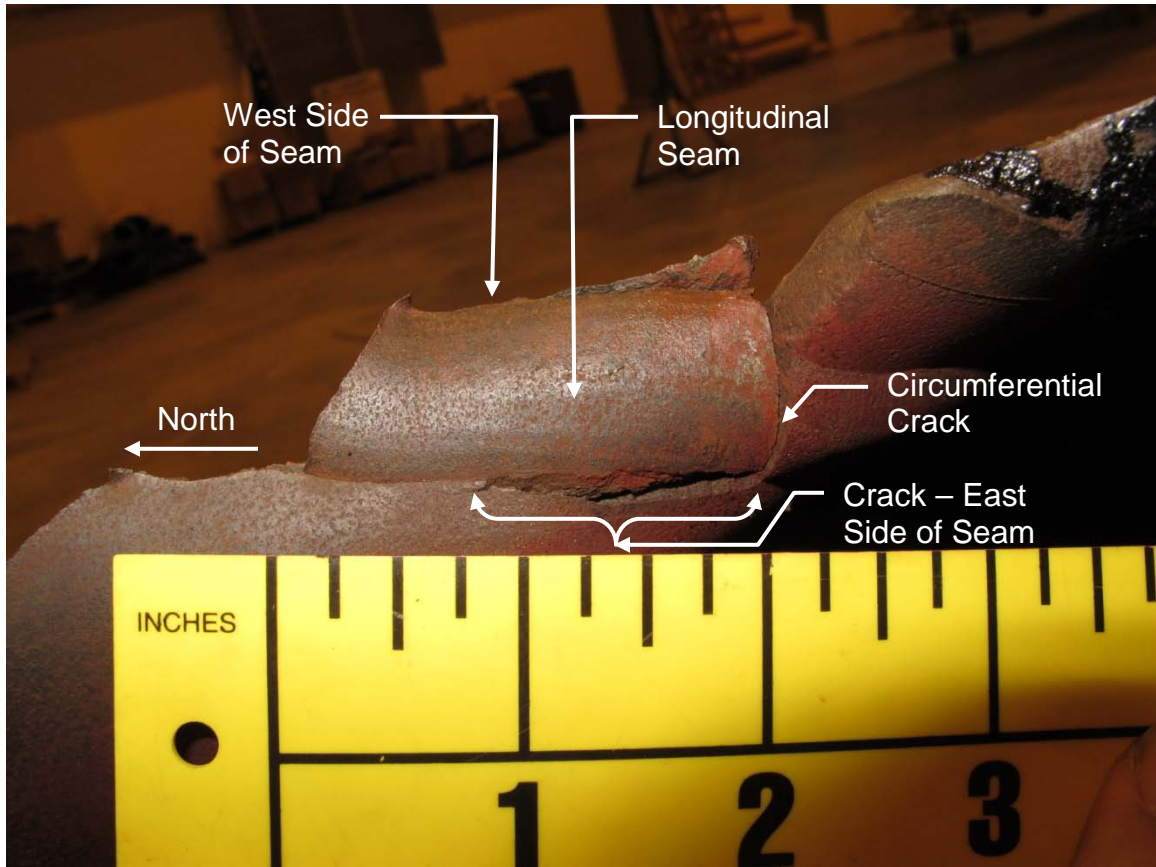
Figure 8: Fracture, a crack, and out of plane bending at a longitudinal seam on the southern section.

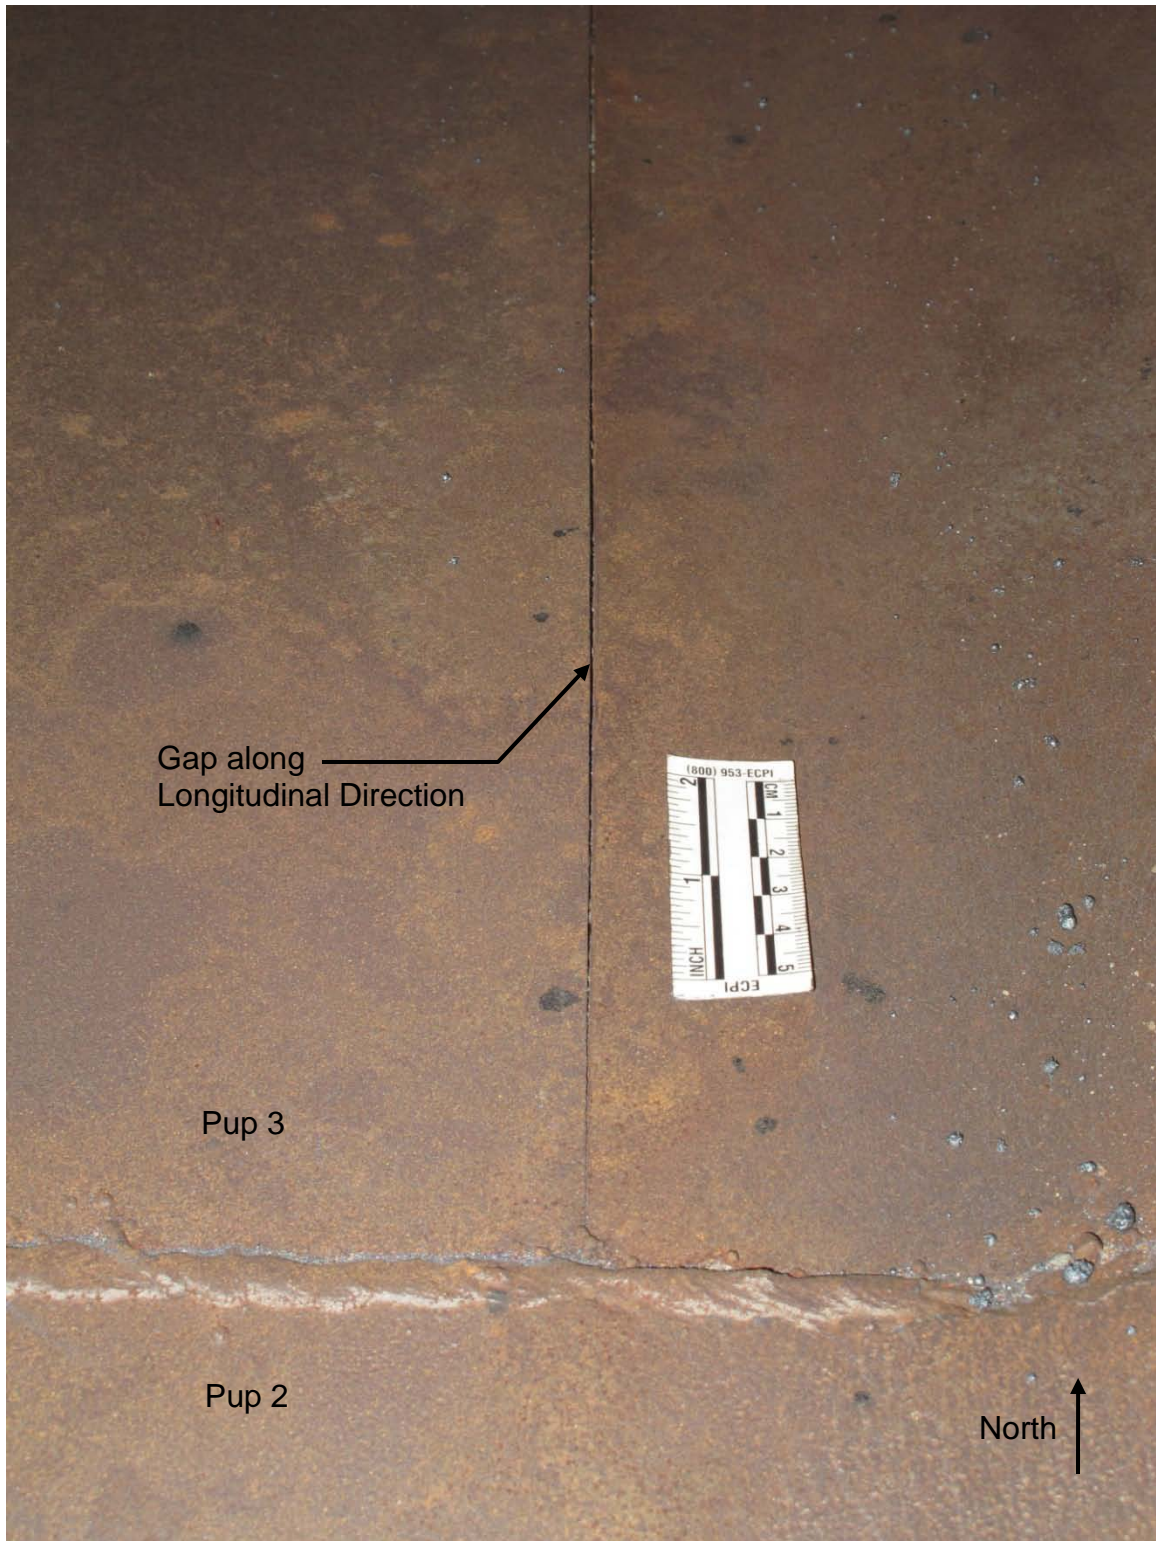
Figure 9: Inside wall of pup 3 showing a longitudinal gap that extended the length of the pup.

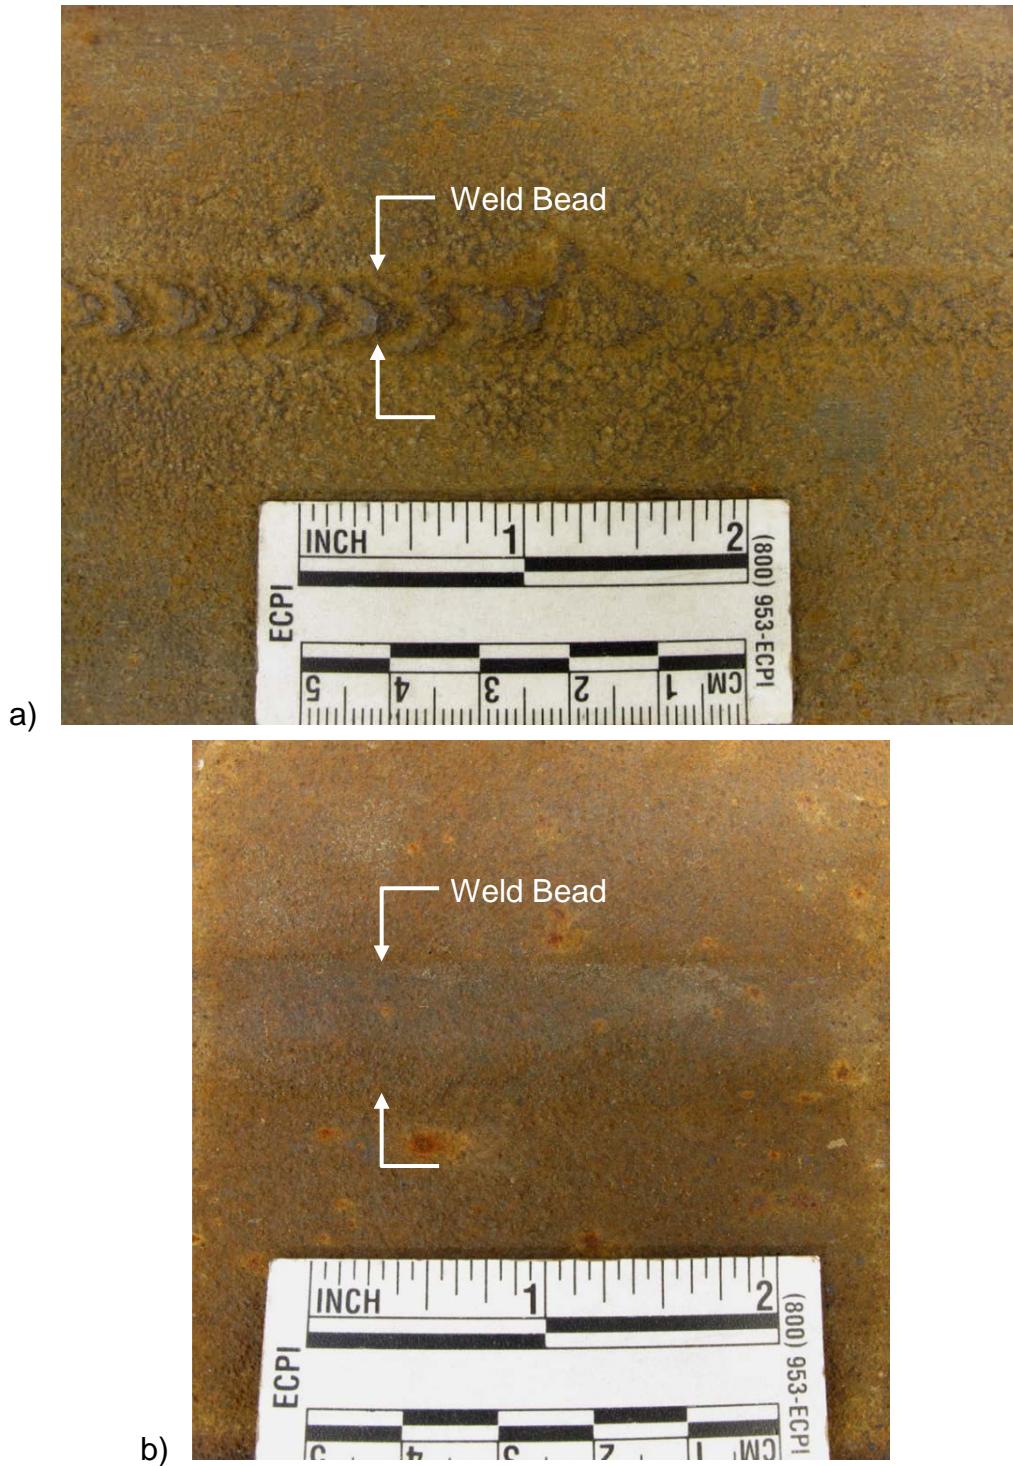
Figure 10: a) Longitudinal weld bead observed on the inside of pup 5; b) Longitudinal weld bead observed on the inside of pup 6.

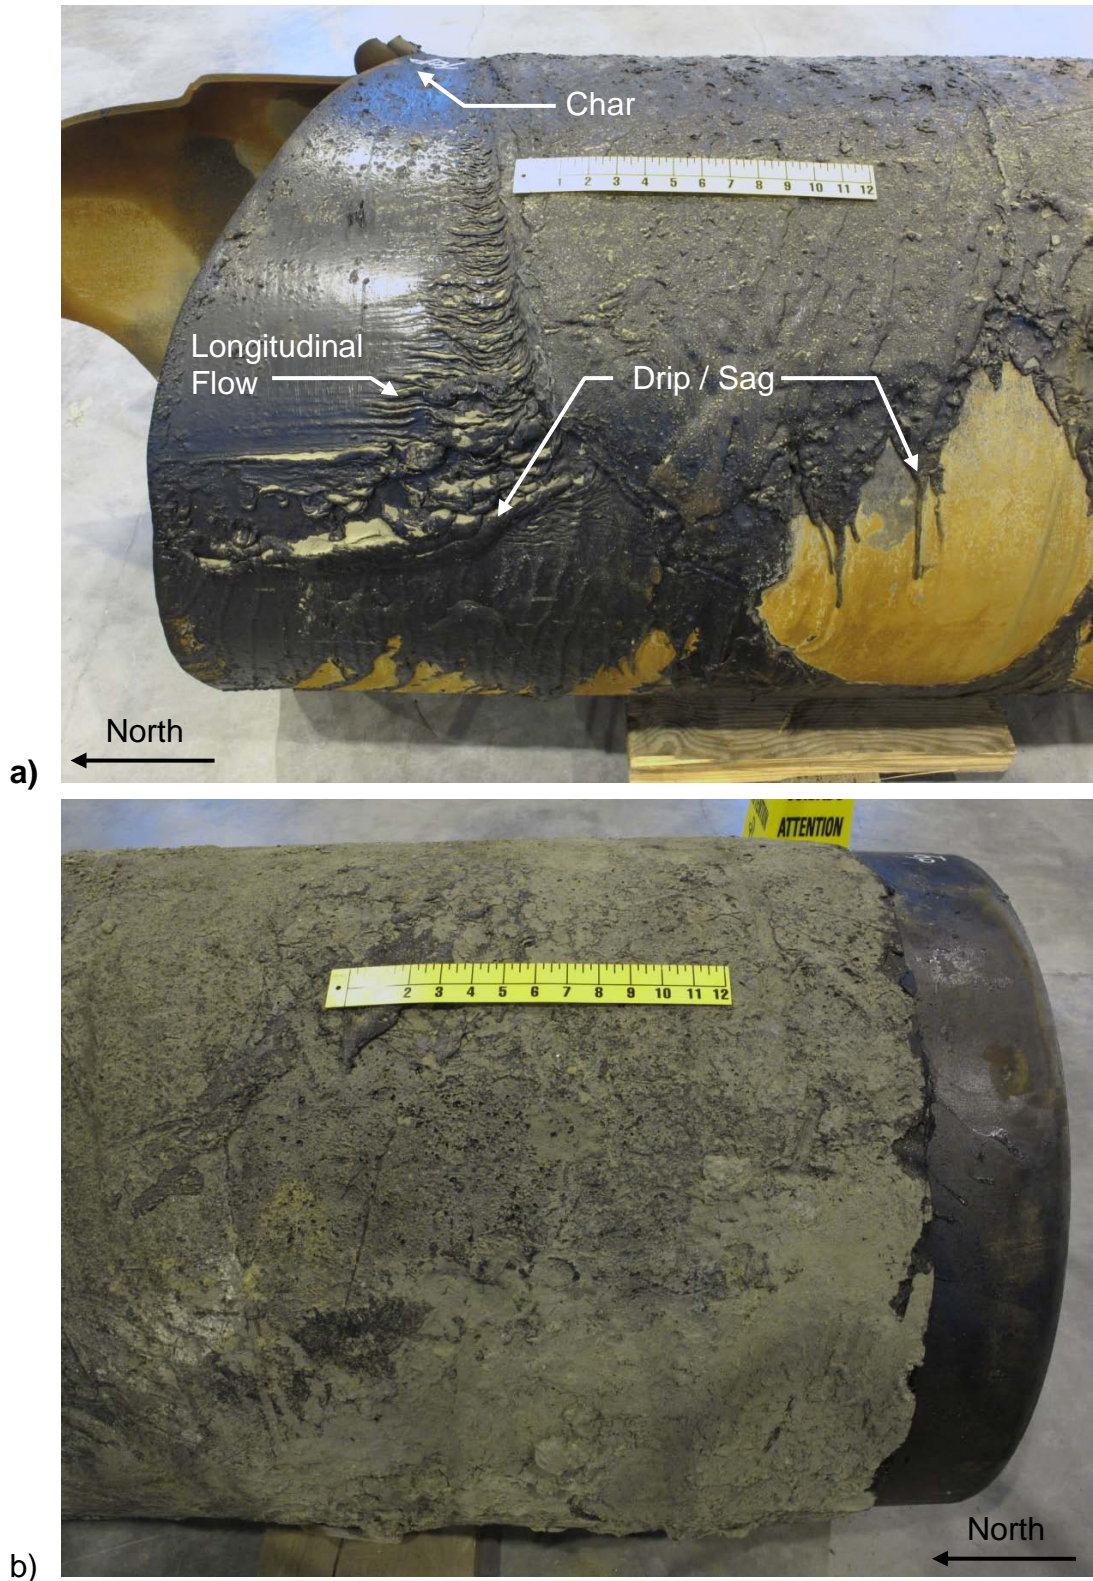
The appearance of the pipe coating was consistent with hot applied asphalt, parts of which had been exposed to elevated temperatures. Examples of the coating condition on the southern sections are shown in figures 2 and 11. No coating was observed on the bottom half of the pipe starting 3 foot – 4 inch from the cut end and continuing to the fractured end. The visible pipe surface was an orange color. The coating on the top half of the pipe close to the fracture exhibited features consistent with drips, sags, and charring as shown in figure 11a. The coating flow patterns were complex with longitudinal and circumferential flow occurring in different regions. Close to the cut end, the coating features were more consistent with as-applied asphalt as shown in figure 11b. No coating was observed on much of the sides and bottom of the northern section as shown in figure 5c. Much of the visible pipe surface was an orange color. Along the top close to the fracture (pup 5) the surface was black and had a slight gloss as shown in figure 12a. Moving away from the fracture, drip marks were observed along the top of pup 6 (not shown). Toward the cut end, the sides and bottom showed little to no indications of heat exposure as shown in figure 12b. The coating on the top and sides of the center section (in its resting position and not as installed) had either a charred or glossy appearance in various locations as shown in figure 13. In some locations, the coating appeared to be comingled with soil. On the underside of the pipe (in its resting position) between pup 1 and pup 2 there was a partially attached piece of coating approximately 32 inch in length, the start of which is indicated by an arrow in figure 13a. There was also an approximately 18 inch wide strip of coating attached to the underside running from pup 1 and continuing south to within 6 foot of the southern fracture, the start of which is also indicated in figure 13a. There were also regions on the underside where no coating was observed and the pipe surface was visible. One region on pup 4 near the girth weld fracture is shown in figure 14a. The region was approximately 12.5 inch at its longest and 6 inch at its widest. The visible pipe surface had an orange/brown appearance. A second region from the underside of the long joint south of

Figure 11: Condition of the asphalt coating on the southern section; a) Adjacent to the circumferential fracture; b) Away from the fracture close to the cut end.

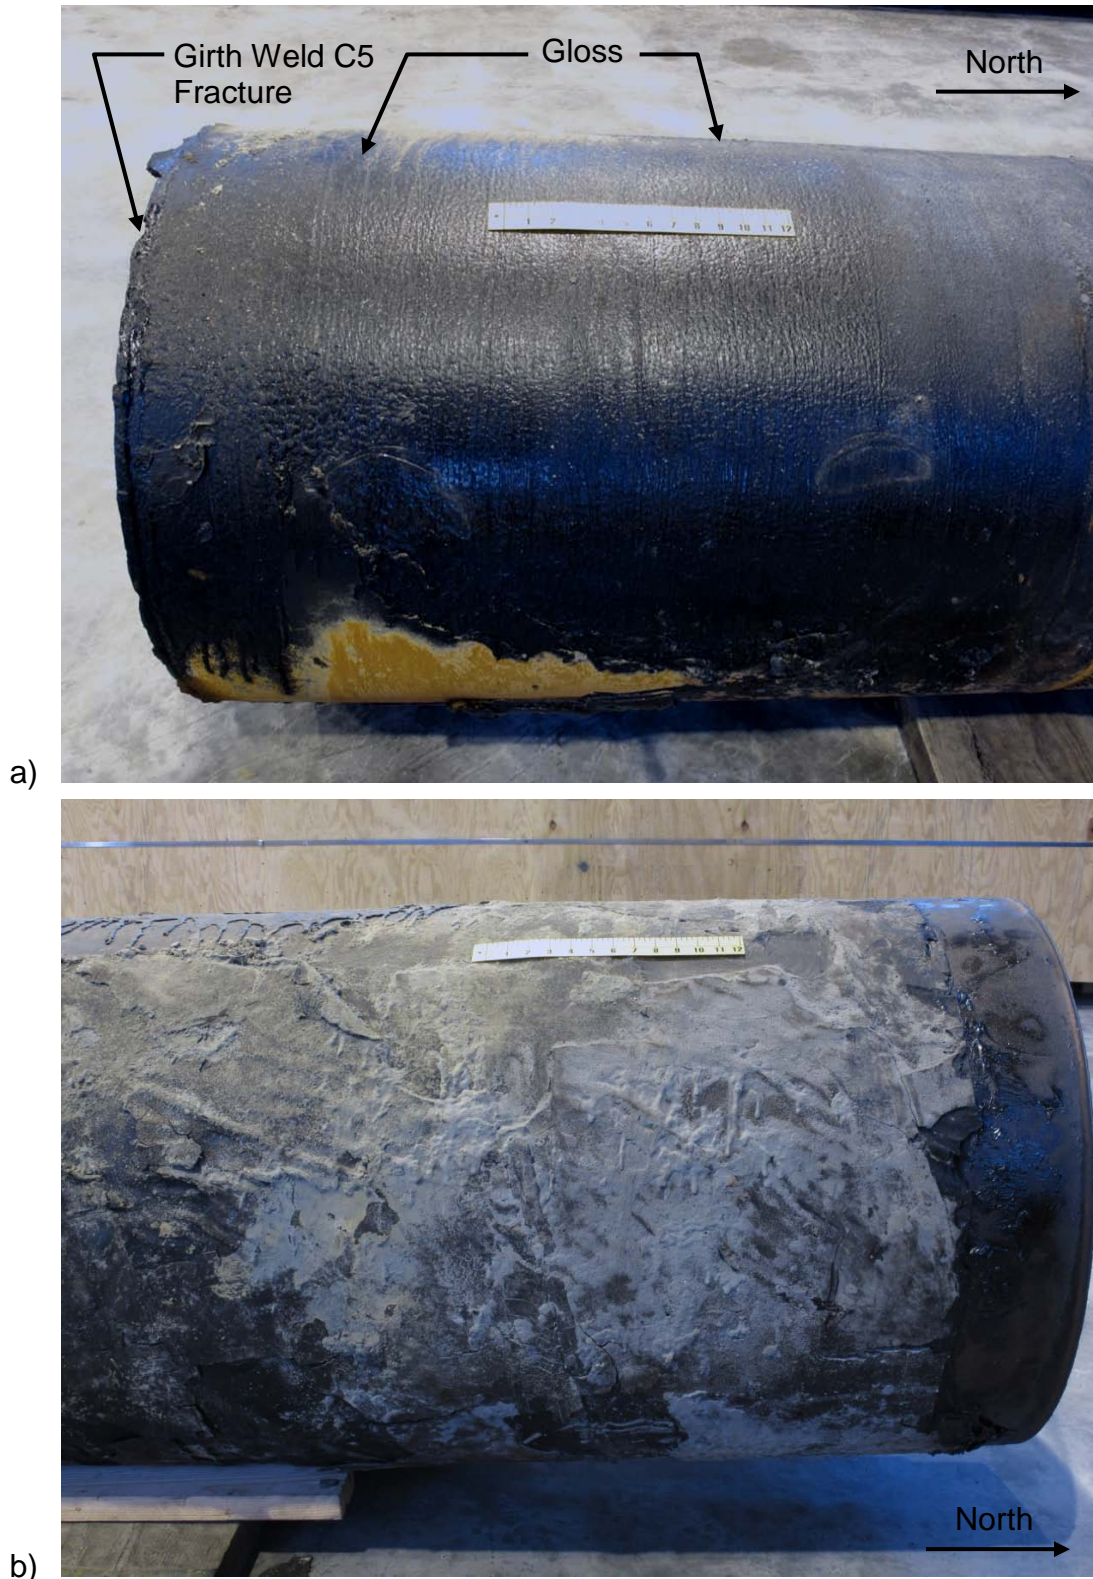
Figure 12: Condition of the asphalt coating on the northern section; a) Top of pup 5 adjacent to the girth weld fracture; b) Away from the fracture close to the cut end.
