NATIONAL TRANSPORTATION SAFETY BOARD

Metallurgical Group Chairman
Factual Report

MATERIALS LABORATORY FACTUAL REPORT

Place : San Bruno, CA
Date : September 9, 2010
Vehicle : Natural Gas Transmission Pipeline
NTSB No. : DCA10MP008
Investigator : Ravi Chhatre, RPH-20

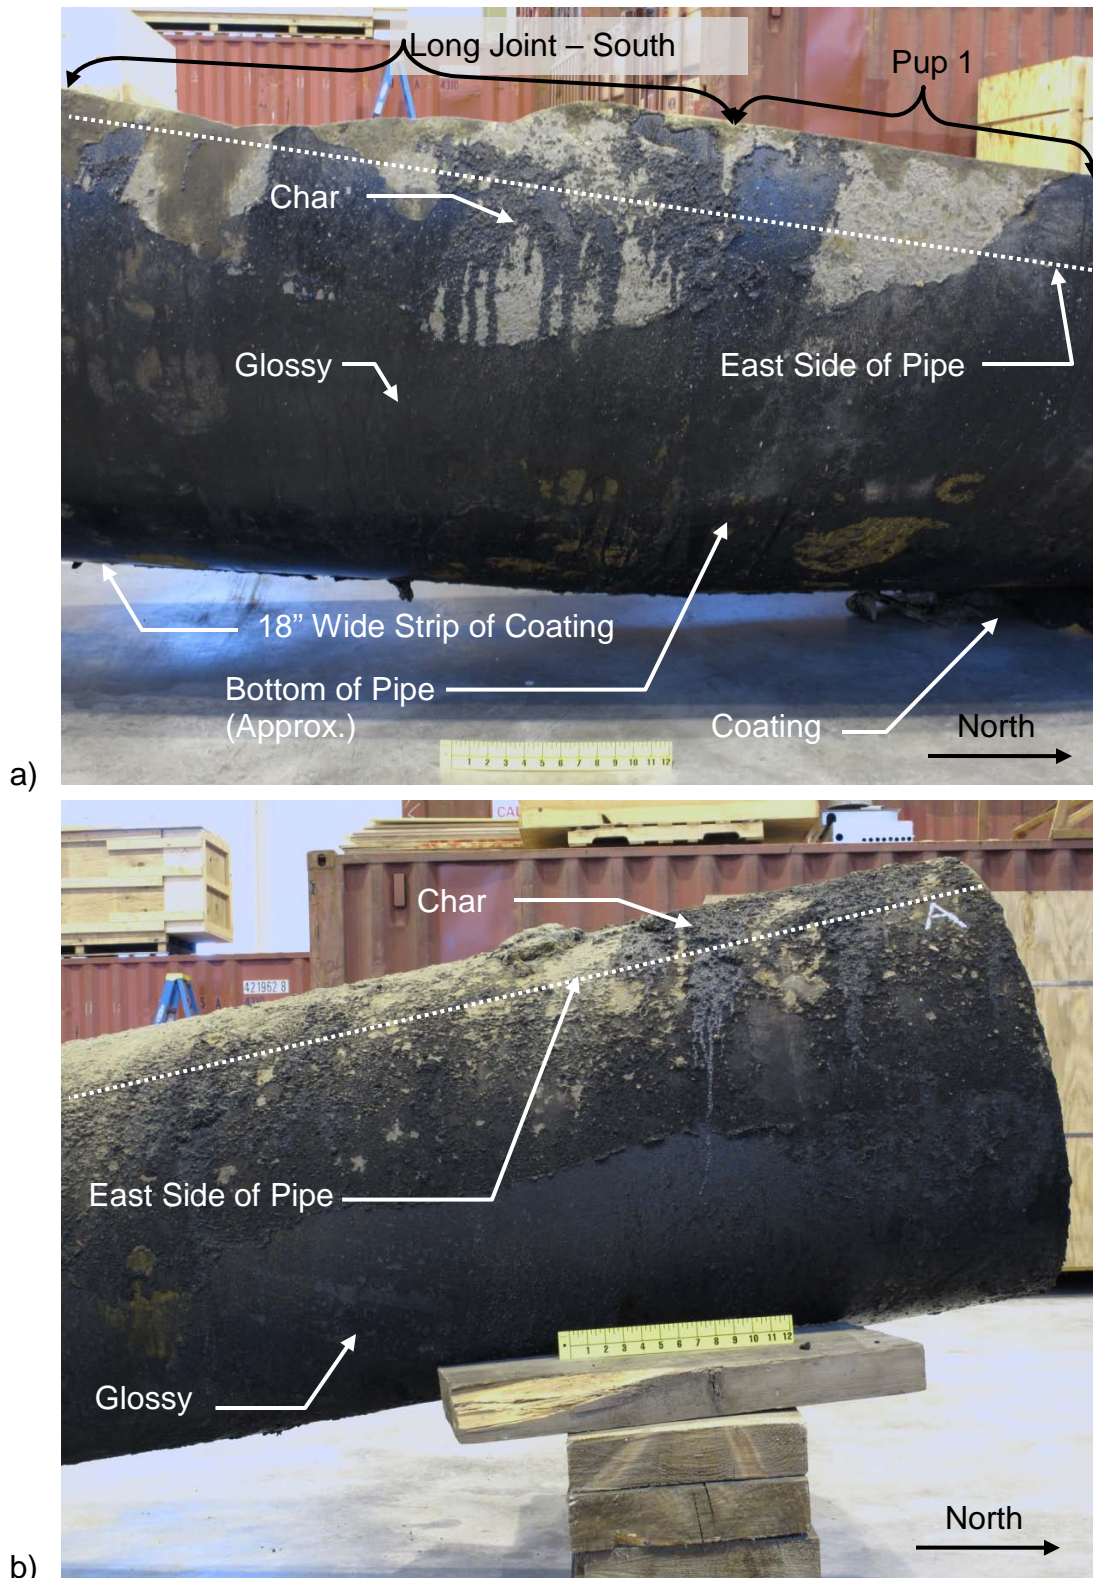
Figure 13: Condition of the asphalt coating on the center section; a) East side / bottom of long joint and pup 1; b) East side / bottom of pup 4 adjacent to girth weld fracture.

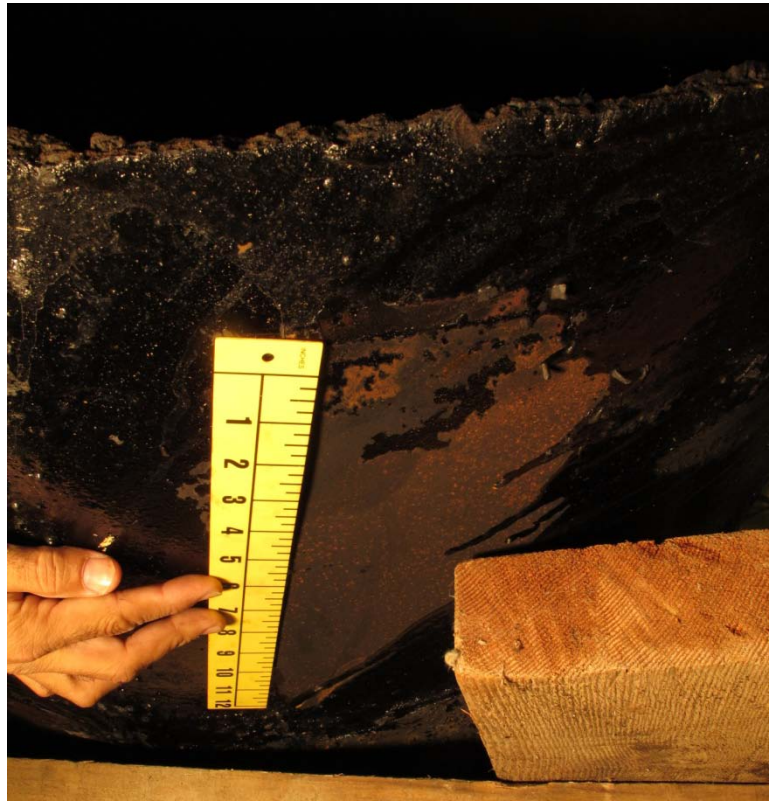
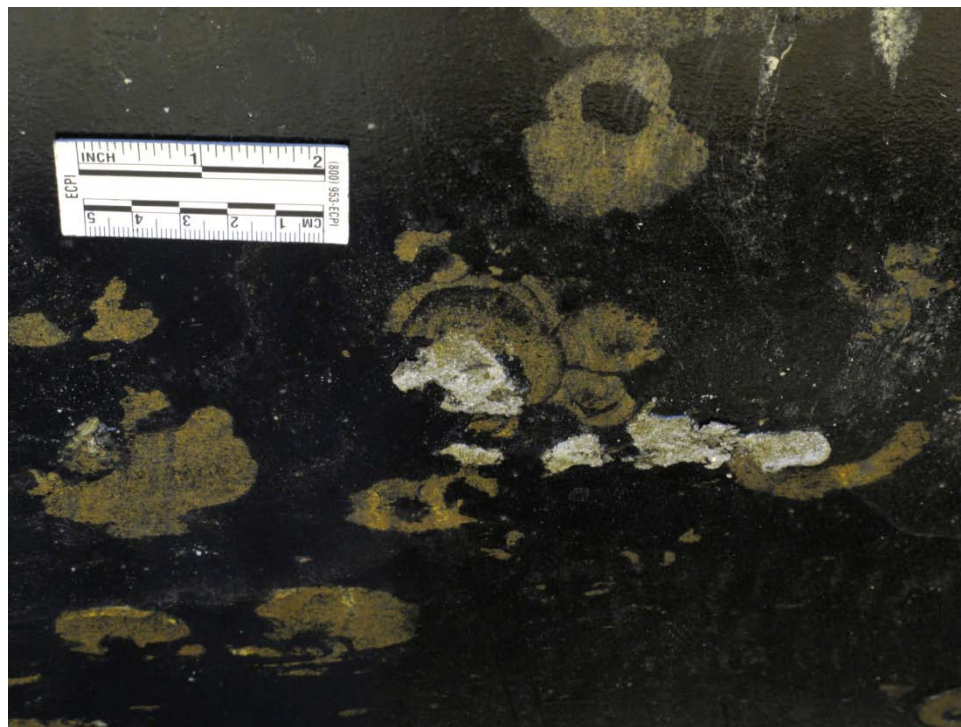
pup 1 is shown in figure 14b. No coating was observed over a cluster of small patches each approximately 2 inch in diameter. The visible pipe surface had an orange/brown appearance. Similar areas of no coating were observed on the undersides of pups 1, 2, and 3.

Figure 14: Examples on the underside of the center section where no coating was observed; a) Underside of pup 4 near the girth weld fracture; b) Underside of long joint to the south of pup 1.

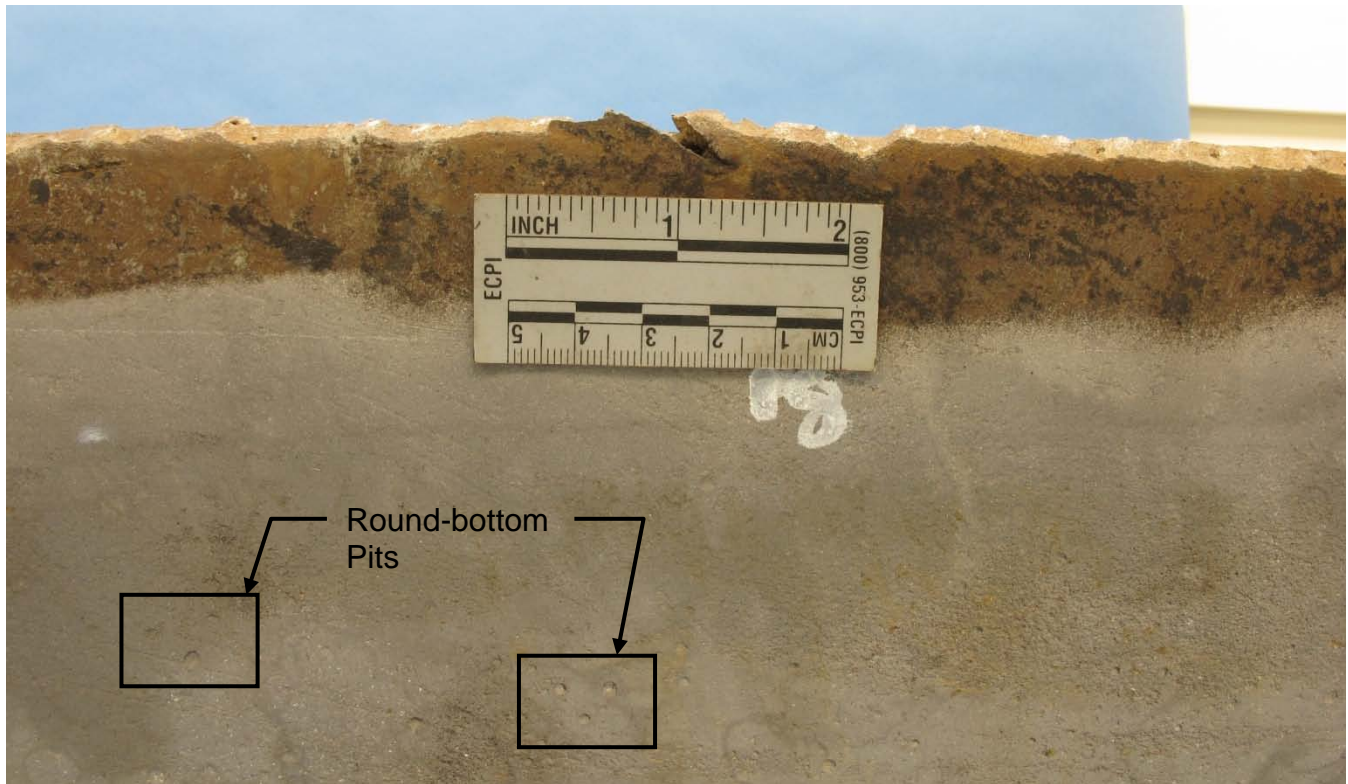
Figure 18: Photograph of pup 2 on the outer diameter adjacent to the longitudinal fracture after grit blasting, magnetic particle inspection, and manual laboratory cleaning of the surface.

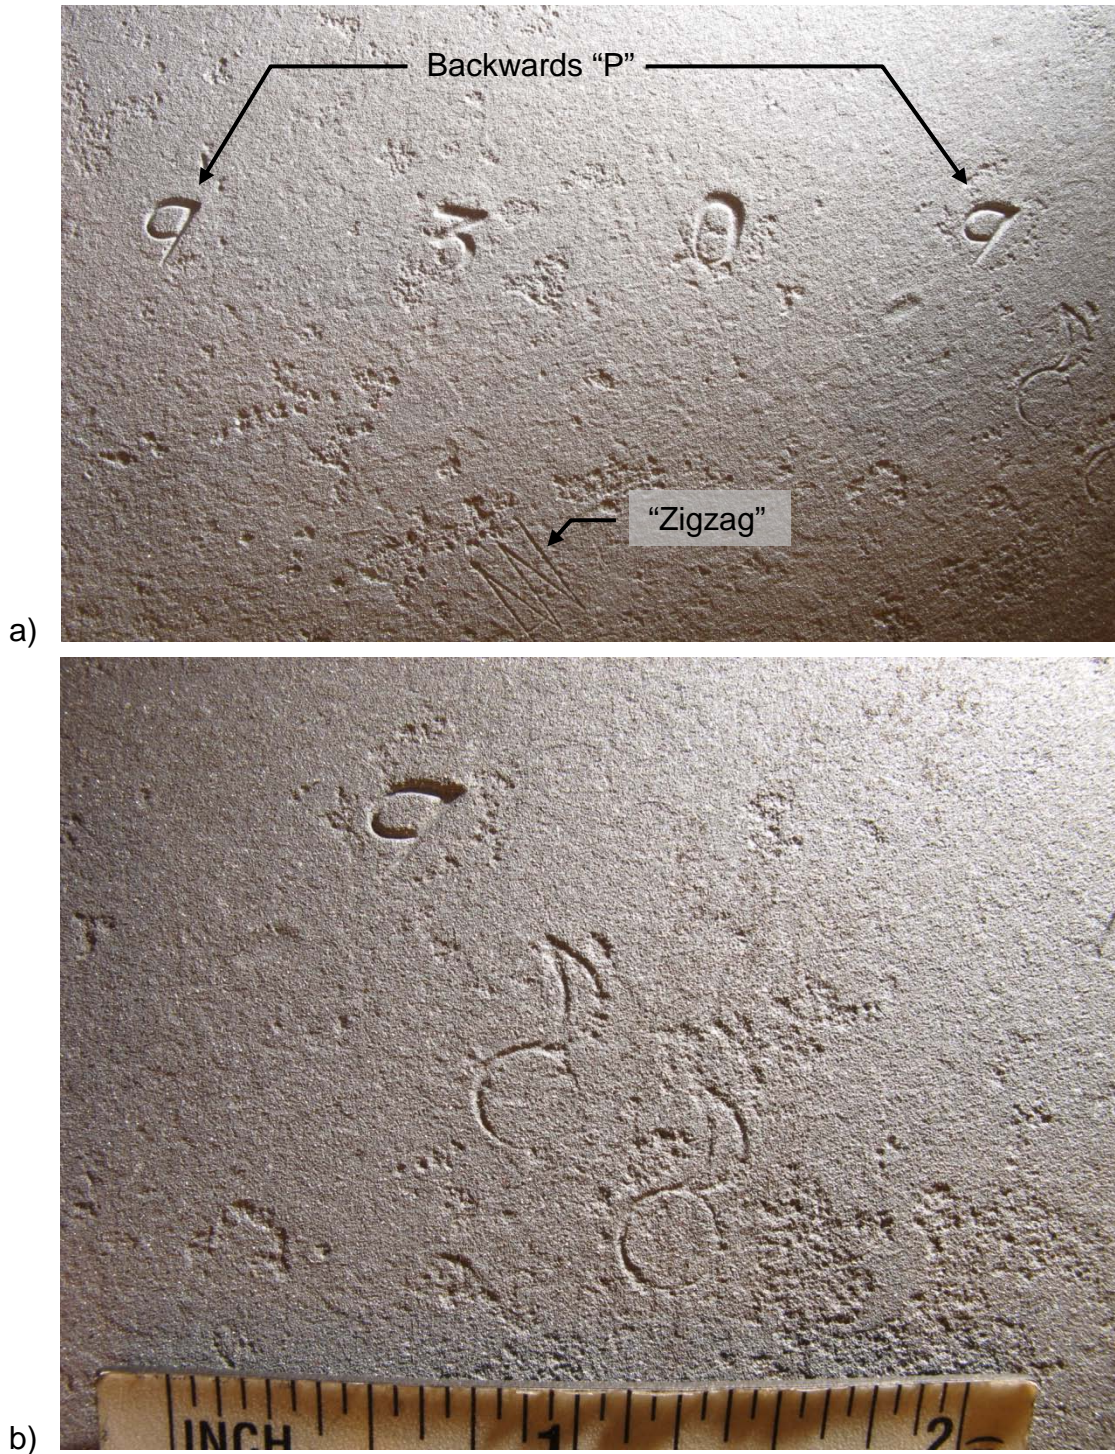
The cleaned pipe was examined visually. There were no visible areas of general external corrosion on the grit blast surfaces nor were there any visible areas of corrosion on the inner diameter surface of the pipe. Upon close inspection, round-bottom pits ranging in depth from 0.004 inch to 0.019 inch were occasionally observed on the outer diameter surface as shown for pup 2 in figure 18. On pups 3, 4, and 5, the appearance of the outer diameter surface longitudinal seams were consistent with mechanical removal of a weld bead (pups 1 – 2 were inconclusive due to masking of the surface). Pipe markings were found on pup 4 approximately 4.5 inch from girth weld C5 and 90° clockwise of the longitudinal seam as shown in figures 19a and b. The markings included the number “30”, two instances of a backwards “P”, five lines arranged in a “zigzag”, and two stamps similar in appearance to a circle-with-a-half-moon.

Figure 19: Pipe markings found on pup 4; a) The number “30”, backwards “P” and five lines forming a “Zigzag”; b) Marking forming a circle and half-moon.

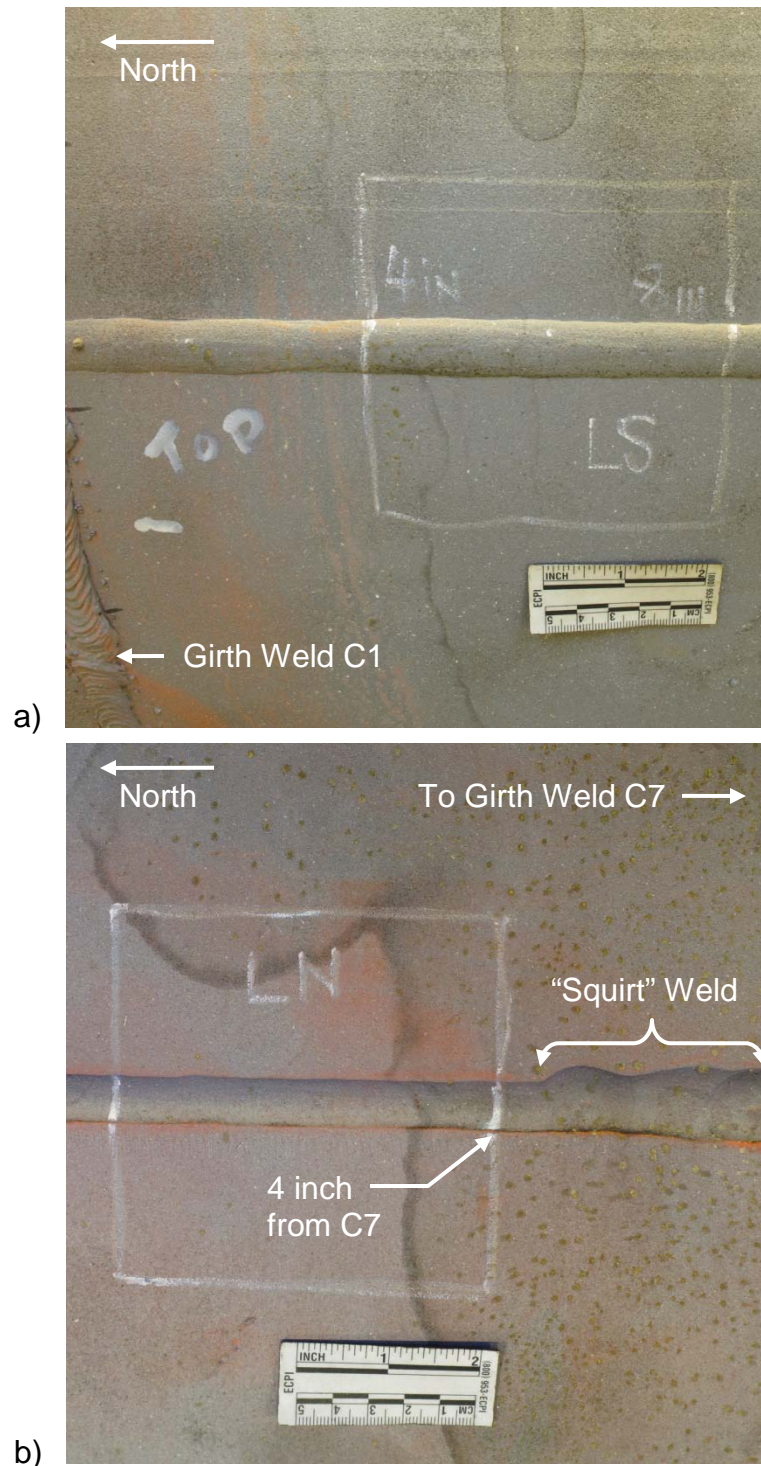
Figure 20: a) Outer weld bead on the long joint south of pup 1. There was no apparent “squirt” weld adjacent to girth weld C1; b) Outer weld bead on the long joint north of pup 6. There was an apparent “squirt” weld adjacent to girth weld C7. The photographs are taken after grit blasting and magnetic particle inspection and prior to sample removal for cross-section metallography.

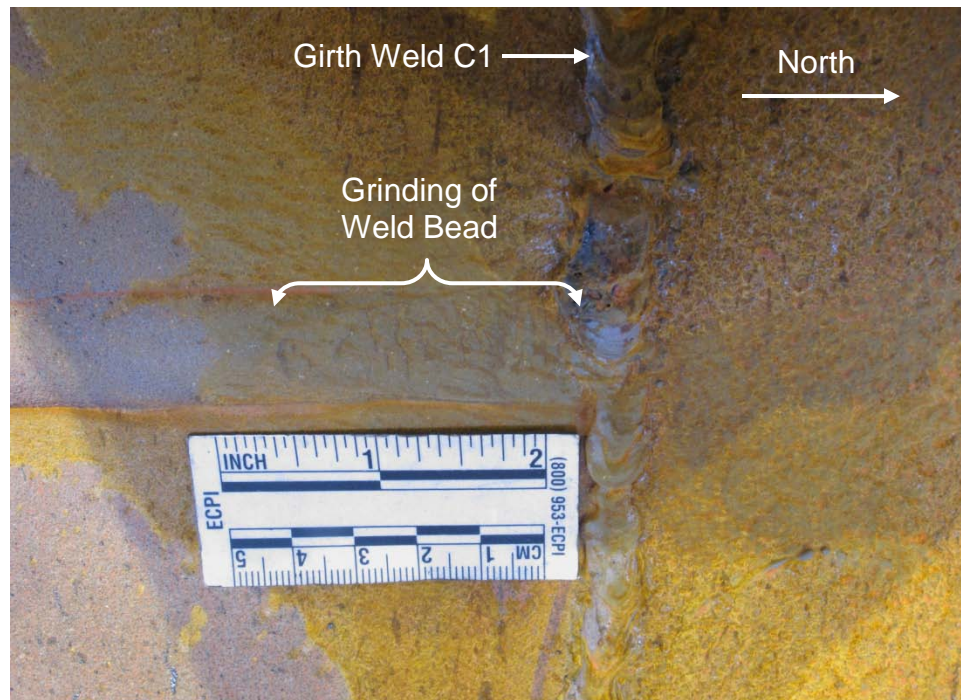
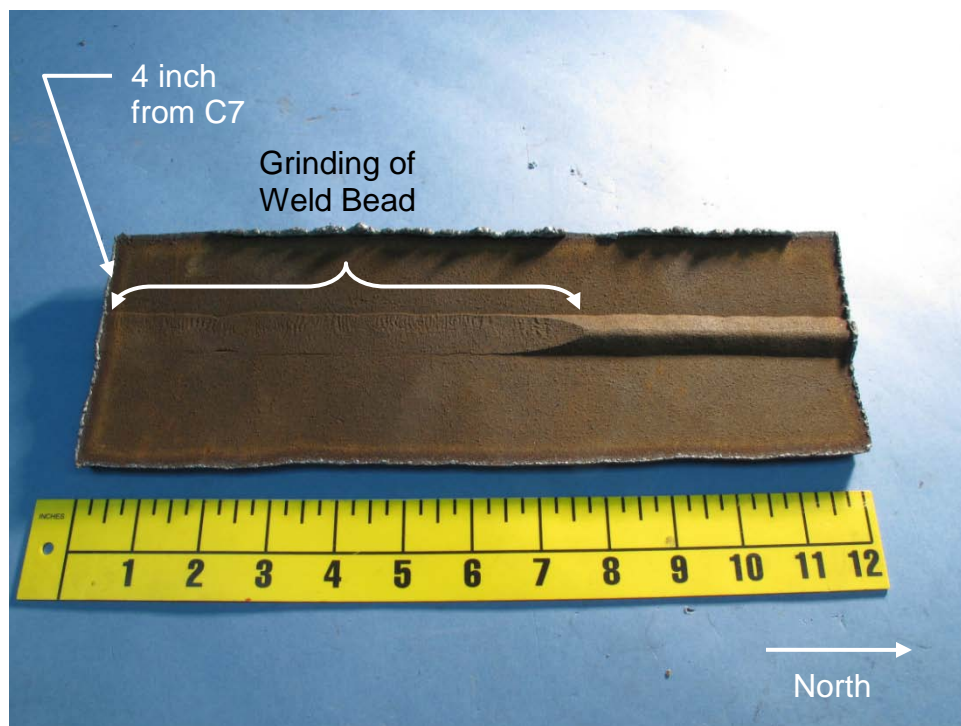
Figure 21: a) Inner weld bead on the long joint south of pup 1. The weld bead was ground over 1.75 inch. The photograph was taken after grit blasting and magnetic particle inspection;
b) Inner weld bead on the long joint north of pup 6. The weld bead was ground over approximately 12 inch. The photograph was taken in the laboratory after the section of pipe was removed using a plasma cutter.

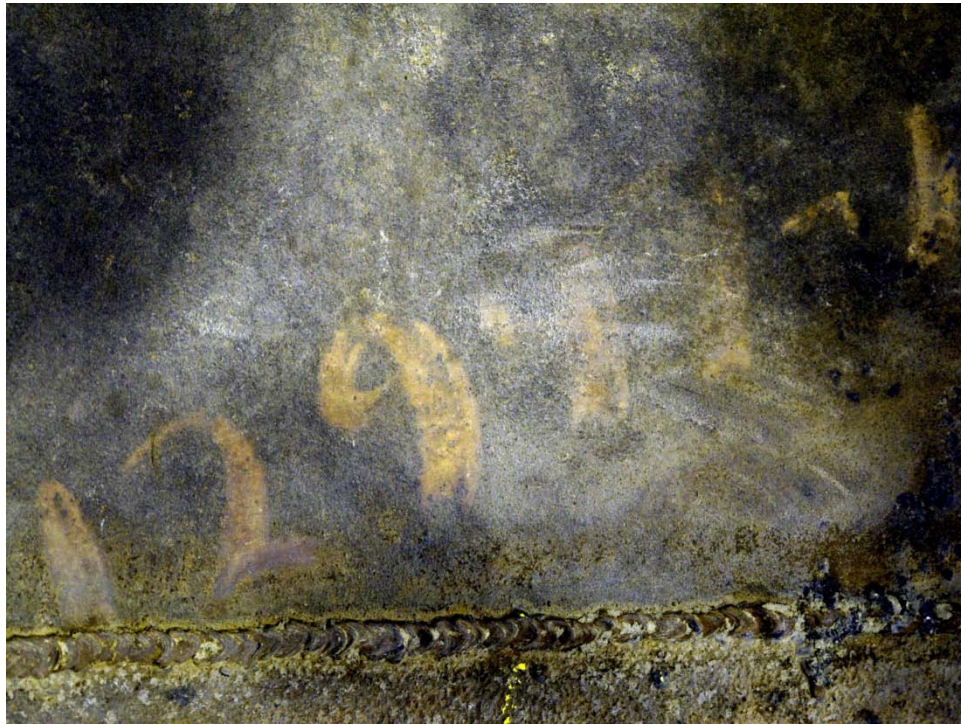
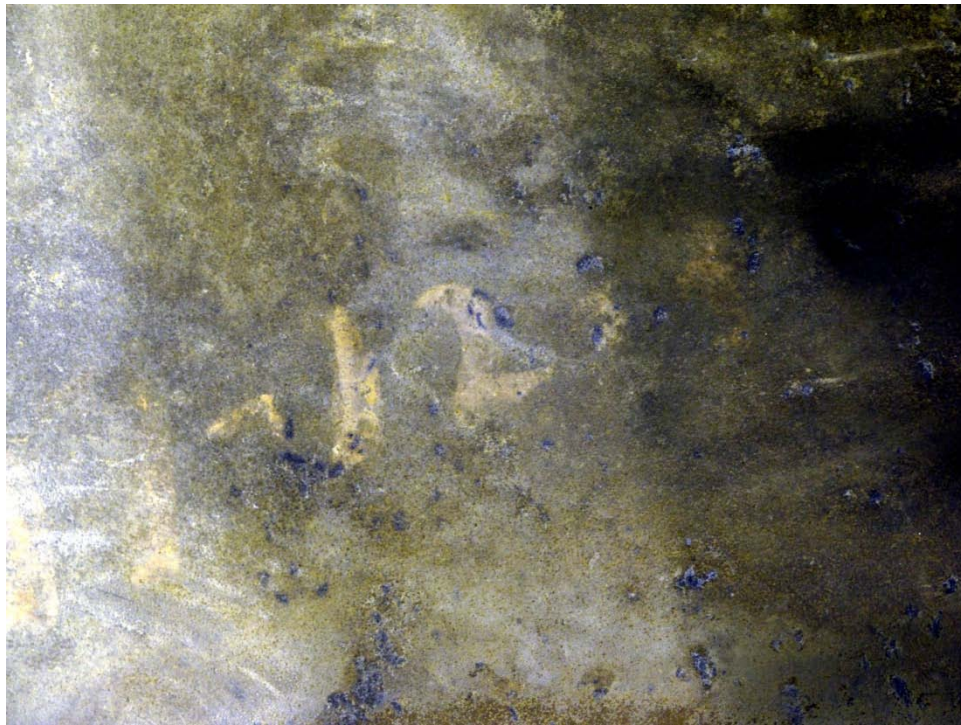
A number was painted on the inside wall of the long joint south of pup 1 near girth weld C1. The paint had faded and the numbers were partly obscured by dirt, rust, and oxidation. The numbers are shown in figure 22 where the contrast of the photo has been altered. The best estimate of the number was 1299(?) – 12-(?). The number and number format was consistent with 0.375 inch wall thickness X52 pipe purchased in 1949^{2,3}.

Figure 22: Photographs of number painted on the inside of the long joint south of pup 1. The contrast has been altered to enhance the visibility of the numbers.

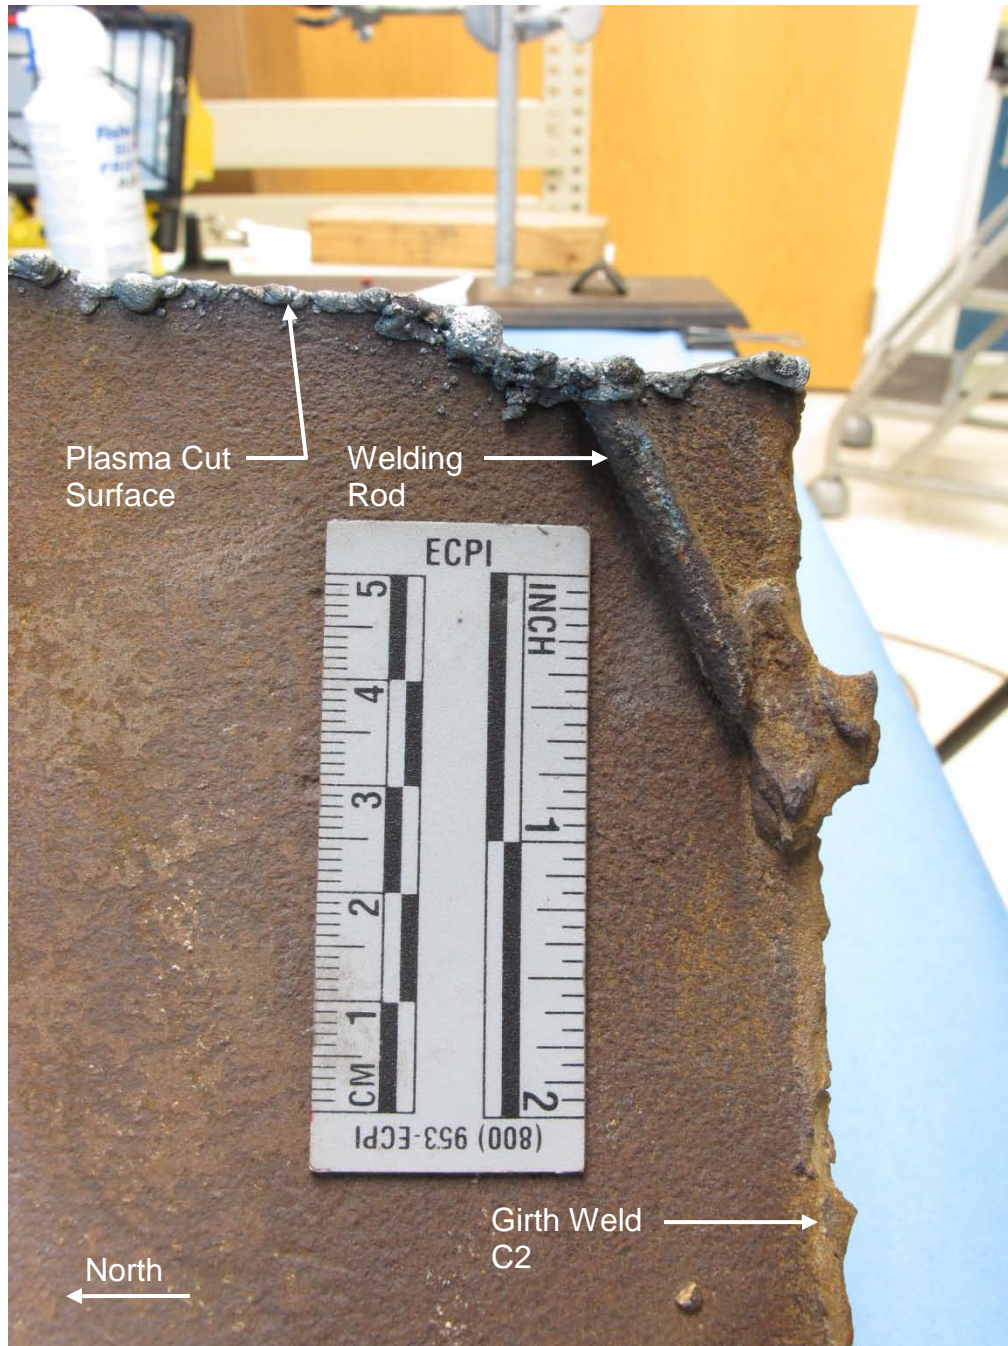
A length of welding rod was found fused to the C2 girth weld on the inside of pup 2 as shown in figure 23. The location was approximately 90° counterclockwise of the longitudinal fracture in pup 2.

Figure 23: Laboratory photo showing length of welding rod fused to the inside of the C2 girth weld on the inner diameter of pup 2.

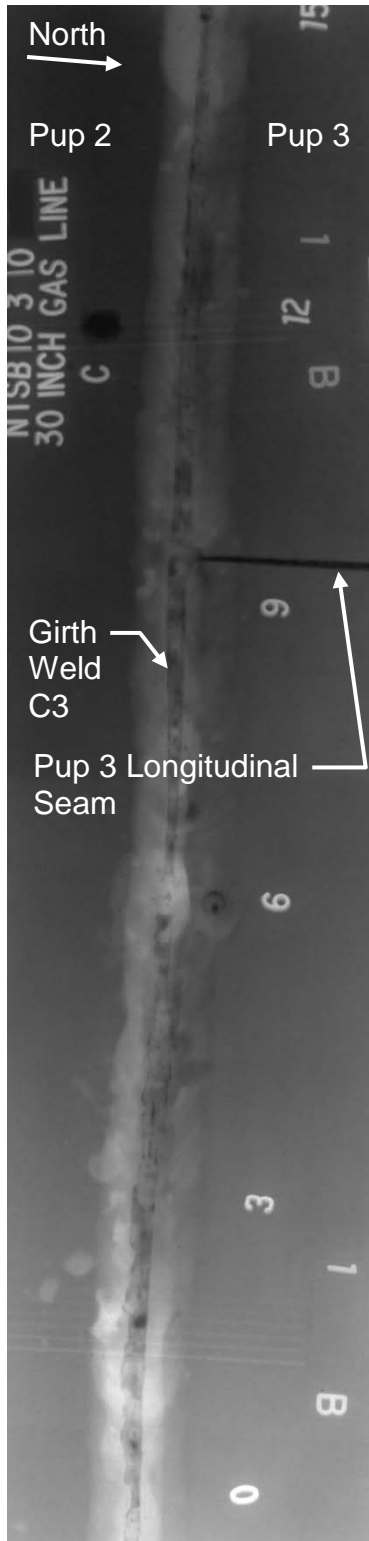
girth welds except C1 and C6. Undercutting defects were exhibited on all intact girth welds except C2 and C3. Four plug welds were observed on pup 4 adjacent to girth weld C4. An example radiograph of girth weld C3 is shown in figure 24. See Appendix B for the complete list of indications on the girth welds.

Figure 24: Radiograph of girth weld C3 from 0 inch – 15 inch (see Table B2) between pup 2 and pup 3. Part of the pup 3 longitudinal seam is visible.

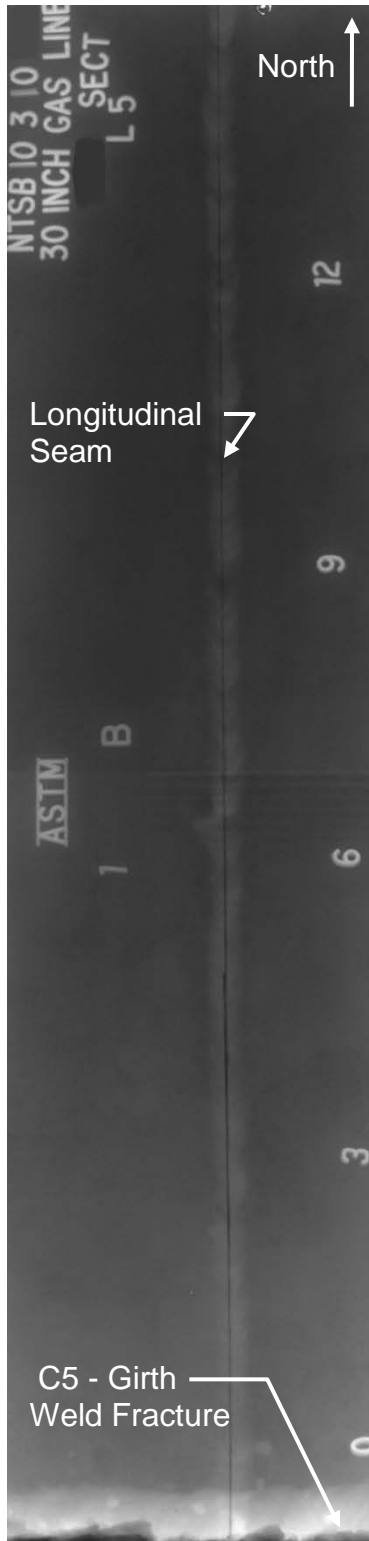
Figure 25: Radiograph of the pup 5 longitudinal seam from 0 inch – 12 inch (see Table B1) adjacent to the C5 girth weld fracture.

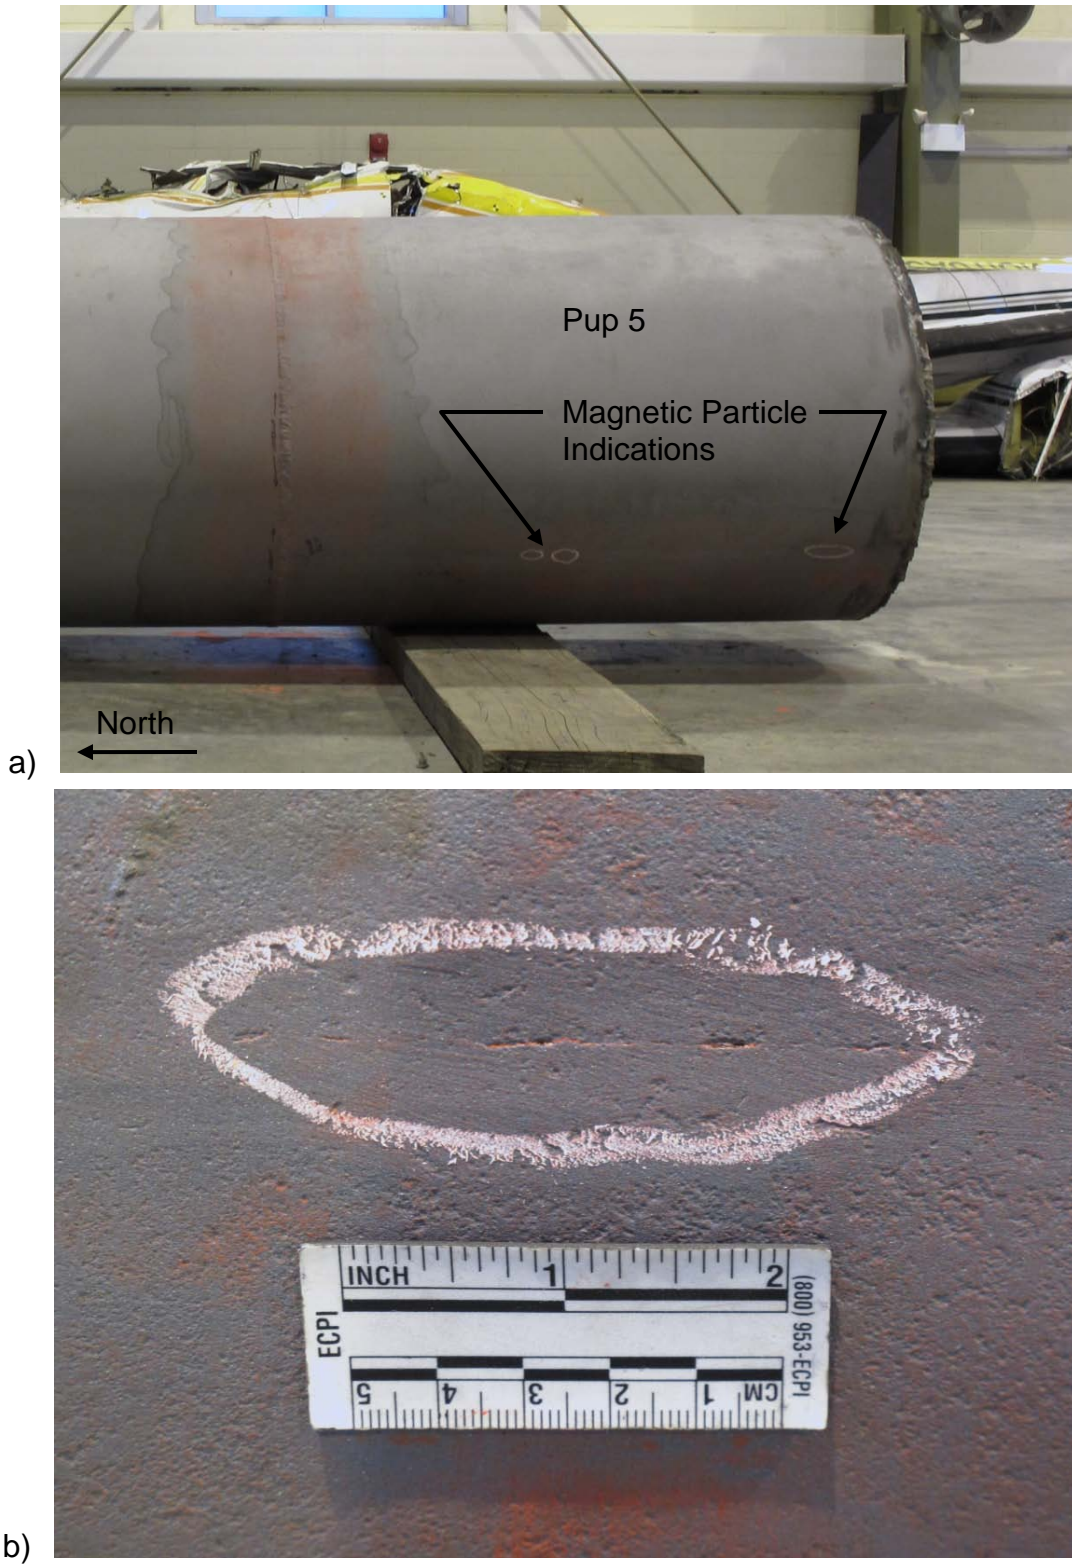
Figure 26: a) Pup 5 showing the location of features detected by magnetic particle inspection; b) Macro photograph of the feature 5.5 inch north of the C5 girth weld.

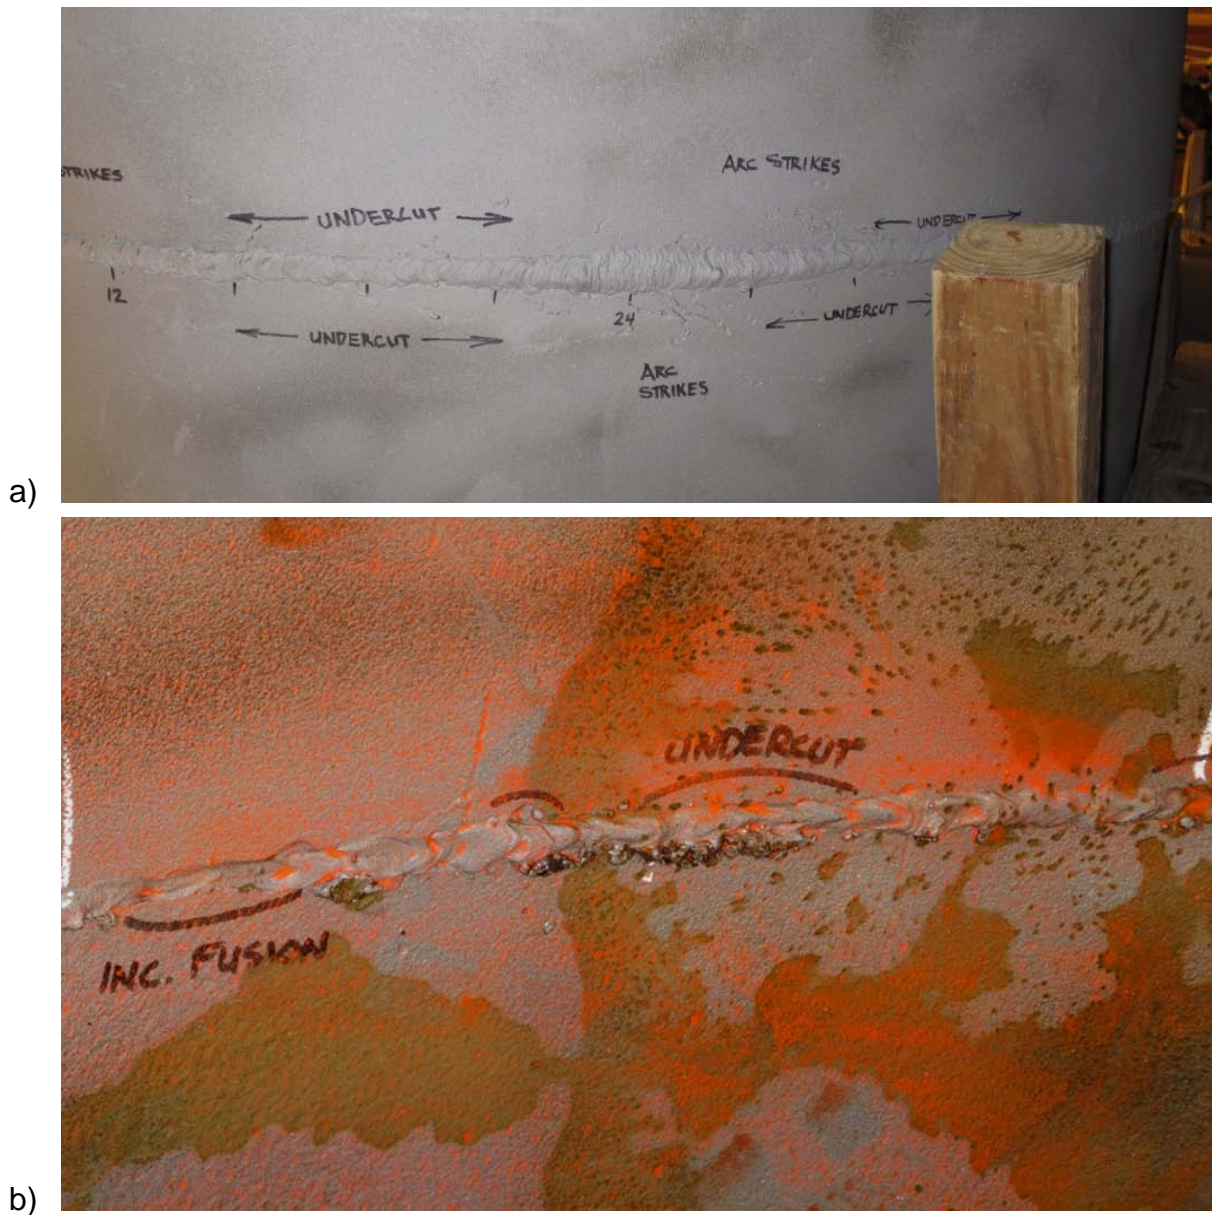
A visual weld inspection was conducted by an American Welding Society certified inspector. The appearance of the longitudinal weld in the long joint south of pup 1 and the long joint north of pup 6 was consistent with a submerged arc welding process. No imperfections were found on the longitudinal welds except for pups 1 – 3 for which lack of weld penetration along the ID surface was observed. Also noted, no evidence of an external weld bead was observed on pups 1 – 5^v. The longitudinal weld bead on pup 5 had been visibly ground. The appearance of the girth welds was consistent with a shielded metal arc welding process. Arc strike and undercut imperfections were observed on the outside diameter of girth weld C1 as shown in figure 27a. Plug welds were observed on pup 4 near C4 and C5 at 90° intervals around the circumference. Undercut and a 1/16" gouge were observed on the outside diameter of girth weld C6. Visual inspection of the inside diameters was consistent with a back welding process rather than welding from the outside diameter. The welds had a poor weld profile consistent with low welding amperage and exhibited various features including cold lap, incomplete fusion between the weld metal and the base metal, slag, under fill along the weld joint, and lack of penetration. An example is shown for a portion of girth weld C2 on the inner diameter shown in figure 27b. The imperfections observed on the girth welds can be found in Table 5.

Figure 27: a) Weld imperfections indicated by visual examination on the external surface of girth weld C1; b) Weld imperfections indicated by visual examination on the internal surface of girth weld C2. The photograph was taken after magnetic particle inspection.

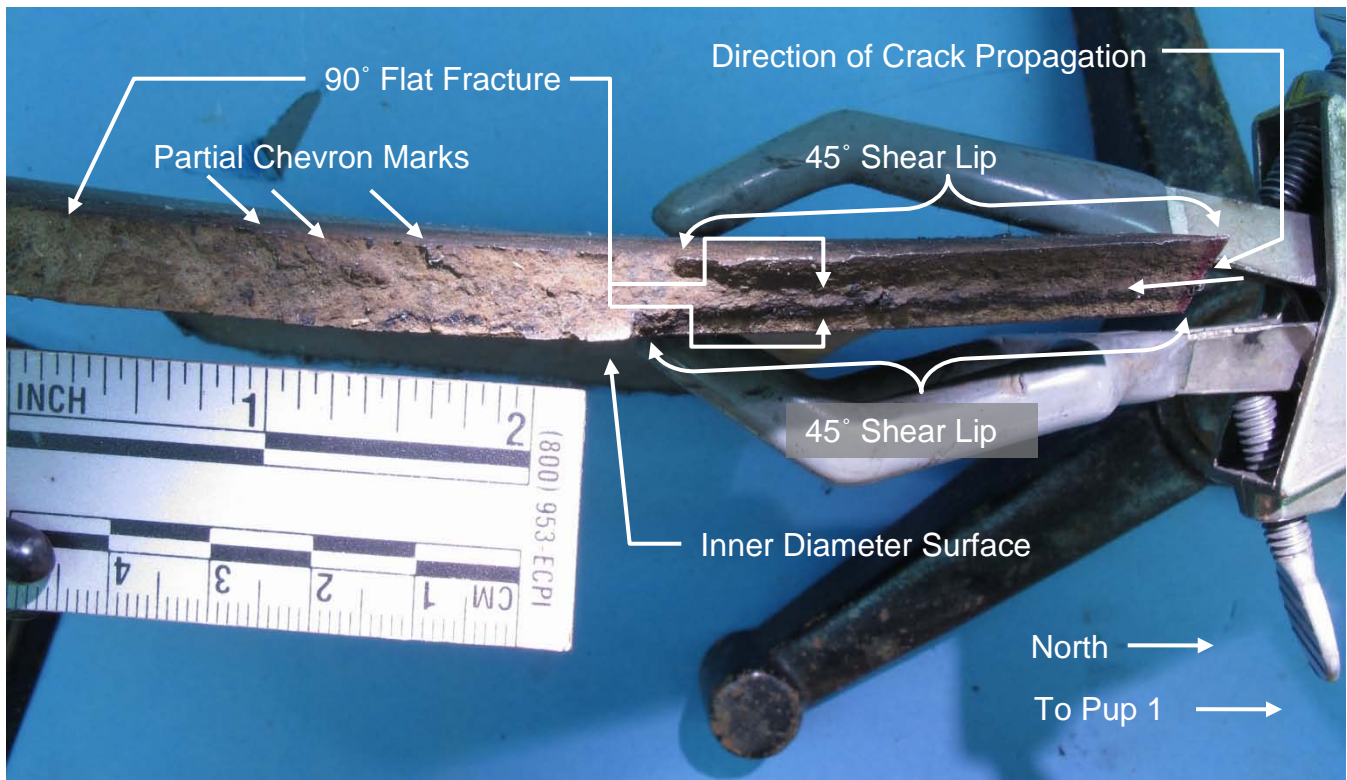
The features on the fracture surface of the long joint south of pup 1 were consistent with overstress fracture with the crack propagating from pup 1. Over the first 3.5 inch adjacent to girth weld C1 (see figure 1), the fracture surface had 45° shear lips along the inner and outer third of the wall and a flat region in the middle third as indicated in figure 29. Moving further away from pup 1 the fracture profile transitioned to a 90° flat fracture consistent with an accelerating fracture. Partial chevron^{vi} features pointing in the direction of pup 1 were observed consistent with overstress fracture.

Figure 29: Counterclockwise fracture surface on the long joint south of pup 1 (see figure 28a). Partial chevron marks and 45° shear lips on the inner and outer wall were consistent with overstress fracture emanating from pup 1.

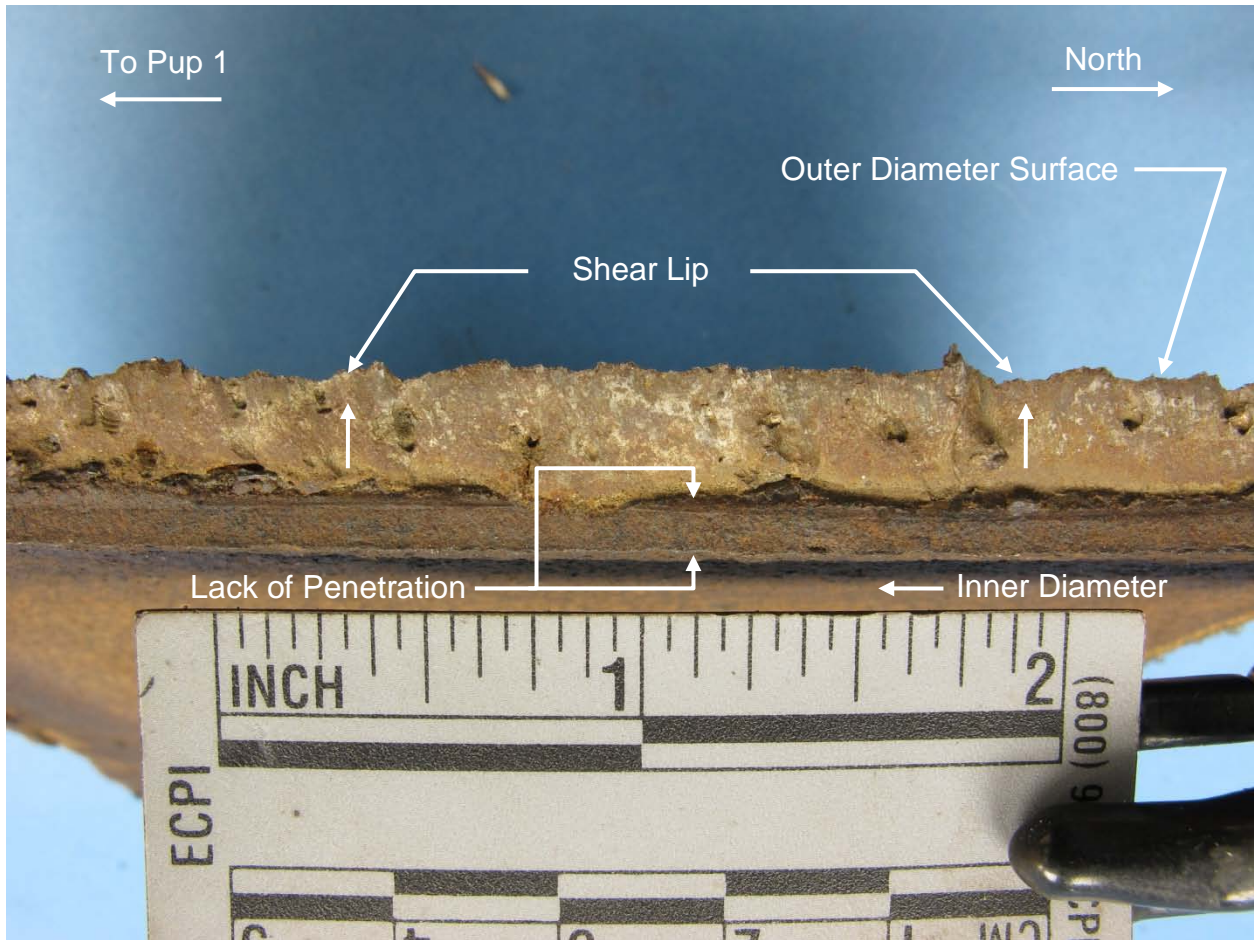
At the other end of the longitudinal fracture, there were features along the pup 2 longitudinal seam consistent with overstress in out-of-plane shear propagating from girth weld C2. The counterclockwise half of the longitudinal seam adjacent to C2 is shown in figure 30. The inner half of the seam had a color and texture similar to the inner wall of the pipe, consistent with lack of weld penetration. The outer half of the seam showed a shear lip and a smeared fracture surface consistent with out of plane shear. The pipe wall on the clockwise half of the fracture exhibited outward bending deformation as shown in figure 31. The bending curvature was greatest adjacent to girth weld C2 and decreased continuously approaching the mid length of pup 2. There was no outward bending deformation on the counterclockwise side of the longitudinal seam on pup 2. The fracture surface and bending deformation were consistent with a crack propagating from girth weld C2.

Figure 30: Counterclockwise half of longitudinal fracture on pup 2 (see figure 28c). Out of plane shear was observed along the longitudinal seam.

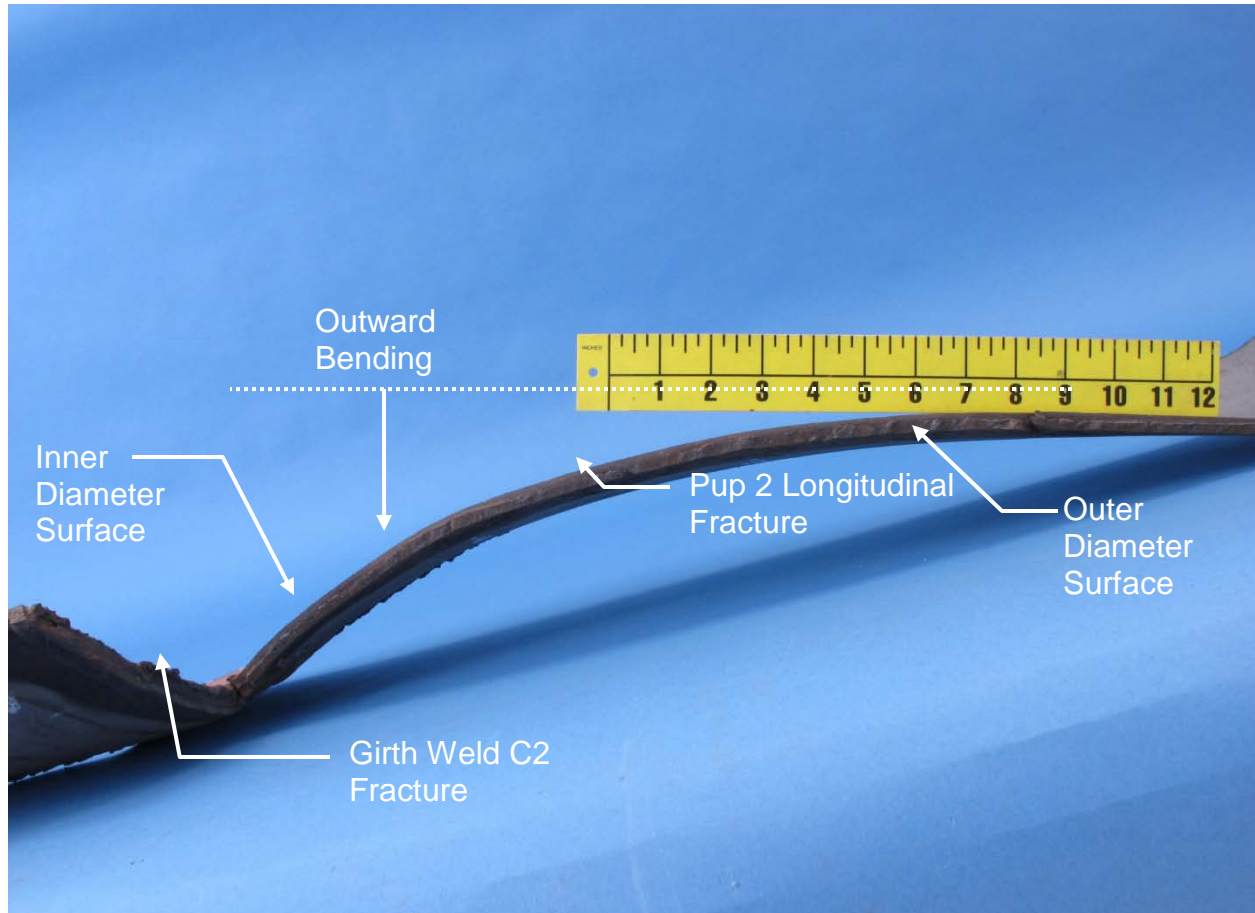
Figure 31: Clockwise half of pup 2 fracture viewed in the transverse direction. The wall was bent radially outward with the highest curvature at girth weld C2 and decreased continuously to a straight wall at mid length.

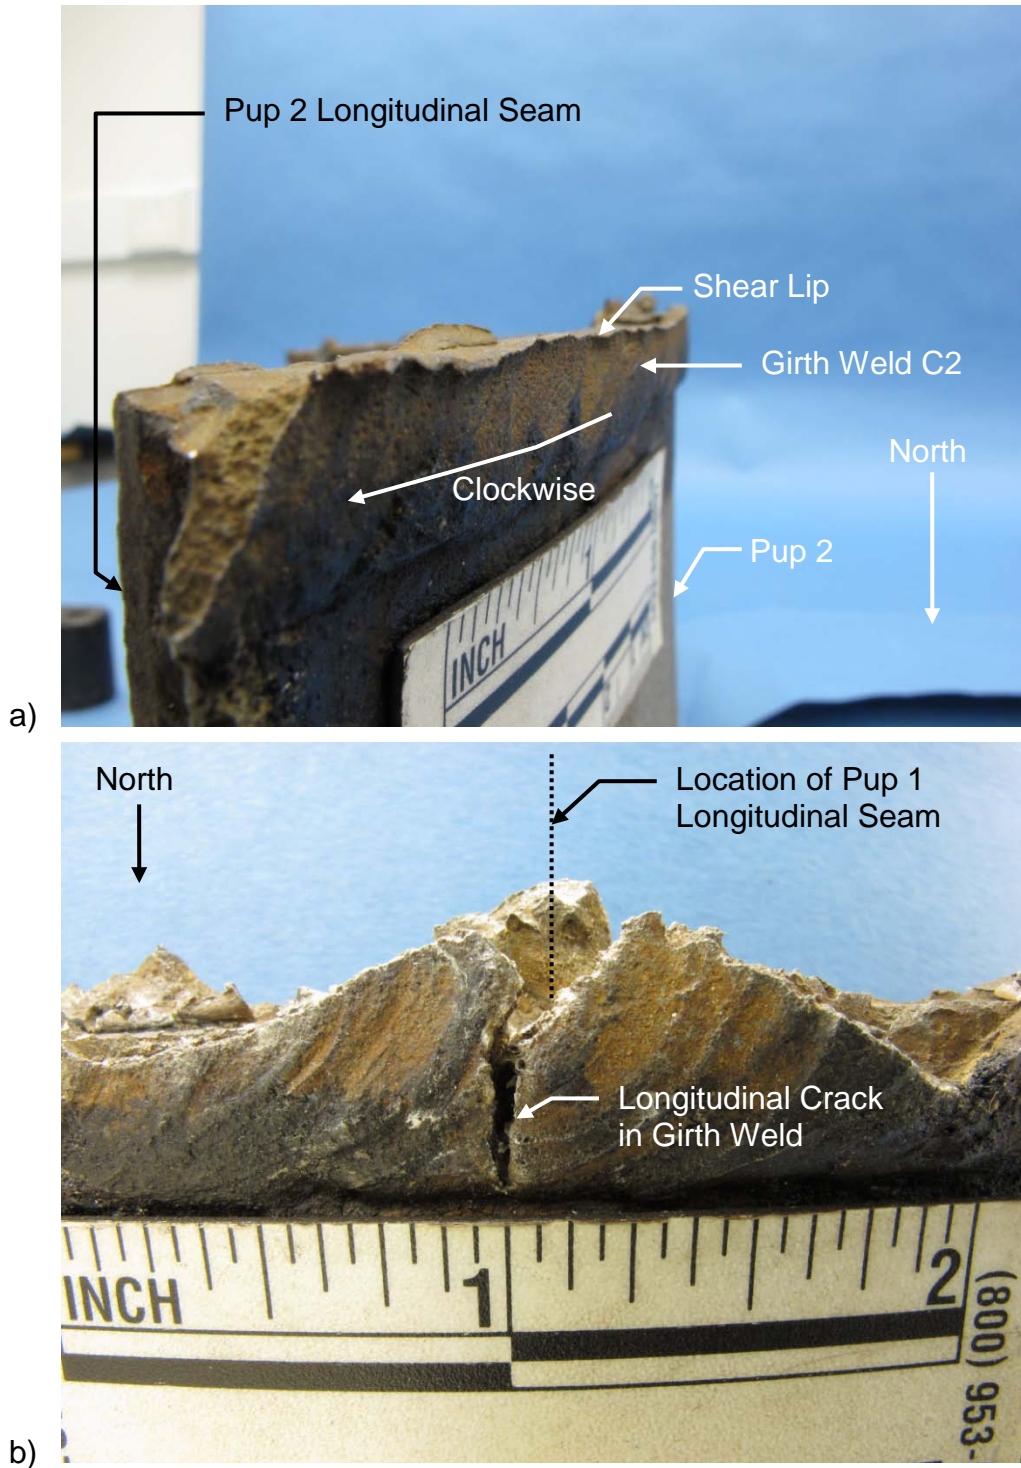
There were fracture features on girth weld C2 consistent with overstress in mixed tension and shear consistent with a crack propagating from the pup 1 longitudinal seam. Approaching the pup 2 longitudinal seam, a shear lip was visible along the girth weld as shown in figure 32a consistent with out of plane shear. At the location where the pup 1 longitudinal seam met the girth weld (see figure 28c), a longitudinal crack was visible in the weld cap as shown in figure 32b. The crack did not continue through the wall of the pipe

Figure 32: a) Shear lip on girth weld C2 fracture surface approaching the pup 2 longitudinal seam; b) Longitudinal crack in girth weld C2 in line with the longitudinal seam in pup 1.
