NATIONAL TRANSPORTATION SAFETY BOARD

Metallurgical Group Chairman
Factual Report

MATERIALS LABORATORY FACTUAL REPORT

Place : San Bruno, CA
Date : September 9, 2010
Vehicle : Natural Gas Transmission Pipeline
NTSB No. : DCA10MP008
Investigator : Ravi Chhatre, RPH-20

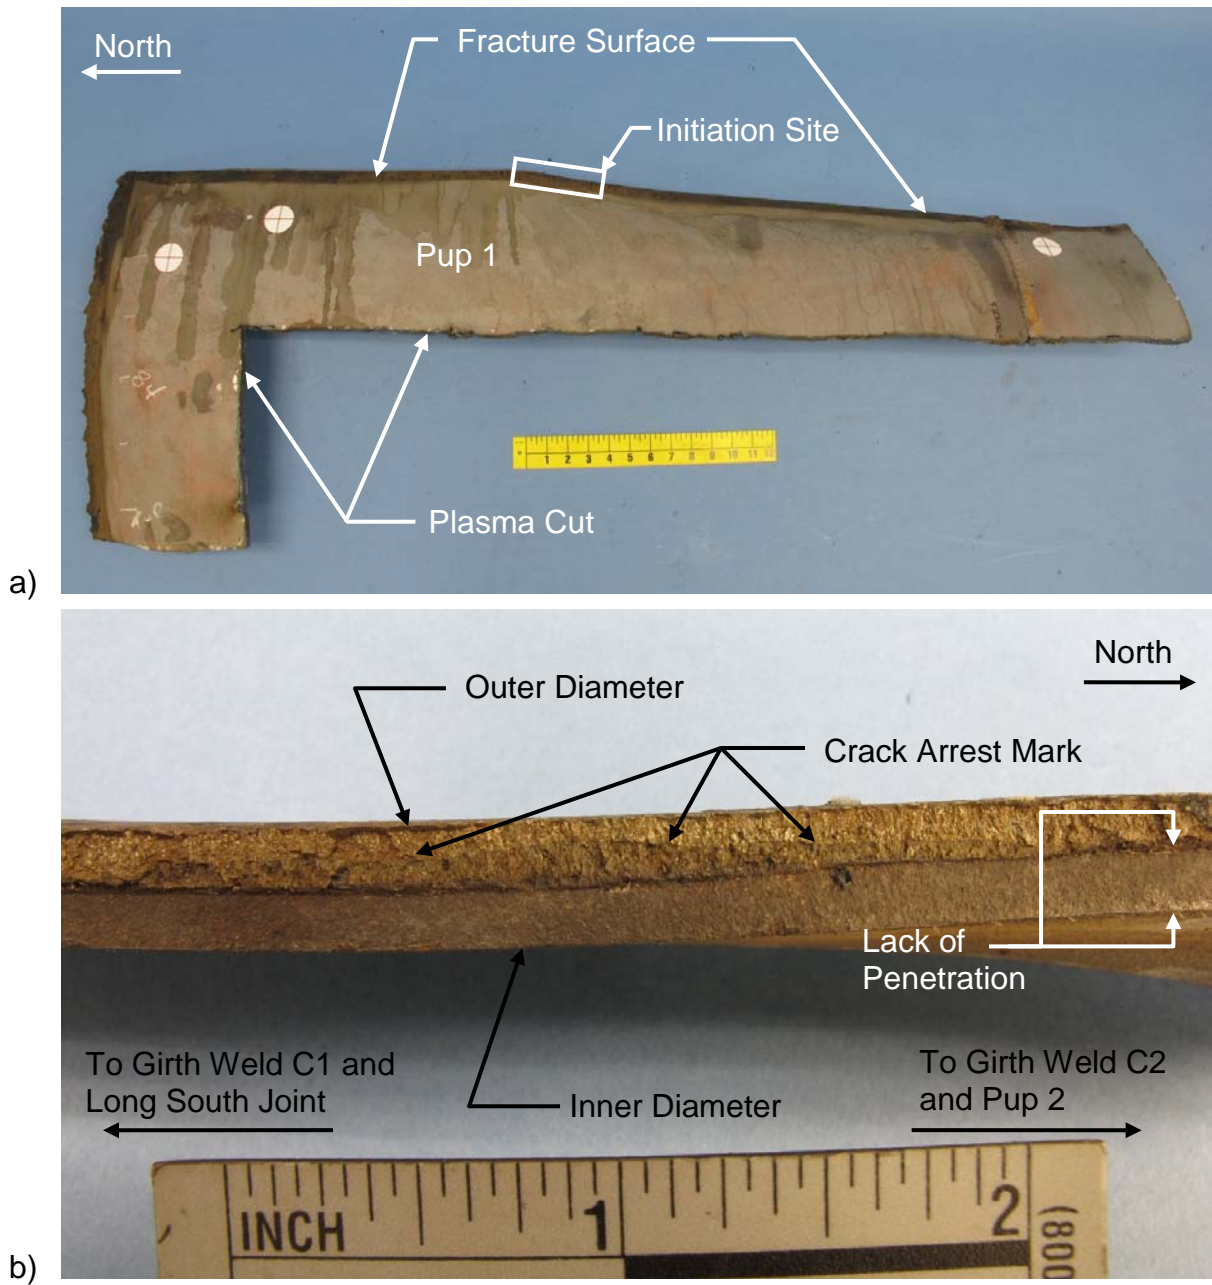
The crack initiation site was found along the pup 1 longitudinal seam at the location shown in figure 33a. The counterclockwise half of the longitudinal seam at the initiation site is shown in figure 33b. The inner half of the seam had a color and texture similar to the inner diameter surface of the pipe, consistent with a lack of weld penetration. The outer half of the seam had a rough texture consistent with a tensile overstress fracture.

The lack of penetration was seen along the entire length of the fractured pup 1 longitudinal seam. The lack of penetration depth and total wall thickness were measured at 10 locations starting 4.25 inch downstream (south) of girth weld C1 and spaced at 4 inch intervals along the pup 1 longitudinal seam from calibrated digital images taken on an optical microscope (measured after the conclusion of the group examination). The data are included in Appendix C. The average lack of penetration depth was 0.140 inch \pm 0.021 inch (1 standard deviation). The average wall thickness on the counterclockwise side of the seam was reduced from 0.367 inch measured in the rest of the pipe to 0.312 inch \pm 0.015 inch. The average percent weld penetration was 55% \pm 7%. Specifications for pipe purchased by PG&E in 1948 and 1949 defined an injurious defect to be one that reduced the wall thickness to less than 90 per cent of the specified wall thickness. The defect was considered repairable if the depth did not exceed 33 – 1/3 per cent of the specified wall thickness and provided the length of the defect was not greater than a length equivalent to one diameter of the pipe (30 inch)^{3,6}. An API 5LX Standard on High-Test Line Pipe from 1954 considered all cracks, sweats, leaks, or other defects in welds to be injurious⁵.

Figure 33: a) Counterclockwise half of pup 1 longitudinal fracture with the location of the crack initiation site indicated; b) cross section view of the longitudinal seam at the initiation site.

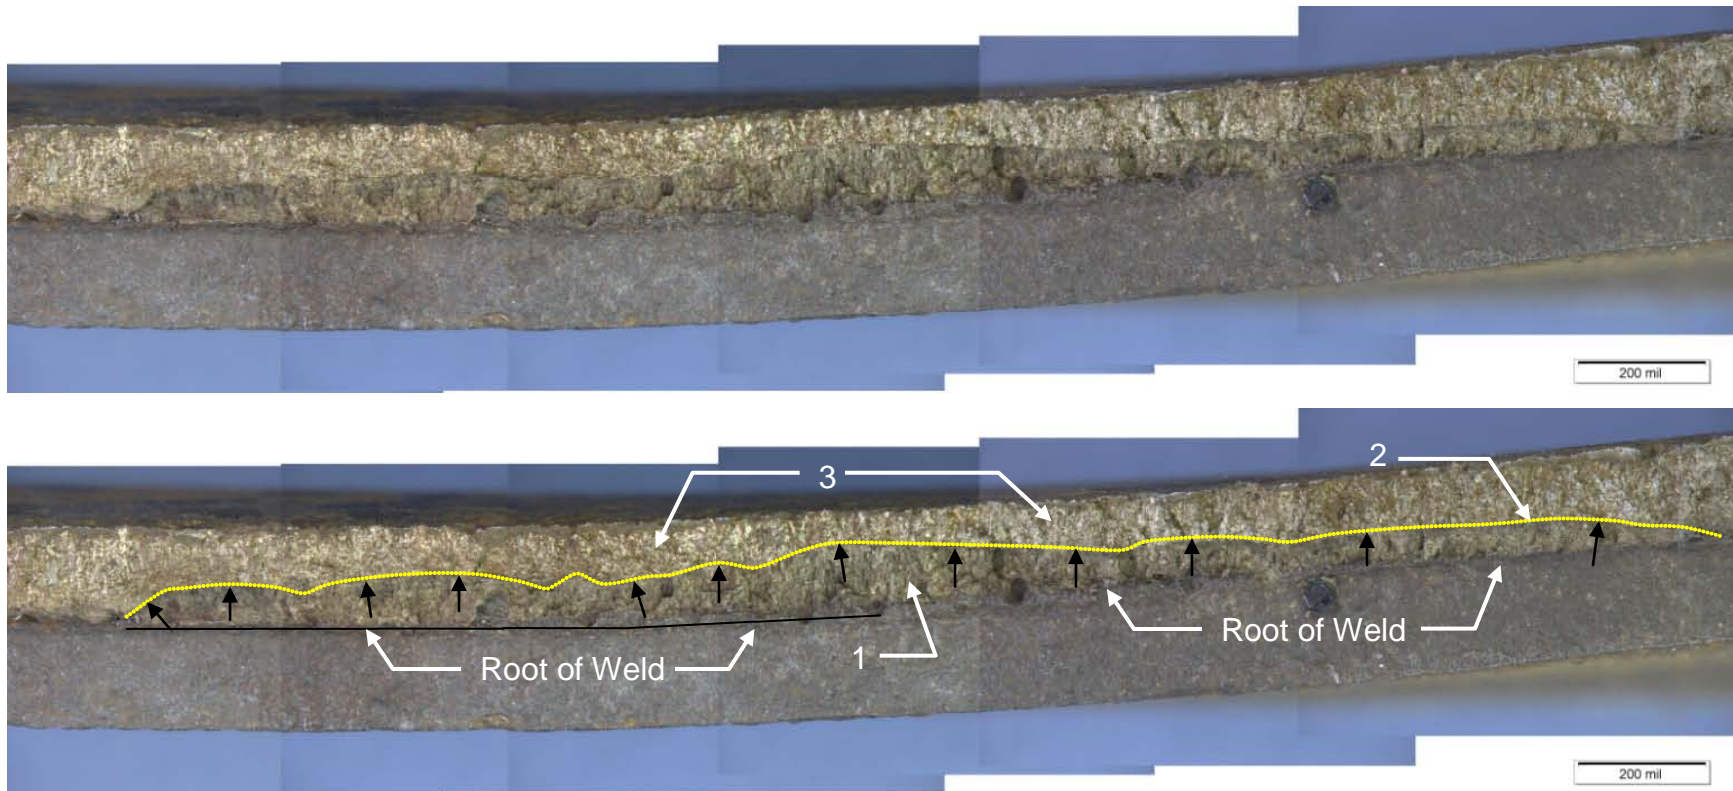
An apparent crack arrest mark was observed using a stereomicroscope between 20.3 inch and 22.7 inch north (downstream) of the C1 girth weld and was identified as the initiation site. The location of the initiation site is indicated in figure 33a. The arrest mark is indicated in figure 33b and in figure 34 by a yellow dotted line labeled “2”. The lack of penetration depth at the initiation site was 0.150 inch. The wall thickness was reduced to 0.332 inch. The percent weld penetration was 55%. The fracture surface in the area labeled zone “1” in figure 34 had a slightly darker tint than the fracture surface in the area labeled zone “3”. Porosity was observed at the root of the weld as indicated in figure 35. The crack arrest mark was 2.4 inch at its widest and was within 0.057 inch of the outer diameter surface at the 21.4 inch mark, its deepest point, also shown in figure 35. In contrast to the rough texture observed over most of the fracture surface, a thin band of flat fracture was seen along the crack arrest mark starting at the 22 inch mark and continuing to the north extent of the crack arrest mark at 22.7 inch. Interpretation of the fracture morphology at the crack arrest mark between the 20.3 inch and 22 inch marks was inconclusive. A micrograph of the fracture surface at the 22.7 inch mark is shown in figure 36. A higher magnification optical micrograph was taken in the region indicated by the black rectangle and is shown without annotations in figure 37a and with annotations in figure 37b. Two dotted yellow lines are superimposed on the micrograph in figure 37b. The area in zone 2 between the dotted yellow lines had a flat morphology compared to the rough morphology

in zones 1 and 3 consistent with progressive fracture. The band was 0.005 inch wide where indicated in the figure and widened as it approached the end of the initiation site.

Figure 34: Optical micrographs of the fracture initiation site in pup 1. Top: Unlabelled micrograph, Bottom: Same micrograph with a crack arrest mark indicated by a yellow dotted line and the three fracture surface morphologies identified by scanning electron microscopy, 1 - ductile overstress (dimple rupture), 2 – progressive fracture, 3 –quasicleavage. The black arrows indicate the approximate direction of crack propagation. Note: The micrographs were taken after an inhibited acid solution was used to remove iron oxides.

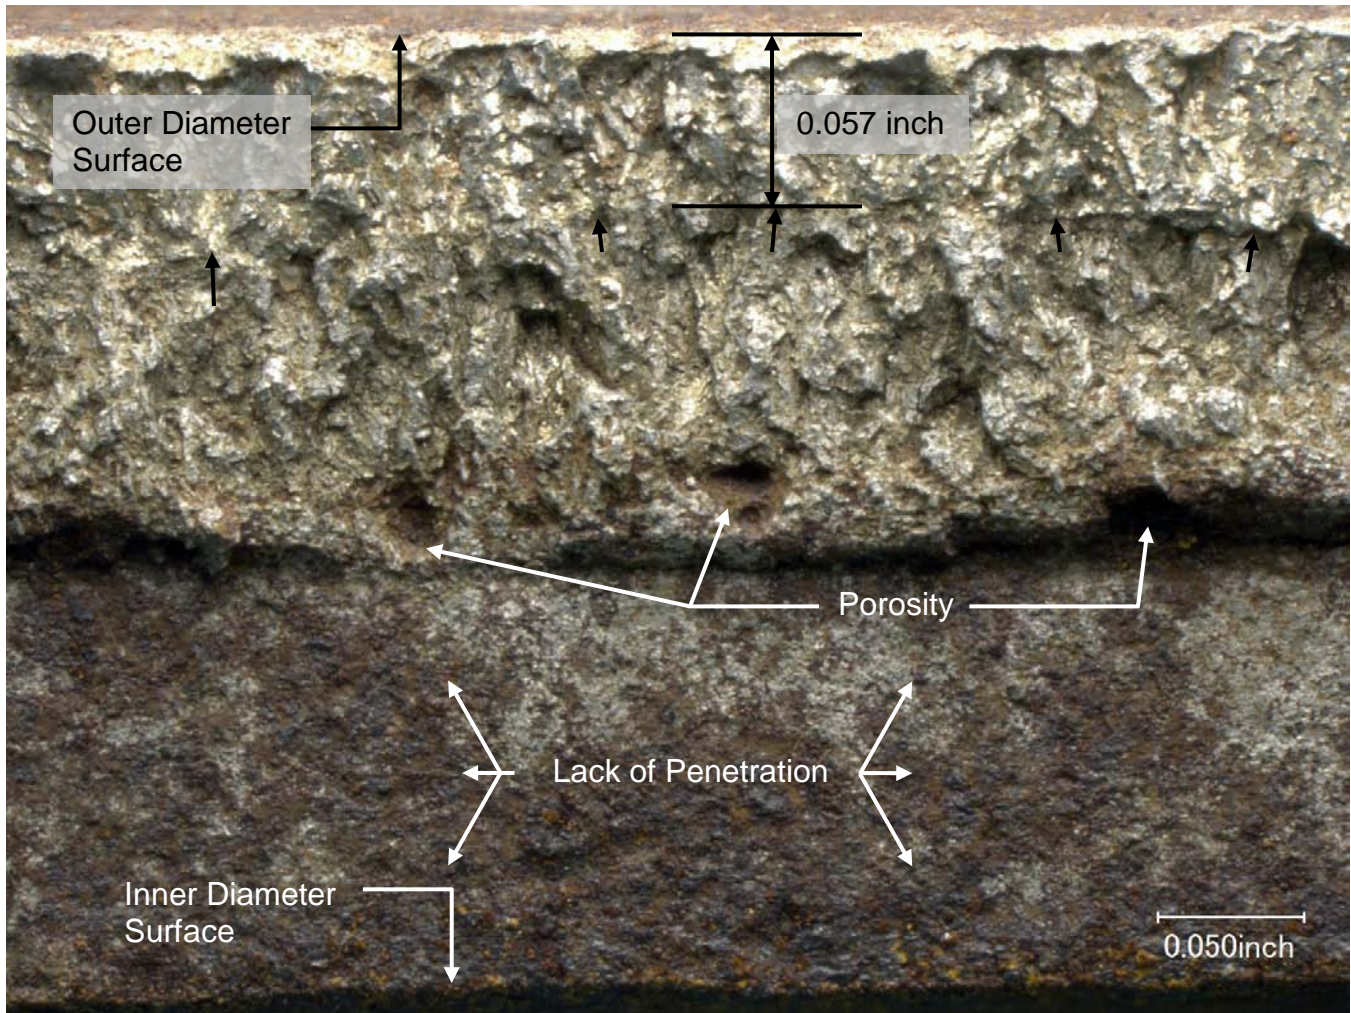
Figure 35: Micrograph of the initiation site in pup 1 at the 21.4 inch mark, the deepest point of the crack arrest mark. The profile of the arrest mark is indicated by the black arrows.

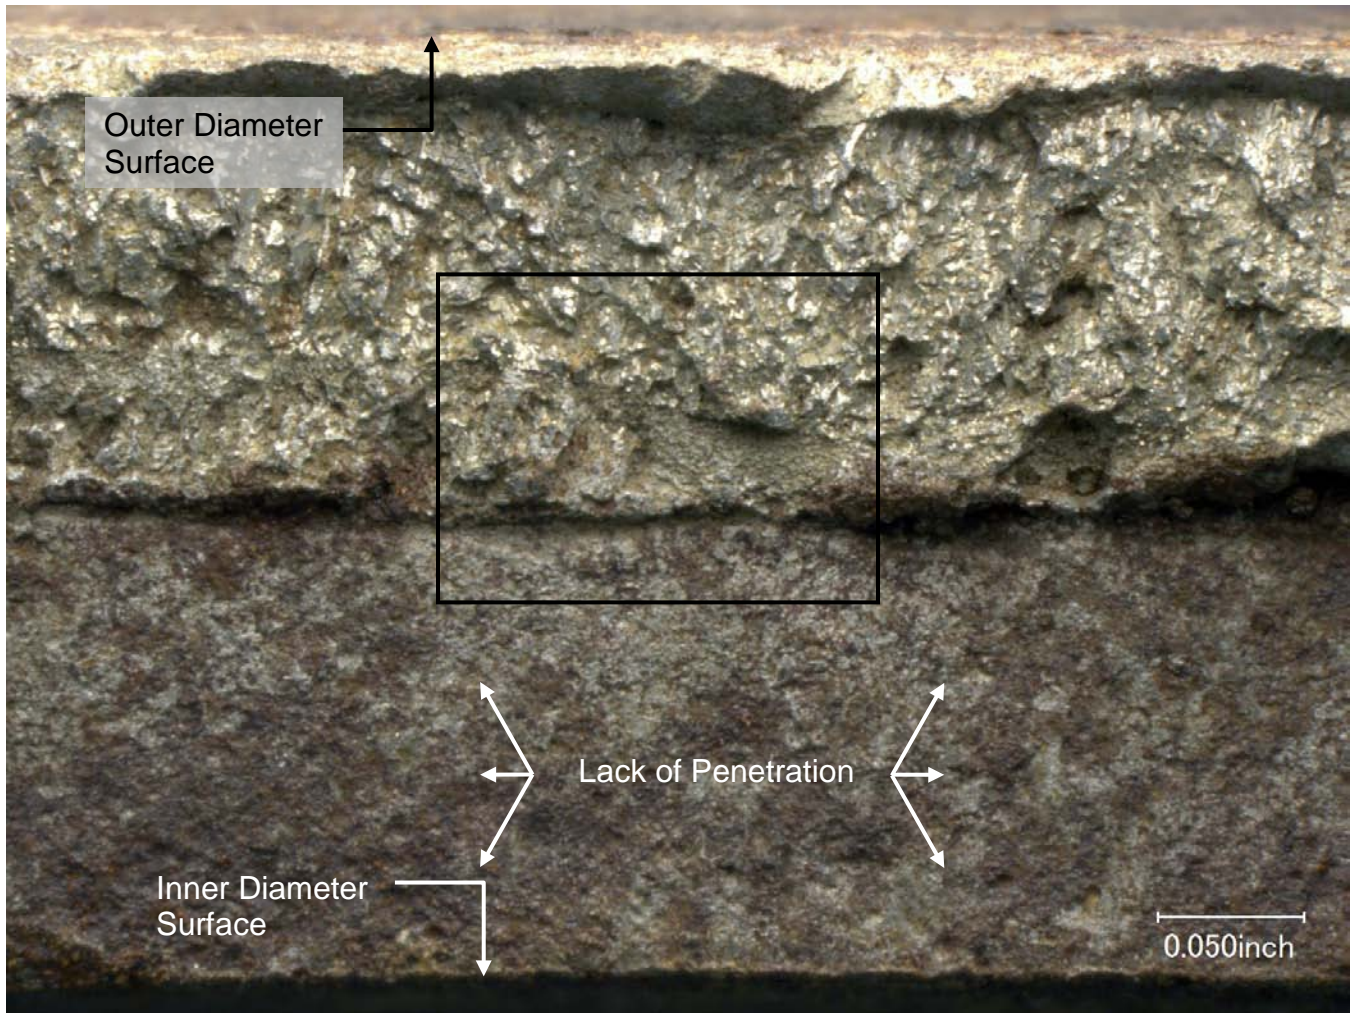
Figure 36: Micrograph of the north end of the initiation site at the 22.7 inch mark. A higher magnification view of the fracture surface in the black box is shown in figure 37.

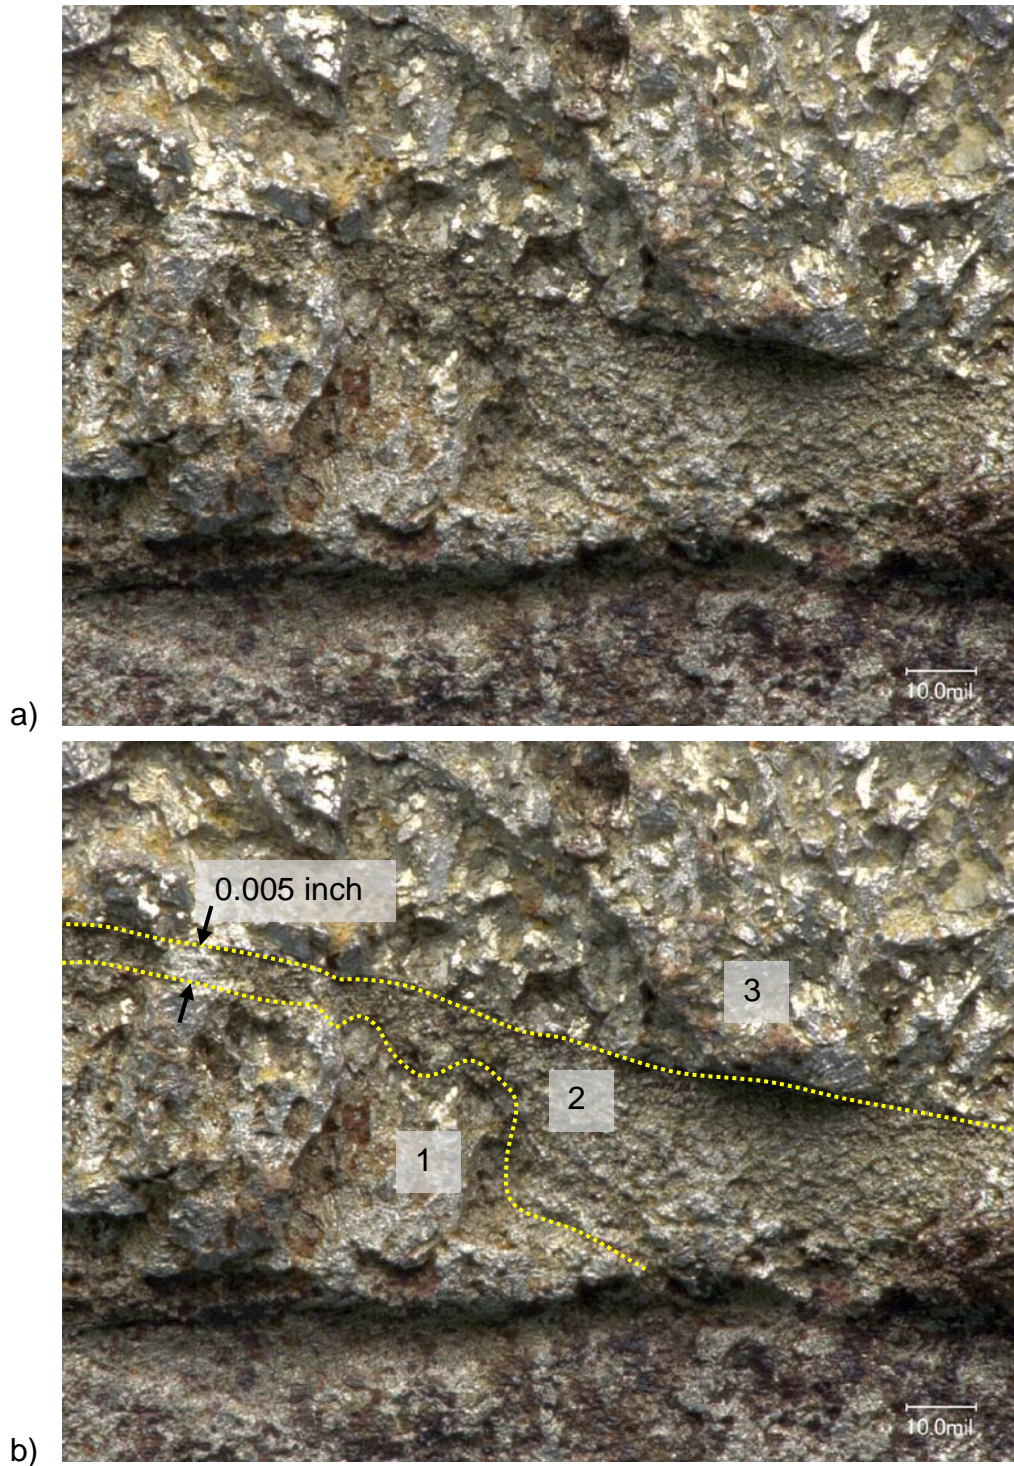
Figure 37: Photomicrograph of the north end of the fracture surface at the 22.7 inch mark. A flat fracture surface region at the crack arrest mark was observed between the yellow dashed lines in the bottom micrograph; a) micrograph without annotations; b) micrograph with annotations.

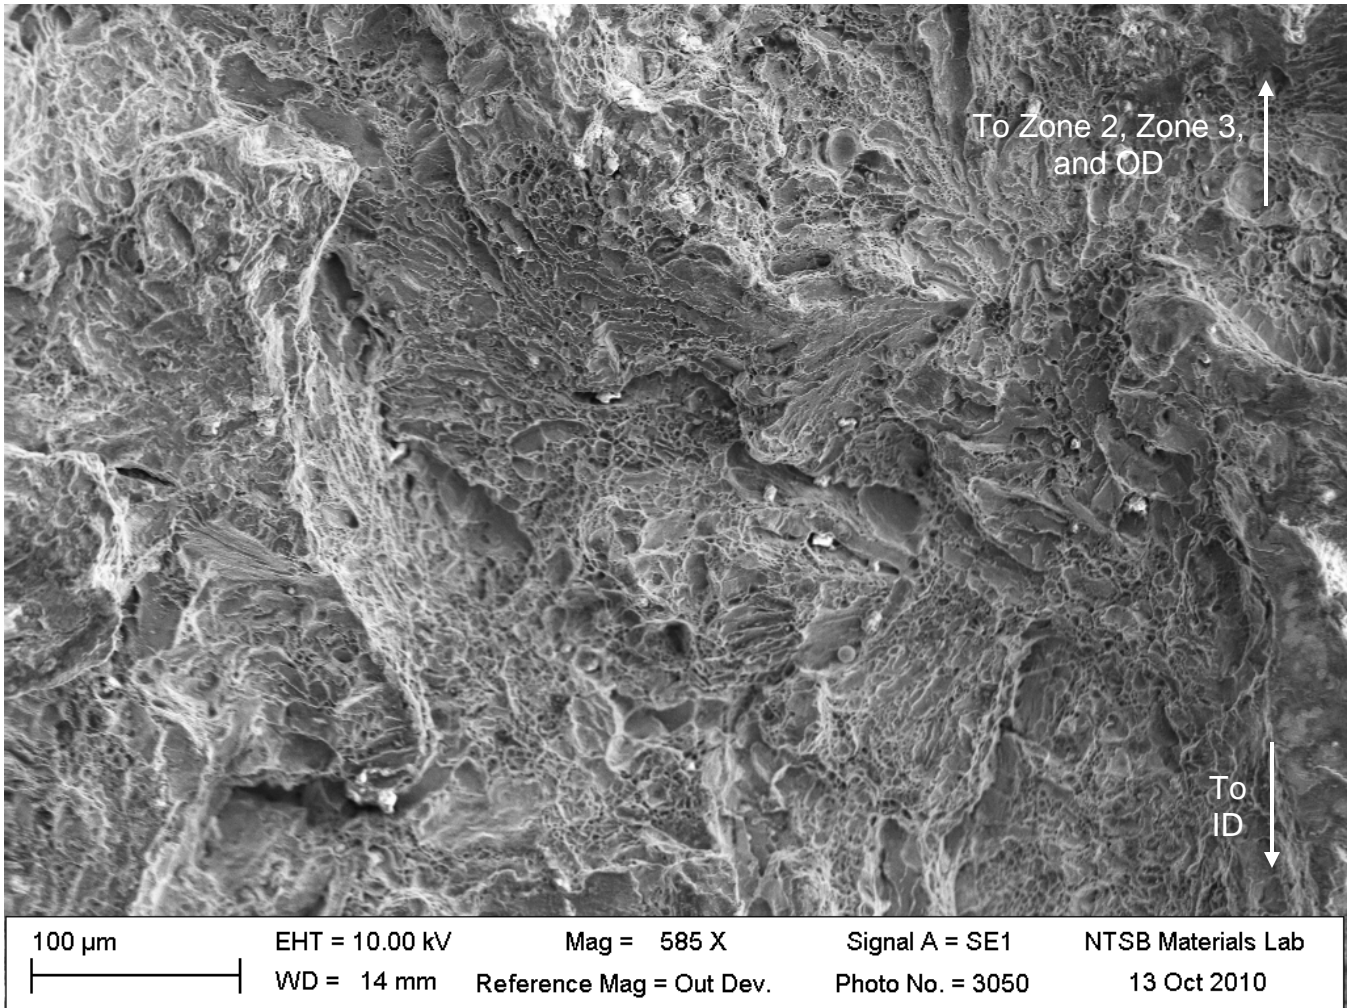
Scanning electron microscopy (SEM) of the fracture initiation site indicated three regions with different fracture morphologies. Referring to figure 34, dimples were observed on the rough fracture surface in zone 1 as illustrated by the SEM micrograph in figure 38, consistent with ductile fracture originating from the root of the weld. The fracture surface along zone 2 was oxidized and largely devoid of features except for a few locations between the 22 and 22.7 inch marks that had been protected by asphalt that had flowed onto the fracture surface. Those regions showed occasional feathery features and, in a few instances, striated features aligned with the crack arrest mark as shown in the SEM micrograph in figure 39. The fracture surface in zone 3 was smooth with hackle marks propagating across the surface as shown in the SEM micrograph in figure 40, consistent with quasicleavage fracture. An inhibited acid solution (ASTM G1 Solution C.3.5)¹² was used to remove rust on the fracture surface to see if it would reveal additional fracture features, however no additional features were observed.

Figure 38: Scanning electron micrograph from zone 1 of the initiation site. Dimples were observed on the fracture surface consistent with ductile fracture.

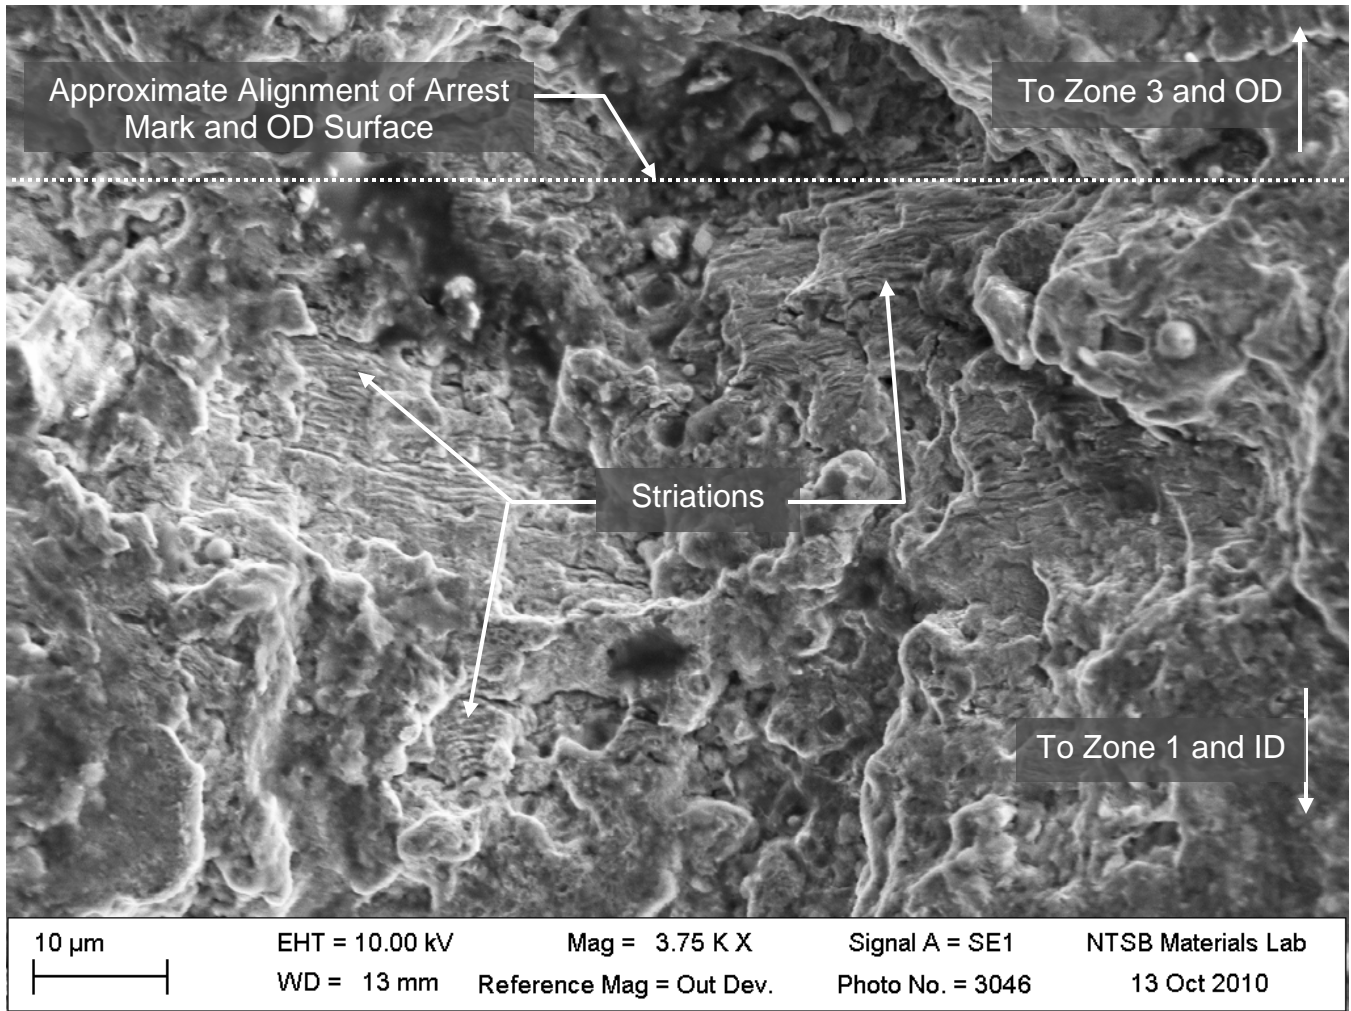
Figure 39: Scanning electron micrograph from zone 2 of the initiation site near the 22 inch mark. Striated features were observed on the fracture surface.

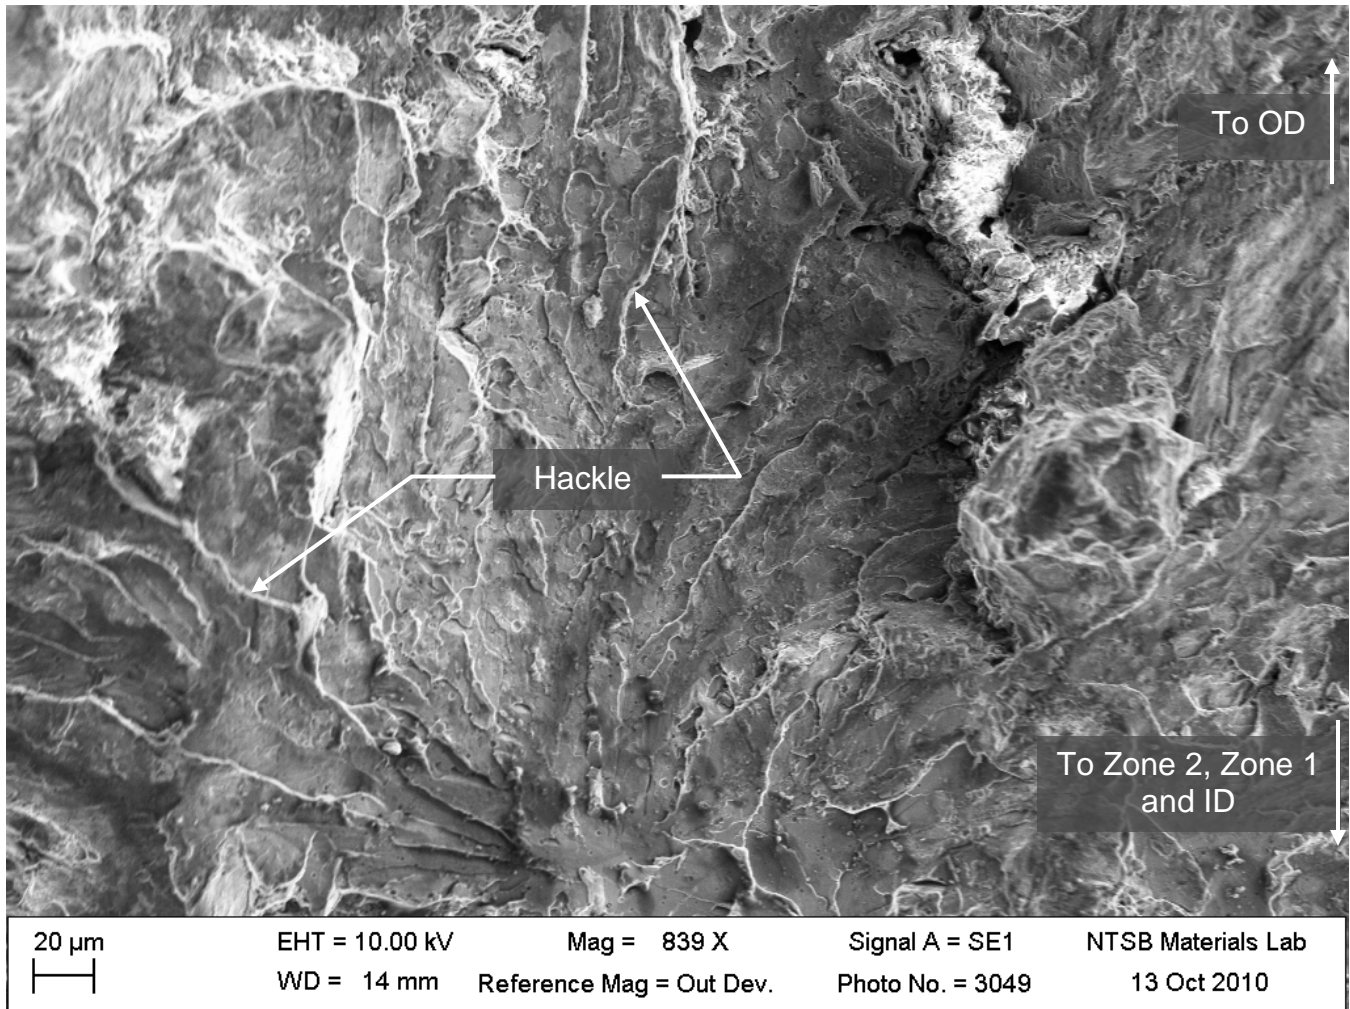
Figure 40: Scanning electron micrograph from zone 3 of the initiation site. The fracture surface had a smooth appearance with hackle marks propagating across the surface consistent with quasicleavage fracture.

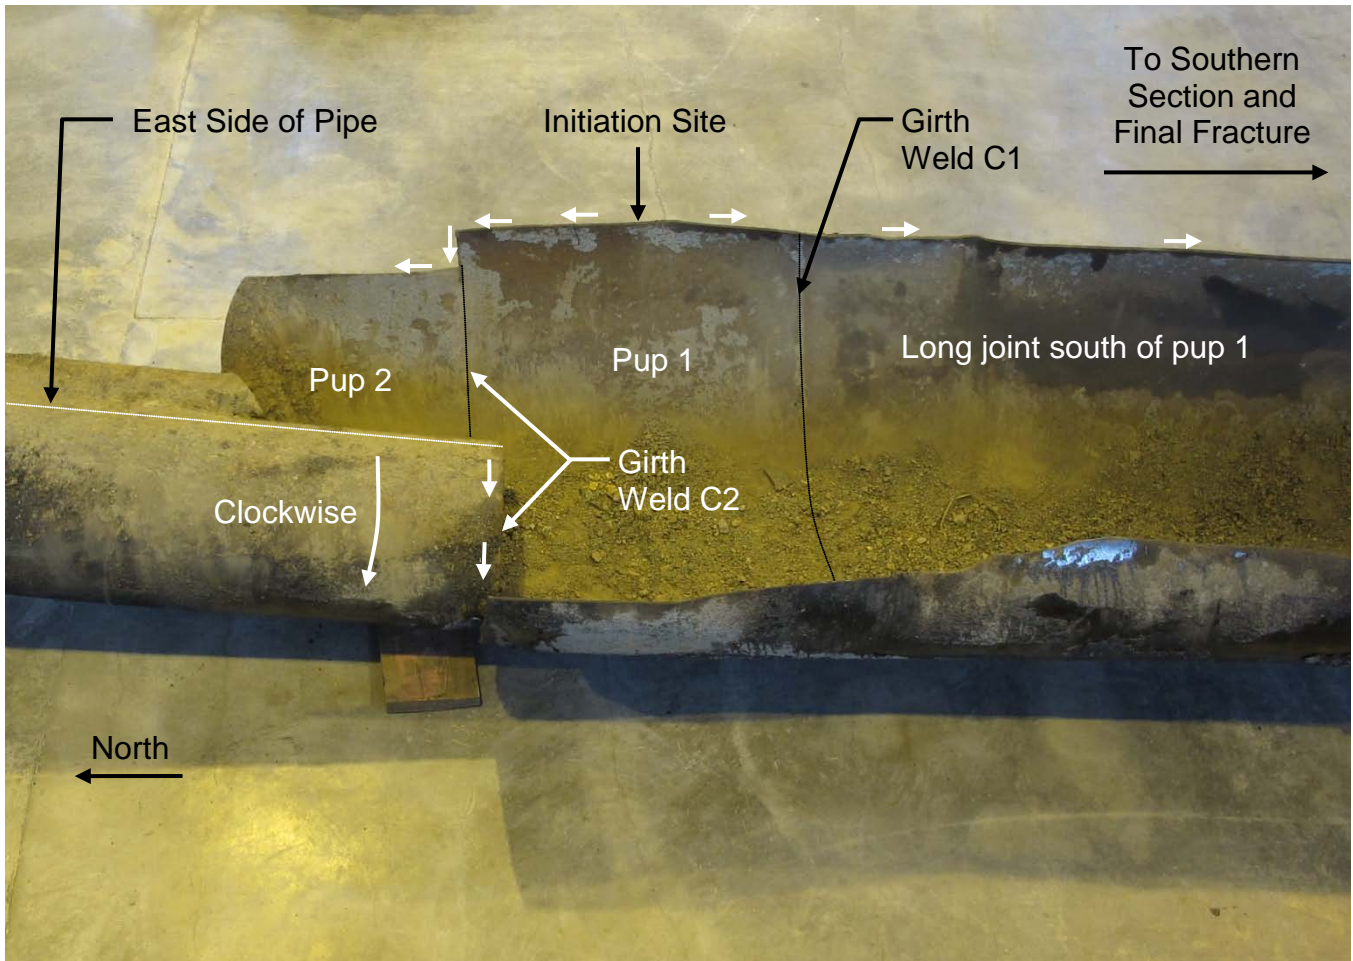
In summary, the fracture features in the center section of pipe were consistent with a crack that initiated in the pup 1 longitudinal seam between 20.3 inch and 22.7 inch north of the C1 girth weld as shown in figure 41. The direction of crack propagation consistent with the fracture features is indicated by the white arrows in the figure. The crack initiated in a manner consistent with ductile overstress from the root of the weld. At the boundary of the ductile overstress region, features consistent with progressive crack growth were observed. Moving toward the outer diameter surface, quasicleavage features were observed consistent with overstress and final rupture. The fracture features were consistent with one branch of the crack propagating south into the long joint south of pup 1 and toward the point of final fracture. The fracture features were consistent with the other branch propagating north until it intersected the C2 girth weld. The fracture features were then consistent with the crack propagating in the counterclockwise and clockwise directions along the C2 girth weld. The counterclockwise branch propagated 27 inch toward the true top of the pipe and arrested. The clockwise branch propagated 6.25 inch where it intersected the pup 2 longitudinal seam. The out of plane bending and shear on the pup 2 longitudinal seam fracture surface were consistent with the crack continuing to propagate north along the pup 2 longitudinal seam where it arrested.

Figure 41: Photograph of center section showing the location of the initiation site in pup 1 and white arrows indicating the direction of crack propagation consistent with the observed fracture features.

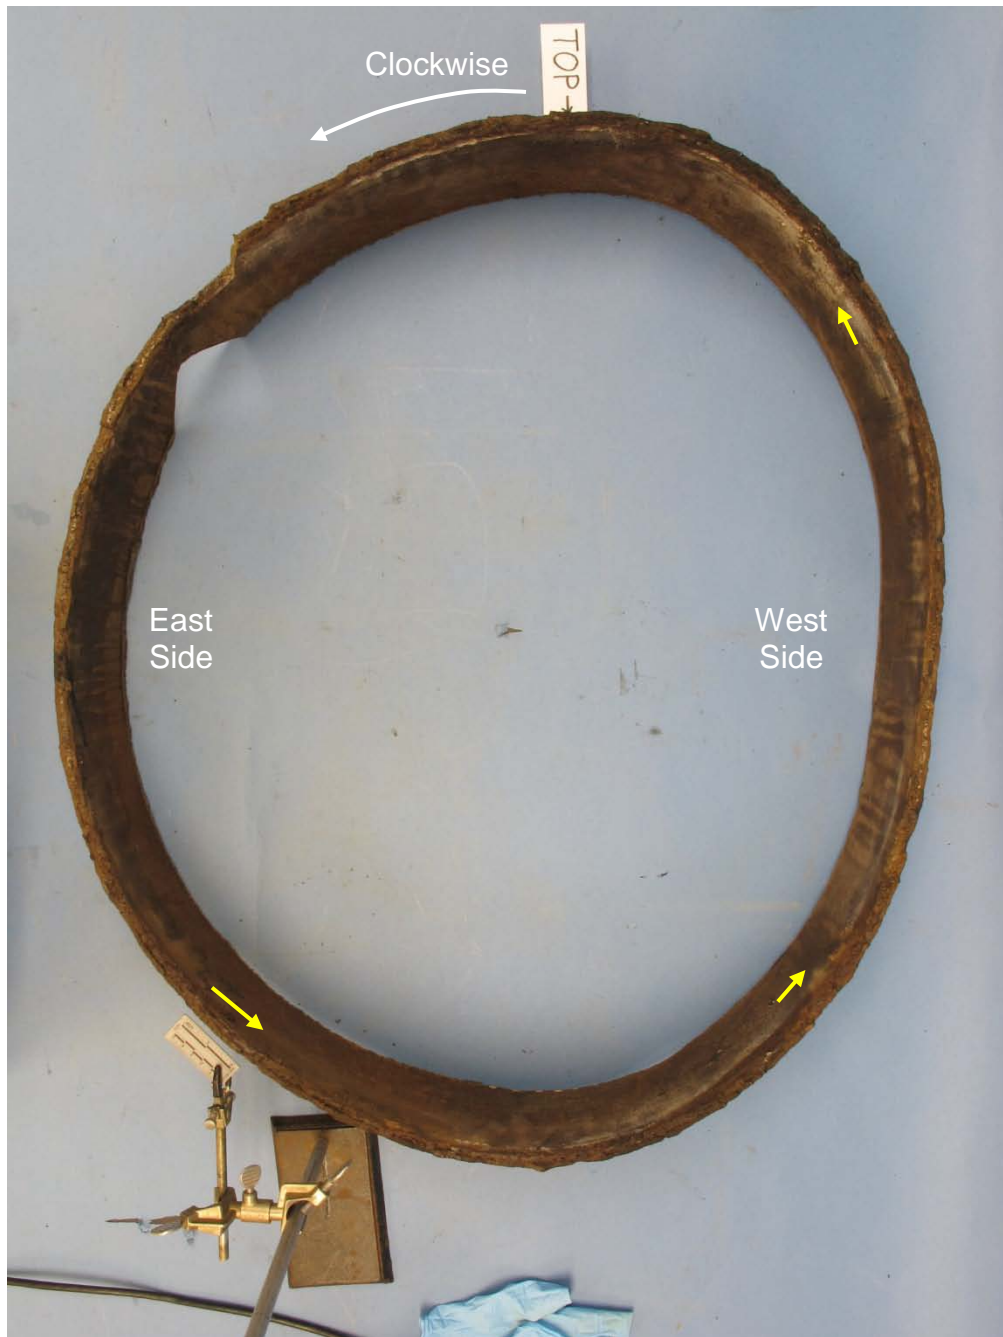
Examination of much of the circumferential fracture at girth weld C5 was inconclusive as the fracture features that might indicate direction of propagation could not be conclusively discriminated from the microstructure of the weld. However, there were several spots indicated by yellow arrows in figure 42 where features similar to chevron or radial lines could be discriminated that enabled a partial determination of the direction of crack propagation. An example macrophotograph is shown in figure 43. The examination indicated that the girth weld fracture likely originated along the east side of the pipe with at

least one branch crack propagating across the bottom of the pipe and around the west side. No signs of corrosion or perforations in the weld were observed.

Figure 42: Photograph of the south half of the girth weld fracture at C5 between pup 4 and pup 5. The view is of the half associated with pup 4 viewed in the south direction (north out of the page). Yellow arrows in the figure indicate where the location and direction of crack propagation could be determined.

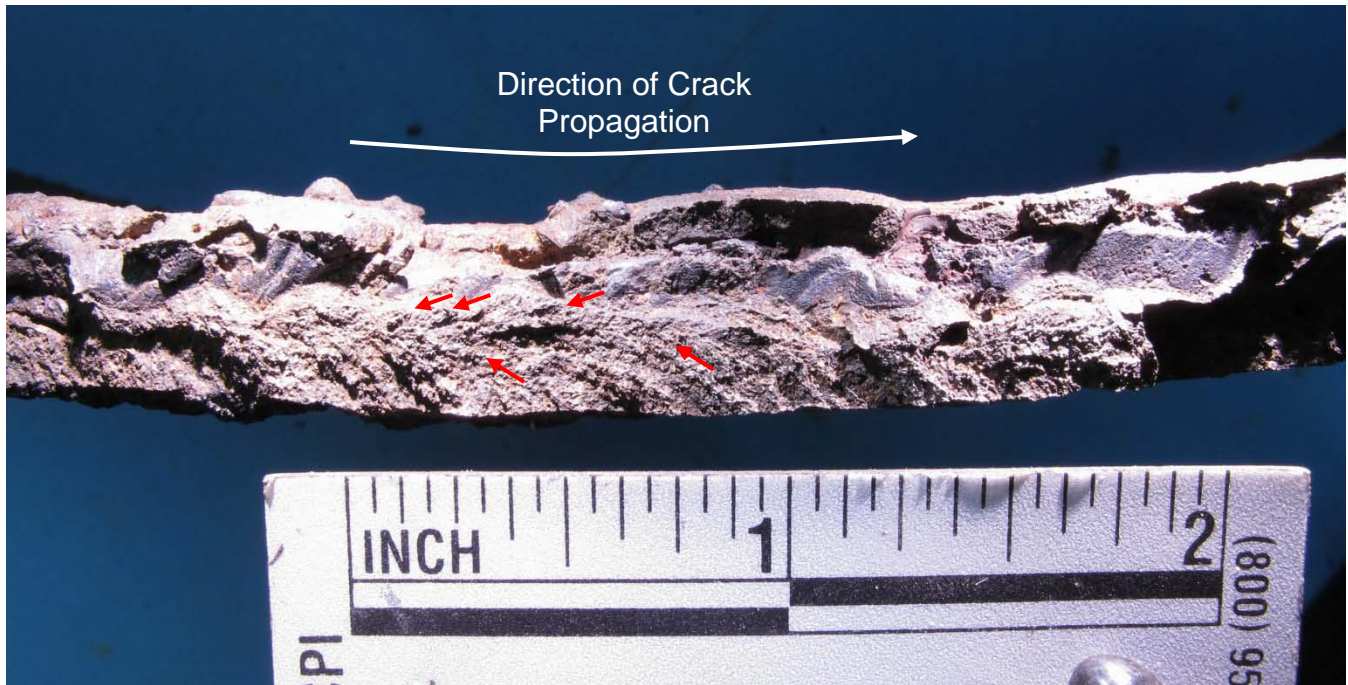
Figure 43: Example macrophotograph of the girth weld fracture surface approximately 150° clockwise from the true top of the pipe. The red arrows indicate lines on the fracture surface that point back in the direction of the crack origin.

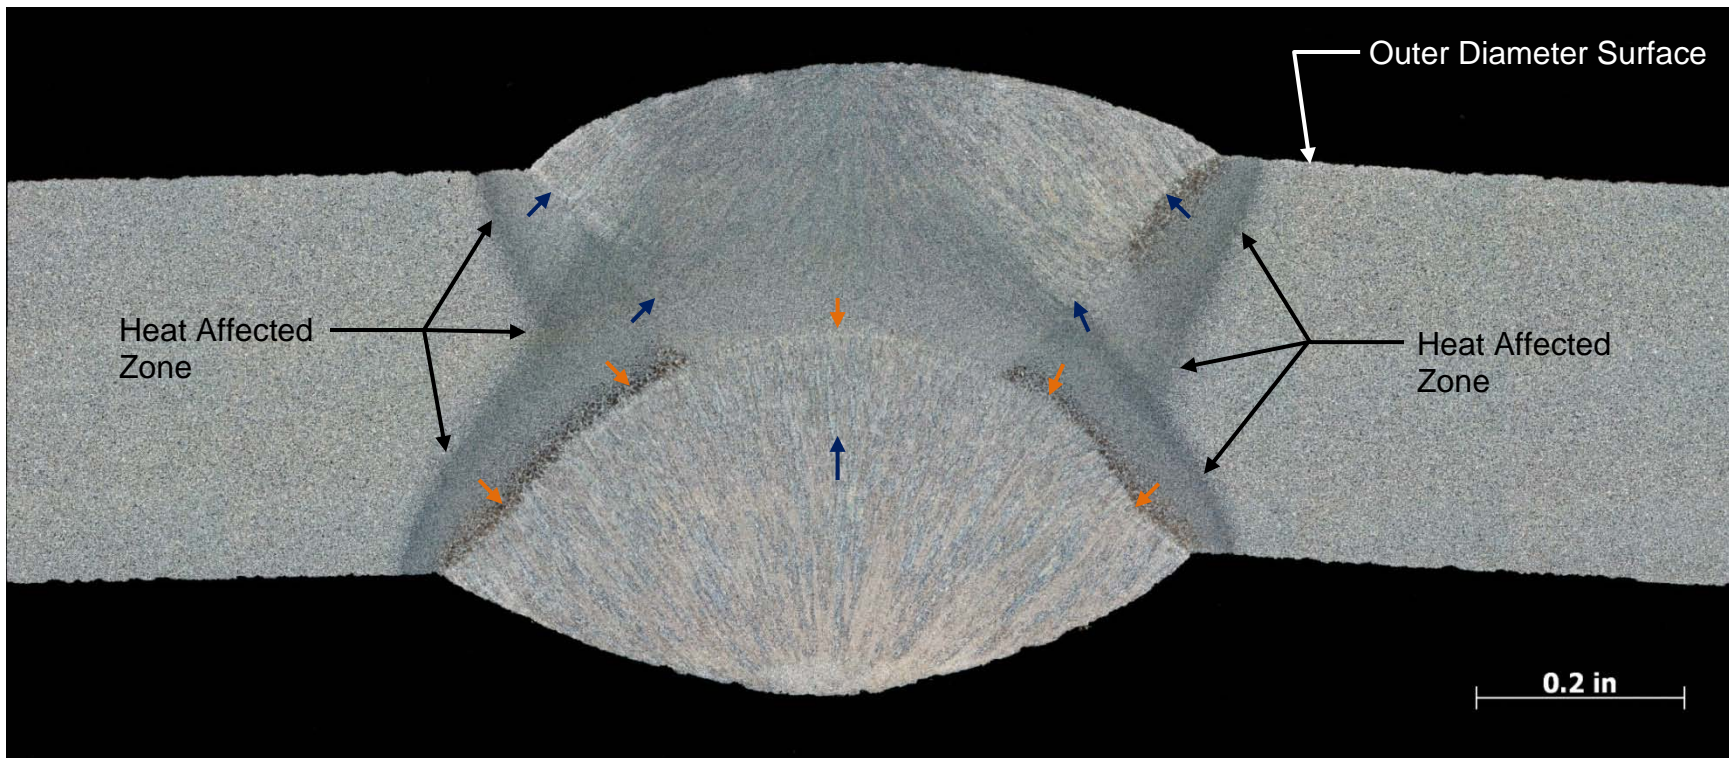
The microstructure of the seam weld in the long joint south of pup 1 was consistent with a double submerged arc welding process as shown in figure 44. The microstructure of the weld was consistent with the first pass along the outer diameter surface and the second pass along the inner diameter surface. The weld pool from the outer pass was 0.659 inch wide at the outer diameter, the weld pool from the inner pass was 0.723 inch wide at the inner diameter, and the two passes overlapped in the middle of the weld by 0.10 inch. The outer diameter weld cap was 0.095 inch proud of the outer diameter surface. The inner diameter weld cap was 0.123 inch proud of the inner diameter surface. There was a 5° angle between the tangent lines to the inner diameter surface on either side of the seam. The heat affected zone had an hourglass shape. It was 0.77 inch wide at the outer diameter, decreased to a width of 0.61 inch in the center of the wall, and increased to a width of 0.81 inch at the inner diameter.

Figure 44: Etched metallographic cross section of the longitudinal seam in the long joint south of pup 1 taken 6 inch south of girth weld C1. The microstructure of the weld was consistent with a double submerged arc welding process. Blue arrows – weld pool from first pass along outer diameter surface. Orange arrows – weld pool from second pass along inner diameter surface.

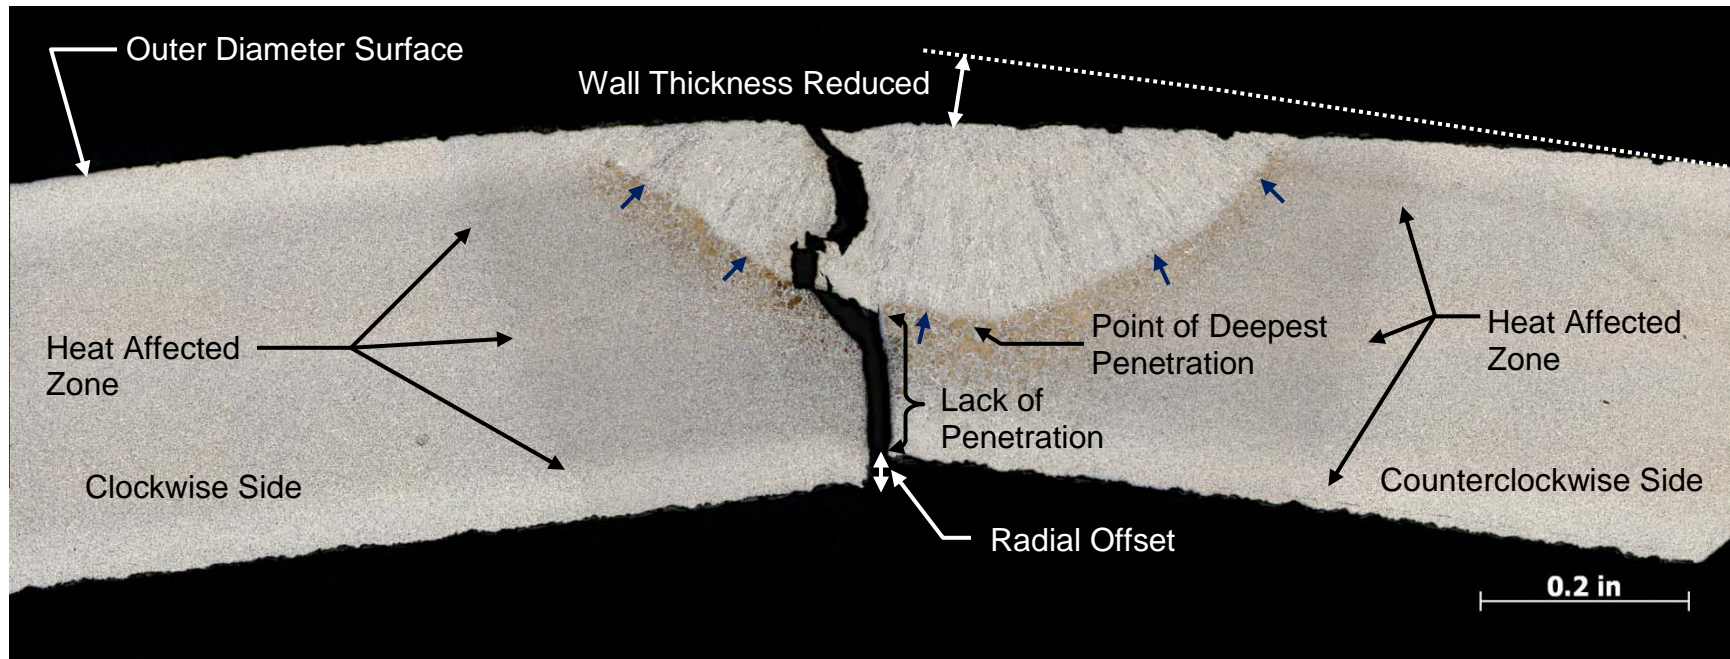
The weld microstructure for pup 1 was consistent with a fusion welding process with filler metal laid down into the weld joint along the outer diameter surface of the seam and a ground down weld cap. A typical cross section 9 inch north of girth weld C1 is shown in figure 45. The two sides of the seam were matched up in the longitudinal direction, and glued together for mounting and polishing. The two sides of the seam are within 0.005 inch or less of one another in the longitudinal direction. The point of deepest weld penetration was 0.185 inch and was off center of the seam by 0.084 inch. The wall thickness on the counterclockwise side of the seam had been reduced to 0.315 inch by grinding. At its widest, the weld was 0.662 inch. There was a 0.030 inch radial offset between the mating edges of the plate and a 15° angle between the tangent lines to the inner diameter surface on either side of the seam. The heat affected zone decreased in width continuously from 0.88 inch wide near the outer diameter surface to 0.72 inch near the inner diameter surface.

Figure 45: Etched metallographic mating fracture cross section of the longitudinal seam in pup 1 taken 9 inch north of girth weld C1. The two sides of the seam are aligned to within 0.005 inch in the longitudinal direction. The microstructure of the weld was consistent with a fusion welding process along the outer diameter surface of the seam. Blue arrows – weld pool boundary along outer diameter surface seam.

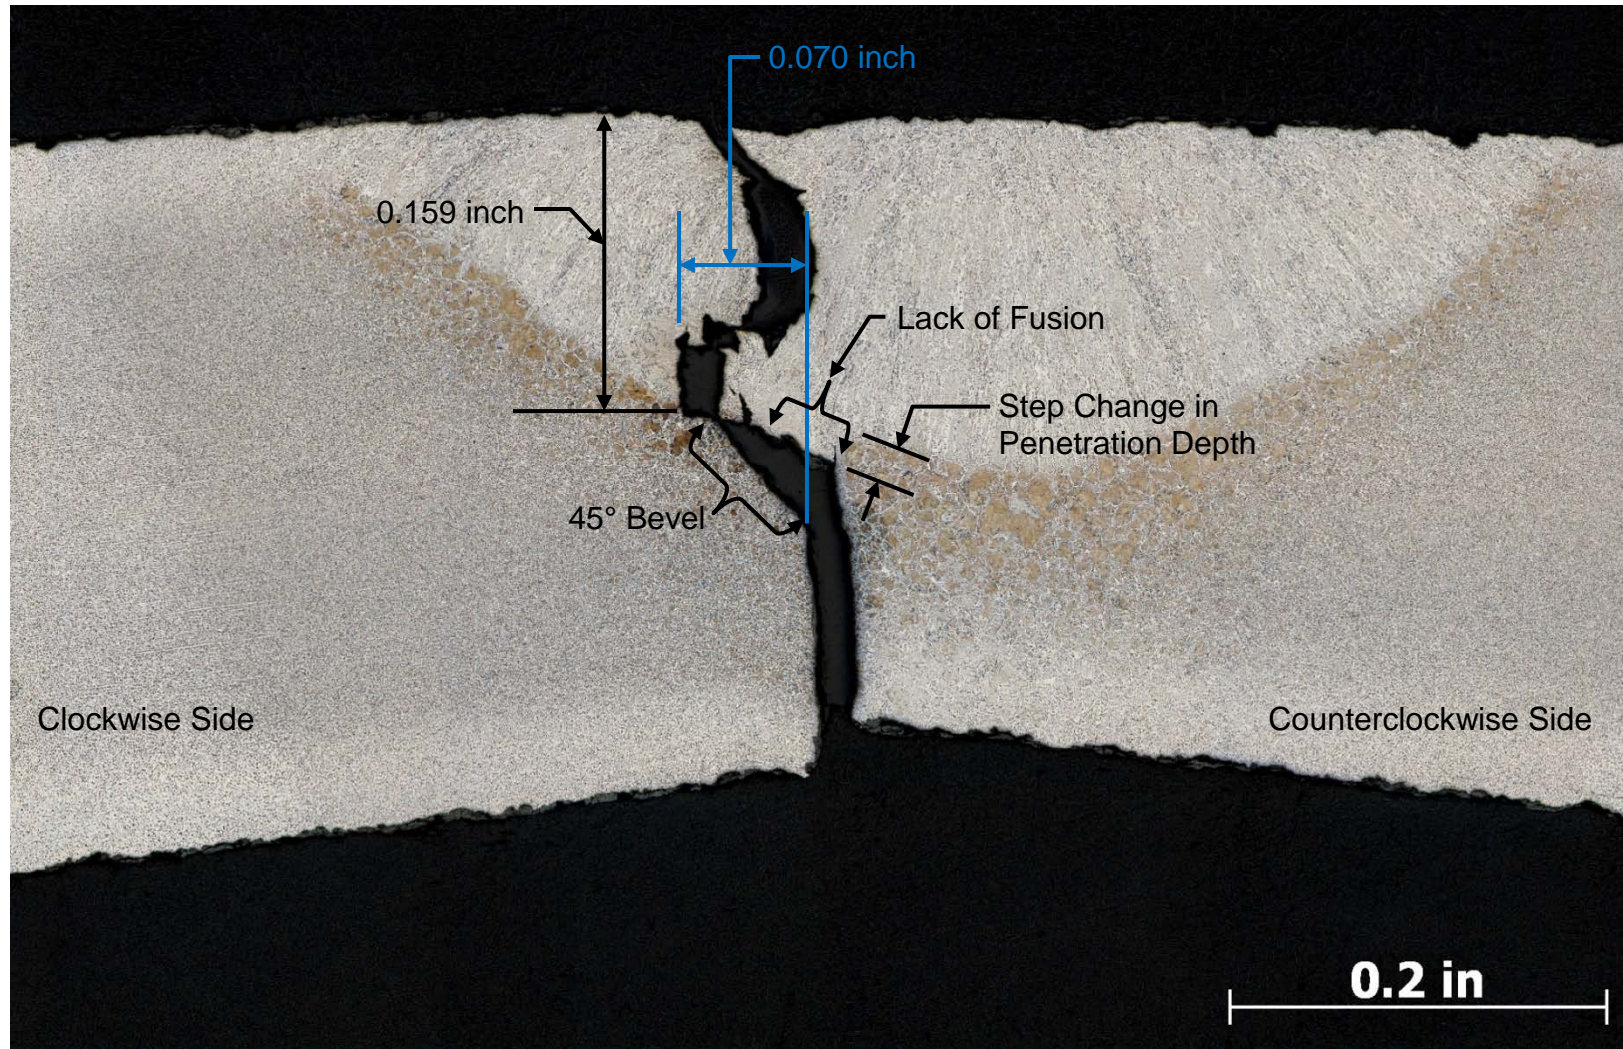
Figure 46: Higher magnification view of the seam in pup 1 (see figure 44) showing the offset from the seam and depth of penetration at the plane of fracture.
