NATIONAL TRANSPORTATION SAFETY BOARD

Metallurgical Group Chairman
Factual Report

MATERIALS LABORATORY FACTUAL REPORT

Place : San Bruno, CA
Date : September 9, 2010
Vehicle : Natural Gas Transmission Pipeline
NTSB No. : DCA10MP008
Investigator : Ravi Chhatre, RPH-20

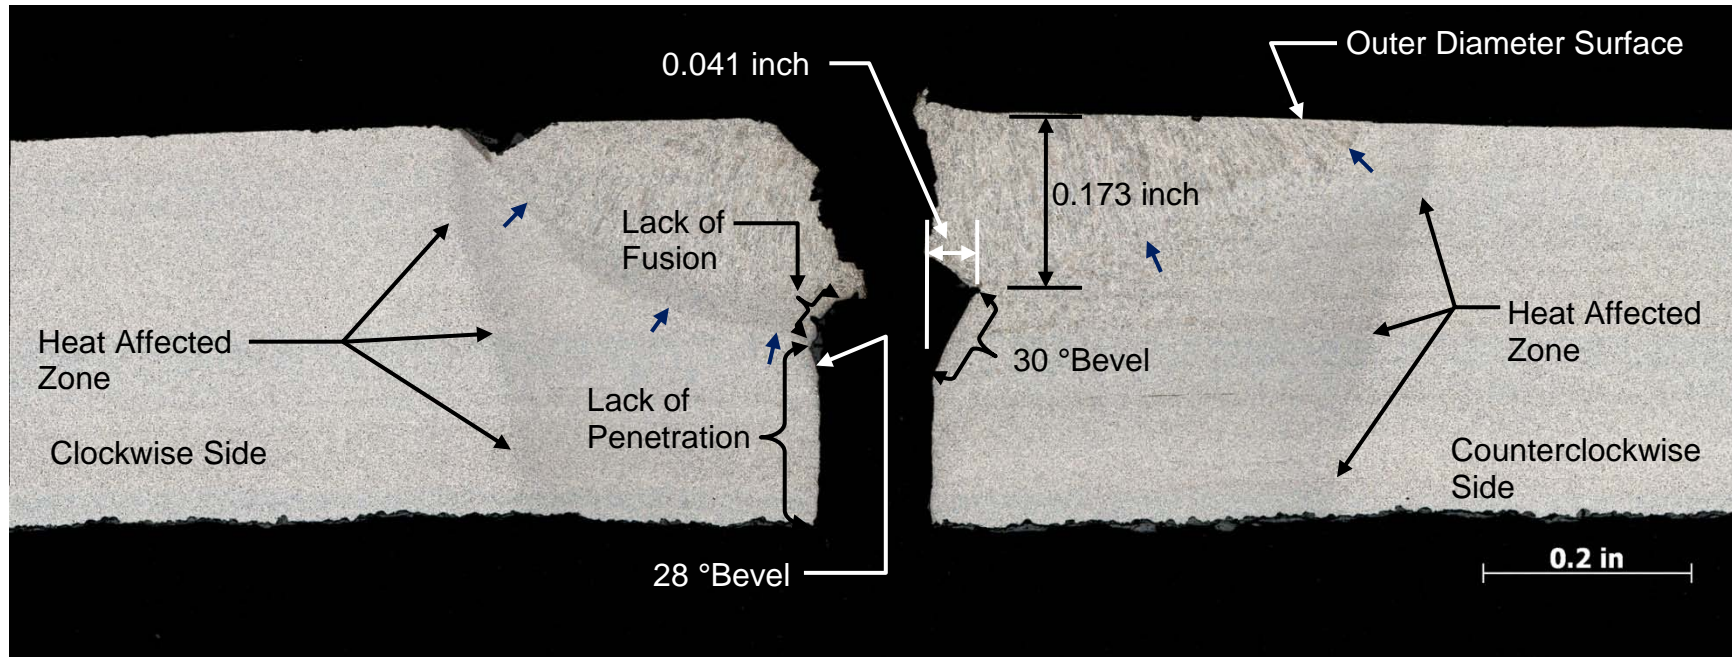
Figure 47: Etched metallographic mating faces cross section of the longitudinal seam in pup 2 taken 9 inch south of girth weld C3. Lineup in the longitudinal direction is within 0.05 inch. The microstructure of the weld was consistent with a fusion welding process along the outer diameter surface of the seam. Blue arrows – weld pool boundary along outer diameter surface seam.

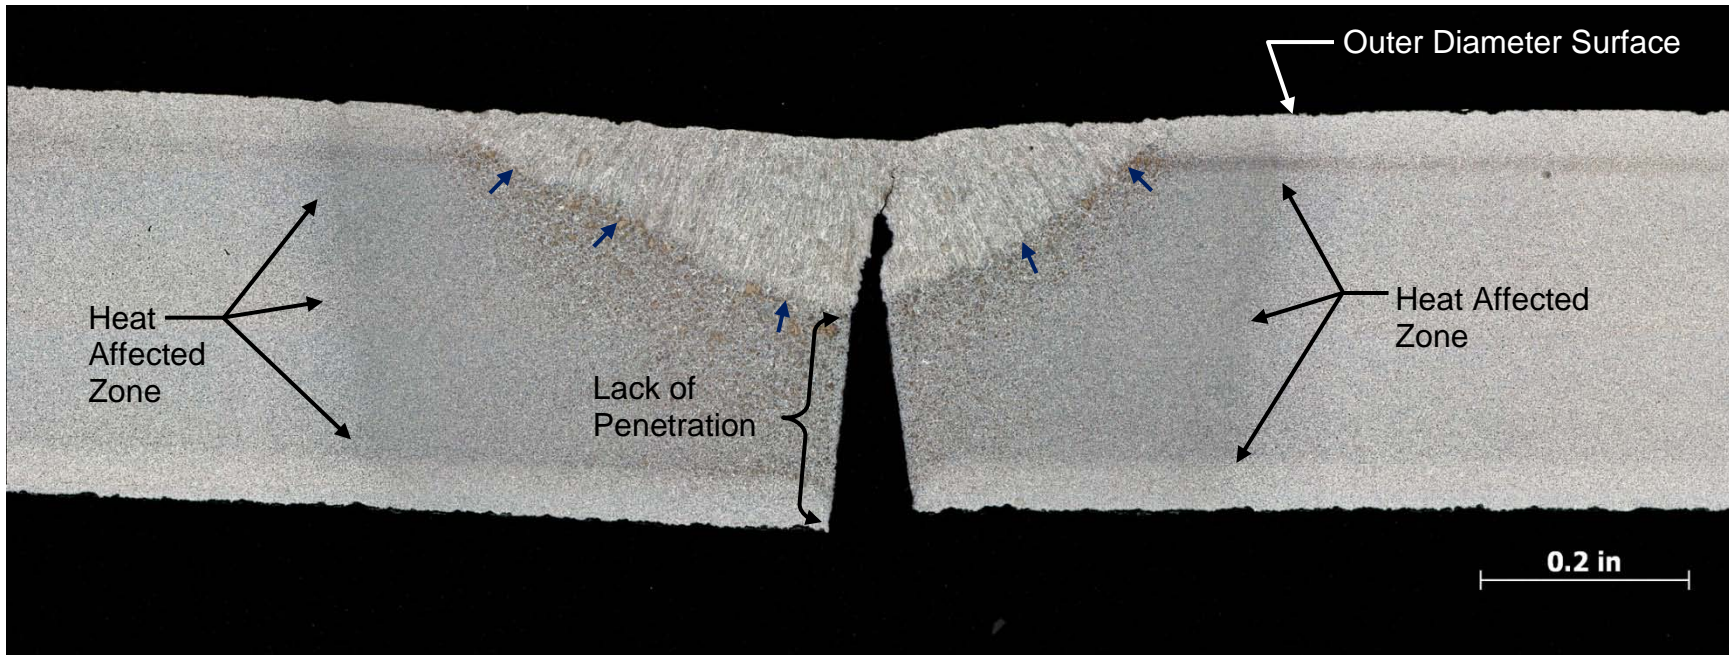
Figure 48: Etched metallographic cross section of the longitudinal seam in pup 3 taken 10 inch north of girth weld C3. The microstructure of the weld was consistent with a fusion welding process along the outer diameter surface of the seam. Blue arrows – weld pool boundary along outer diameter surface seam.

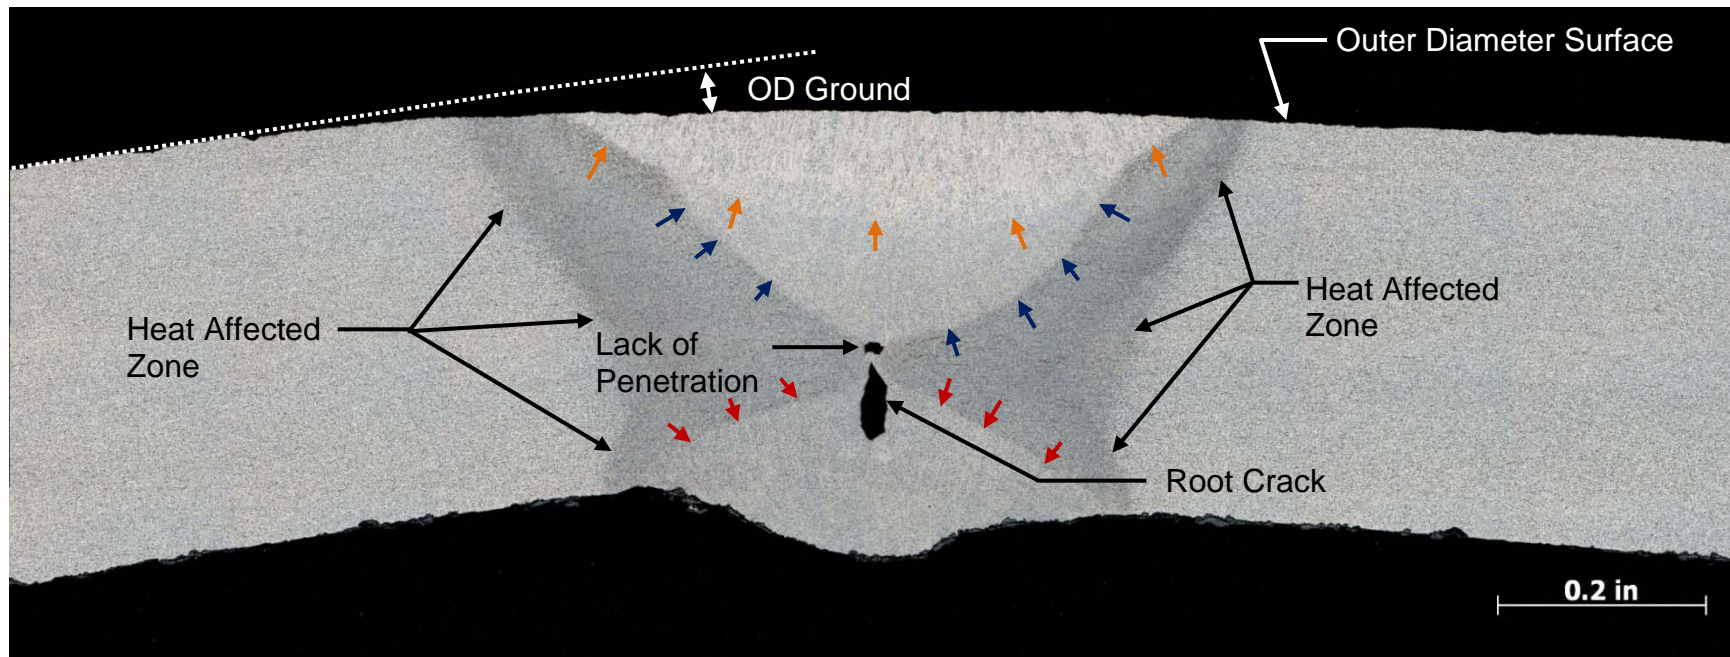
Figure 49: Etched metallographic cross section of the longitudinal seam in pup 4 taken 8 inch south of girth weld C5. The microstructure of the weld was consistent with a multi-pass fusion welding process along the outer diameter surface of the seam and a fusion welding process along the inner diameter surface of the seam. Blue arrows – weld pool boundary from first pass along outer diameter surface. Orange arrows – weld pool boundary from second pass along outer diameter surface. Red arrows – weld pool boundary from pass along inner diameter surface.

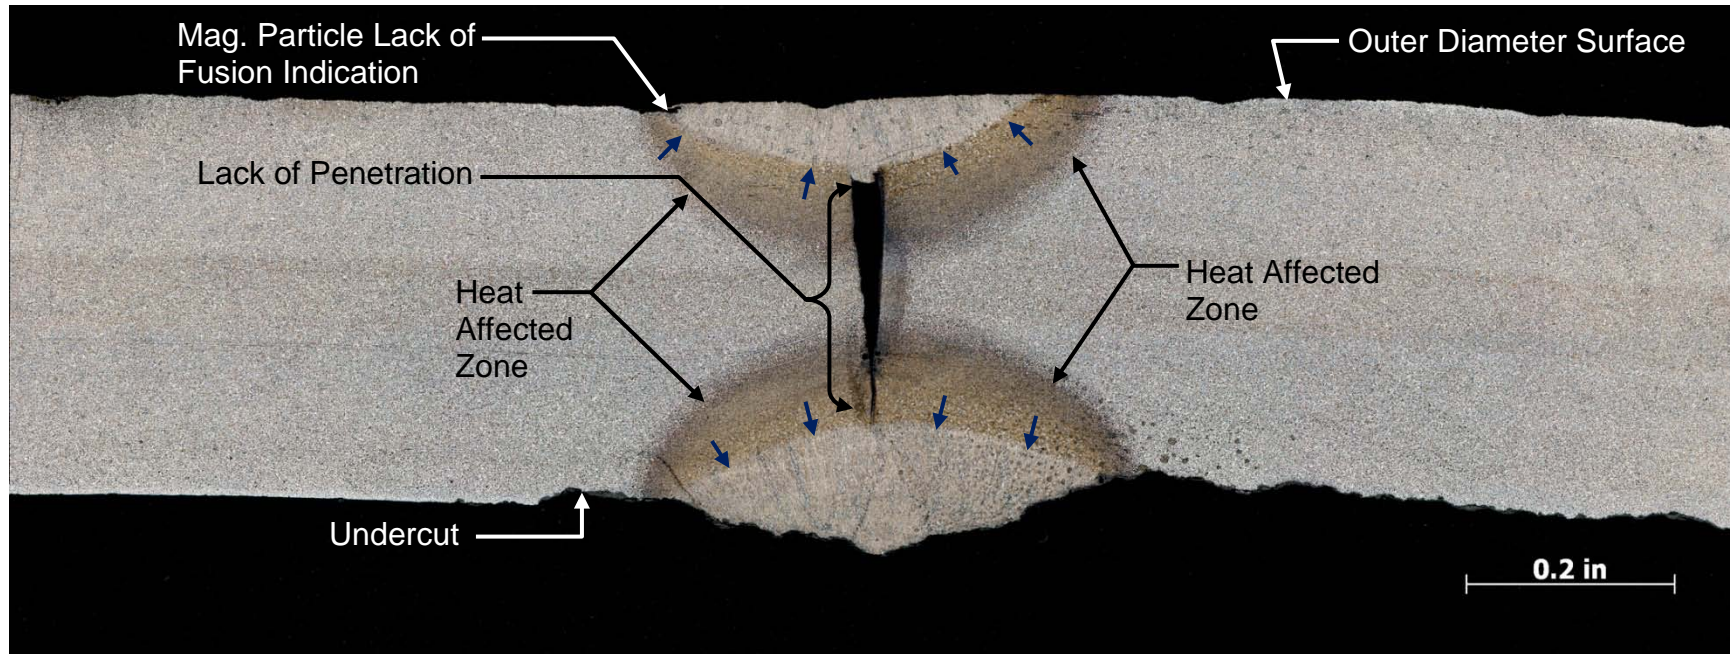
Figure 50: Etched metallographic cross section of the longitudinal seam in pup 5 taken 5.5 inch north of girth weld C5 where magnetic particle inspection indicated lack of fusion. The microstructure of the weld was consistent with a fusion welding process along the outer diameter surface of the seam and a fusion welding process along the inner diameter surface of the seam. Blue arrows – weld pool boundaries along outer and inner diameter surface seams.

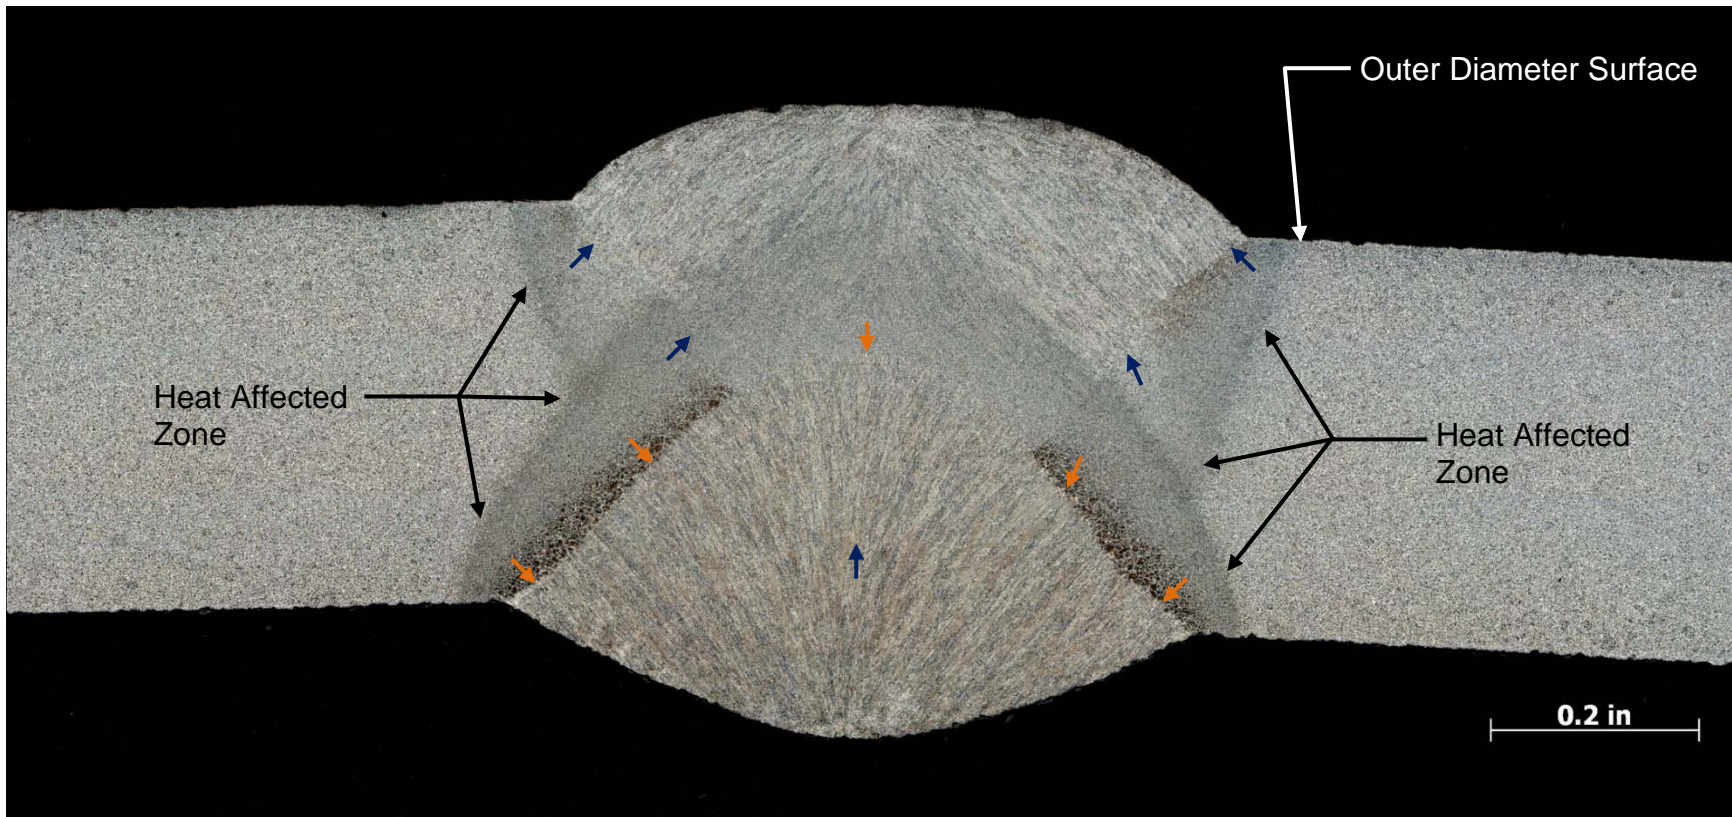
Figure 51: Etched metallographic cross section of the longitudinal seam in the pup 6 taken 6 inch north of girth weld C6. The microstructure of the weld was consistent with a double submerged arc welding process. Blue arrows – weld pool from first pass along outer diameter surface. Orange arrows – weld pool from second pass along inner diameter surface.

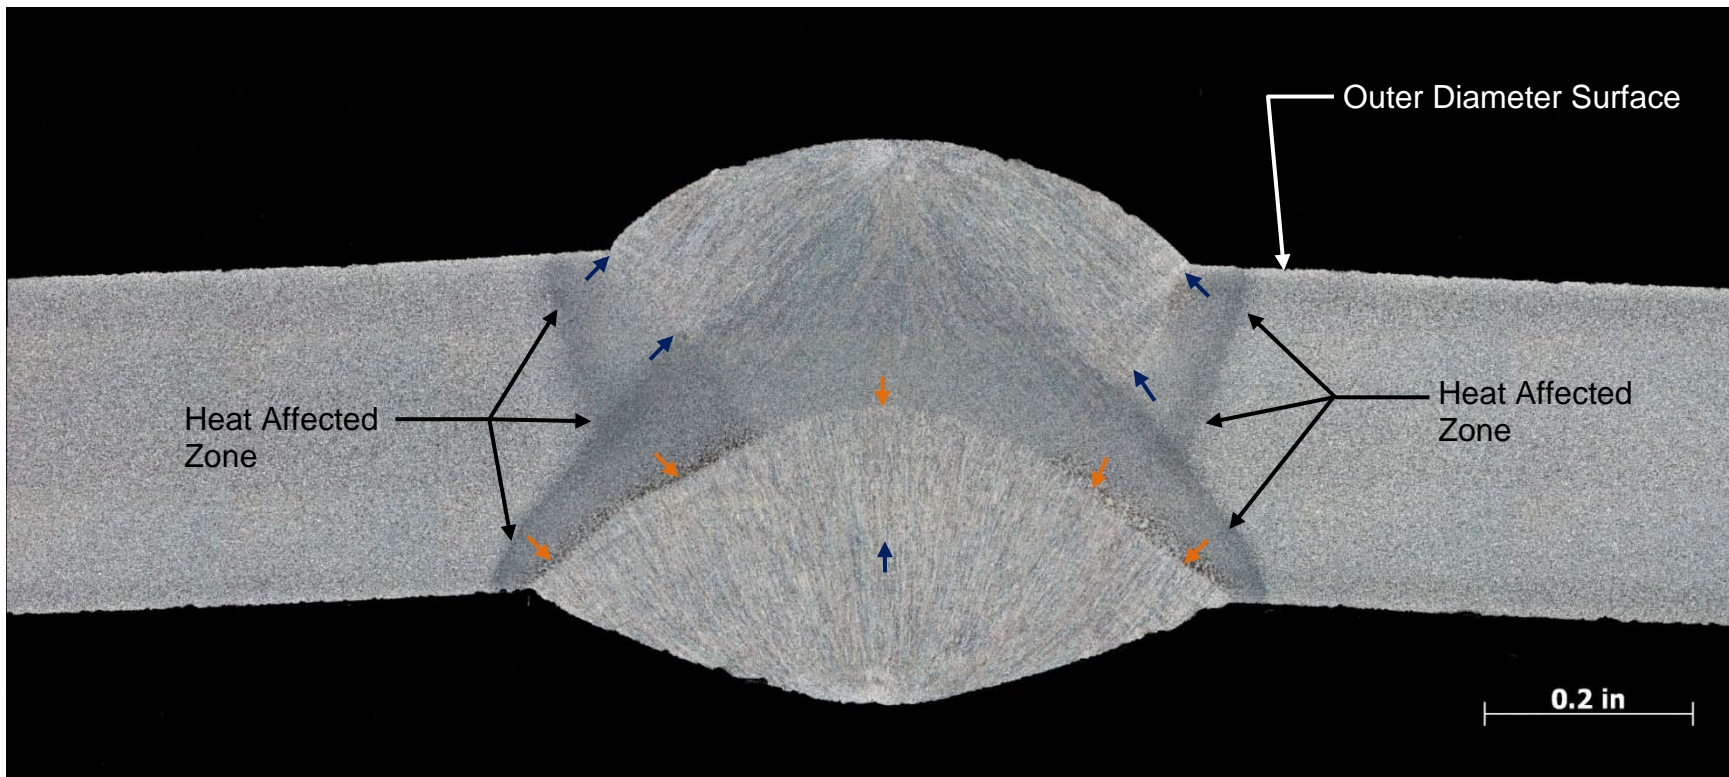
Figure 52: Etched metallographic cross section of the longitudinal seam in the long joint north of pup 6 taken 14 inch north of girth weld C7. The microstructure of the weld was consistent with a double submerged arc welding process. Blue arrows – weld pool from first pass along outer diameter surface. Orange arrows – weld pool from second pass along inner diameter surface.
