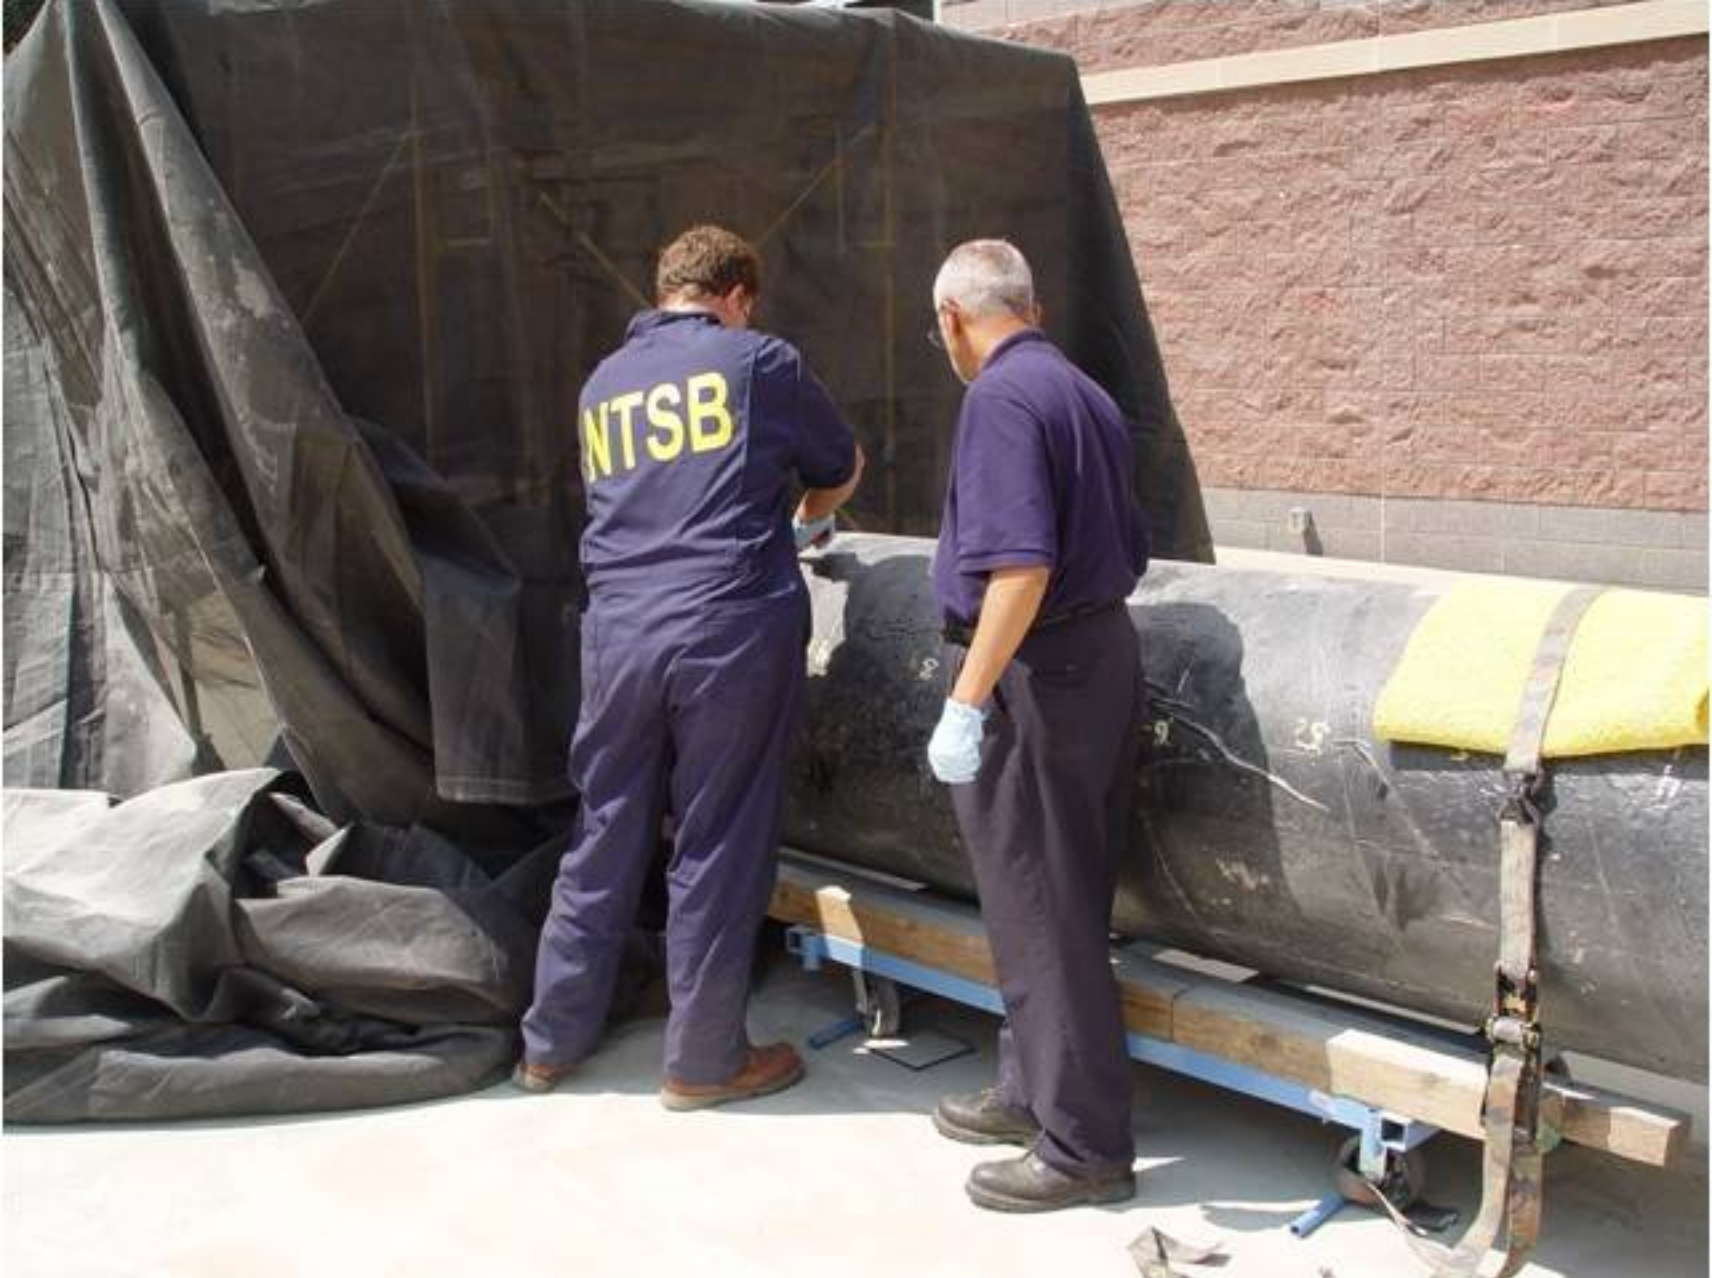
Metallurgical Group- Picture 16 Metallurgical team members inspect the finish from early grit blasting of the ruptured pipe (piece b) at the NTSB Ashburn, Virginia facility.
