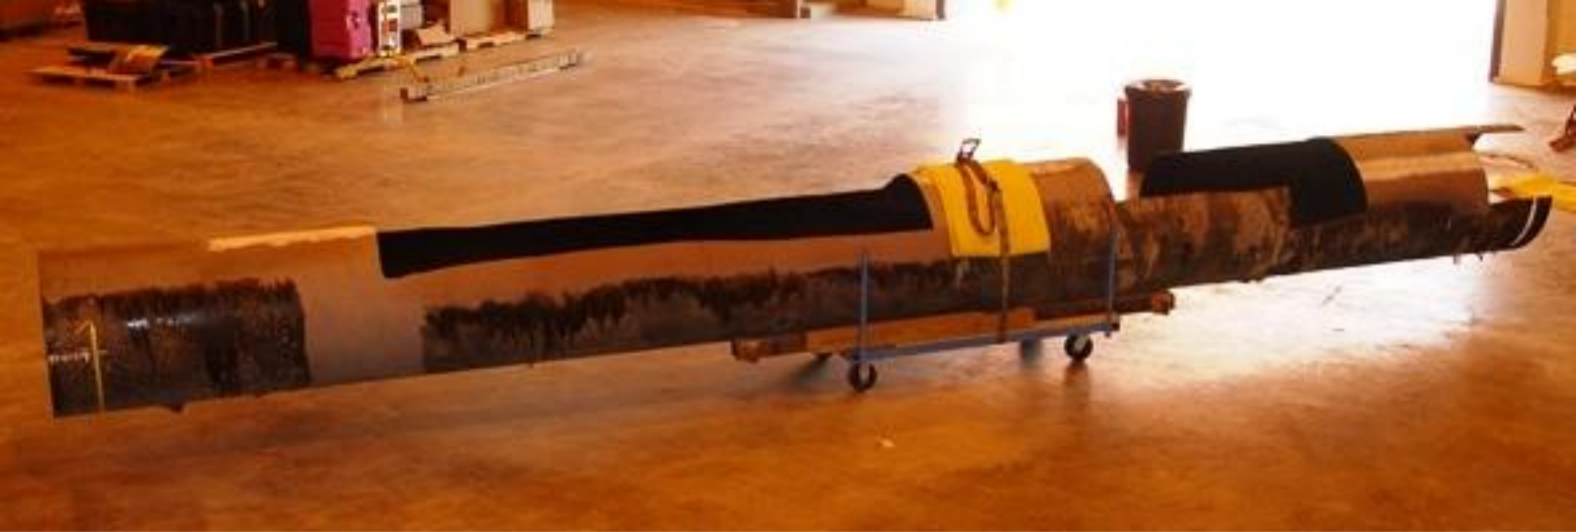
Metallurgical Group-Picture 19 Ruptured pipe piece showing areas where samples have been cut at the NTSB Ashburn, Virginia Facility
