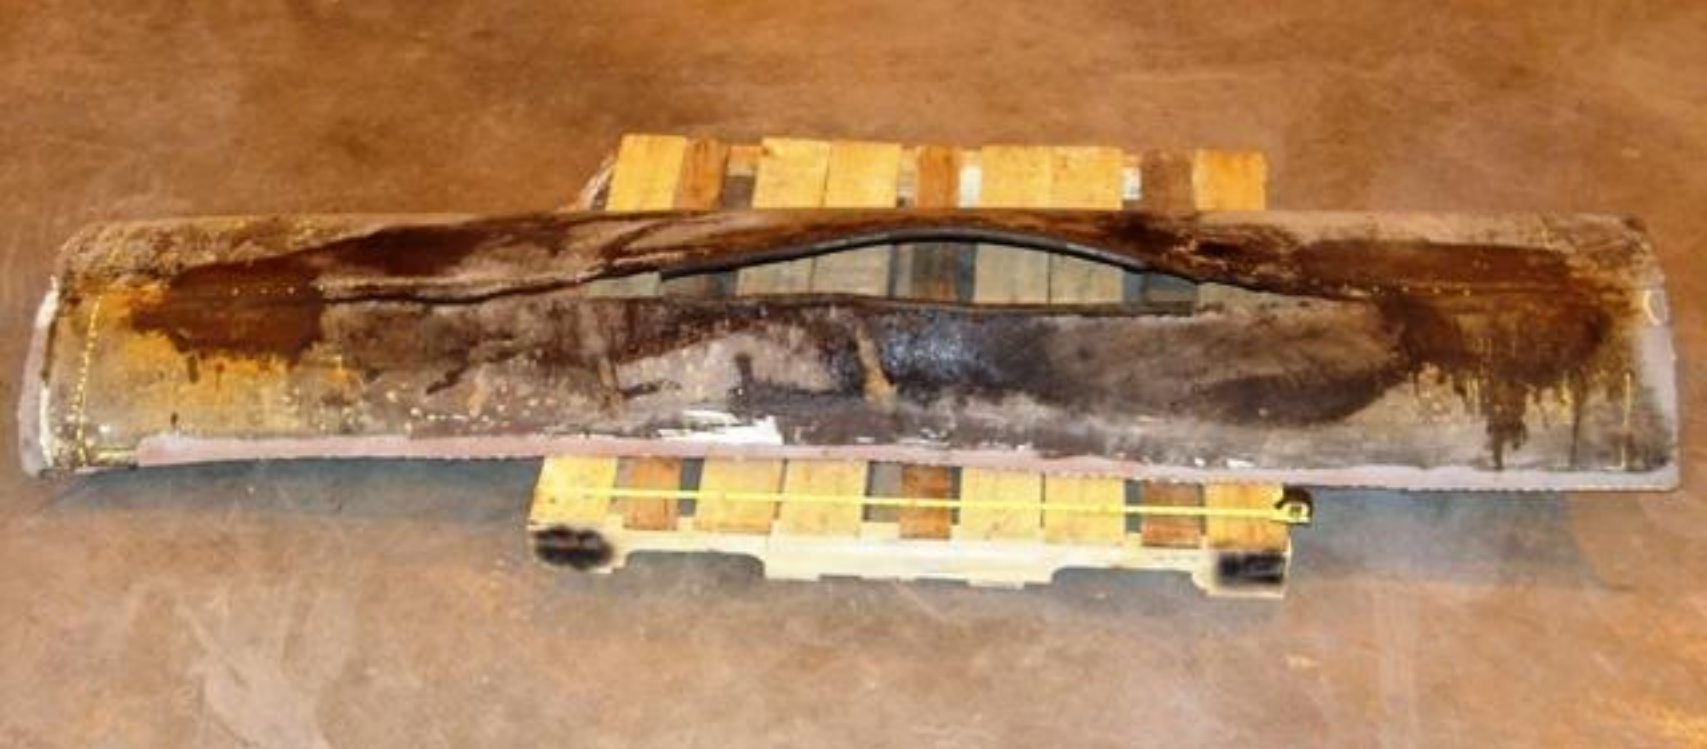
Metallurgical Group-Picture 20 Sample containing the rupture removed from the ruptured pipe piece at the NTSB Ashburn, Virginia Facility.
