May 28, 2002

N.T.S.B.

RE: Examination of Failed Aluminum Spars From a Cessna Aircraft
N444JV LAX02FA101; SEAL Job No. 9034

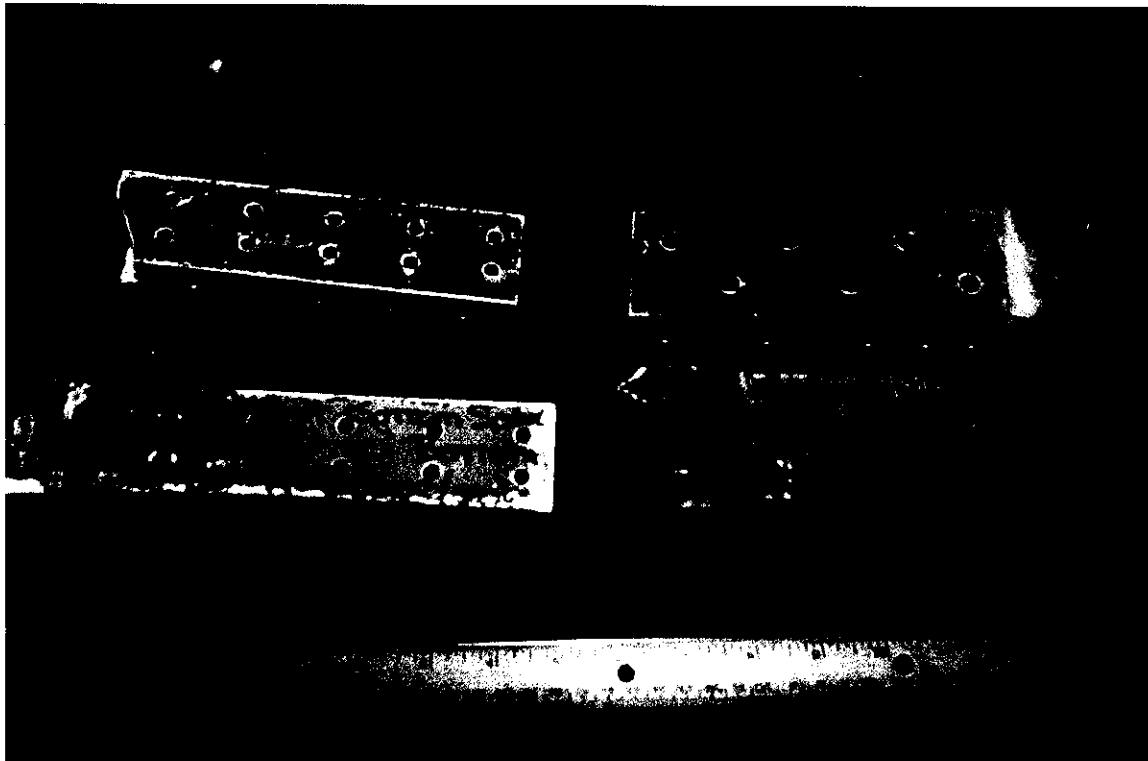
VISUAL EXAMINATION: Figure 1 shows the failed aluminum spars received for examination. The fracture surface of the spars was examined using a stereo light microscope. Then, specimens for chemical analysis, hardness testing, and electrical conductivity measurements were removed.

Figure 1. A color photograph showing the failed aluminum spars received for examination.

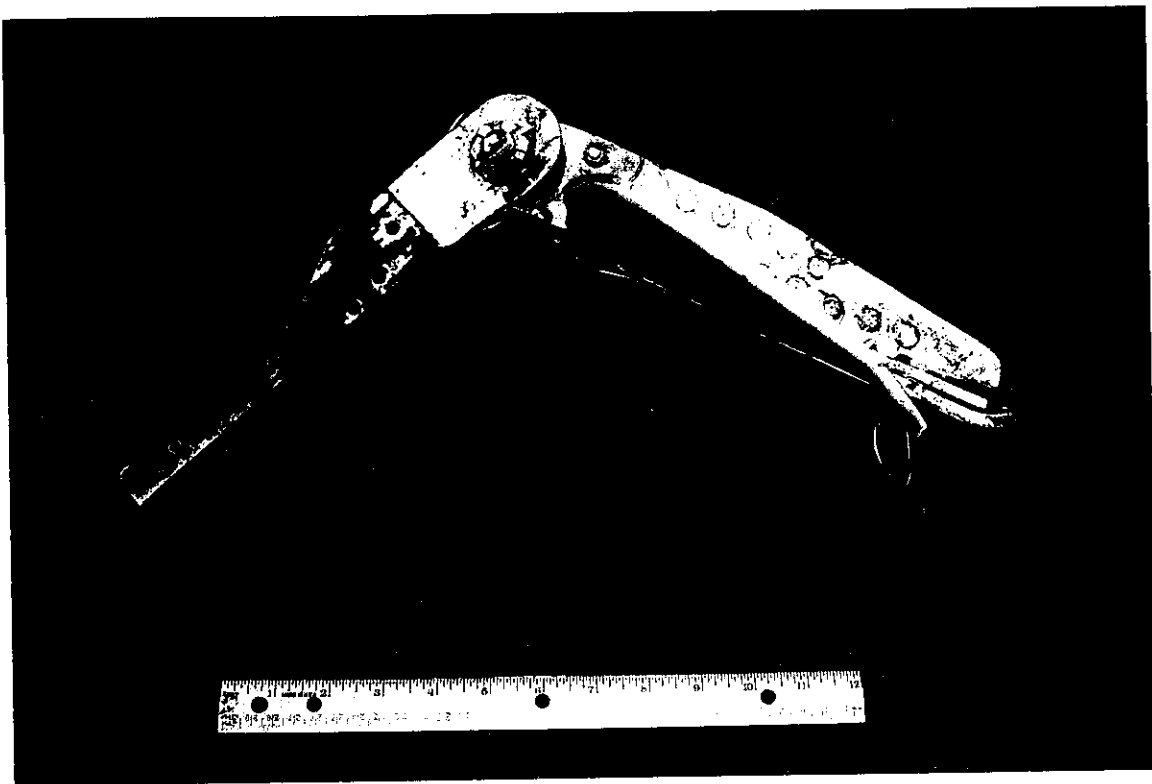
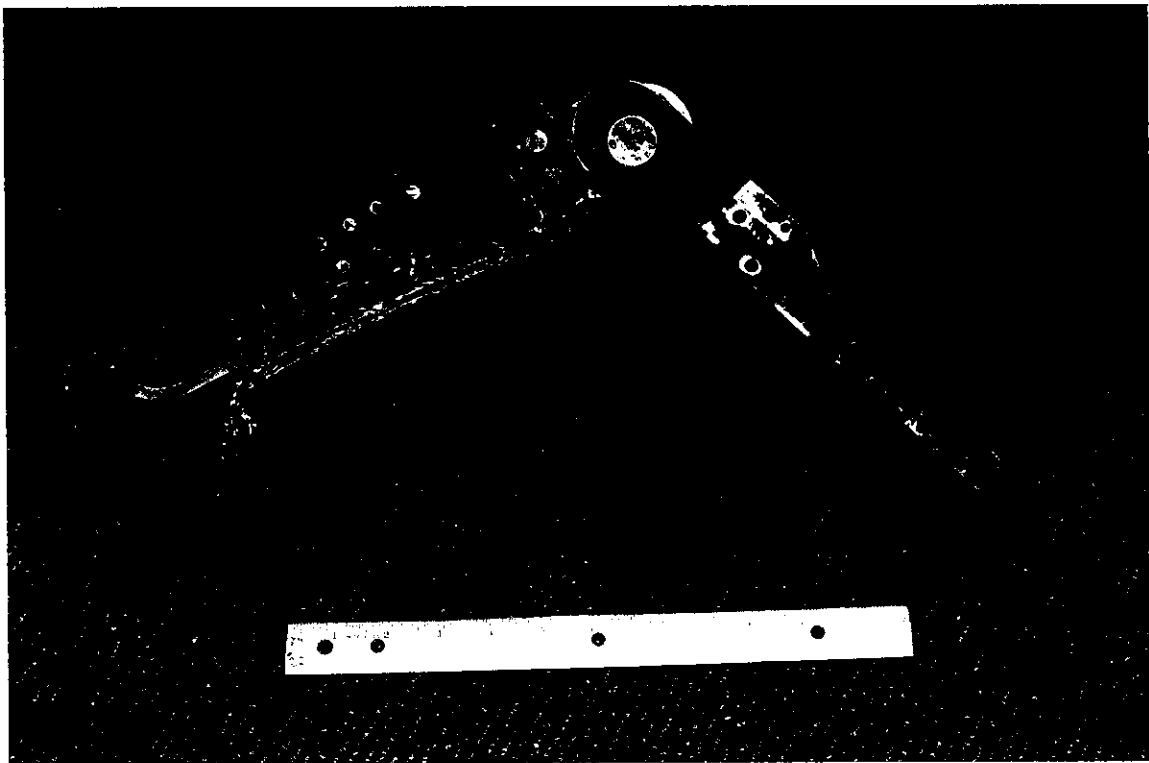
Figures 2(a) through 3(a) show the Front Bottom Spar with a fractured cap. The fracture surface was non-planar and relatively rough; Figure 3(b). The fracture surface features indicate that the failure of the cap was caused by an overload fracture; Figures 3(b) through 4(b).

Figure 2. Color photographs of the failed "Front Bottom Spar" with fractured cap. (a) View 1. (b) View 2.

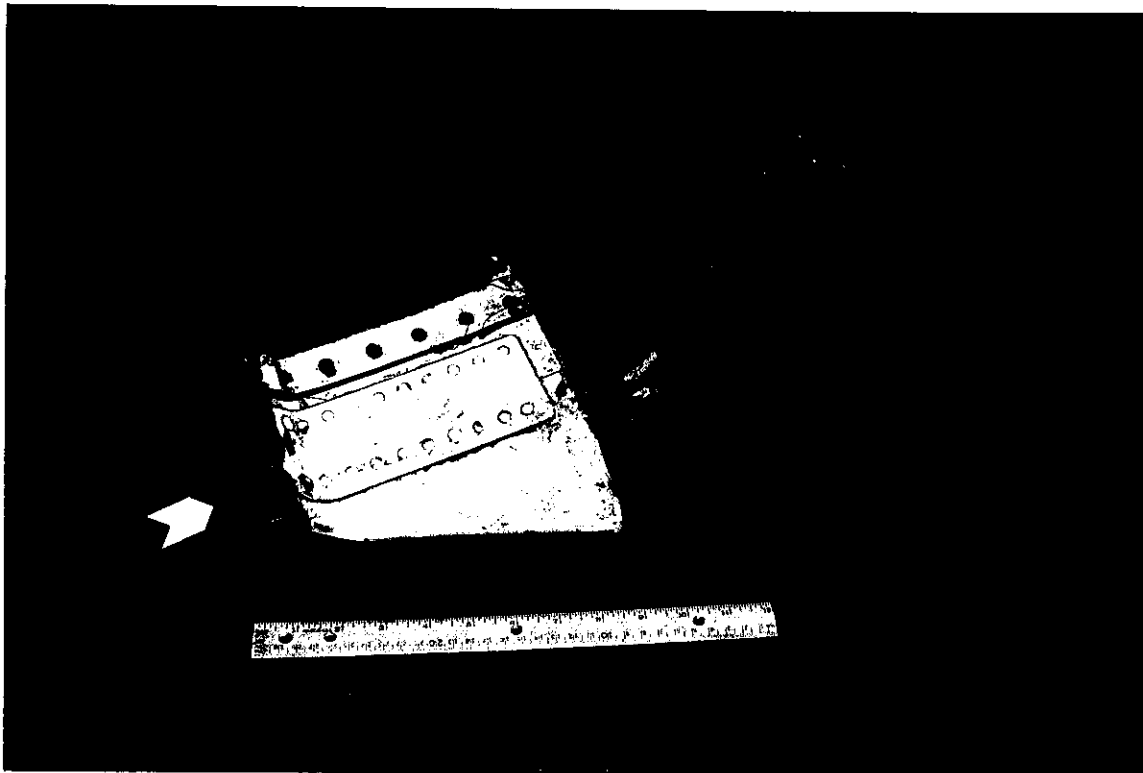
Figure 3. Color photographs of the failed "Front Bottom Spar" with fractured cap. (a) Overall view. (b) From an area indicated by the arrow in Figure 3(a), showing the fracture surface.

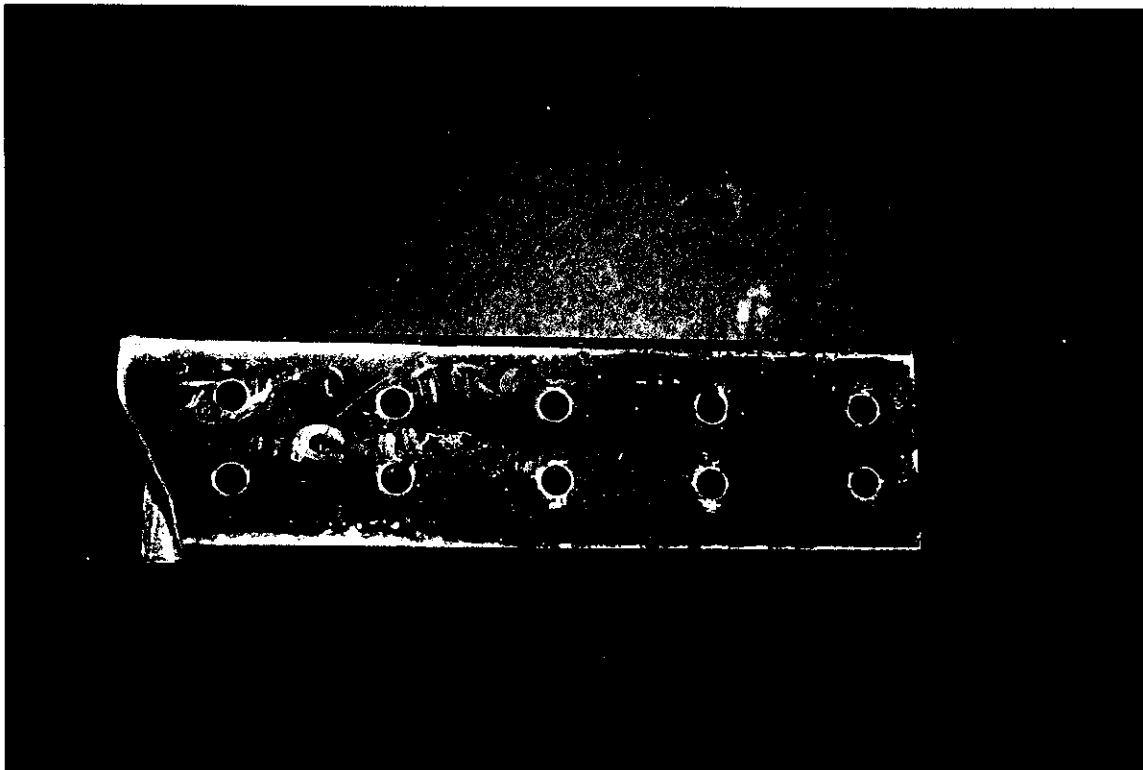
Figure 5(a) shows the Front Top Spar. The fracture surface was non-planar and relatively rough; Figure 5(b). The fracture surface features indicate that the failure of the spar was caused by an overload fracture; Figures 5(b) through 6(b).

Figure 5. Color photographs of the failed "Front Top Spar". (a) Overall view. (b) Fracture surface.

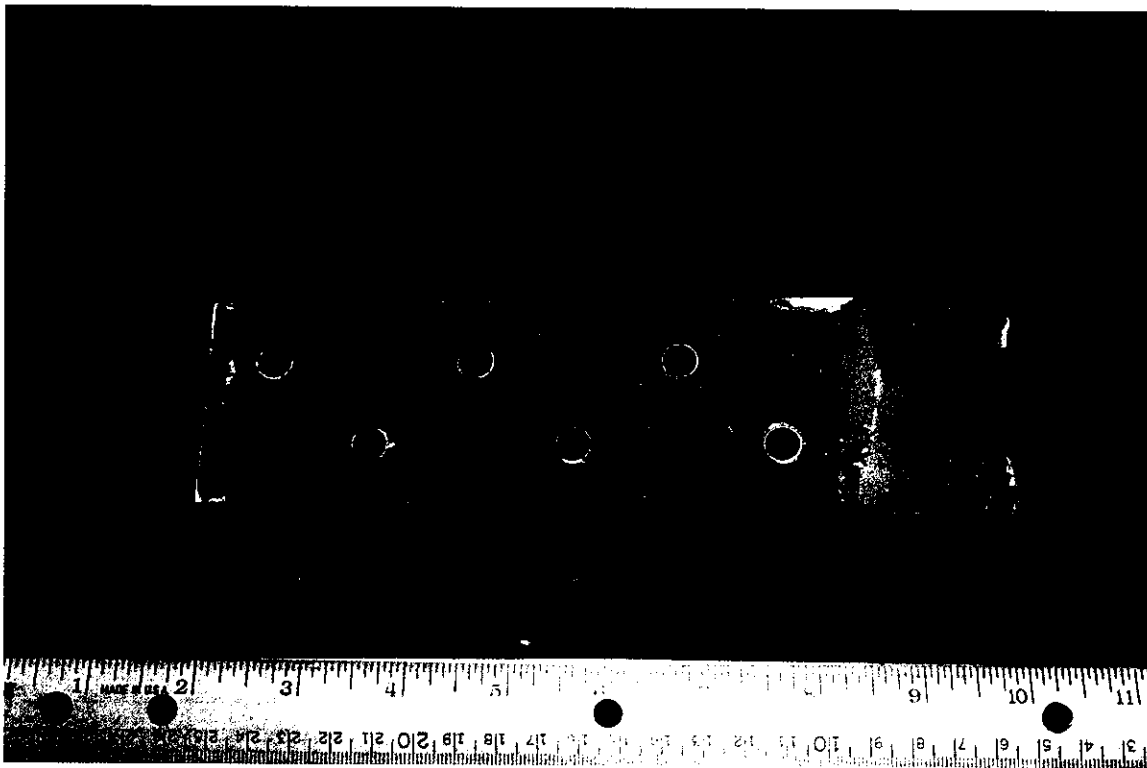
Figure 5(a) shows the Rear Top Spar. The fracture surface was non-planar and relatively rough; Figure 5(b). Faint Chevron marks were observed on the fracture surface; Figures 8(a) and 8(b). The fracture surface features indicate that the failure of the spar was caused by an overload fracture; Figures 8(b) and 6(b).

Figure 7. A color photograph of the failed "Rear Top Spar".

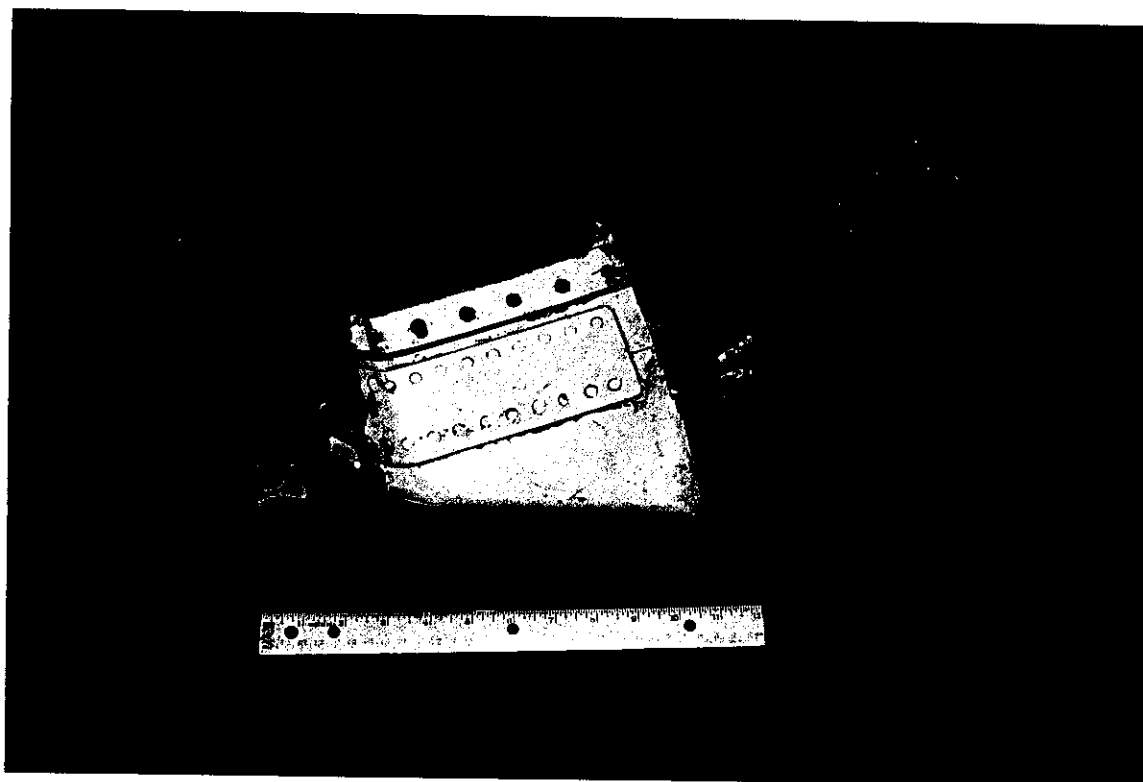
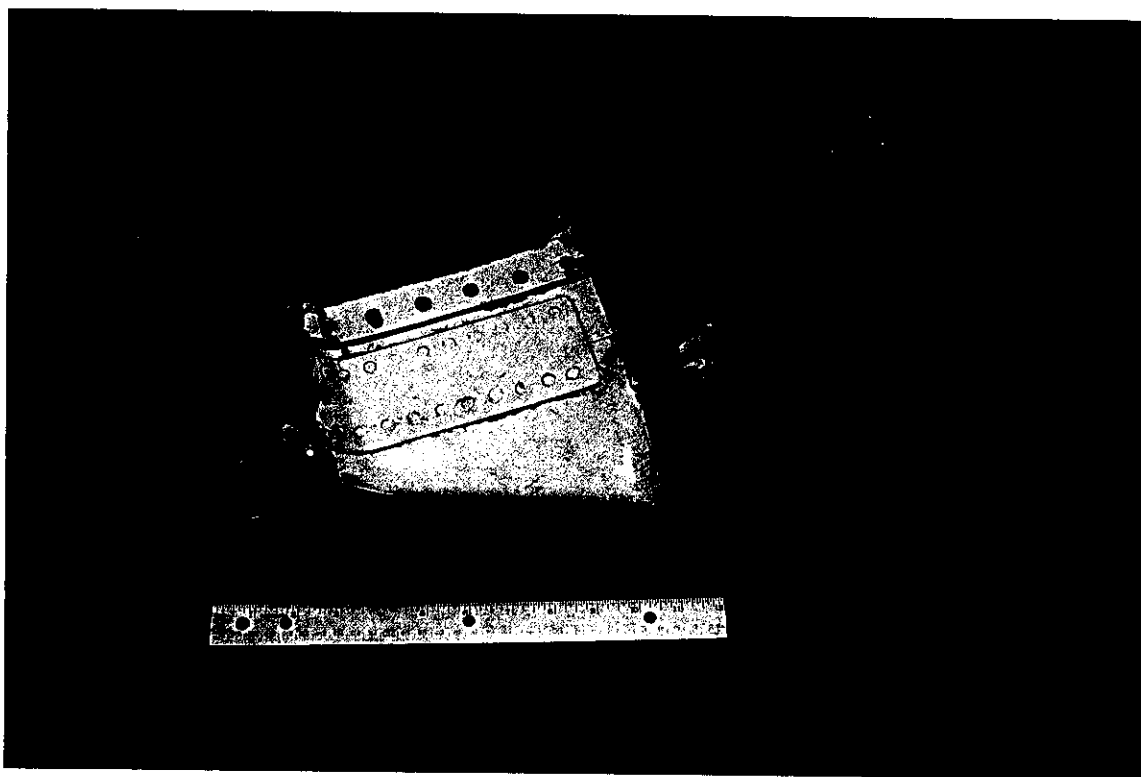
Figures 13(a) through 14(b) show the locations of specimens for chemical analysis, hardness testing and electrical conductivity. A secondary crack was revealed during cutting the specimen from "Front Bottom Spar" fractured cap; Figures 15(a) through 16(b). Examination of the fracture surface revealed an elliptical crack arrest line; Figures 17(a) and 17(b). It was requested to perform fractographic examination of the fracture surface of the secondary crack using a Scanning Electron Microscope (SEM).

Figure 15. Color photographs of the failed "Front Bottom Spar", showing a fracture surface after the specimen for chemical analysis was partially cut. (a) View 1. (b) View 2.

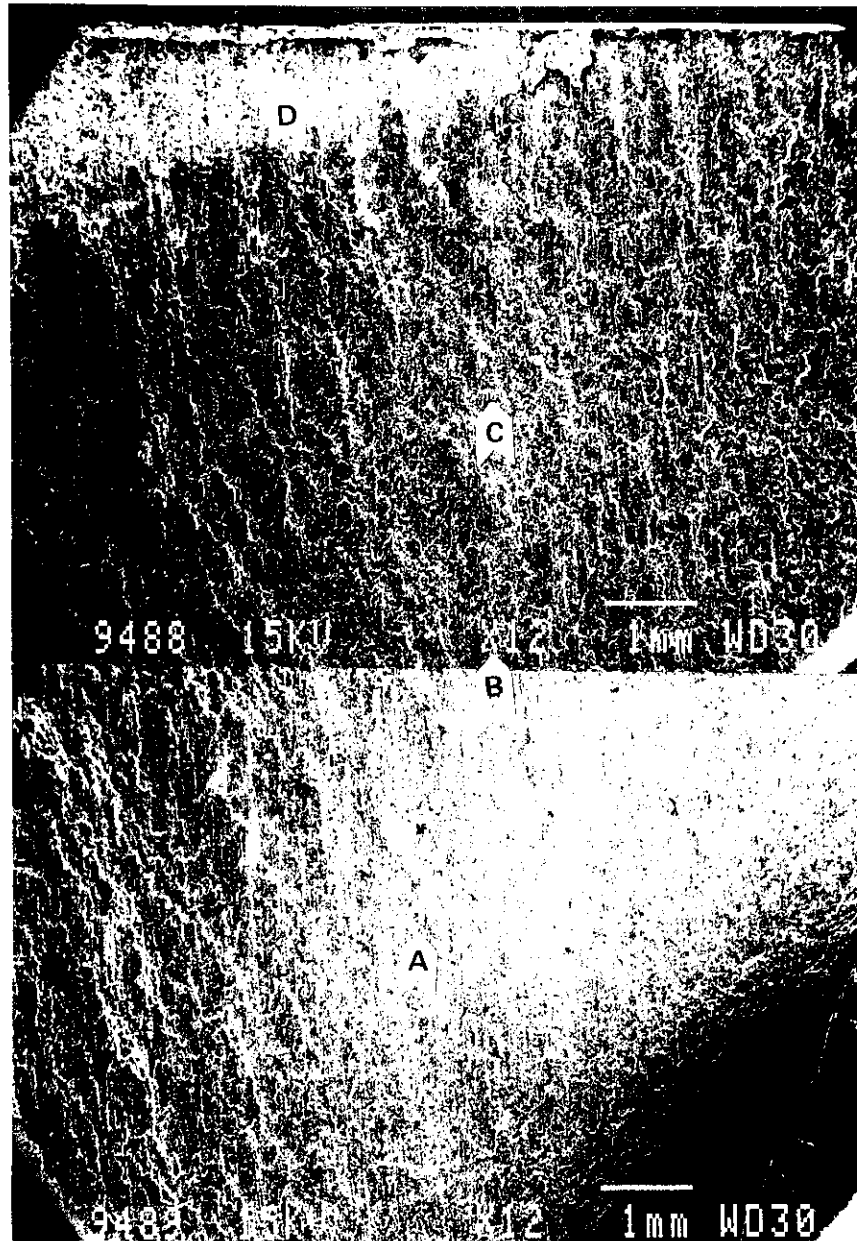
SEM FRACTOGRAPHY: Figure 22 was obtained from an area marked "A" in Figure 17(b). Examination of various areas of the fracture surface revealed the presence of dimples indicative of an overload fracture; Figures 23(a) through 26(a). Figure 27 shows the edge of the fracture surface. Examination of an area marked "E" in Figure 27 revealed the presence of dimples indicative of an overload fracture; Figures 28(a) and 28(b). The results of SEM fractographic examination indicate that the secondary crack of the "Front Bottom Spar" with elliptical crack arrest lines was also due to an overload fracture.

Figure 22. A montage of SEM fractographs obtained from a portion of the fracture surface of "Front Bottom Spar" marked "A" in Figure 17(b), showing the locations of subsequent fractographs; 12X.

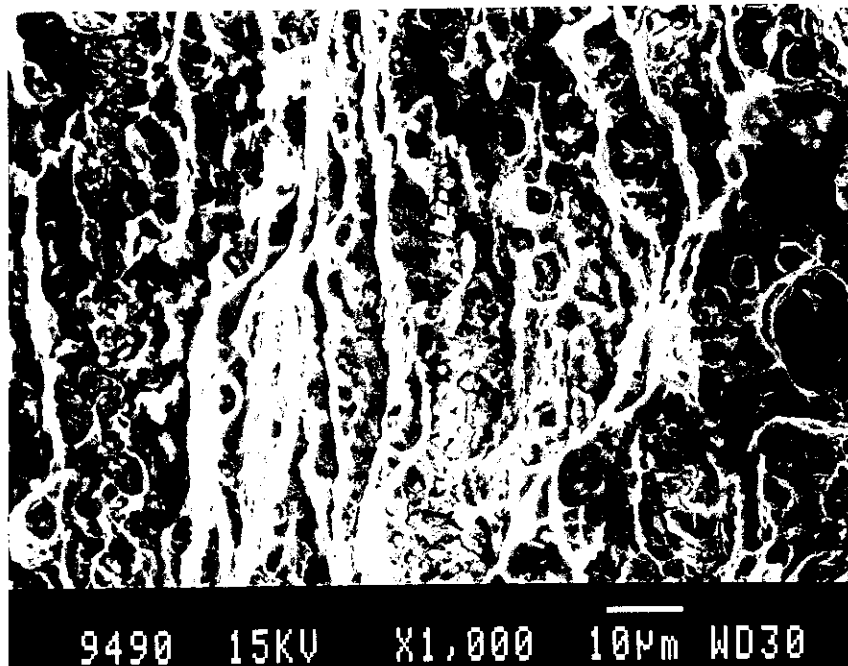
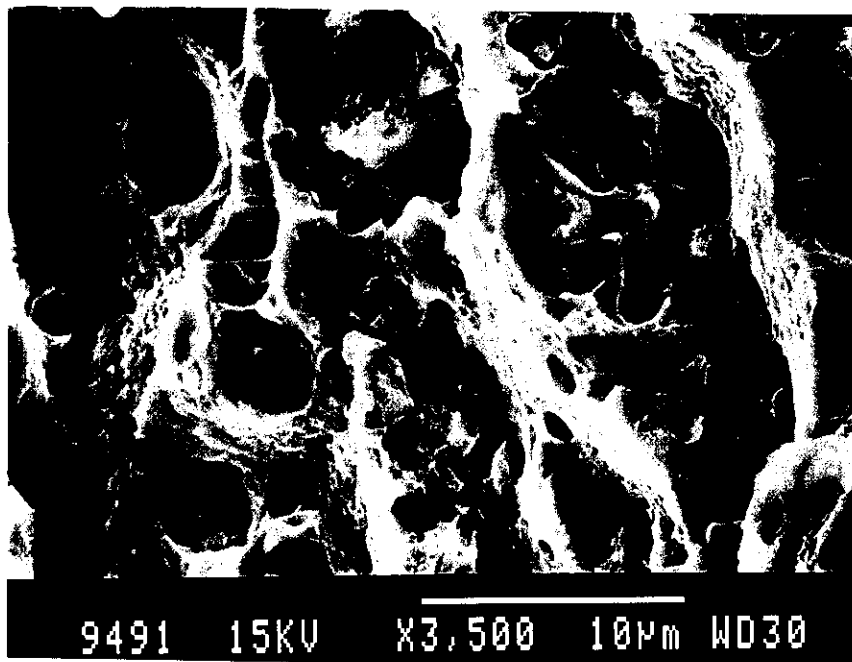
Figure 23. SEM fractographs obtained from an area marked "A" in Figure 22, showing dimples indicative of an overload fracture. (a) 1,000X. (b) 3,500X.

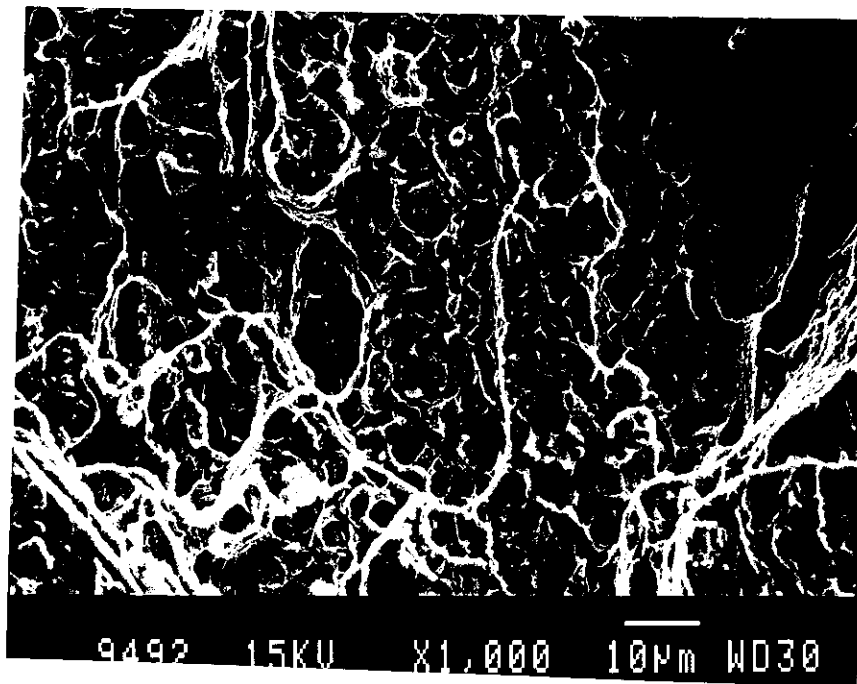
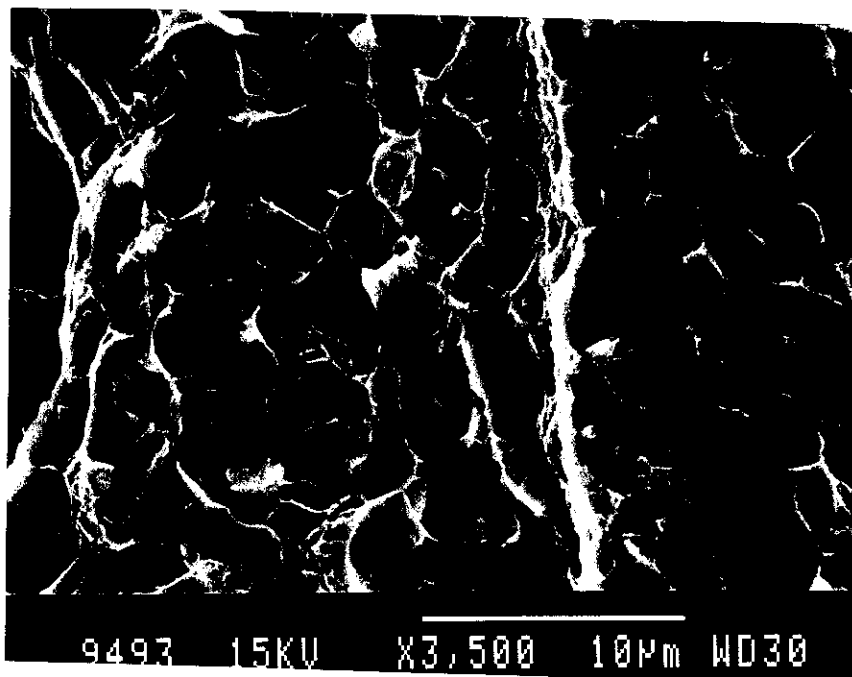
Figure 24. SEM fractographs obtained from an area marked "B" in Figure 22, showing dimples indicative of an overload fracture. (a) 1,000X. (b) 3,500X.

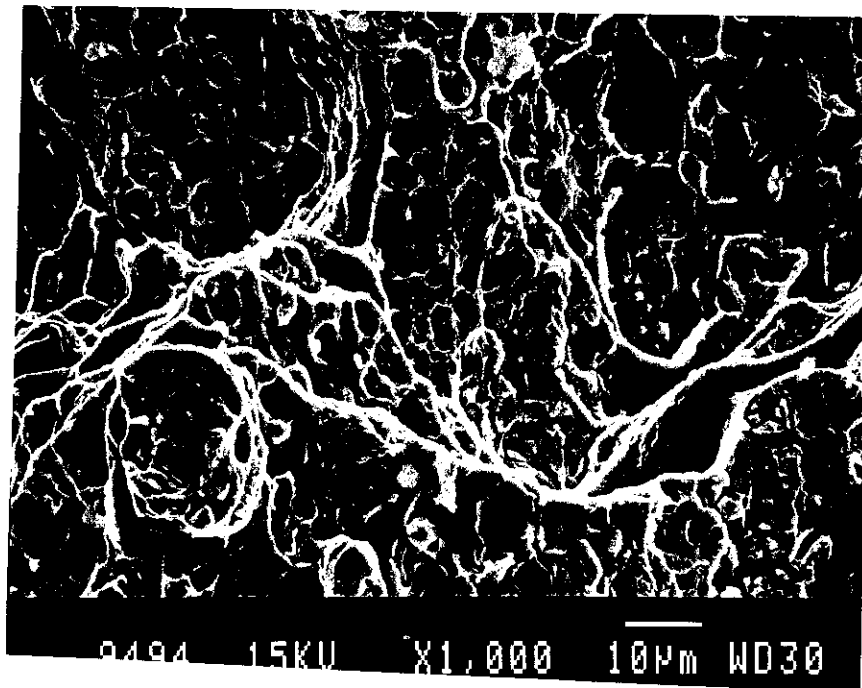
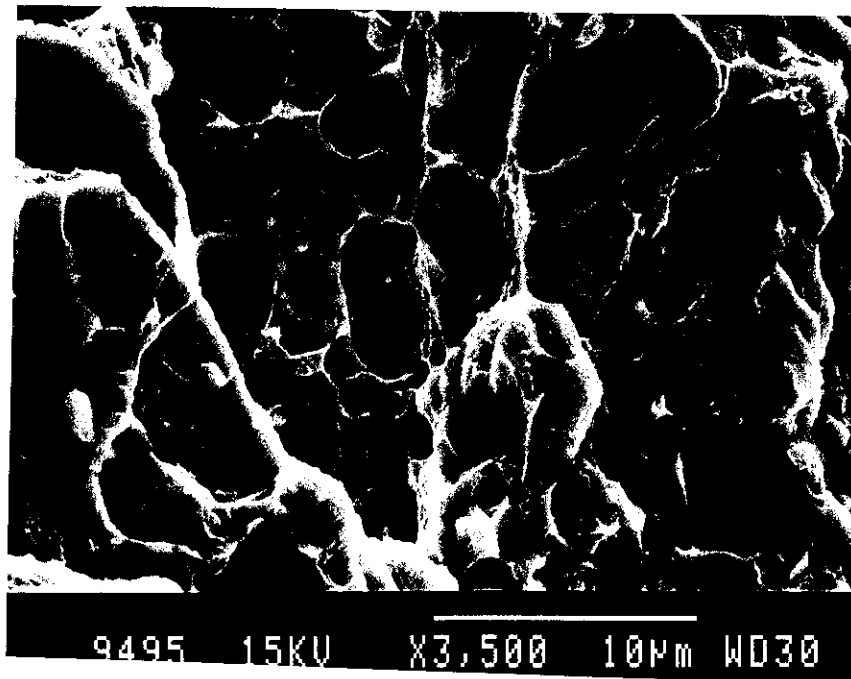
Figure 25. SEM fractographs obtained from an area marked "C" in Figure 22, showing dimples indicative of an overload fracture. (a) 1,000X. (b) 3,500X.

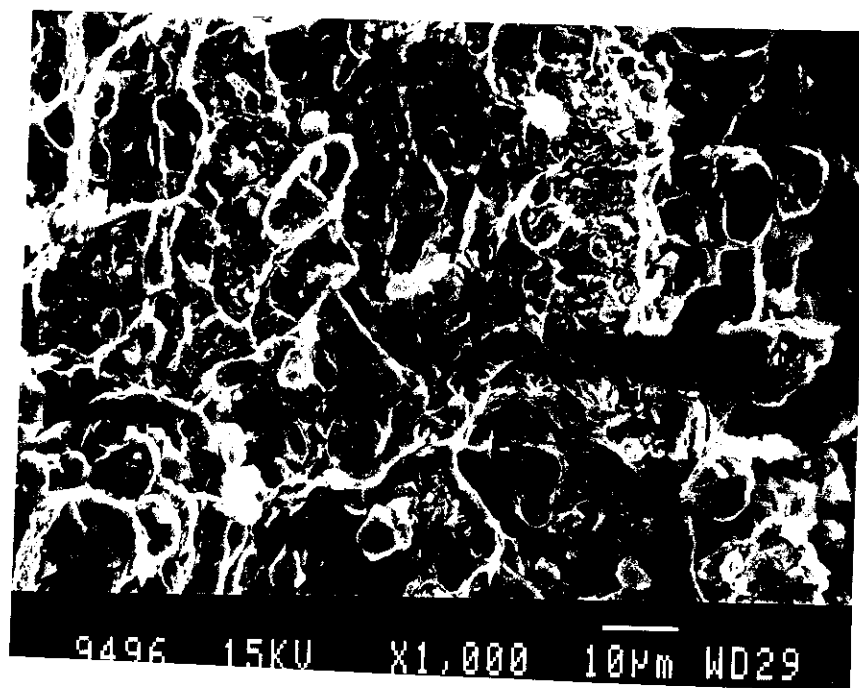
Figure 26. SEM fractographs obtained from an area marked "D" in Figure 22, showing dimples indicative of an overload fracture. (a) 1,000X. (b) 3,500X.

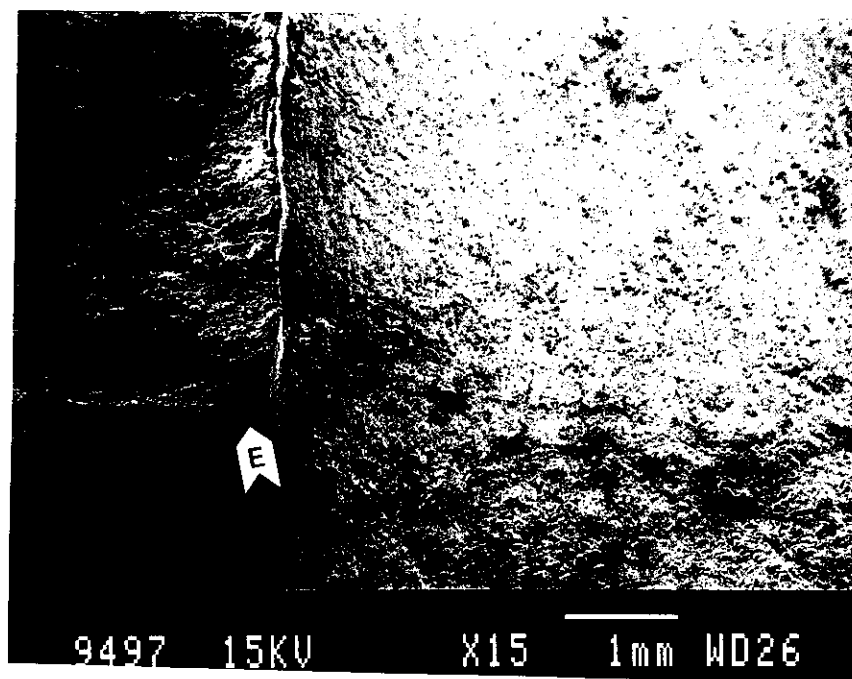
Figure 27. An SEM fractograph obtained from an area marked "B" in Figure 17(b), showing the location of subsequent fractographs; 15X.
