NATIONAL TRANSPORTATION SAFETY BOARD

METALLURGIST'S FACTUAL REPORT

Report No. 97-117

Place : Pensacola, Florida
Date : July 6, 1997
Vehicle : MD-88, N927DA
NTSB No. : DCA96-M-A068
Investigator : Thomas Conroy, As-10

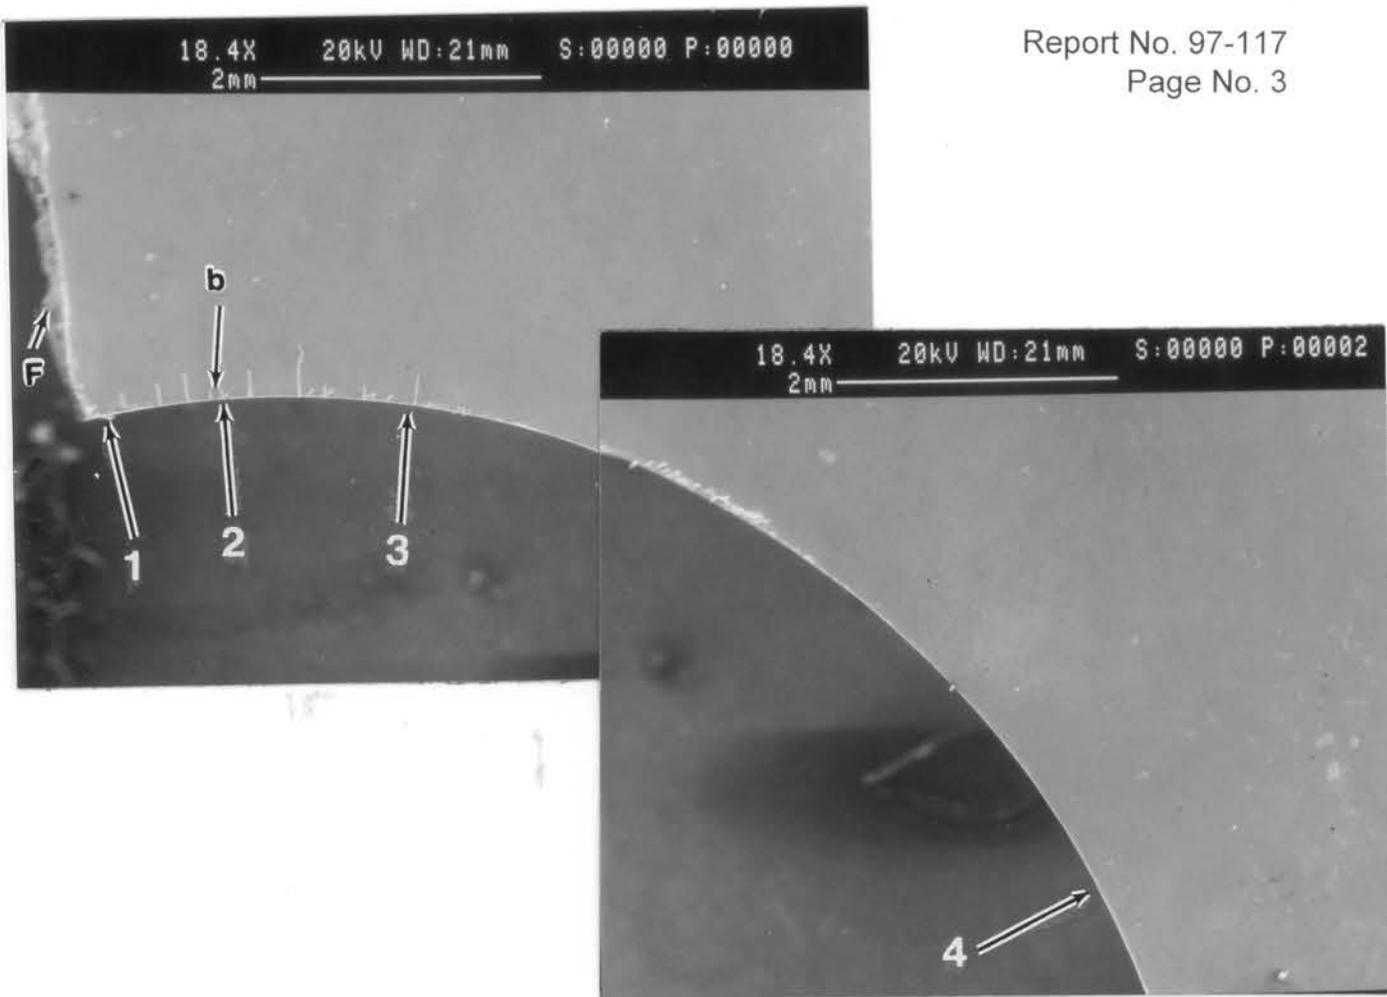
The section was returned to the NTSB materials laboratory and was subsequently analyzed by X-ray Energy Dispersive Spectroscopy (EDS) for iron distribution and content. The scanning electron microscope (SEM) image of the analyzed surface is shown in figure 1 with arrow "F" denoting the fracture face. The small thin isolated iron-rich band was located at a distance of about 0.0374 inch (0.95 mm) from the fracture face in the area indicated by arrow "b" in this figure. A higher magnification view of this band is shown in figure 2 (see arrow "b").

Figure 1. SEM view of the surface of the metallographic specimen through the fracture origin. Arrow "F" denotes the fracture face, arrow "b" -- the location of the small isolated iron-rich band, and arrows "1", "2", "3", and "4" -- the locations of transverse (radially inward) EDS analyses.

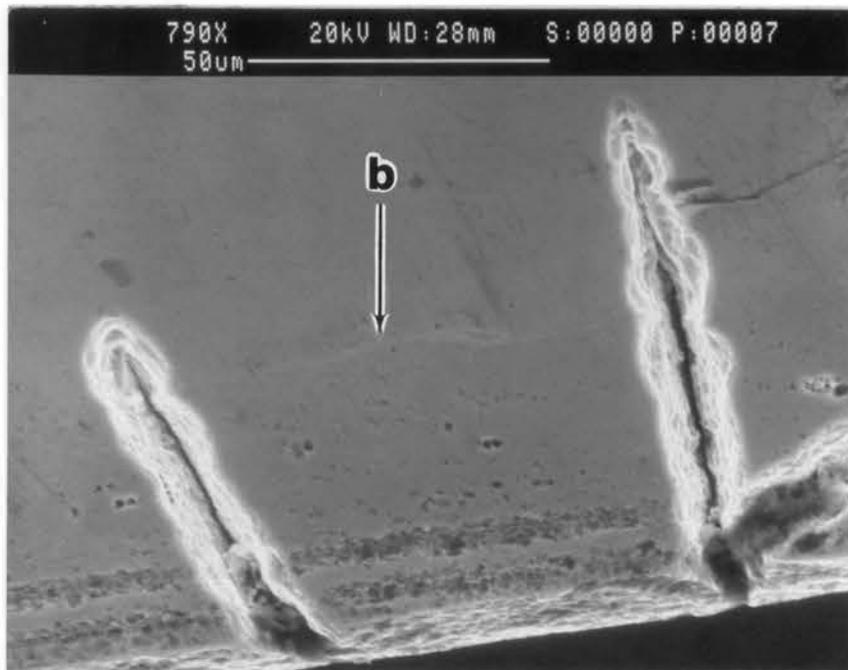
Figure 2. The small isolated iron-rich band (arrow "b") in the area of severely deformed material.

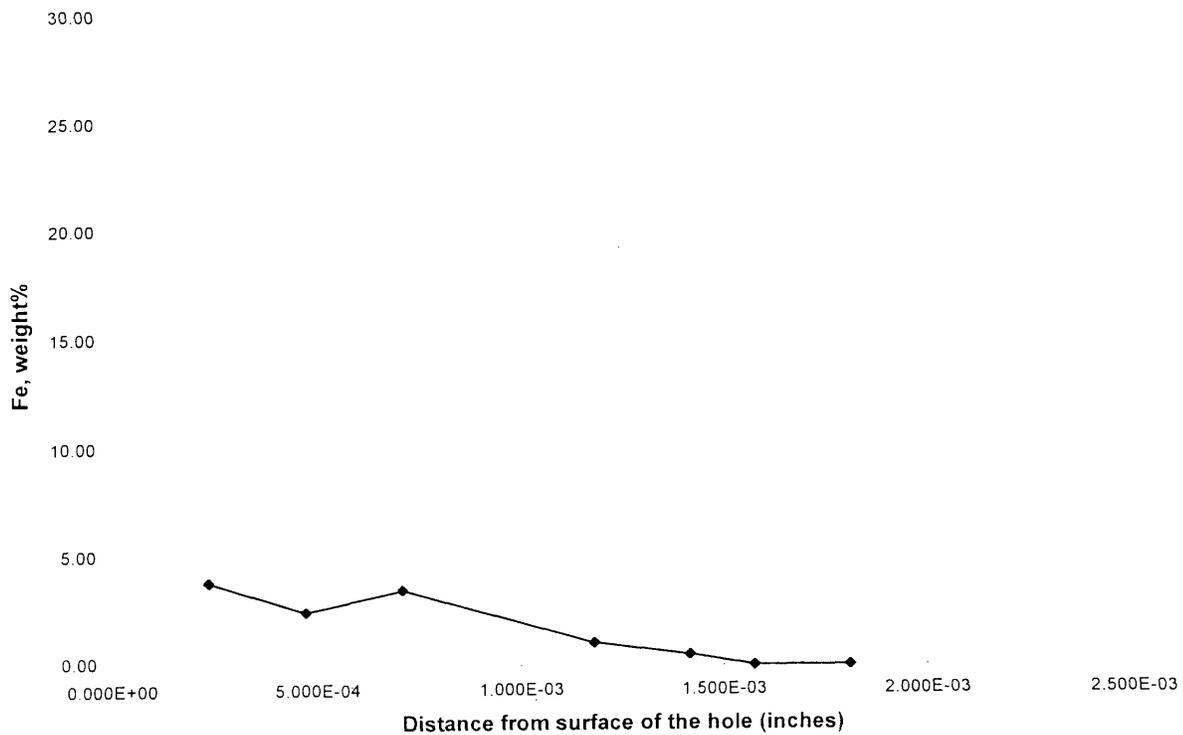
Iron concentration traverse at a radial position 0.15 millimeters from the fracture		
Depth from hole wall surface in inches	Depth in microns	Iron (Fe) content, weight %
2.362E-04	6	3.90
4.724E-04	12	2.53
7.087E-04	18	3.55
1.181E-03	30	1.04
1.417E-03	36	0.50
1.575E-03	40	0.00

Figure 3. Concentration of iron radially inward from the hole wall (through the altered microstructure zone) at position 0.150 mm from the fracture face.

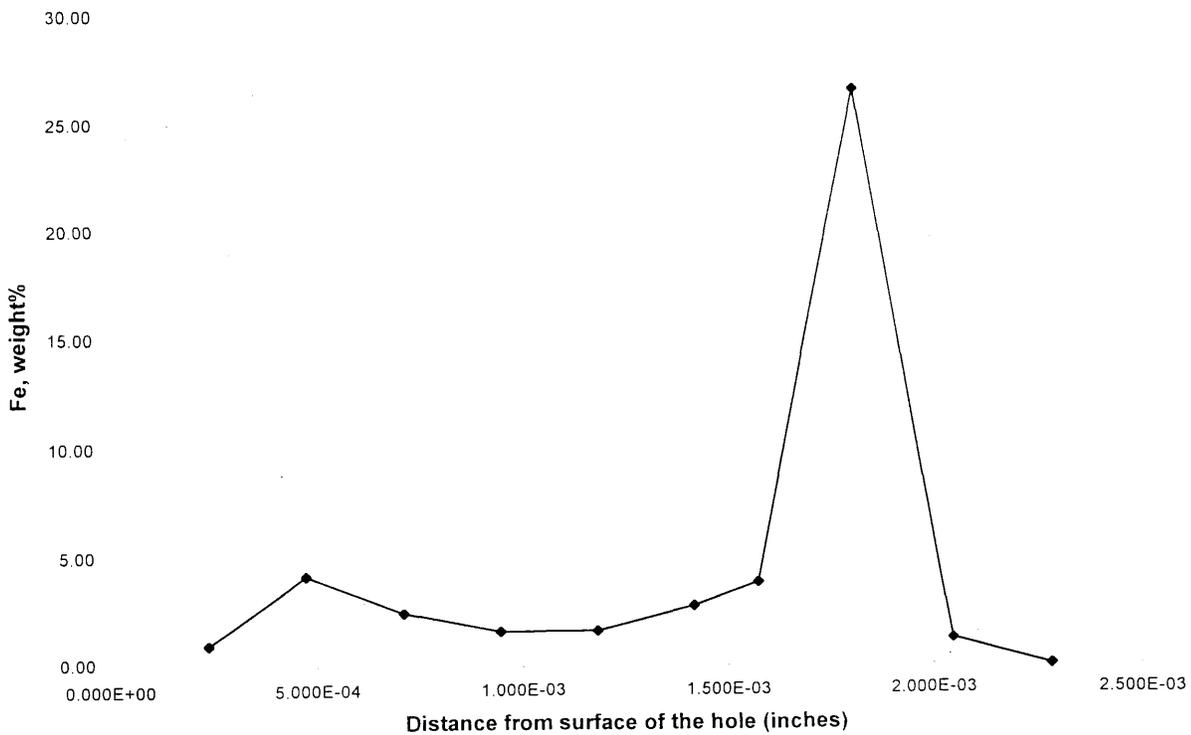
In order to determine the extent and concentration of iron in the altered microstructure, EDS spectra were collected transversely through the thickness (from the hole wall radially inward) at four separate radial position lines at 0.15, 0.95, 2.25, and 6.0 millimeters (mm) from the fracture plane, as indicated by arrows "1", "2", "3", and "4", respectively, in figure 1. At each of this position, X-ray spot source data was collected every four to six microns inward from the hole wall until no iron was detected. No iron was found in the radial position that did not contain a layer of altered microstructure (position "4", 6.0 mm from the fracture). However, iron was found at the other three radial positions. Figures 3, 4, and 5 contain tables and graphical representations displaying iron concentrations at these three locations. The large peak of iron concentration in figure 4 corresponds to the thin band of iron indicated by arrow "b" in figure 2.

Iron concentration traverse at a radial position 0.95 millimeters from the fracture		
Depth from hole wall surface in inches	Depth in microns	Iron (Fe) content, weight %
2.362E-04	6	1.02
4.724E-04	12	4.25
7.087E-04	18	2.51
9.449E-04	24	1.62
1.181E-03	30	1.66
1.417E-03	36	2.81
1.575E-03	40	3.91
1.811E-03	46	26.72
2.047E-03	52	1.20
2.283E-03	58	0.00

Figure 4. Concentration of iron radially inward from the hole wall (through the altered microstructure zone) at position 0.95 mm from the fracture face

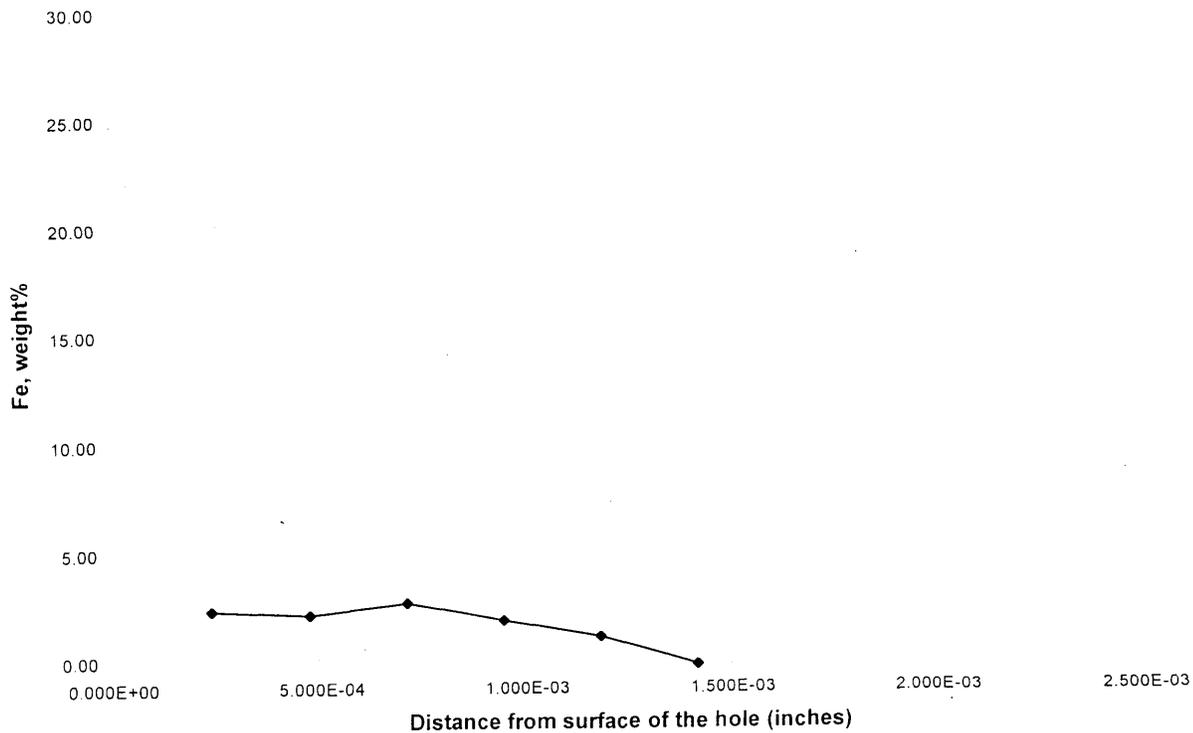
Iron concentration traverse at a radial position 2.25 millimeters from the fracture		
Depth from hole wall surface in inches	Depth in microns	Iron (Fe) content, weight %
2.362E-04	6	2.55
4.724E-04	12	2.35
7.087E-04	18	2.90
9.449E-04	24	2.06
1.181E-03	30	1.31
1.417E-03	36	0.00

Figure 5. Concentration of iron radially inward from the hole wall (through the altered microstructure zone) at position 2.25 mm from the fracture face
