Metallurgist's Factual Report No. 97-85

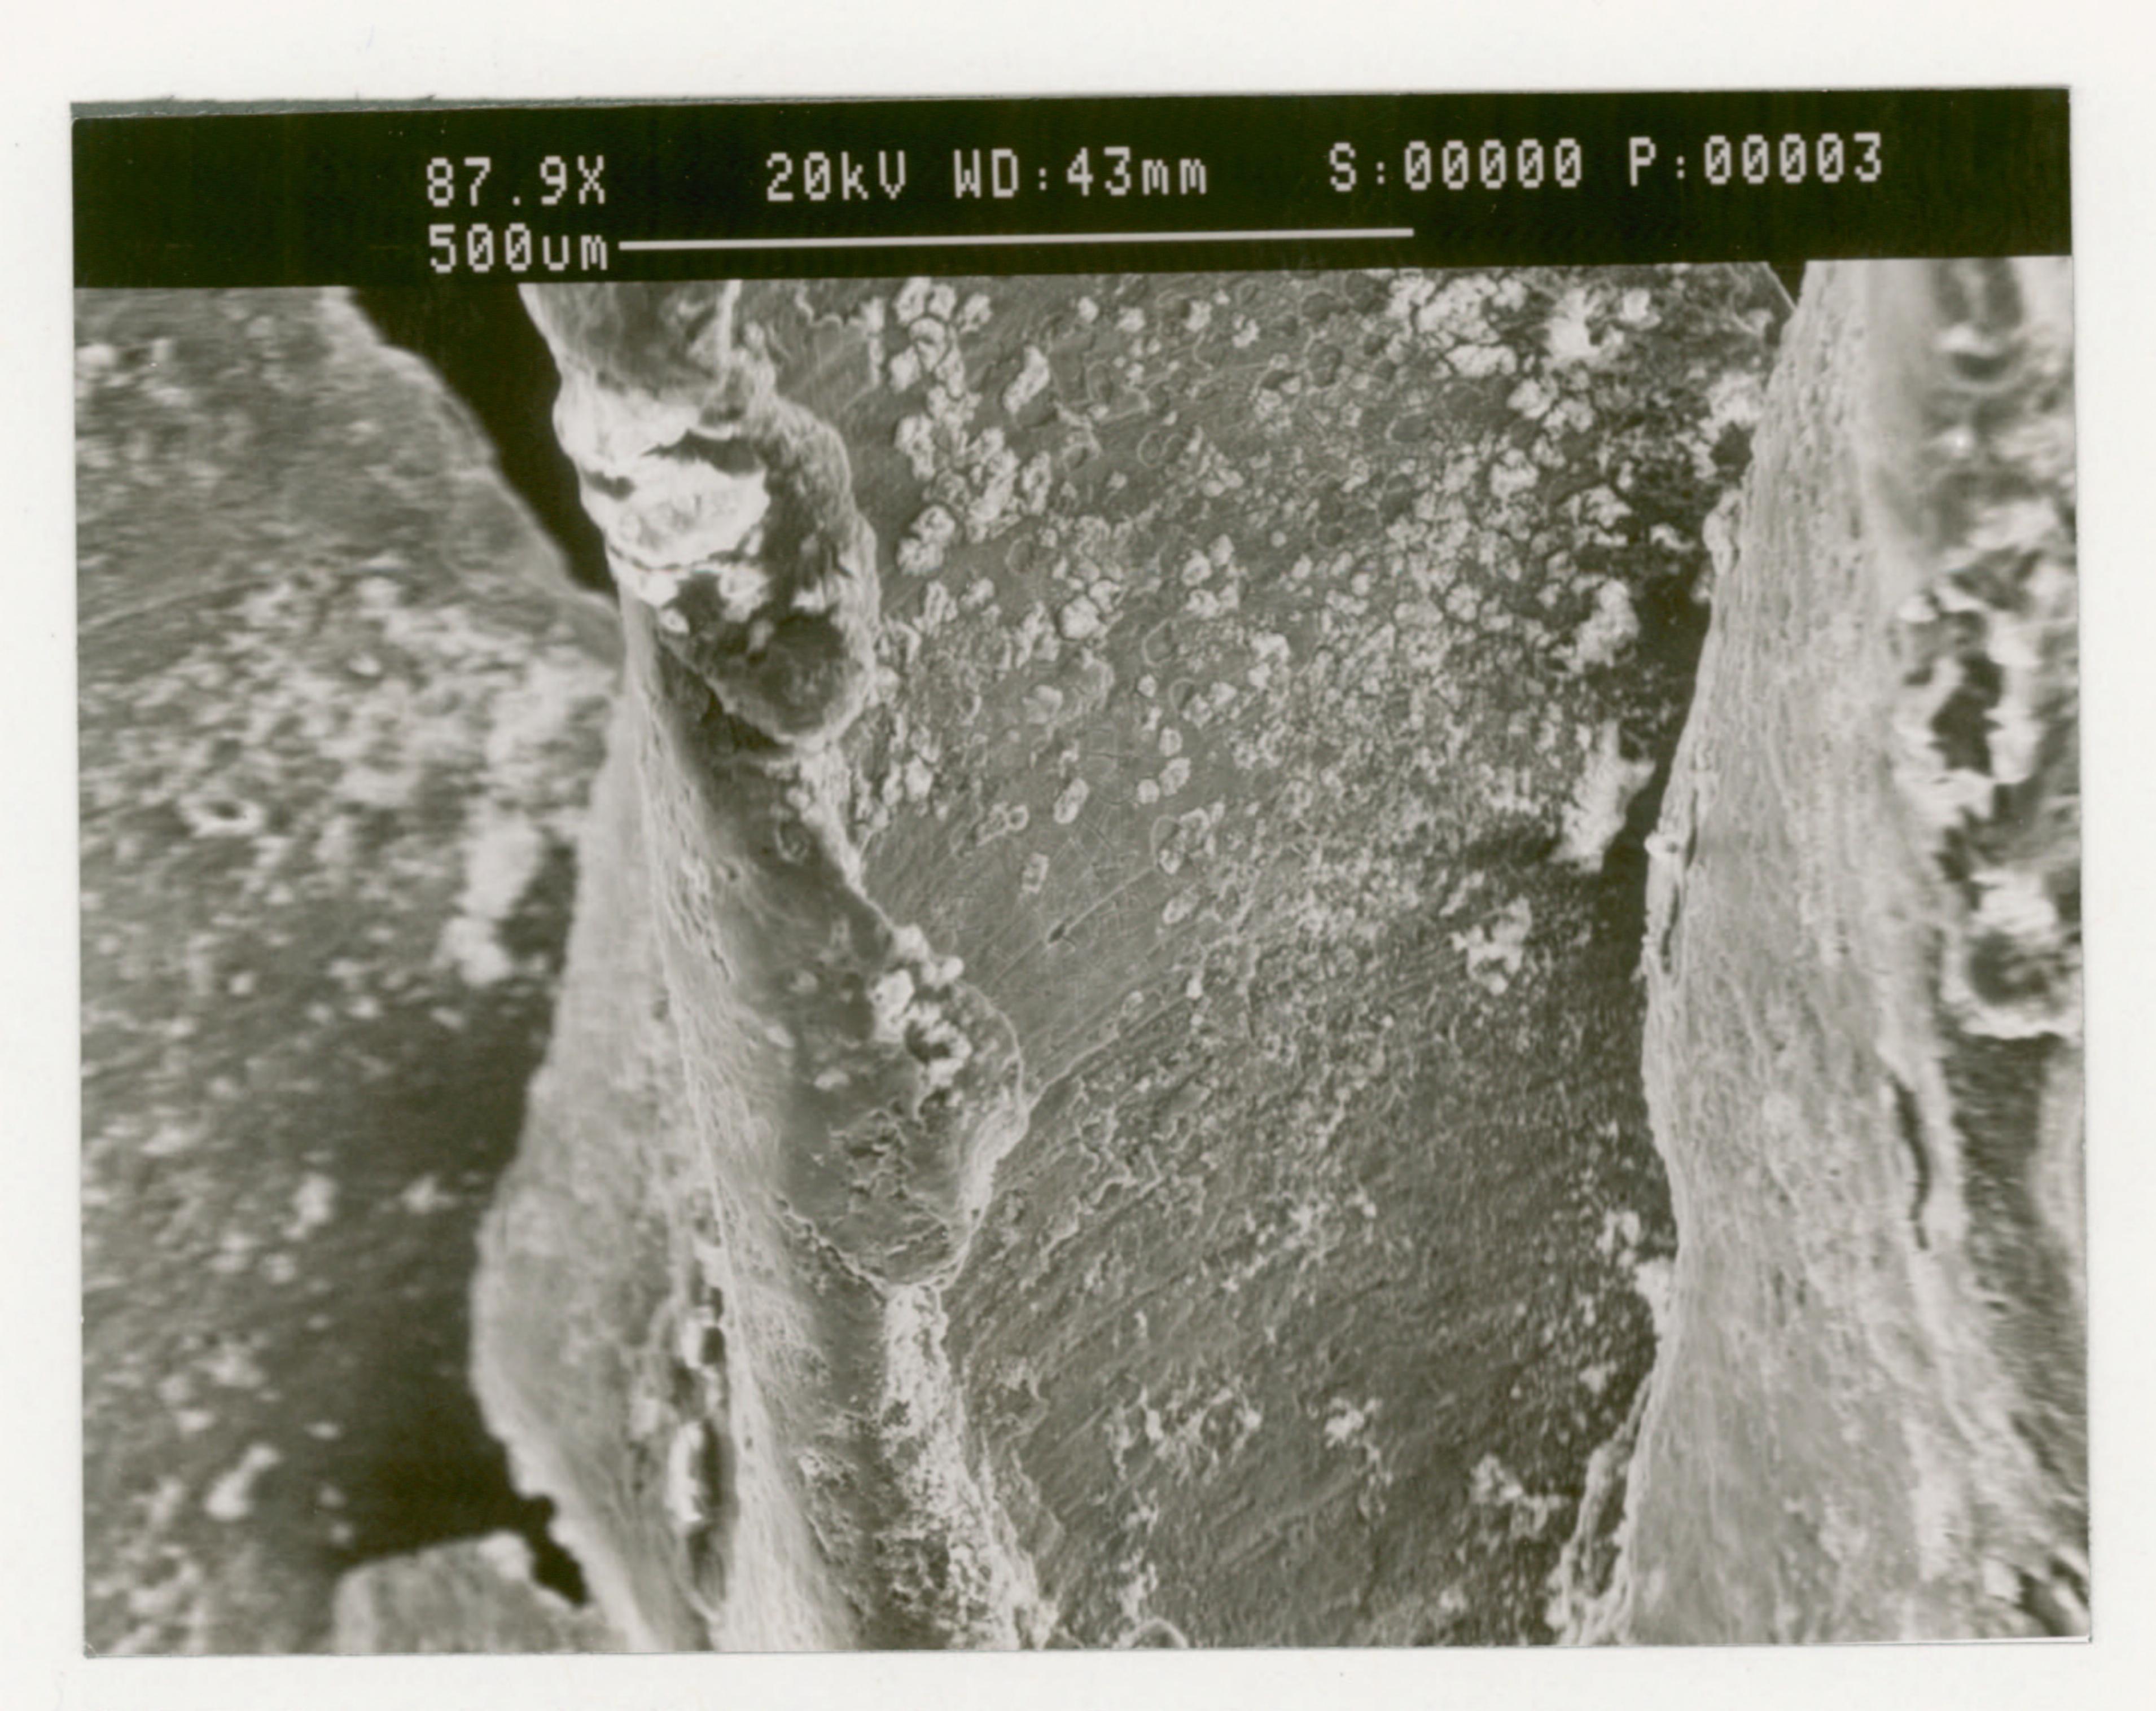
Figure 3. SEM photograph of the surface of a spike tooth fracture area on the landing light surround structure. (87.9X)

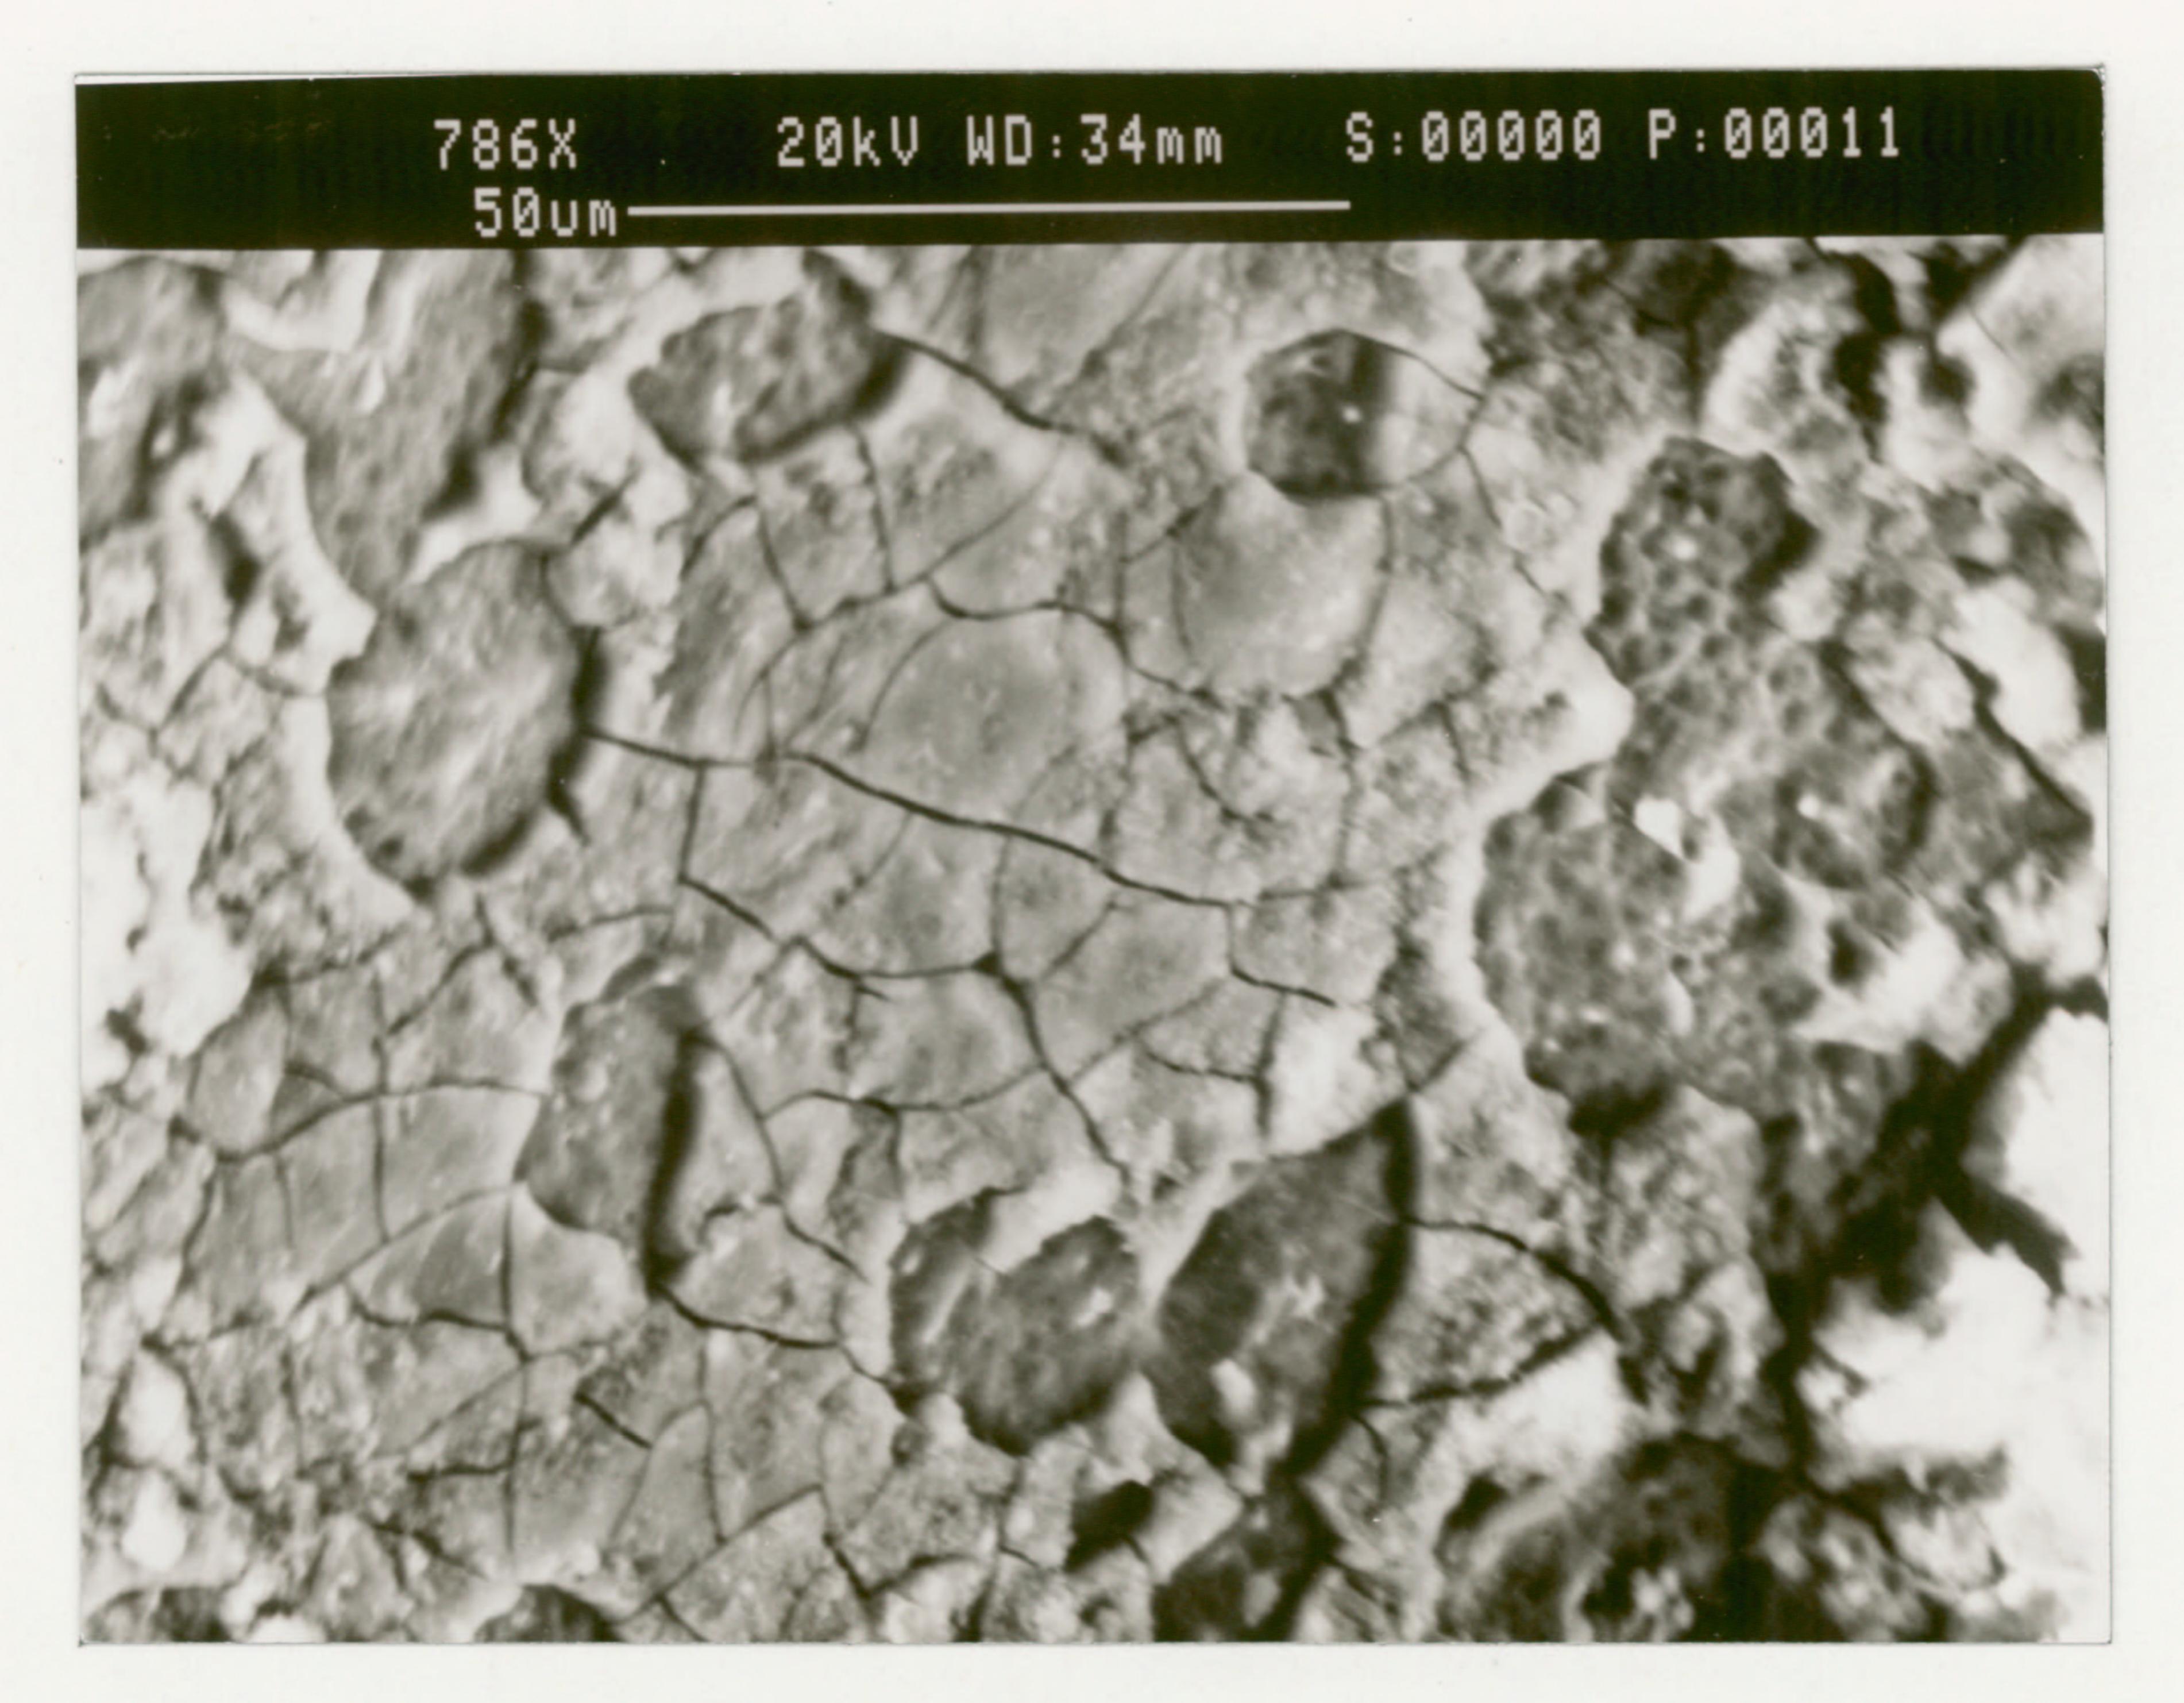
Figure 4. Higher magnification SEM photograph of the mud-cracked oxides on the surface of the spike tooth fracture area on the landing light surround structure. (786X)
