NATIONAL TRANSPORTATION SAFETY BOARD

METALLURGIST'S FACTUAL REPORT

Report No. 96-57

Place : Aliquippa, Pennsylvania
Date : September 8, 1994
Vehicle : Boeing 737-3B7, N513AU
NTSB No. : DCA94-M-A076
Investigator : Thomas A. Haueter

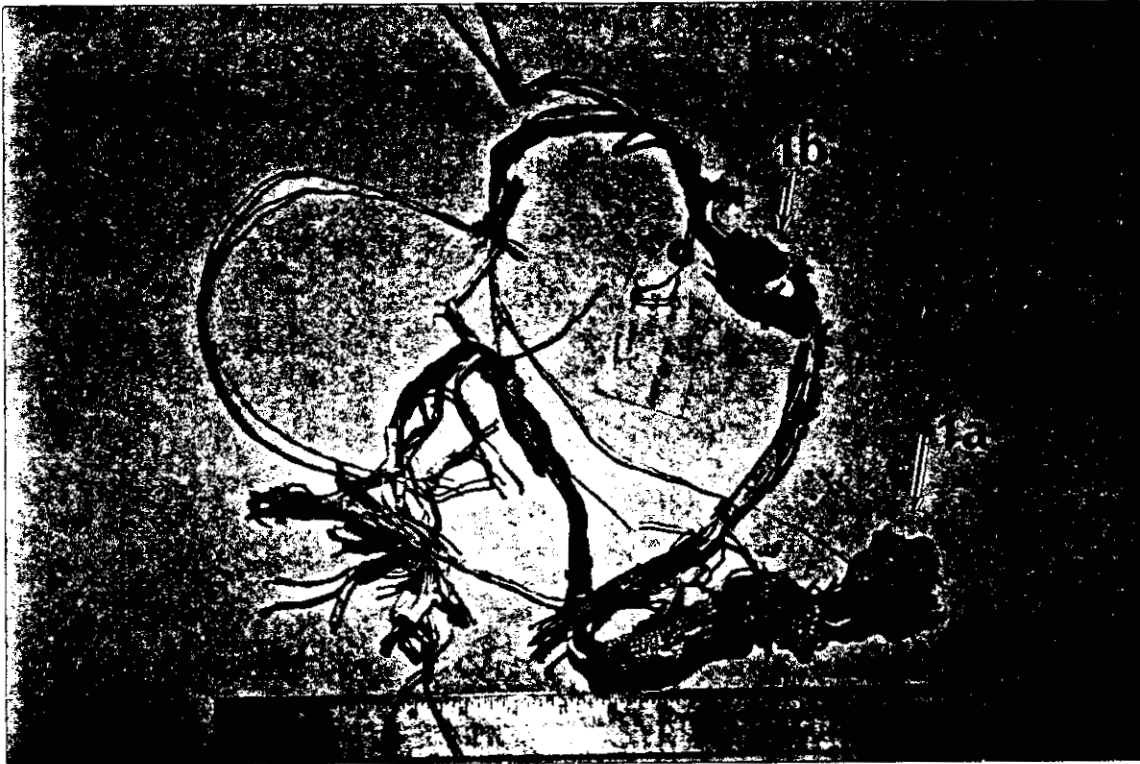
An overall view of the wire bundle listed as No. 1 in the component examined list is shown in figure 1. The plug denoted by arrow "1a" in this figure was heavily damaged and the internal pins were partially exposed. Close up views of this plug are shown in figures 2 and 3. No evidence of blue and/or green color deposits were found on this bundle with the exceptions noted below.

The bracket piece with the blue-green stain was removed from the D05923J/P connector indicated by "1b" in figure 1. One corner of the square mounting plate on the "J" side of the connector was broken off. In general, the connector was in relatively good condition. However, it was noted that the "J" connector clamp end and threaded portion was crushed over a distance of about 0.5 inch.

Figure 1. Overall view of one of the wire bundles. Arrows "1a" and "1b" denote the plugs.

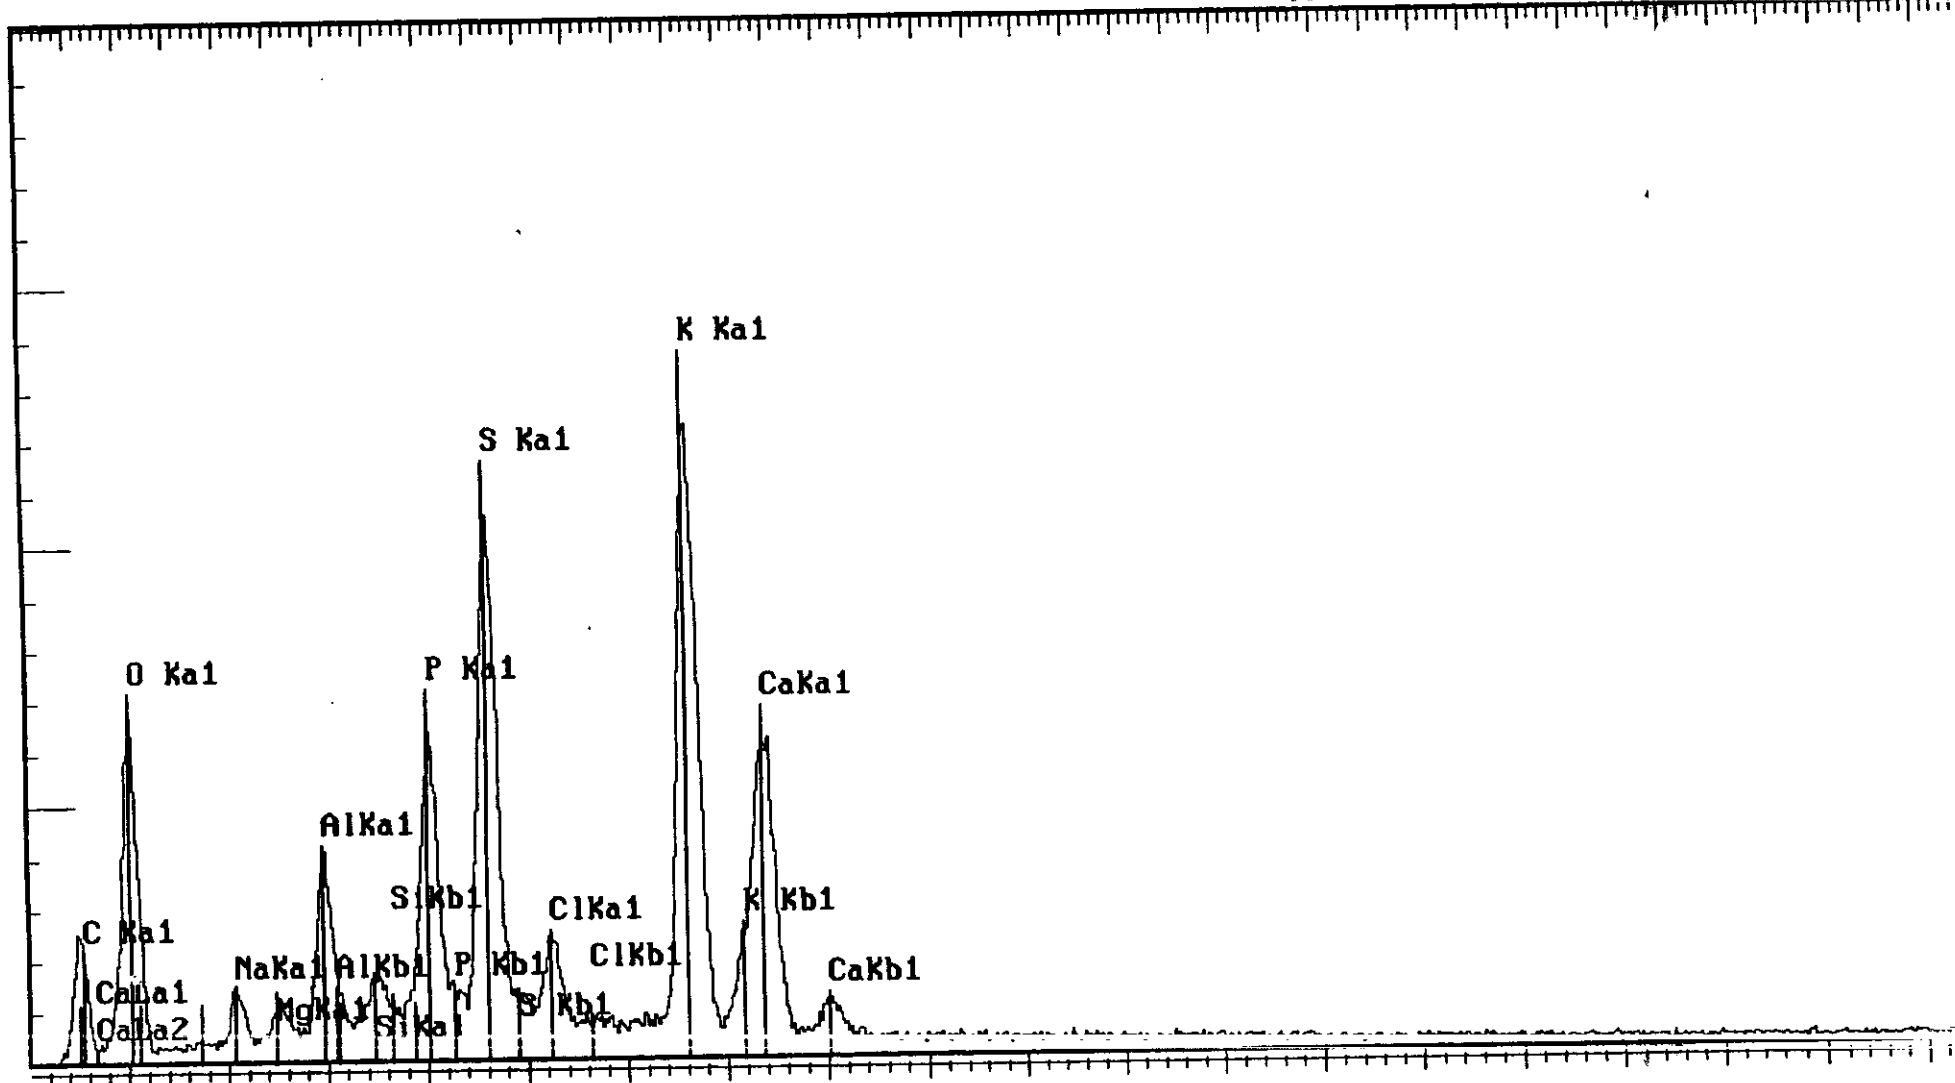
Spectrum: SAMPLE7

An exemplar plug containing the "Blue Water" deposits was submitted by Boeing for comparative analysis. The EDS analysis of a sample of these deposits produced a spectrum containing the characteristic peaks of C, O, Na, Mg, Al, P, Si, S, Cl, K, and Ca (see spectrum for SAMPLE 7 in Appendix).

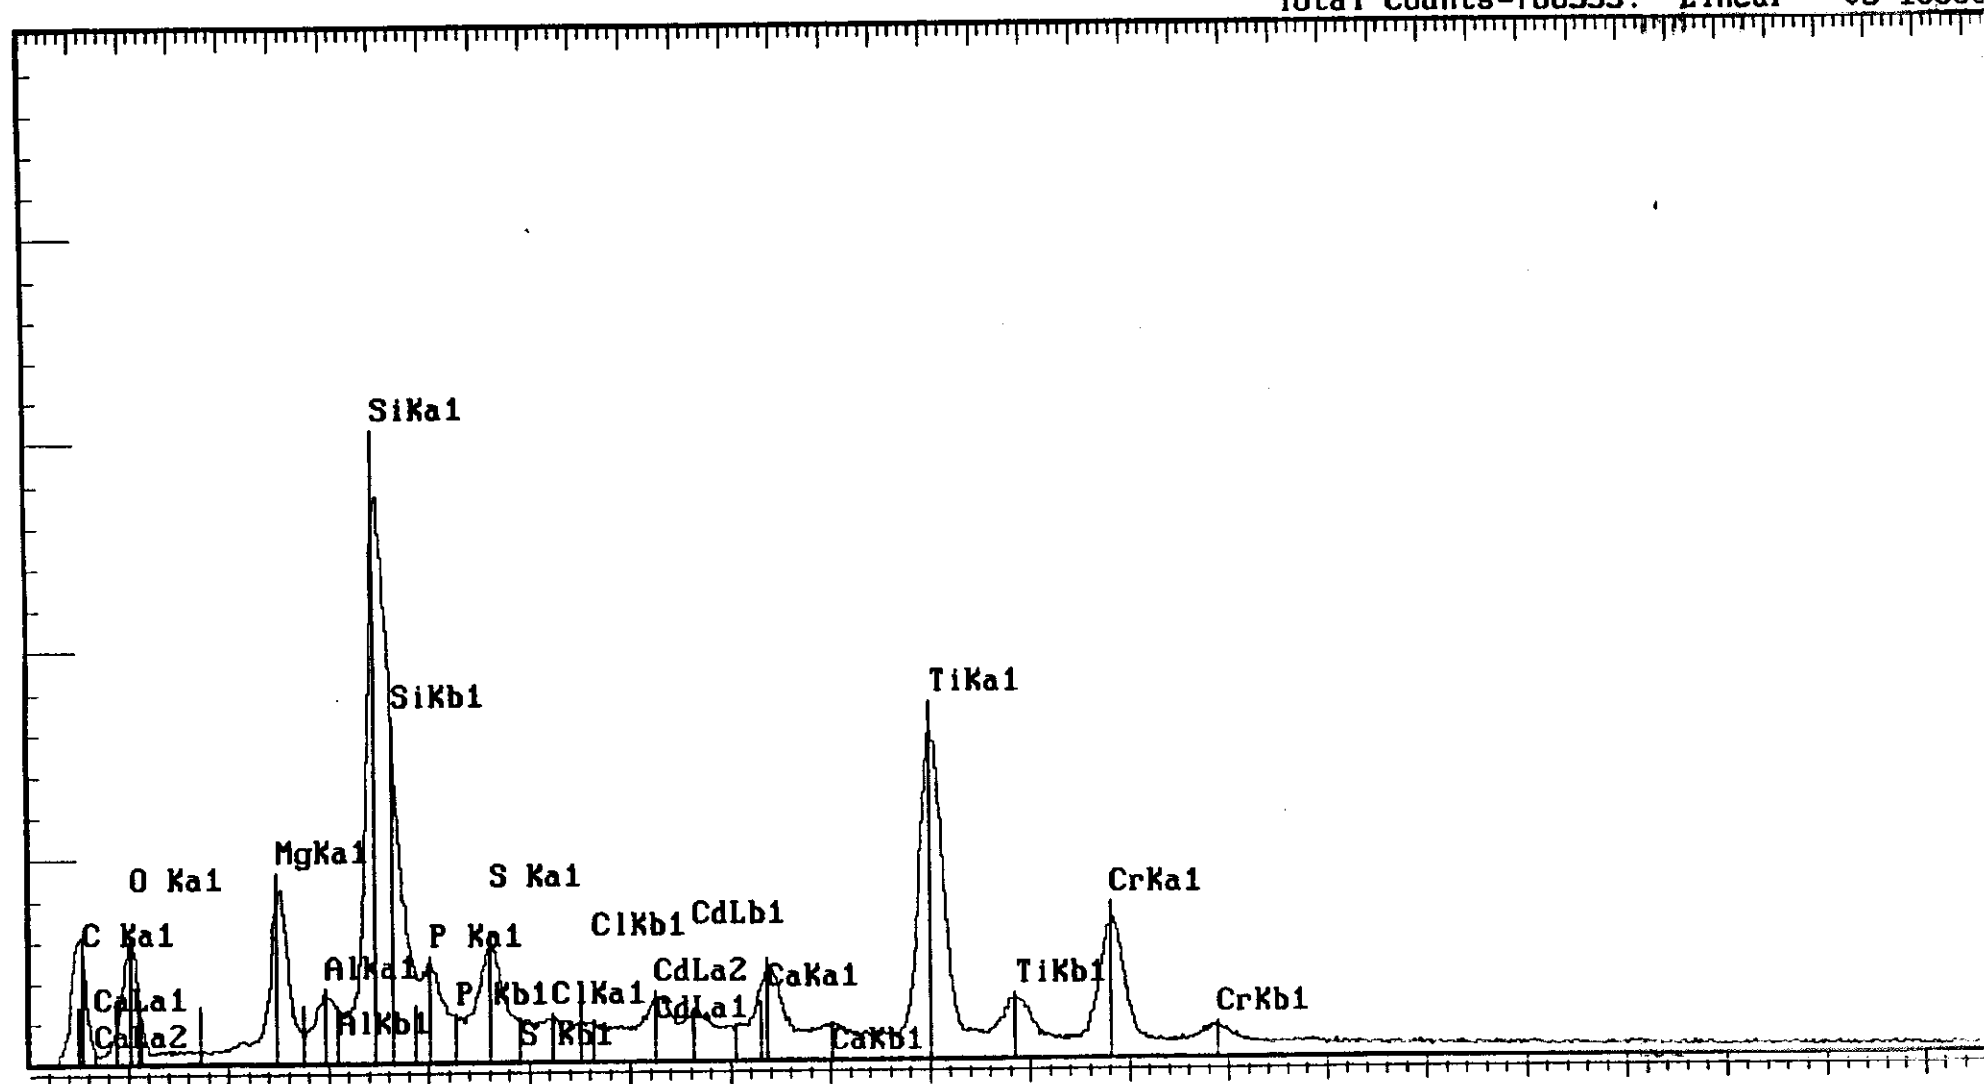
Spectrum: SAMPLE8-1

Blue-green color deposit from the edge of white paint

The analysis of this deposit produced the characteristic peaks of C, O, Mg, Al, Si, P, S, CL, Ca, Cd, Ti, and Cr (see spectrum for SAMPLE8-1 in Appendix.)

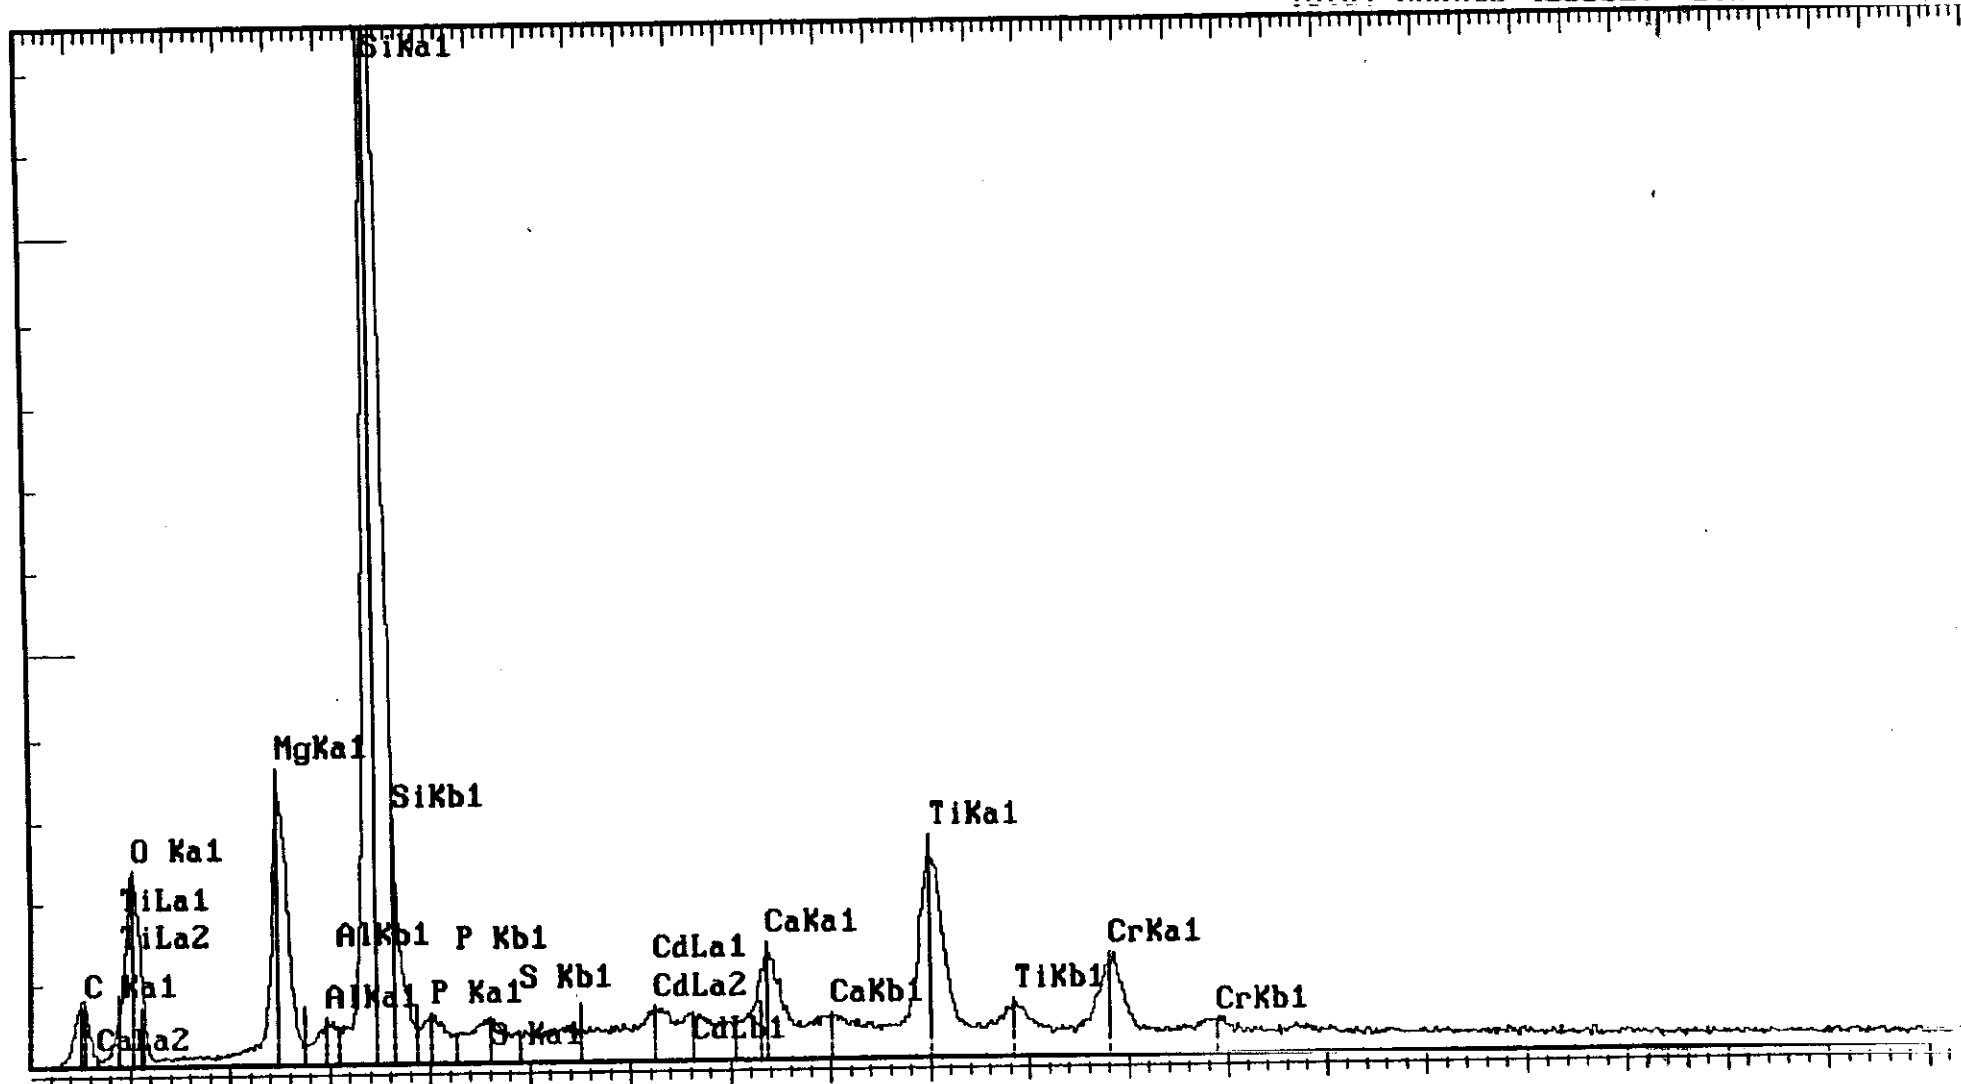
Spectrum: SAMPLE8-2

Light green color deposit from the area of the bracket that had not been painted

The analysis of this deposit produced the characteristic peaks of C, O, Ca, Mg, Al, Si, P, S, Cd, Ca, Ti, and Cr (see spectrum for SAMPLE 8-2 in Appendix).

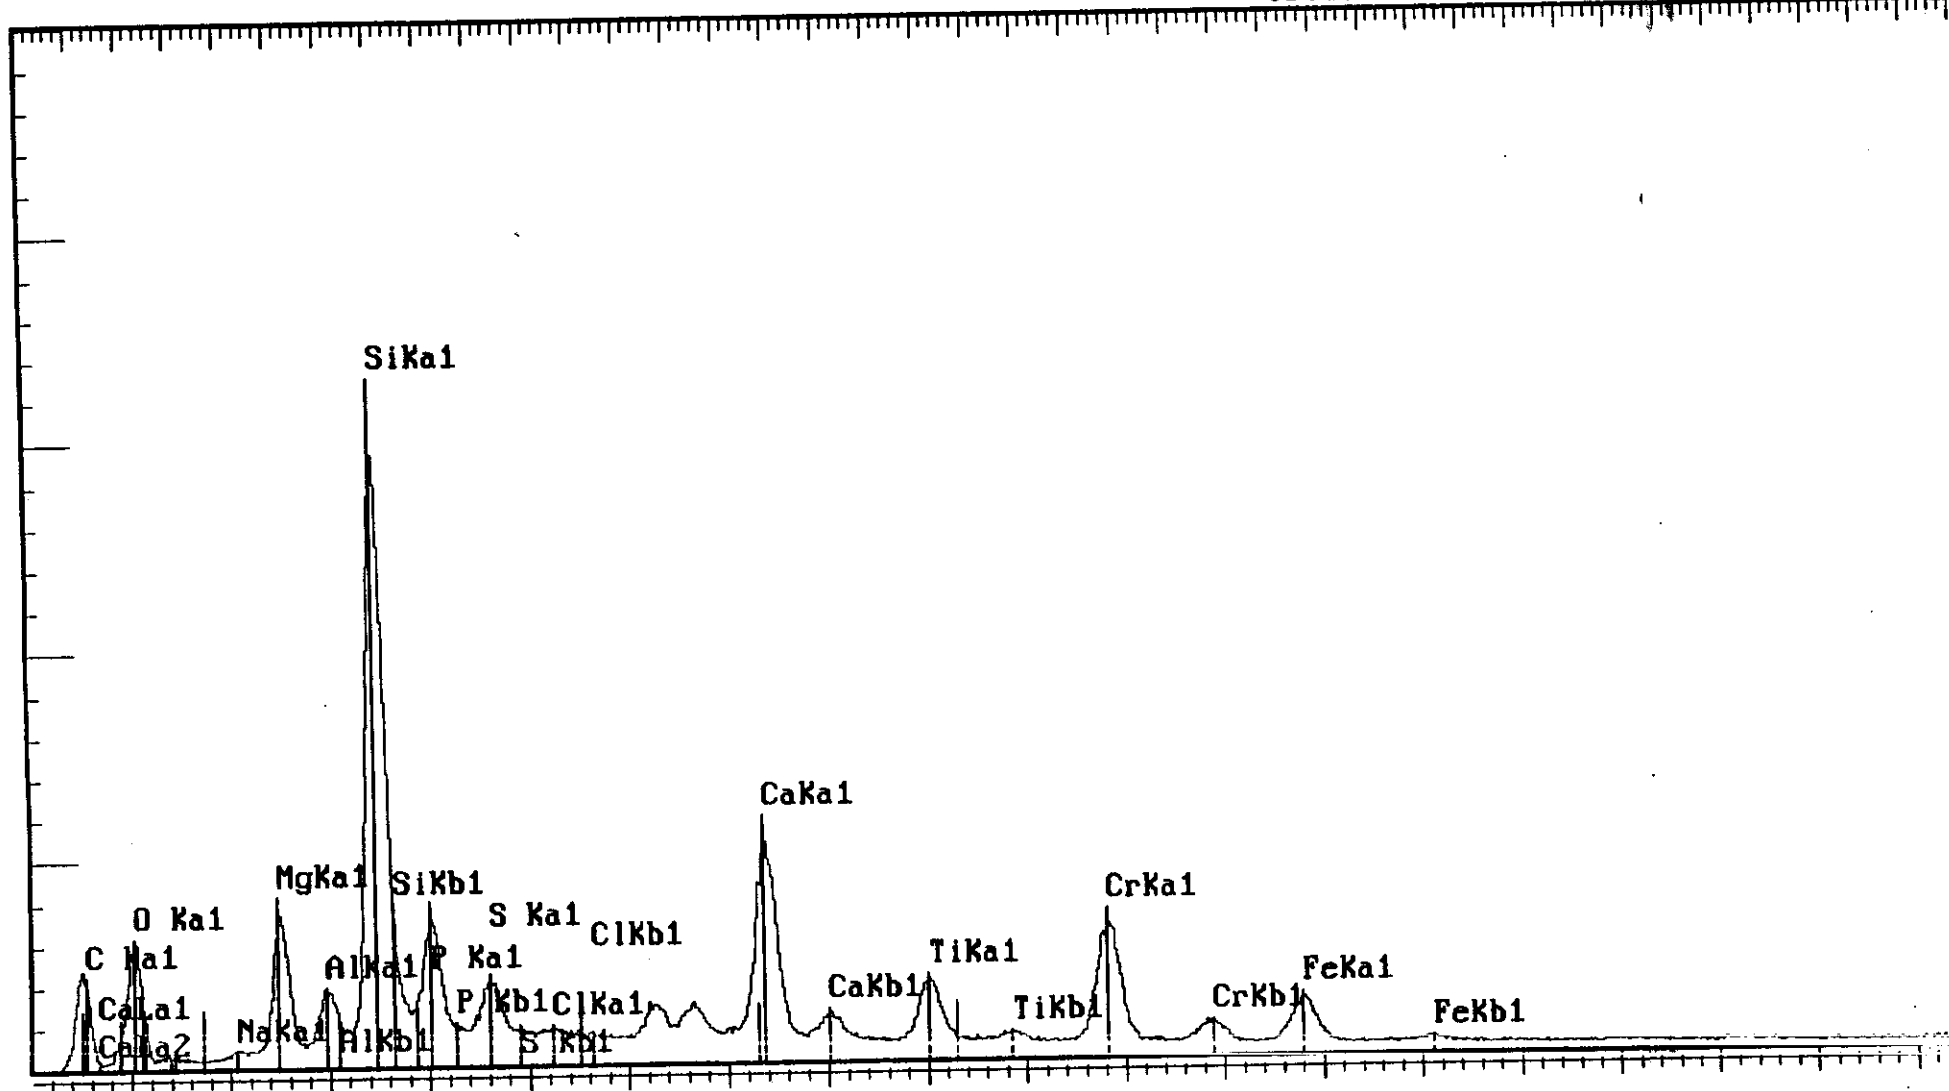
Spectrum: SAMPLE8-3A

The analysis of the first sample produced a spectrum containing the characteristic peaks of C, O, Ca, Na, Mg, Al, Si, P, S, Cl, Cr, and Fe (see spectrum for SAMPLE8-3A in Appendix).

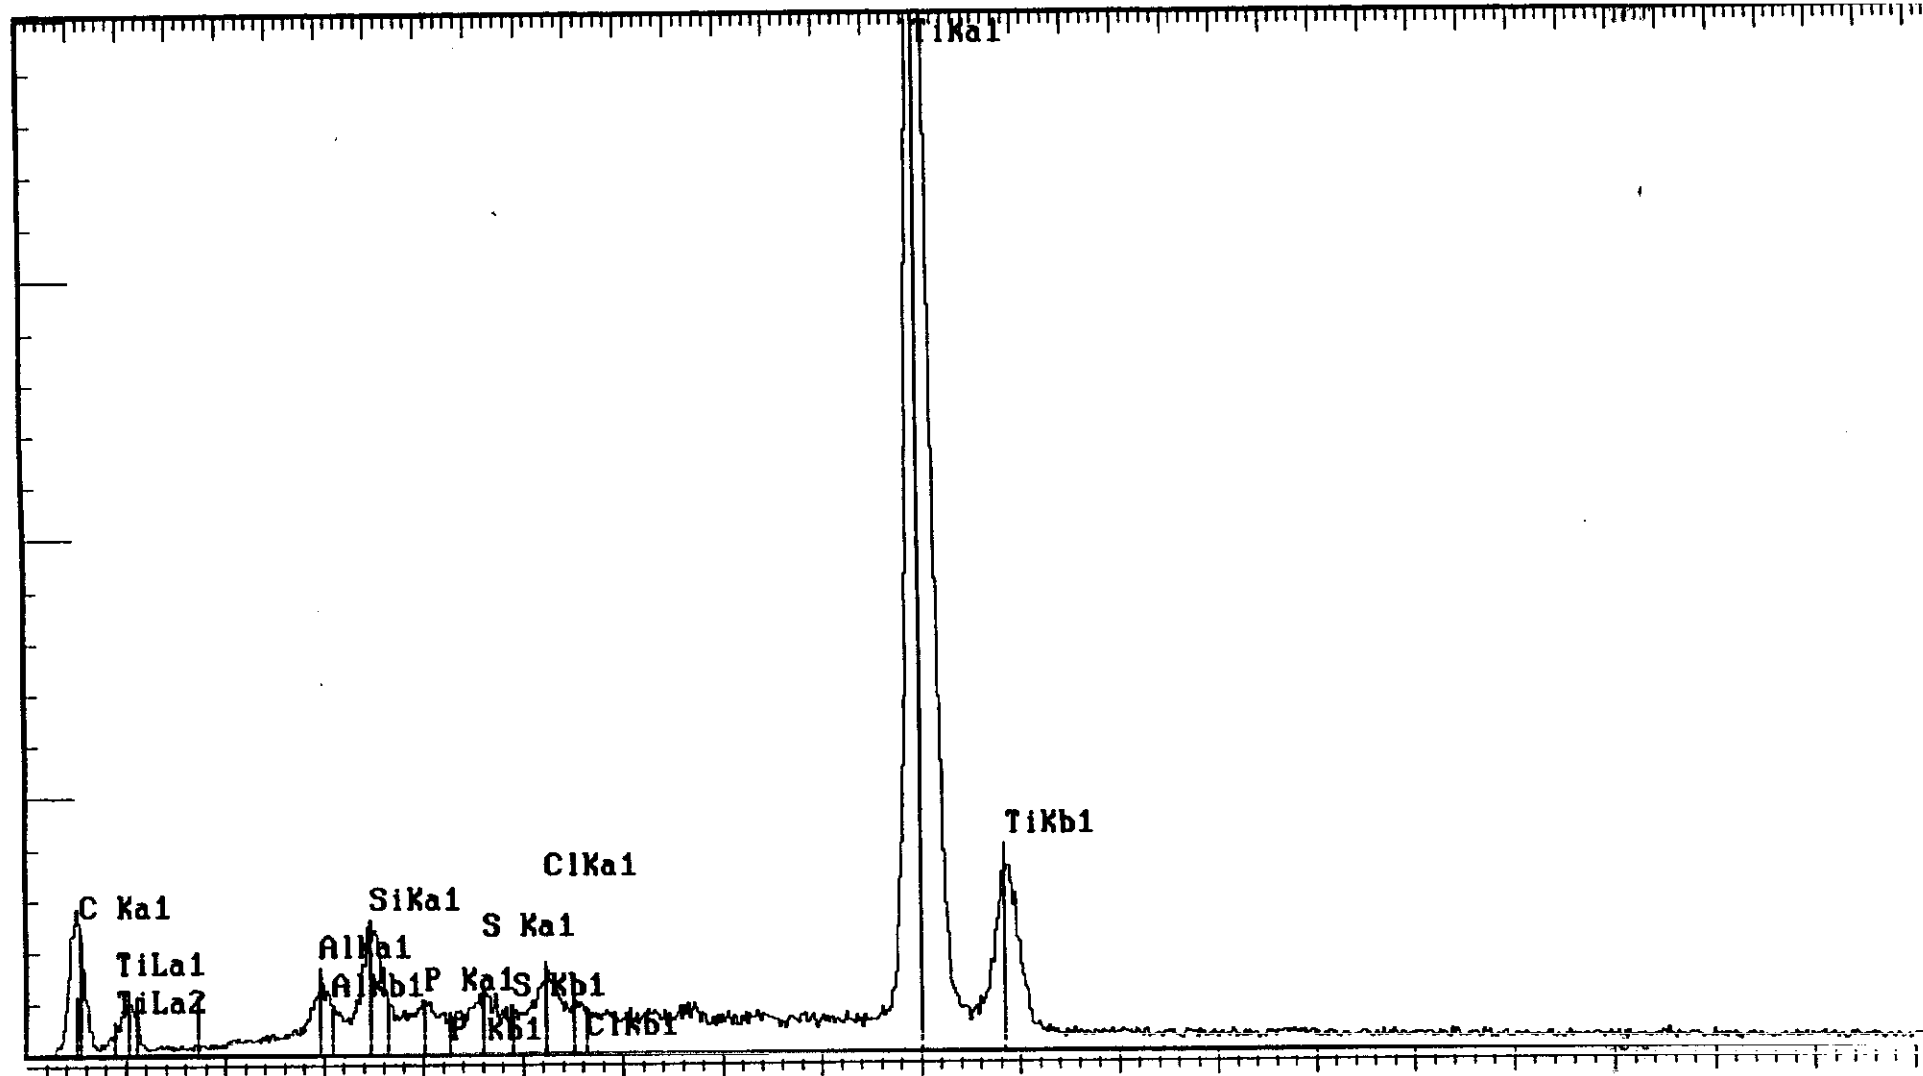
Spectrum: SAMPLE8-3B

The analysis of the second sample produced a spectrum containing the characteristic peaks of C, Ti, Al, Si, P, S, and Cl (see the spectrum for SAMPLE8-3B in Appendix).
