**From:** McAtee Nancy  
**Sent:** Wednesday, February 06, 2013 4:21 PM  
**To:** Hicks Ralph  
**Cc:** Budinski Michael  
**Subject:** Email report for ERA12LA356  
**Attachments:** 1207Image23419.jpg; black splice 1.tif

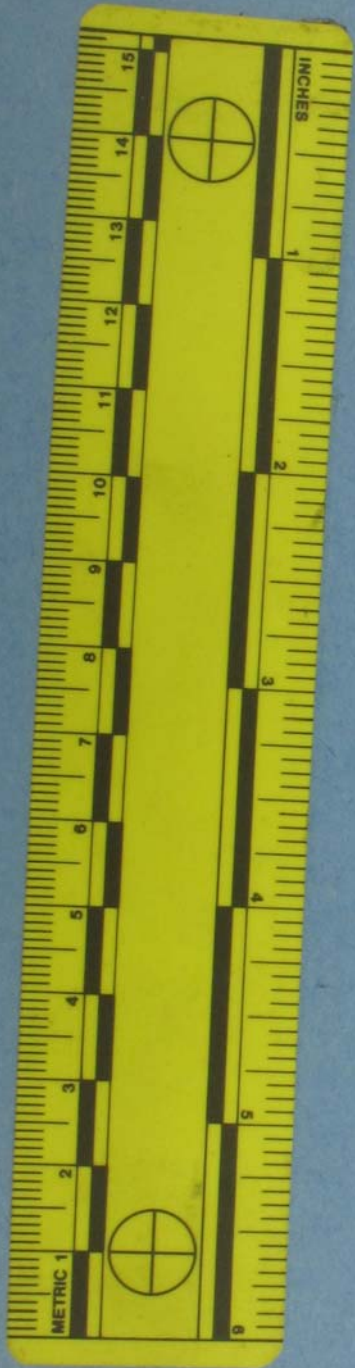
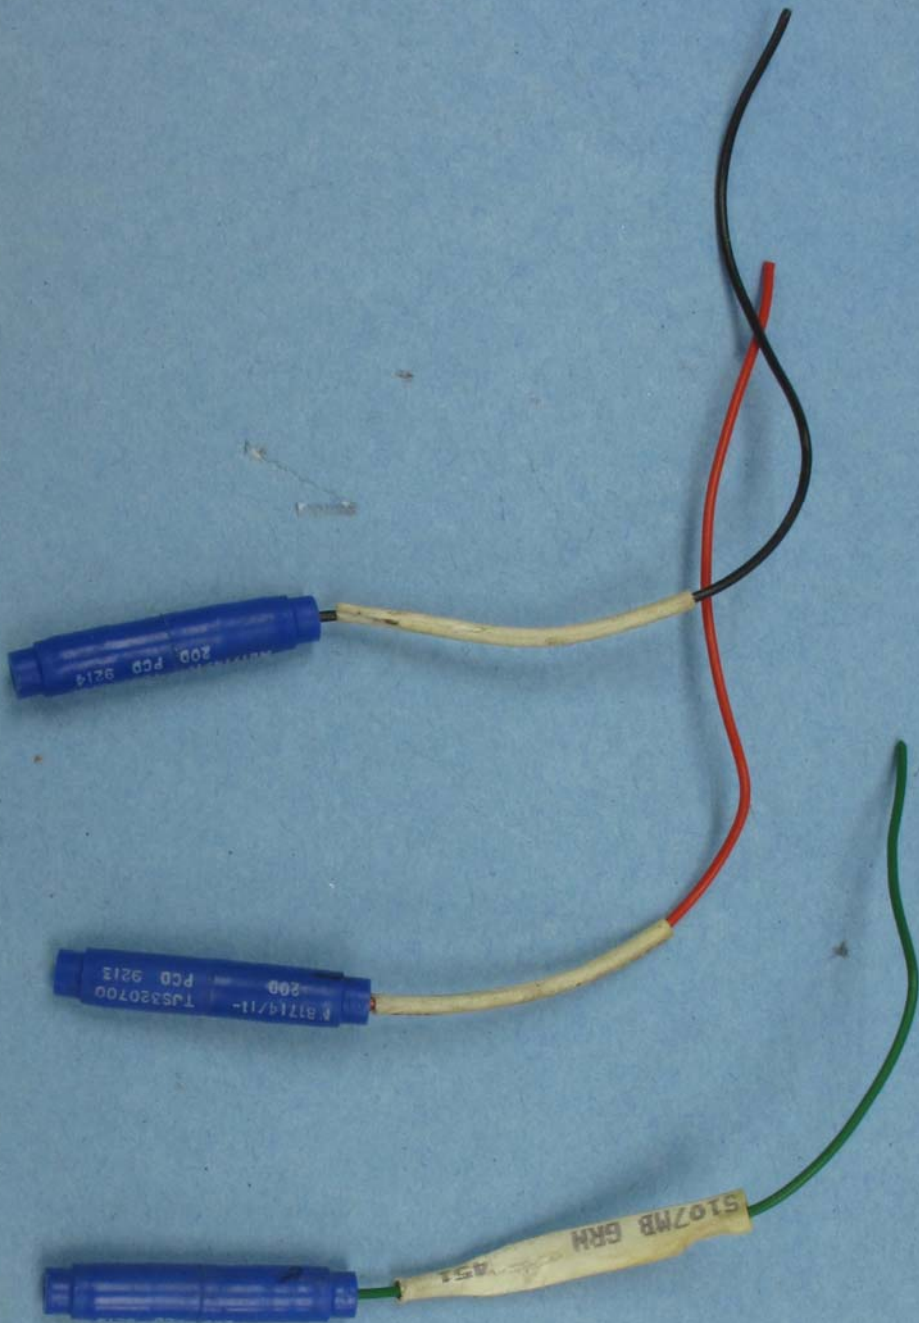
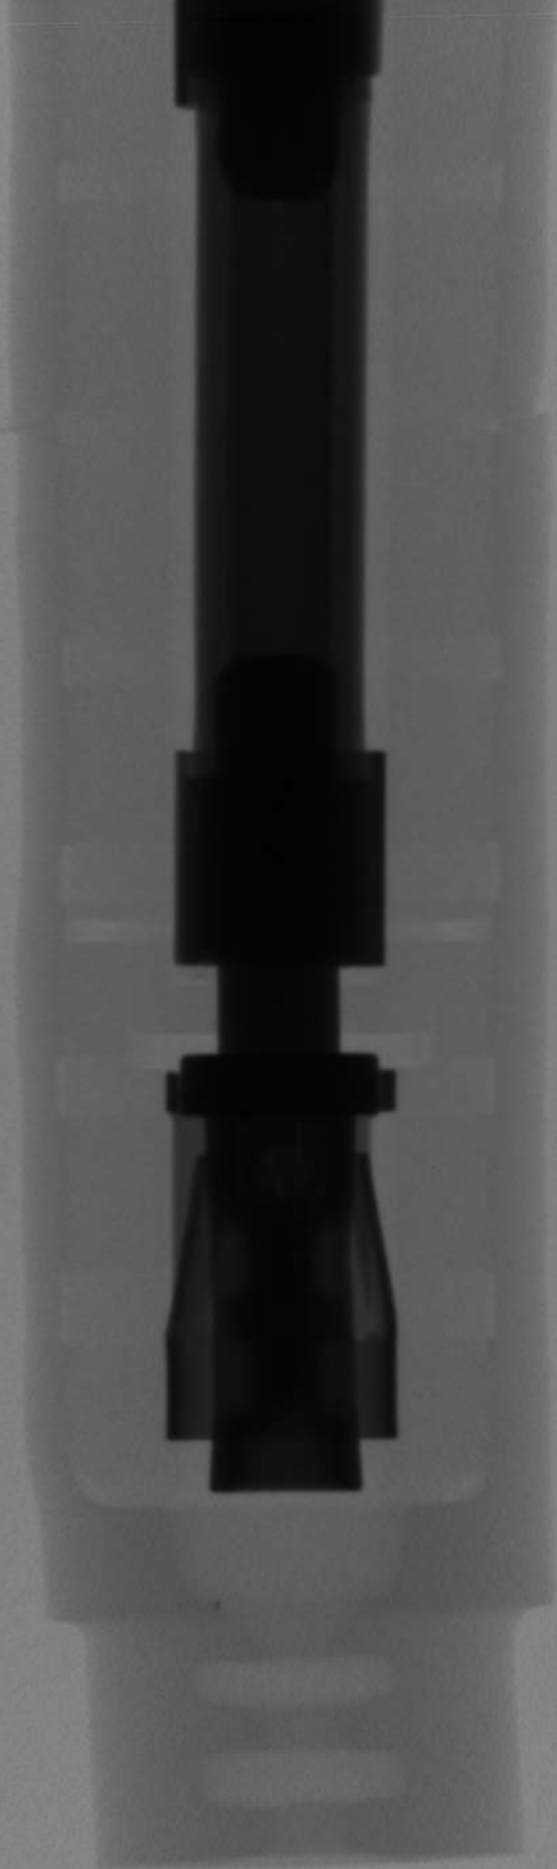
The three sets of splices from the Cabin Door Warning System were examined in the Materials Laboratory. The splices met Mil Spec M81714-11-20B. Each submitted splice had wiring installed on only one side of the splice. A photograph of the splices is attached to this email. Each splice was x-rayed to determine if wiring at some point was present on both sides of the splice. The radiographs from all three splices showed no sign of wiring having been installed on the "open" side of the splice. An exemplar radiograph is attached to this email. The outer covering was removed from one of the splices to expose the open end of the splice. There was no evidence of marks, scratches or any other damage consistent with a wire having been installed and then pulled out. In addition, there were no remains of wiring present in the open end. Therefore, the condition of the splices was consistent with wiring having been installed in only one end of the splice.
