## **NATIONAL TRANSPORTATION SAFETY BOARD**

**Group Chairman's Factual Report**

**METEOROLOGY**

**CEN13FA122**

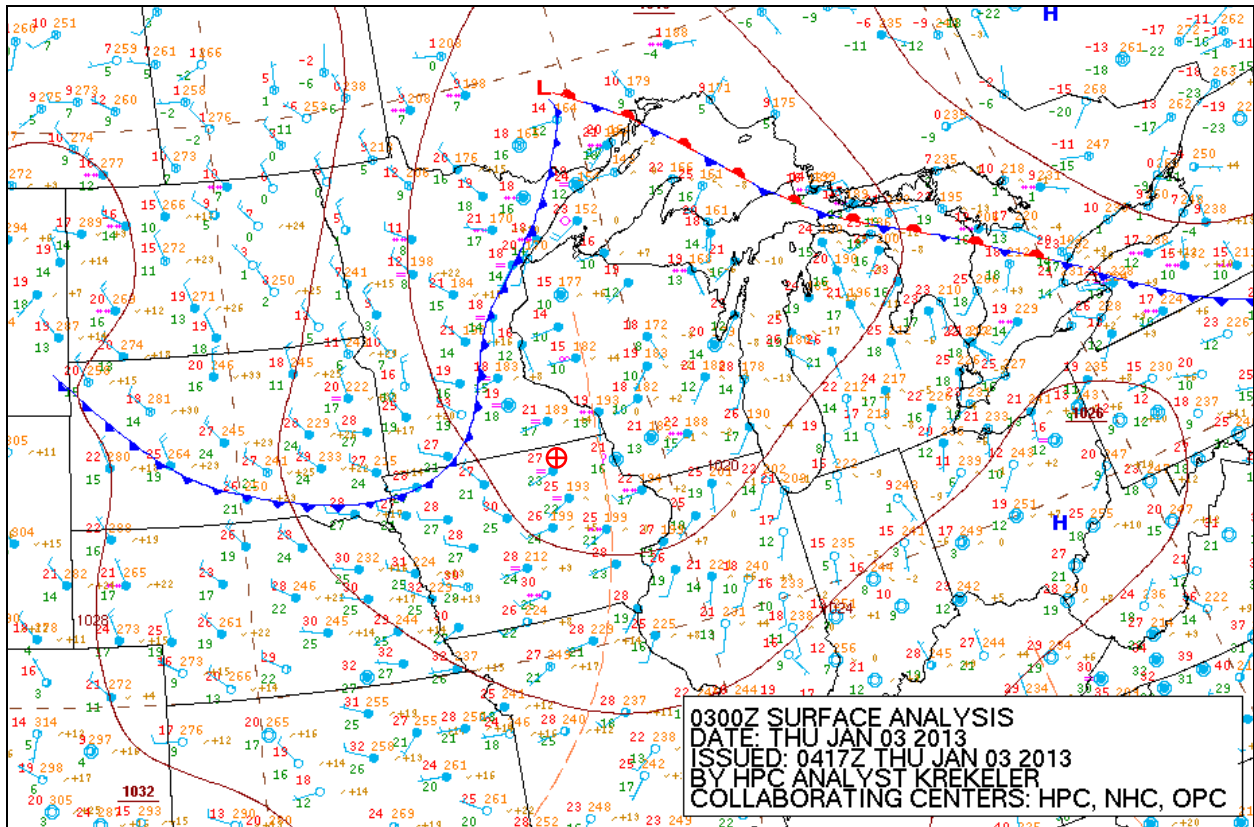
The NWS Surface Analysis Chart for 2100 CST on January 2, 2013 is included as figure 1 with the approximate accident site marked by a red cross. The chart depicted a low pressure at 1016-hPa over Ontario with a cold front extending southward from the low across Minnesota and into northwestern Iowa. Ahead of the cold front stretched a trough of low pressure that extended southward across Wisconsin, into eastern Iowa, and then curving southwestward into Missouri. The accident site was located ahead of the cold front and behind or west of the trough of low pressure.

The station model in the immediate vicinity of the accident site ahead of the cold front indicated westerly wind at approximately 5 knots, visibility restricted in mist, overcast clouds, a temperature of 27° Fahrenheit (F), and a dew point of 23° F. Numerous other station models northeast through southeast of the site over central and eastern Iowa, eastern Minnesota reported visibility restriction in mist with several stations reporting light snow.

Figure 1 - NWS Surface Analysis Chart for 2100 CST

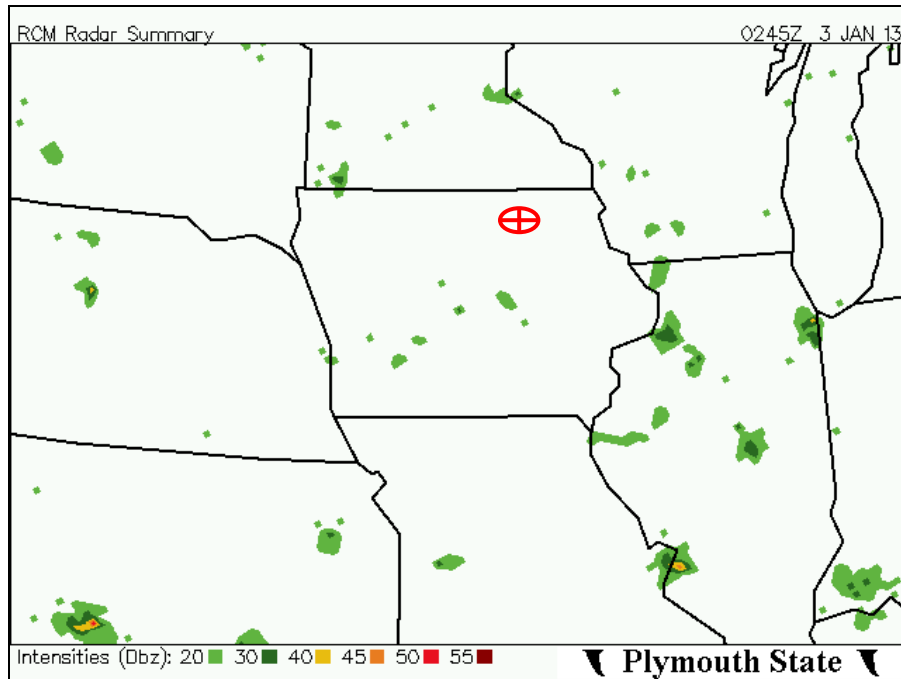
The NWS regional radar mosaic for Iowa depicted no significant meteorological echoes over the accident site surrounding the period, and with only several small areas of very light intensity echoes associated with light snow showers. Figure 2 is a radar coded message (RCM) plot of the echoes at 2045 CST.

**Figure 2- Radar Coded Message plot of echoes at 2045 CST**

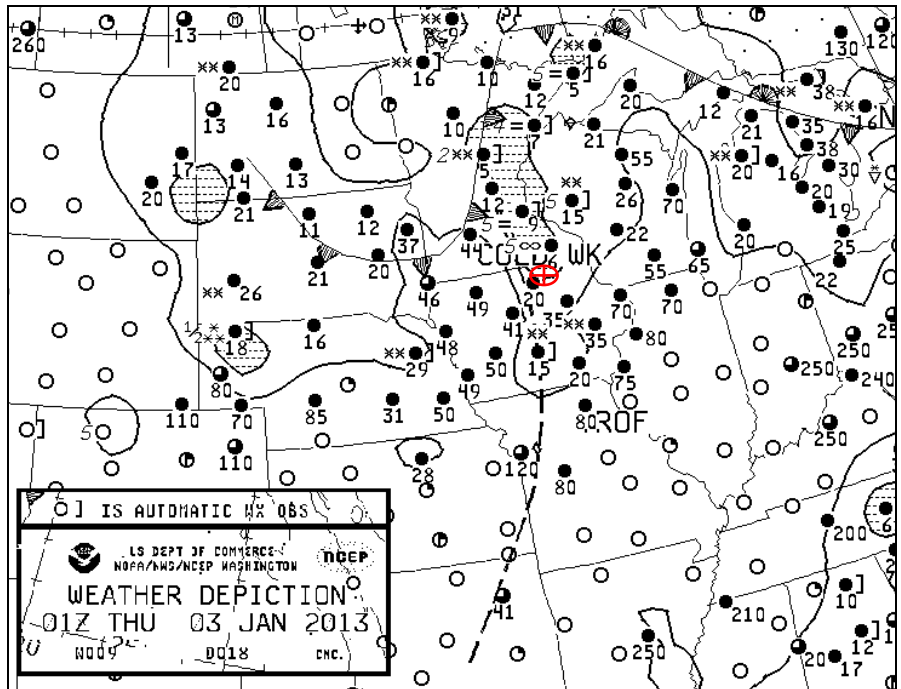
The NWS Weather Depiction Charts for 1900 and 2200 CST (0100Z and 0400Z on January 3, 2013) centered over the region were document in figures 3 and 4 respectively to document the general flight conditions being depicted over the region. The chart at 1900 CST depicted an area of instrument flight rule (IFR) conditions<sup>2</sup> due to low ceilings along the cold and ahead of the cold front and the trough Minnesota, western Wisconsin, into northern Iowa in the vicinity of the accident site, depicted by a shaded contour line. That area was enclosed by a large area of marginal visual flight rule (MVFR) conditions<sup>3</sup> which stretched over eastern Minnesota and Iowa with several stations reporting light snow. General visual flight rule (VFR) conditions<sup>4</sup> were depicted over western Iowa depicted without a contour line.

Figure 3 - NWS Weather Depiction Chart for 1900 CST

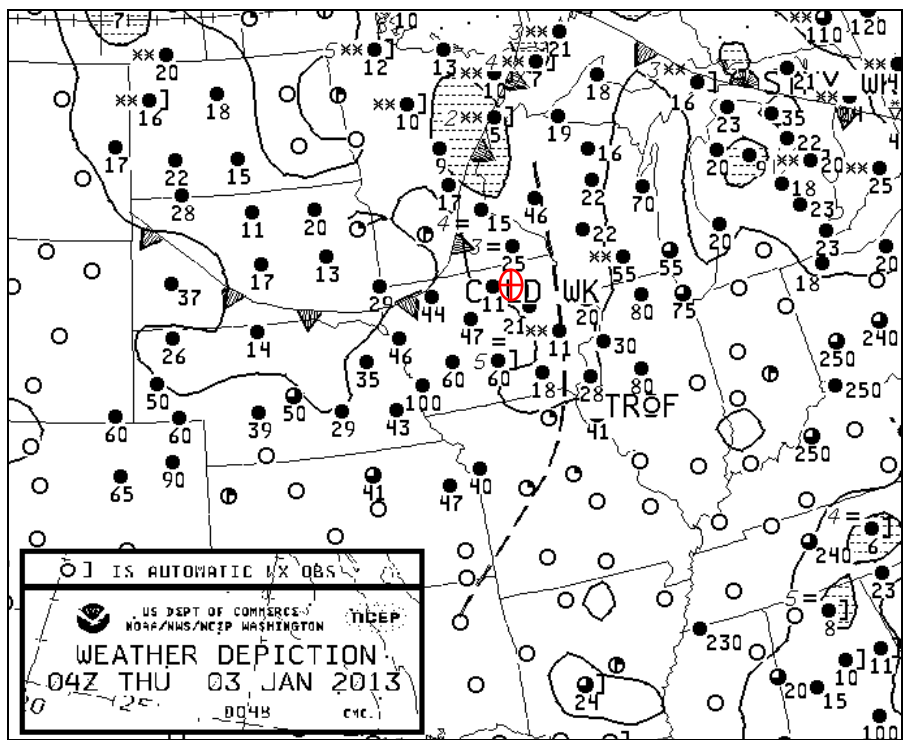
The chart for 2200 CST depicted a smaller area of IFR conditions over Minnesota, with a MVFR conditions continuing over eastern Minnesota and Iowa, and most of Wisconsin. MVFR conditions were depicted surrounding the accident site with overcast ceilings.

Figure 4 - NWS Weather Depiction Chart for 2200 CST

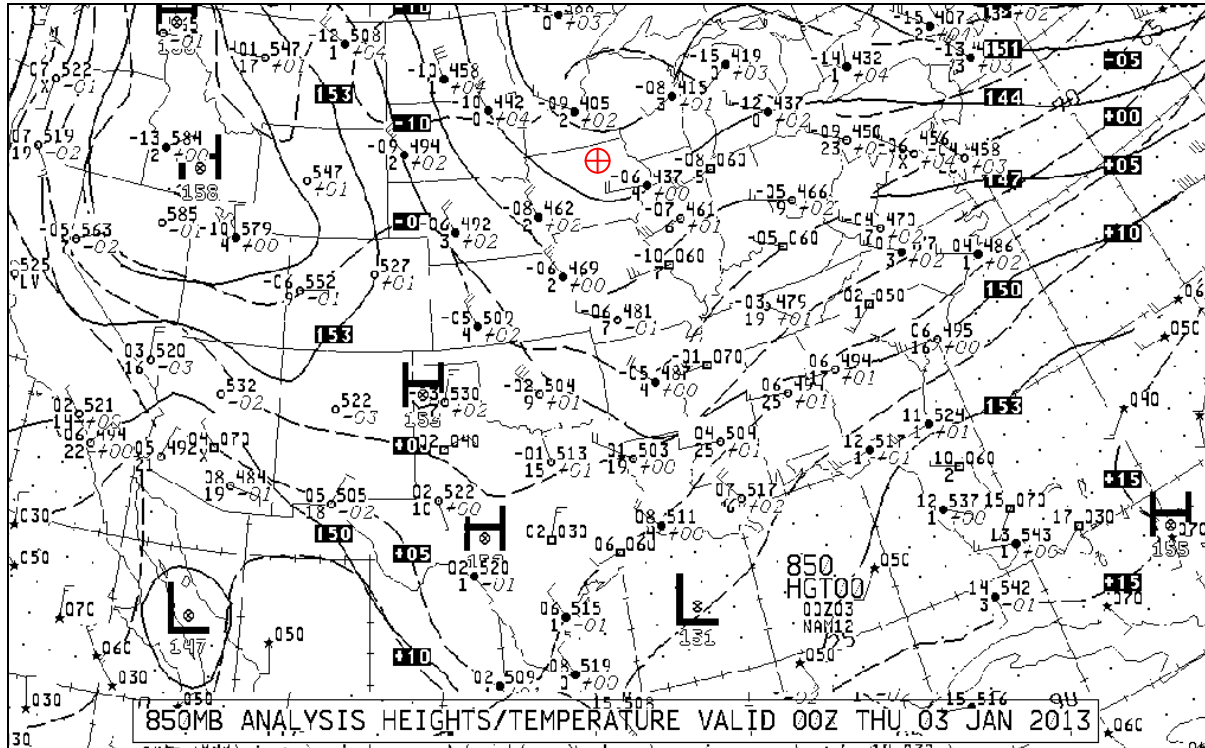
The NWS 850-hPa Constant Pressure Charts for January 2, 2013 at 1800 CST (0000Z on January 3, 2013) is included as figures 5, depicting the conditions at approximately 5,000 feet

over the area. The chart depicted a short wave trough extending southward across Minnesota, Iowa, into Missouri with a cyclonic shift in winds. The closest station model for Davenport, Iowa immediately southwest of the accident site indicated a westerly wind at 20 knots, a temperature of -6° Celsius (C), a temperature-dew point spread of 4° C, implying near saturated conditions at that level with a 70 meter height drop in the last 12-hours.

Figure 5- NWS 850-hPa Constant Pressure Chart for 1800 CST

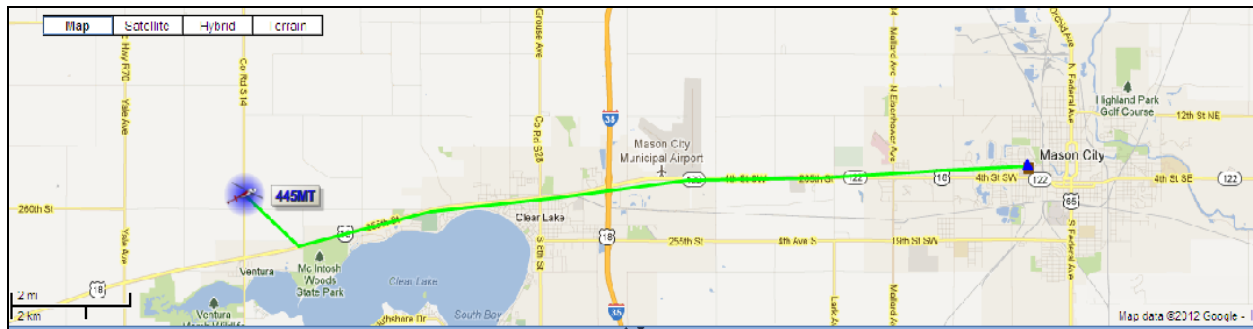
Figure 6 is a plot of the helicopter flight path based on position reports provided by the helicopters global positioning system (GPS).

Figure 6 - Flight Track of N445MT

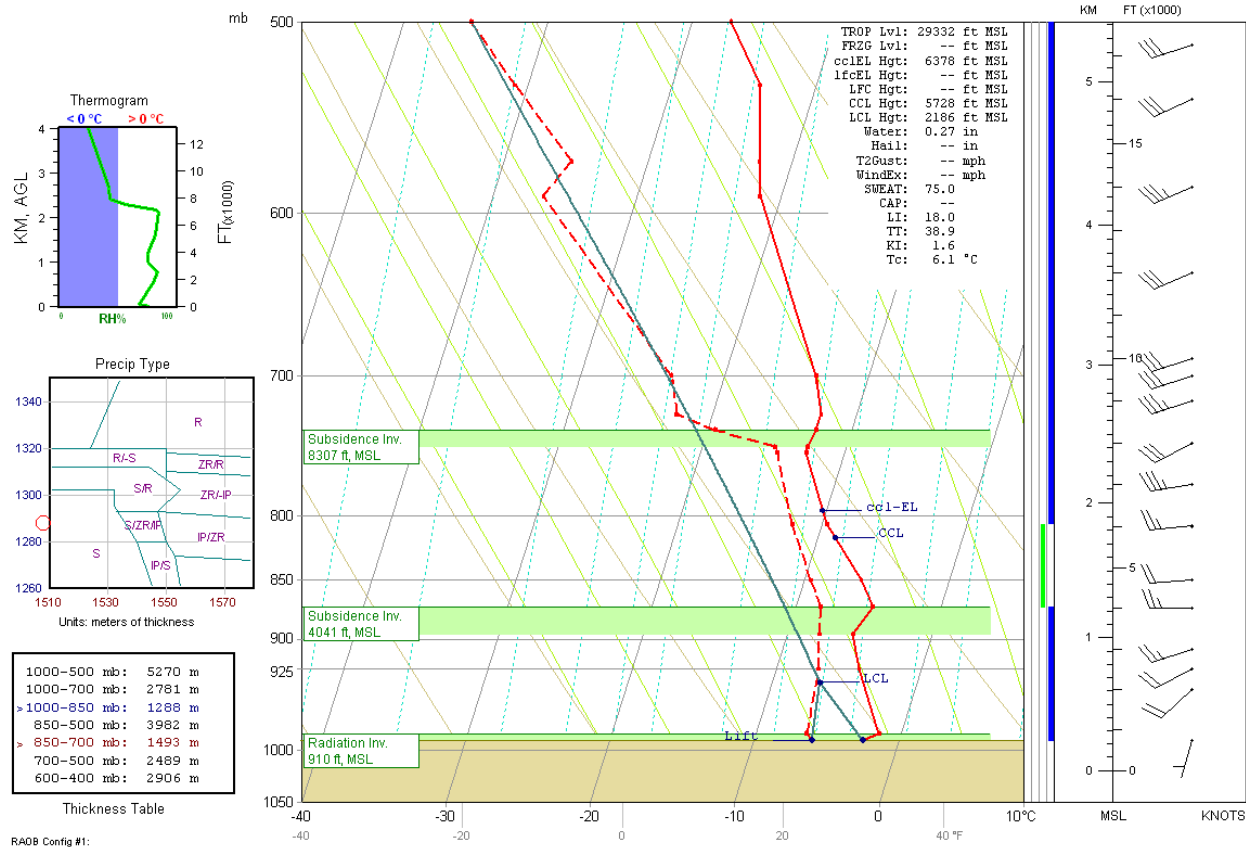
The closest upper air sounding or rawinsonde observation (RAOB) was from the NWS Davenport (KDVN), Iowa, site number 74455, located approximately 153 miles southeast of the accident site at an elevation of 751 feet. The 1800 CST (0000Z on January 3, 2013) sounding was plotted on a standard Skew-T log P diagram<sup>6</sup> utilizing RAOB<sup>7</sup> software is included as figure 7 from the surface to 500-hPa or 18,000 feet. The sounding depicted the entire depth of the sounding below freezing even with several temperature inversions noted below 18,000 feet. The estimated base of the clouds of lifted condensation level (LCL)<sup>8</sup> was at 1,435 feet agl. The sounding had a relative humidity greater than 75 percent from the LCL to approximately 8,000 feet. The sounding was stable with a lifted index (LI)<sup>9</sup> of 18 which support stratiform type clouds with the potential for snow showers. The precipitable water content of the sounding was 0.27 inches.

**Figure 7 - Davenport, Iowa 1800 CST sounding**

The wind profile indicated a surface wind from the south or 195° at 6 knots with winds veering to the west above the surface and increasing in speed. The mean 0 to 6 kilometer wind was from 250° at 28 knots.

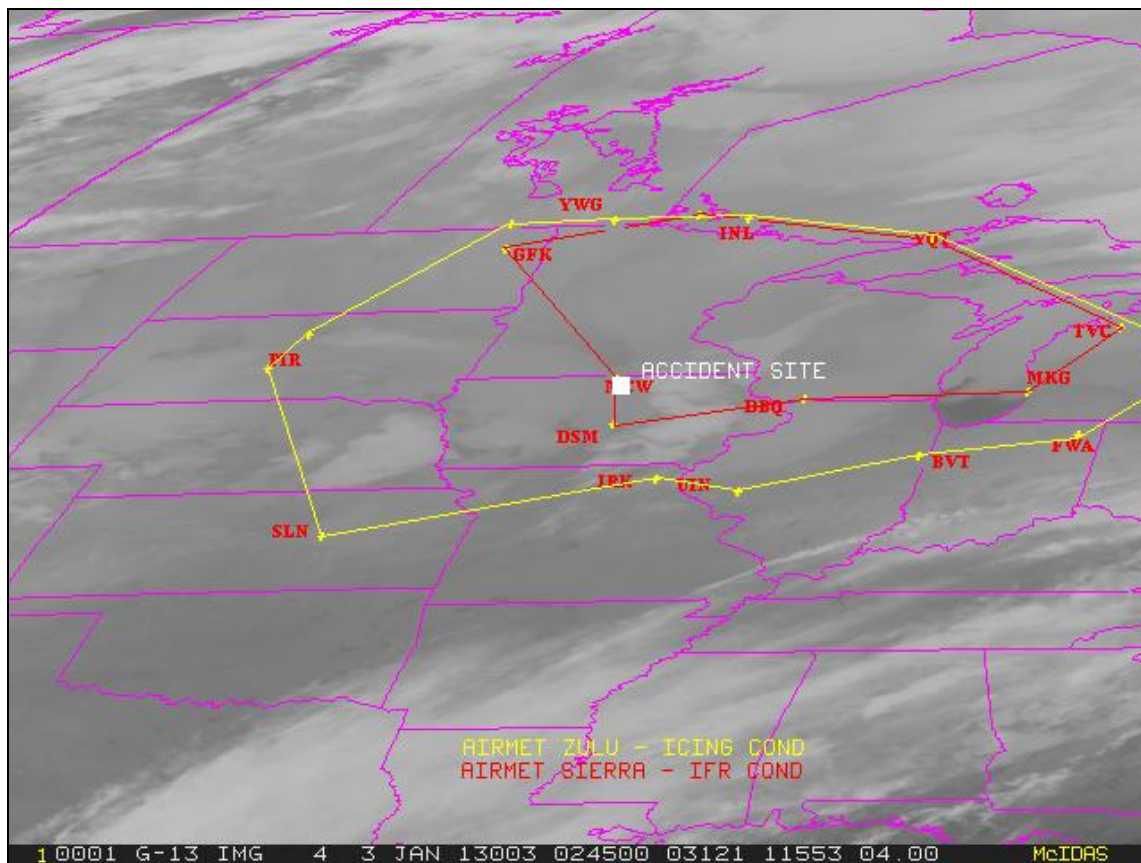
The NWS had AIRMET Sierra current for IFR conditions or ceilings below 1,000 feet and/or visibility less than 3 miles in mist, and moderate icing conditions below 10,000 feet over the

accident site. Figure 9 is a plot of the advisory over the GOES-13 infrared satellite image for 2045 CST when the advisories were issued.

Figure 9 - AIRMETs issued at 2045 CST
