**NATIONAL TRANSPORTATION SAFETY BOARD**  
**Office of Aviation Safety**  
**Washington D.C. 20594**

Meteorological Factual Report  
DCA98MA015

Location: 32 degrees 31 minutes north latitude 157 degrees 27 minutes east longitude  
Date: December 28, 1997  
Time: About 1340Z  
Aircraft: Boeing 747-122, N4723U, United Airlines Flight 826 [UAL826]

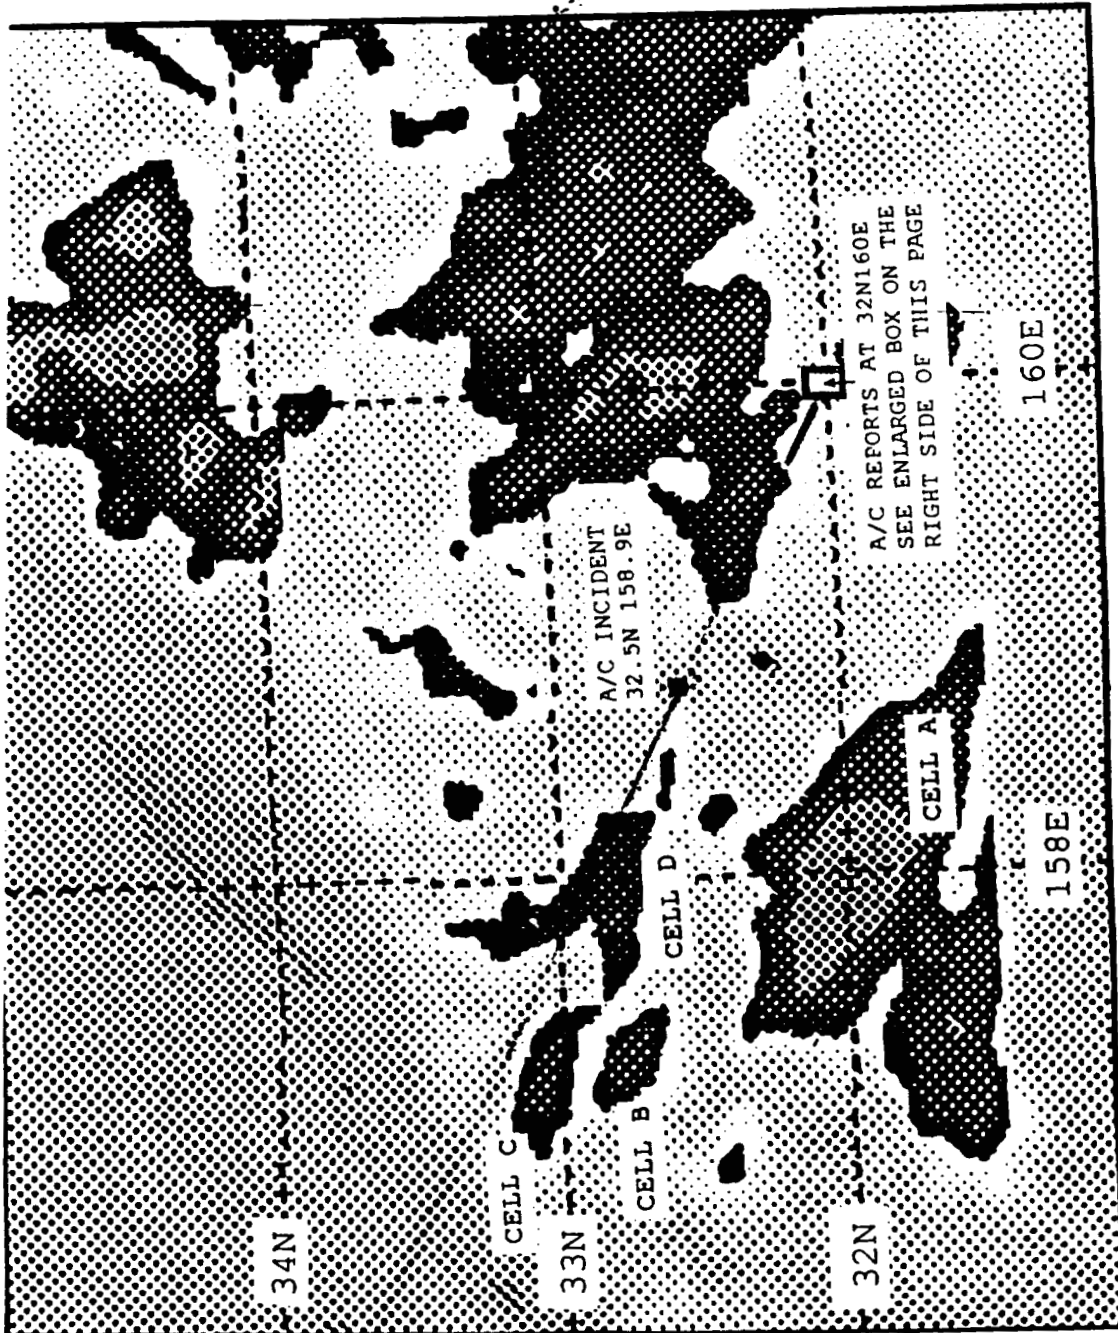
ESTIMATED CLOUD TOPS BASED ON DEC. 28 1334Z GMS IR SATELLITE  
 TEMPERATURES AND 28/1149Z TO 28/1502Z AIRCRAFT REPORTED FLIGHT  
 LEVELS/TEMPERATURES 32N 160E

- CELL A - FL390
- CELL B - FL370
- CELL C - FL370
- CELL D - FL290

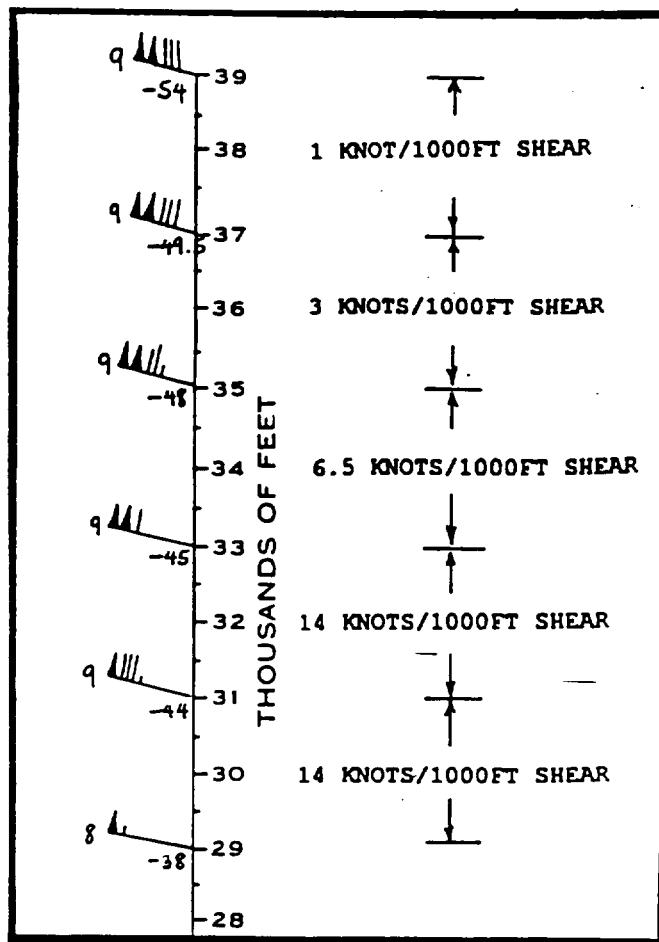
FLIGHT LEVEL WIND SPEEDS/TEMPERATURES/SHEARS  
 BASED ON AIRCRAFT REPORTS AT 32N160E FOR THE  
 TIME PERIOD 28/1149Z TO 28/1502Z
