National Transportation Safety Board Office of Aviation Safety Washington, D.C. 20594-2000 April 17, 2000

METEOROLOGICAL FACTUAL REPORT DCA00MA030

Location: Burbank, California Date: March 5, 2000

Time: 1810 Pacific Standard Time (0210 UTC March 6, 2000) Aircraft: Southwest Airlines flight 1455, Boeing 737-300, N6685SW

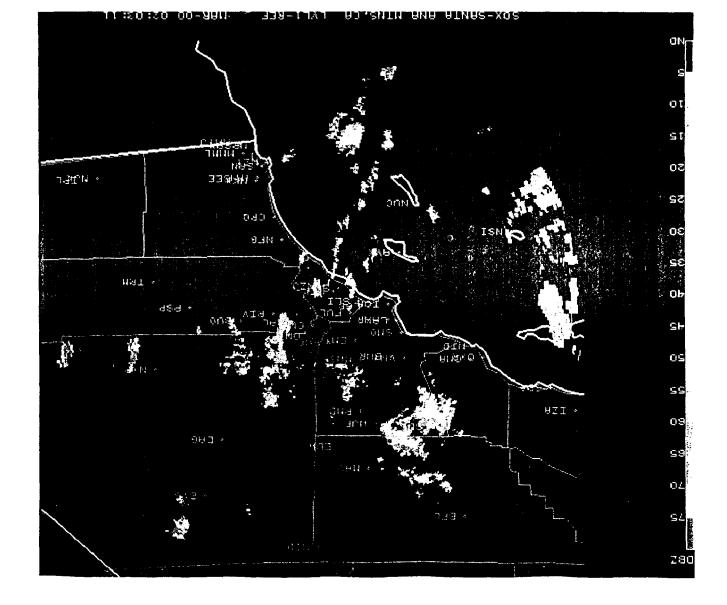
The base reflectivity from the 0.5 degree elevation scan from 0000Z through 0400Z on March 6, 2000, was examined on-line from the National Center for Atmospheric Research (NCAR) achieve data. The images indicated only scattered echoes over the region with none impacting the Burbank Airport. Attachment 7 is the base reflectivity

at 0203:11Z from SOX - Santa Ana Mountains. The reflectivities ranged from 5 dBZ to 35 dBZ or light to moderate intensities, or NWS VIP Level 1 and 2 activity, with only an isolated area of 40 dBZ or level 3 indicated off the coast.

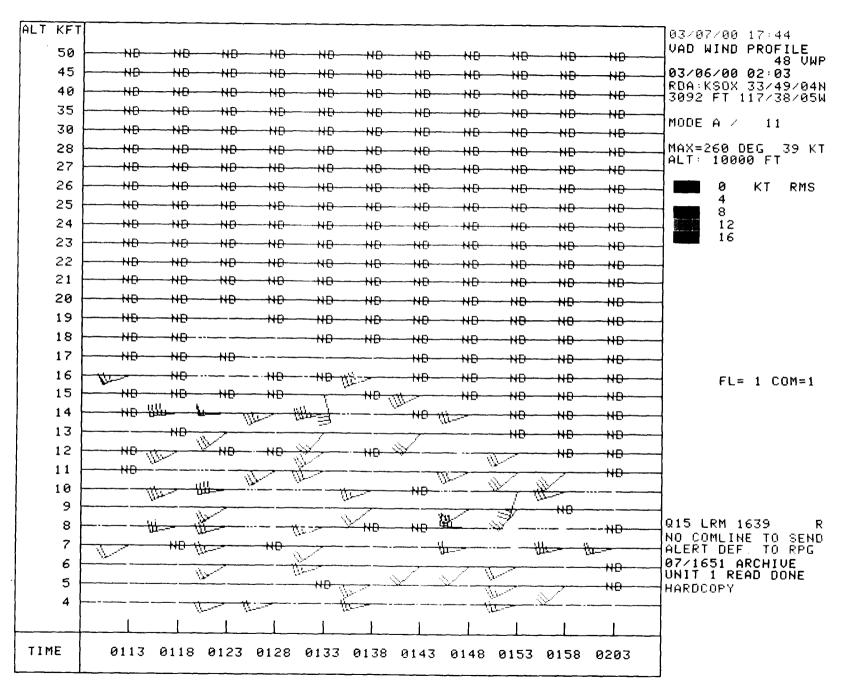
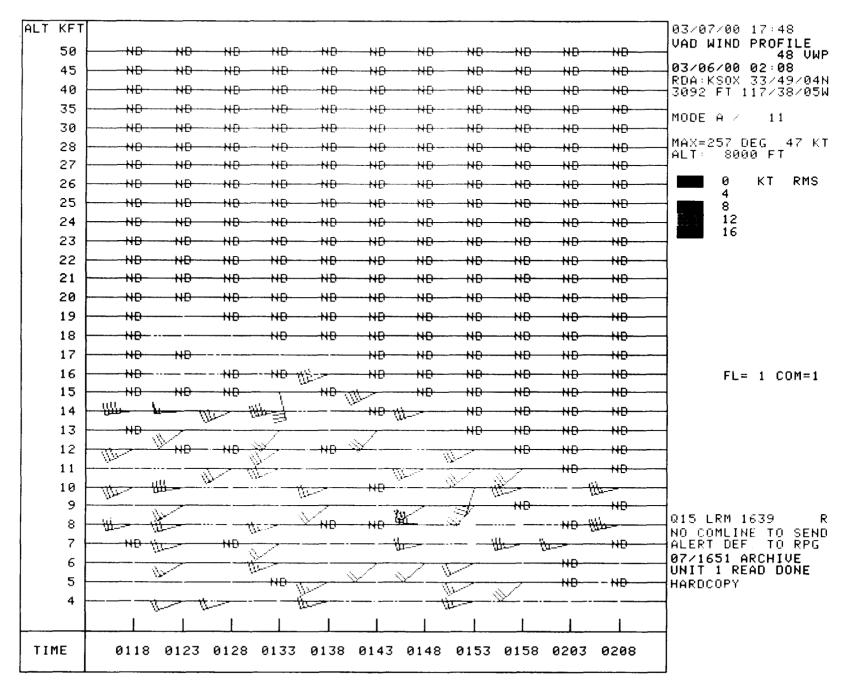
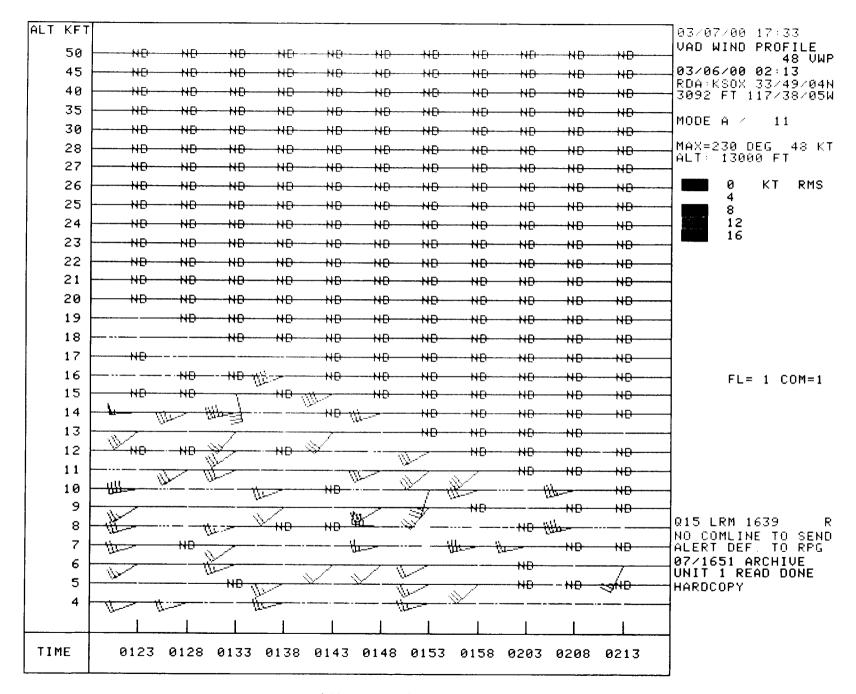
While SOX reported three volume scans during the period, from 0113Z to 0213Z (attachment 9-11), at 0208Z and 0213Z the wind was observed from the west at 25 knots, with a RMS error of 4 knots or less.

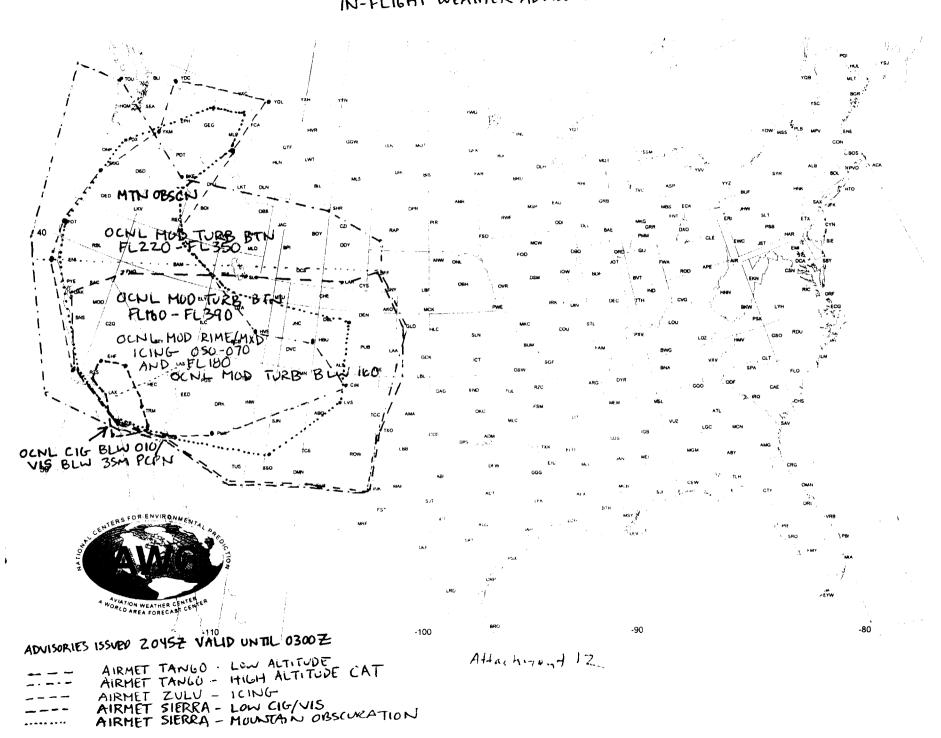
IN-FLIGHT WEATHER ADVISORIES

The NWS Aviation Weather Center (AWC) located in Kansas City, Missouri had the following AIRMET series of in-flight weather advisories⁶ current at the time of the accident (attachment 12 plot and text):

AIRMET Tango update 5 for turbulence issued at 2045Z on March 5, 2000, and valid until 0300Z on March 6, 2000. The advisory covered sections of California, Oregon, Idaho, Wyoming, Nevada, Utah, Colorado, Arizona, and New Mexico. Two separate advisories were included, one advisory for high altitude clear air turbulence and one advisory for low altitude turbulence. The high altitude advisory was for occasional moderate turbulence between 16,000 feet and 39,000 feet, with conditions continuing beyond 0300Z to 0900Z. The low altitude advisory was for occasional moderate turbulence below 16,000 feet, with conditions continuing beyond 0300Z to 0900Z.

AIRMET Zulu update 5 was issued at 2045Z and was valid until 0300Z. The area encompassed sections of Washington, Oregon, California, Idaho, Montana, Nevada, Utah, Colorado, Arizona, and New Mexico. The advisory warned of occasional moderate rime to mixed icing in-clouds and in-precipitation between 5,000 to 7,000 feet, and 18,000 feet. Conditions were expected to continue beyond 0300Z.

There were two separate AIRMET Sierra advisories current for the area. One AIRMET was issued for occasional ceilings below 1,000 feet and/or visibility below 3 miles in precipitation. The other AIRMET was issued for occasional mountain obscuration in clouds and precipitation. Both AIRMETs were expected to continue beyond 0300Z.
