NATIONAL TRANSPORTATION SAFETY BOARD  
Office of Aviation Safety  
Washington D.C. 20594

METEOROLOGICAL GROUP CHAIRMAN'S FACTUAL REPORT

DCA-94-MA-065

Aircraft: Douglas DC-9-31, N954VJ, Owned by USAir, Inc., and  
Operated as USAir Flight 1016.

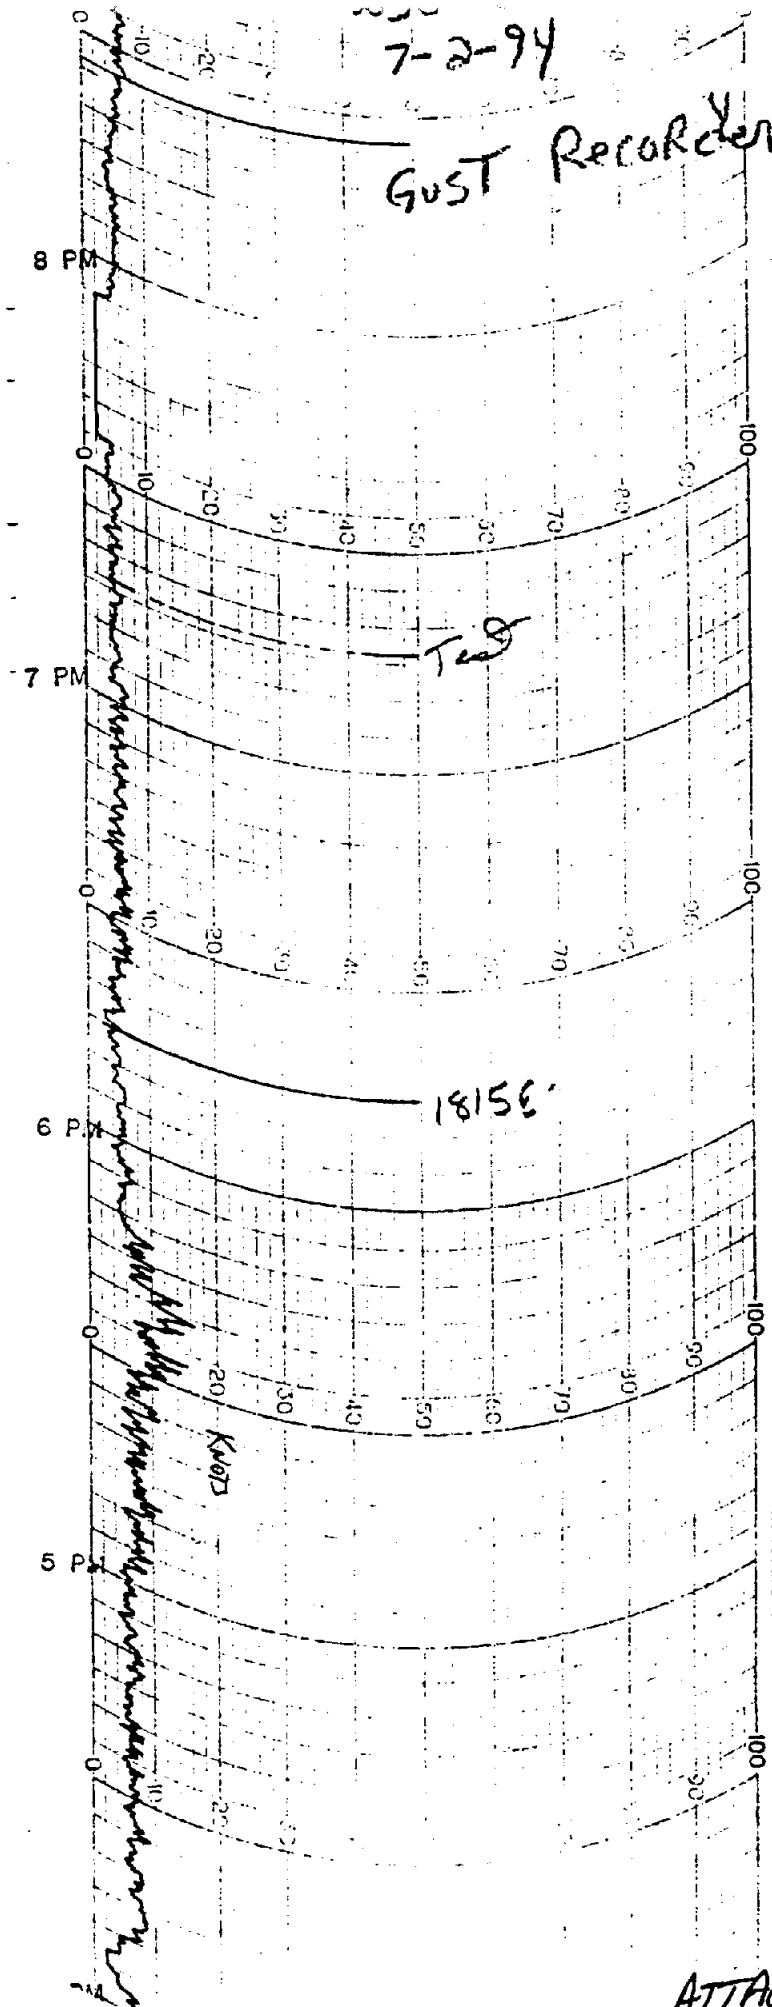
# GUST RECORDER

The Gust Recorder record showed that between 1830 and 1900 the wind speed varied between 4 and 16 knots. Four knots occurred about 1854 and 16 knots occurred about 1840. The wind sensor is located about 100 feet northwest of the Weather Service Office. The wind sensor is at a height of about 15 feet. All times are estimated chart times. See Attachment 1.

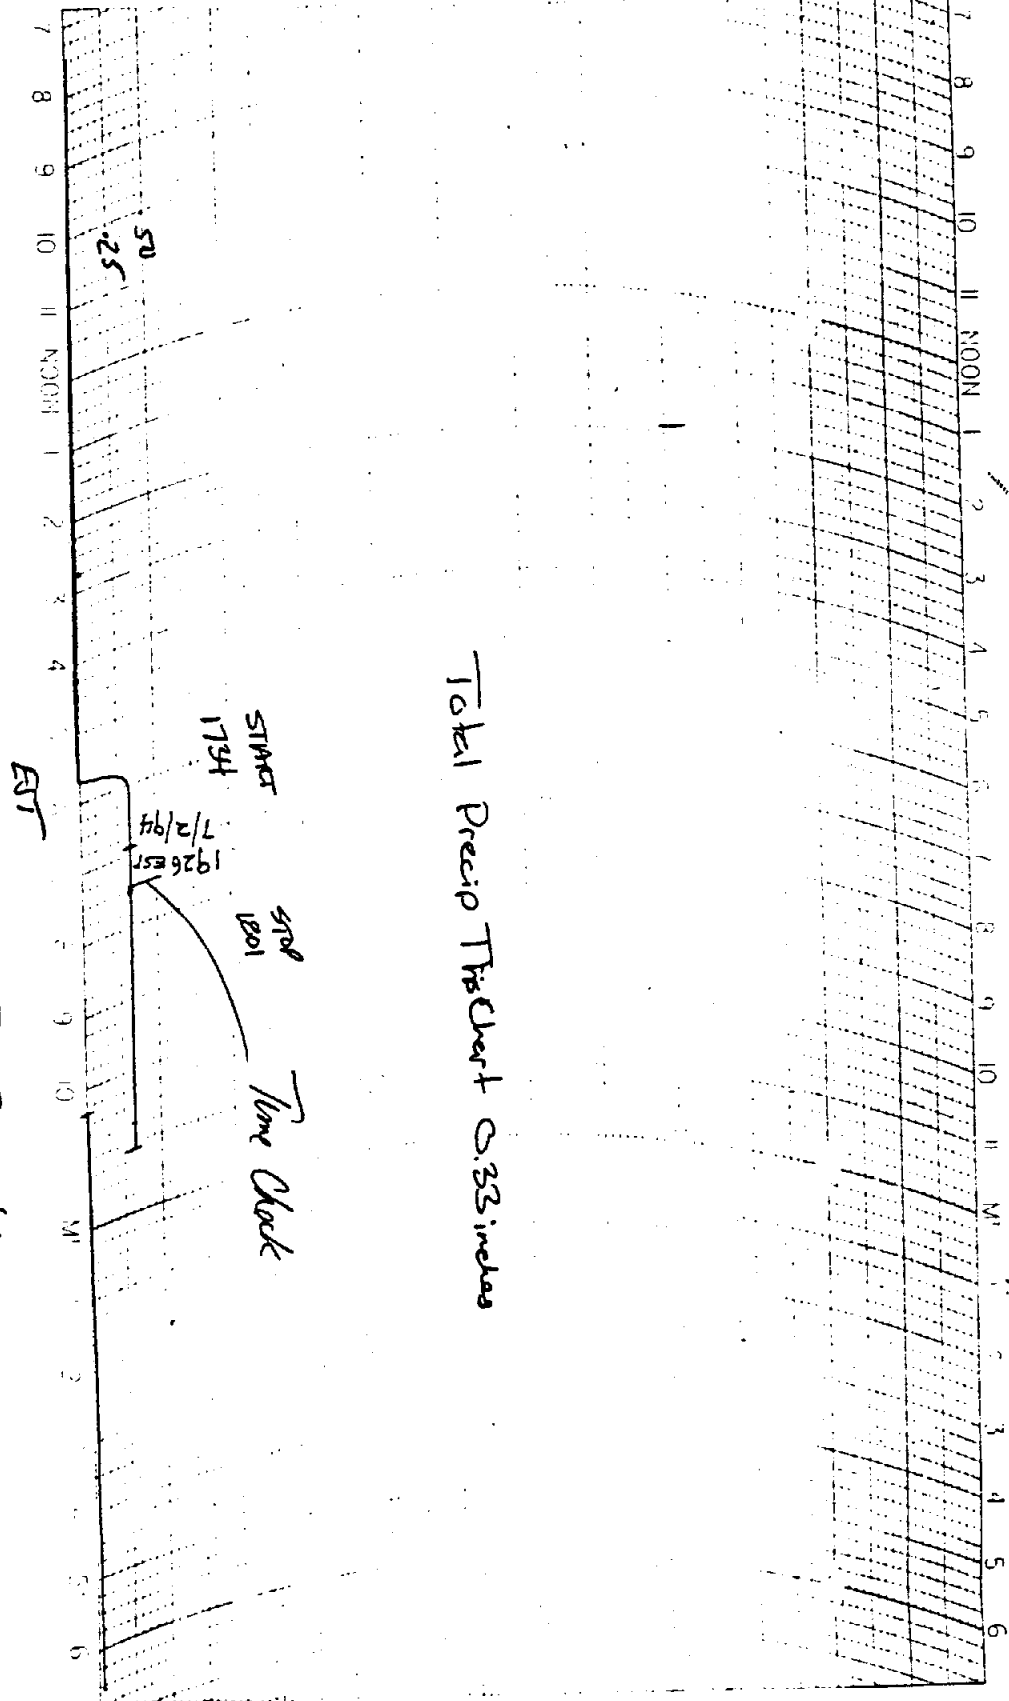
# CLT WSO RAIN GAUGE

The Rain Gauge Record showed that between about 1845 and 1900 about .33 inches of rain was measured. The Rain Gauge is located on the roof of the NWS Office. All times are estimated chart times. See Attachment 2.

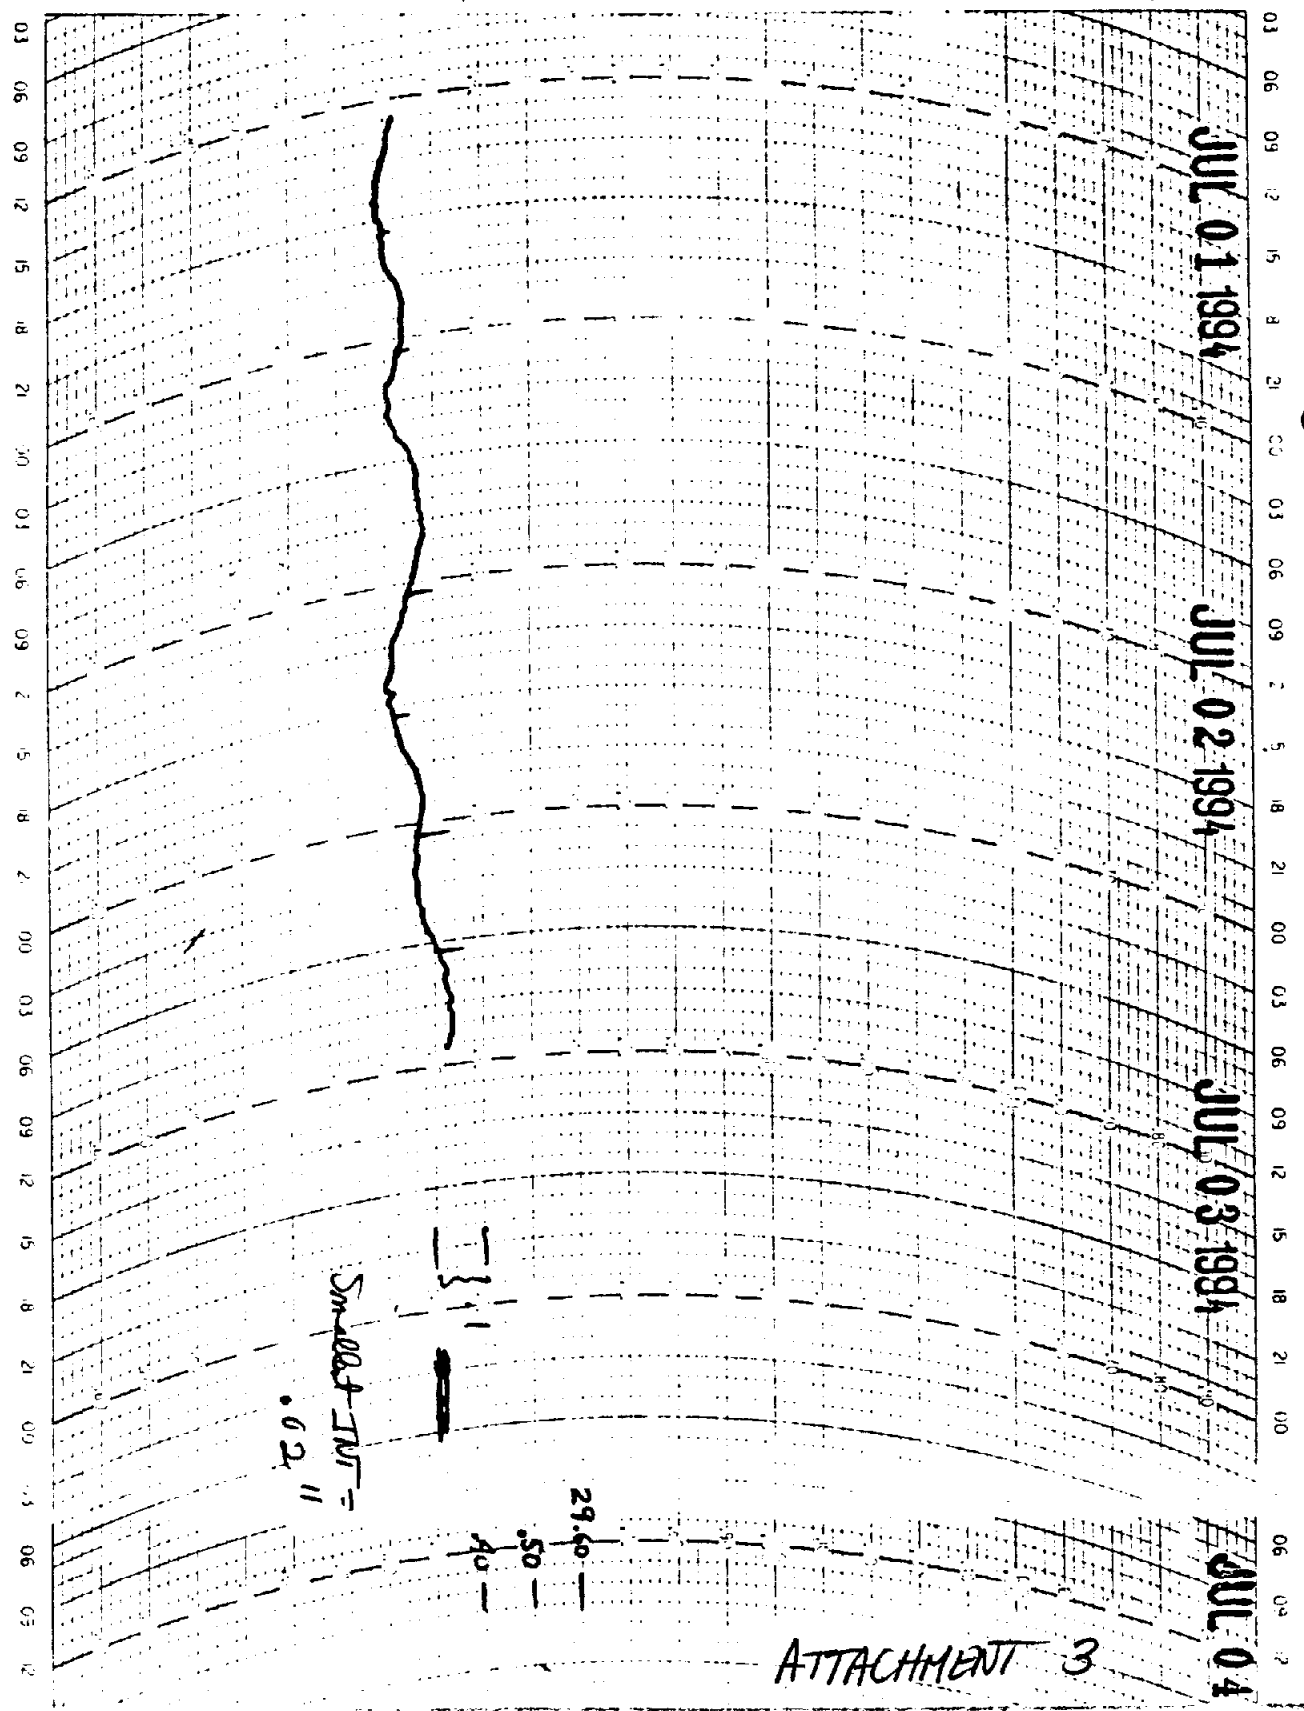
ATTACHMENT 3

The Barograph Record showed a station pressure of about 29.20 inches of Hg. at 1800 and 29.21 inches of Hg. at 1900. The maximum pressure change during this period was about .02 inches of Hg. This occurred about 1835. All times are estimated chart times. See Attachment 3.

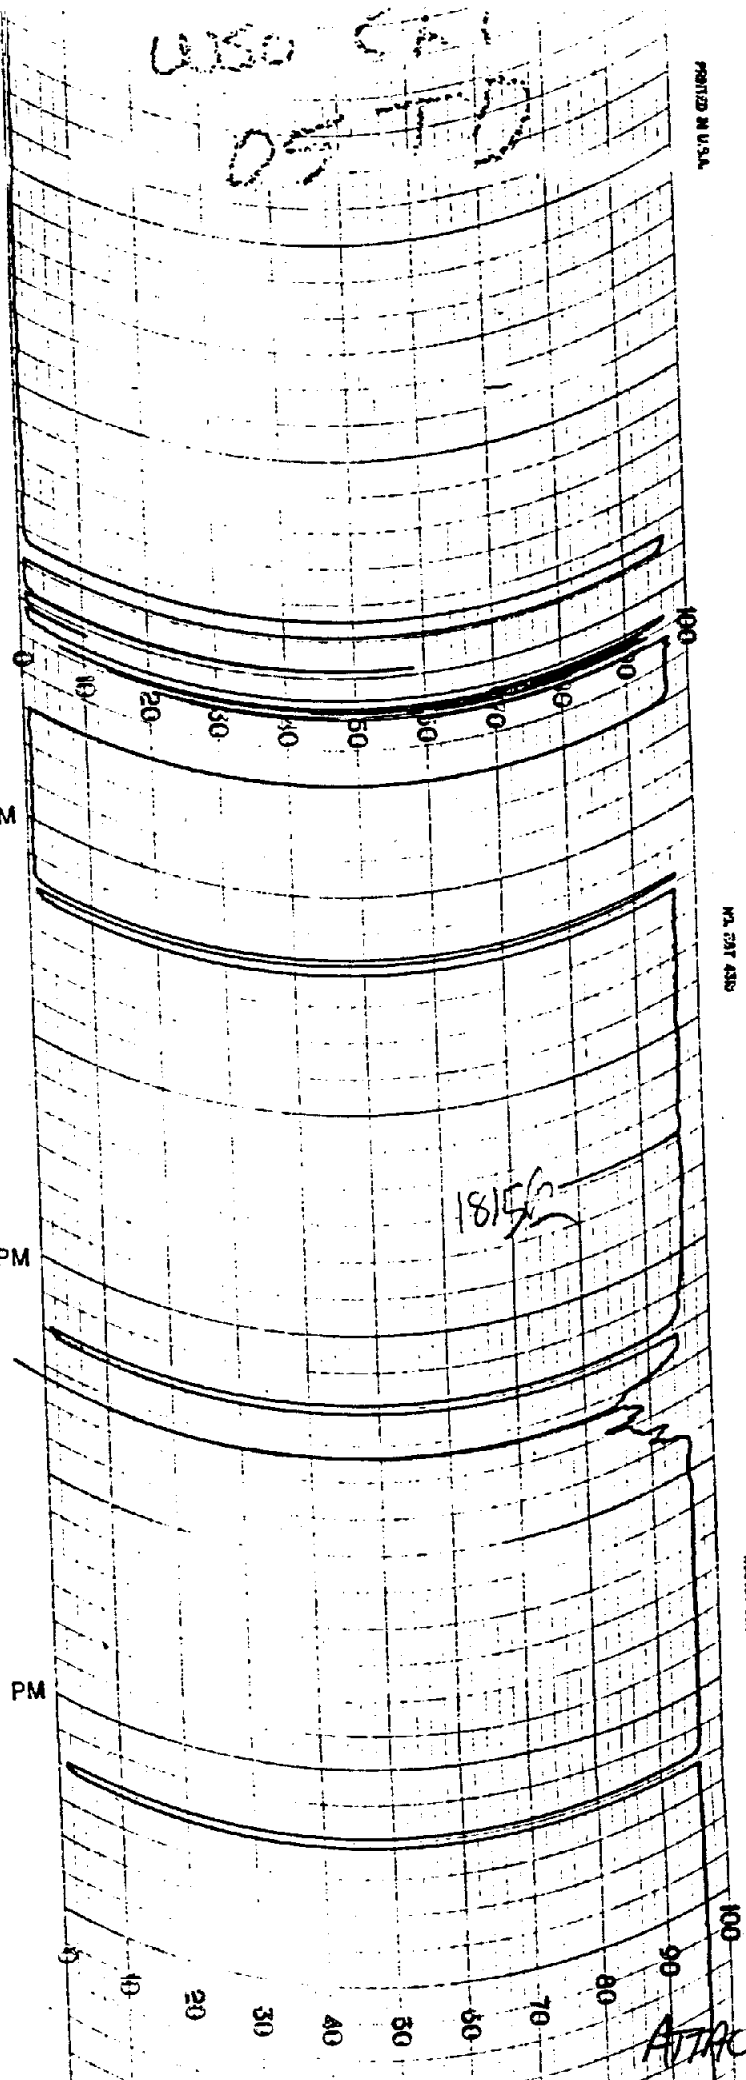
ATTACHMENT 4

During the period 1840 to 1845 there was a decrease in transmittance to a value of less than 0 % (RVR less than 500 feet). See Attachment 4.

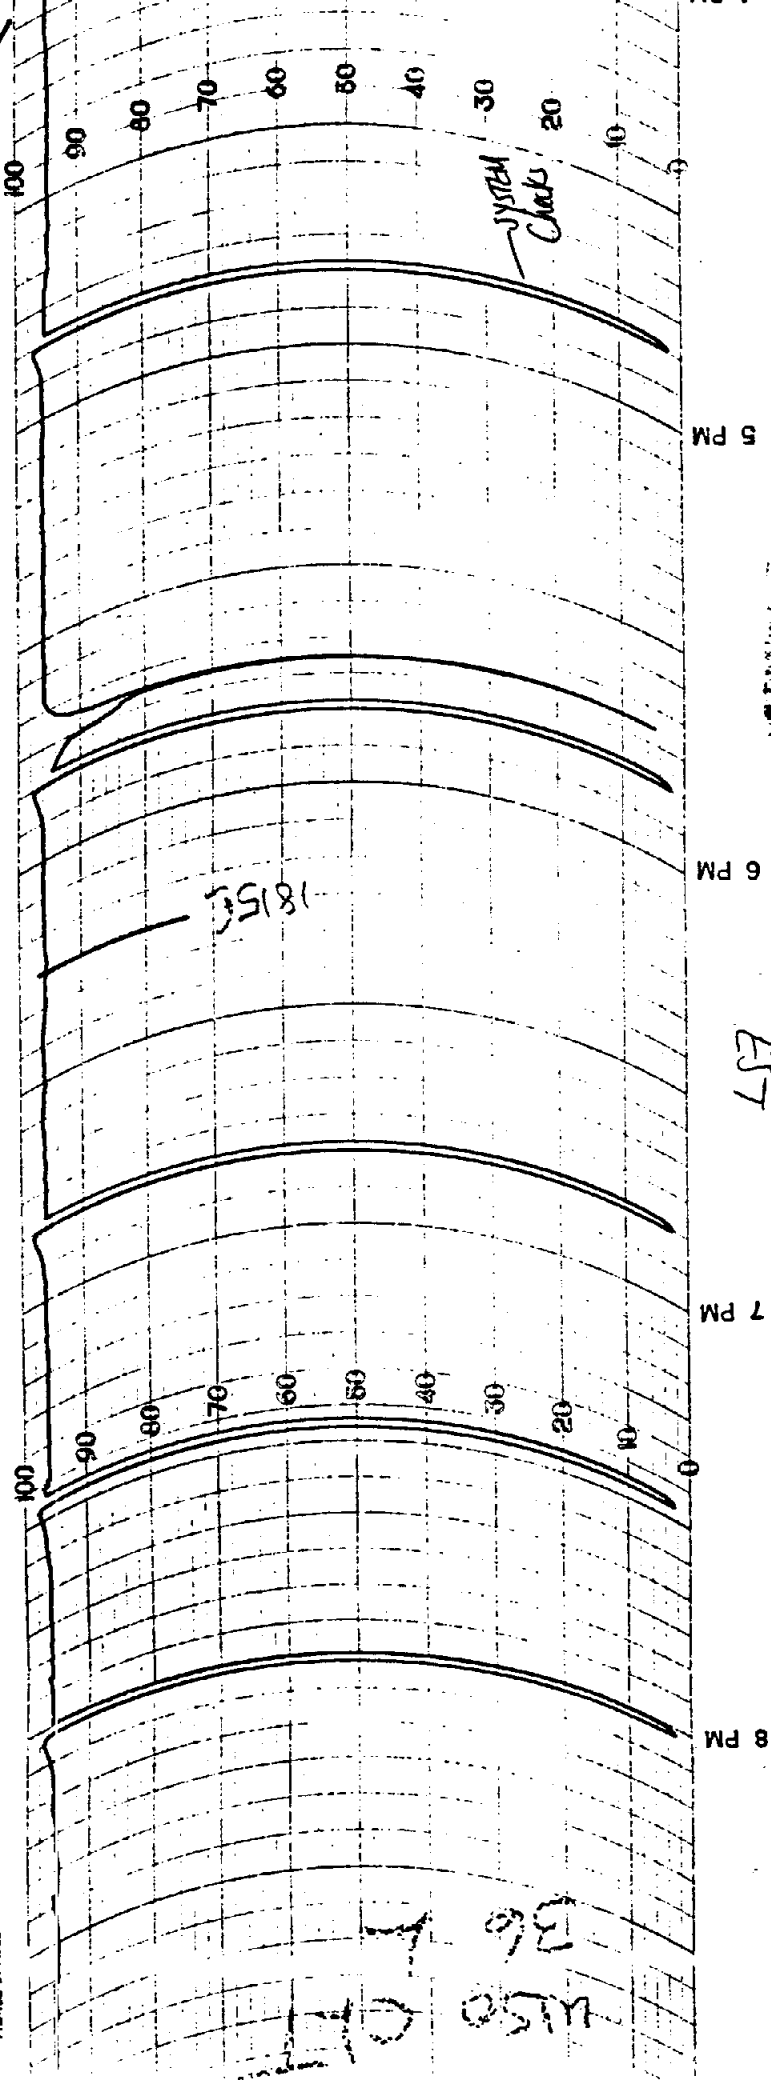
RWNY 36L TD

During the period 1840 to 1845 there was a decrease in transmittance to 5 % (RVR less than 500 feet). See Attachment 5.
