**Docket No. SA-543**

**NATIONAL TRANSPORTATION SAFETY BOARD**

Meteorology Group Chairman  
Factual Report

**METEOROLOGICAL FACTUAL REPORT  
DCA10MP008**

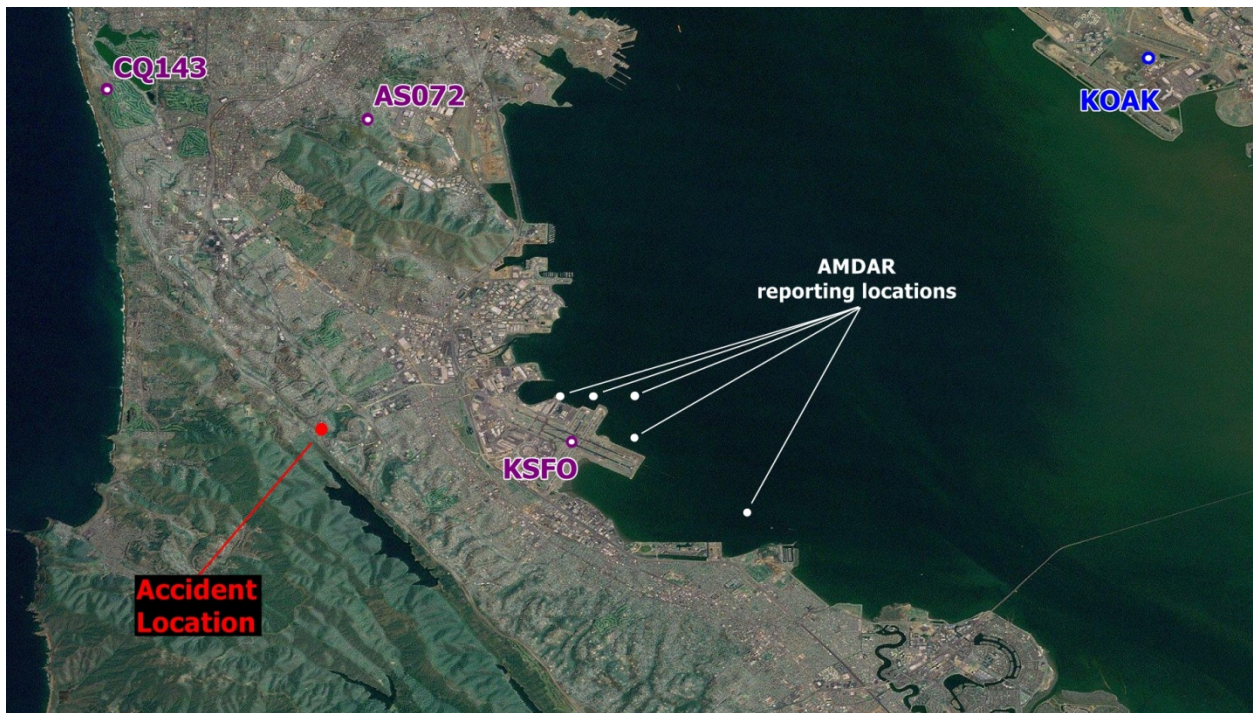
**Figure 1** – Locations of data sources presented in Section 1.0

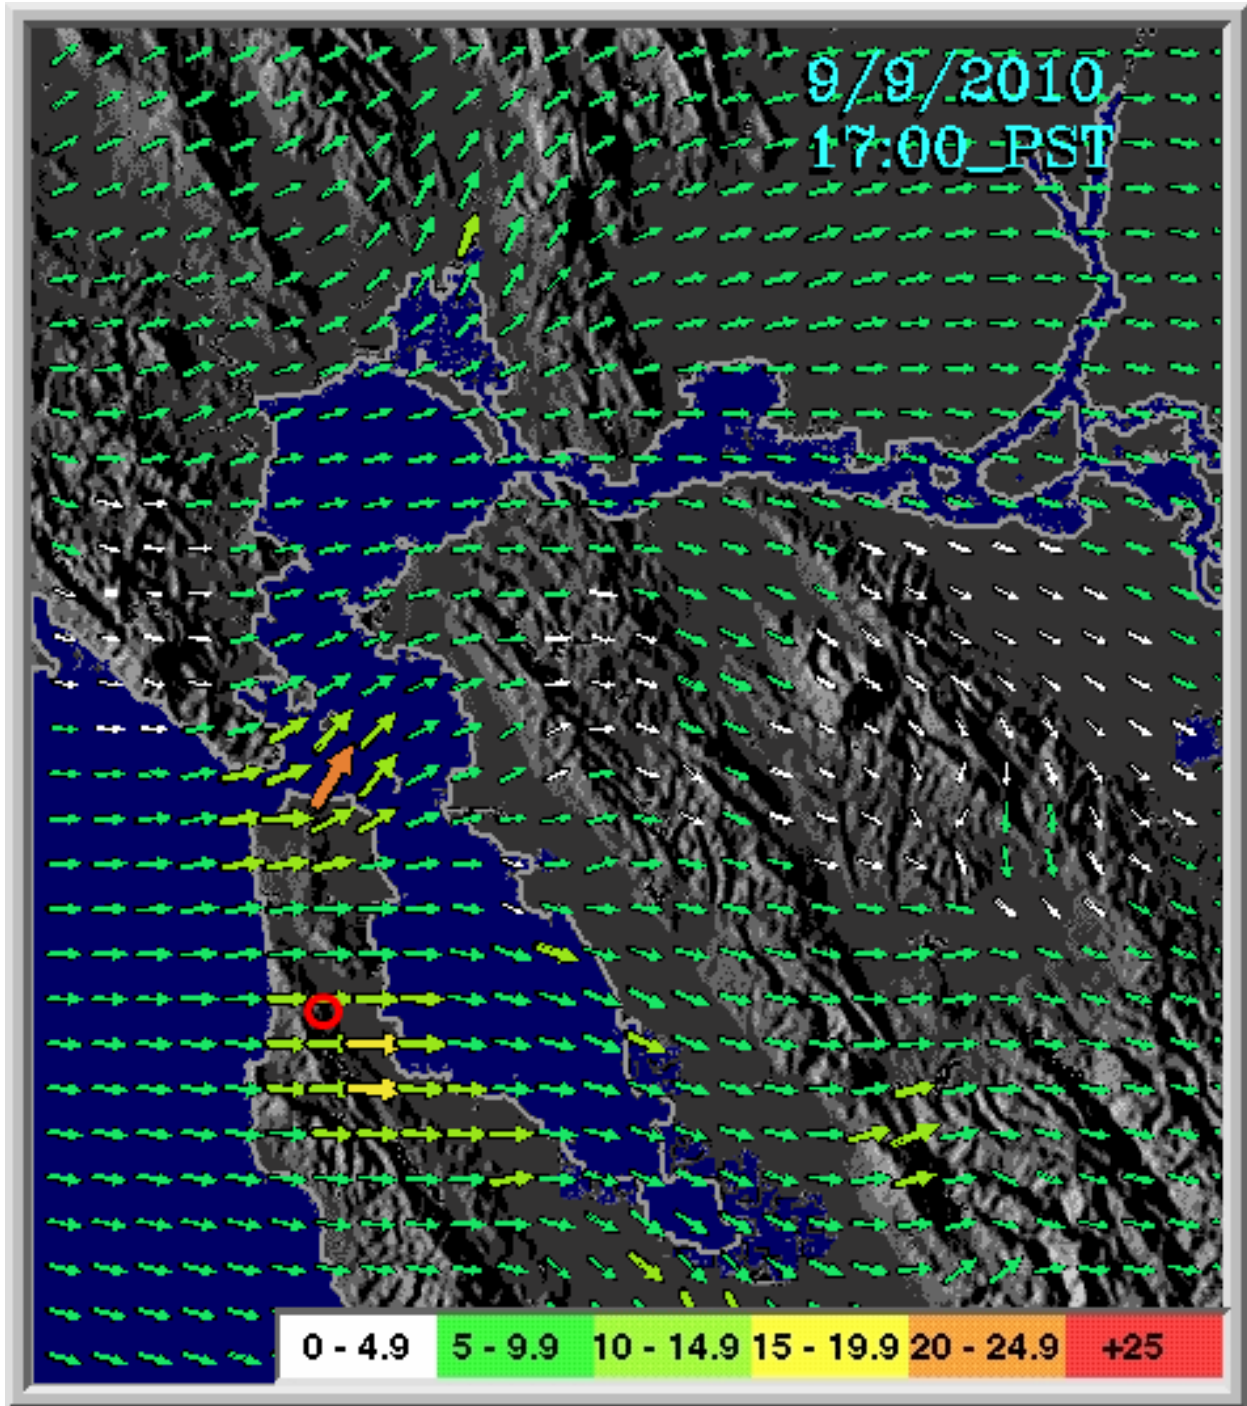
Graphical output from the Bay Area Wind Flow Model for 1700, 1800 and 1900 PDT on September 9, 2010 (figures 2-4), are presented here. Wind vectors are valid for 10 meters above the surface and the magnitude is in knots. The model data indicated that the area near the accident location (red circle) was experiencing westerly winds between 10 and 15 knots during the time period. The area immediately to the southeast of the accident site was experiencing slightly higher wind magnitudes (values approaching 20 knots).

**Figure 2** – Bay Area Wind Flow Model output for 1700 PDT. Wind magnitude in knots. Vectors valid for 10 meters above the surface. Red circle indicates accident location.

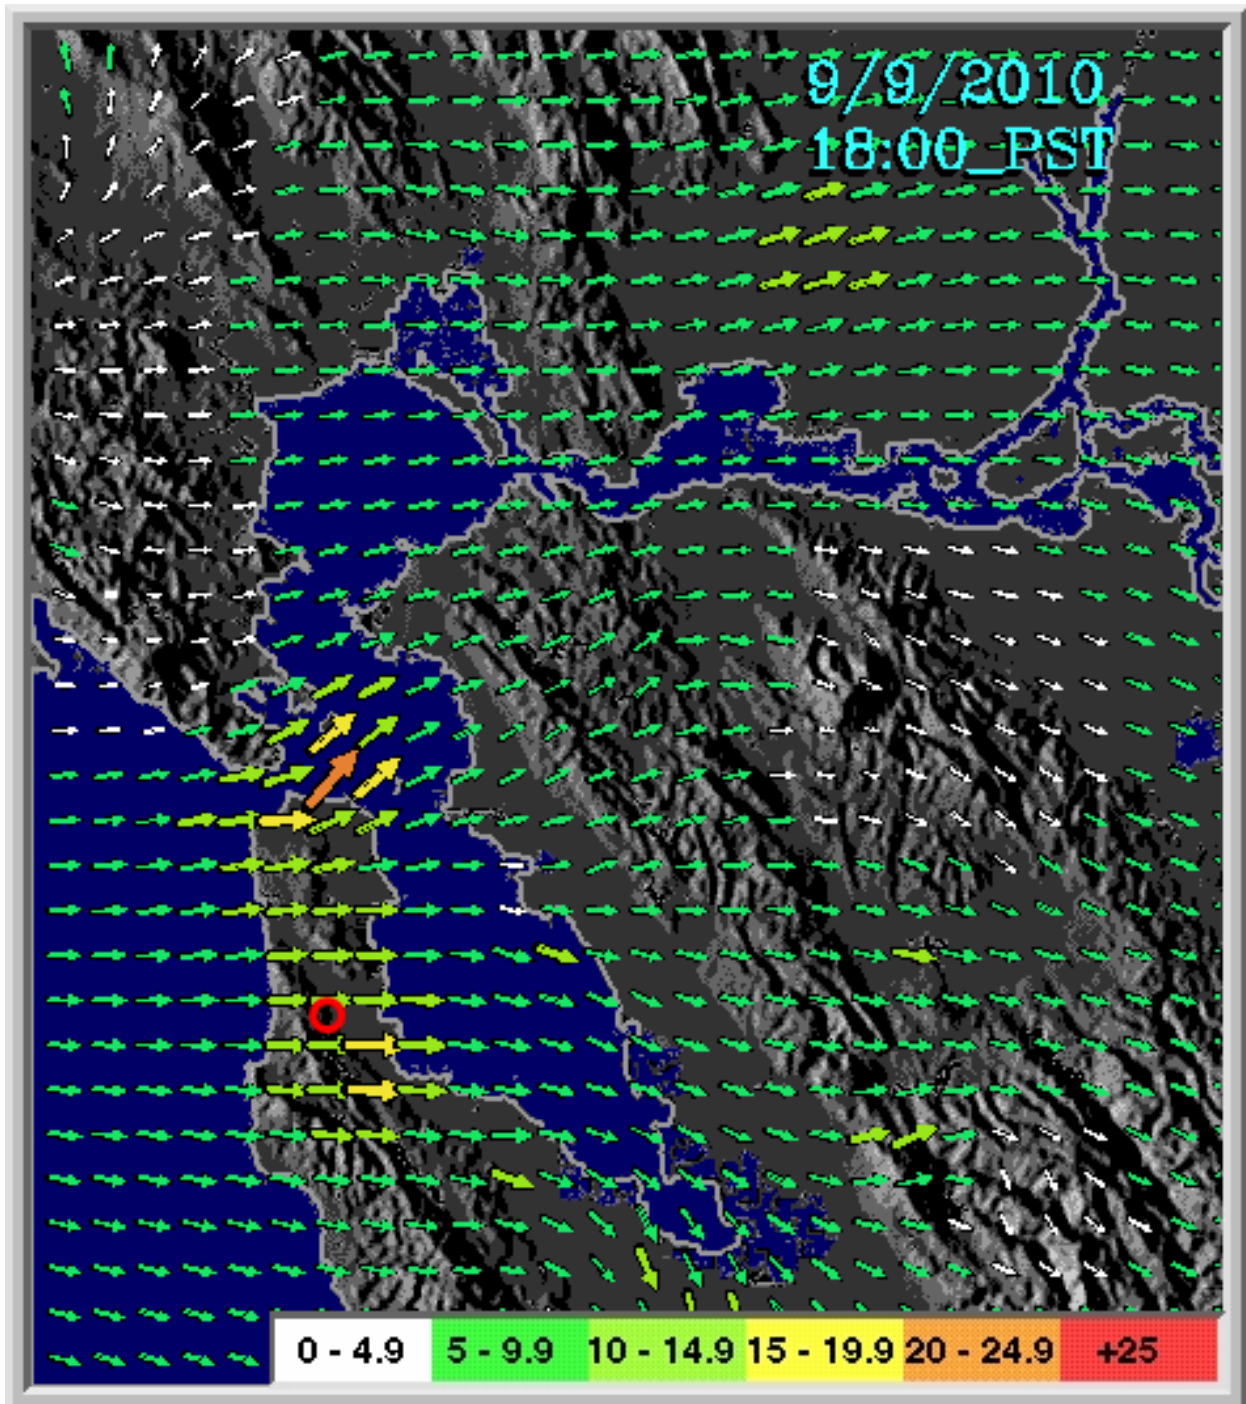
**Figure 3** – Bay Area Wind Flow Model output for 1800 PDT. Wind magnitude in knots. Vectors valid for 10 meters above the surface. Red circle indicates accident location.

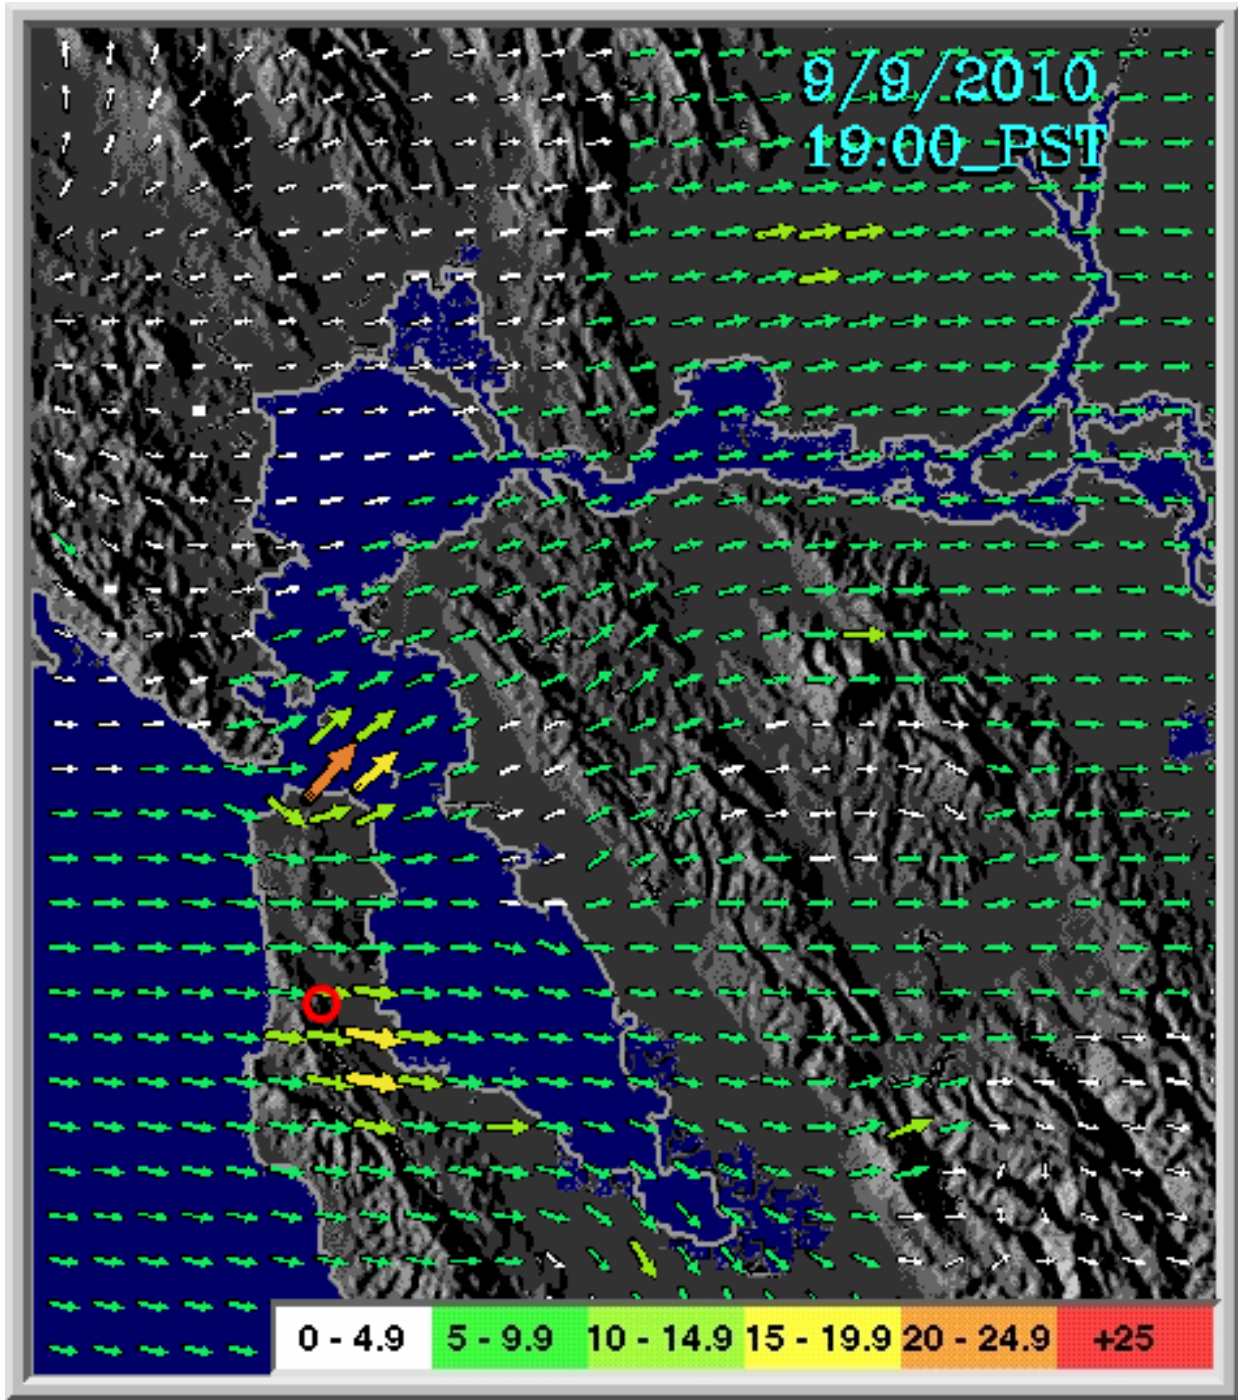
**Figure 4** – Bay Area Wind Flow Model output for 1900 PDT. Wind magnitude in knots. Vectors valid for 10 meters above the surface. Red circle indicates accident location.

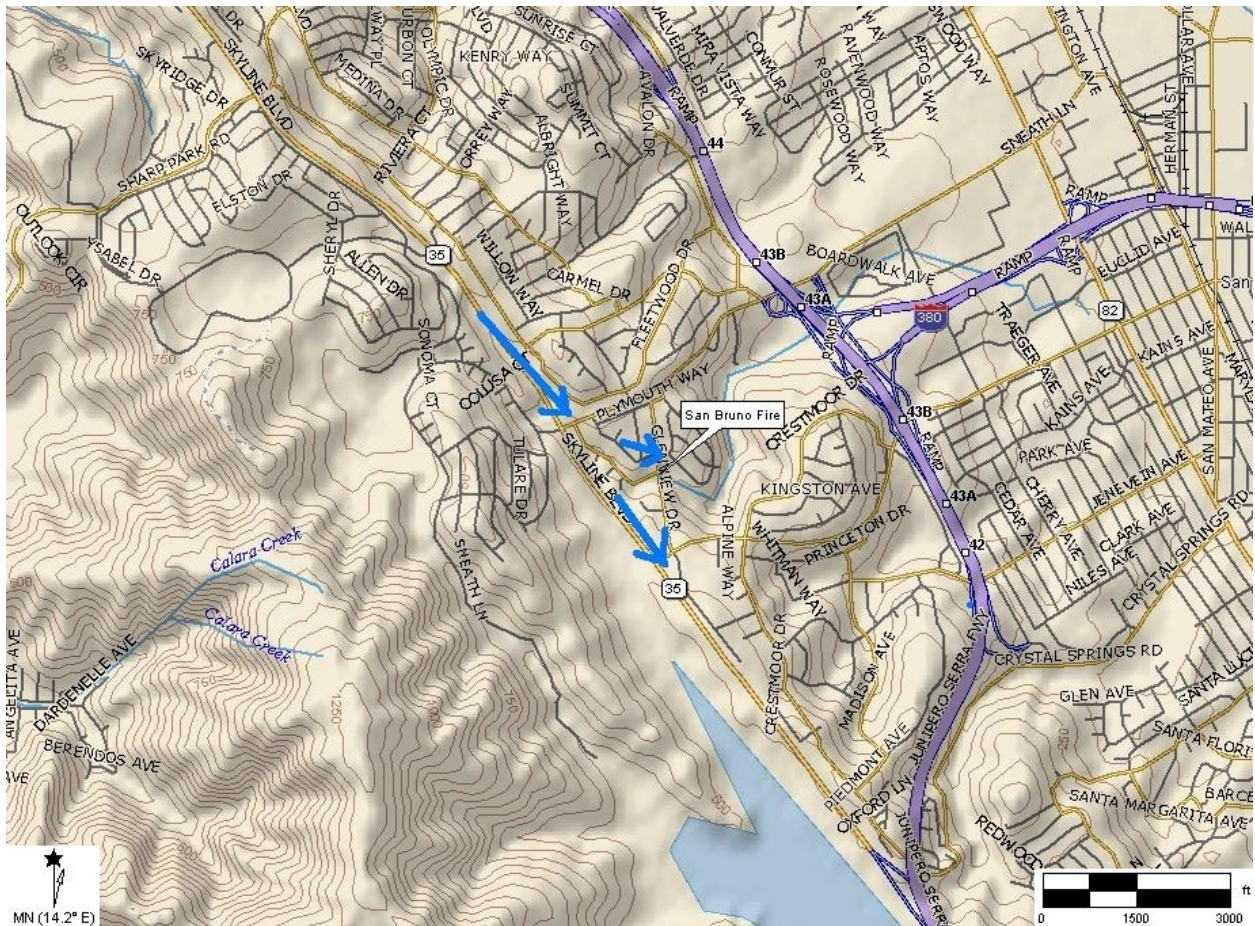
An analysis of local wind conditions during the period surrounding the accident was performed by Mr. Jan Null, a certified Consulting Meteorologist with Golden Gate Weather Services. Mr. Null assessed that the wind flow toward the accident neighborhood would have been northwesterly, arriving down “Skyline Boulevard.” Slightly northwest of the accident location, a branching of the northwesterly wind would have brought a weaker flow across the accident neighborhood from the west-northwest (figure 5), with eddying also occurring. Mr. Null estimated that wind speeds between 1800 and 2100 PDT would have been in the “15 to 20 mile per hour range.”

**Figure 5** – Mr. Null’s assessment of the branching of the local wind flow across the accident neighborhood.
