NATIONAL TRANSPORTATION SAFETY BOARD

Group Chairman's Factual Report

METEOROLOGY

ANC15MA041

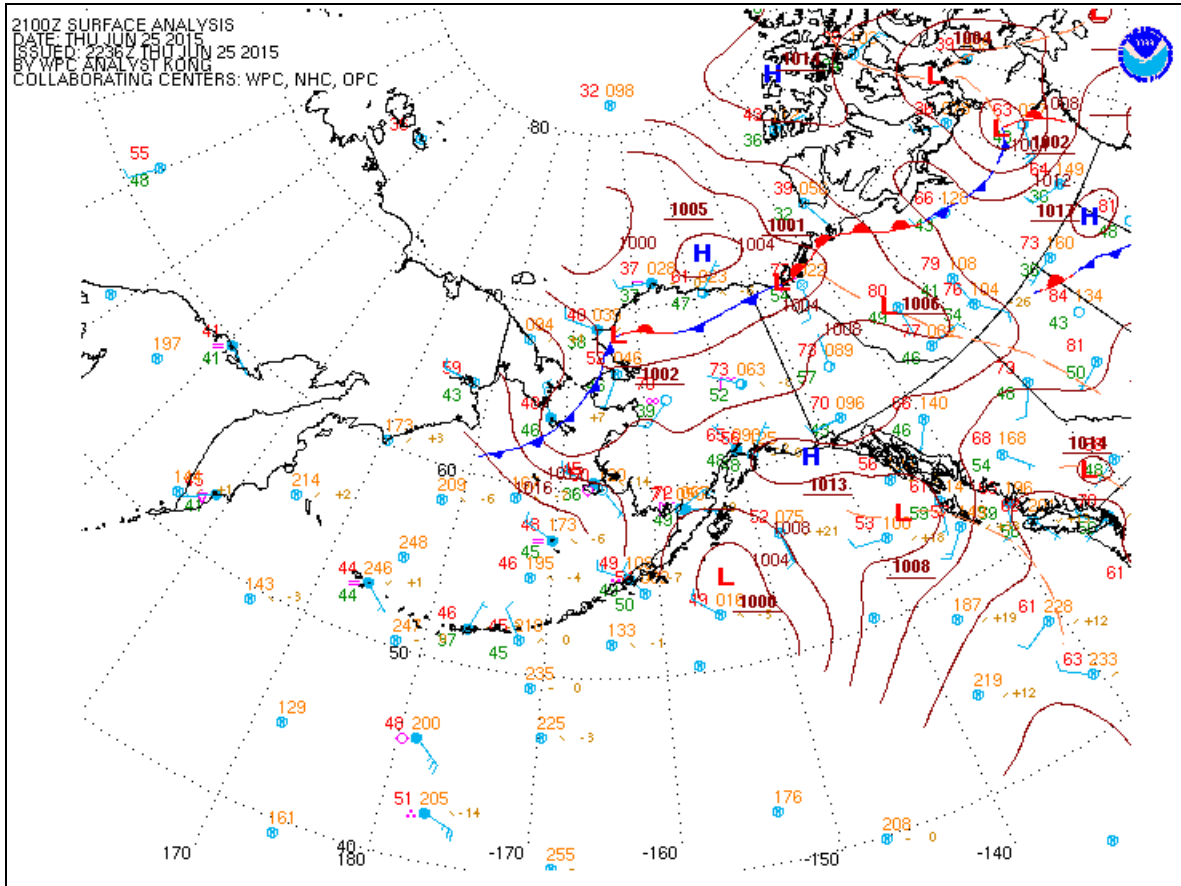
Figure 1 - NWS Surface Analysis Chart for 1300 AKDT

The NWS Alaska Surface Analysis Chart for 1300 AKDT (2100Z) on June 25, 2015 created by the Weather Prediction Center (WPC) is included in figure 1. The chart depicted a series of low pressure systems in the Gulf of Alaska and the Pacific Ocean, with one low off the southeast Alaska coast at 1008-hectopascals (hPa) to the southwest of the accident site, with a trough of low pressure extending southeastward off the southeast Alaska and British Columbia, Canadian

coast. The trough was previous being depicted associated with a dissipating occluded frontal system.

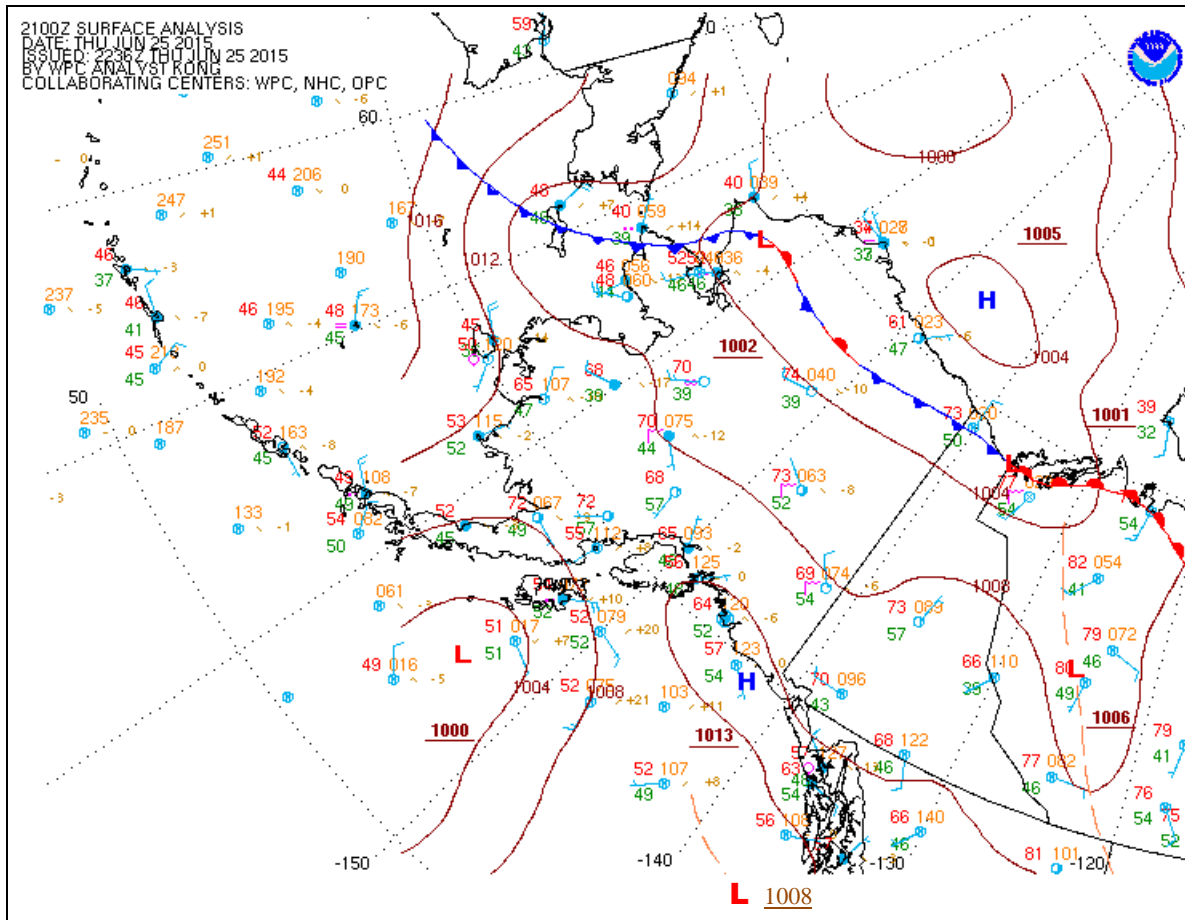
Figure 2 - Surface Analysis Chart for 1300 AKDT

An enlarged version of the Alaska Surface Analysis Chart for 1300 AKDT is included as figure 2, with the low pressure system at 1008-hPa immediately southwest of the Ketchikan area added in for reference. The chart depicted the trough of low pressure off the southeast Alaska coast and station models, which indicated winds from the southeast at 10 to 15 knots, visibility restricted in rain showers, and broken to overcast sky conditions.

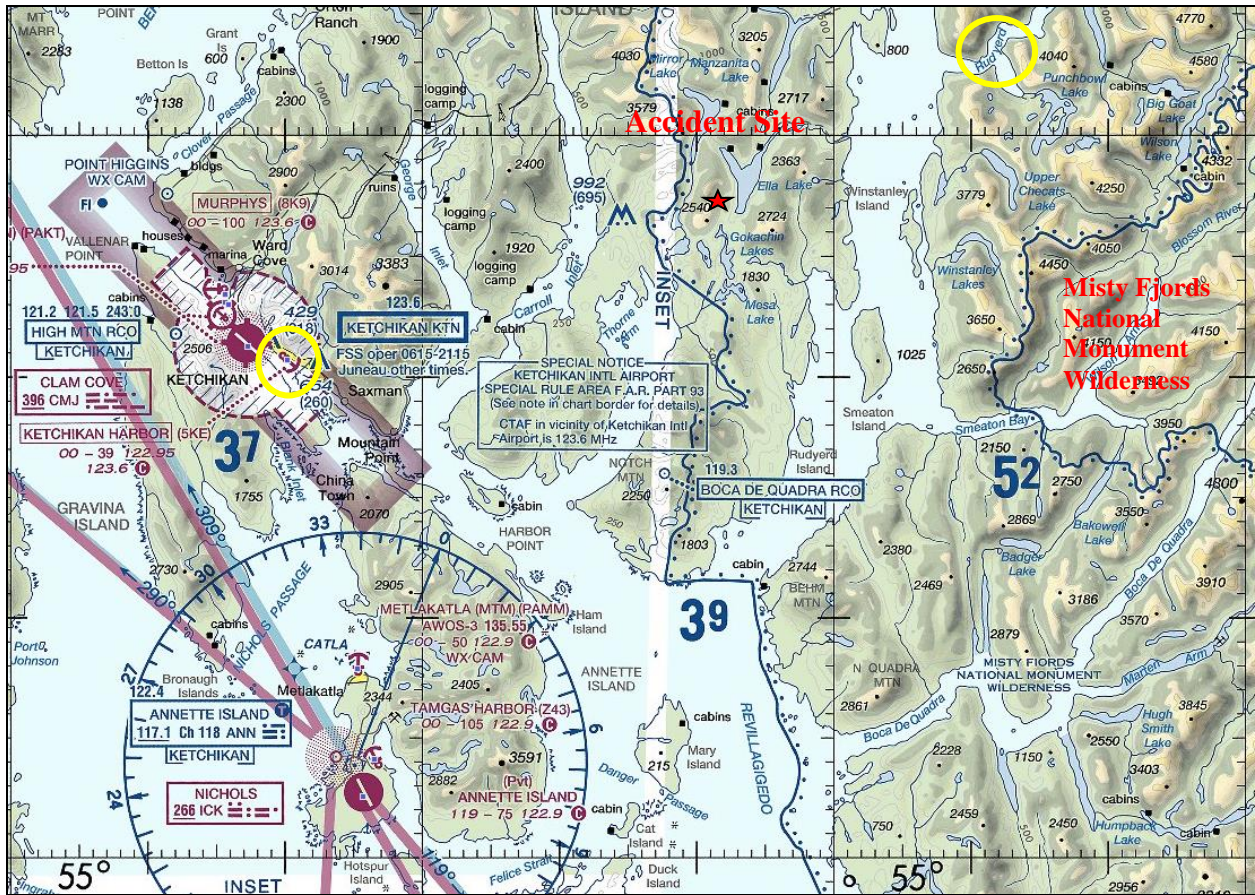
Figure 3 - Sectional chart of the area

A close up of the NOAA Sectional Chart for the Ketchikan area is included as figure 3 with the accident site marked by a star to the east-northeast of the Ketchikan International Airport. The spot elevation approximately a mile south of the accident site was 2,540 feet, and to the southeast along the route of flight was 2,724 feet. The Maximum Elevation Figure (MEF) for the quadrant to maintain a safe altitude from terrain between the Misty Fjord and Ketchikan area was noted as 3,900 and 3,700 feet. That altitude would allow a 200 to 300 feet agl safety clearance for trees and/or vegetation over the highest terrain noted in the quadrant, rounded up to the nearest 100 feet, which was located immediately east of Ketchikan at 3,383 feet and at 3,591 feet to the southeast, and east of Annette Island.

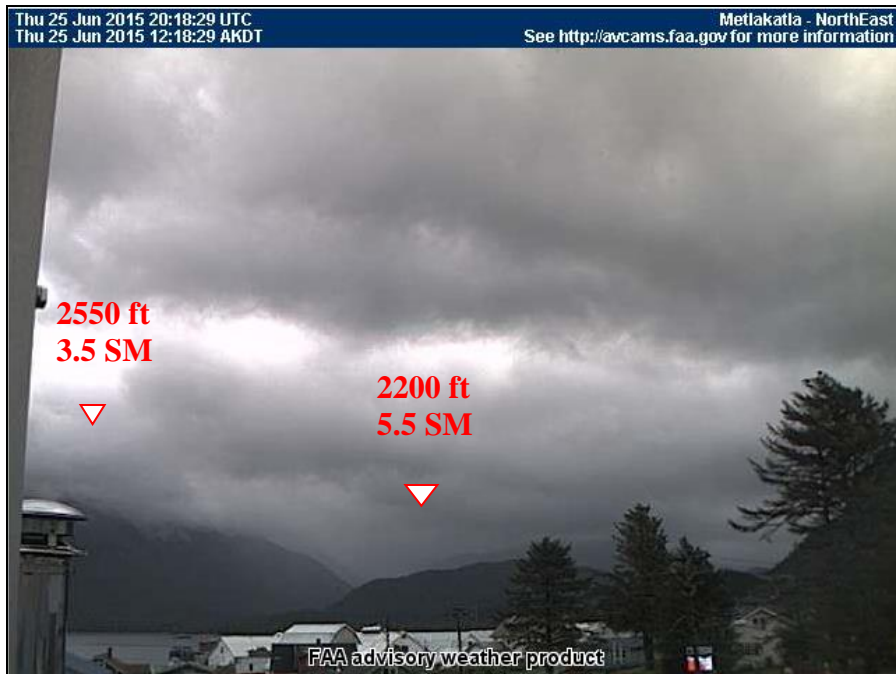
Figure 4 - Weather camera image at 1218 AKDT looking northeast

An image from the FAA weather camera at 1218 AKDT is included as figure 4 depicting the conditions at the approximate time of the observations. The mountain peaks 3 ½ SM away at 2,550 feet and at 5 ½ SM at 2,200 feet are obscured by the clouds in the image.

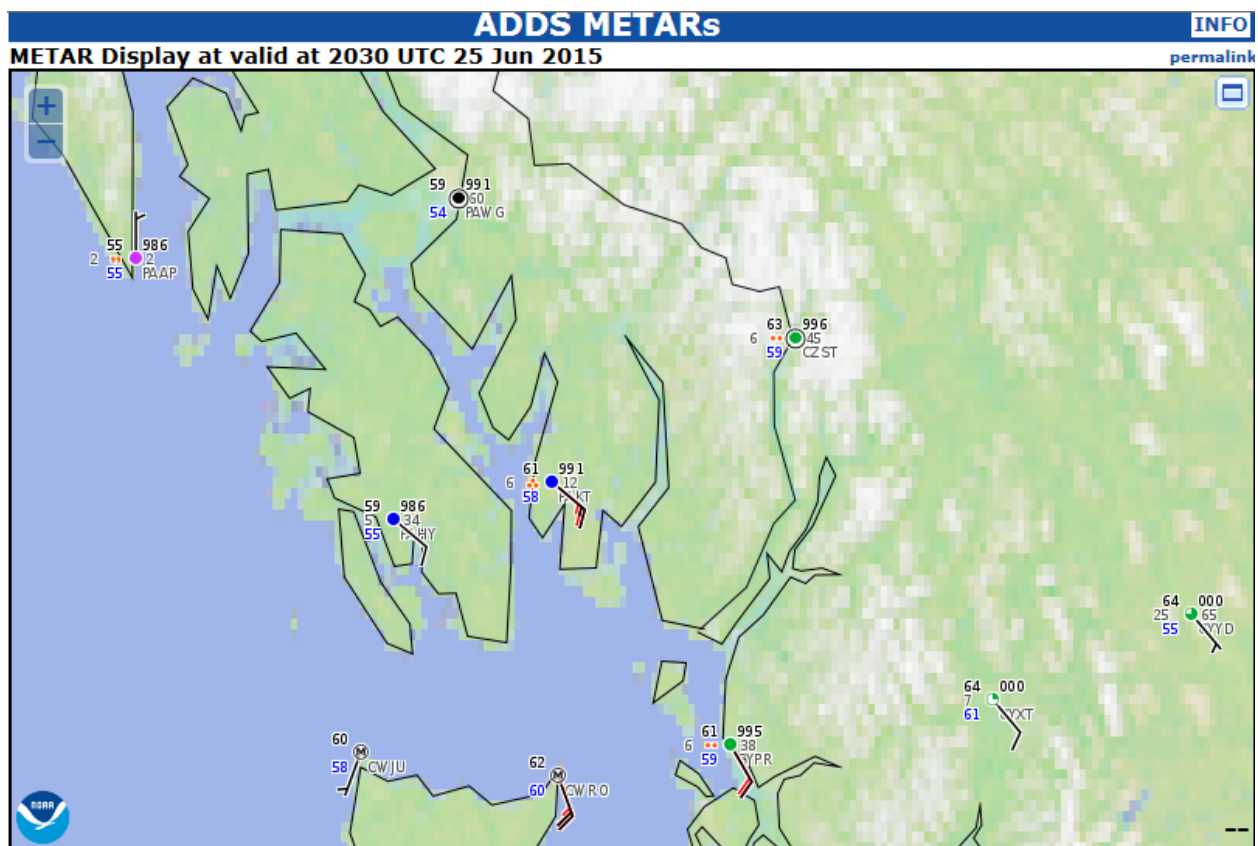
Figure 5 - NWS display of Weather observations in the area at 1230 AKDT

The NWS Aviation Weather Center (AWC) website display of hourly observations at 1230 AKDT is included as figure 4. The chart depicted the general flight categories by the color coded station models, with green for VFR, blue for MVFR conditions, red for IFR, and pink for LIFR conditions.

The station model for Ketchikan indicated MVFR conditions with wind from the southeast at 12 knots gusting to 23 knots, visibility 6 miles in moderate rain, overcast skies, temperature 61° Fahrenheit (F), dew point 58° F, sea level pressure 999.1-hPa.

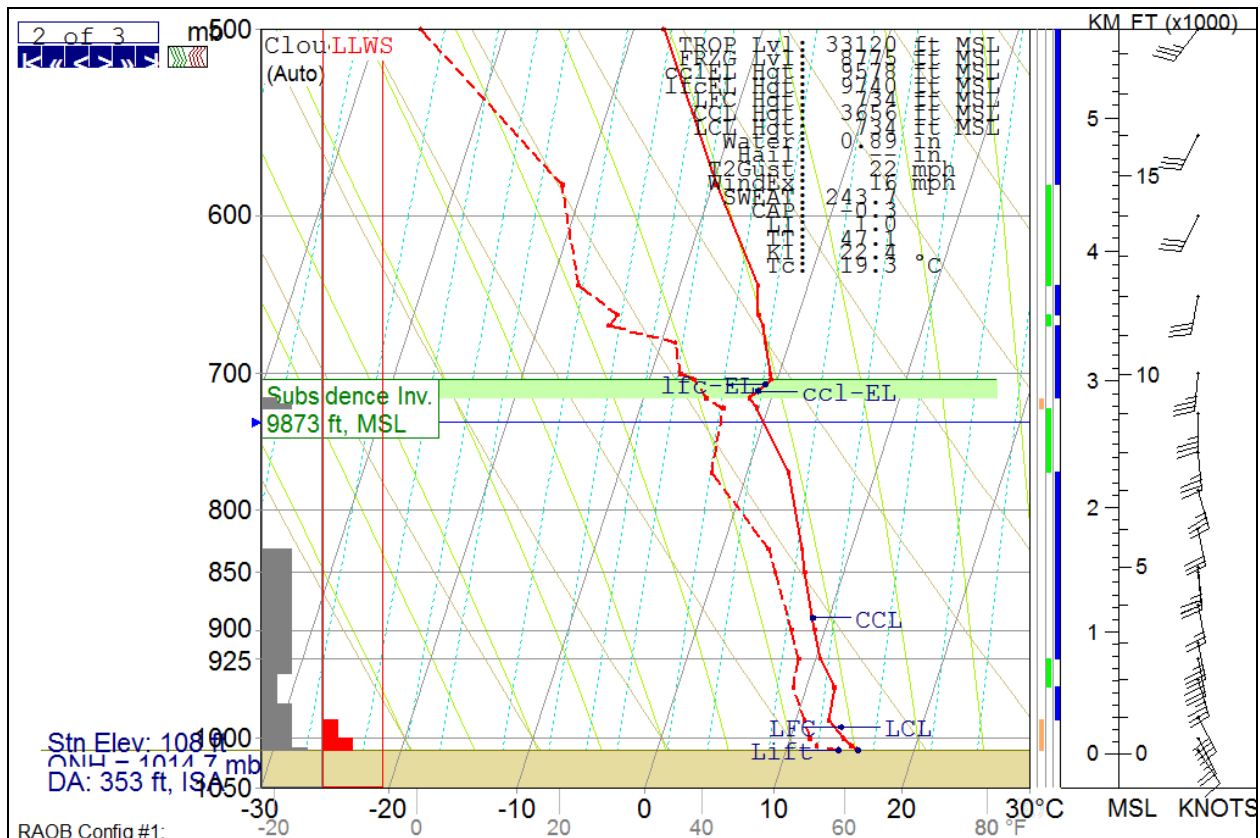
Figure 6 – Annett Island sounding at 1600 AKDT

The Annette Island sounding indicated a moist low level environment with a relative humidity greater than 80% from the surface to 5,000 feet supporting clouds, with the base of clouds indicated by the lifted condensation level (LCL)⁶ and the level of free convection (LFC)⁷ at 988-hPa or 626 feet agl. The freezing level was identified at 8,775 feet, with an inversion or increase in temperature due to subsidence at 10,000 feet, with drier air above. The sounding indicated a Lifted Index (LI) of 1.0 and indicated a conditional unstable atmosphere supporting nimbostratus type clouds. The precipitable water content was 0.89 inches.

The Annette Island sounding wind profile indicated a surface wind from 150° at 11 knots, with winds veering to the south and south-southwest with height, with wind speeds increasing with height. A low level jet was identified immediately above the surface at 800 feet with winds from

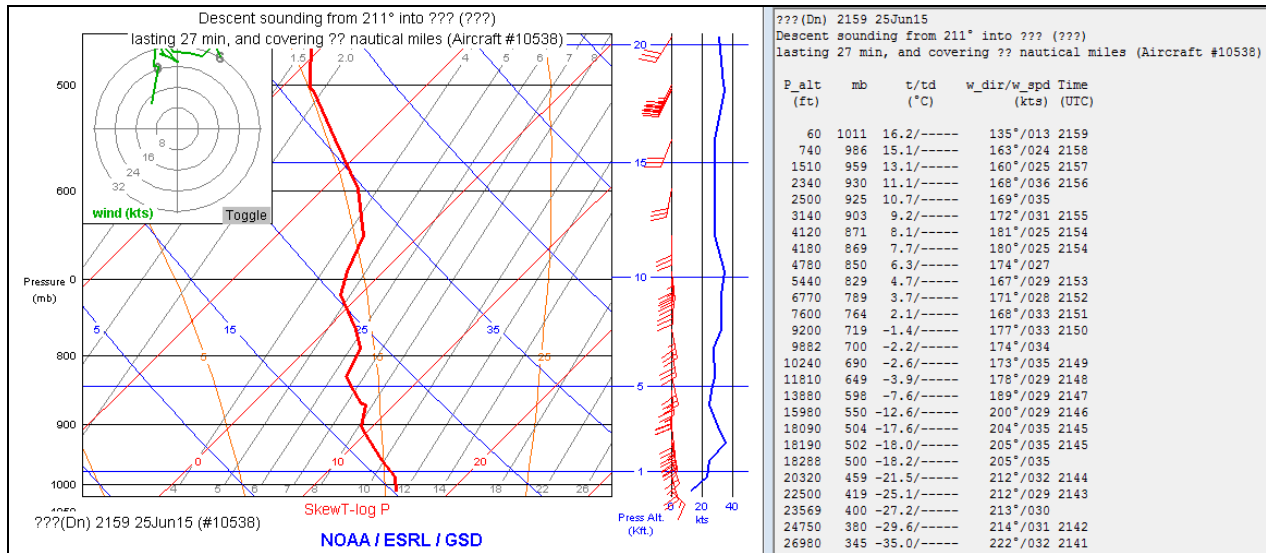
Figure 8 - AMDAR aircraft sounding from Ketchikan at 1359 AKDT

A search of the NOAA Earth System Research Laboratory/Global Systems Division (ESRL/GSD) website (<http://amdar.noaa.gov/>) for Aircraft Meteorological Data Reports (AMDAR) provided an upper air data closer to the time of the accident from aircraft identified as #10538 that descended into Ketchikan International Airport at 1359 AKDT (2159Z). Figure 7 is a plot of the aircraft's descent sounding.

The aircraft sounding indicated a similar temperature and wind profile as the Annette Island sounding. The freezing level was identified near 8,000 feet, and ruled out any icing threat to the accident airplane. The aircraft did not have a moisture sensor and did not provide any indication on potential cloud layers. The wind profile also confirmed a low-level wind maximum at 2,340 feet within wind from 168 at 36 knots, and indicated a light to moderate low-level wind shear condition.

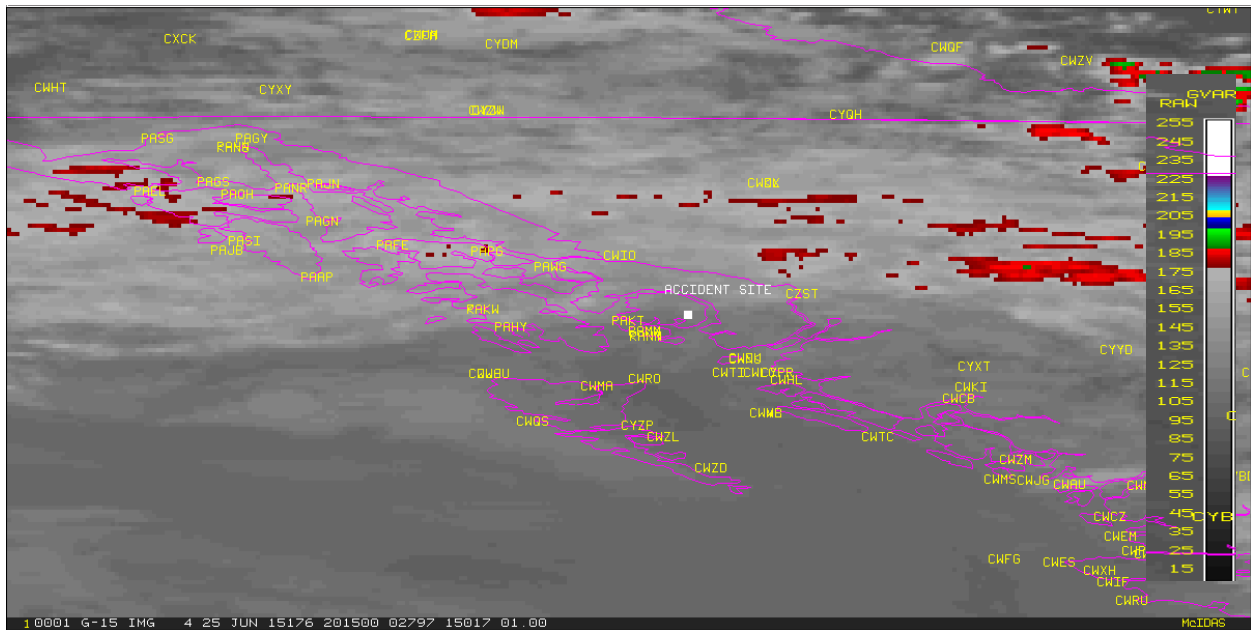
Figure 9 - GOES-15 infrared image at 1215 AKDT

Figure 8 is the GOES-15 infrared image at 1215 AKDT at 4X magnification, with a standard MB temperature enhancement curve applied to highlight the higher and colder cloud tops. The image depicted an extensive area of low clouds over the area. The radiative cloud top temperature over the accident site was 271° Kelvin or -2.16° C, which corresponded to cloud tops near 11,000 feet based on the upper air sounding. Figure 9 is the GOES-15 visible image at 2X magnification for the same time period highlighting the extent of the stratiform to nimbostratus type clouds over the area, with overcast clouds over the accident site.

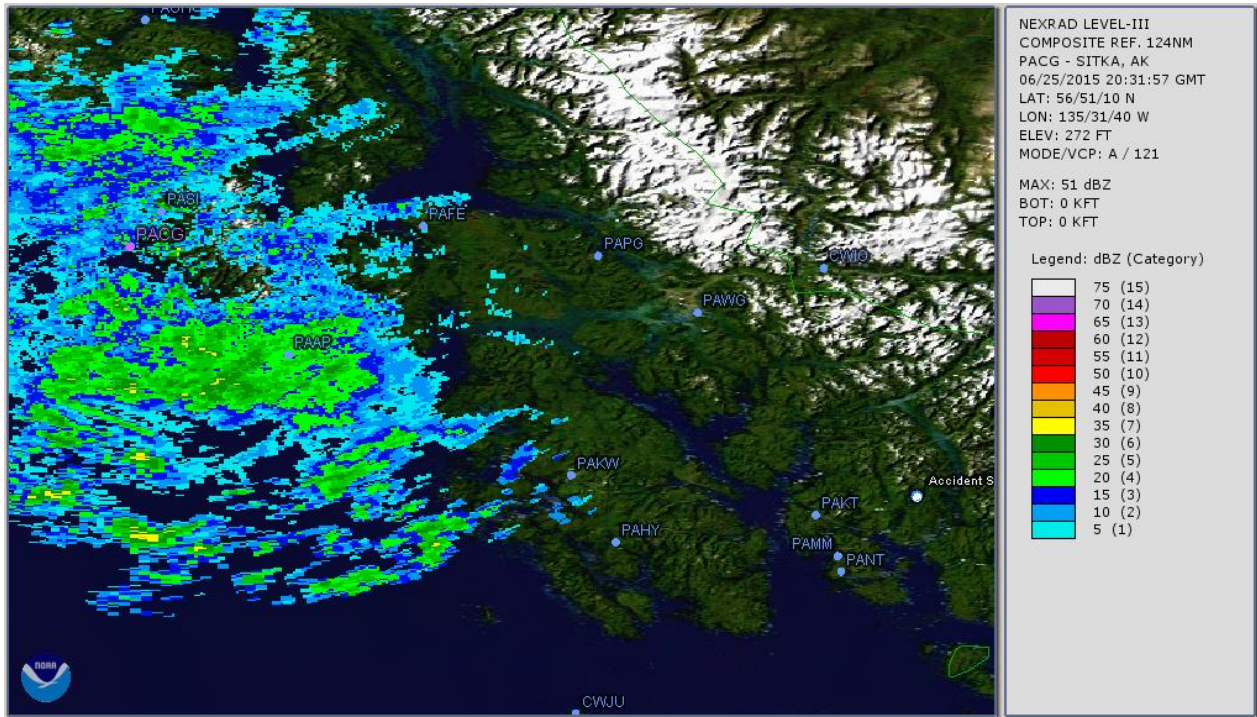
Figure 11 - Sitka WSR-88D composite reflectivity image at 1231 AKDT

Figure 10 is the NWS Sitka WSR-88D composite reflectivity image at 1231 AKDT. The radar image depicted numerous rain showers with echoes in the range of 20 to 35 dBZ over the Alaska Pacific coastal sections to the west and northwest.

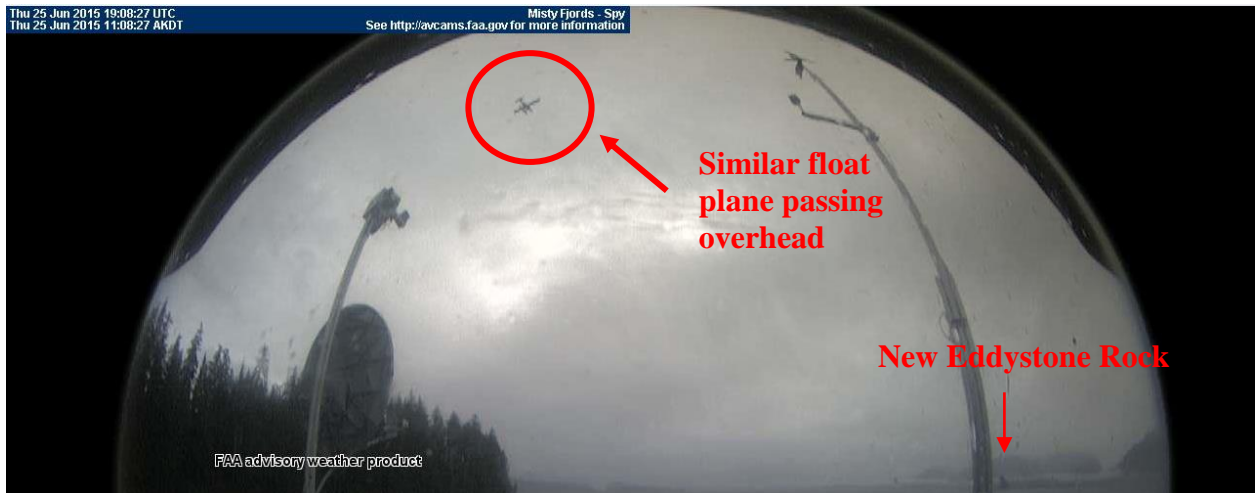
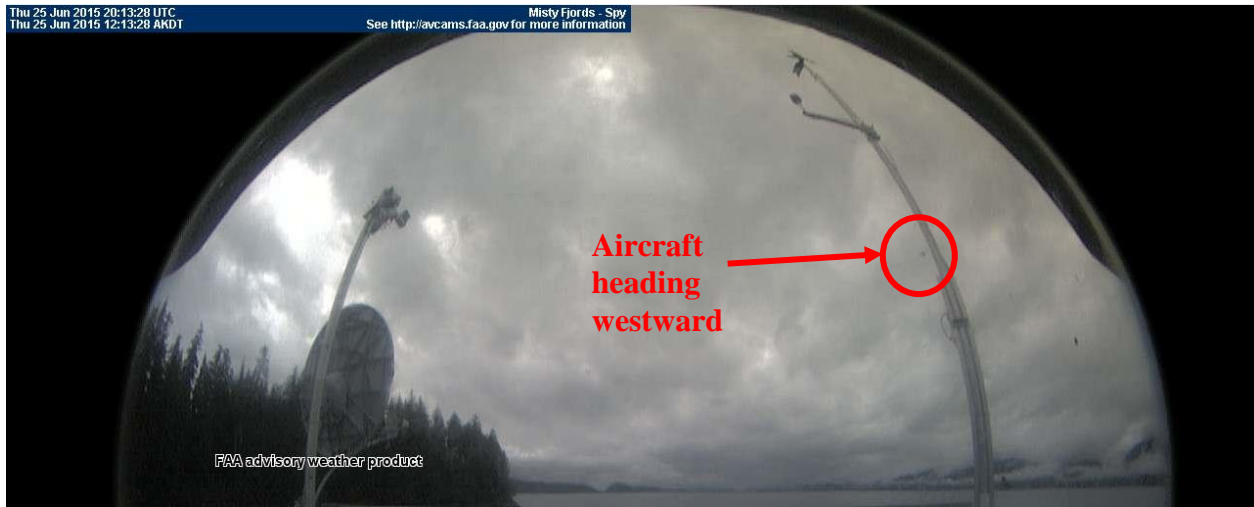
A review of the Misty Fjords camera between 0909 through 1500 AKDT detected an aircraft flying over the site at 1108 AKDT heading southward and again at 1213 AKDT heading westward. The images are included as figures 15 and 16 respectively. This camera view is not normally broadcasted, and is looking at the instrumentation towards the southwest.

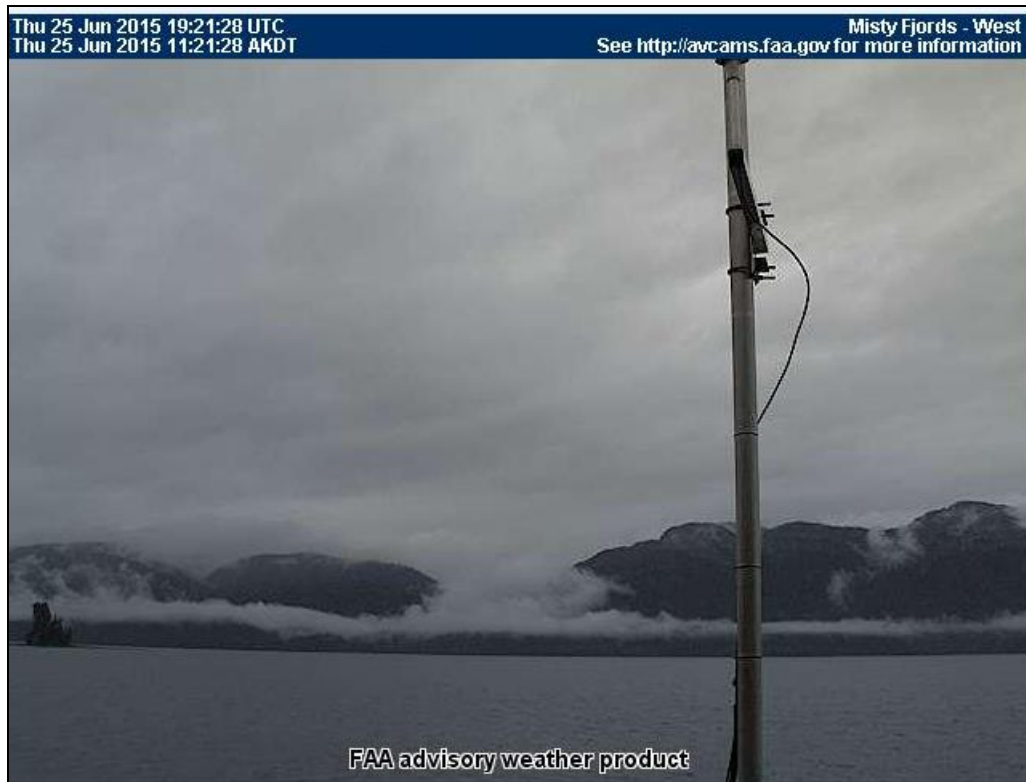
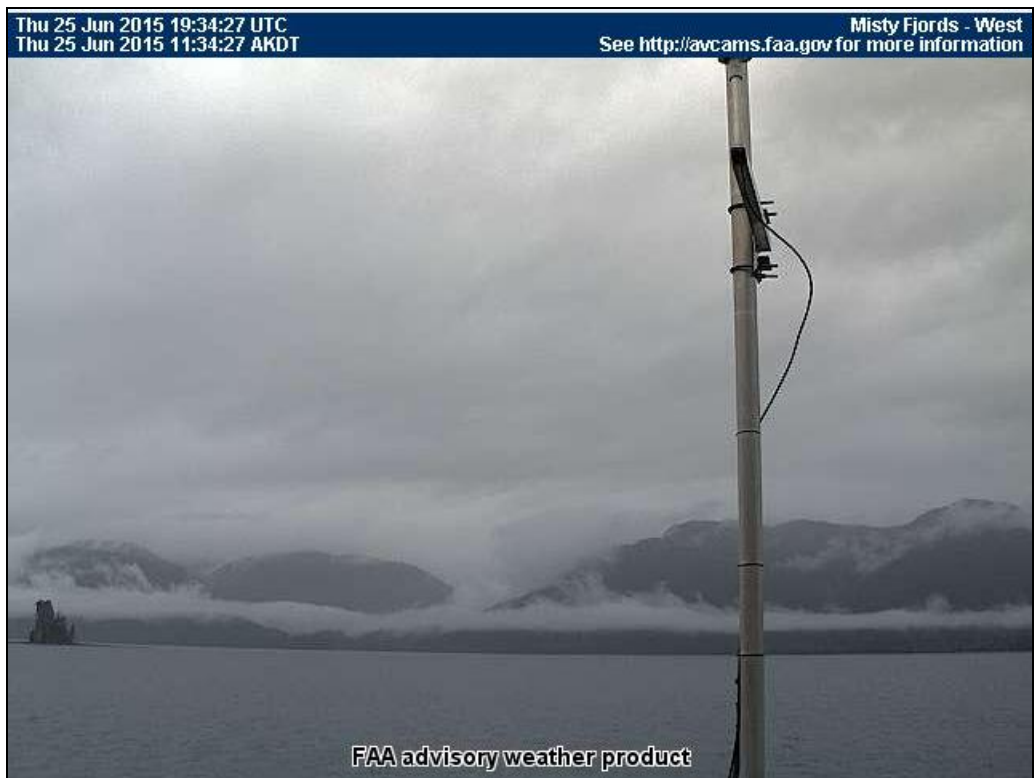
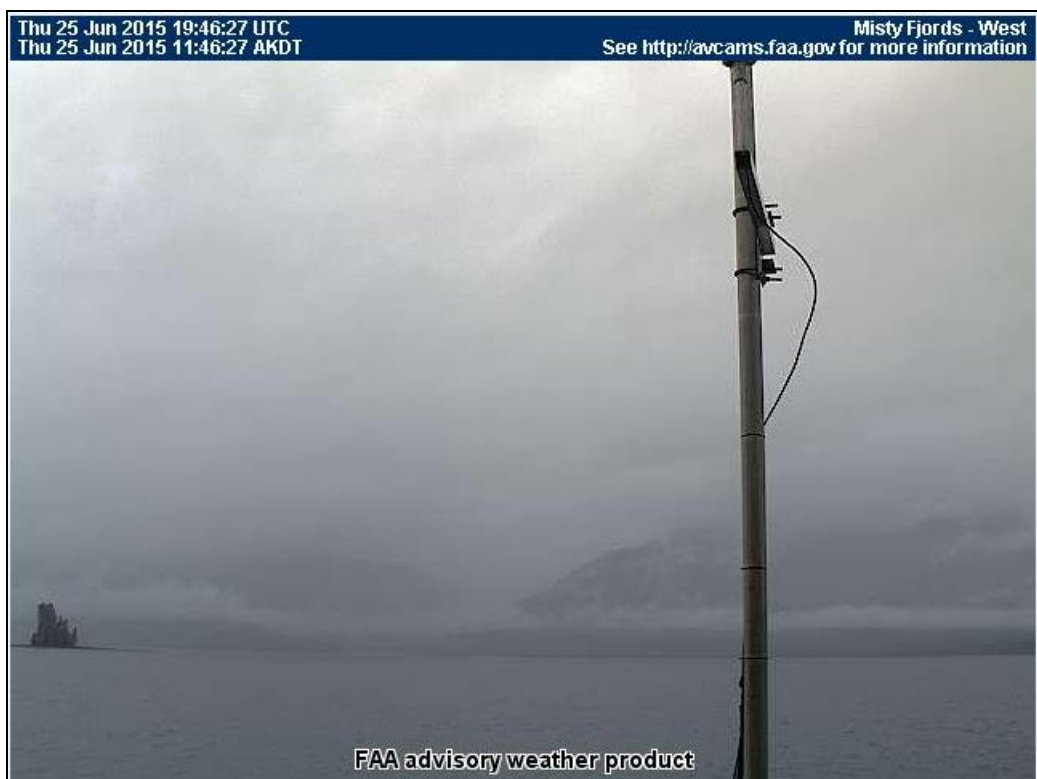
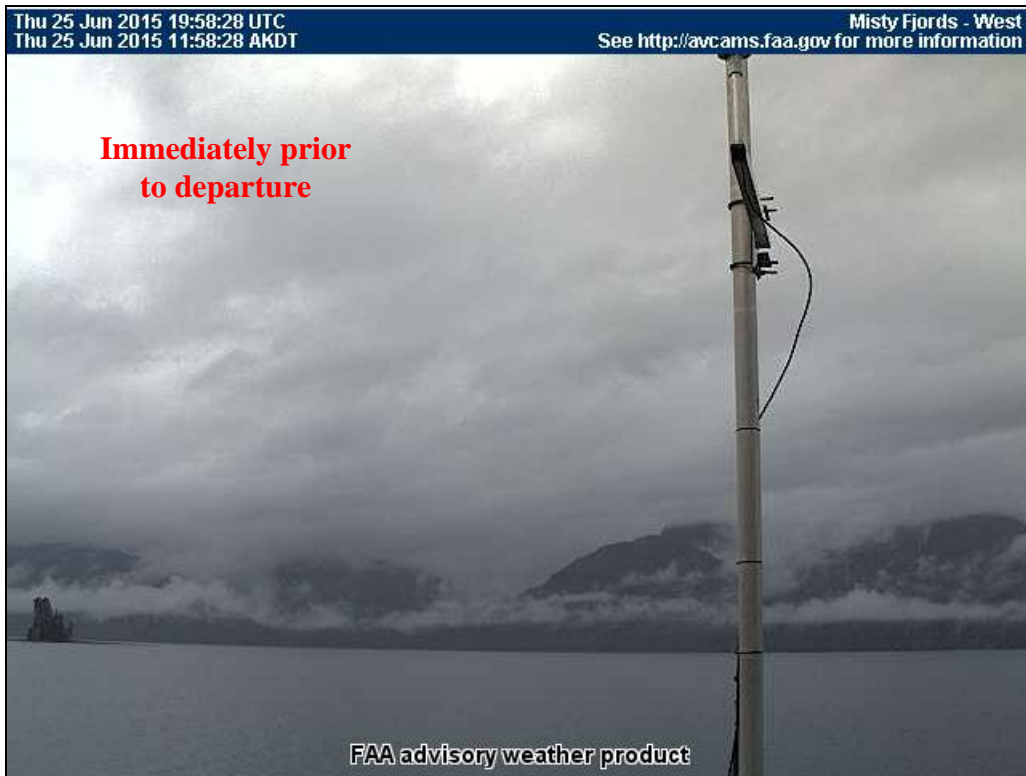
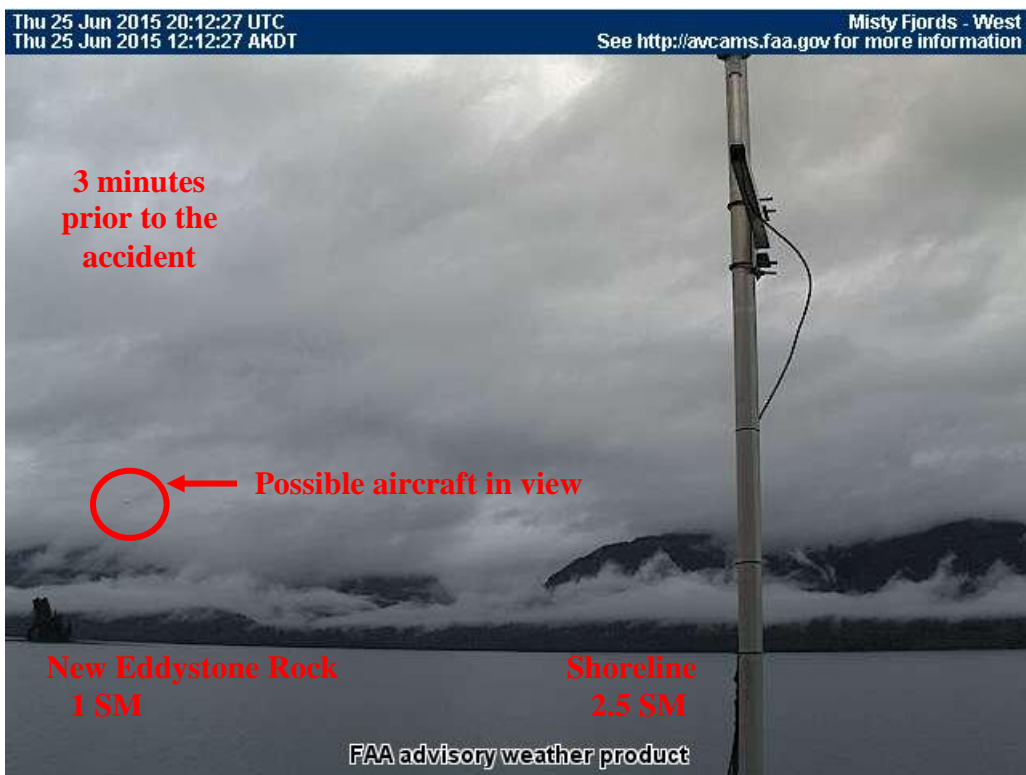
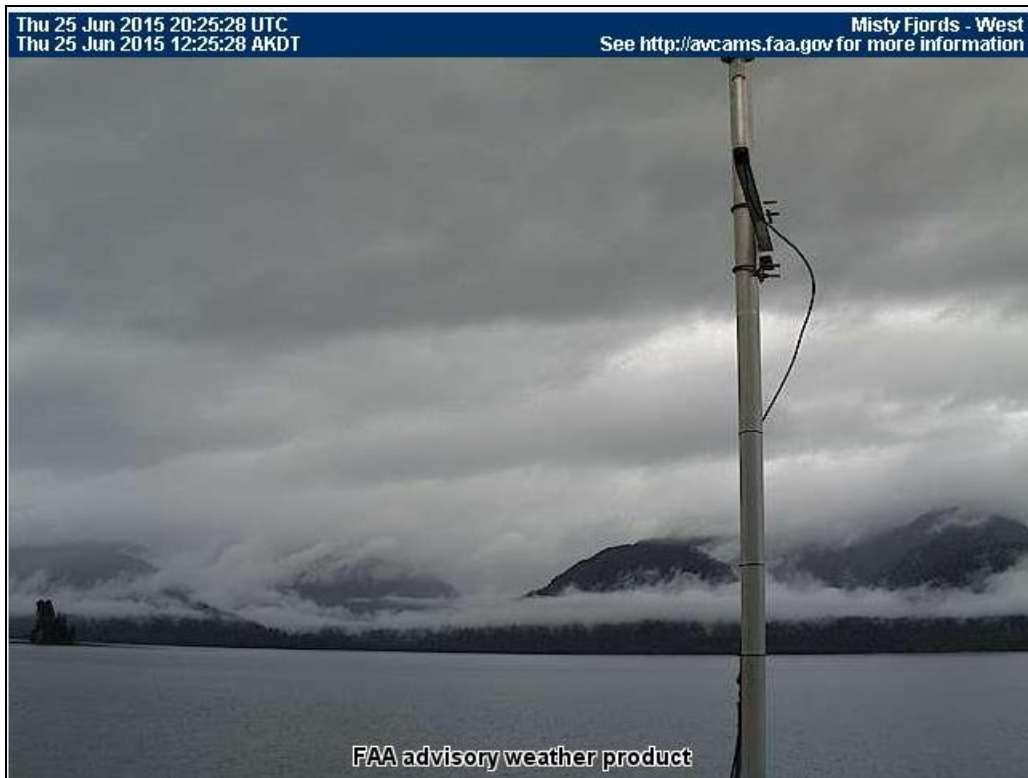
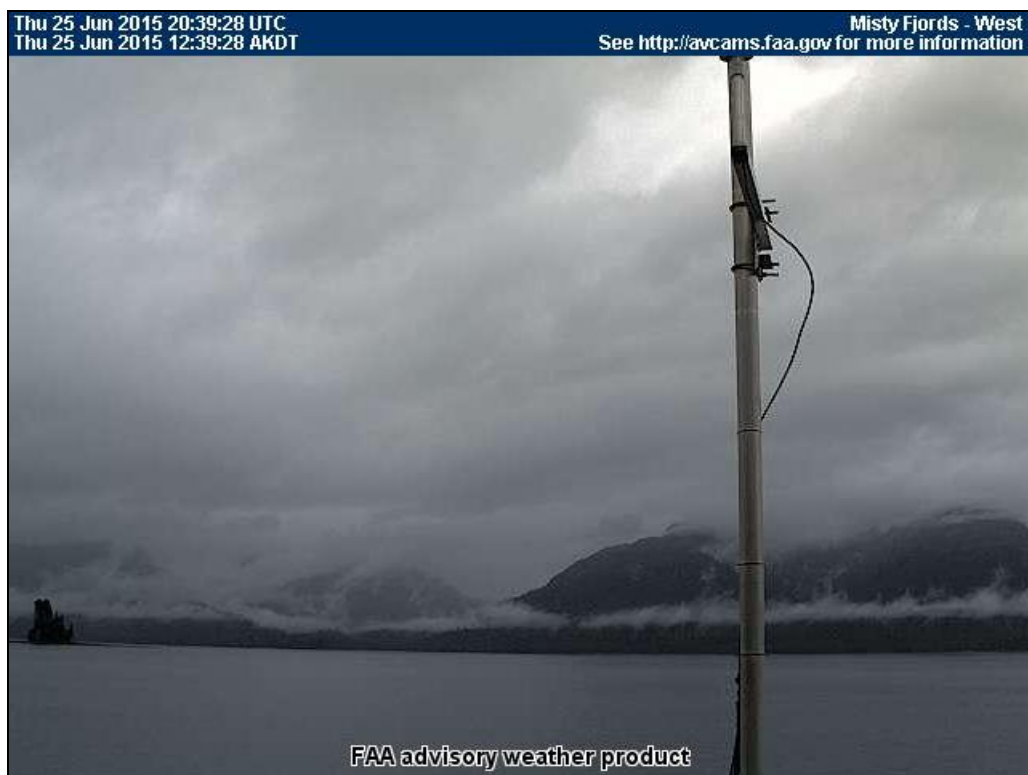
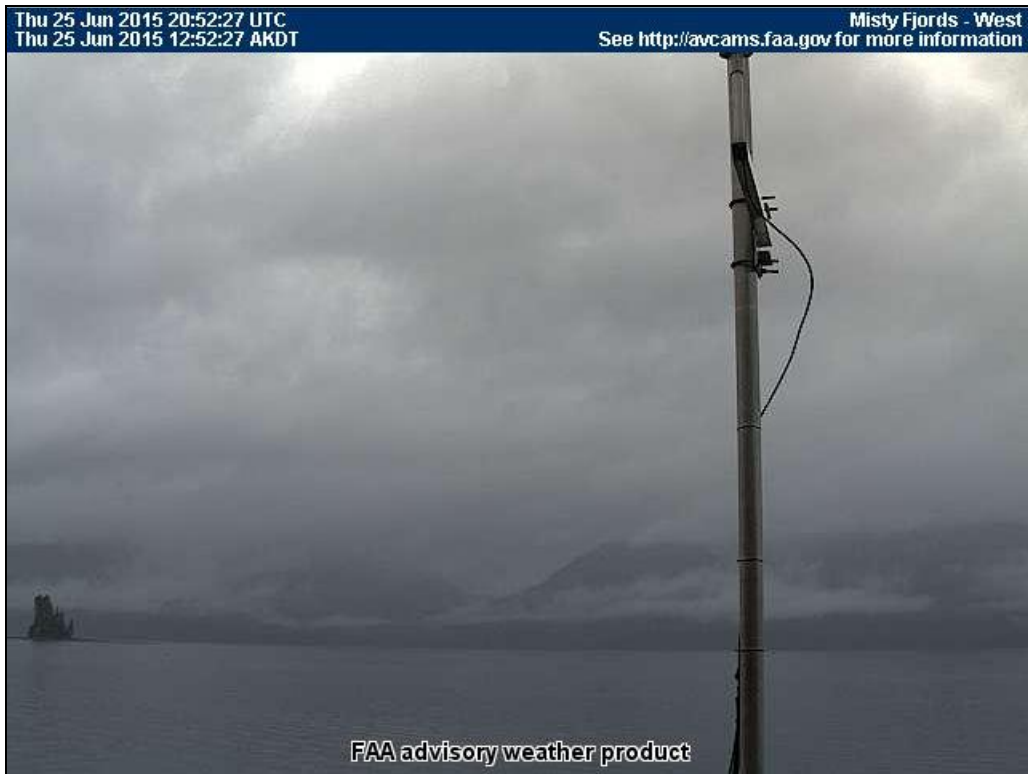
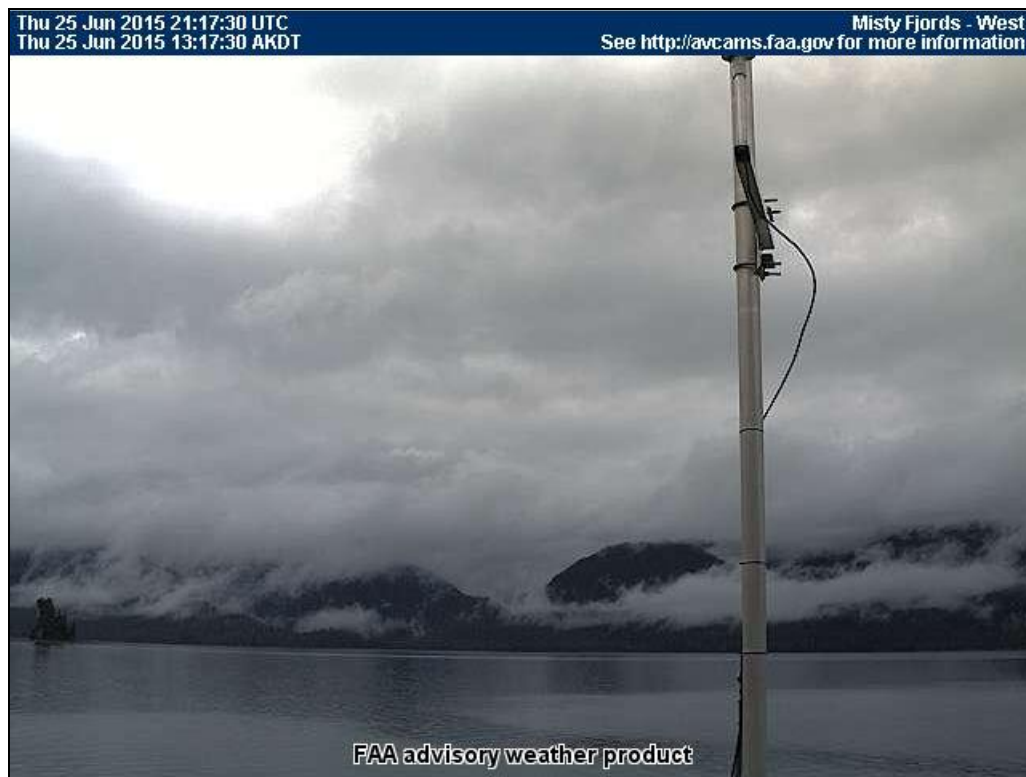
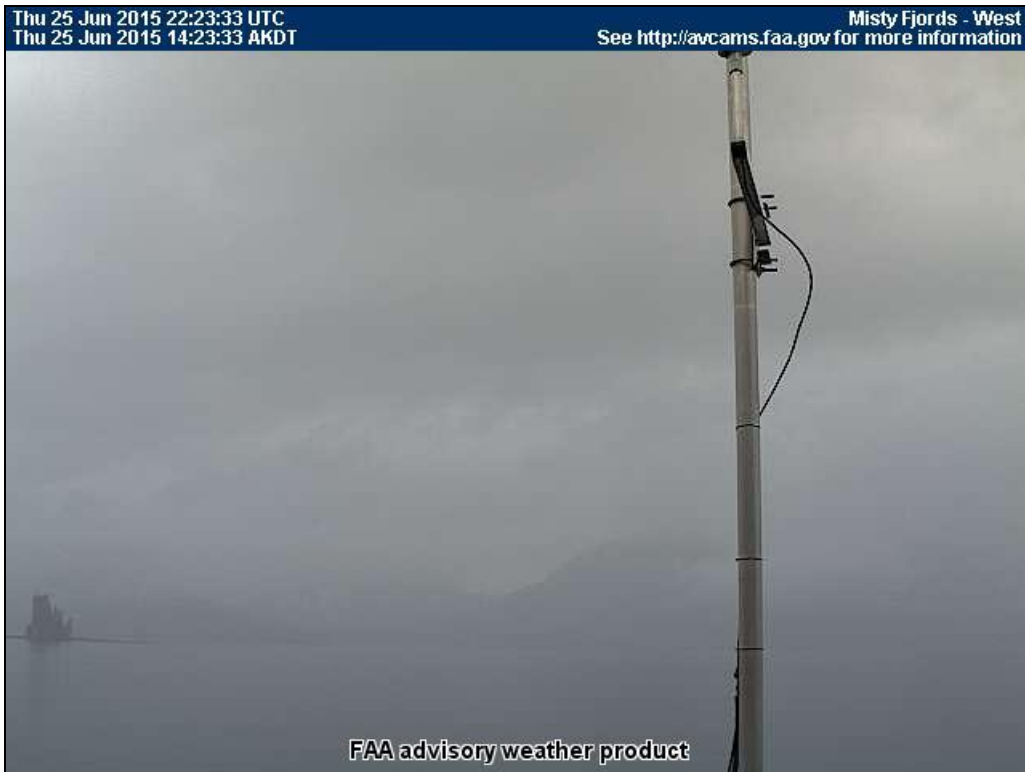
Figures 17 through 26 are the Misty Fjords West camera images from 1121 through 1423 AKDT, at approximately 12 minute increments. The higher ridge elevations are obscured during the period, with a layer of stratiform clouds below the peaks. Visibility is also noted to decrease to less than 3 statute miles during the period, where the shore line is not clearly identifiable.

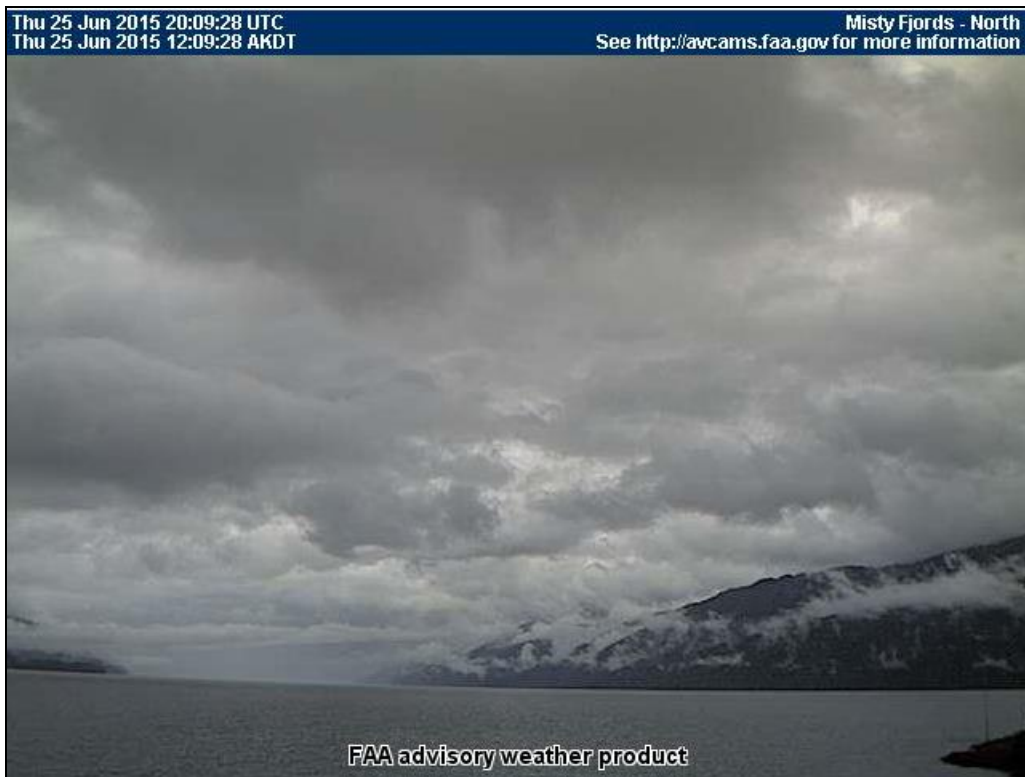
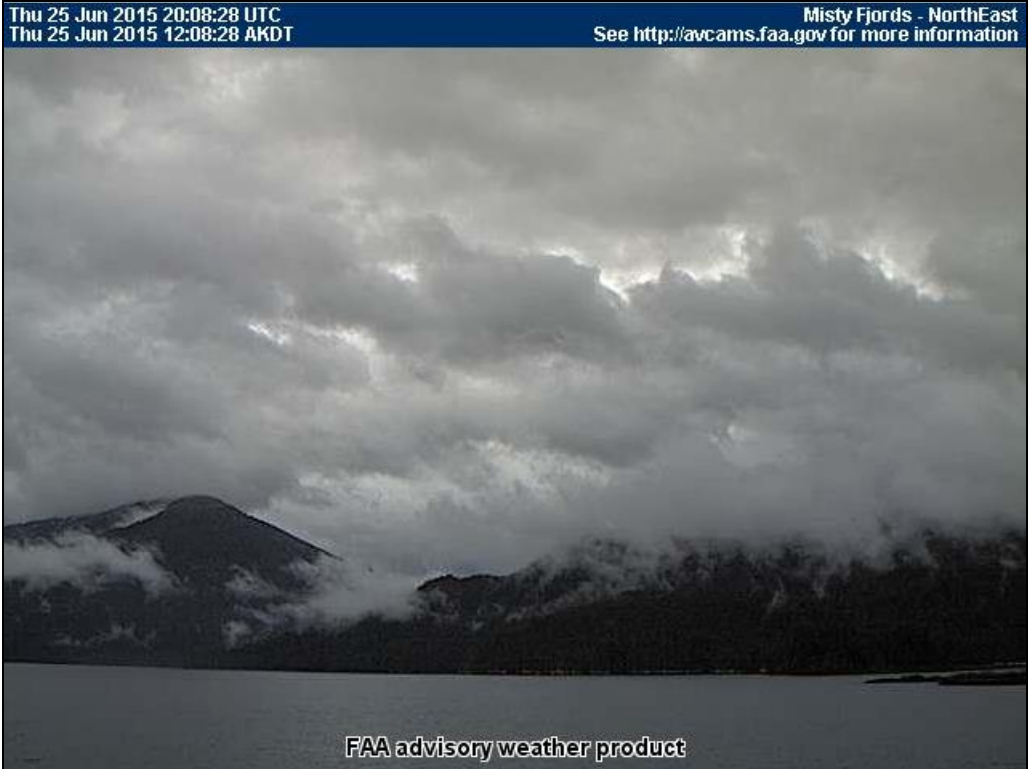
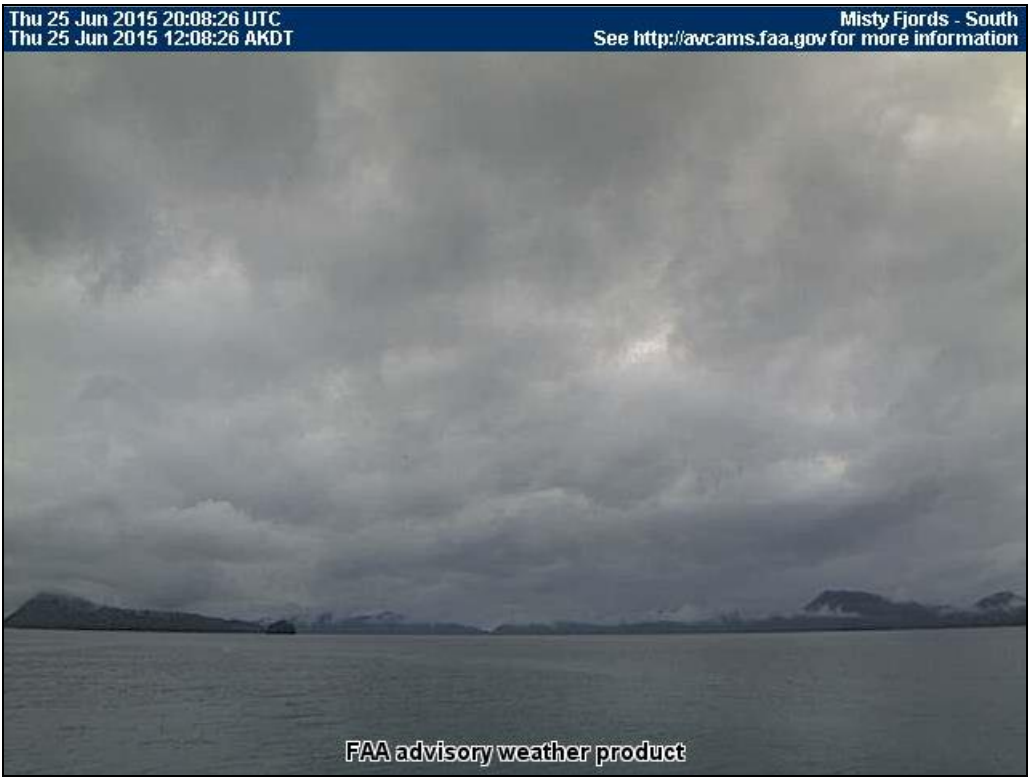
Figures 27 through 29 are the images from the North, Northeast, and South between 1208 and 1209 AKDT. The images also show broken to overcast cloud over the area with most of the higher terrain obscured by clouds, and with several lower stratiform clouds over the terrain and scattered rain showers.
