NATIONAL TRANSPORTATION SAFETY BOARD

Group Chairman's Factual Report

METEOROLOGY

ANC15MA041

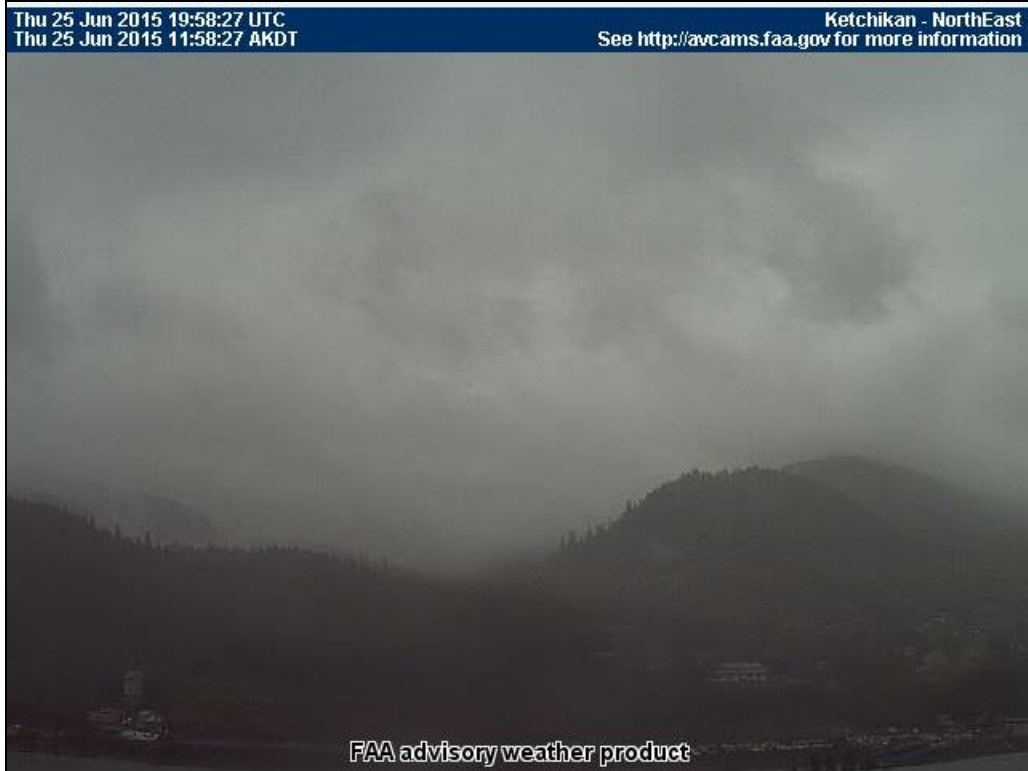
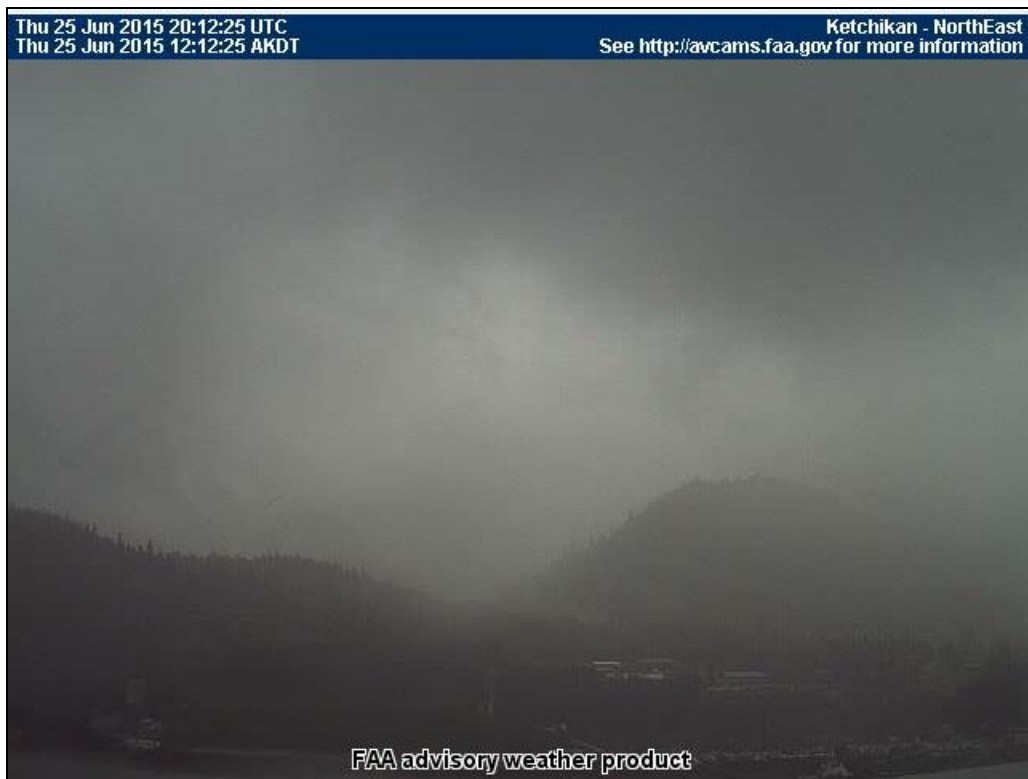
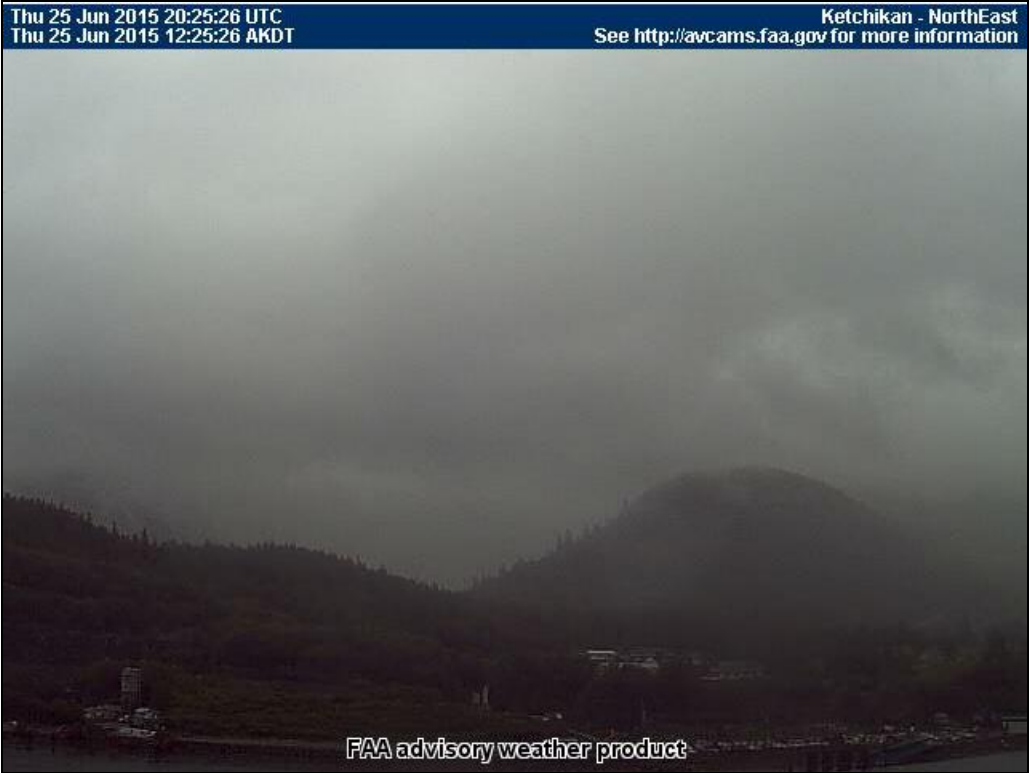
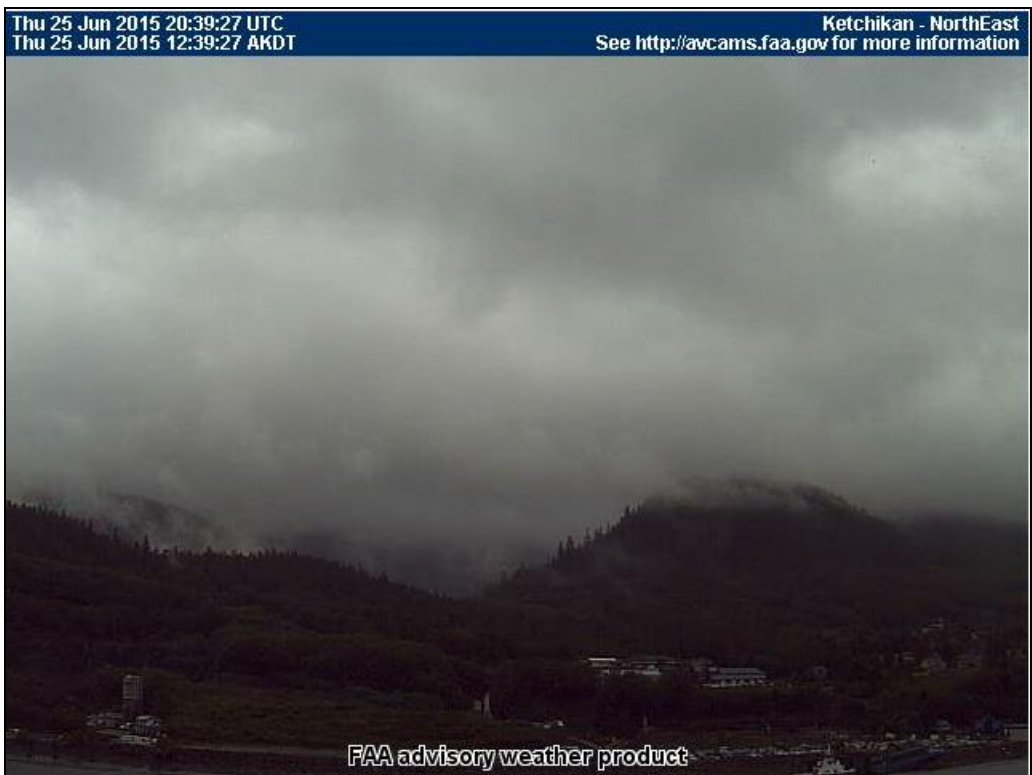
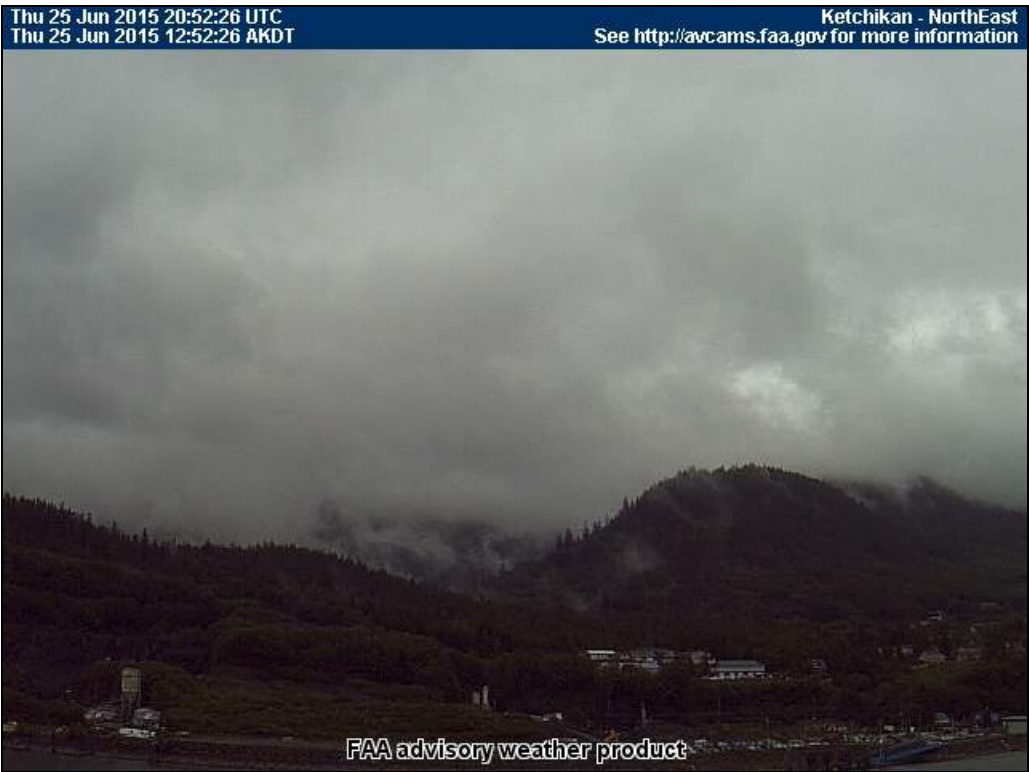
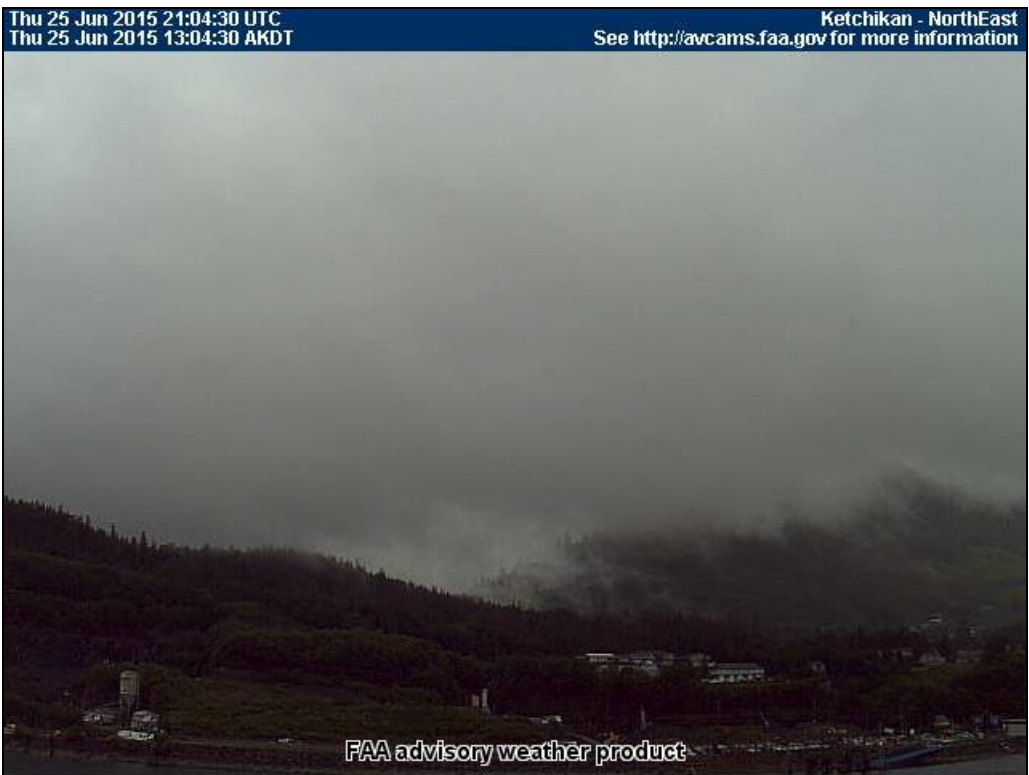
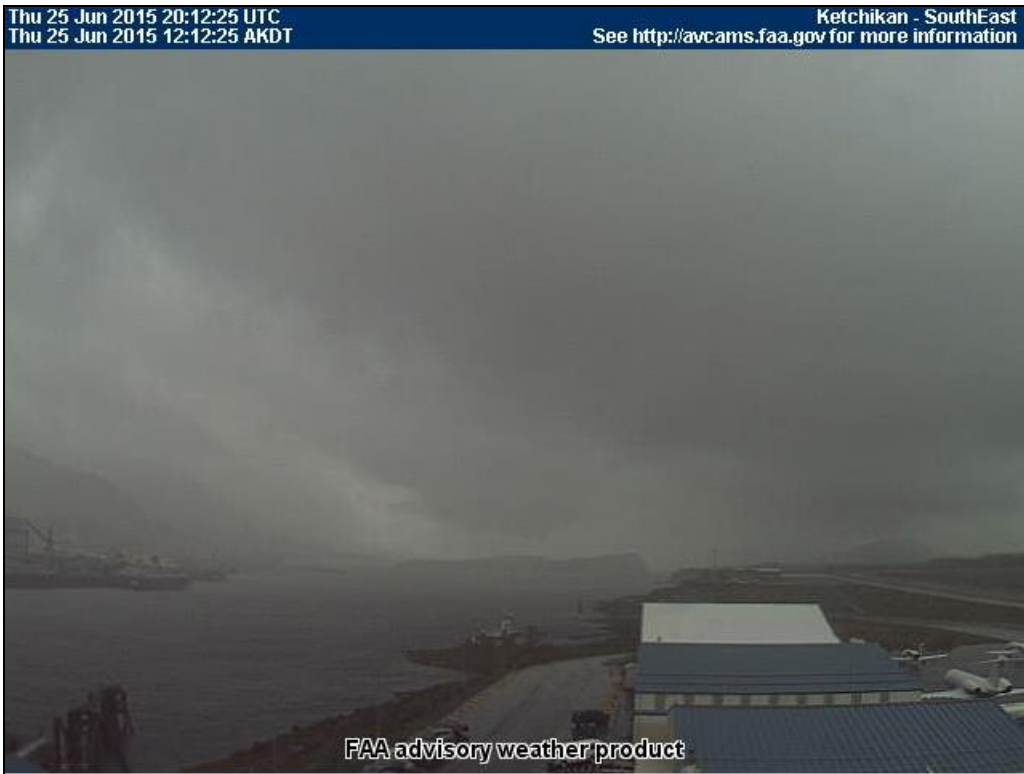
Figures 33-38 are the Ketchikan northeast camera views at 1158 through 1304 AKDT at approximately every 12 minutes, and depicted the higher terrain 2 miles away completely obscured by clouds during the period, and the ridges at 1,200 feet and 1 mile away occasional obscured by clouds and poor visibility. Figure 39 is the southeast camera view at 1212 AKDT.

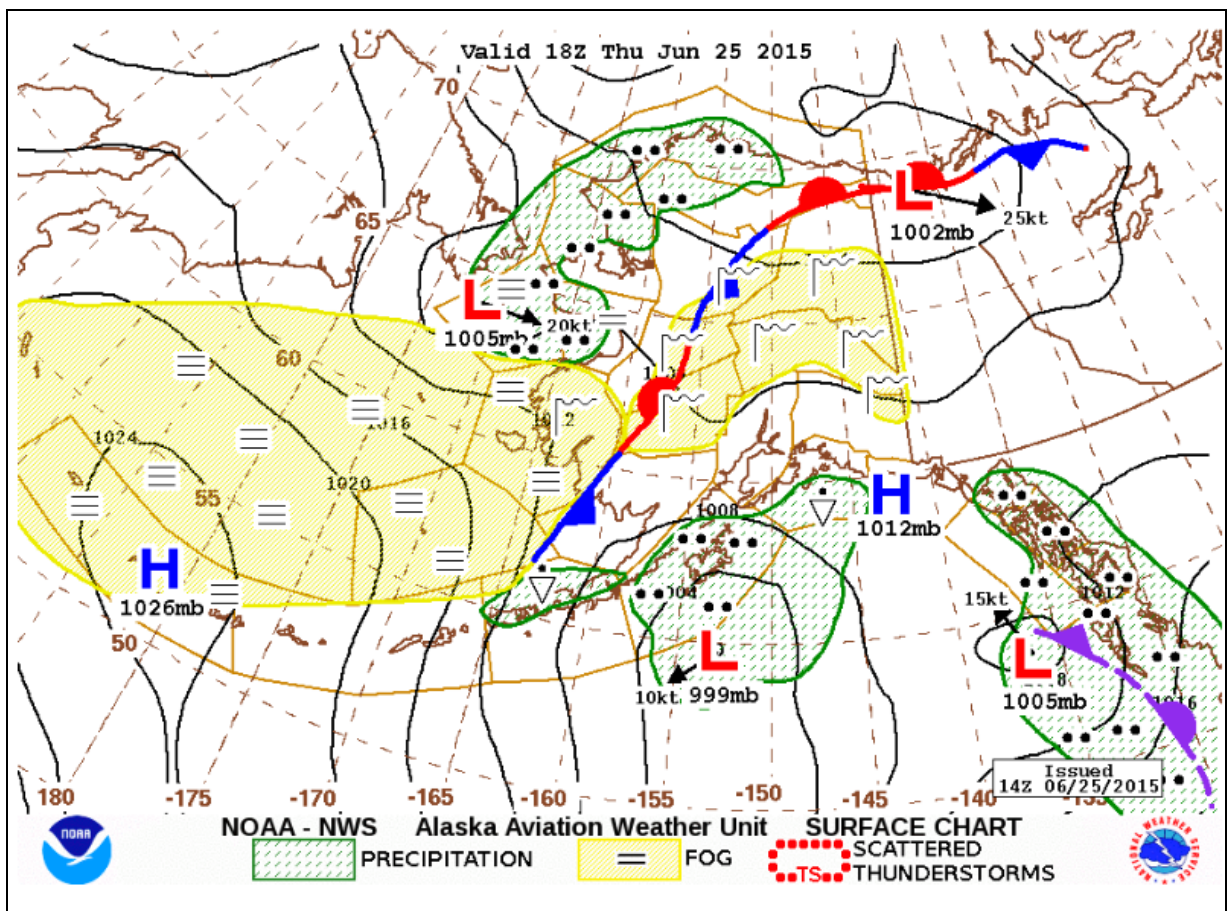
Figure 40 - The NWS Surface Forecast issued at 0600 AKDT and valid for 1000 AKDT

The NWS AAWU also issues several different weather graphics to depict the weather conditions over the region. Figure 40 is the NWS AAWU Surface Analysis issued at 0600 AKDT and depicted the low pressure system at 1005-hPa off the southwest coast of Alaska associated with the dissipating occluded front. A large area of light continuous rain over 50% of the area was expected during the period.

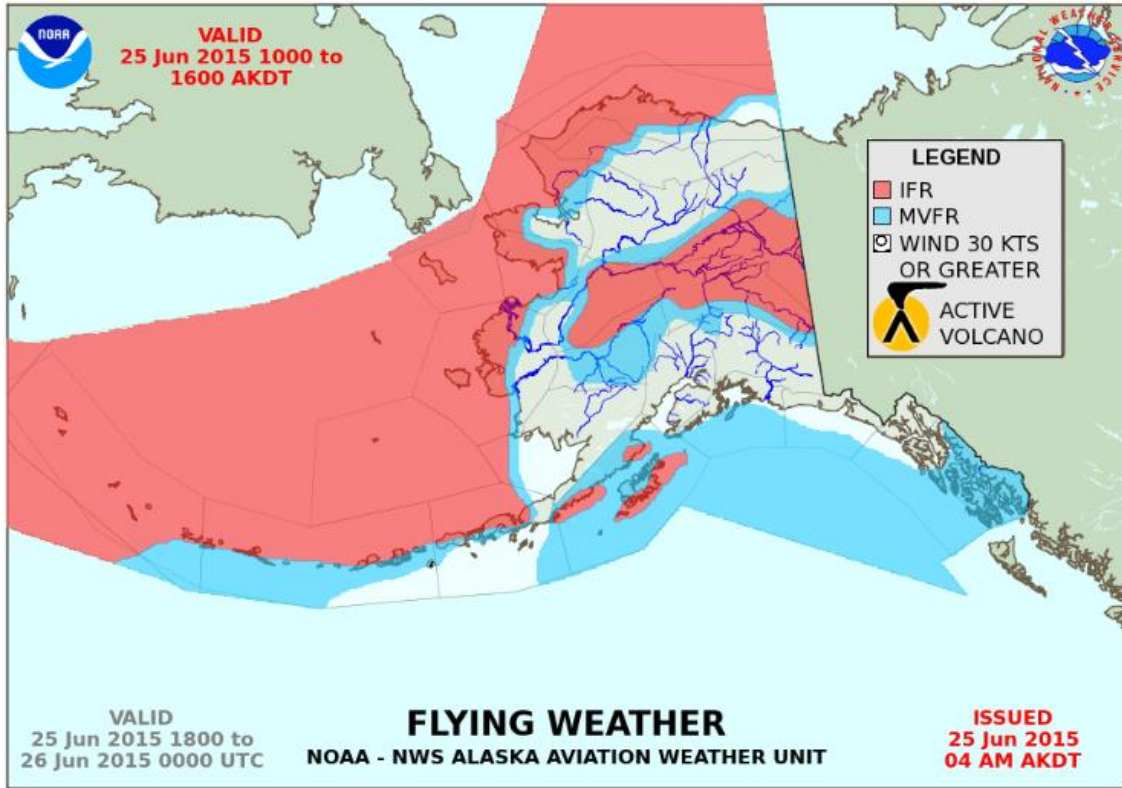
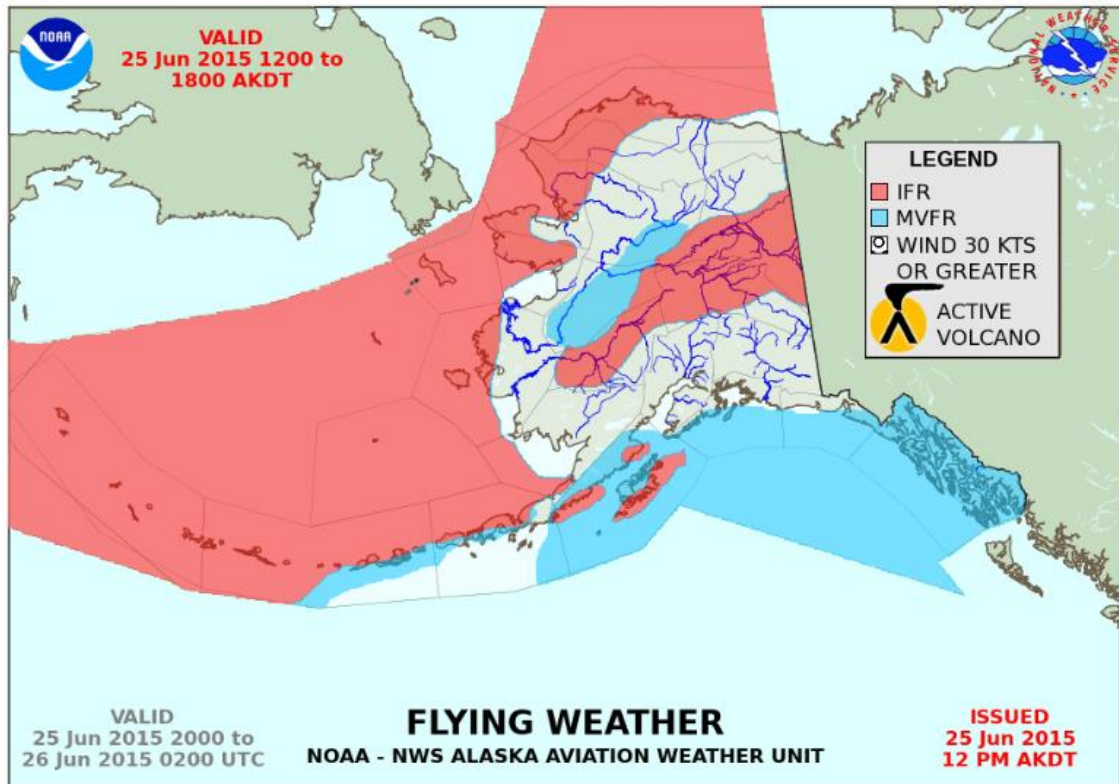
Figures 41 and 42 are the NWS AAWU Flying Weather graphics which depicted the general flight categories expected during the period. Both charts covering the period from 1000 through 1800 AKDT expected MVFR conditions to prevail over southeast Alaska during the period.

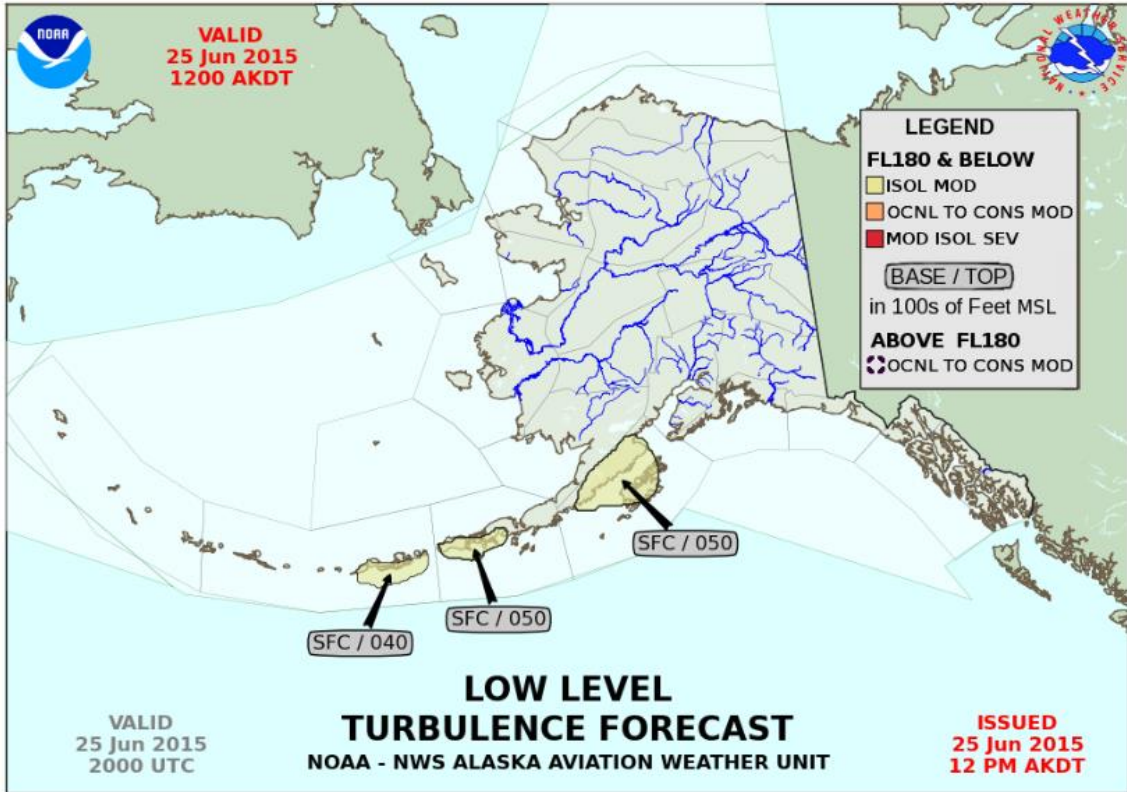
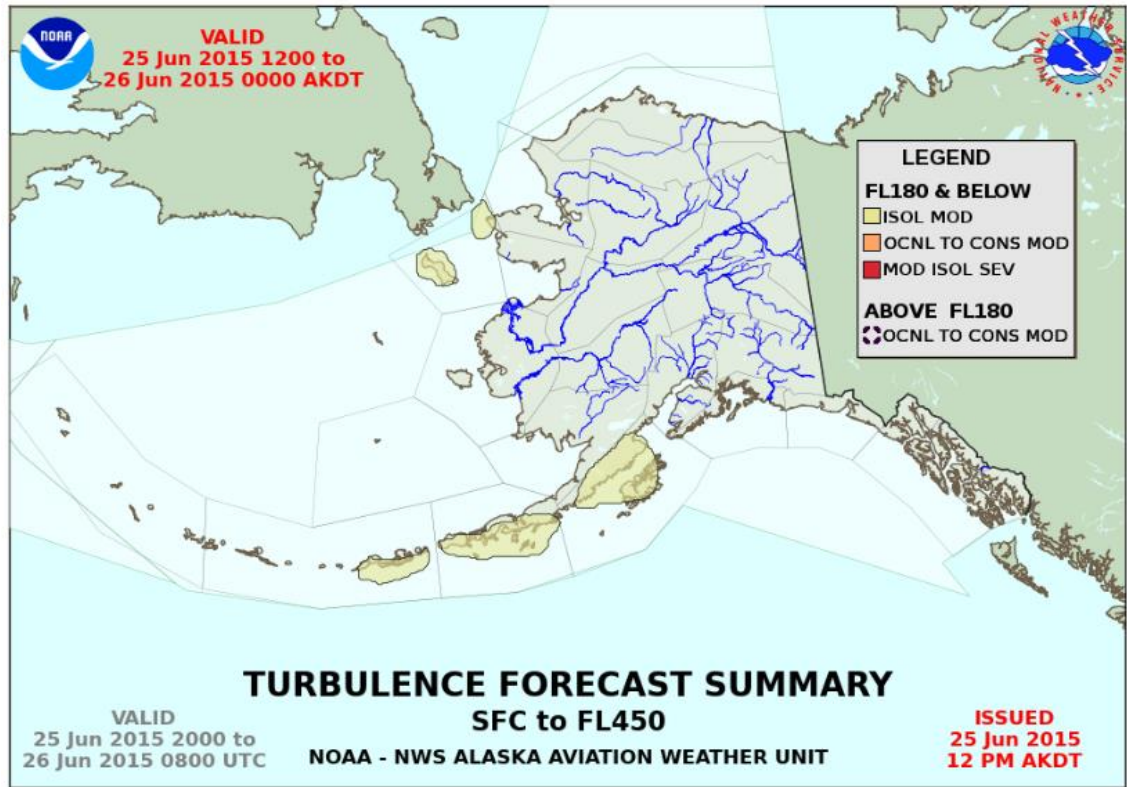
Figures 43 and 44 are the NWS AAWU turbulence forecasts for the period, with no significant turbulence expected for the southeast section of Alaska during the period.
