NATIONAL TRANSPORTATION SAFETY BOARD

Group Chairman's Factual Report

METEOROLOGY

ANC17FA049

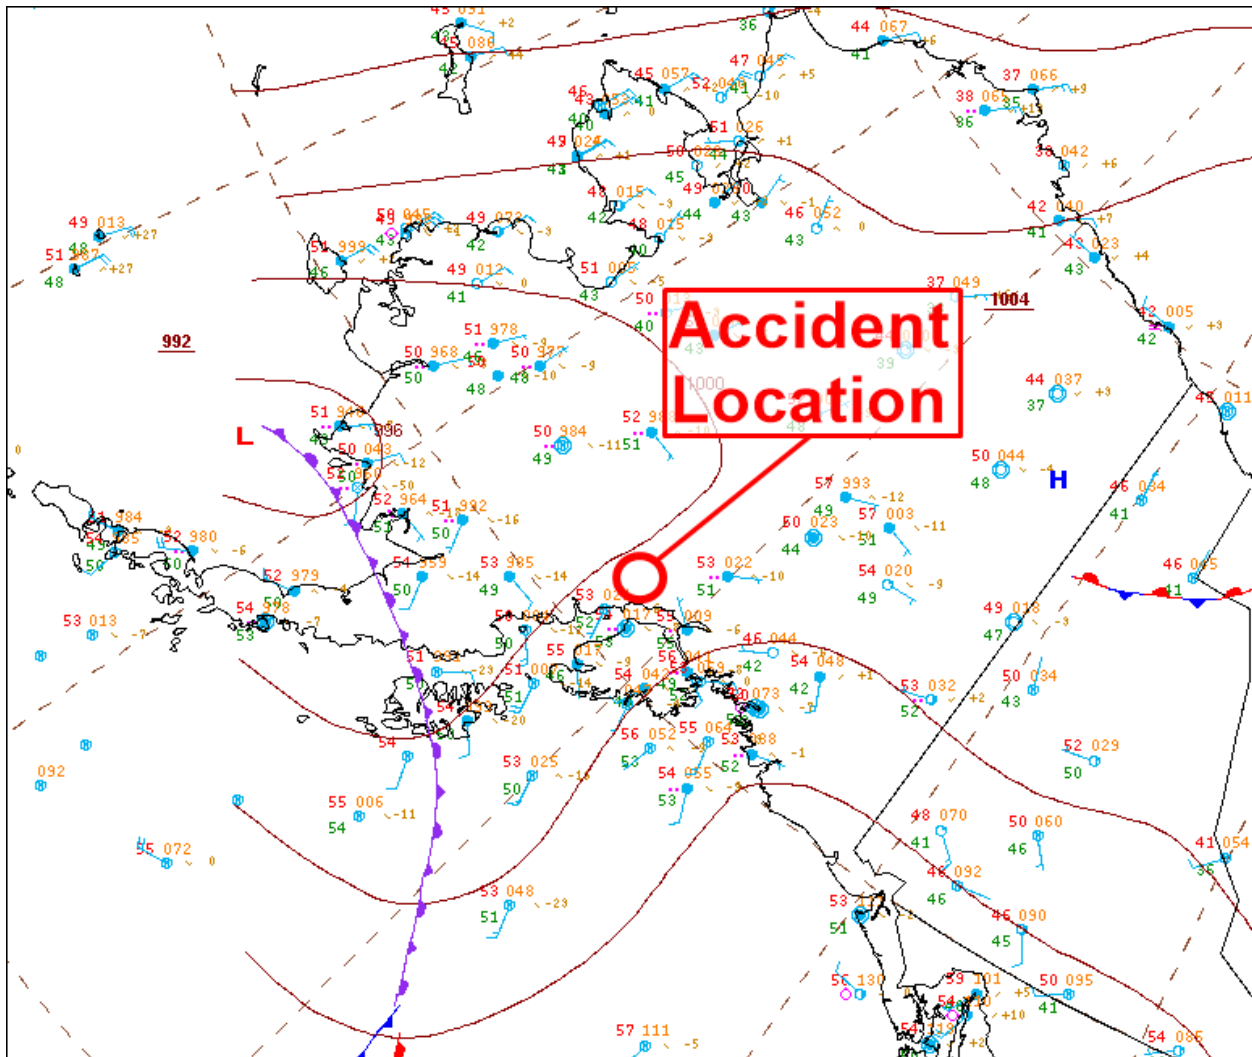
The National Weather Service (NWS) Surface Analysis Chart for 2200 AKDT is presented in figure 1. The surface analysis chart identified a 992 hectopascals (hPa) low pressure center near the southwestern Alaska coast in Bristol Bay. Station models south, southeast and east of the accident location depicted light continuous rain with temperatures in the 50's degrees Fahrenheit (°F), dewpoint depressions as low as 1°F and light and variable (or calm) winds.

Figure 1 - NWS Surface Analysis Chart for 2200 AKDT.

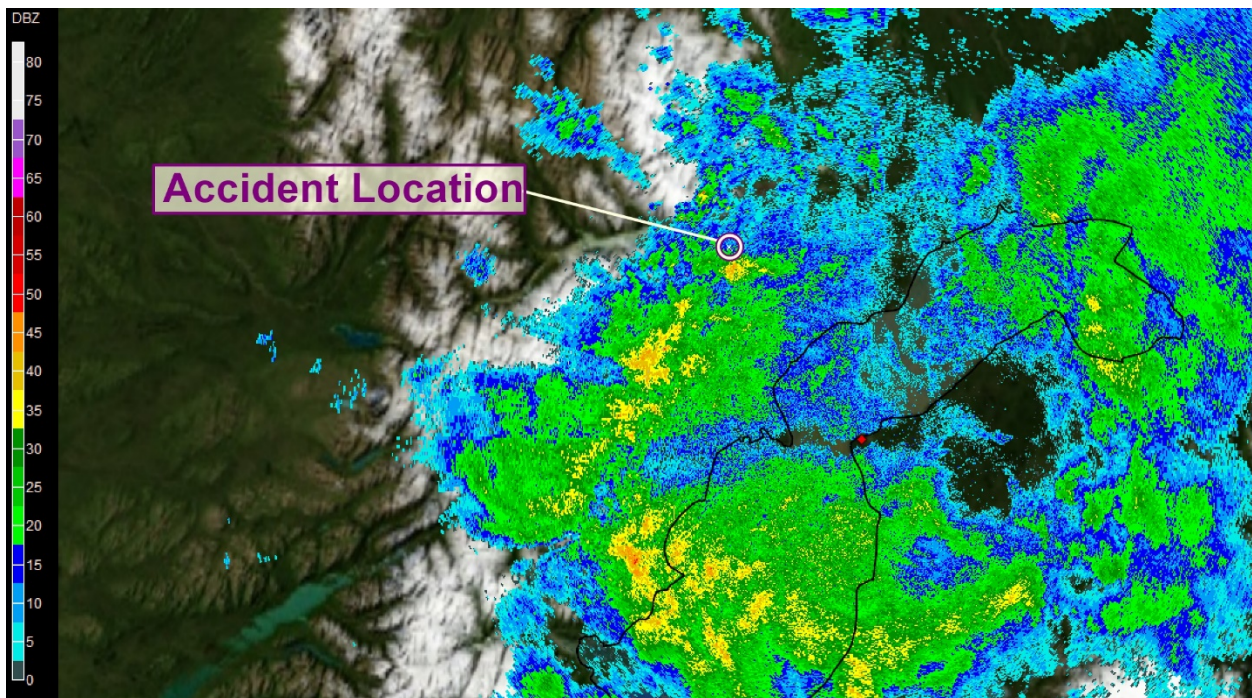
The PAHG imagery surrounding the accident period identified reflectivity features consistent with light to extreme³ intensities of precipitation in the region and adjacent to the accident site. A vertical cross-section of a “cell” adjacent to the accident location (figure 7) identified the highest values of reflectivity (in decibels [dBZ]) were located between about 4,000 and 6,000 feet.

Figure 2 – PAHG 1.4° Level-II reflectivity product from a sweep initiated at 2222:35 AKDT.

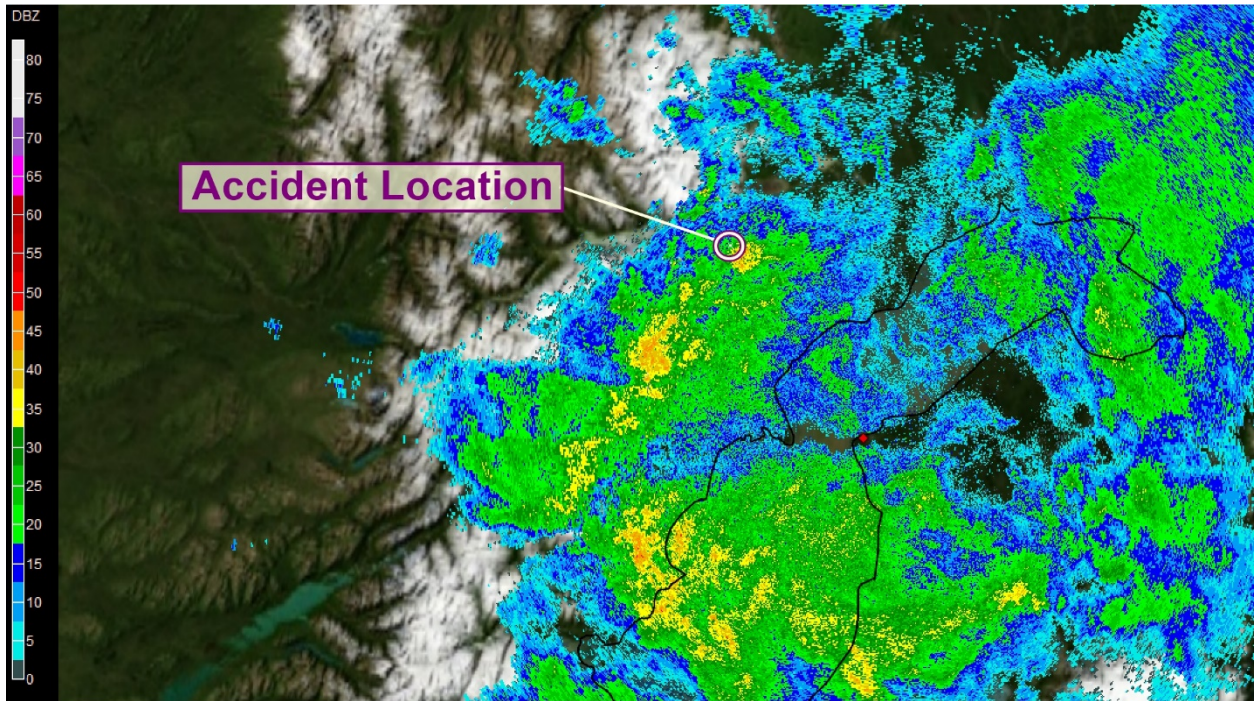
Figure 3 – PAHG 1.4° Level-II reflectivity product from a sweep initiated at 2228:23 AKDT.

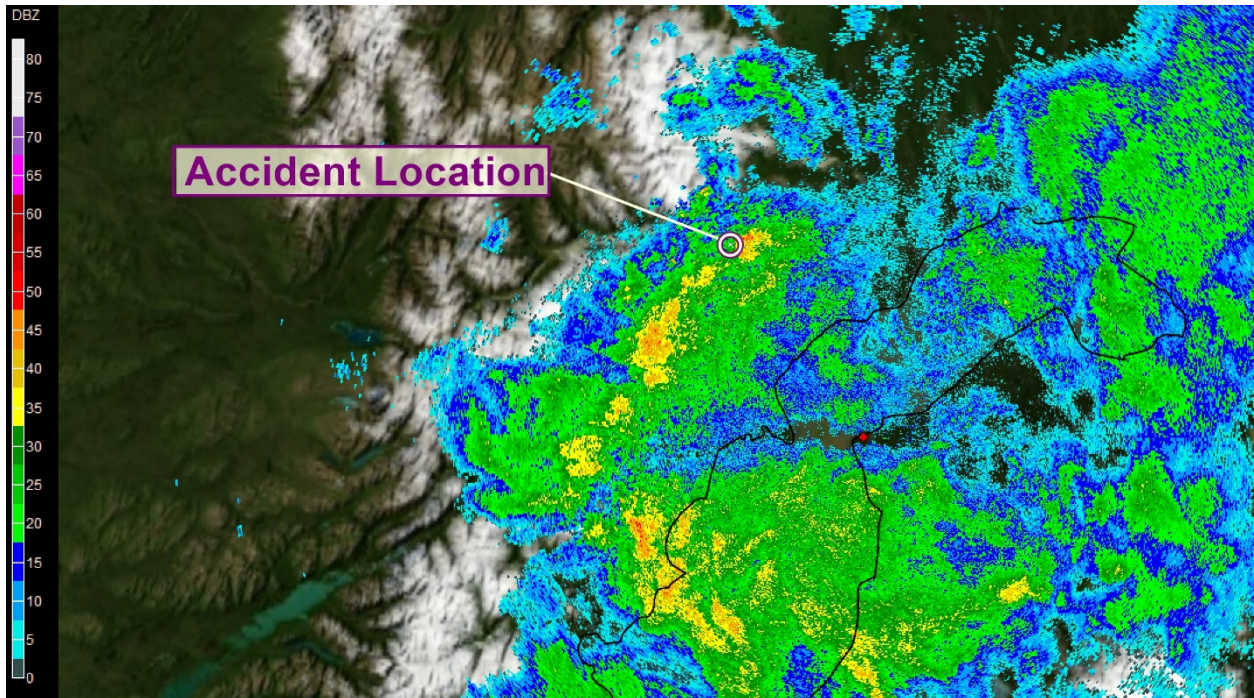
Figure 4 – PAHG 1.4° Level-II reflectivity product from a sweep initiated at 2234:11 AKDT.

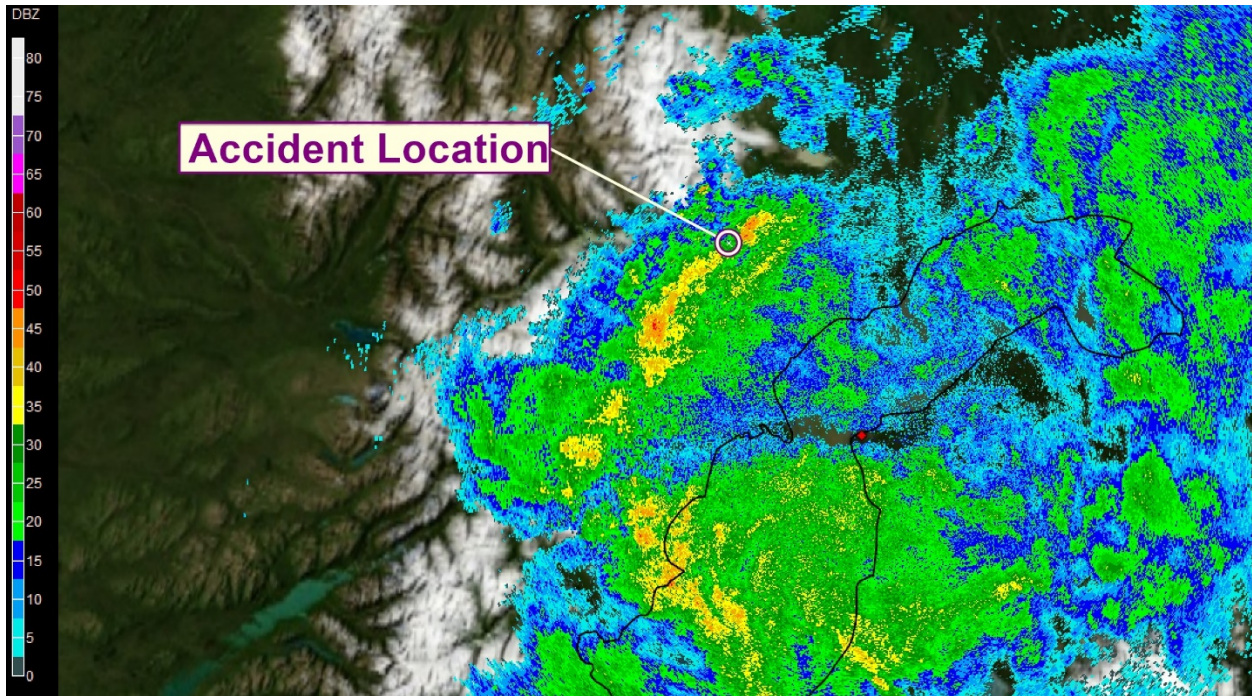
Figure 5 – PAHG 1.4° Level-II reflectivity product from a sweep initiated at 2239:59 AKDT.

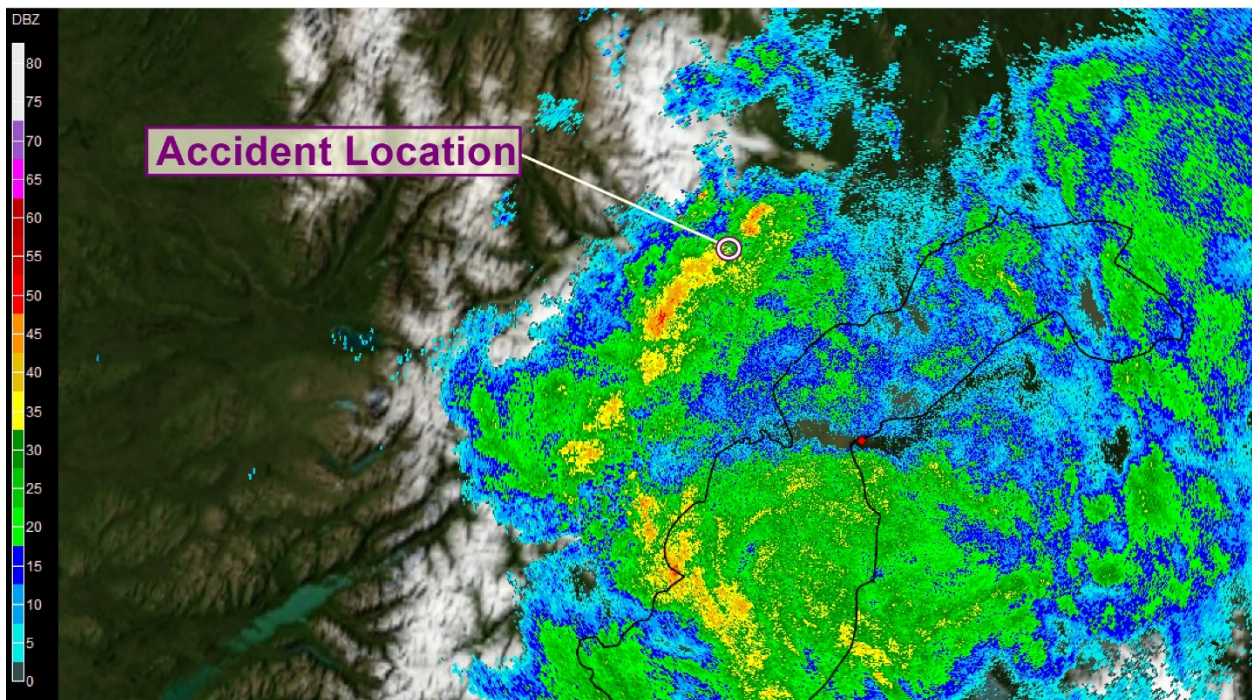
Figure 6 – PAHG 1.4° Level-II reflectivity product from a sweep initiated at 2245:47 AKDT.

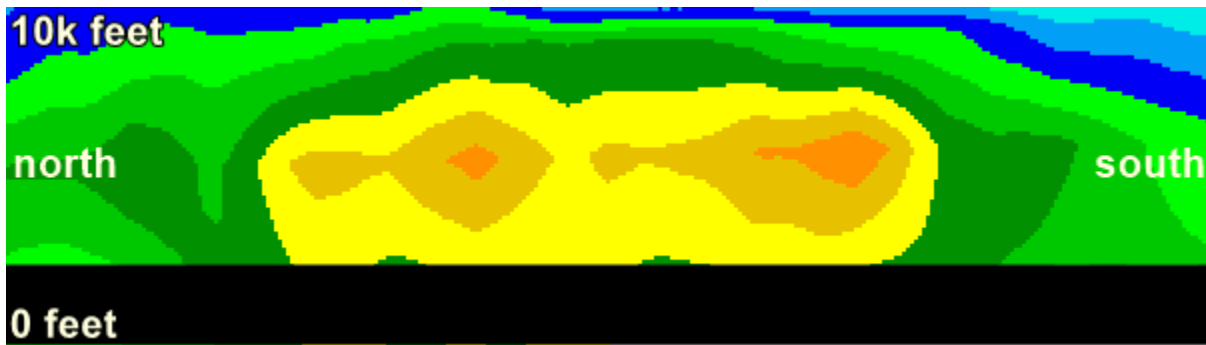
Figure 7 – North-south 0-10,000 feet (approximate) vertical cross-section of the Level-II reflectivity product from the volume scan initiated at 2233:08 AKDT through the cell adjacent to and to the east of the accident site. Color table is as presented in figures 2-6.

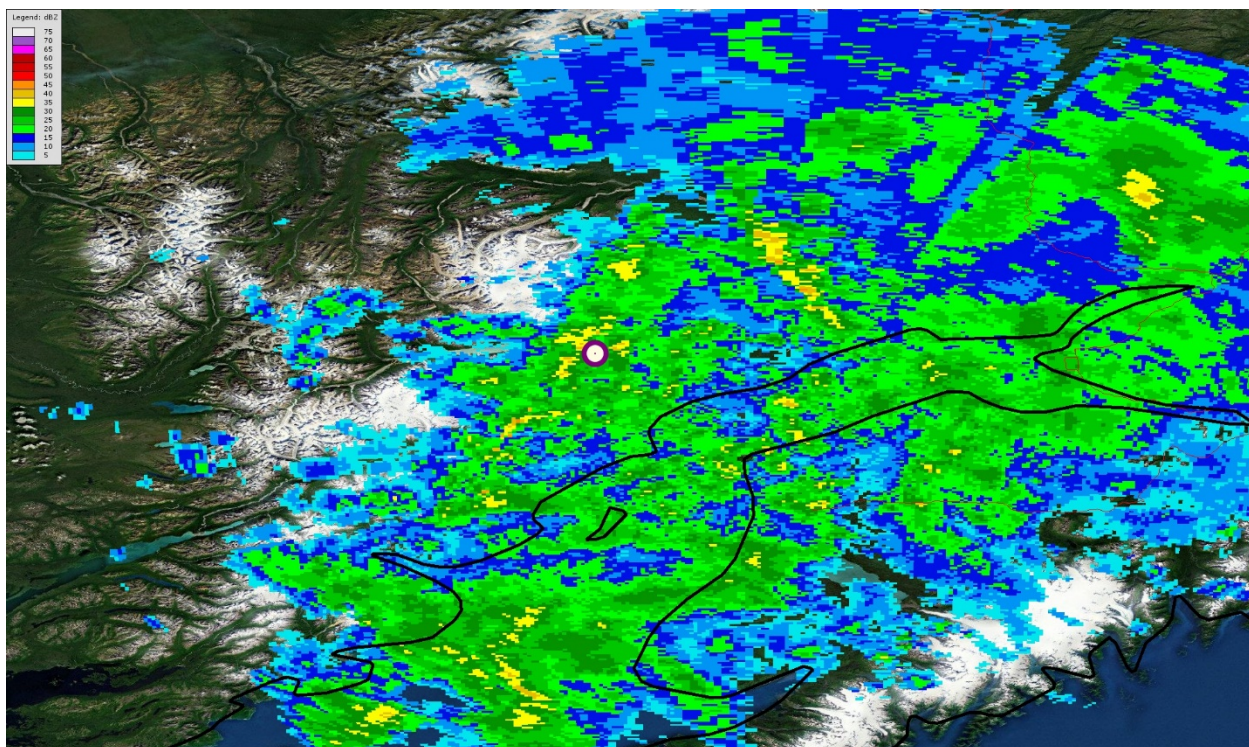
WSR-88D Level-III composite⁴ weather radar imagery from PAHG for the times surrounding the third Kenai Flight Service Station telephone weather briefing (see section 15), are presented in figures 8-11. This composite imagery identified an extensive area of reflectivity surrounding the accident location and extending east through the Anchorage area.

Figure 8 – PAHG Level-III composite reflective image from a volume scan initiated at 2056 AKDT. The white dot denotes the accident location.

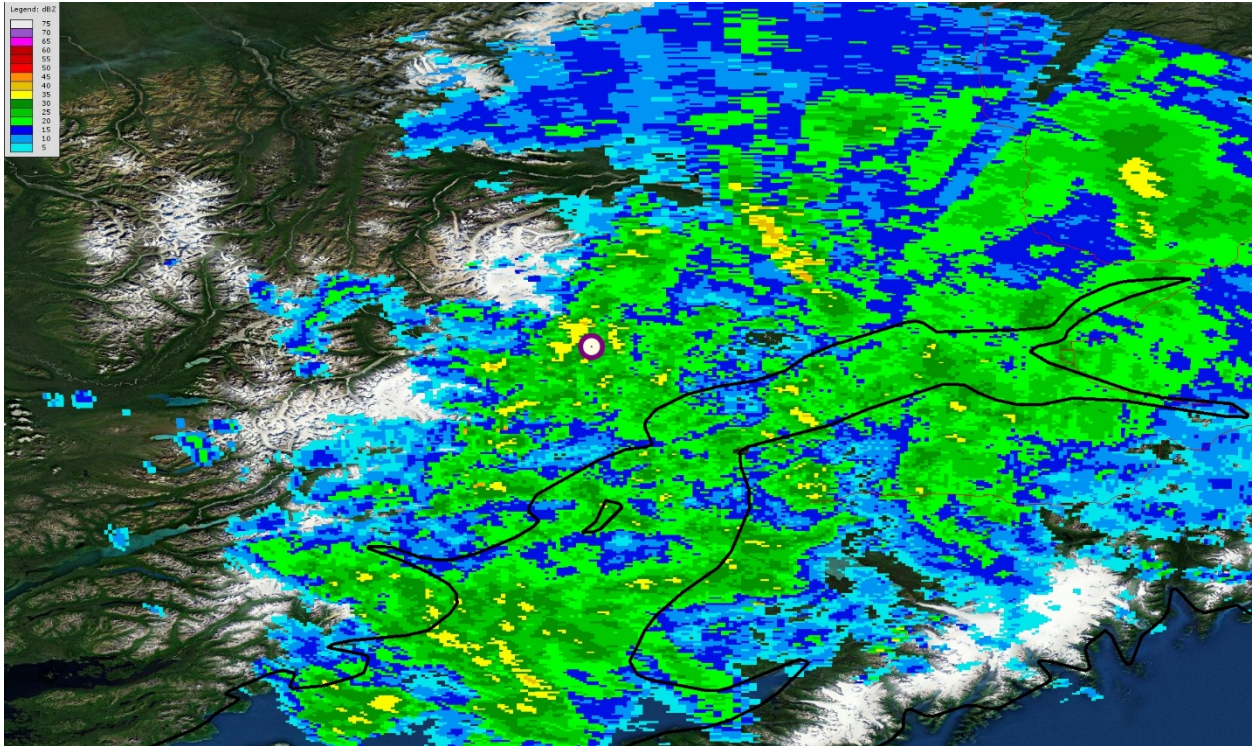
Figure 9 – PAHG Level-III composite reflective image from a volume scan initiated at 2102 AKDT. The white dot denotes the accident location.

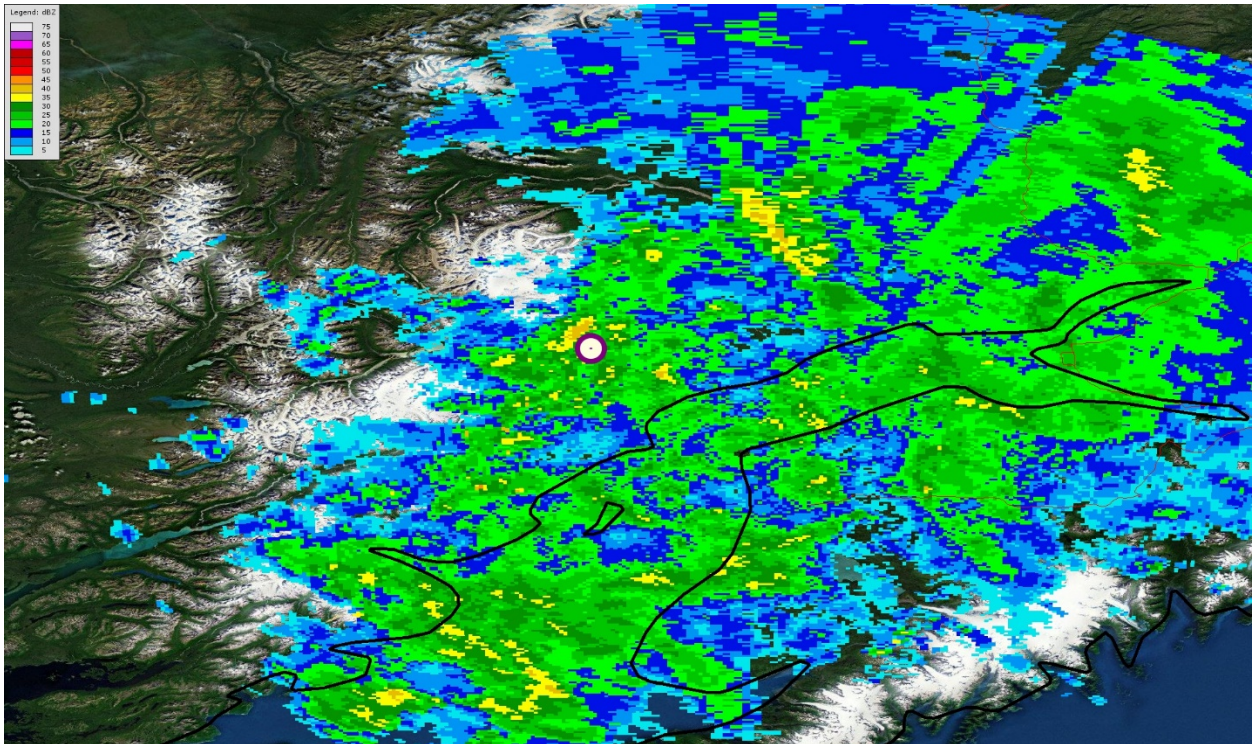
Figure 10 – PAHG Level-III composite reflective image from a volume scan initiated at 2108 AKDT. The white dot denotes the accident location.

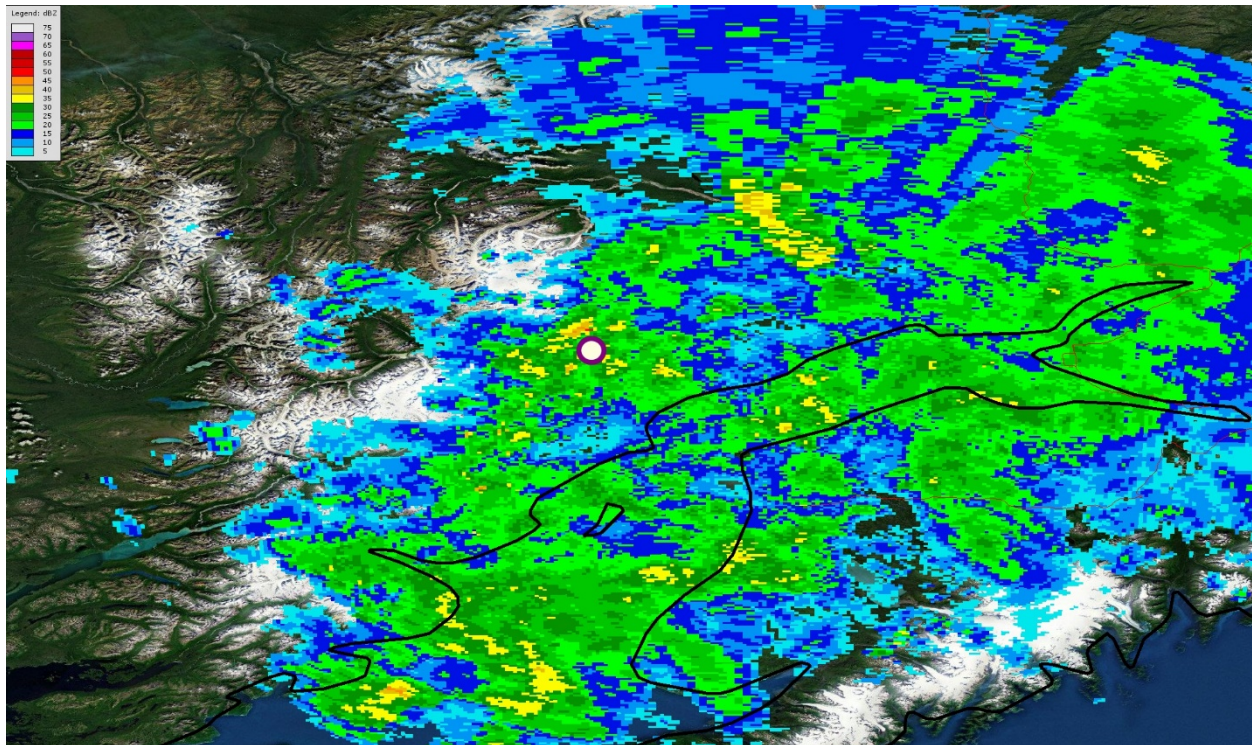
Figure 11 – PAHG Level-III composite reflective image from a volume scan initiated at 2114 AKDT. The white dot denotes the accident location.

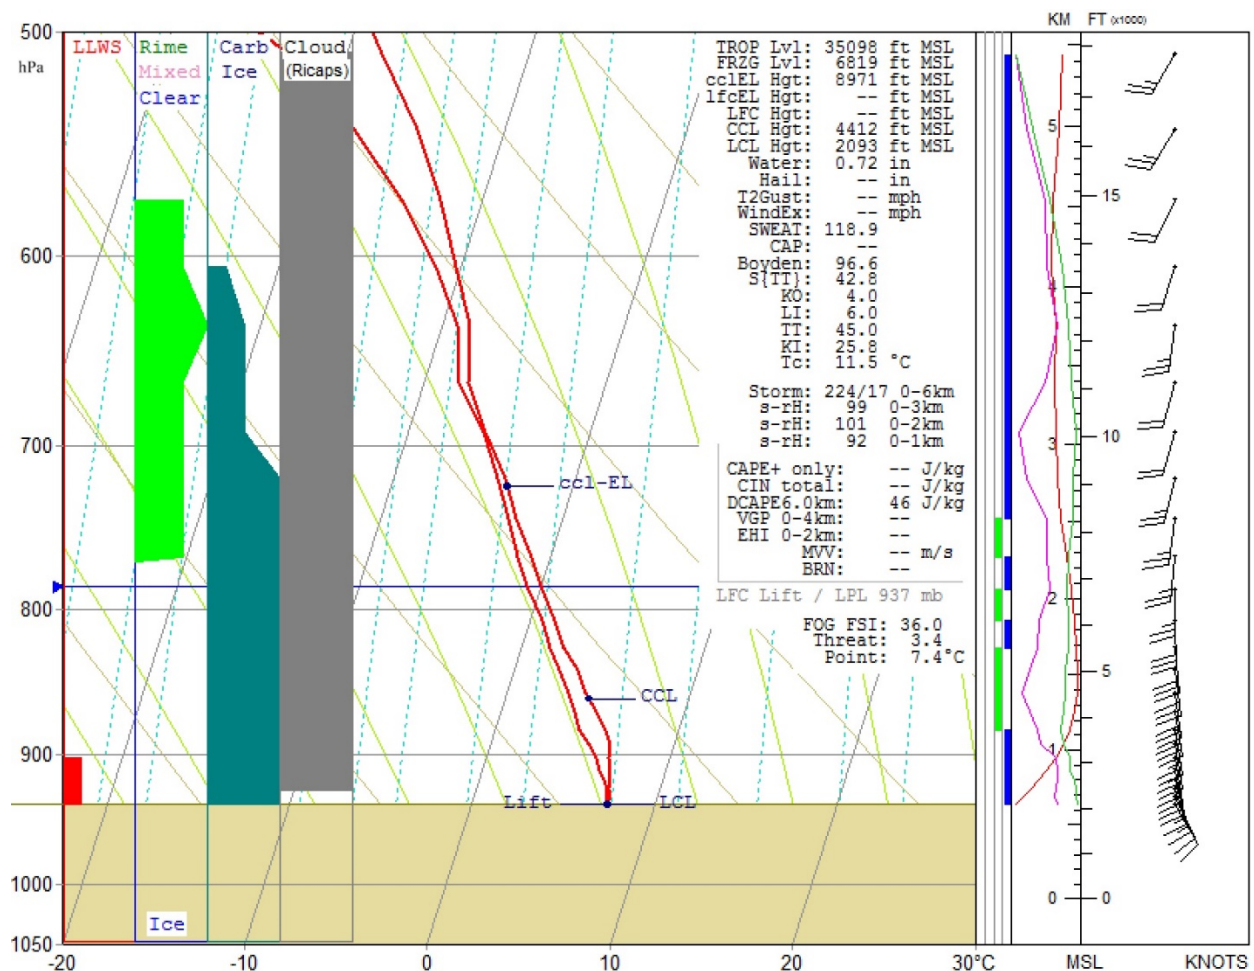
A Global Data Assimilation System (GDAS) model sounding (figure 12) for the accident location at 2200 AKDT was retrieved from the National Oceanic and Atmospheric Administration's Air Resources Laboratory. Below 13,000 feet the wind was generally from the south with magnitudes below 30 knots. The wind magnitude was 9 knots at 2,100 feet but increased to 29 knots at 5,500 feet. Calculations made by the Rawinsonde Observation Program did not yield any significant areas of non-convective turbulence for this atmosphere but did identify light low-level wind shear in the lowest 1,000 feet agl. It also identified light to moderate severities of icing between about 7,000 to 15,000 feet. The freezing level was at about 6,800 feet. Relative humidity was greater than 90 percent between near the surface and about 14,000 feet.

Figure 12 – GDAS model sounding data in SkewT/LogP format for 2200 AKDT at the accident site, surface to 500 hPa.

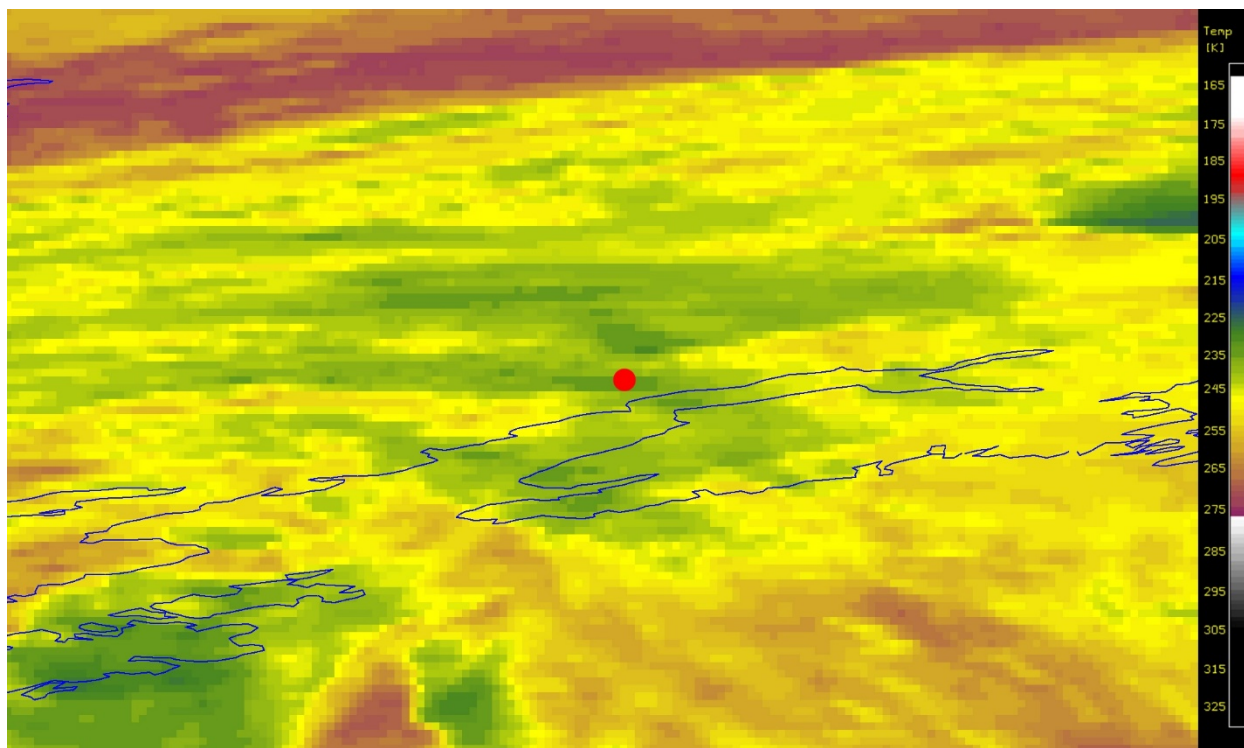
Geostationary Operational Environmental Satellite (GOES)-15 infrared ($10.7\mu\text{m}$) data were obtained from an archive at the Space Science Engineering Center at the University of Wisconsin-Madison. Imagery from 2230 AKDT is presented in figure 13. The GOES-15 infrared cloud-top temperatures varied in the accident region around the accident time. Considering the GDAS sounding (data not plotted in figure 12), cloud top heights in the accident regional are estimated to be above 20,000 feet. It should be noted that figure 13 has not been corrected for any parallax error.

Figure 13 – GOES-15 infrared imagery (brightness temperature in degrees Kelvin) from 2230 AKDT. Accident location denoted by red dot. This image has not been corrected for any parallax error.

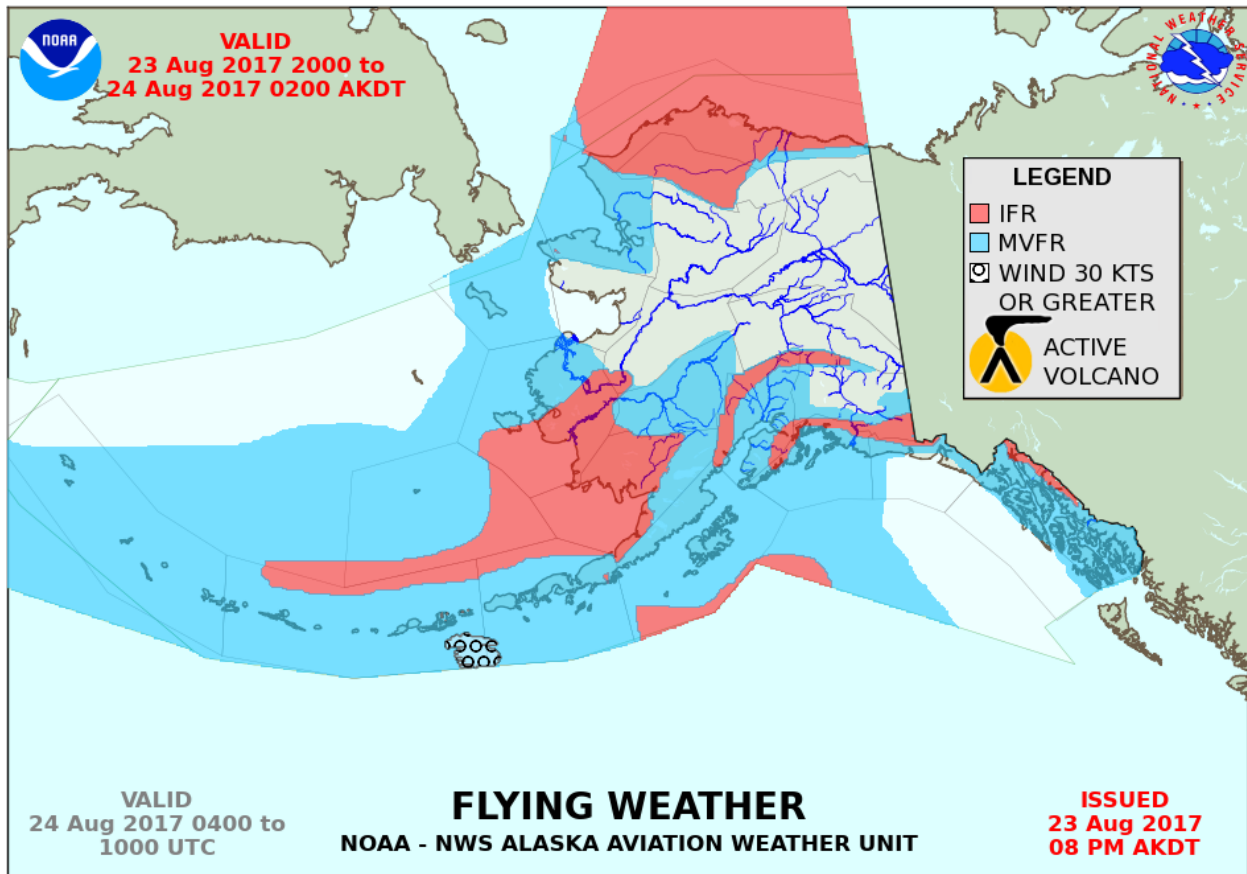
Graphical products issued by the AAWU applicable to the accident time are presented in figures 14-18. The graphics identified IFR or MVFR⁷ conditions⁸, isolated moderate icing between 8,000 and 15000 feet, isolated moderate turbulence below 6,000 feet and light or moderate precipitation at the accident location at or near the accident time.

Figure 14 – Flying Weather graphic issued at 2000 AKDT and valid between 2000 AKDT on August 23, 2017, and 0200 AKDT on August 24, 2017.

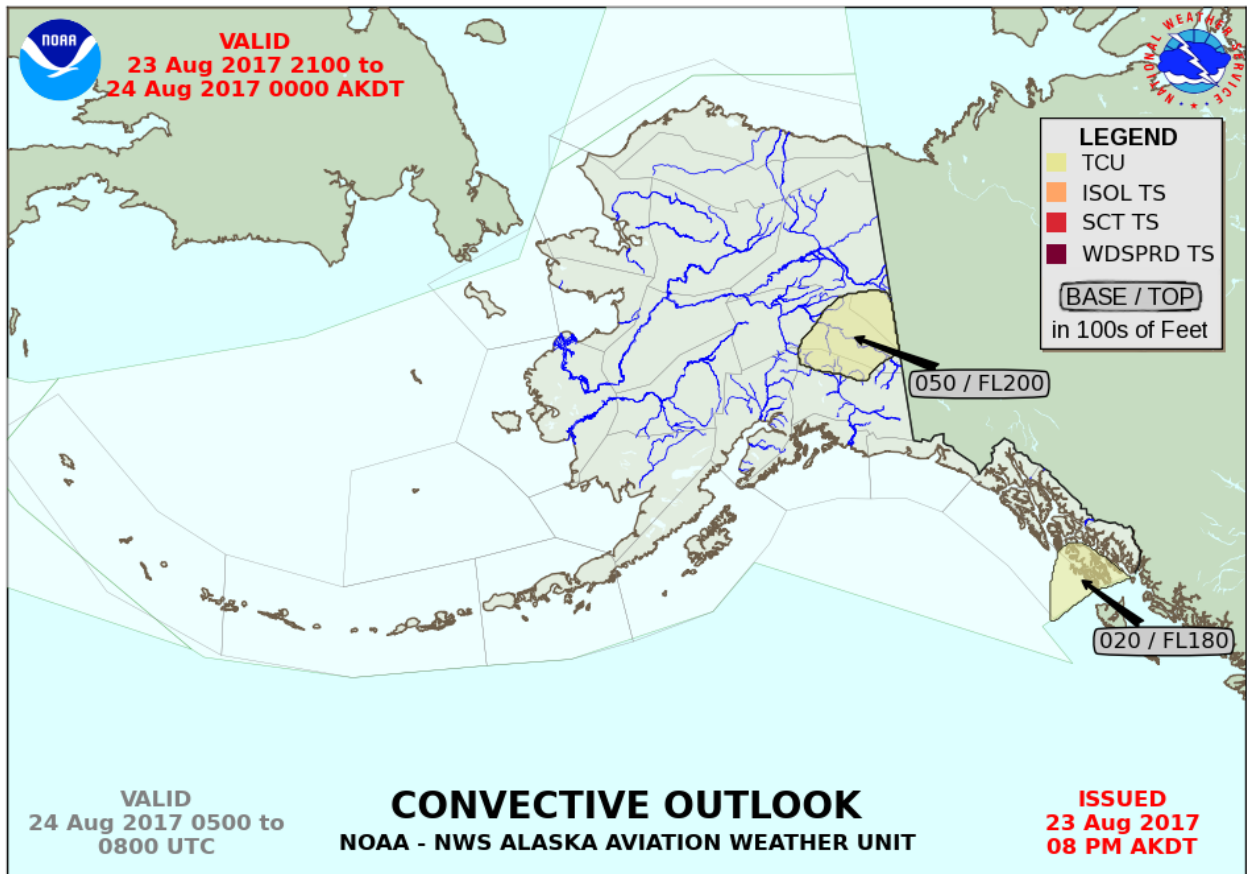
Figure 15 – Convective Outlook graphic issued at 2000 AKDT and valid between 2100 AKDT on August 23, 2017, and 0000 AKDT on August 24, 2017.

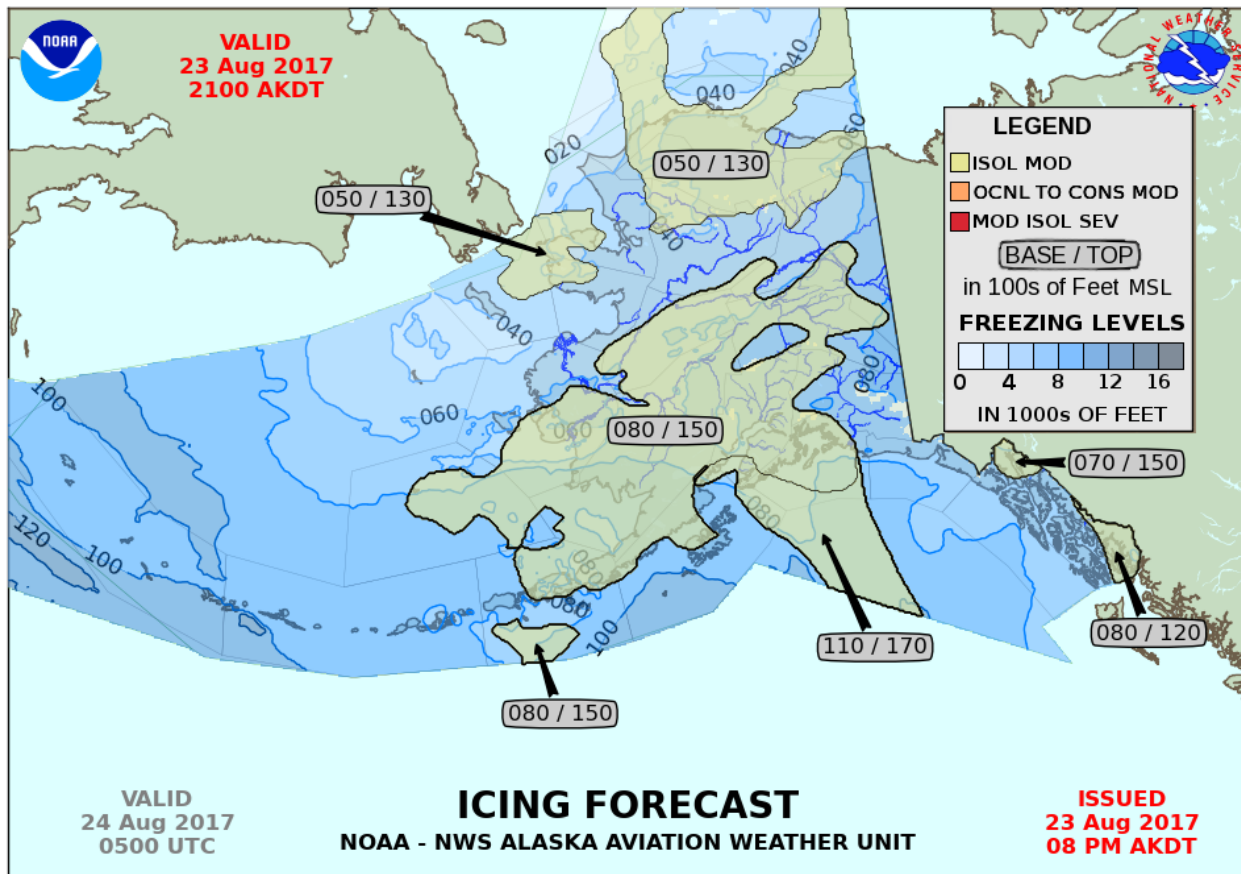
Figure 16 – Icing Forecast graphic issued at 2000 AKDT and valid for 2100 AKDT.

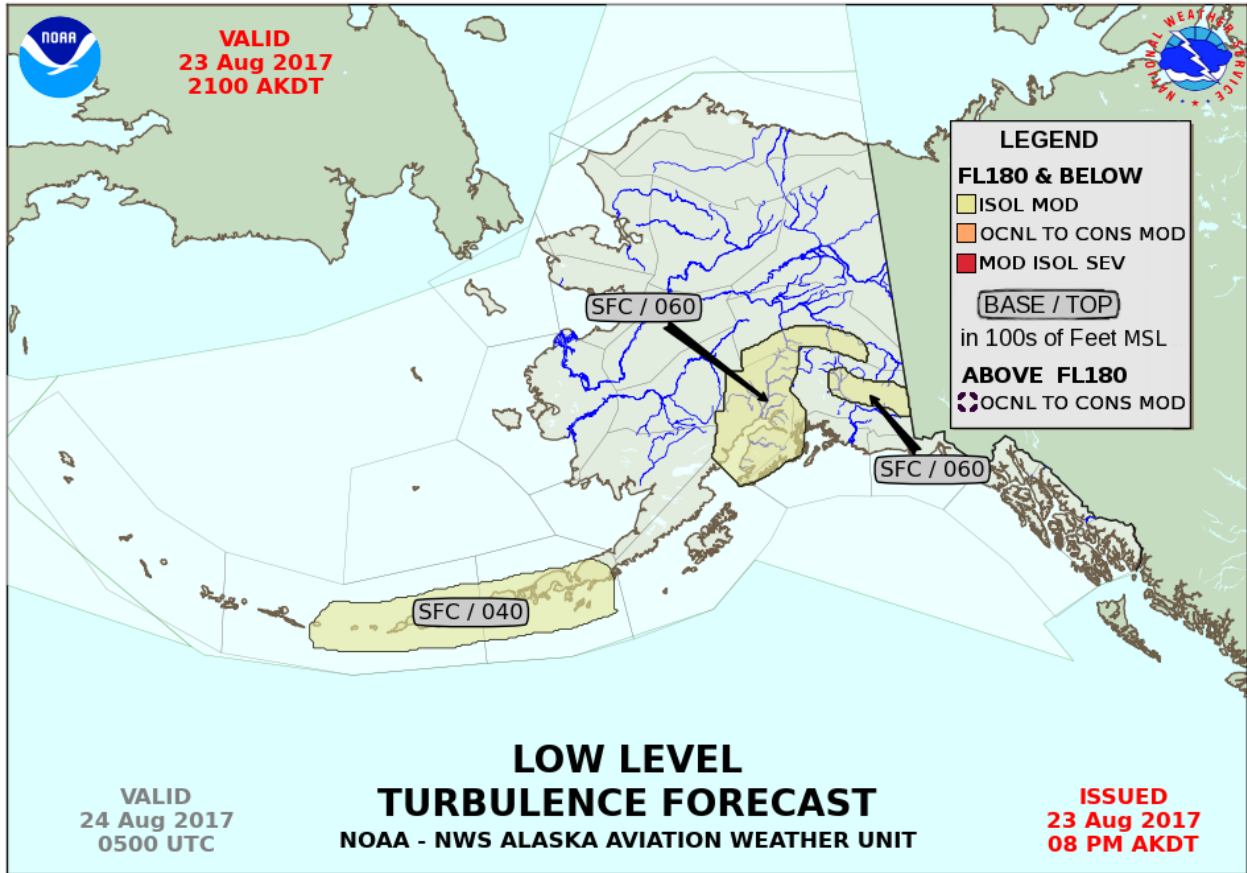
Figure 17 – Low Level Turbulence Forecast graphic issued at 2000 AKDT and valid for 2100 AKDT.

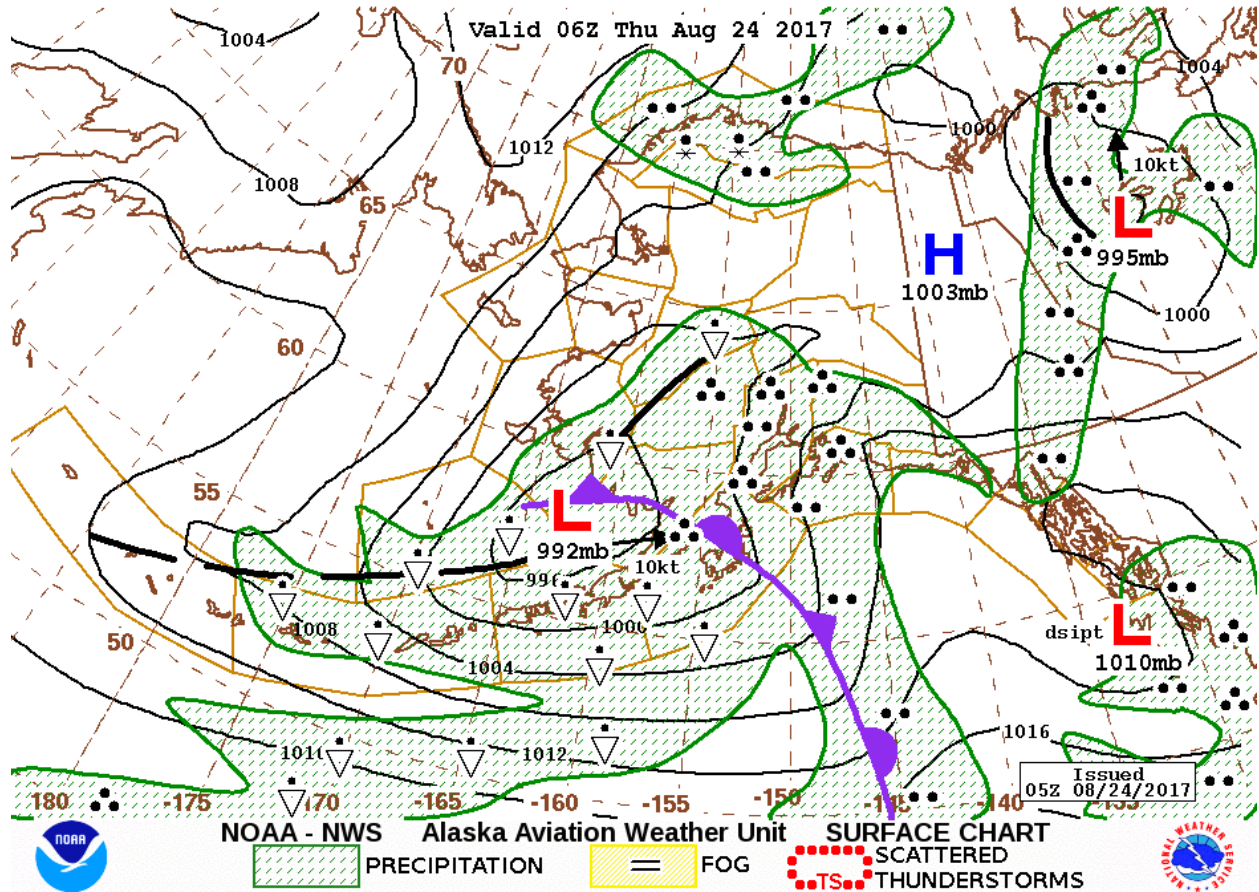
Figure 18 – Surface Chart issued at 2100 AKDT and valid for 2200 AKDT.
