NATIONAL TRANSPORTATION SAFETY BOARD

Group Chairman's Factual Report

METEOROLOGY

ERA15FA099

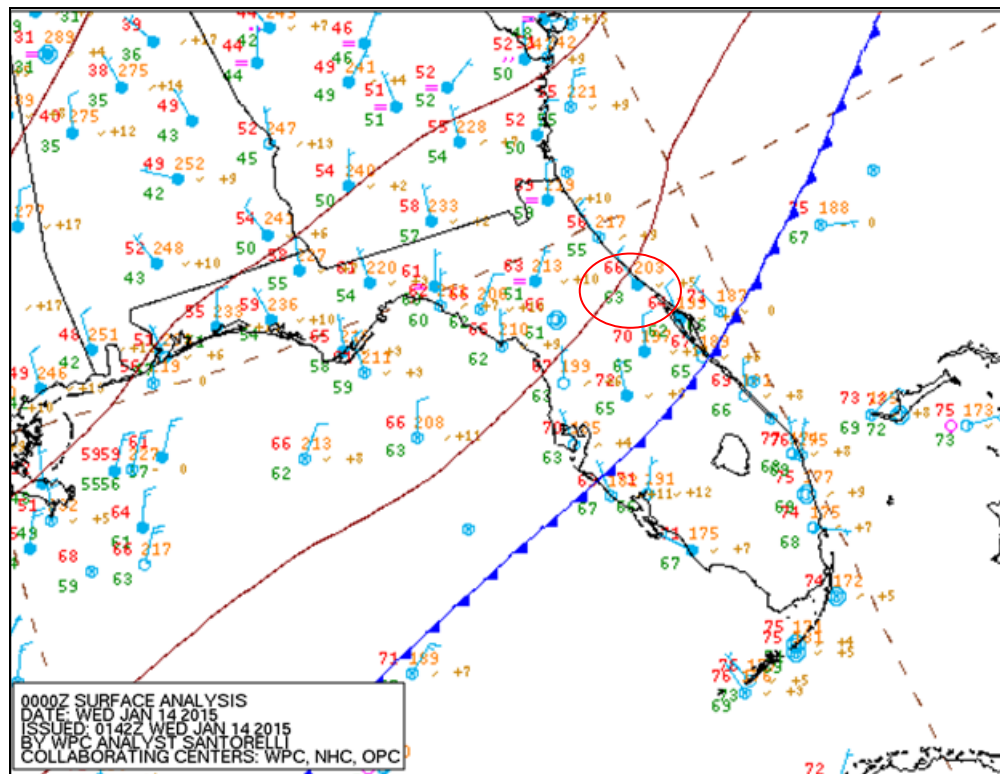
Figure 1 – NWS Surface Analysis Chart for 1900 EST

The southeast section of the NWS Surface Analysis Charts for 1900 and 2200 EST on January 13, 2015 (0000Z and 0300Z on January 14, 2015) are included as figures 1 and 2 respectively, with a circle around the approximate accident site. The 1900 EST chart depicted a cold front immediately south of the area across central Florida, moving southward. The station models behind the cold front depicted northerly winds of 10 knots or less, overcast skies, with numerous stations over northern Florida and Georgia reporting visibility restricted in mist and fog. Ahead of the cold front, light winds and scattered clouds were being reported. Temperatures ranged from the 70s degrees Fahrenheit (F) ahead or south of the front, falling into the 60s to 50s north or behind the front. The station model for Daytona Beach at 1900 EST indicated a wind from the north at approximately 10 knots, overcast skies, temperature of 66° F, and a dew point of 63° F, with a sea level pressure of 1020.3-hectopascals (hPa).

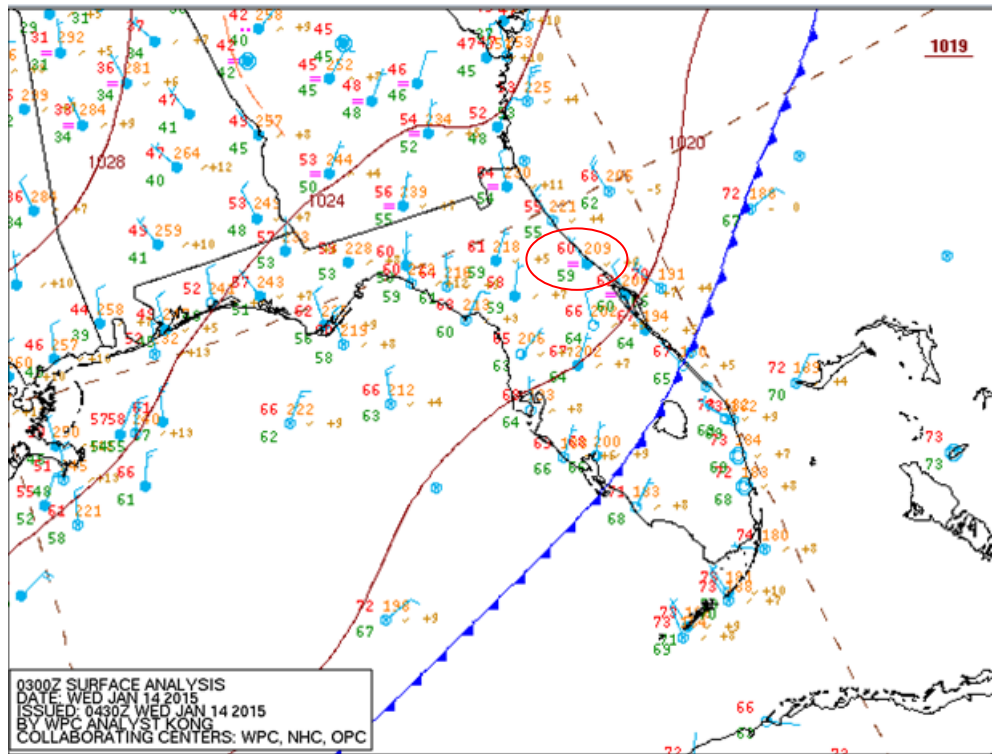
Figure 2 - NWS Surface Analysis Chart for 2200 EST

The chart for 2200 EST continued to depict the cold front moving southward across Florida with several stations north of the front reported northerly wind at approximately 10 knots, overcast clouds, with visibility restricted in mist or fog. The station model for Daytona Beach indicated north wind at approximately 10 knots, visibility restricted in mist, temperature 60° F, dew point 59° F, and sea level pressure 1020.9-hPa. Visibility restrictions in mist were also reported to the south in the Titusville area, and to the north over Jacksonville.

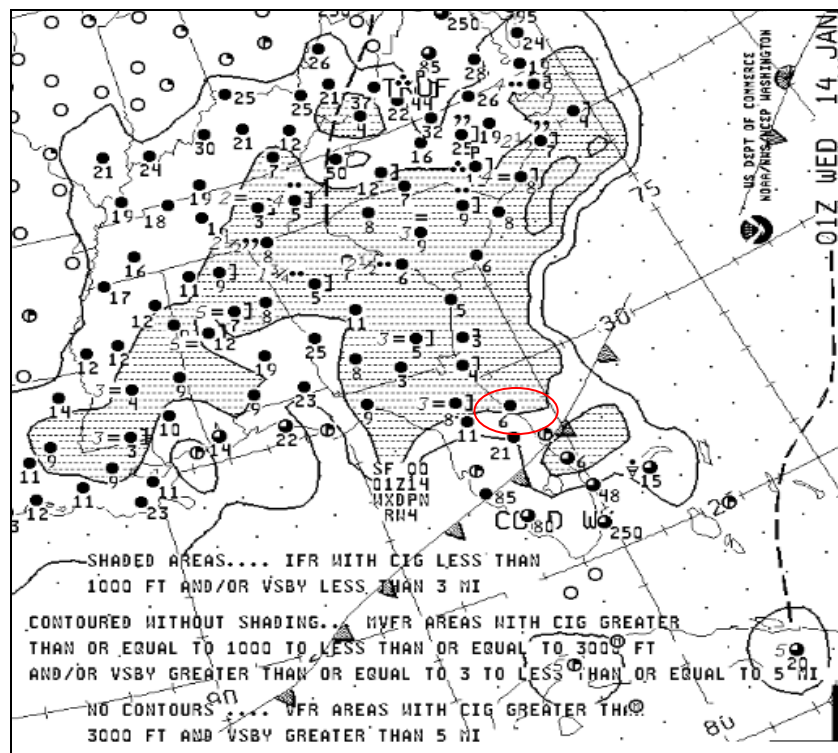
Figure 3 - NWS Weather Depiction Chart for 2000 EST

The southeast section of the NWS Weather Depiction Chart for 2000 EST (0100Z on January 14, 2015) is included as figure 3, and depicted the general flight categories² over the region approximately an hour before the accident. The chart depicted the cold front's position based

upon the 1900 EST Surface Analysis Chart position across central Florida immediately south of the accident site. A shaded contour line depicted the instrument flight rule (IFR) conditions that extended behind the cold front and extended from Daytona Beach west and northward over northern Florida, most of Georgia, South Carolina, and portions of North Carolina, Tennessee, and over a large section of Alabama, Mississippi, and Louisiana. A second area of IFR conditions was depicted along the cold front over southeast Florida. An unshaded contour depicted marginal visual flight rule (MVFR) conditions and extended over the New Smyrna Beach area and across central and southeastern Florida. Visual flight rule (VFR) conditions were depicted without a contour and extended over the Tampa Bay area southward and into southern Florida.

The Daytona Beach station model indicated IFR conditions with an overcast ceiling at 600 feet agl.

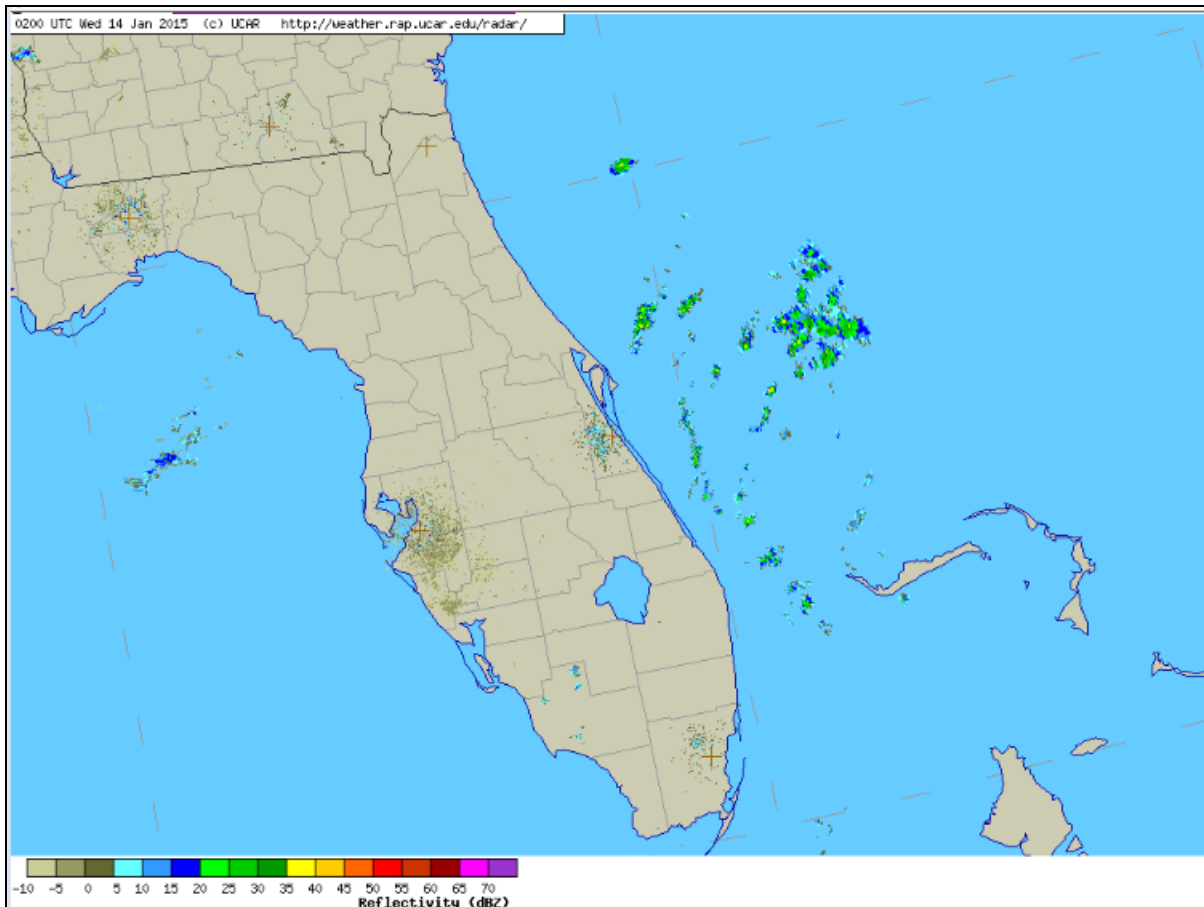
Figure 4 – Regional radar mosaic for 2100 EST

The National Center for Atmospheric Research (NCAR) - Research Application Laboratory (RAL) regional radar mosaic image for 2100 EST is included as figure 4. The image depicted no significant meteorological weather echoes in the vicinity of the accident site, with only a few scattered light intensity echoes southeast of the accident site off the Cape Canaveral and southeast Florida coast. No thunderstorms were depicted in the immediate vicinity of the accident site.

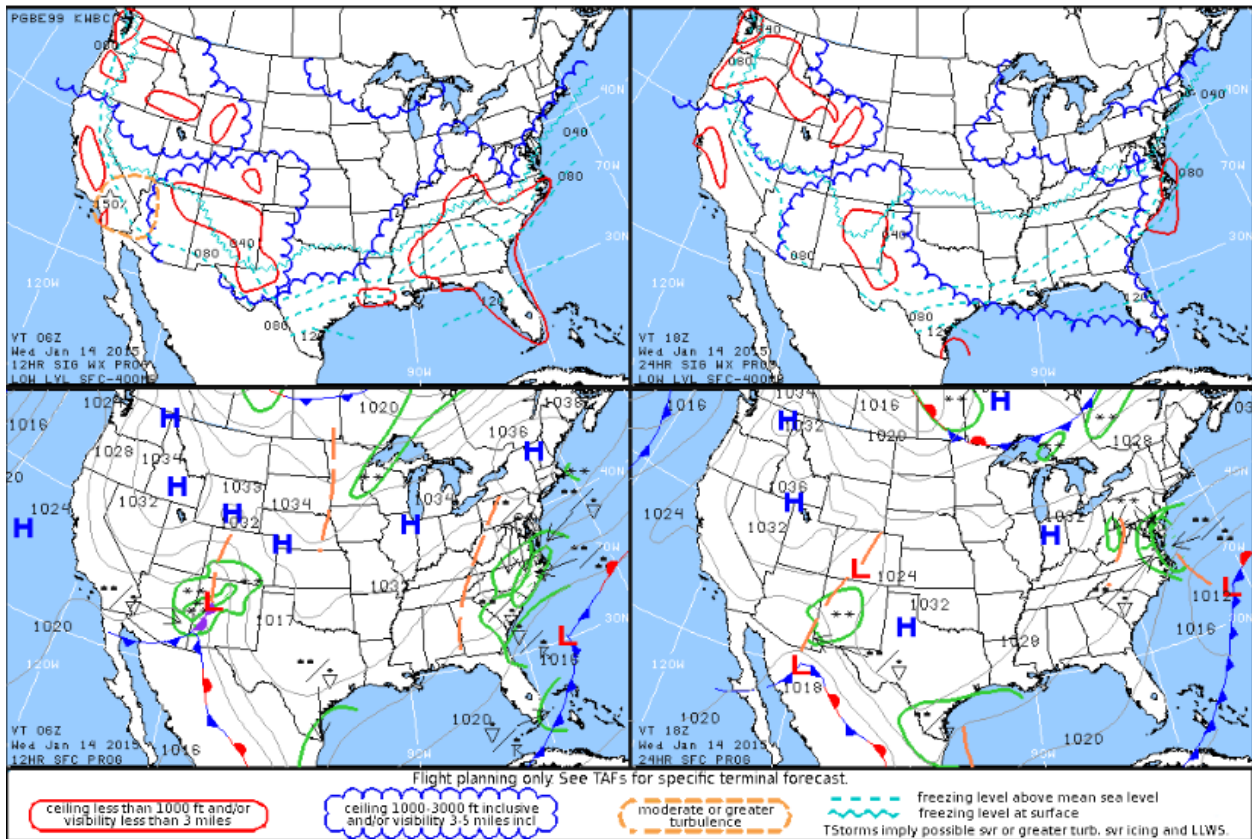
Figure 5 - NWS 12 and 24 hour Low-level Significant Weather Prognostic Chart

The NWS 12 and 24 hour Low-Level Significant Weather Prognostic Chart valid for 0100 and 1300 EST on January 14, 2015 are included as figure 5. The left portion of the chart depicted the forecast conditions during the evening and depicted the cold front moving into the Florida straight off the southeastern coast. Behind the cold front a small area of rain showers was expected along the northeast Florida coast and off shore. The top left portion of the chart depicted the general flight categories expected during the period, including an extensive area of IFR conditions by the red contour line over the entire southeastern United States. A blue scalloped line indicated an expected area of MVFR conditions through the mid-Atlantic coast into the northeast coastal areas and as far west as Texas.

The significant weather prognostic chart indicated that IFR conditions were expected over the region during the evening hours or by 0100 EST.

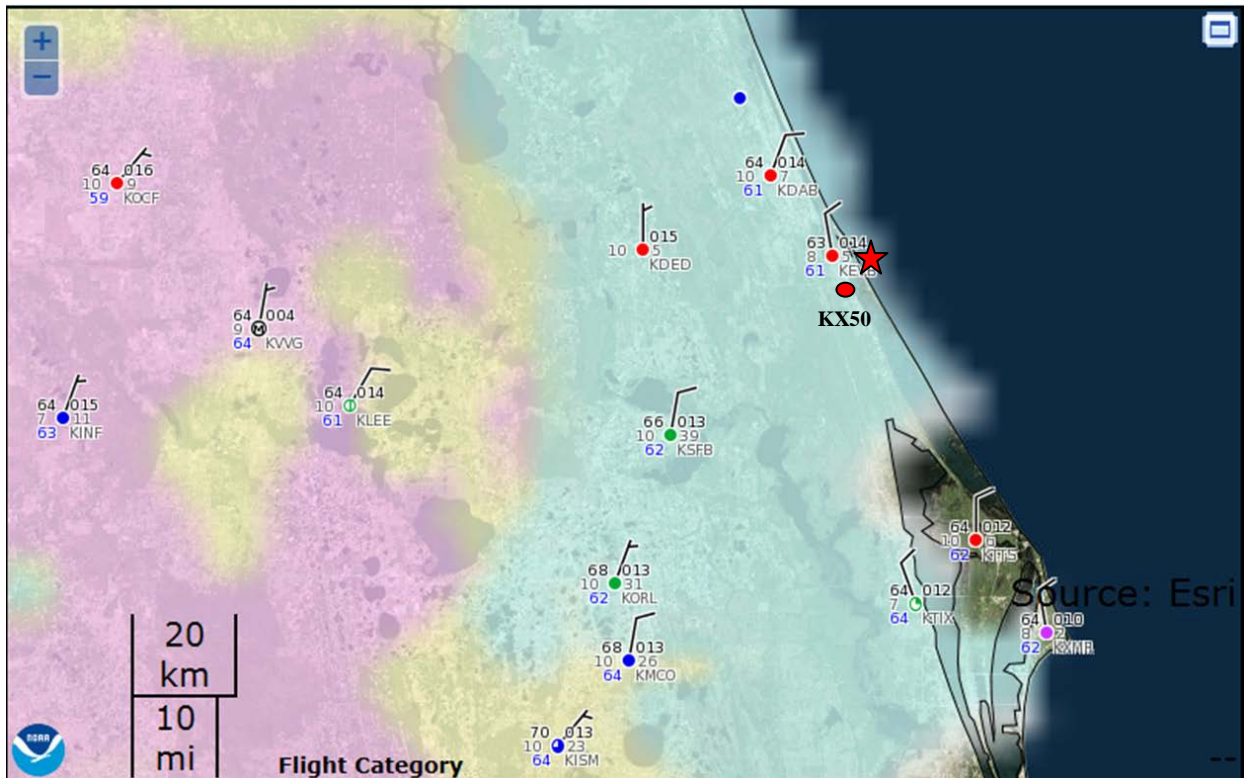
Figure 6 – plot of observations at 2100 EST

Figure 6 is a plot of the observations at 2100 EST from the NWS Aviation Weather Center weather tool, with the station models color coded for the flight categories.

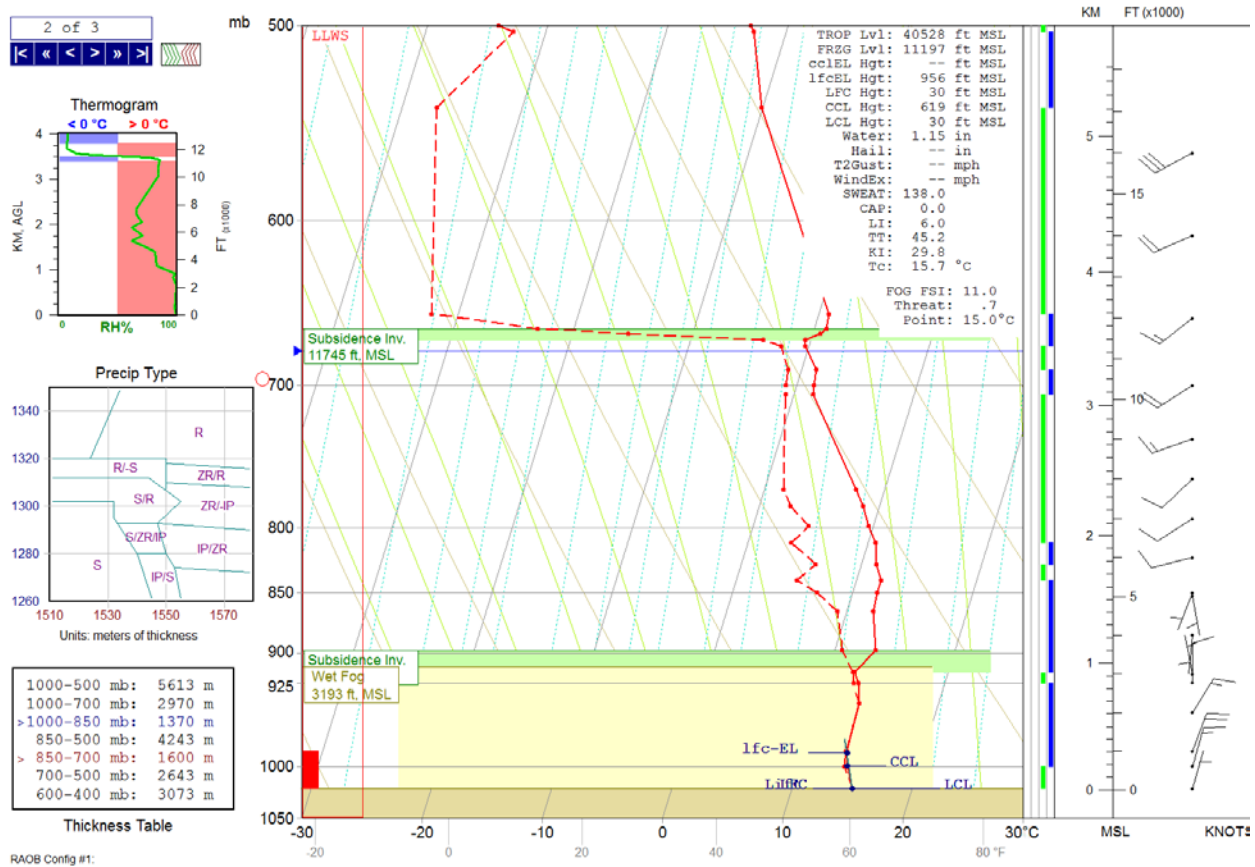
Figure 7 – Jacksonville (KJAX) 1900 EST sounding

The sounding indicated the surface conditions as a northerly wind from the 015° at 3 knots, temperature and dew point 15° C. The lifted condensation level (LCL)⁹ and level of free convection (LFC)¹⁰ were both identified at the surface, with the convective condensation level

(CCL)¹¹ at 500 feet agl. The sounding was saturated from the surface through 3,600 feet with relative humidity greater than 98%. An inversion was noted at this level (green shading) with drier air above to approximately 10,000 feet, where moisture again increased to 80% relative humidity through 11,500 feet. The freezing level was identified at approximately 11,000 feet and is indicated by a thin blue line on the plot in the immediate vicinity of a second inversion. The sounding was stable with a Lifted Index (LI)¹² of 6.0, and supported stratiform type clouds and fog.

The sounding wind profile indicated the low-level winds were from the north to northeast through 3,500 feet, which shifted to the south and then west-southwest with height above the low-level temperature inversion. At approximately 1,000 feet a small increase in wind to 20 knots was noted implying some potential low-level wind shear, but at a low magnitude or “light” category. The mean 0 to 6 kilometer or 18,000 feet wind was from 247° at 15 knots. Wind speeds were less than 30 knots through 15,000 feet and no significant turbulence was indicated below 18,000 feet.

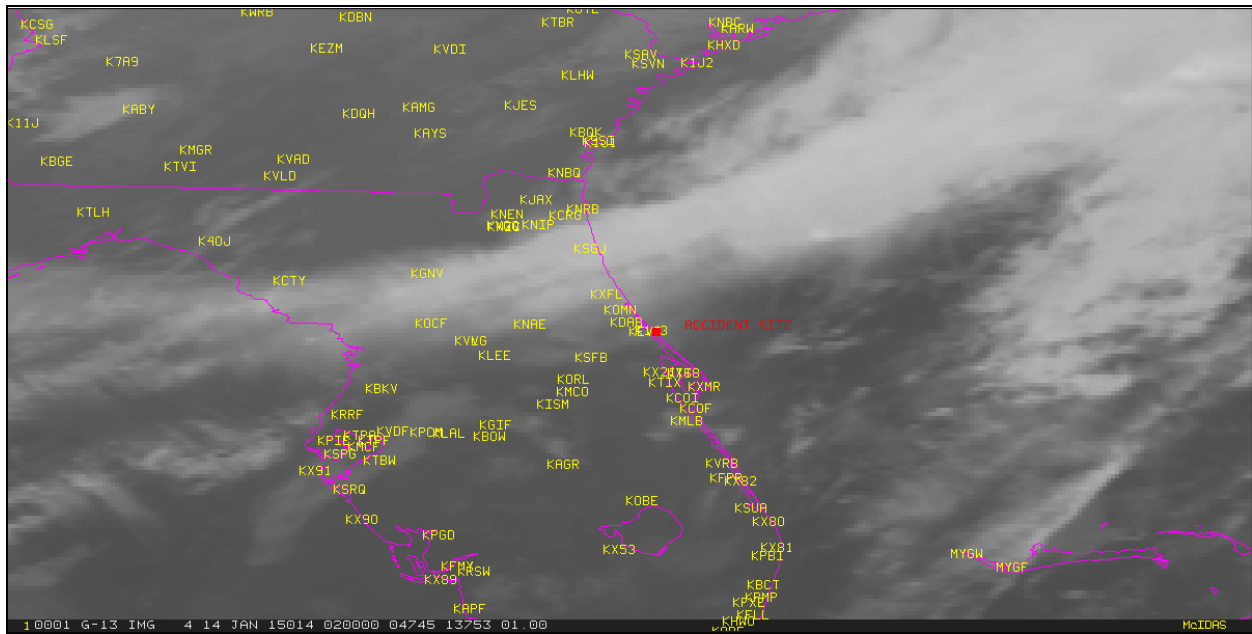
Figure 9 - GOES-13 infrared satellite image at 2100 EST

Figure 9 is the GOES-13 infrared image at 2100 EST (0200Z) at 4X magnification. The image depicts an extensive area of low stratiform clouds by the low gray tones over the accident site and over northern Florida into Georgia, with a band of higher cirrus clouds stretching east-to-west across the region immediately north of the accident site. The radiative cloud top temperature over the low stratiform clouds and the accident site was 274° Kelvin (K) or 0.8° C, which corresponded to cloud tops near 10,000 feet. The image depicted no significant thunderstorms in the vicinity of the accident site.

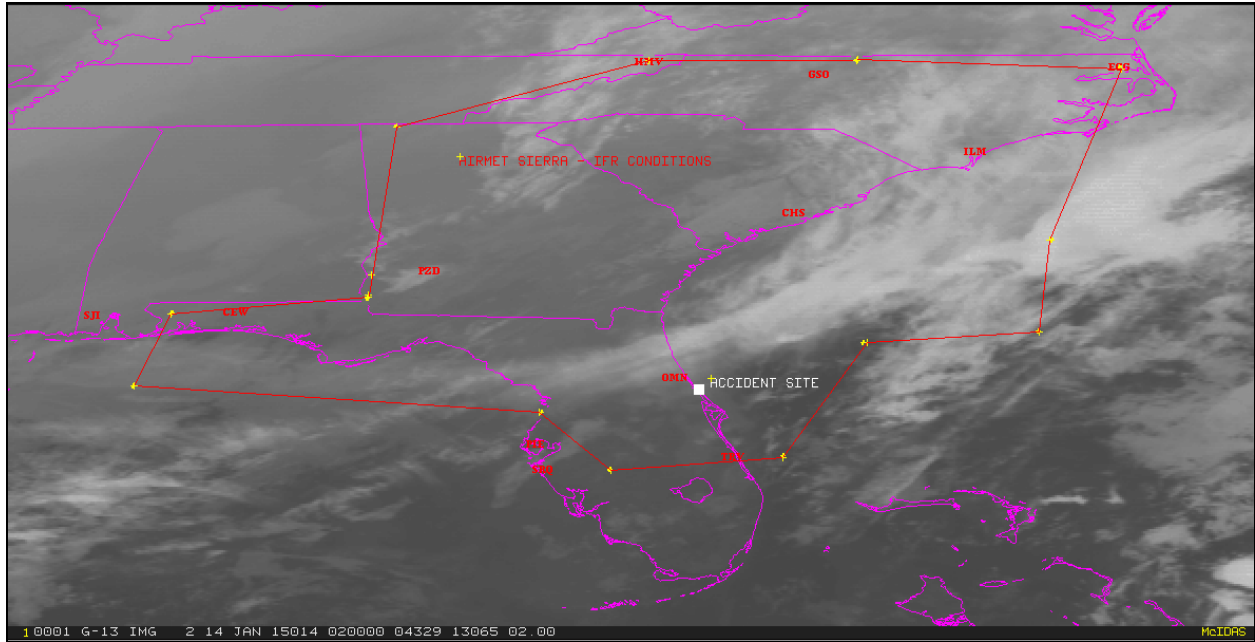
Figure 9 - Plot of AIRMET Sierra over the GOES-13 infrared satellite image at 2100 EST

Figure 9 is a plot of AIRMET Sierra, which was current over the accident site for ceilings below 1,000 feet and visibility below 3 miles in precipitation and mist. The advisory was current before the flight's departure and was expected to continue beyond 2200 through 0400 EST.

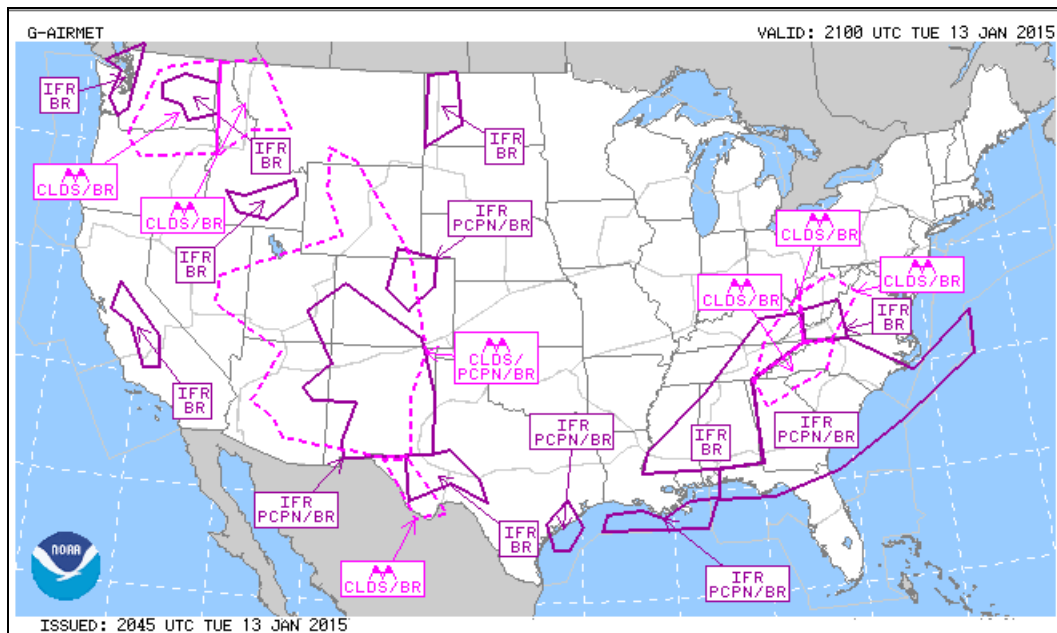
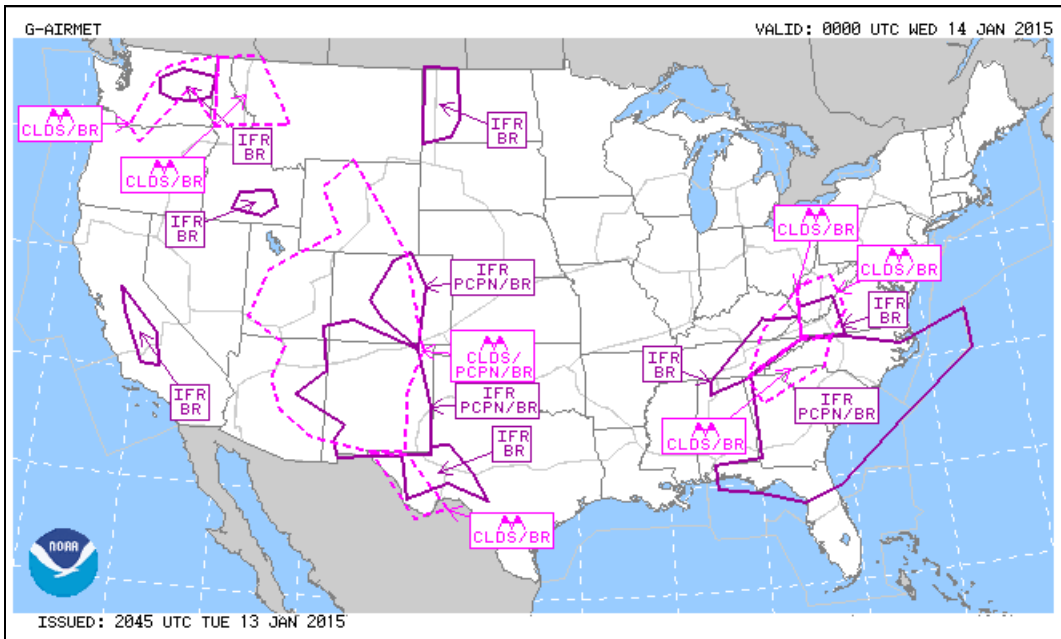
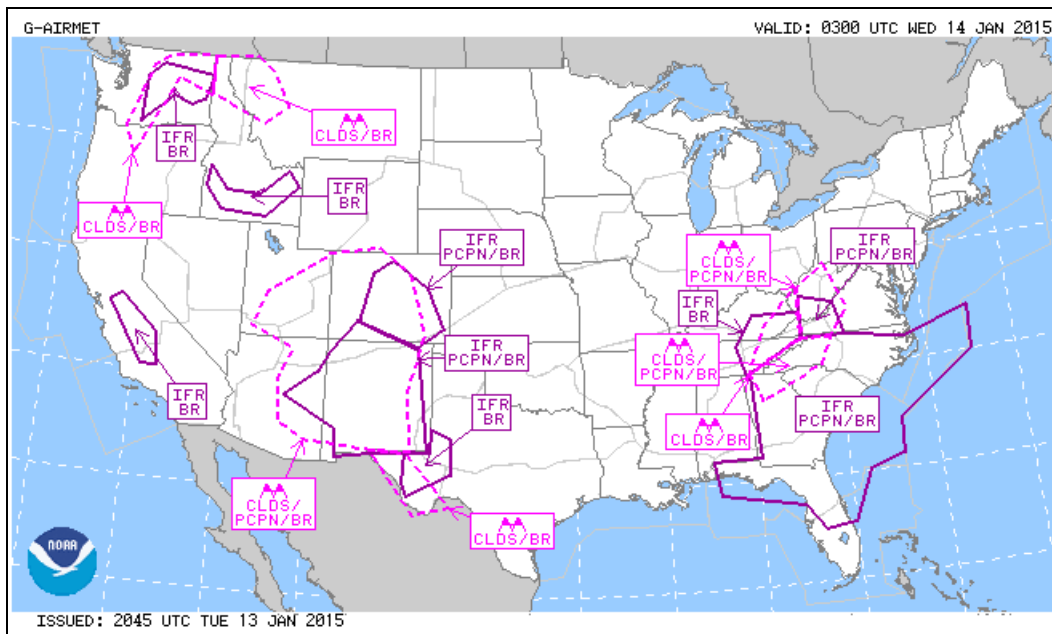
The NWS AWC also issues graphic AIRMETs or G-AIRMETs on their web site (<http://aviationweather.gov/gairmet>). Figures 10-12 are the G-AIRMETs issued for IFR conditions at the initial time or for the existing conditions, and the 3-hour and 6-hour forecasts. The graphic images depicted IFR conditions over northern Florida at 1600 EST with the conditions spreading southward immediately north of the accident site at 1900 EST, and over the area by 2200 EST.
