RE: ERA17FA190

We appreciate the opportunity to respond to the draft factual report. Please accept the attached as Metro Aviation's submission on ERA17FA190.

Addendum for ERA17FA190

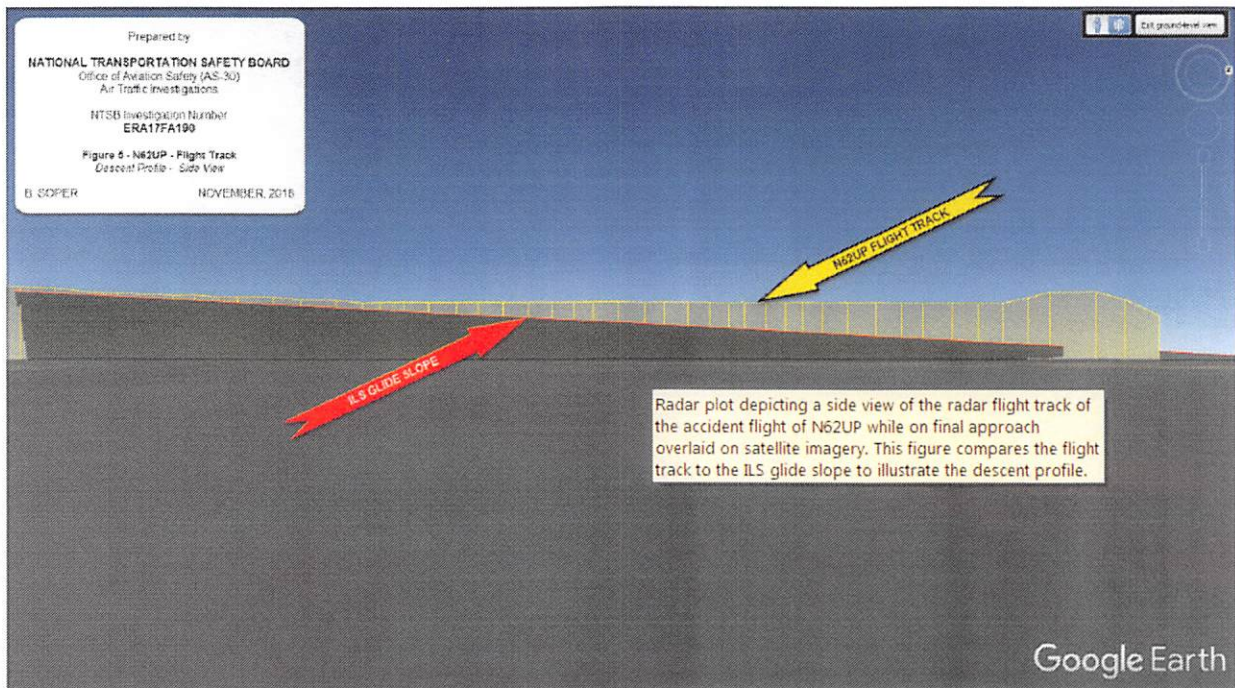
Figure 5 - Radar flight track of the final segment of the accident flight of N62UP. This is a side view of the final segment, with the ILS glideslope depicted in order to illustrate the descent profile of N62UP while on final approach.

Both the PHL and ILG ATC facilities failed to notice or react to N62UP not descending on glide slope after passing the final approach fix on course. Controllers at both facilities stated they would ordinarily provide advisories to both course and azimuth to aircraft inside the final approach fix.
