# **BEECHCRAFT PREMIER ACCIDENT INVESTIGATION REPORT**

This report documents the findings on six actuators installed on Beechcraft 390 Premier 1A N777VG involved in an accident on February 20, 2013 detailed in NTSB Identification ERA13MA139. Included in the documented findings will be the position each actuator is believed to have been in at the time of impact.

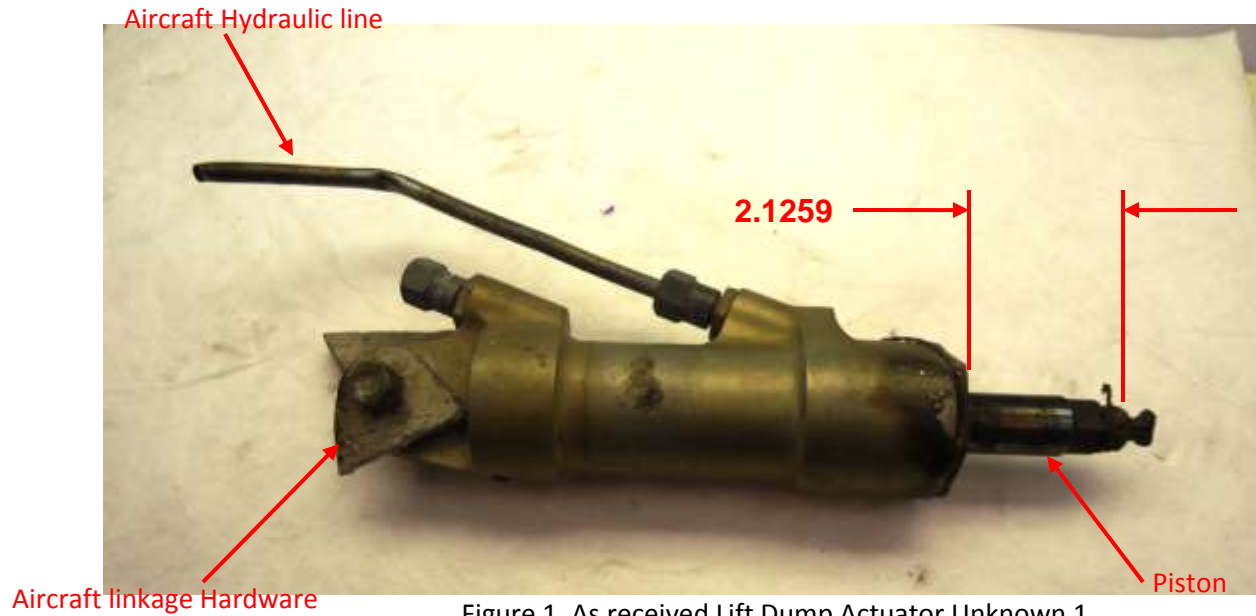
The unit was received in dirty and burnt in some locations. The piston exhibited heat discoloration on exposed length of piston. The nameplate was missing from the manifold. The actuator was received with the aircraft hinge joint connected to the lug end of the manifold. An aircraft hydraulic line was connected to the hydraulic retract port. The rod end had been machined off when removing the actuator from the aircraft. The extended piston length was measured to be 2.1259 inches from the piston gland to the rod end nut.

Figure 1. As received Lift Dump Actuator Unknown 1

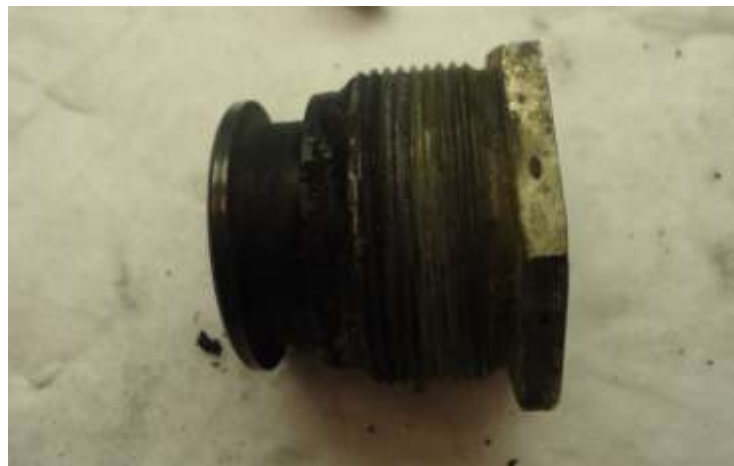
The piston gland was untorqued and removed from the manifold. The retaining seals were burnt and crumbled upon removal. A second extended piston length measurement was recorded. The length from the mouth of the manifold to the end of the piston was 2.123 inches. A burr in the manifold bore was observed and prevented the piston from being removed from the manifold through the bore mouth. To remove the piston, the manifold was sectioned to remove the lug end. The manifold was cut approximately 4.48 inches from the bore mouth. The piston was then pressed out of the manifold through the cut end. To better view the burr that prevented the piston from being removed through the bore mouth, the manifold was halved down the centerline. All components were photographed and bagged.

Figure 2. Removed piston gland

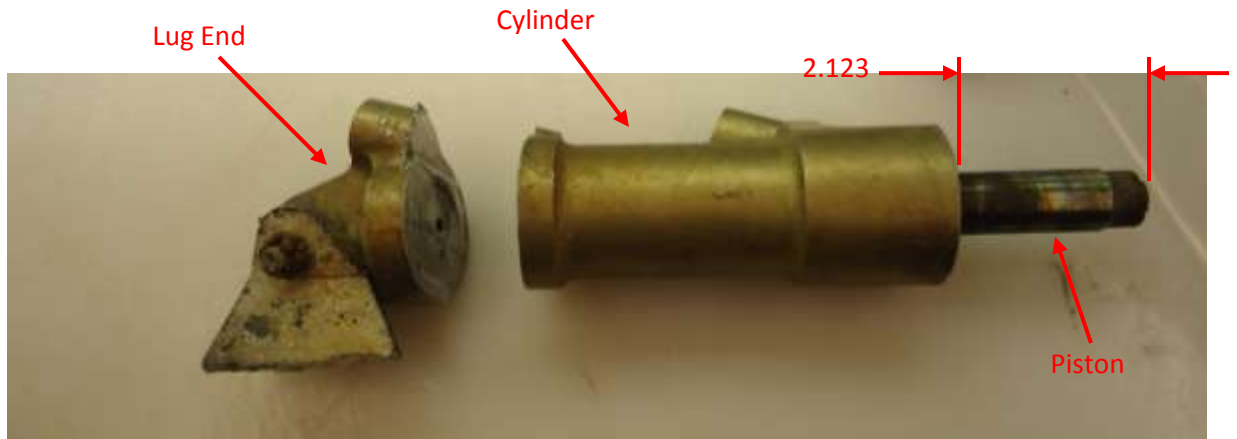
Figure 3. Sectioning of lug end

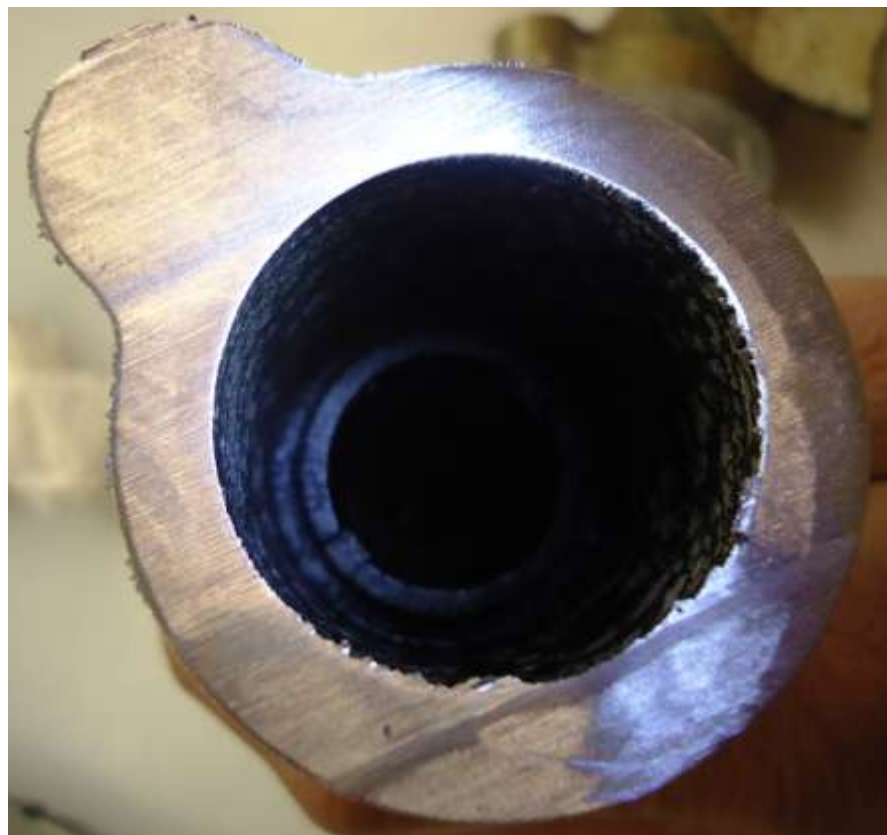
Figure 4. Cylinder bore of actuator

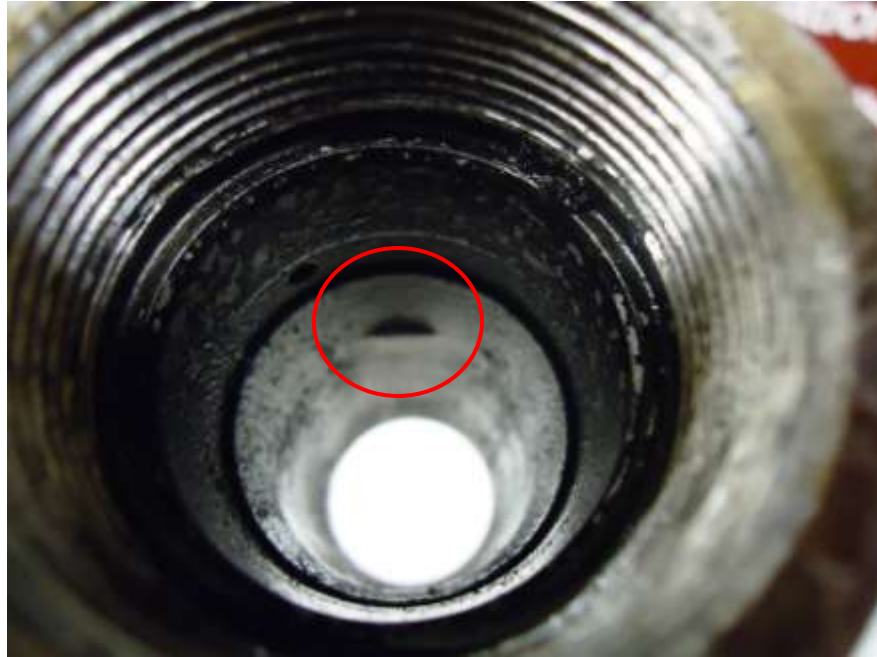
Figure 5. Burr (circled in red) observed preventing piston from being removed through the bore mouth

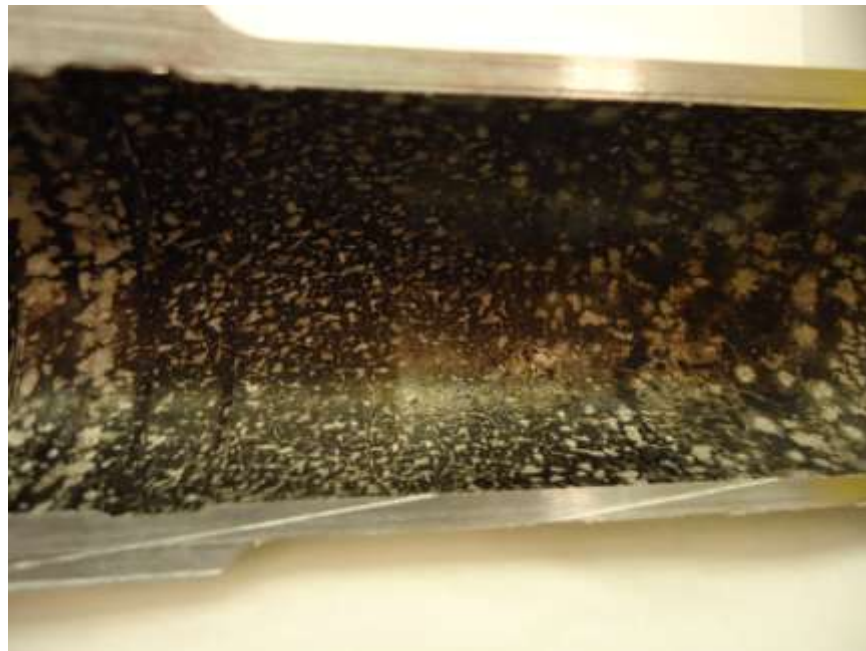
Figure 6. Sectioned manifold – Half 1

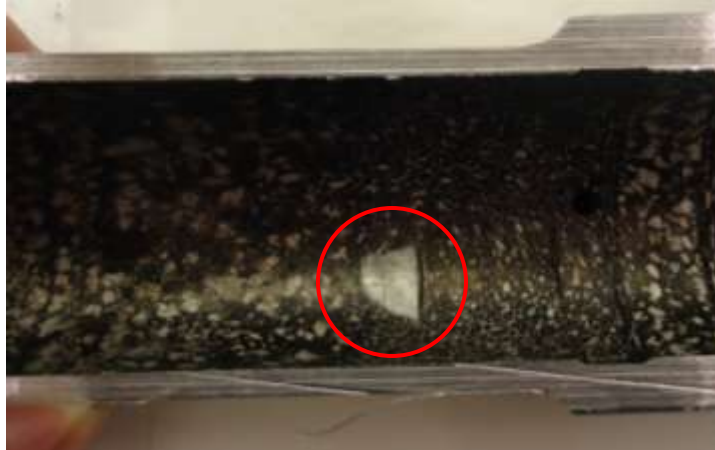
Figure 7. Sectioned manifold – Half 2. Burr and "scuff" mark present.

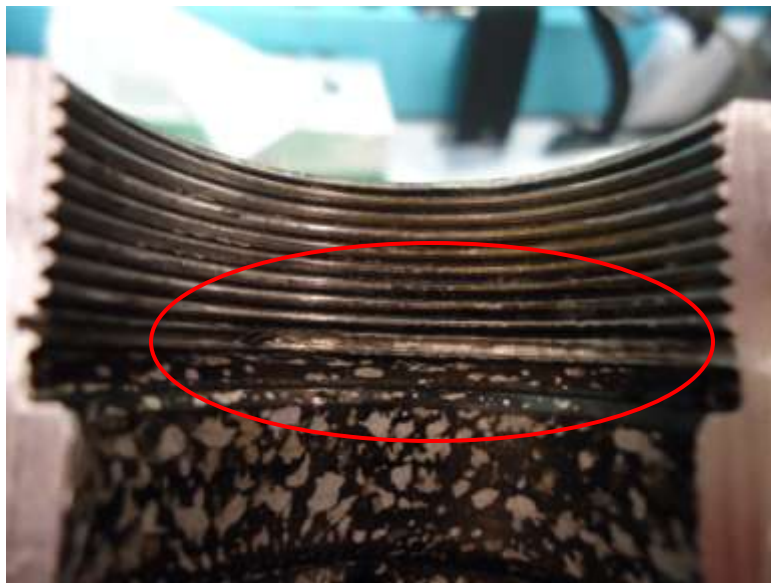
The piston gland threads on the manifold and the piston gland were damaged. The last thread on the manifold and gland were crushed, as well as a partial ring burr connected to the last manifold thread. Each half of the manifold showed evidence of burnt oil on the metallic surfaces. A small area of bare metal ("scuff" mark) was present behind the burr (Figure 7) preventing the piston from being removed through the bore mouth. The burr was approximately 2.3245 inches deep from the bore mouth. The scuff mark was approximately .332 inches in length. Based on a nominal extended piston length of 2.580 inches and being measured at 2.123 extended length, the piston was determined to be .457 inches from being in the fully extended position.

Figure 8. Damaged manifold threads (circled in red)

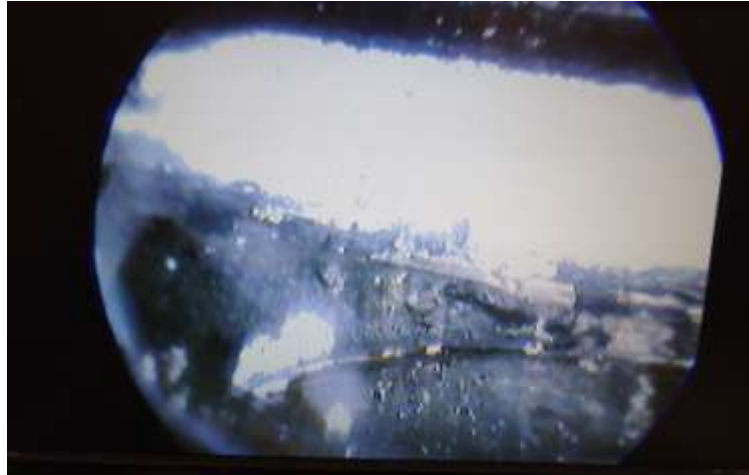
Figure 9. Thread burr seen on manifold threads (borescope image)

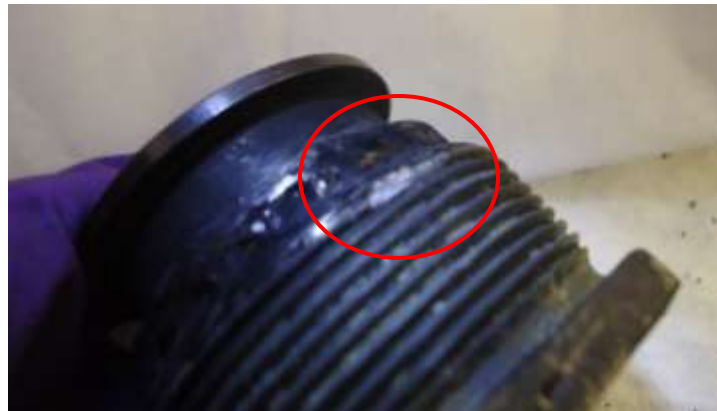
Figure 10. Damaged thread on piston gland (circled in red)

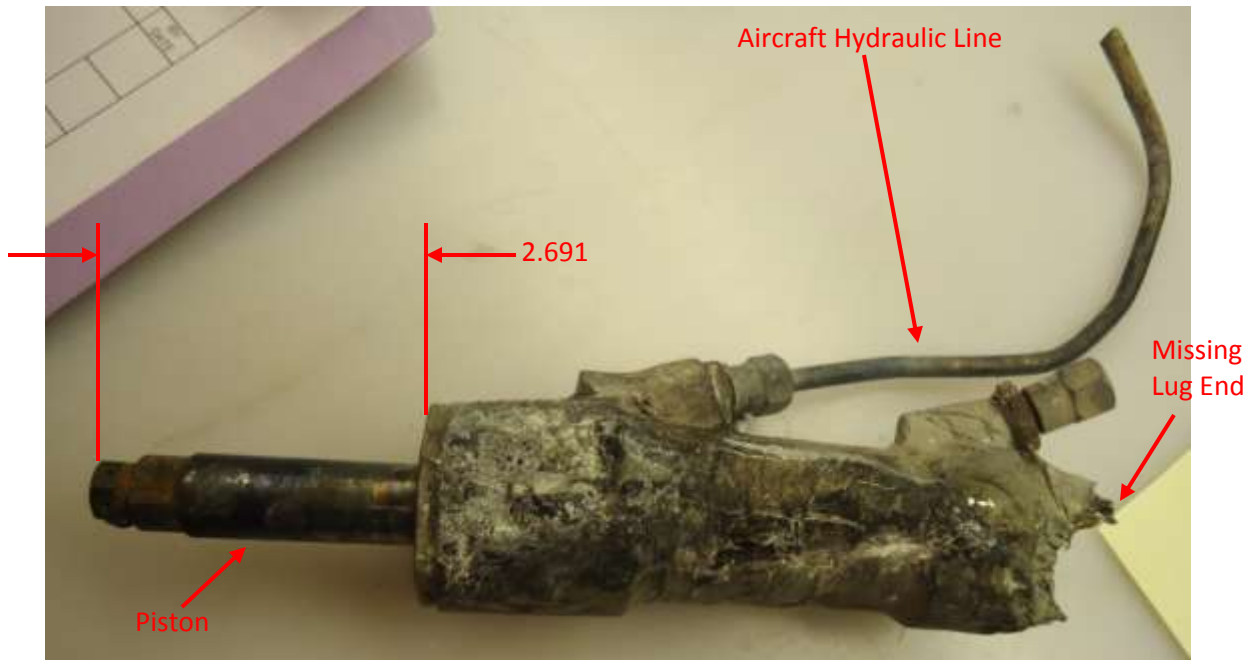
The unit was received in with no name plate. The manifold had been severely burnt and melted. The lug end of the manifold was no longer intact. The rod end had been snapped off the piston. The actuator was received in with hydraulic line attached to manifold port. The manifold was observed to be bent and twisted out of round. The hydraulic ports on manifold were bent. The extended piston length was measured to be 2.691 inches from the piston gland to the rod end nut.

Figure 11. As received Lift Dump Actuator Unknown 2

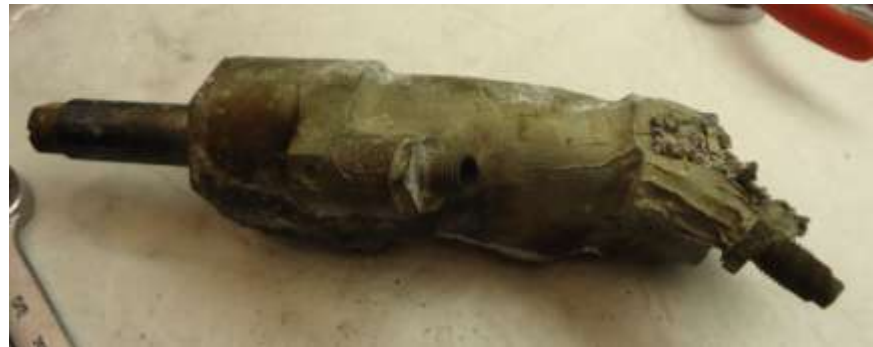
Figure 12. As received Lift Dump Actuator Unknown 2

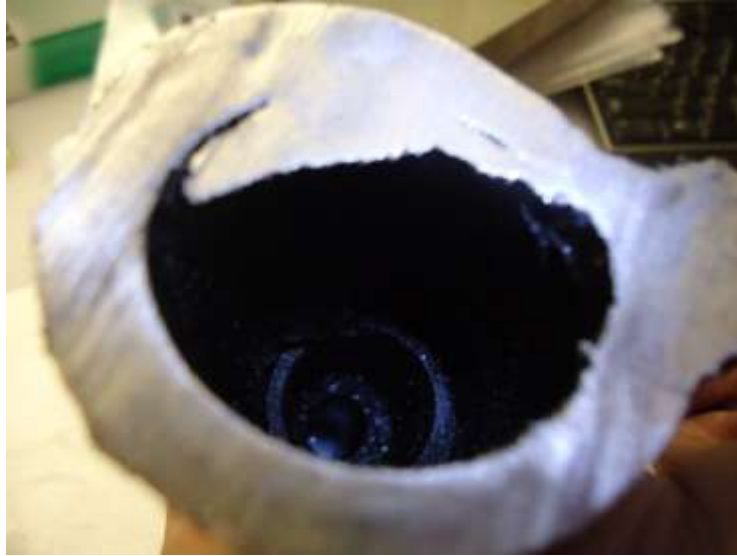
The piston gland could not be untorqued from the manifold. To determine if the piston could be pressed out from the lug end of the manifold, the manifold was sectioned approximately 4.48 inches from the manifold bore mouth. After the lug end was removed, the manifold was observed to be severely out of round and the piston could not be pressed out in that direction. The actuator was then cut down its centerline to view the positions of the internal components. All components were photographed and bagged.

Figure 13. Cylinder bore of manifold after sectioning lug end

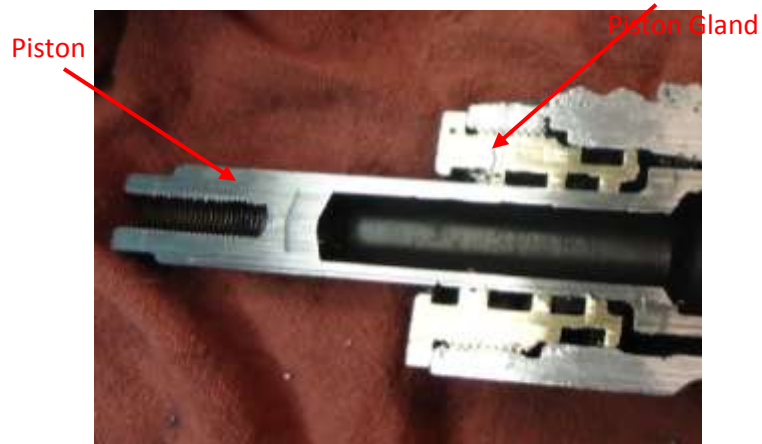
The sectioned halves showed that the manifold had been deformed internally which captured the internal components in the position at time of accident. The sections, as well as a stack-up analysis, show that the piston was .221 inches from bottoming on the piston gland in the fully extended position.

Figure 14. Sectioned half of actuator assembly in fully extended position

**Lift Dump Actuator Unknown 2:** The sections and stack-up analysis of this unit showed that the unit was .221 inches from full extend at time of impact. The lift dump is a two position actuator and requires hydraulic pressure to extend or retract the unit. As no hydraulic command was applied to the unit post accident, the actuator could not change position.

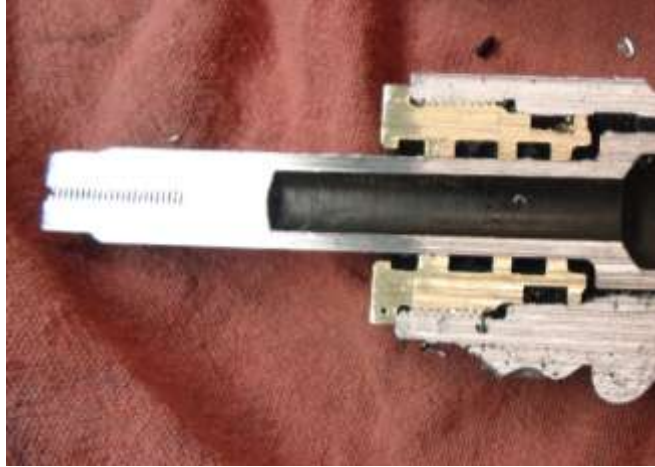
Figure 15. Sectioned half of actuator assembly in fully extended position

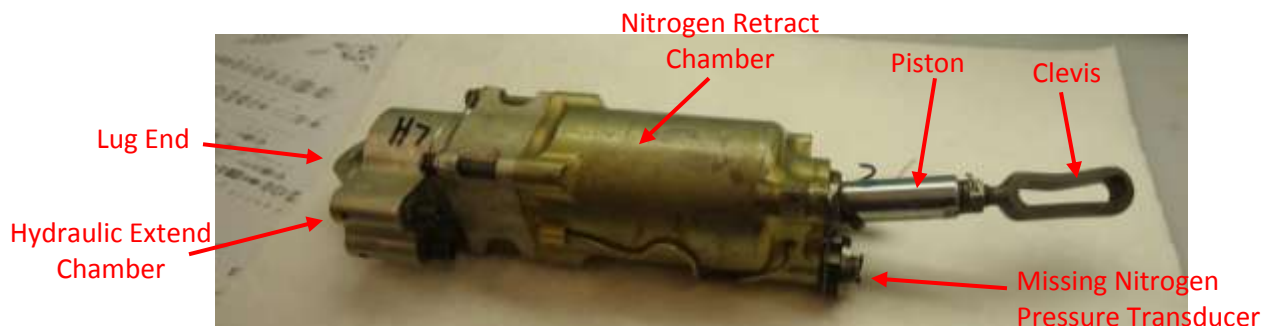
This unit was received in with no nameplate or nitrogen caution tags. The nitrogen pressure transducer had been broken off from the manifold. The fill port plug was damaged with material having been displaced. The fluid transfer tube was bent out of nominal alignment. The lug end of the manifold was bent and missing the bearing. The hydraulic pressure port was bent. The piston and clevis were severely bent. The piston was observed to be fractured at the location it exited the piston gland. The piston gland seals were protruding at this point. The clevis was no longer torqued onto the piston, and it was deformed from its manufactured form with gouges in the material. Tiewire was missing in several locations on the actuator. There was no nitrogen charge remaining in the nitrogen retract chamber.

Figure 16. As received Blow Down Actuator S/N: 0463

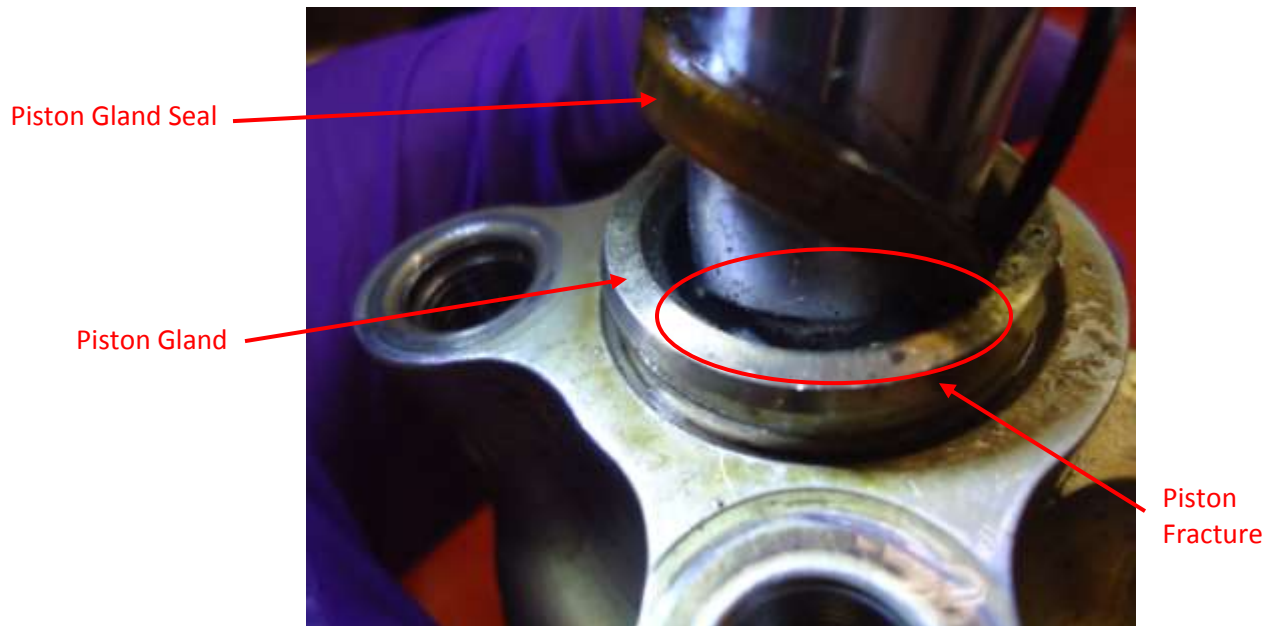
Figure 17. Fractured and bent piston. Gland seals extruding from piston gland.

**Blow Down Actuator S/N: 0463:** This actuator was seized in the full extend position due to the impact bending the piston off the centerline, as well as fracturing it. The misalignment prevented the compressed nitrogen from retracting the piston. The fracture provided a leak path for the nitrogen gas out of the nitrogen retract chamber.

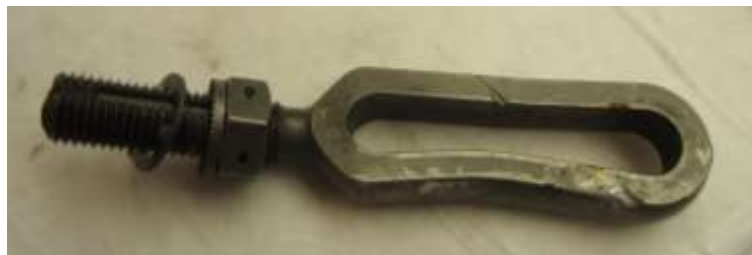
Figure 18a. Deformed clevis removed from end of piston with gouges present

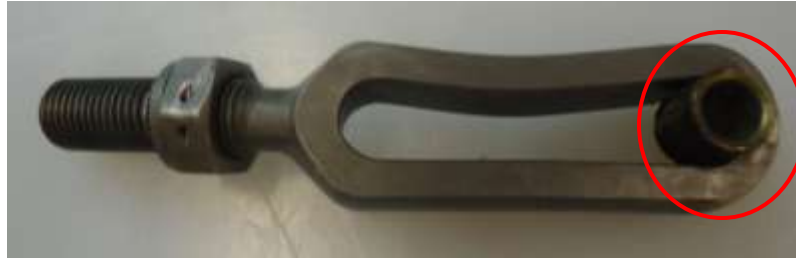
Aircraft bushing in outboard end.

Figure 18b. Deformed clevis with aircraft bushing installed in outboard end.

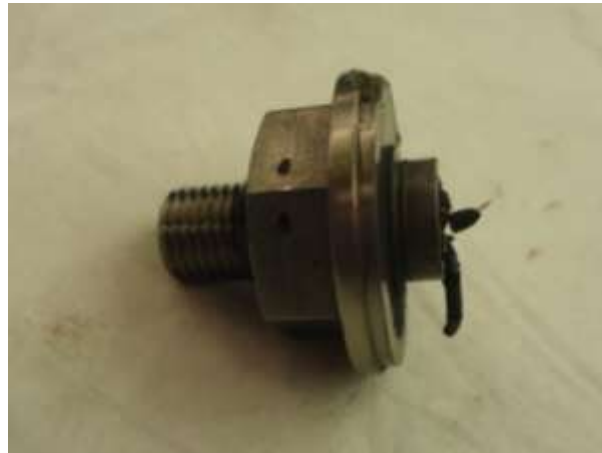
Figure 19. Remainder of nitrogen pressure transducer removed from nitrogen retract chamber

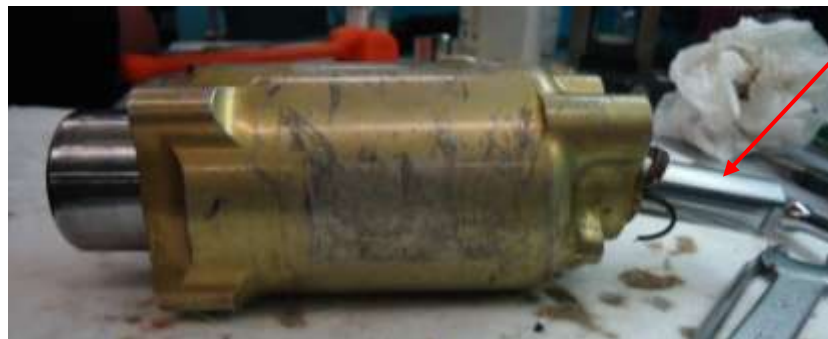
Figure 20. Actuator assembly with hydraulic extend chamber removed

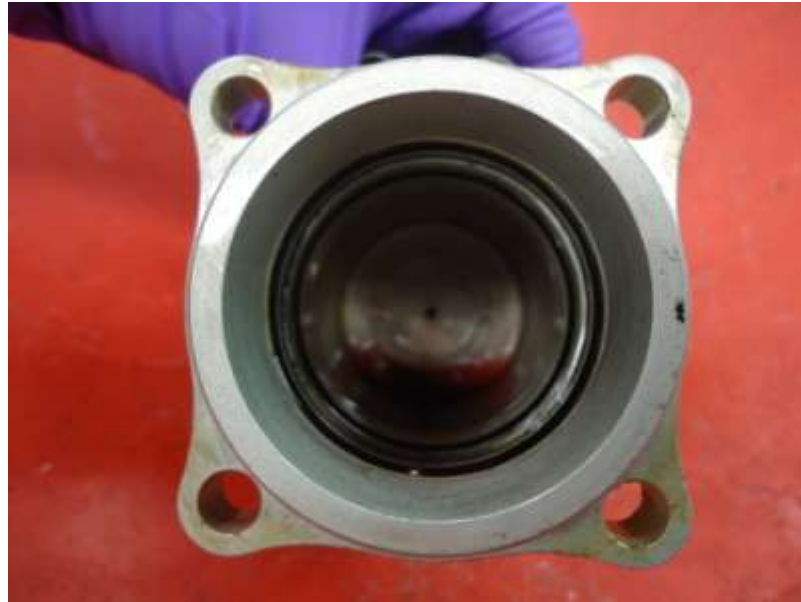
Figure 20. Hydraulic extend chamber

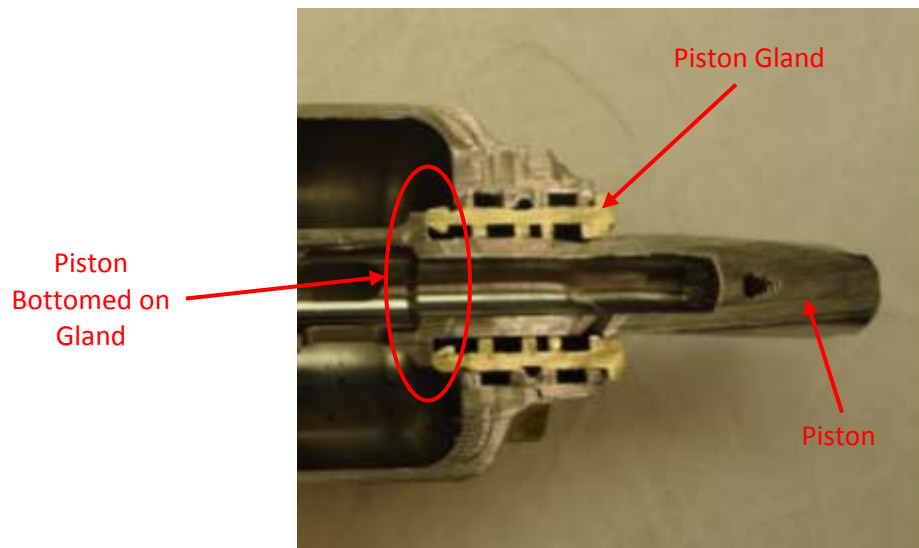
No indications of position at time of impact were present in the hydraulic extend chamber. The sections of the nitrogen retract chamber showed that the internal components had been fully extended at time of impact.

Figure 21. Sectioned actuator assembly in fully extended position

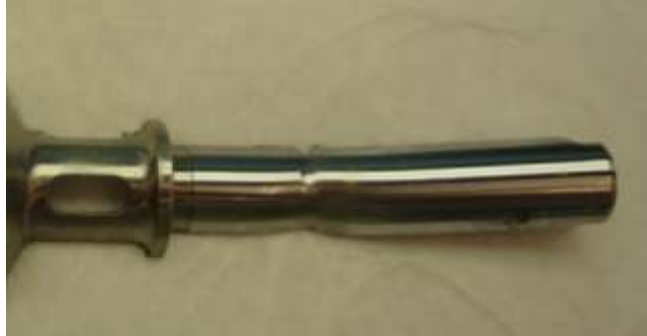
Figure 22. Sectioned actuator piston

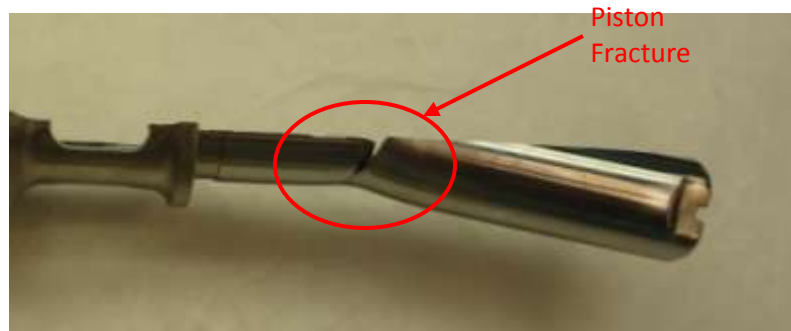
Figure 23. Sectioned actuator piston, rotated to show fracture

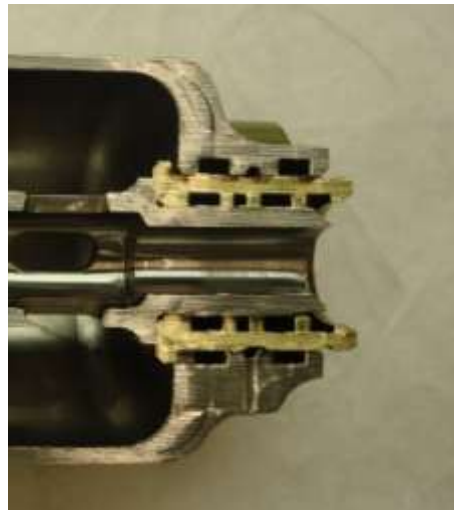
Figure 24. Sectioned actuator assembly in fully extended position

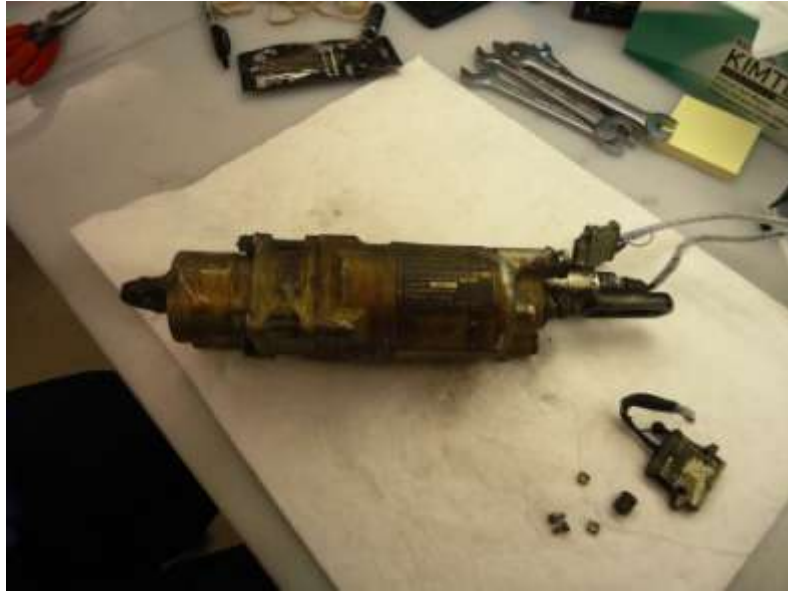
This unit was received in with its nameplate and nitrogen caution tags. The unit showed signs of being burnt and was coated in a tacky residue. The nitrogen pressure transducer housing was dented. Aircraft electrical connector was attached to actuator electrical connector, and the plastic coil was intact on the electrical cable. The piston was fully retracted in the unit. An aircraft bushing was present in the actuator clevis. The nitrogen pressure voltage was checked

Figure 25. As received Blow Down Actuator S/N: 0459

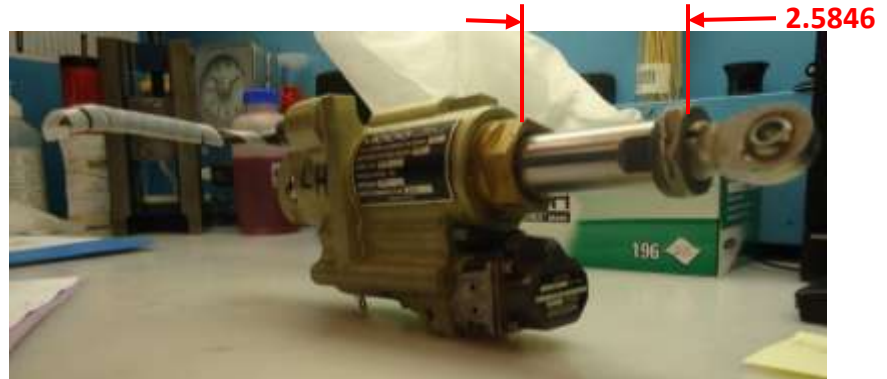
This unit was received with its nameplate present. The electrical connector on the unit was missing, as well as a portion of the electrical cable. The plastic coil was intact on the electrical cable. The lug end bearing was tight and could not be rotated by hand. The lug end of the manifold was bent off the actuator centerline. The manifold was damaged in various locations. The extended length of the piston was measured to be 2.5846 inches from the piston gland to the rod end nut. The motorcap of the servovalve was cracked by one of the mounting bolts, and another of the mounting bolts was bent.

Figure 26. As received Roll Control Actuator S/N: 0473

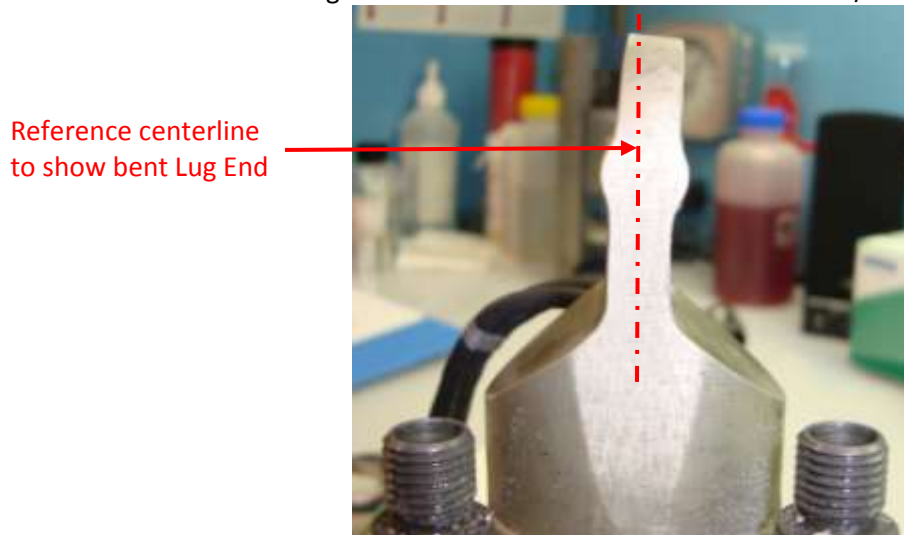
Figure 27. Bent lug end of roll control actuator

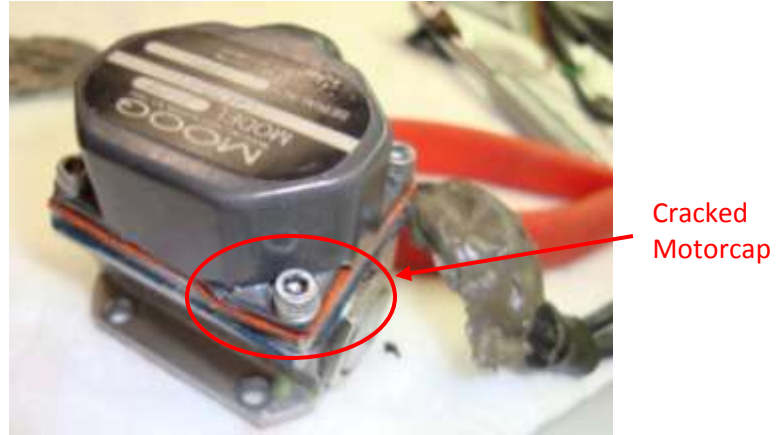
Figure 28. Cracked servovalve motorcap

An evaluation test was attempted on this unit, but could not be completed due to leakage out of the servovalve motorcap crack.

Since there was leakage out of the servovalve cap, it was determined that there was internal damage to the servovalve causing high internal leakage which prevents hydraulic pressure from reaching the piston. The piston exhibited normal signs of wear within the stroke length. No anomalies were seen on the bypass valve, piston gland, or LVDT. When examining the manifold under 10x magnification, witness marks were observed near the fully extended position. A stack-up analysis shows that the as received piston position was .022 inches from the nominal full extend position.

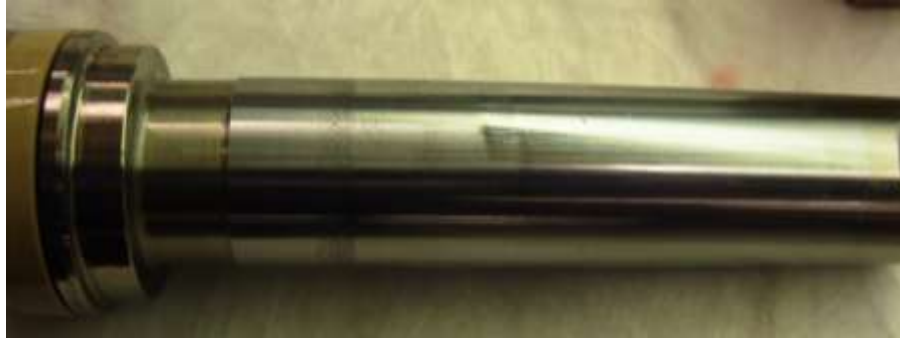
Figure 29. Actuator piston with normal signs of wear

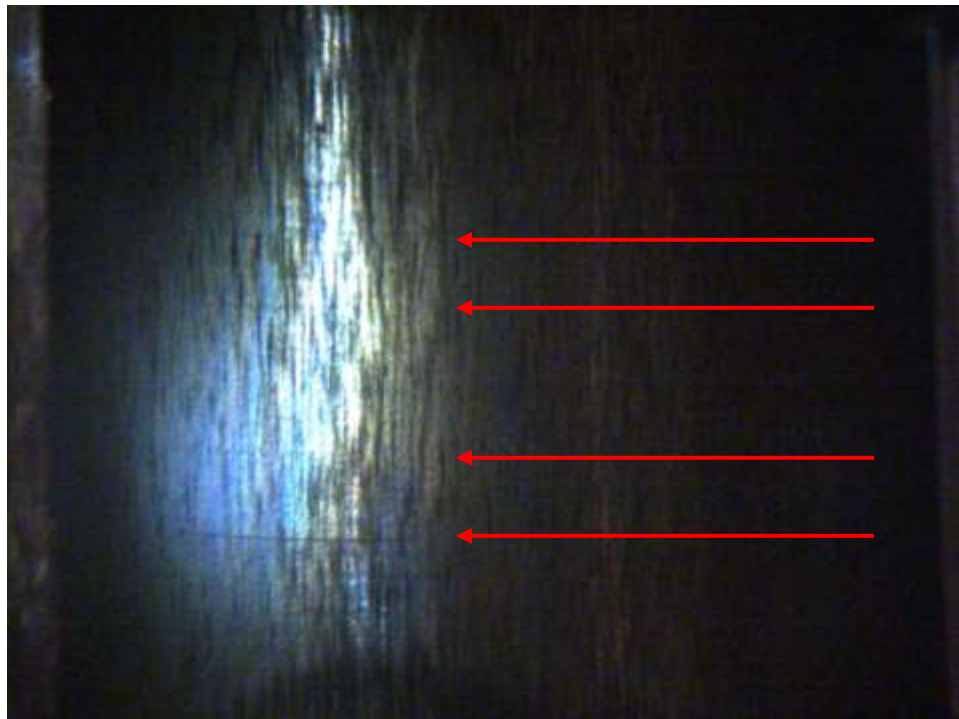
Figure 30. Witness marks observed at 10x magnification on sectioned half of manifold. Marks appear in the fully extended area of the manifold.

**Roll Control Actuator S/N: 0473:** This actuator was determined to be in the full extend position as evidenced by witness marks in the manifold, and a stack-up analysis showing that the piston was .022 inches from nominal full extend. This distance is within the stroke length tolerance.

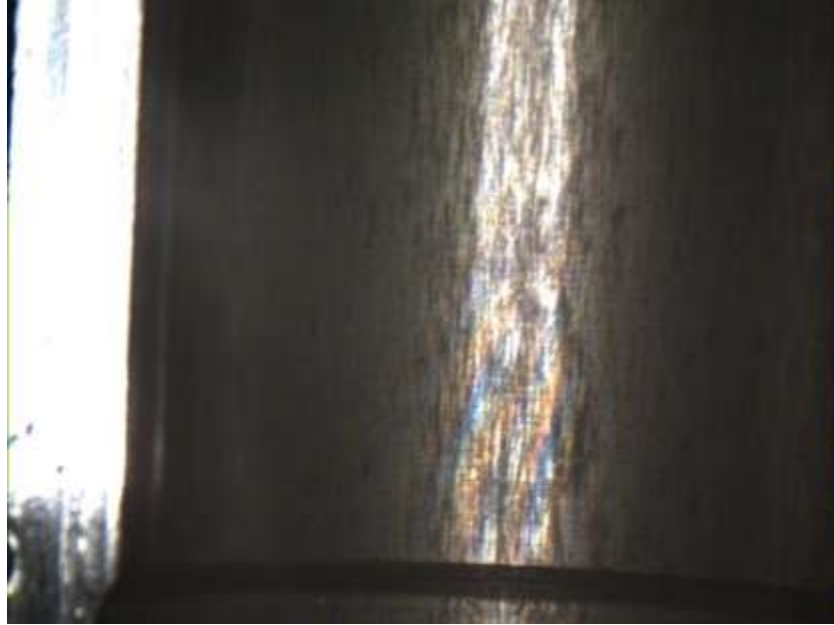
Figure 31. No witness marks observed at 10x magnification on the other sectioned half of the manifold

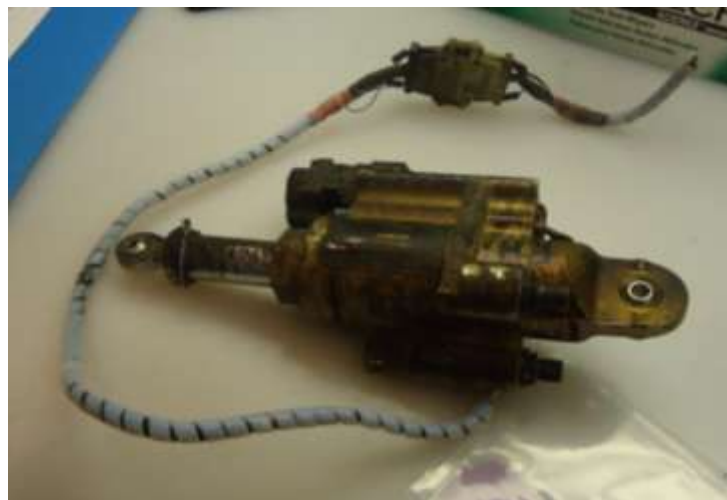
The unit was received in with its nameplate present. The unit was received in dirty and burnt in some locations. The aircraft connector was attached to the actuator electrical connector, and the plastic coil was intact on the wire cable. Some tie wire was not in the correct direction of pull. The piston rod end bearing was loose. The extended length of the piston was measured to be 2.4057 inches from the piston gland to the rod end nut.

Figure 32. As received Roll Control Actuator S/N: 0469

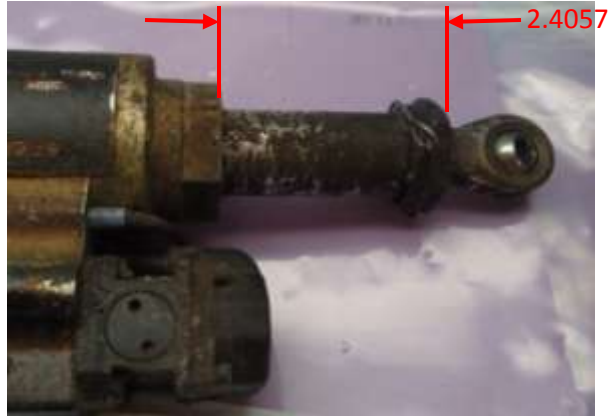
Figure 33. Residue present on actuator piston

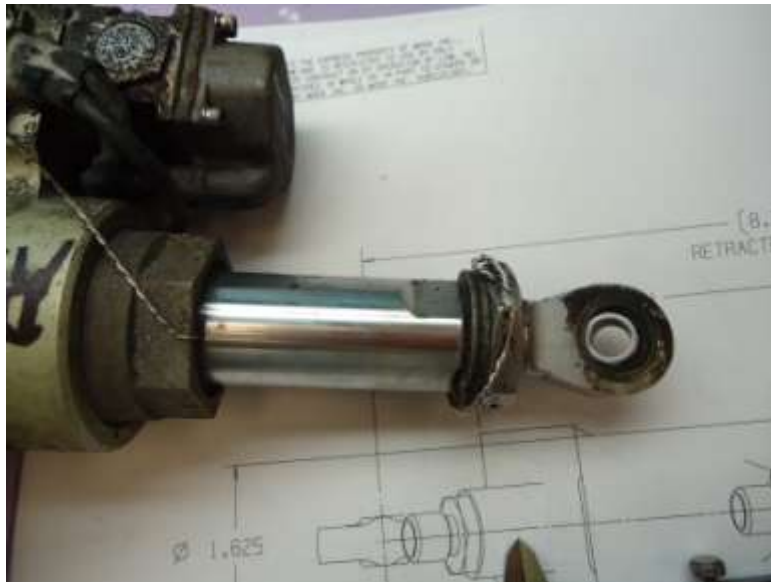
Figure 34. Residue removed from piston prior to evaluation testing
