Motor Carrier Photos 1 - 11

Oxnard, California

HWY15MH006

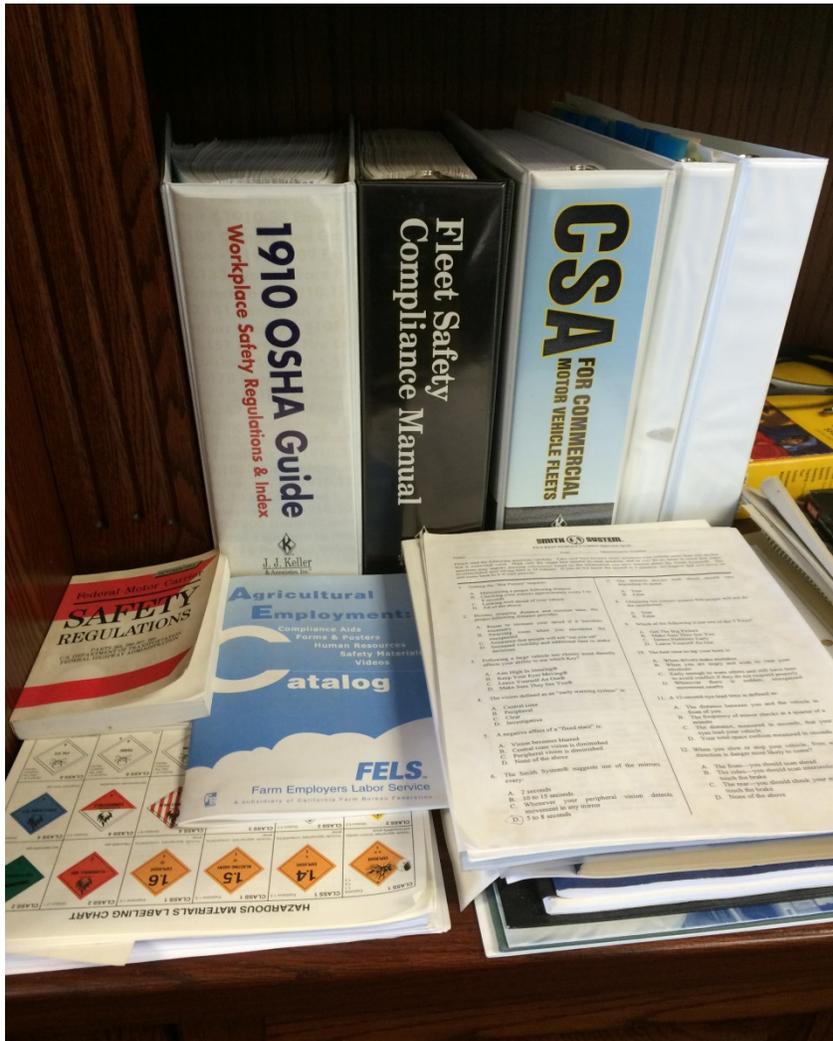
Photo 1 – This photo depicts compliance help aids maintained in the safety department by the motor carrier.

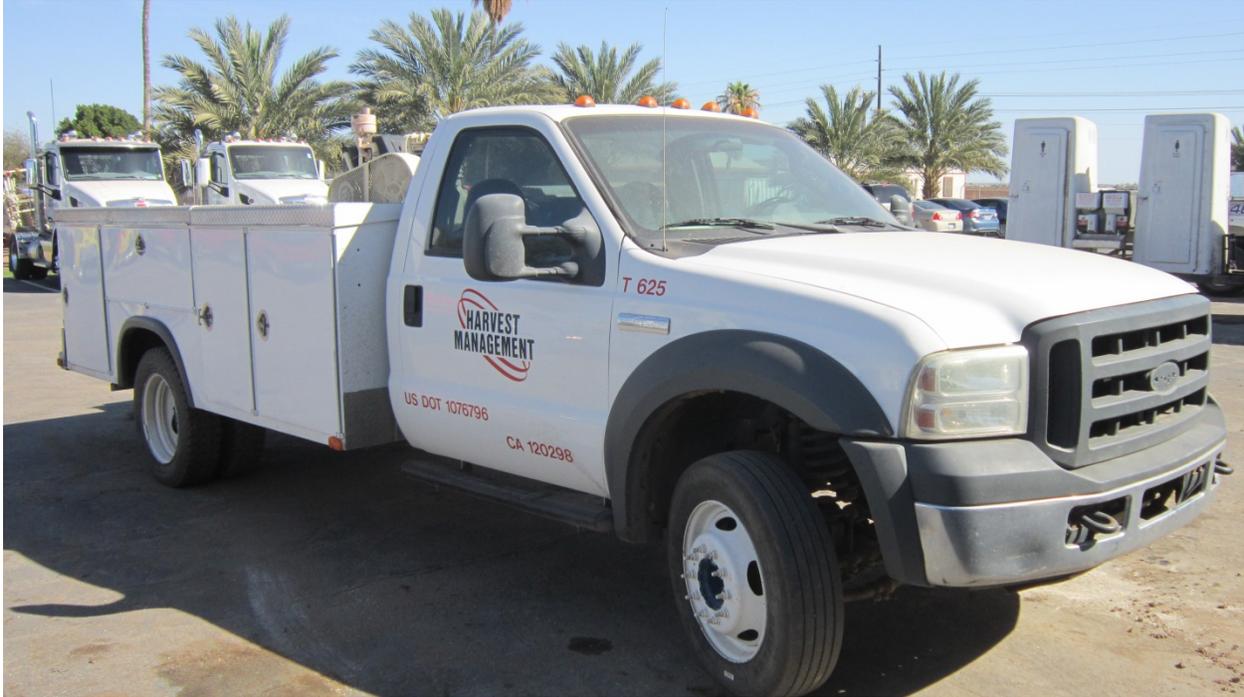
Photo 2 – This photo depicts an exemplar vehicle of the accident vehicle involved in this crash. This photo shows an identical F450 Ford Pickup truck owned by Harvest Management. This truck represents the same make, model, year and configuration as the accident vehicle.

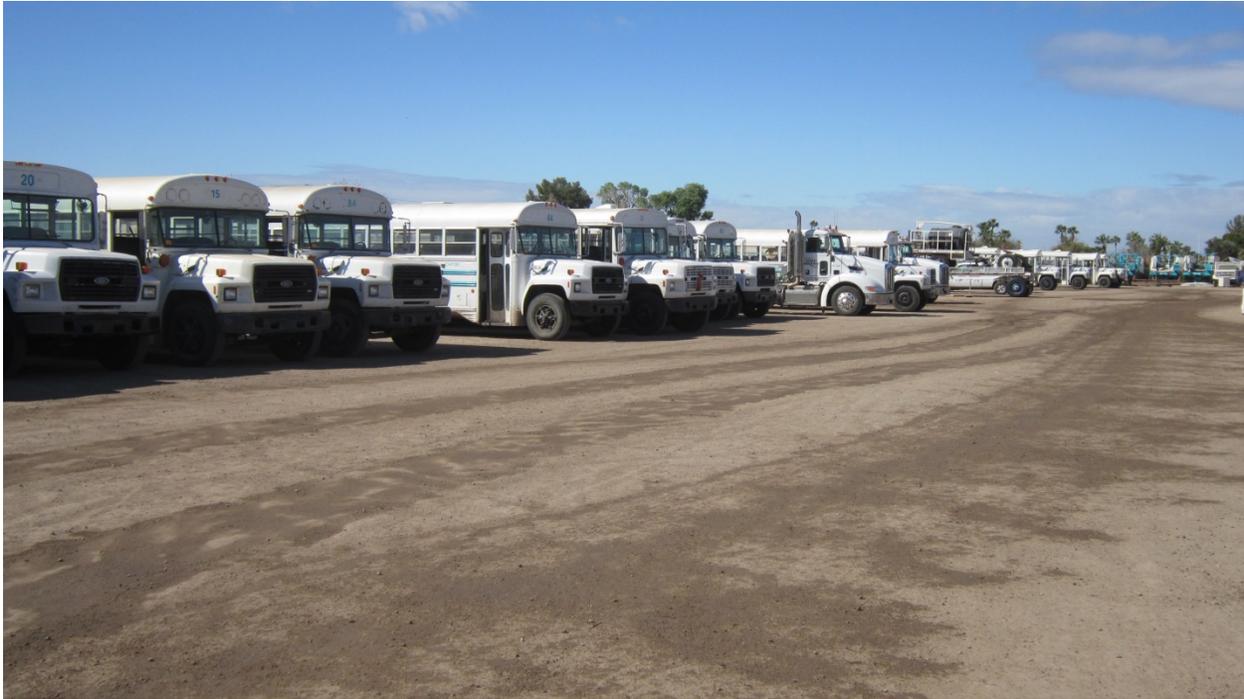
Photo 3 – This photo depicts some of the buses owned and operated by the carrier. These buses transport farm workers during the harvest season.

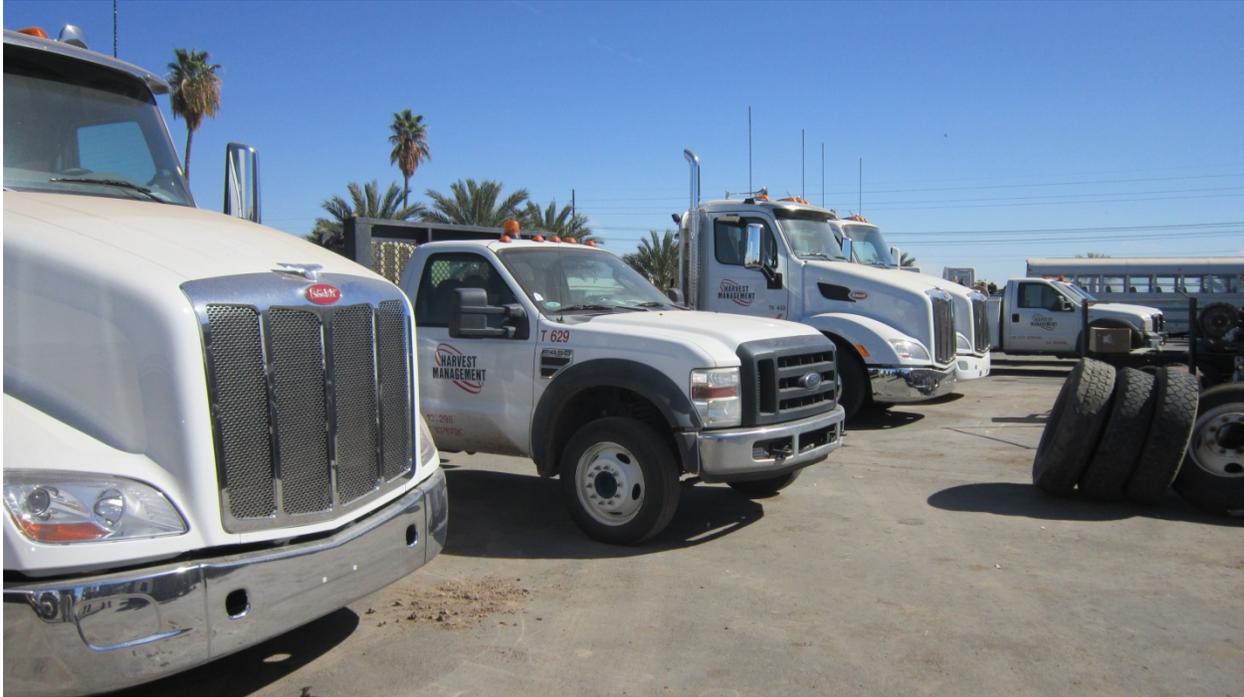
Photo 4- This photo depicts some of the various power units owned and operated by the carrier.

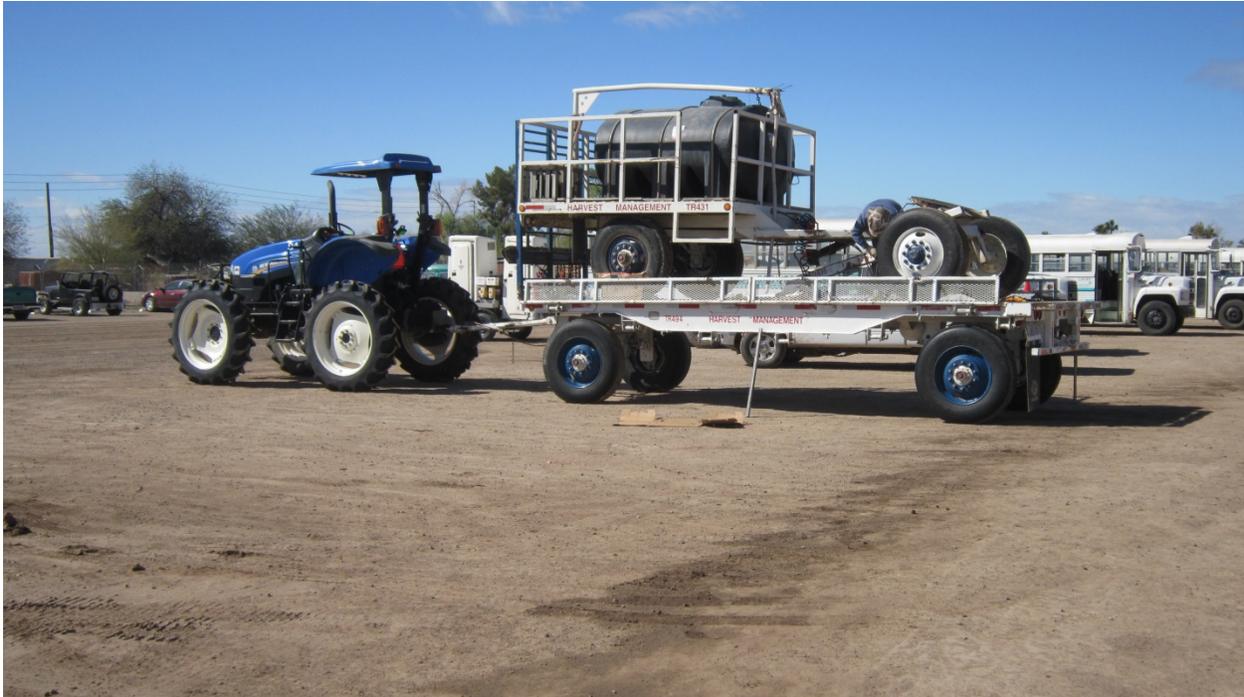
Photo 5 –This photo depicts an example of the farm equipment operated by the carrier.

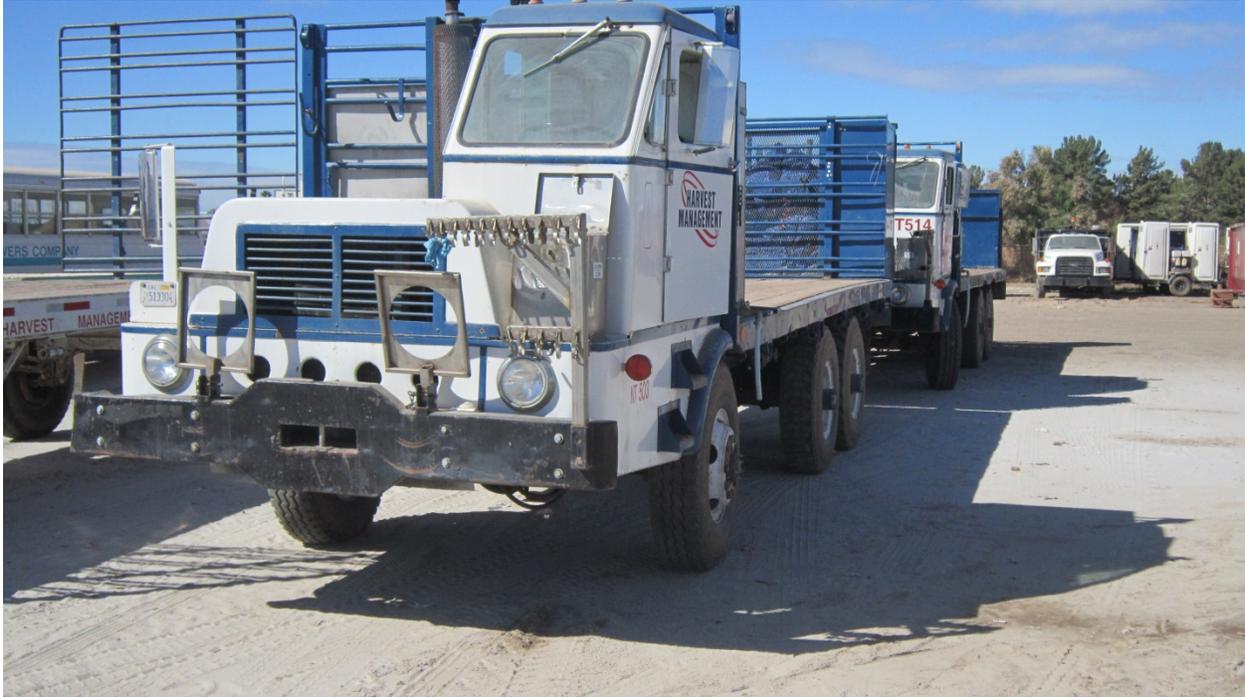
Photo 6 – This type of truck is used in the farming operation by the carrier.

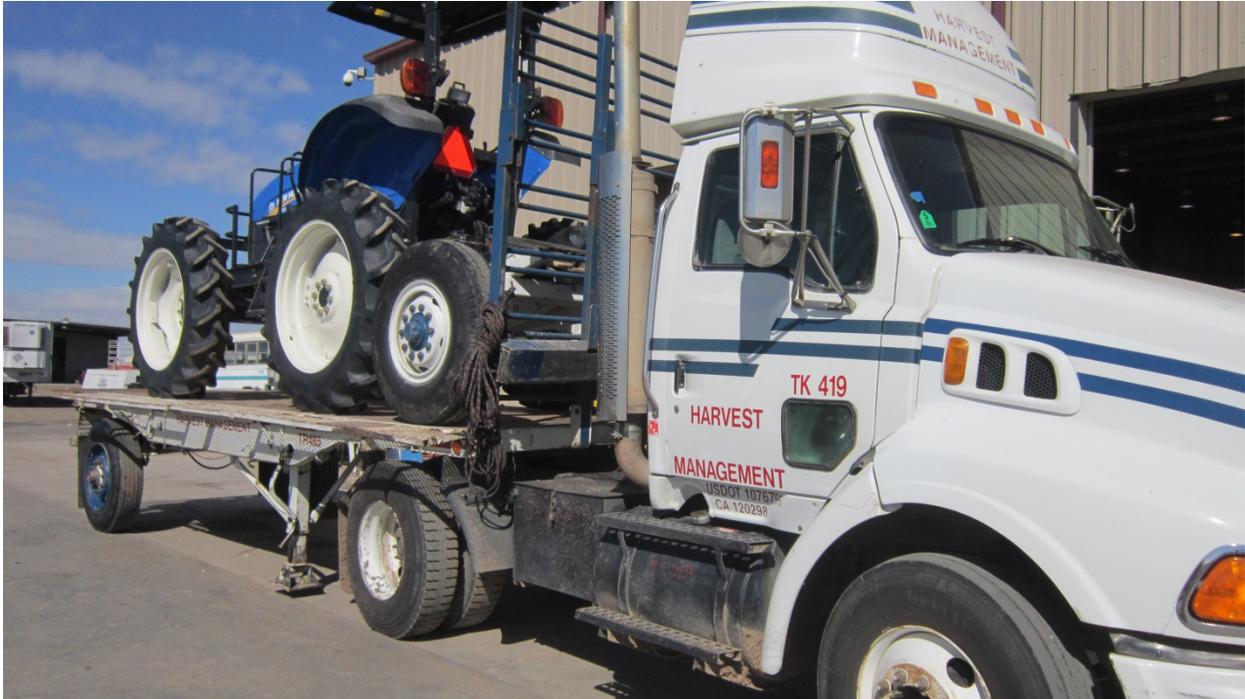
Photo 7 – This photo depicts an example of how the farm equipment is transported in interstate commerce from one farm project to the next.

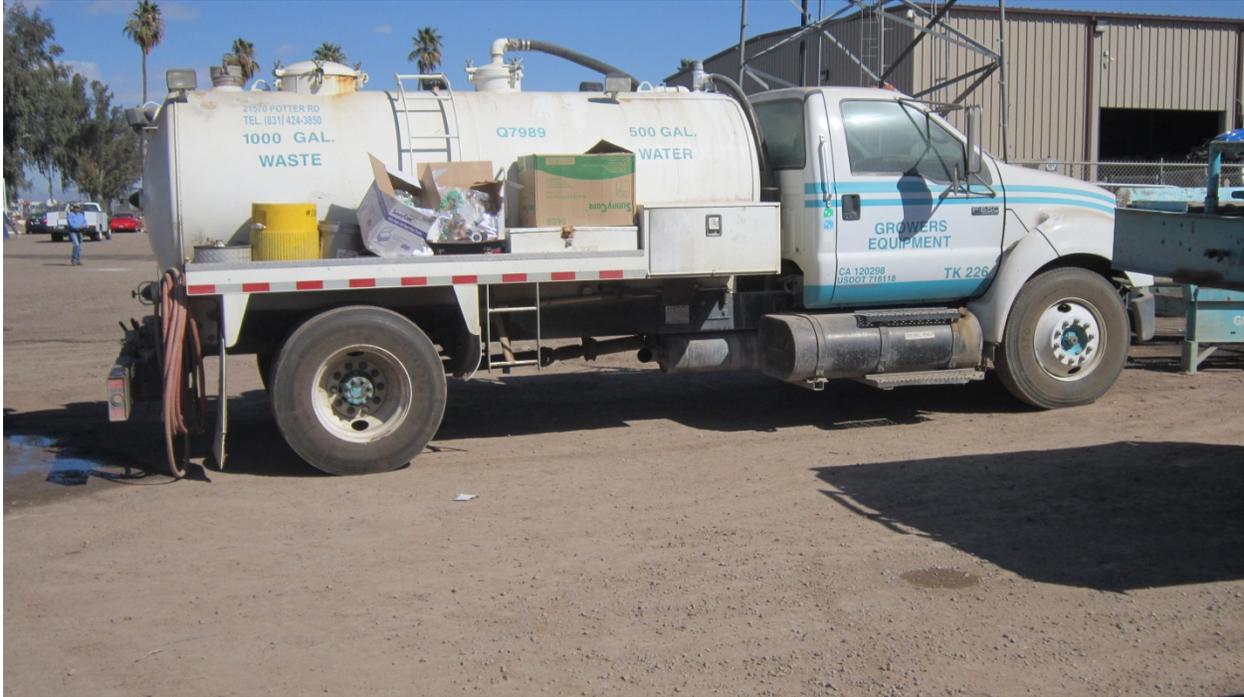
Photo 8 – This photo depicts a water truck owned and operated by the motor carrier. Local law requires the carrier to spray water on the roads to maintain the dust created by farm traffic.

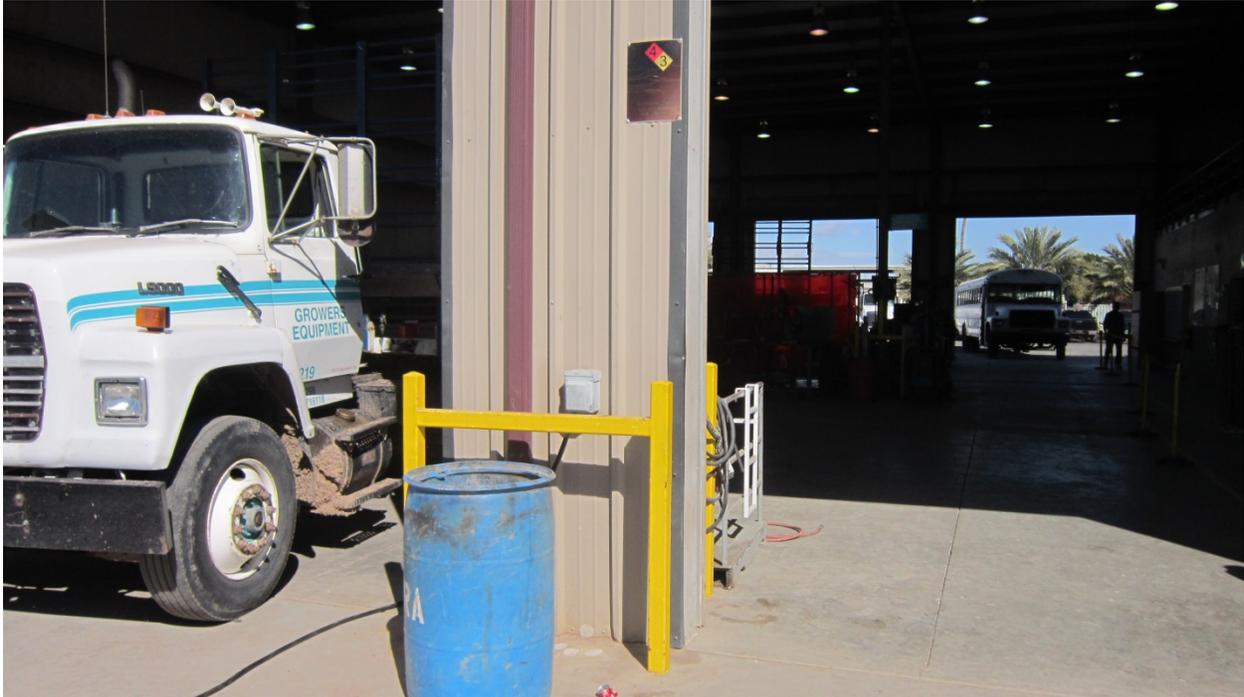
Photo 9 – This photo depicts the 24 hour maintenance shop operated by The Grower’s Company

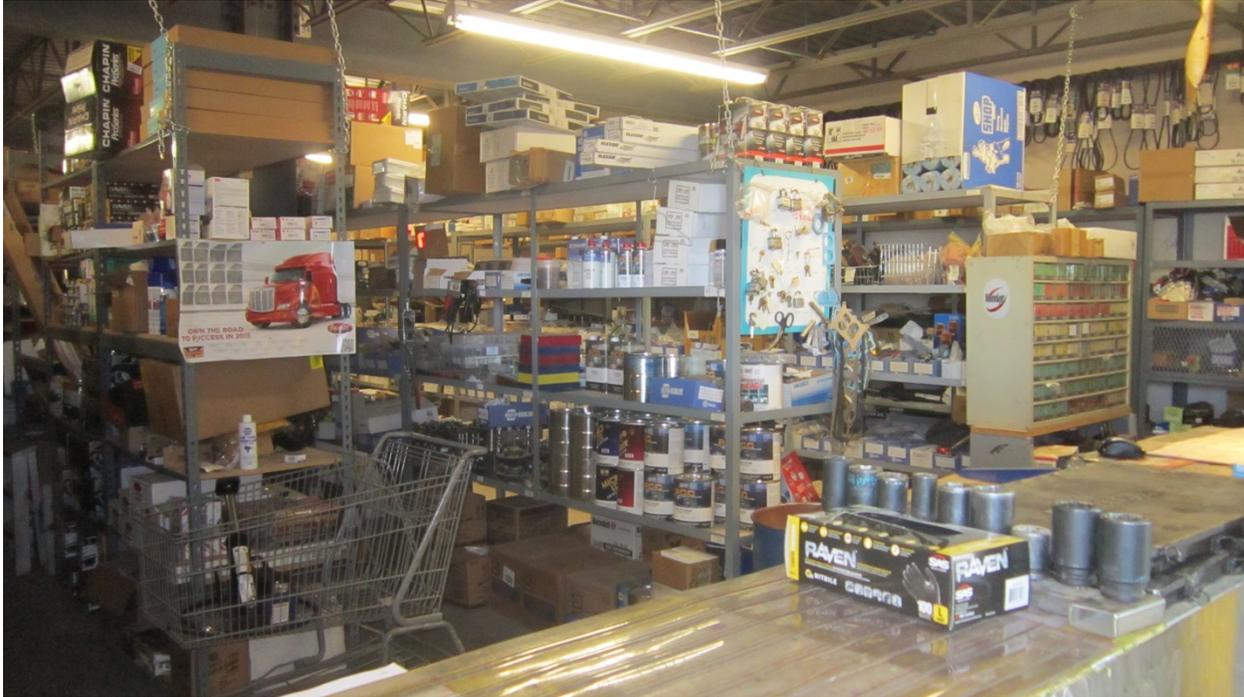
Photo 10 – This photo depicts The Grower’s on-site NAPA Dealer auto parts shop.
