**Mullen Trucking, LP
Technical Review Comments**

**Bridge Strike & Collapse
Mt. Vernon, WA
05/23/2013**

**HWY-13-MH-012
(51 Pages)**

Re: Collapse of Bridge Span
May 23, 2013, Mr. Vernon, Washington
NTSB Investigation: HWY13MH012

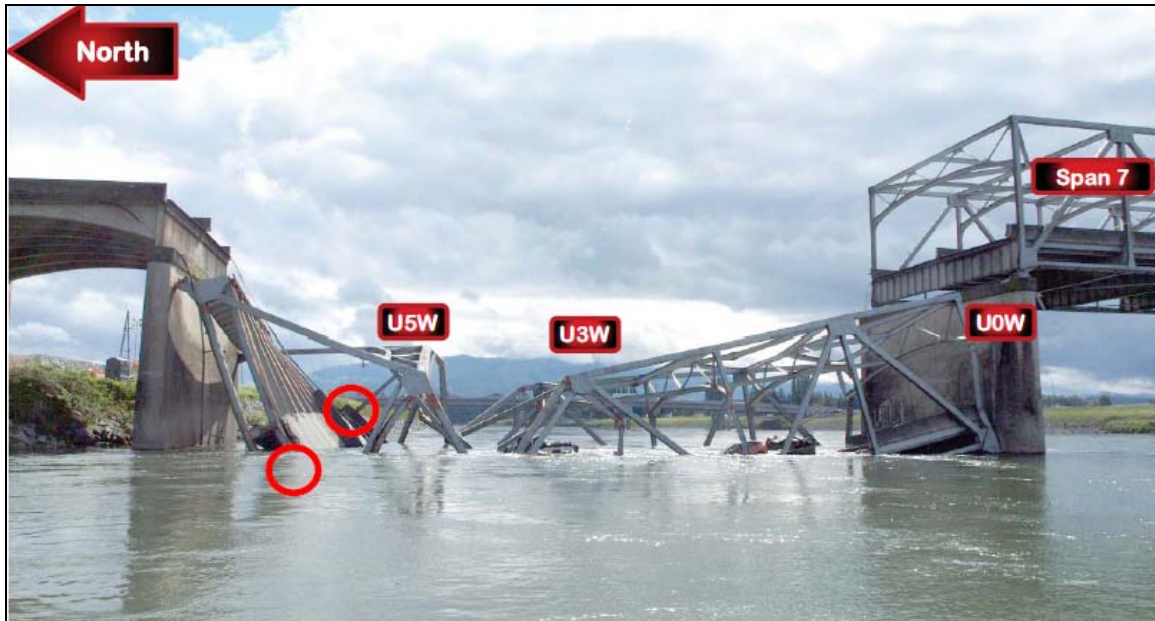
Based on the photographs taken and shown in Figure 5, we believe that the bottom chords were visible at node 5 and for some distance south toward node 4. If this is correct, and if NTSB has any additional photographs or inspection data, we recommend that they be included in this factual report.

Materials Laboratory Report Figure 5, Top View of collapsed span 8 from downstream (west) side. Red circles added at what appear to be node L5E and L5W.

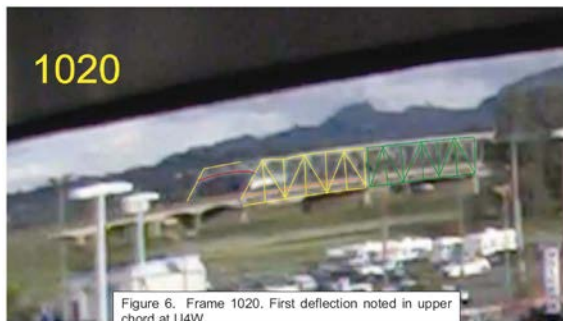
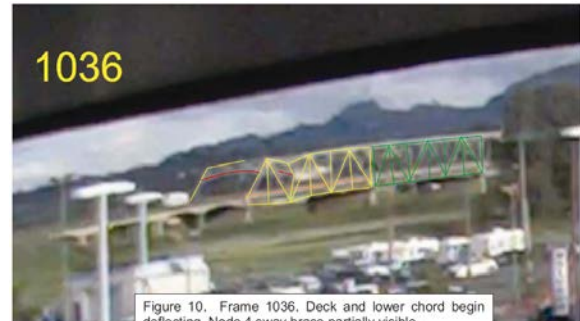
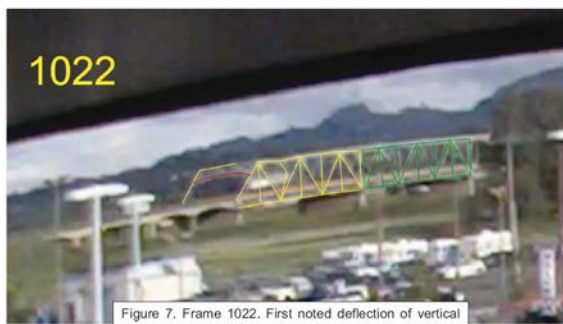
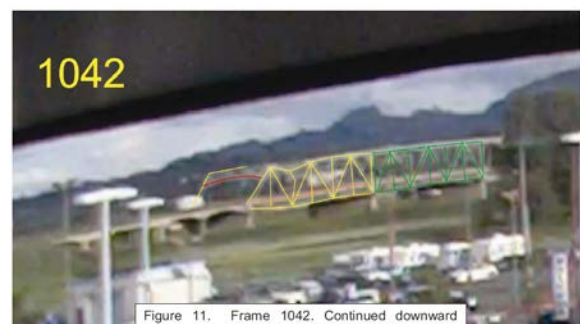
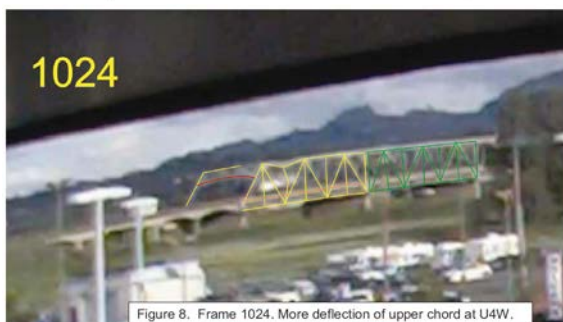
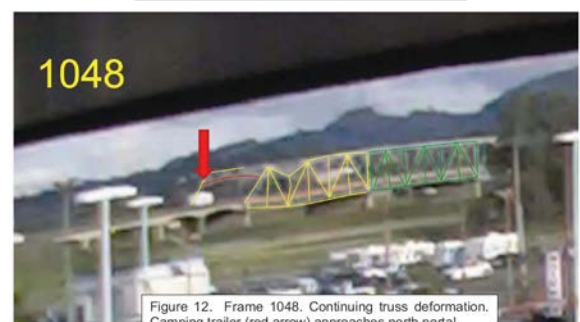
This connection between sway brace 4 and the vertical member U4W-L4W exhibits significant differences relative to a similar connection between sway brace 3 and the vertical member U3W-L4W, which also sustained heavy impact from the load during the event. Also, a nearly identical connection between sway brace 4 and the vertical member U4W-L4W on span 7 was severely impacted by the load; however, span 7 did not catastrophically fail.

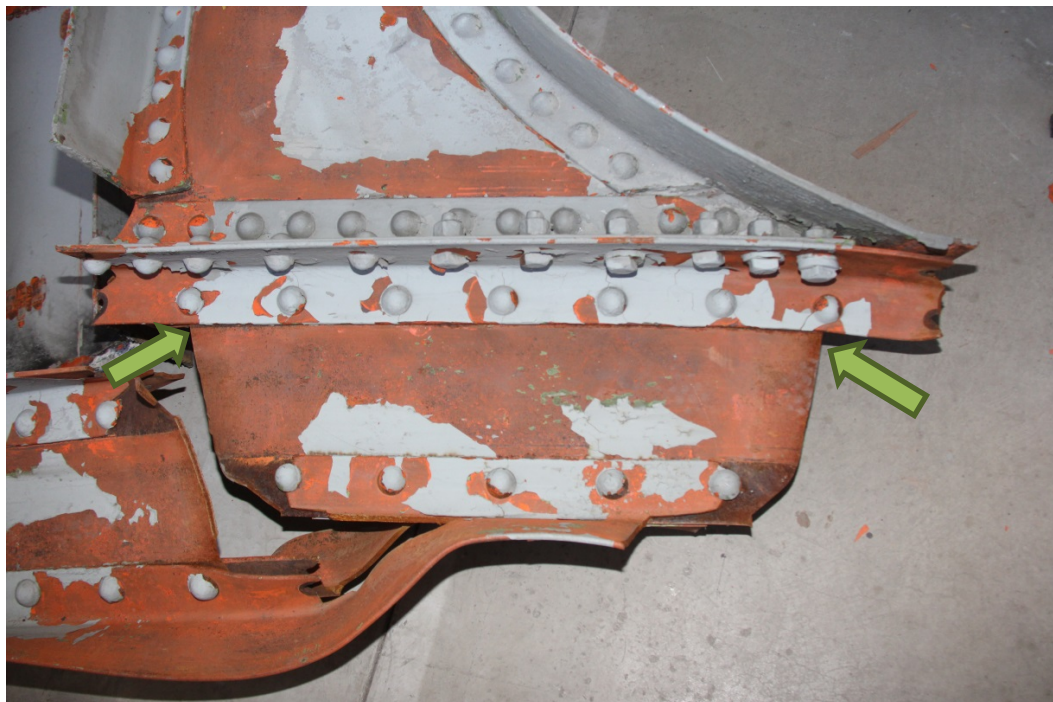
Significant portions of the fracture surfaces around the connection of sway brace 4 to member U4W-L4W cannot be examined because they are underneath or obscured by other component members (please see photographs 1 and 2 below). **There is no question that this is a critical fracture area and that it is a key to understanding the sequence of events and failure. It cannot be fully evaluated by visual examination alone. We recommend detailed visual, microscopic and laboratory examination.** We would be pleased to assist with this process, or take the lead under NTSB supervision.

Photograph 1: Overview of connection of sway brace 4 with the U4W-L4W vertical. Note that the web of member U4W-L4W is fractured at riveted connections (arrows) that cannot be visually examined without additional work.

In light of the above observations, we believe a thorough examination of the fractures, materials and fasteners at the connections to the vertical member U4W-L4W are warranted to uncover any potential pre-existing issues that may have contributed to the failure. In addition, historical information on repairs and damage would provide valuable information for the analysis. **The fact that similar connections on span 8 and other spans on the Skagit bridge did not fail in the same manner after the sway brace was impacted indicates that the span 8 to U4W-L4W vertical connections, or other connections that are configured the same, may well have been susceptible to failure.**

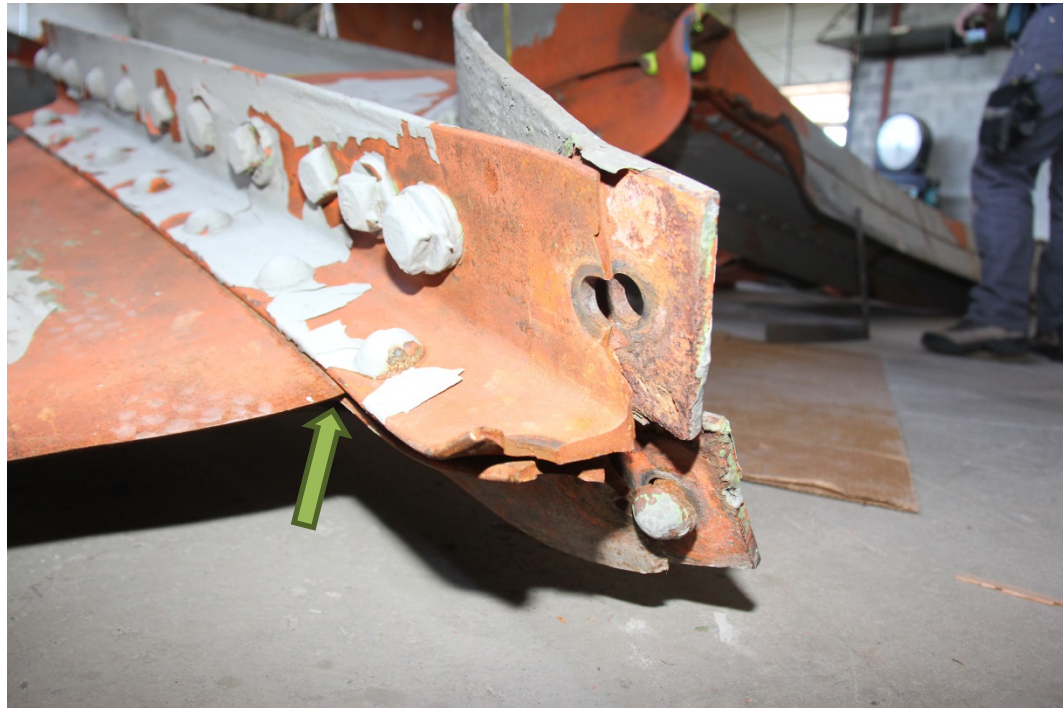
Photograph 2: Close up of the lower portion of the critical fracture on member U4W-L4W showing that fracture cannot be visually examined. The area is between and obscured by the two "L" brackets (arrow).

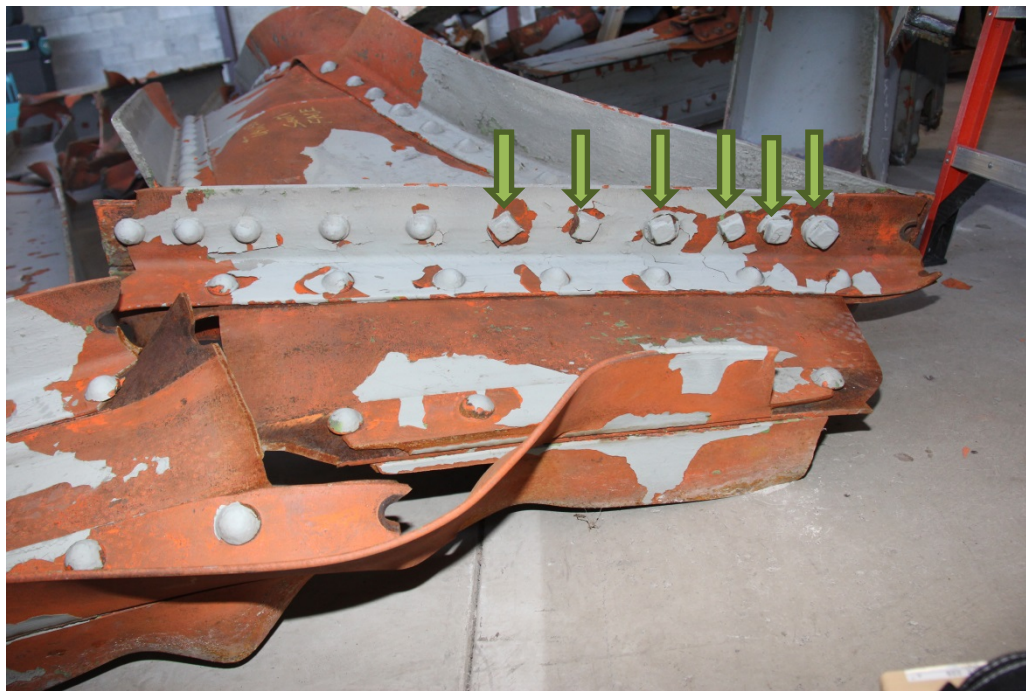
We also note that many of the rivets at the connection of sway brace 4 to the U4W-L4W vertical appear to have been replaced with bolts at some time in the past (see Photographs 3 and 4 below). A total of 12 of 22 of the fasteners connecting the flange of the U4W-L4W vertical to sway brace 4 were bolted. In comparison, it is our understanding that one of the 22 fasteners connecting the flange of sway brace 3 to the U3W-L3W vertical was bolted. This suggests that previous repairs had been made in this area or that a systemic

Photograph 3: The connection of sway brace 4 to the U4W-L4W vertical. Note the bolts and washers toward the lower part of the connection (arrows).

issue exists at connections with the same configuration as sway brace 4 on span 8. We respectfully suggest that the reason for the rivet replacement should be investigated and that the connection area and related fracture surfaces be examined in a laboratory. We would be pleased to assist with this process, or take the lead under NTSB supervision.

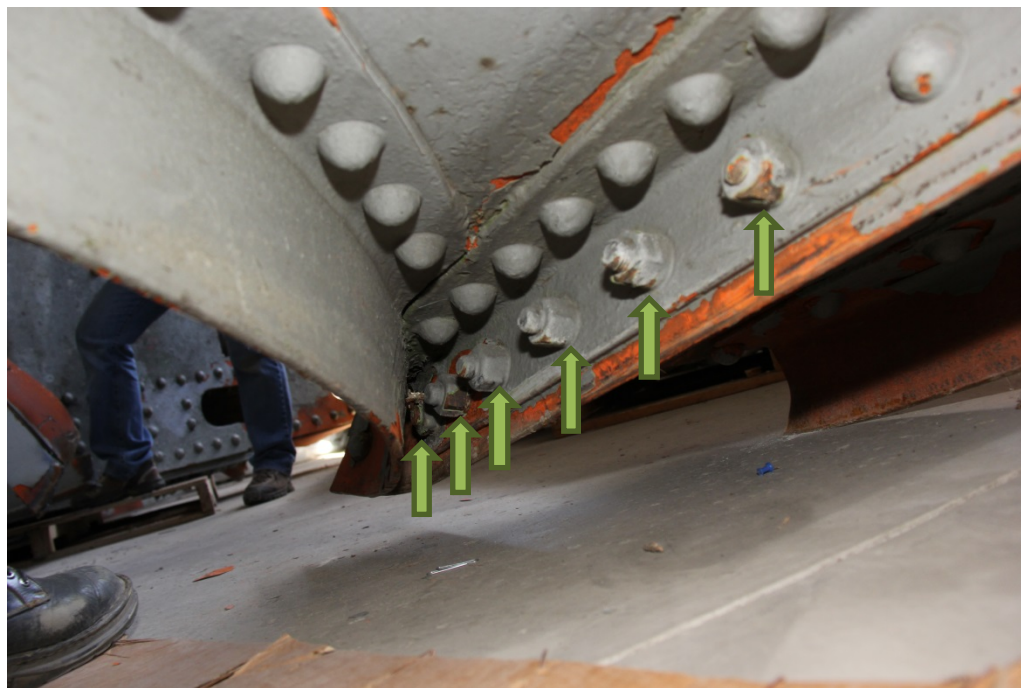
Photograph 4: Opposite side of the connection from that shown in Photograph 3. Note the bolted connections with washers toward the lower part of the connection.

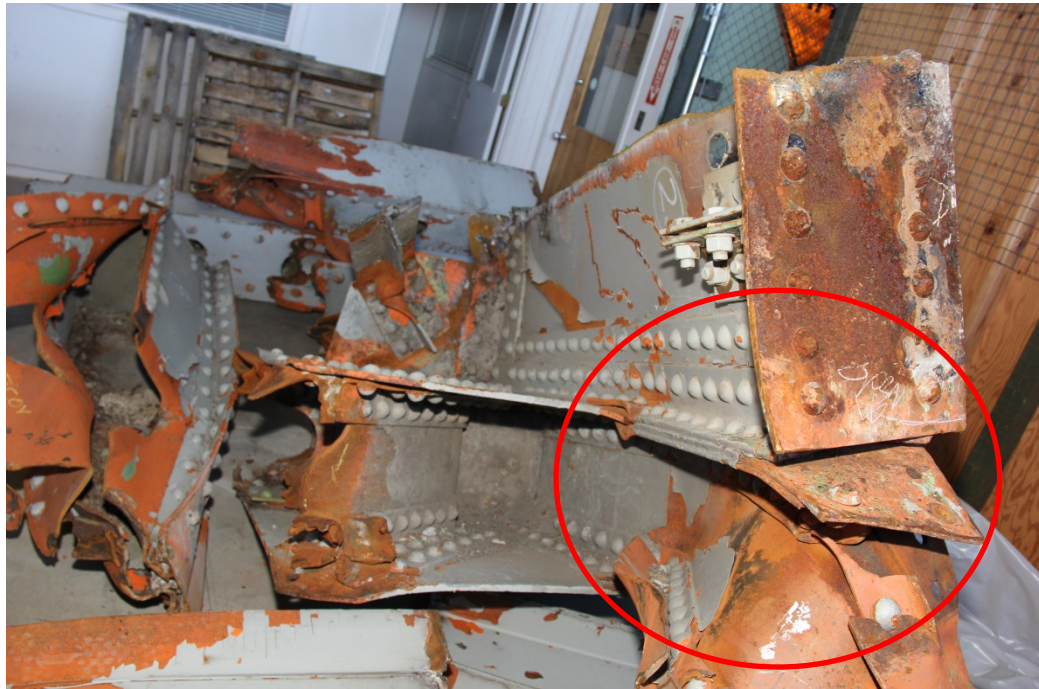
Detailed examination of the connection of the U4W-L4W vertical to L4W node and any associated lateral or rotational displacement will be important for any modeling of the span.

Photograph 5: Node L4W. The area of connection with the U4W-L4W vertical is shown in the circled area.

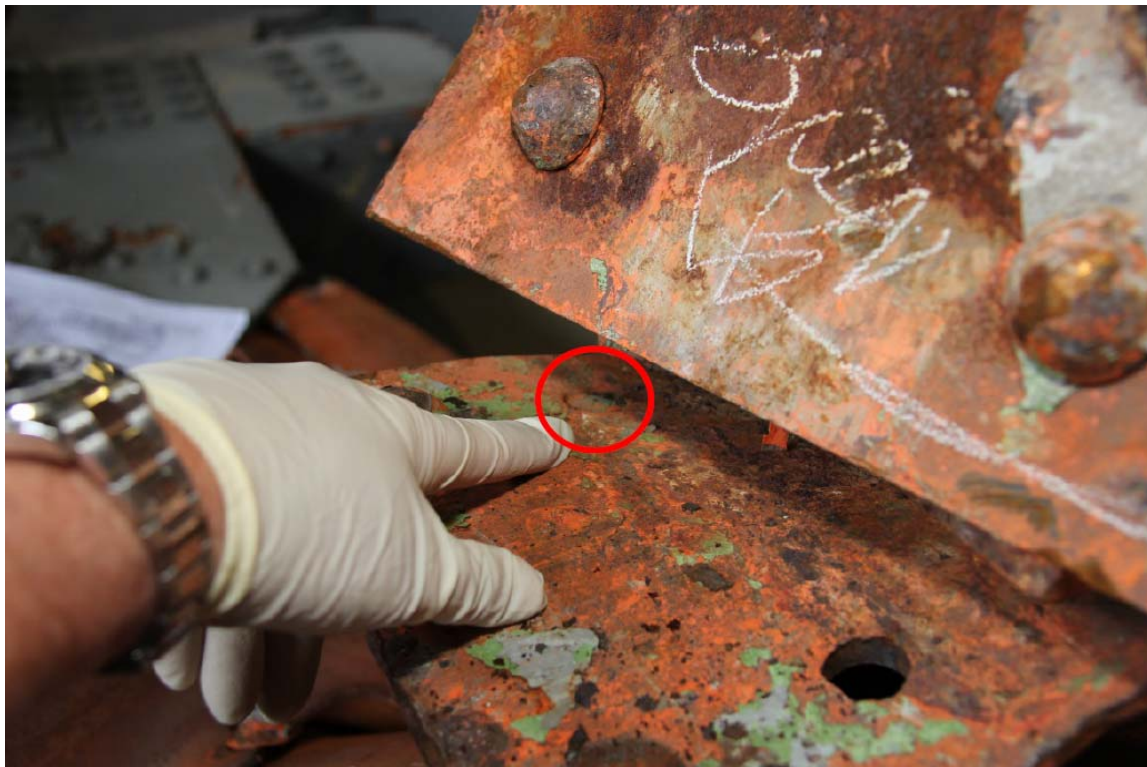
In the midst of examination of accident damage to L4W, it was discovered that at least two rivets at the top of U4W-L4W connection to the L4W node were actually cut and did not extend through the connections. Photographs 6 and 7 below show one of these two cut rivets. Despite the cuts, the rivet heads were left in place, making it impossible to know that there were functionally no rivets in place.

Photograph 6: The rivet at the connection of U4W-L4W at the top of node L4W was cut (arrow) with no connection to the mating material.

We request that the factual report make note of these cut rivets and the inability to know how many other such cut rivets the structure may contain.

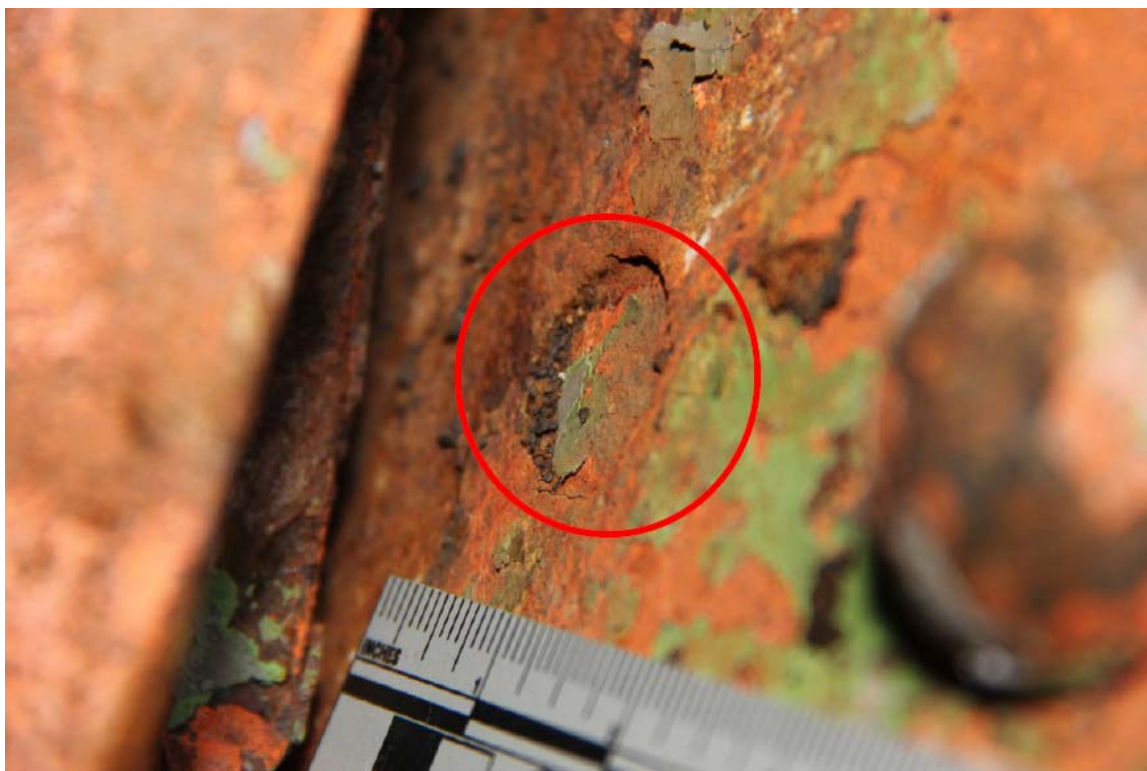
Photograph 7: Closer view of the rivet at the connection of U4W-L4W at the top of node L4W was cut with no connection to the mating material.

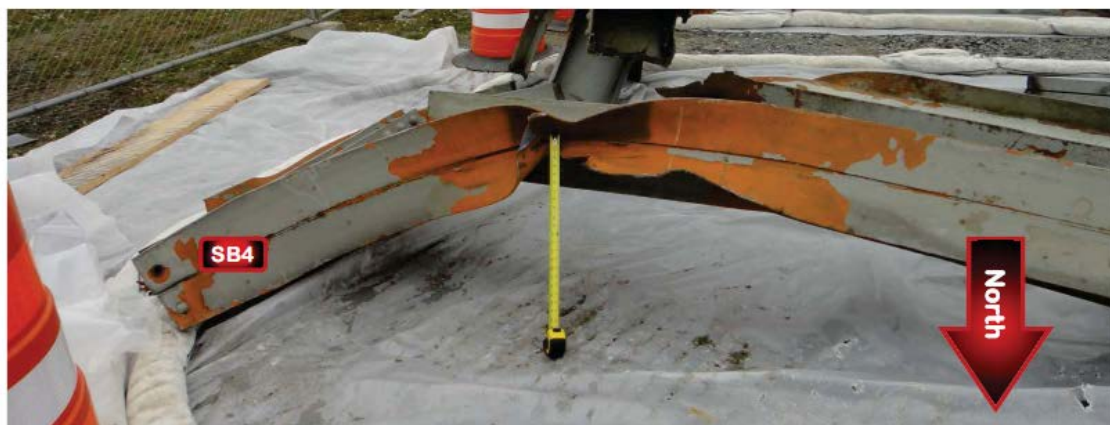
Figure 16. Impact damage to sway brace 4 above with extent of bowing depicted below.

The entire lower chord of the sway frame was deformed and bowed to the south centered at the tear across the width of the traffic lane. **The permanent deflection from straight measured about 24 inches at the tear.** The lower chord of the sway brace remained attached to the vertical. However, the vertical was fractured as noted in a previous section. **See Figure 16 Lower.**

While we do not disagree with the measured approximation of the deflection in sway brace 4, we think it is important to identify and discuss that the deflected condition as measured is post incident and post recovery. Although not specifically stated in the report, we believe that the observed and recorded deflection of span 8, sway brace 4, will be compared with the deflection and damage of the sway braces on span 7, which can be attributed almost exclusively to impact with the load. Figure 28 on page 36 implies that a comparison can be drawn by showing the

We request that notation be made that the damage and deflection observed post-recovery in the sway braces on span 8 is likely a combination of (1) impact with the load, (2) the forces of the span collapse itself, and (3) recovery efforts.

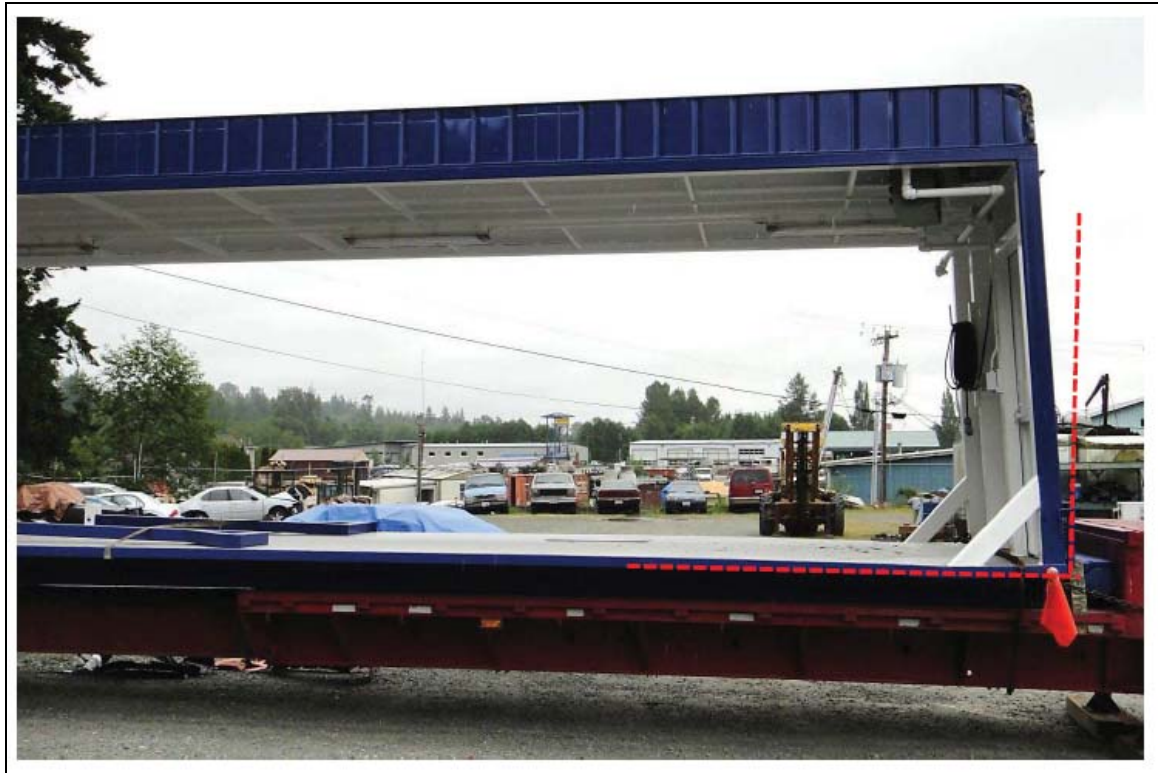
No specific information is provided on the measured angular displacement of the casing shed in the report. Red dotted lines at a right angle are superimposed over the photo, presumably to provide the reader with some reference as to the extent of the racking. Because the casing shed is shown in an oblique view rather than straight-on or orthogonal, however, the superimposed right angle inappropriately accentuates the racking: the angle depicted in Figure 29 measures approximately 5.5 degrees whereas the actual angle of the accident load racking was approximately 3 degrees (See photographs 8 to 12 below).

While the 2.5 degree difference between the 3.0 degree actual scope of the racking and the 5.5 degrees shown in Figure 29 may not seem significant to the casual reader, the amount of energy required to achieve the relative different degree of deformation is substantial. In order not to mislead the reader, we suggest removing the red dotted lines and including the above photographs and analysis.

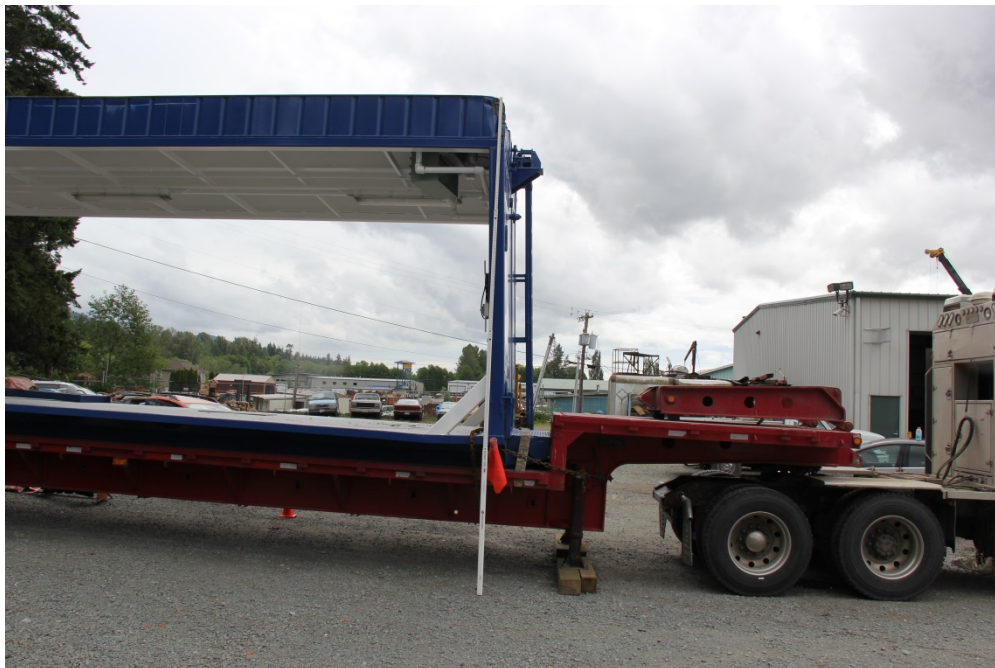
Photograph 8: Side view of the front of the load.

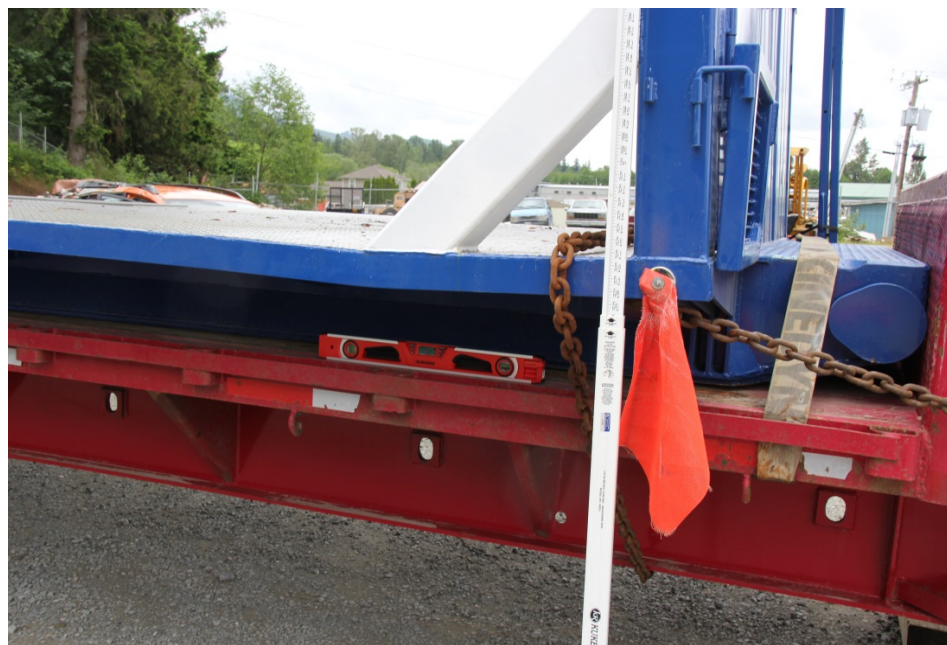
Photograph 9: Digital level positioned to obtain angle of trailer which is a similar angle as the base of the load.

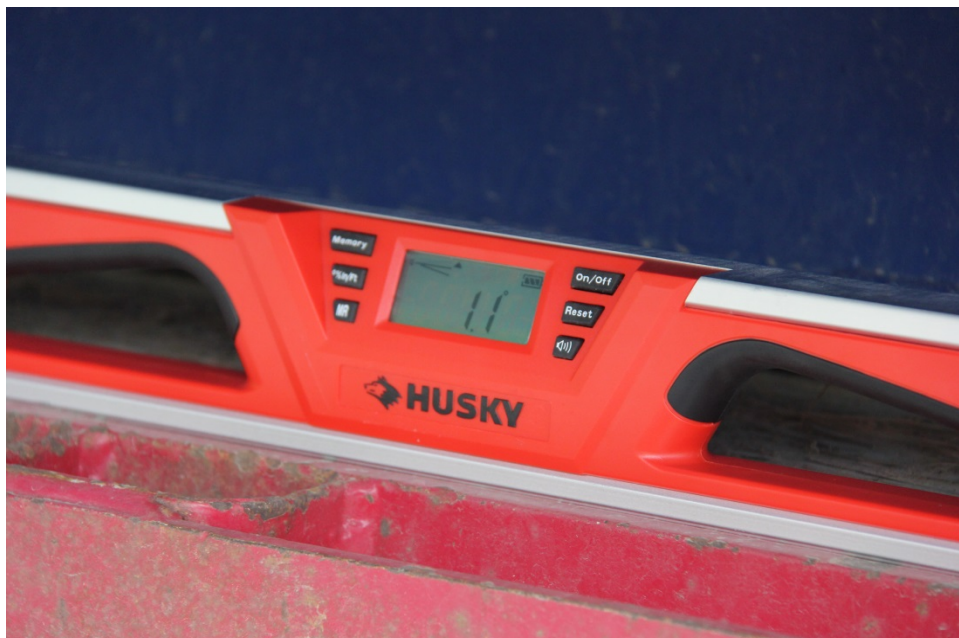
Photograph 10: Trailer is sloping 1.1 degrees downward toward the front of the trailer.

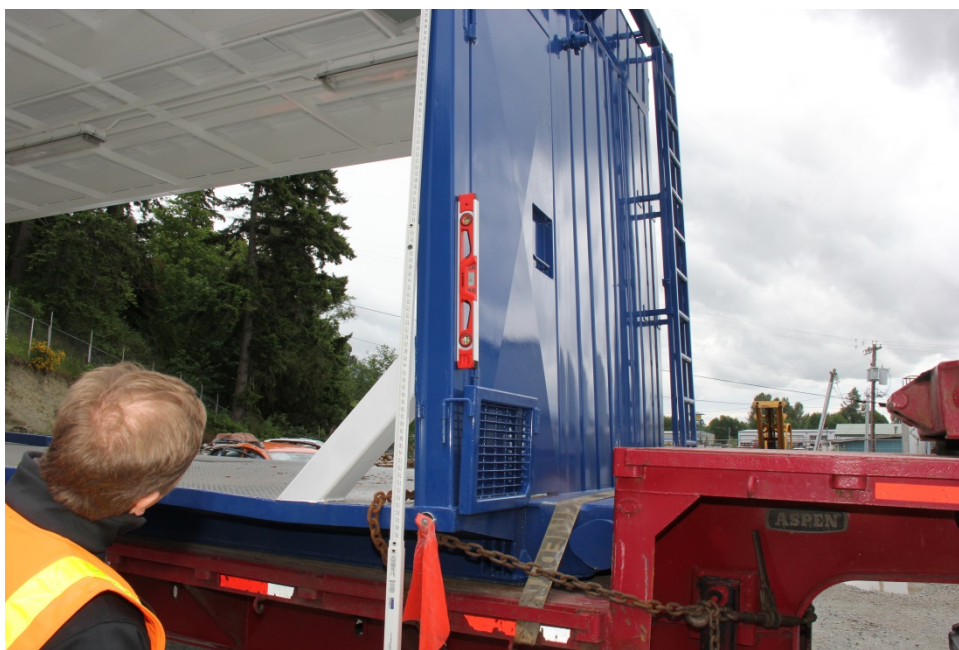
Photograph 11: Digital level positioned to obtain the angle of the front surface of the load.

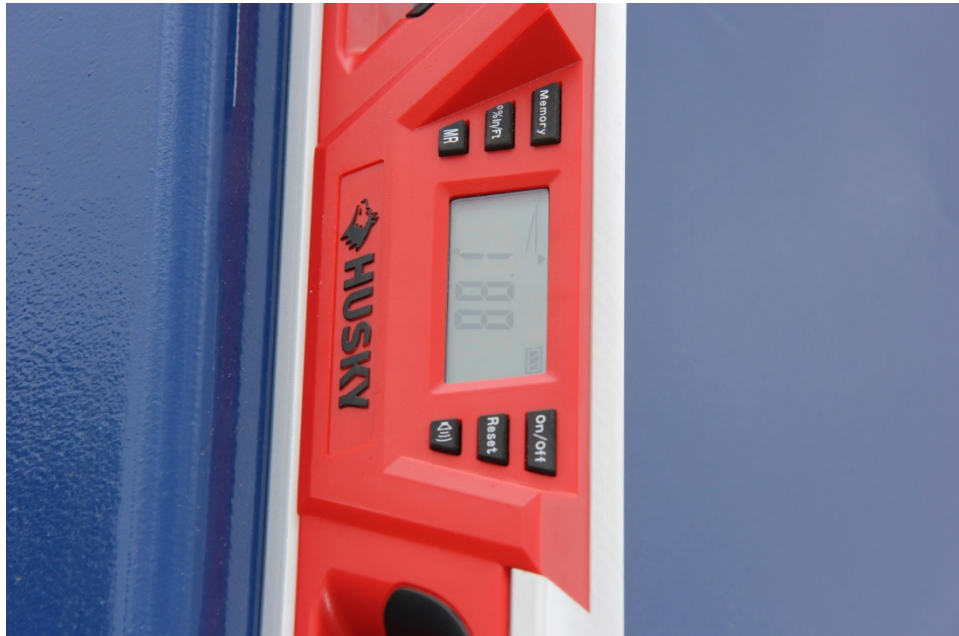
Photograph 12: Angle of the front surface of the load is 88.1 degrees (1.9 degrees from vertical) tilted toward the rear of the trailer. The total approximate angle is 3.0 degrees (1.1 plus 1.9).

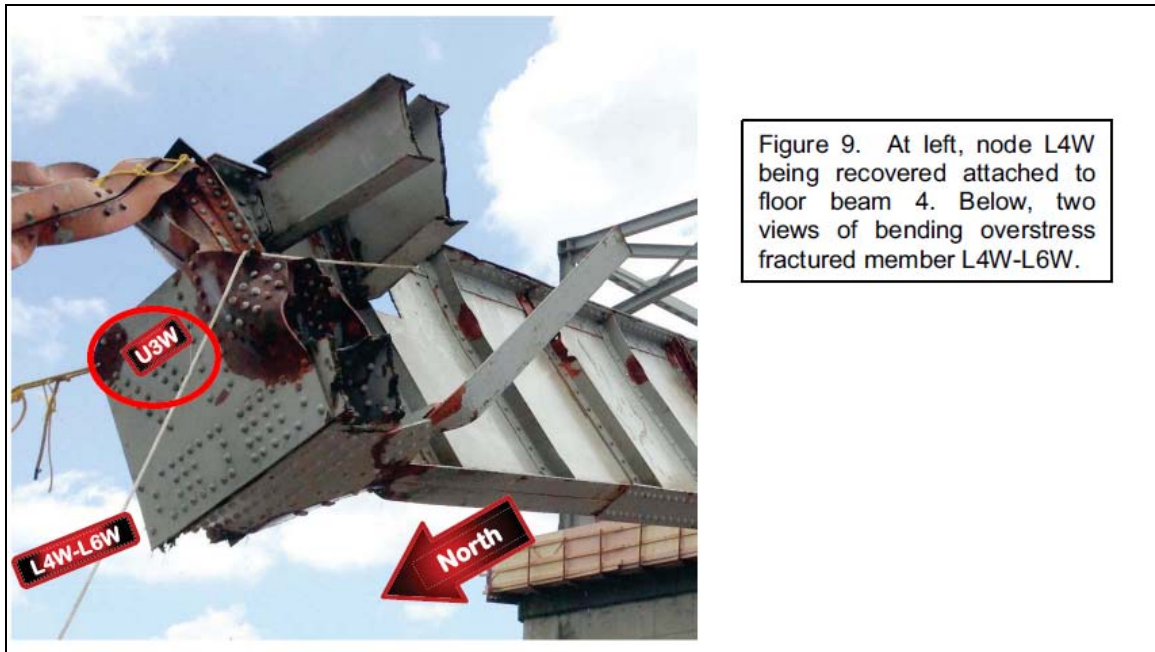
The node in the photograph below appears to be **L4W**, not U3W. (The label in the photo is mis-labeled. The caption is correct.)

Figure 9. At left, node L4W being recovered attached to floor beam 4. Below, two views of bending overstress fractured member L4W-L6W.

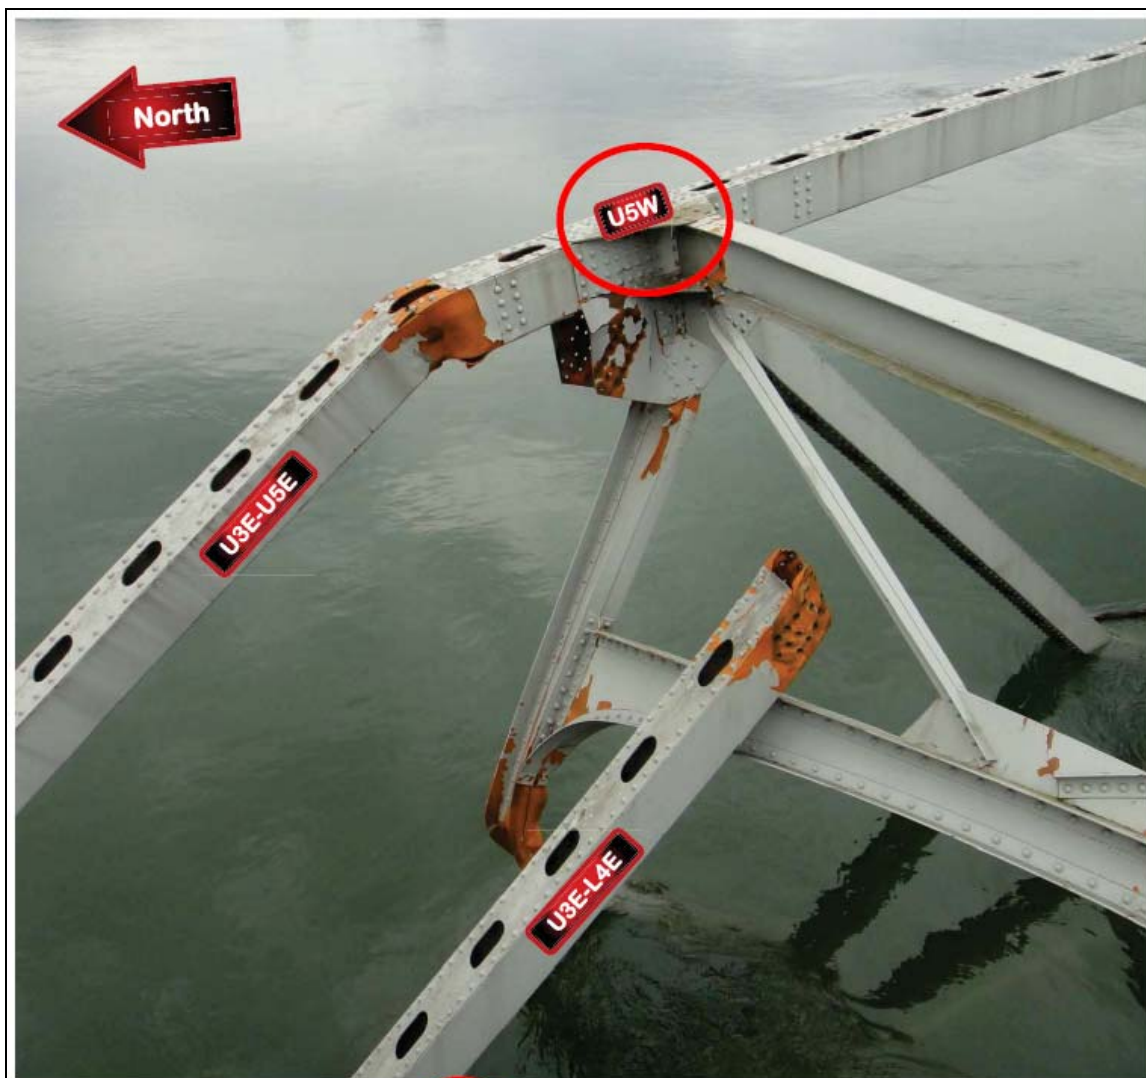
The node in the photograph below appears to be U3E, not U5W. The caption refers to the node as U5E. This is also incorrect. The node is U3E.

Figure 11. Node U5E with separated member U3E-L4E.

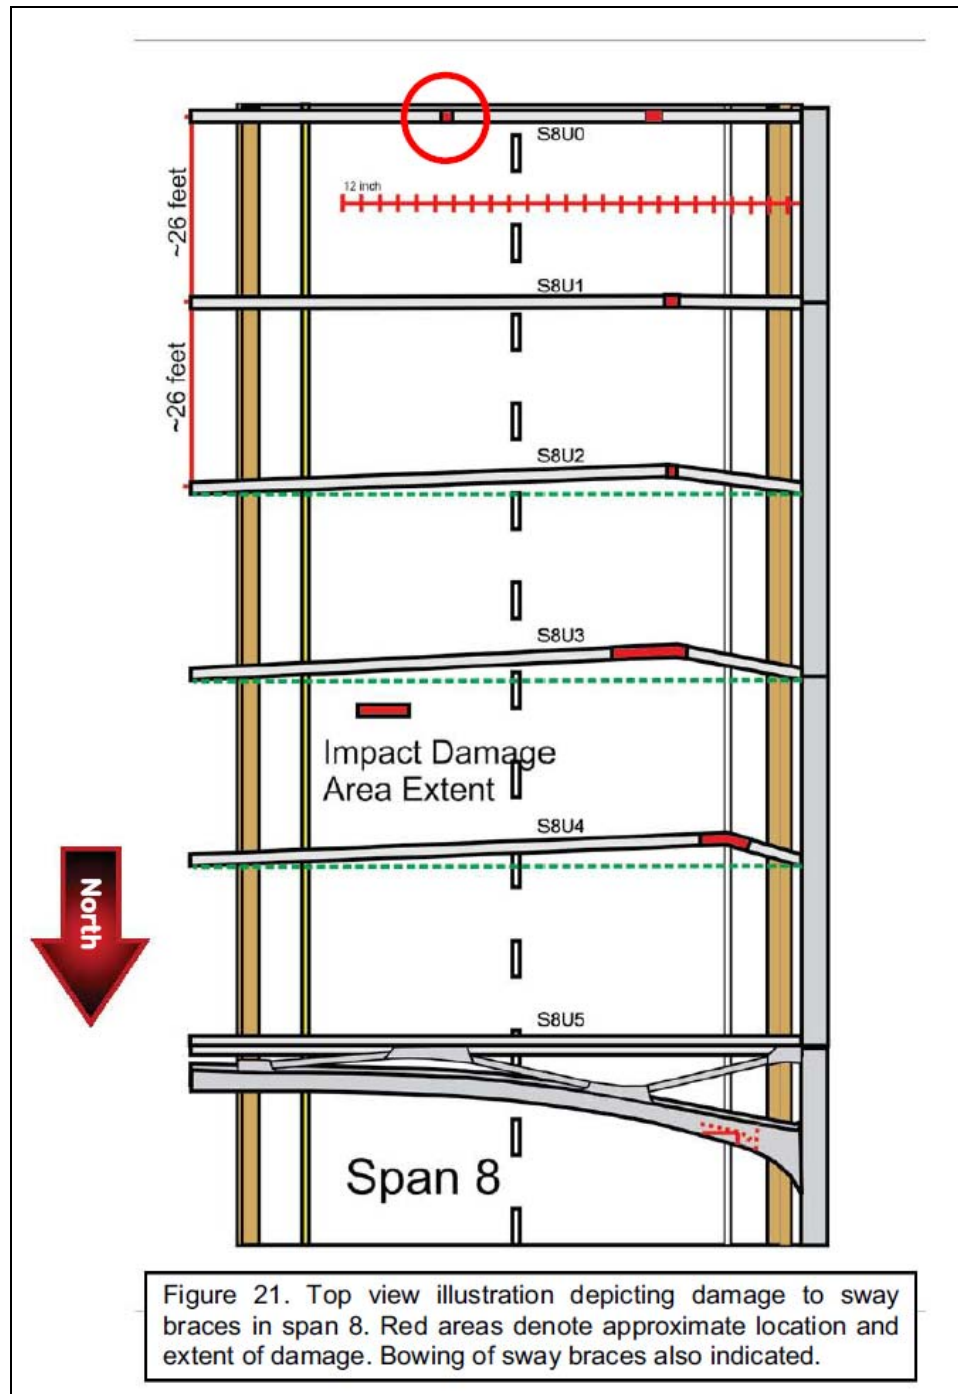
Two damage locations are shown on sway frame S8U0. While the reference to this damage implies that it is accident related, the distance from the inboard damage (circled in red) to the road surface (likely approximately 18 feet) would seem to make it unlikely that it is related to the 05/23/2013 accident. Is there any evidence that this inboard damage is from the subject accident? If not, we recommend that reference to the damage be removed from the report or it be noted that this damage is not likely accident related.

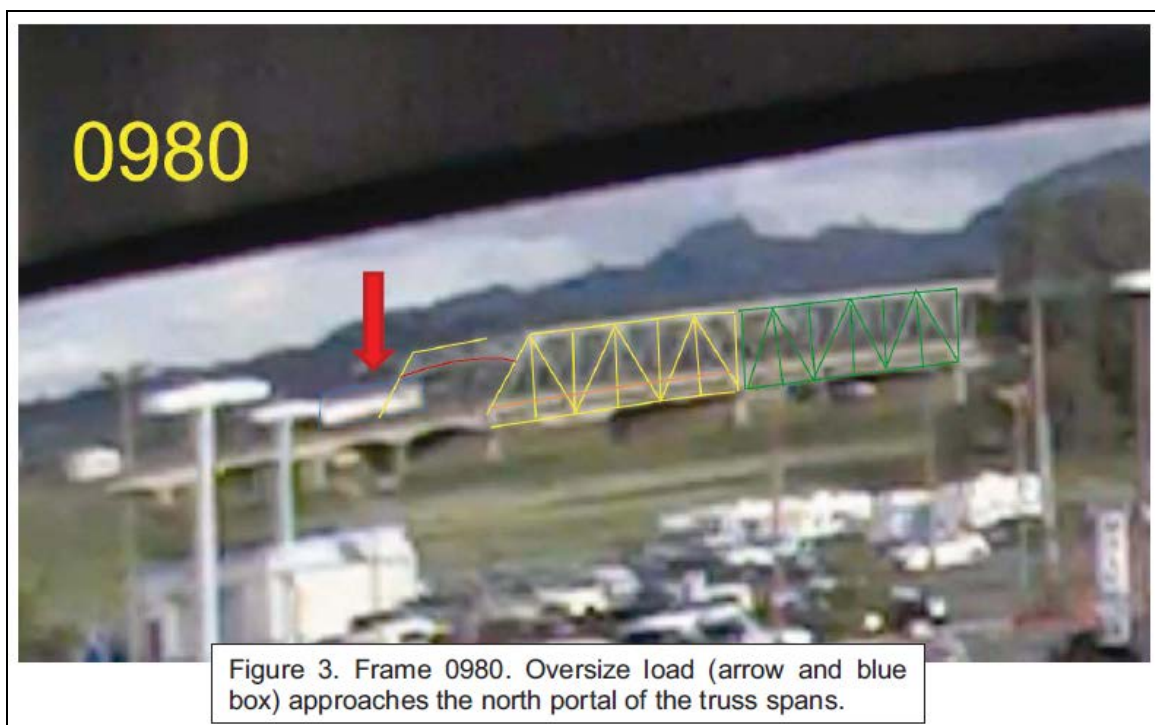
The description accompanying Figure 3 on page 5, however, notes only the oversize load (with an arrow and blue box) but is silent about the white trailer on the east side of the load that is actually more prominently featured in the photo:

Figure 3. Frame 0980. Oversize load and white trailer (arrow and blue box) approach the north portal of the truss spans.

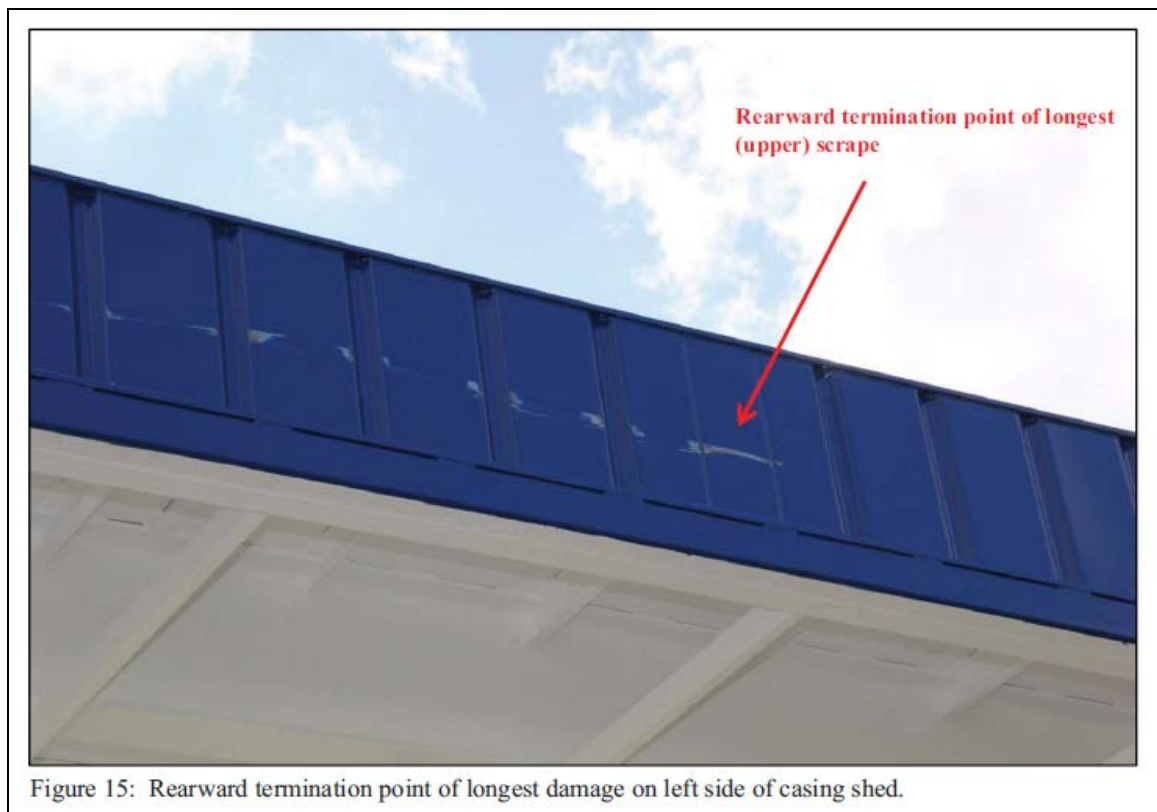
The casing shed also exhibited scrape marks along a portion of the left side upper sidewall. These marks consisted of gouging to the painted surface with some indentation and tearing of the steel at the forward left corner. At the forward end, the contact damage terminated at multiple points with three individual areas being discernible. The areas of damage were longitudinally oriented and extended rearward along the face of the upper sidewall at an apparent uniform spacing. The marks also exhibited a change in vertical height as they progressed longitudinally.
