NATIONAL TRANSPORTATION SAFETY BOARD

Multi-Function Display Memory Card

Specialist's Factual Report

Location: Manhattan New York
Date: October 11, 2006, 2:42 Eastern Daylight Time (EDT)
Aircraft: Cirrus SR20, N929CD
Operator: private
NTSB Number: DCA07MA003

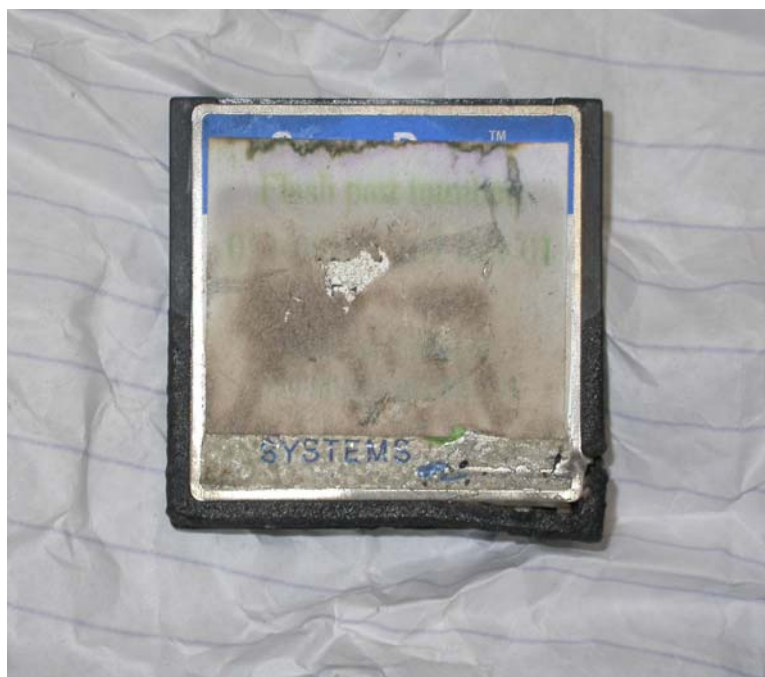
Photograph 1

The compact flash memory card that was installed in the accident aircraft's MFD display was removed at the accident scene and shipped to the Vehicle Recorder Laboratory. The card appeared to be generally in good shape with what seemed to be only minor physical damage to the plastic case that holds the memory circuit board. (See photograph 1)

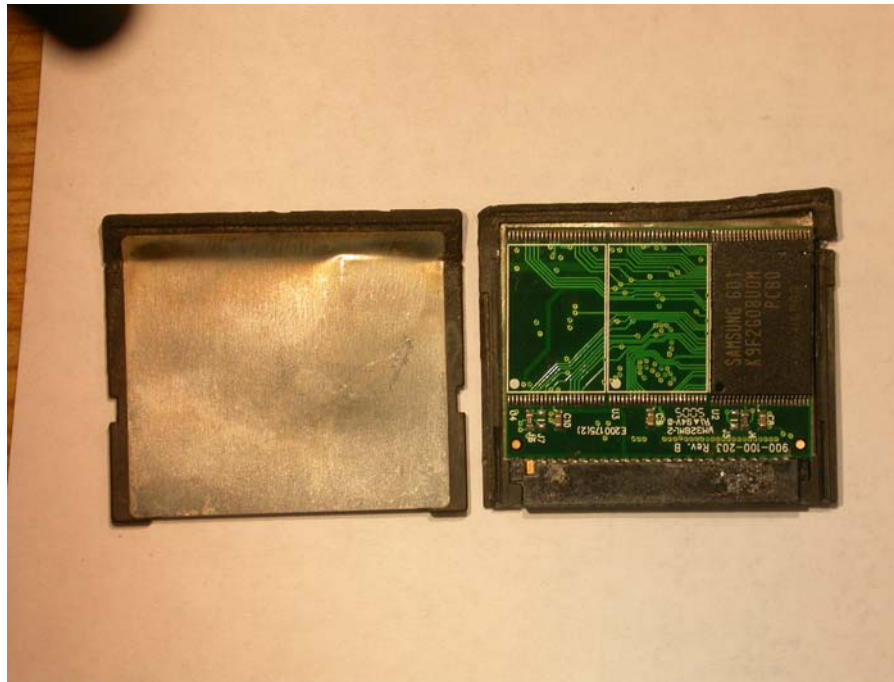
Photograph 2 bottom of card

The plastic case was removed to expose the interior components of the CF memory card. (See photograph 2 bottom of card)

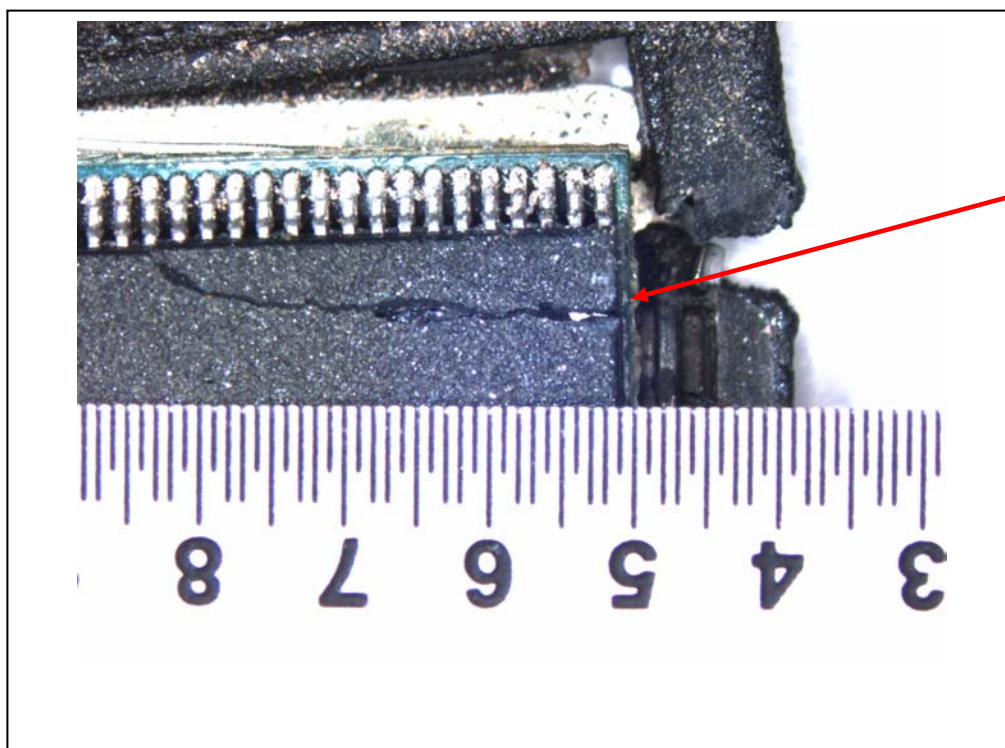
Photograph 3

It can be seen in photograph 3 that the memory chip installed on the bottom of the circuit card showed signs of physical damage at one corner of the chip. This damaged had fractured the epoxy from pin 25 (end pin) thru pin 41 of the chip. (displayed scale is in tenths of an inch)

The chip was de-soldered from the memory card during the recovery process. The fractured corner of the chip detached completely from the remainder of the memory device. All of the pins (25 thru 41) no longer made electrical contact with the memory device. This electrical discontinuity rendered the chip unreadable and the data was not recovered.

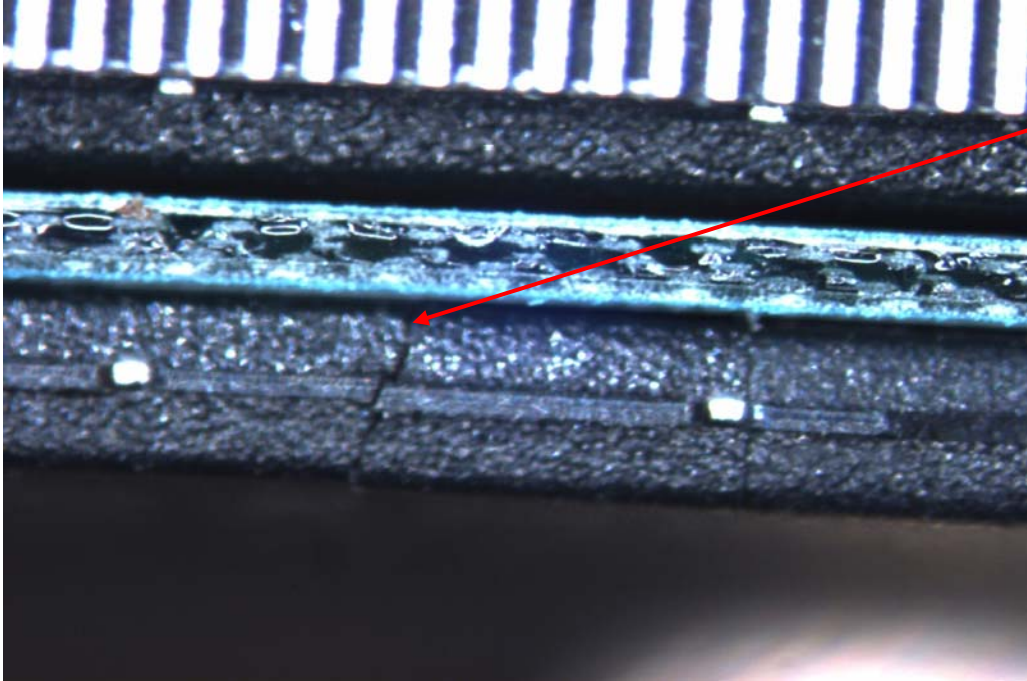
Photograph 4

The other memory device that was located on the top of the CF card appeared to have a very small hairline fracture that extended thru the device at approximately the half-way point. This fracture was severe enough to prevent the memory device from responding to attempts to read its information. (See photograph 4)

No useable information was recovered from either of the two flash memory devices that were installed on the CF card.
