NATIONAL TRANSPORTATION SAFETY BOARD

Multiple Electronic Devices

Specialist's Factual Report
by Bill Tuccio, Ph.D.

Location: Bloomington, Illinois
Date: April 7, 2015
Aircraft: Cessna 414A
Registration: N789UP
Operator: Make It Happen Aviation, LLC
NTSB Number: CEN15FA190

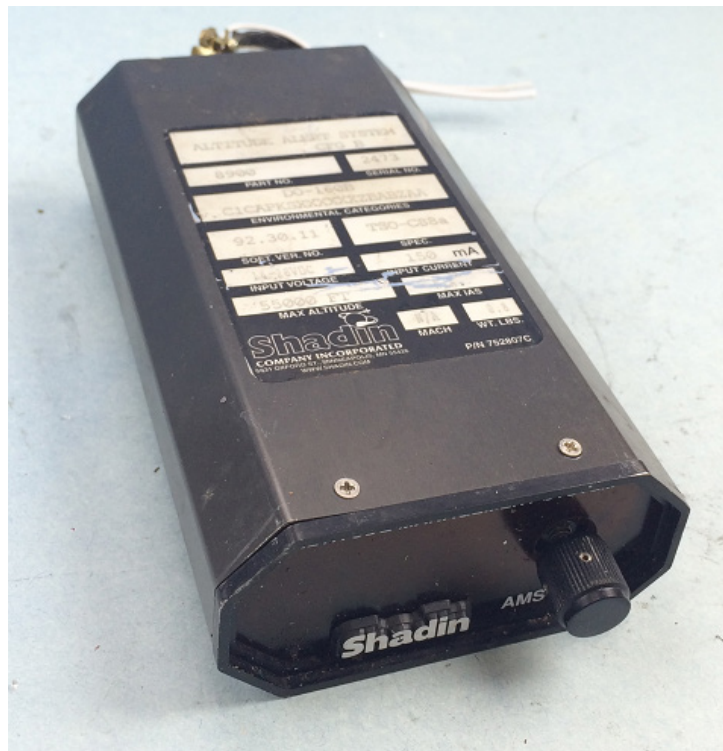
Figure 1. Shadin Altitude Alert System.

Upon arrival at the Vehicle Recorder Division, an exterior examination revealed the unit had not sustained any damage (see figure 1). External power was applied and the unit started normally. All display modes were examined.

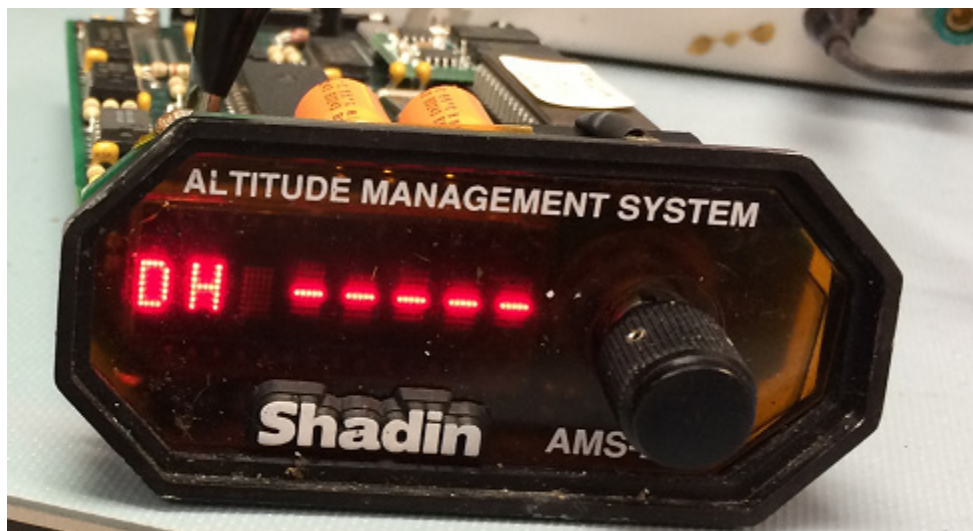
Figure 2. Shadin Altitude Alert System example display of decision height.

All altitude screens displayed blank values. Figure 2 is an example display for decision height. It could not be determined if the blank values were due to the device not being used by the pilot or if the values were not retained between power cycles.

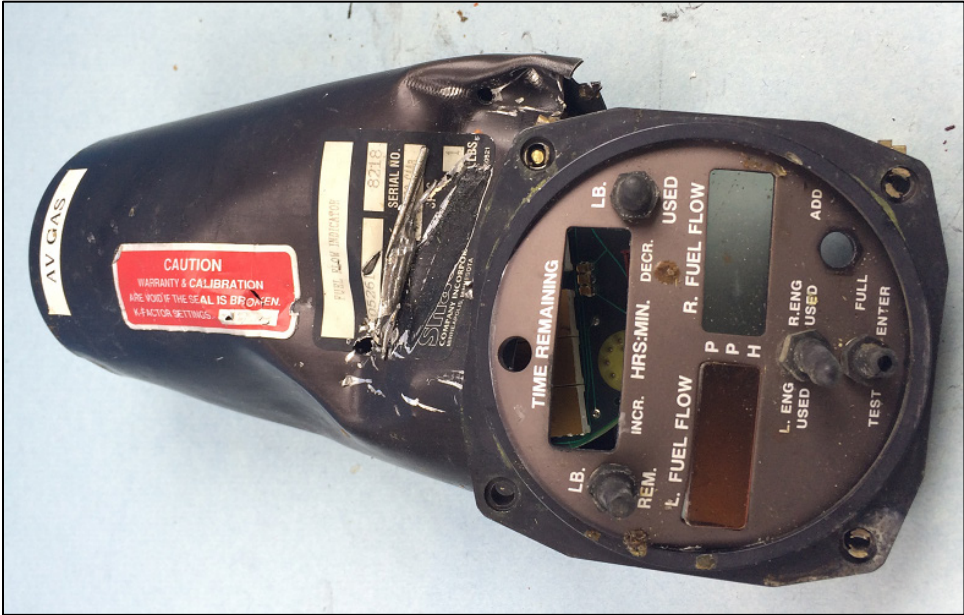
Figure 3. Shadin Fuel Flow Indicator as received.

Upon arrival at the Vehicle Recorder Laboratory, an exterior examination revealed the unit had sustained significant impact damage, as shown in figure 3. An internal inspection revealed the non-volatile memory¹ chip was cracked, as shown in figure 4.

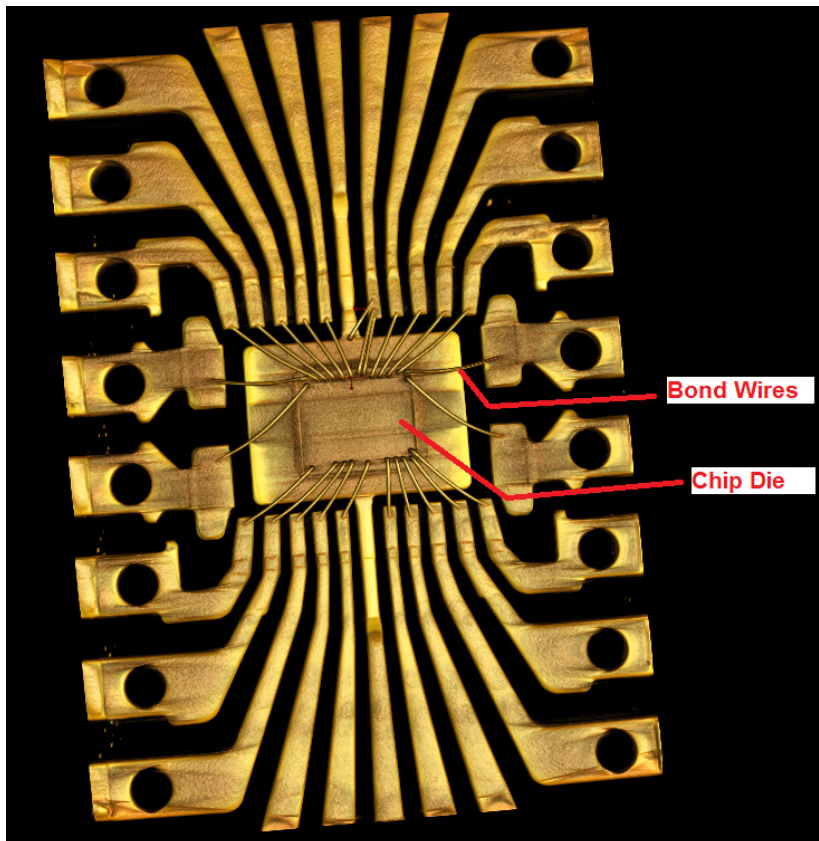
Figure 5. CT scan of chip internals.

The chip was examined using a computed tomography (CT) scan, as shown in figure 5. The CT scan showed the interior wire bonds were intact; however, the status of the chip die could not be determined. Attempts were made to read the chip using an EEPROM reader; however, these attempts were unsuccessful. The chip was then put in a surrogate device, and an error was received as shown in figure 6.

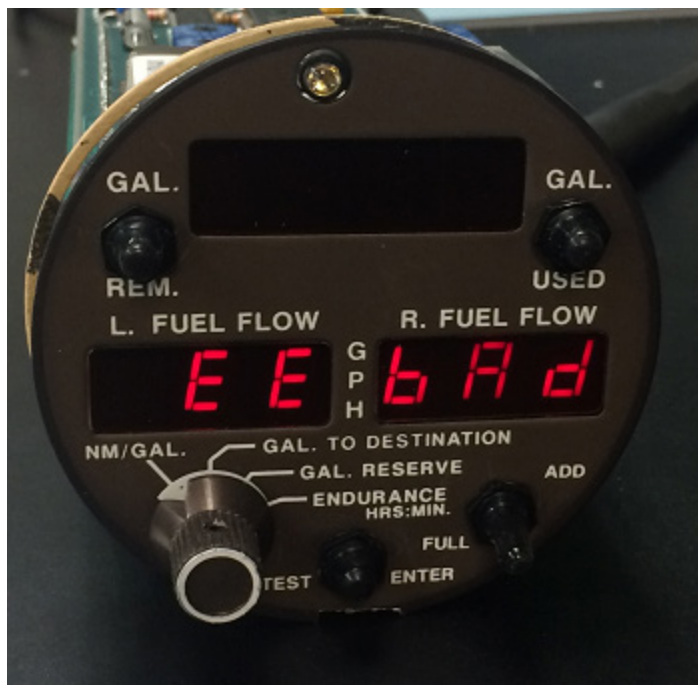
Figure 6. Readout with accident chip in surrogate.

No data was recovered from the Shadin fuel flow indicator.

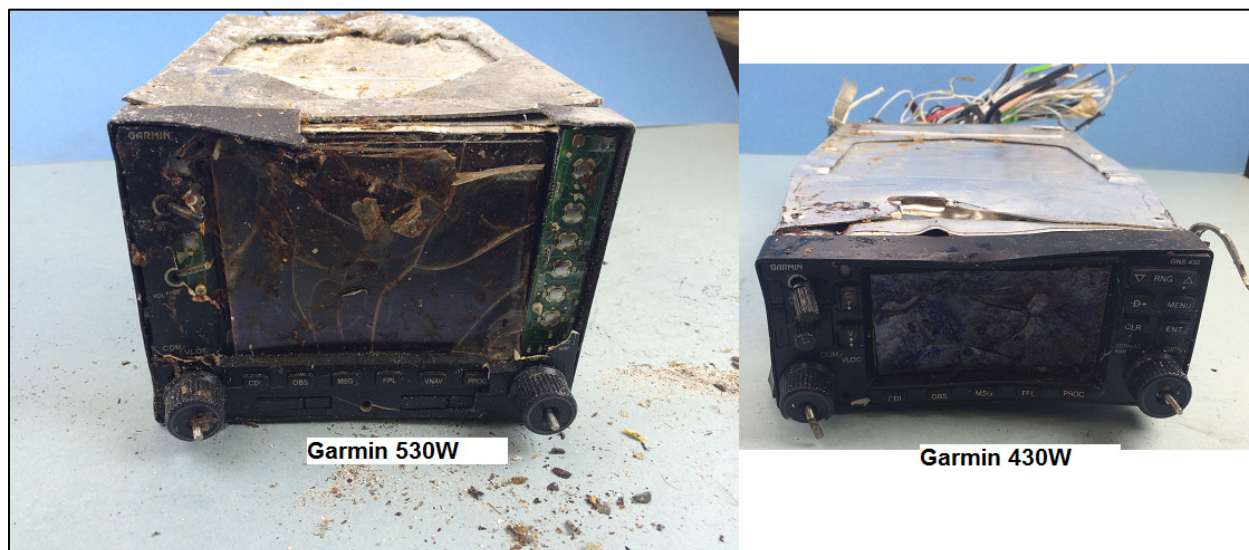
Figure 7. Garmin 530W and 430W as received.

Upon arrival at the Vehicle Recorder Laboratory, an exterior examination revealed both units had sustained significant impact damage, as shown in figure 7. The front-loading IFR database cards were undamaged and read in an NTSB Garmin 430. The screens and interface button panels on each unit were replaced and each unit powered on successfully; allowing last frequency and CDI mode to be examined.

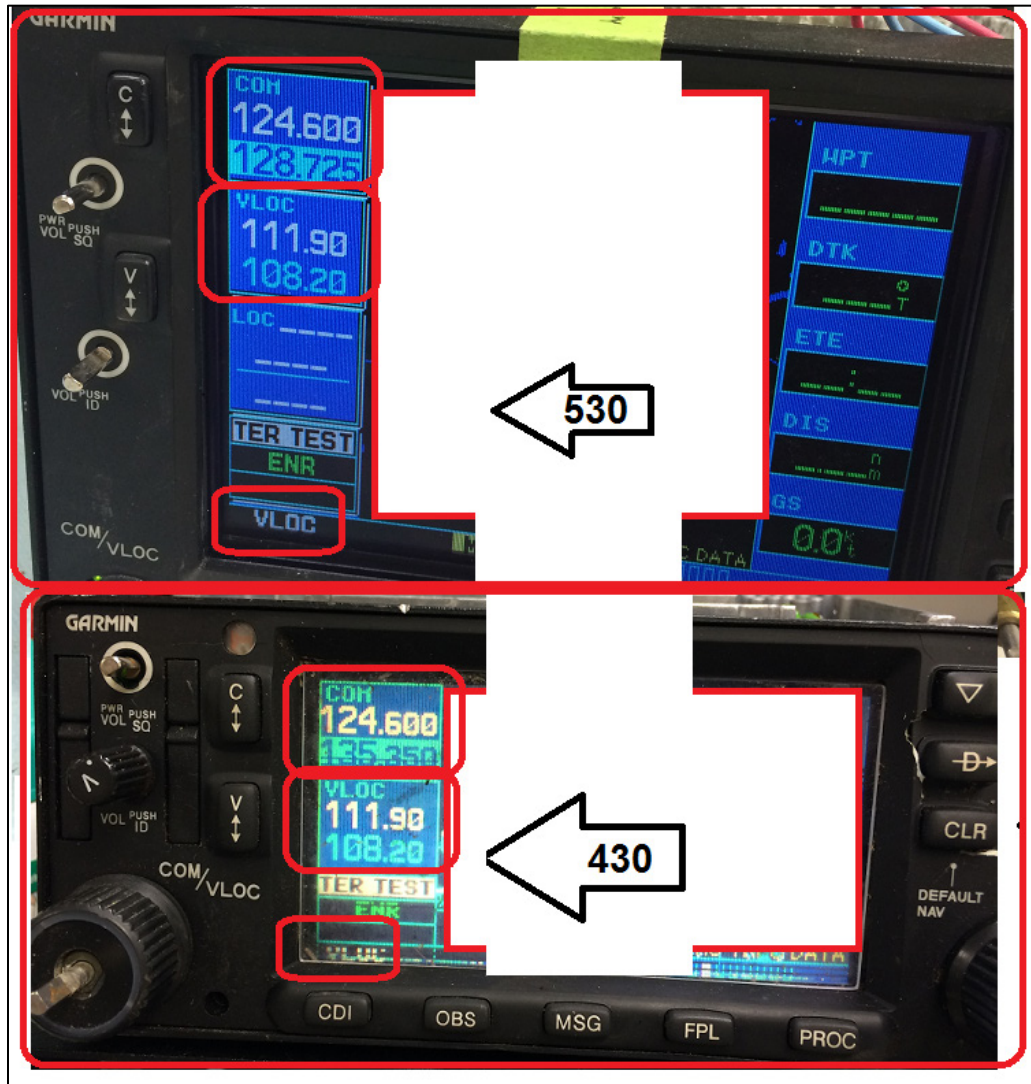
Figure 8. Garmin 530W/430W with front screen/button interface replaced.

The IFR database on both cards expired on April 30, 2015. Table 1 summarizes frequencies and CDI modes recovered from each unit, and figure 8 shows the units powered on with repaired screens. In figure 8, the navigation display area is redacted as the displayed information was related to the repair process and not the accident flight.

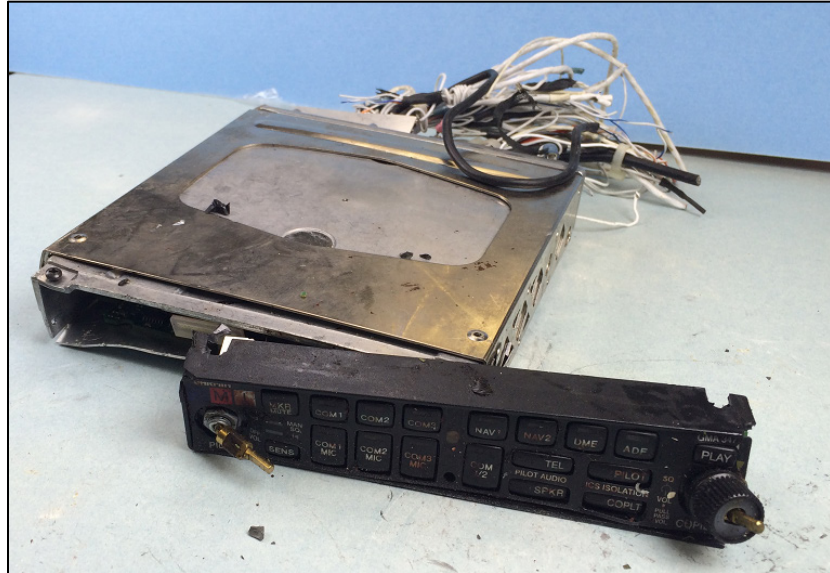
Figure 9. Garmin GMA 347 as received.

Upon arrival at the Vehicle Recorder Laboratory, an exterior examination revealed the unit had sustained significant impact damage, as shown in figure 9. Since the unit does not record any information, no effort was made to repair the unit.

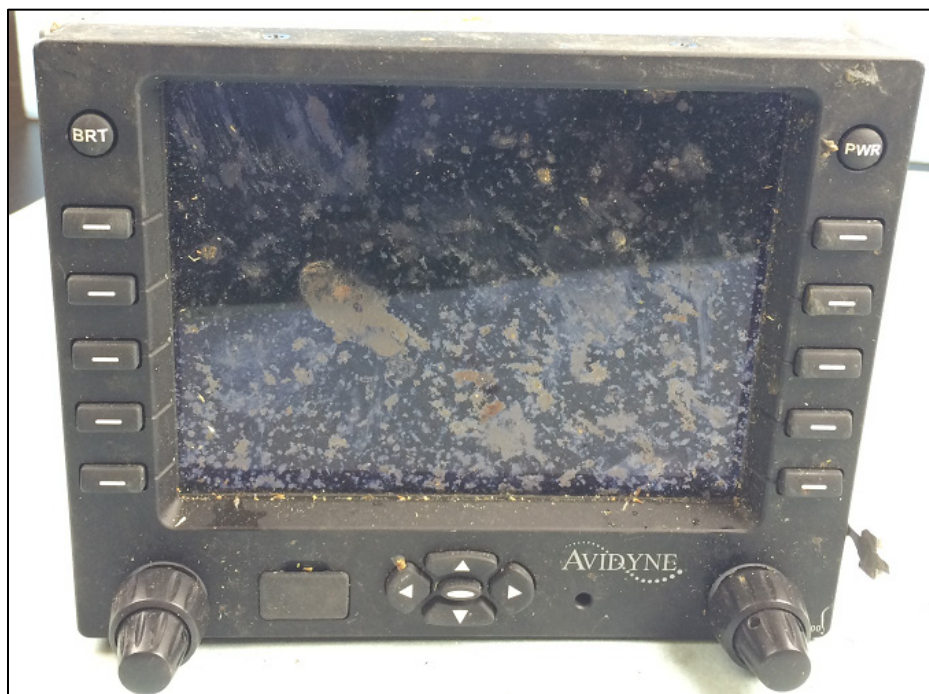
Figure 10. Avidyne EX600 as received.

Upon arrival at the Vehicle Recorder Laboratory, an exterior examination revealed the unit had sustained minor impact damage, as shown in figure 10. Given the nature of the recorded information, no attempt was made to recover information.

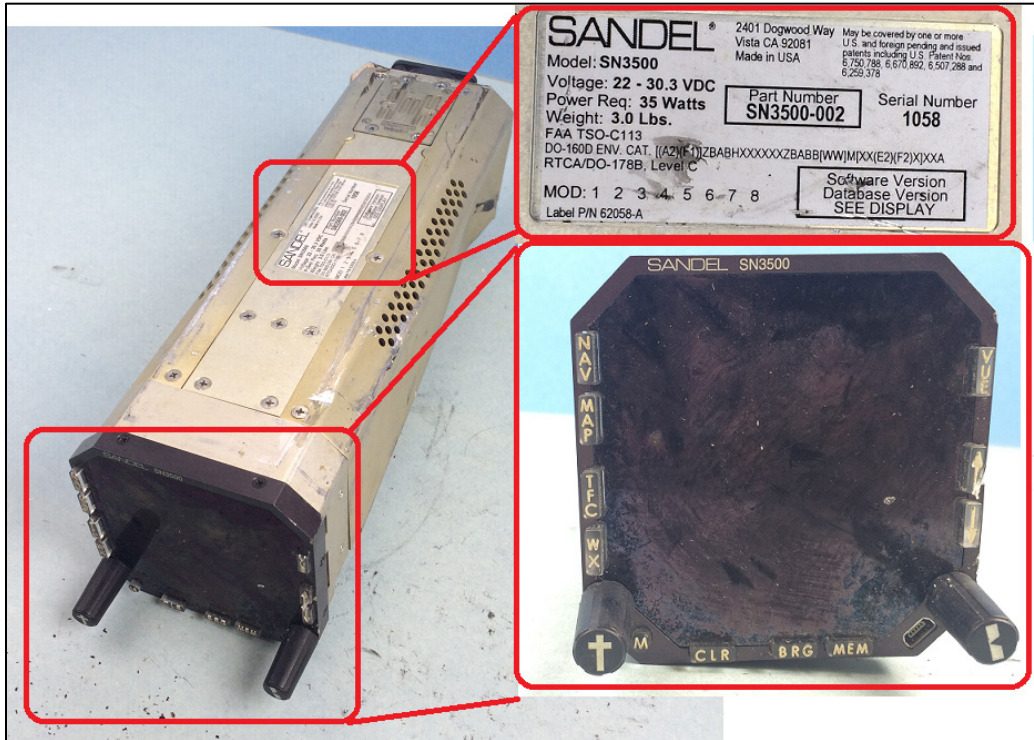
Figure 12. Sandel SN3500 as received (datatag and front of unit, expanded views).

Upon arrival at the Vehicle Recorder Laboratory, an exterior examination revealed the unit had sustained minor impact damage, as shown in figure 12. Due to the impact damage, the unit was sent to the manufacturer for downloading and decode of the information.

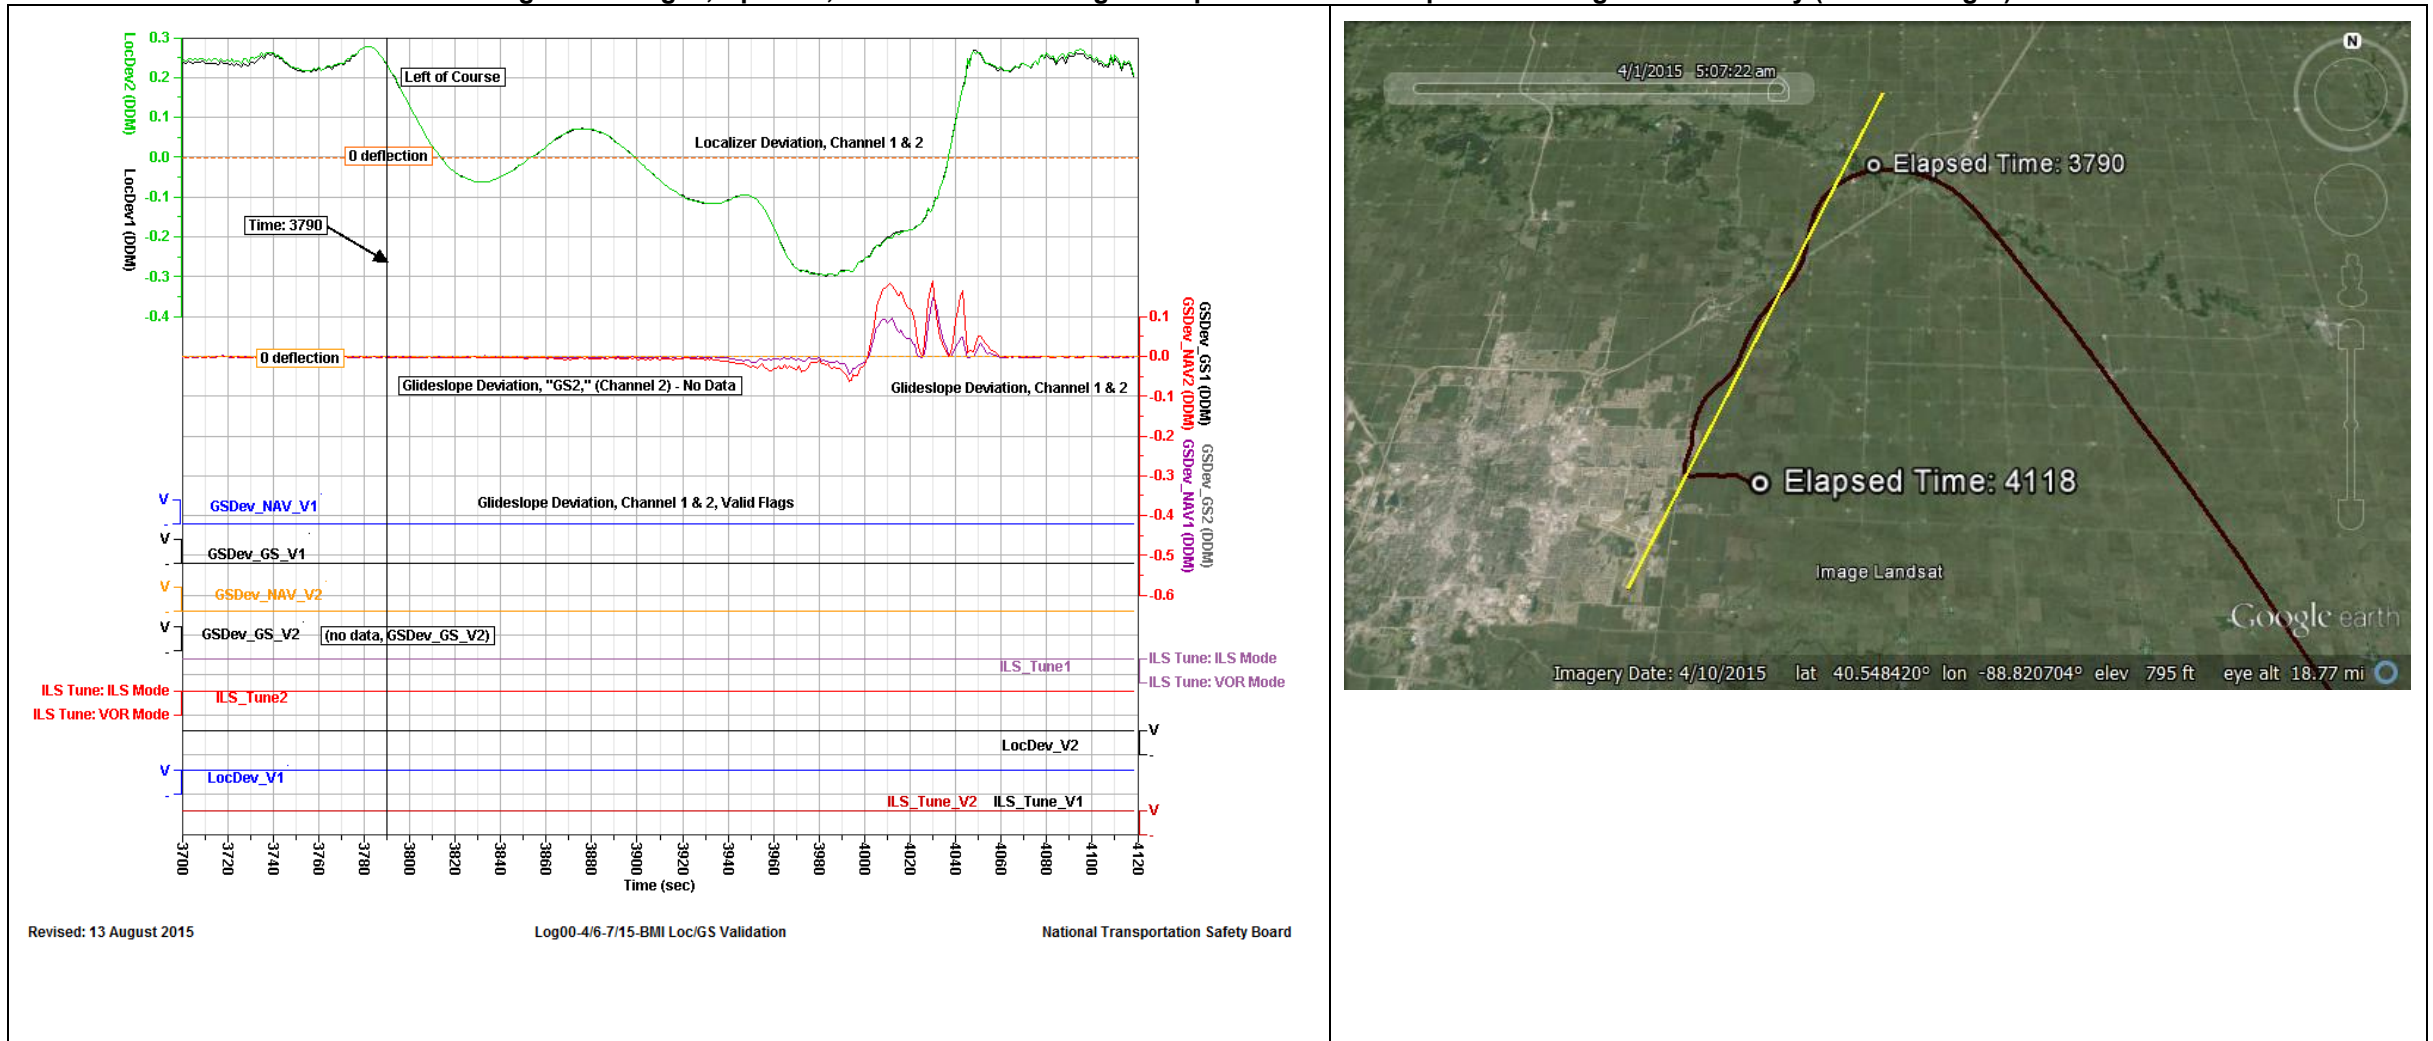
Figure 18. Log00, April 6/7, 2015 - localizer and glideslope deviations compared to Google Earth overlay (accident flight).

Figure/Log/Airport	Localizer	Glideslope
14/01/BMI	Nav 1 & Nav 2 both ILS mode and valid; positive (+) was left of course	Nav 1 & Nav 2 both achieved a valid state; first valid state occurred about 3.4nm from approach end of the runway (1.1 nm after EGROW outer marker)
15/04/MDW	Nav 1 & Nav 2 both ILS mode and valid; due to multiple parallel runways, sign could not be determined	Nav 1 & Nav 2 both achieved a valid state
16/06/BMI	Only Nav 1 in ILS mode and valid; negative (-) was right of course	Only Nav 1 in ILS mode and achieved a valid state
17/08/IND	Nav 1 & Nav 2 both ILS mode and valid; negative (-) was right of course	Nav 1 and Nav 2 both achieved a valid state; however, the valid state was achieved about 0.6 nm from the approach end of the runway.
18/00/BMI	Nav 1 & Nav 2 both ILS mode and valid; positive (+) was left of course	Nav 1 and Nav 2 never achieved a valid state

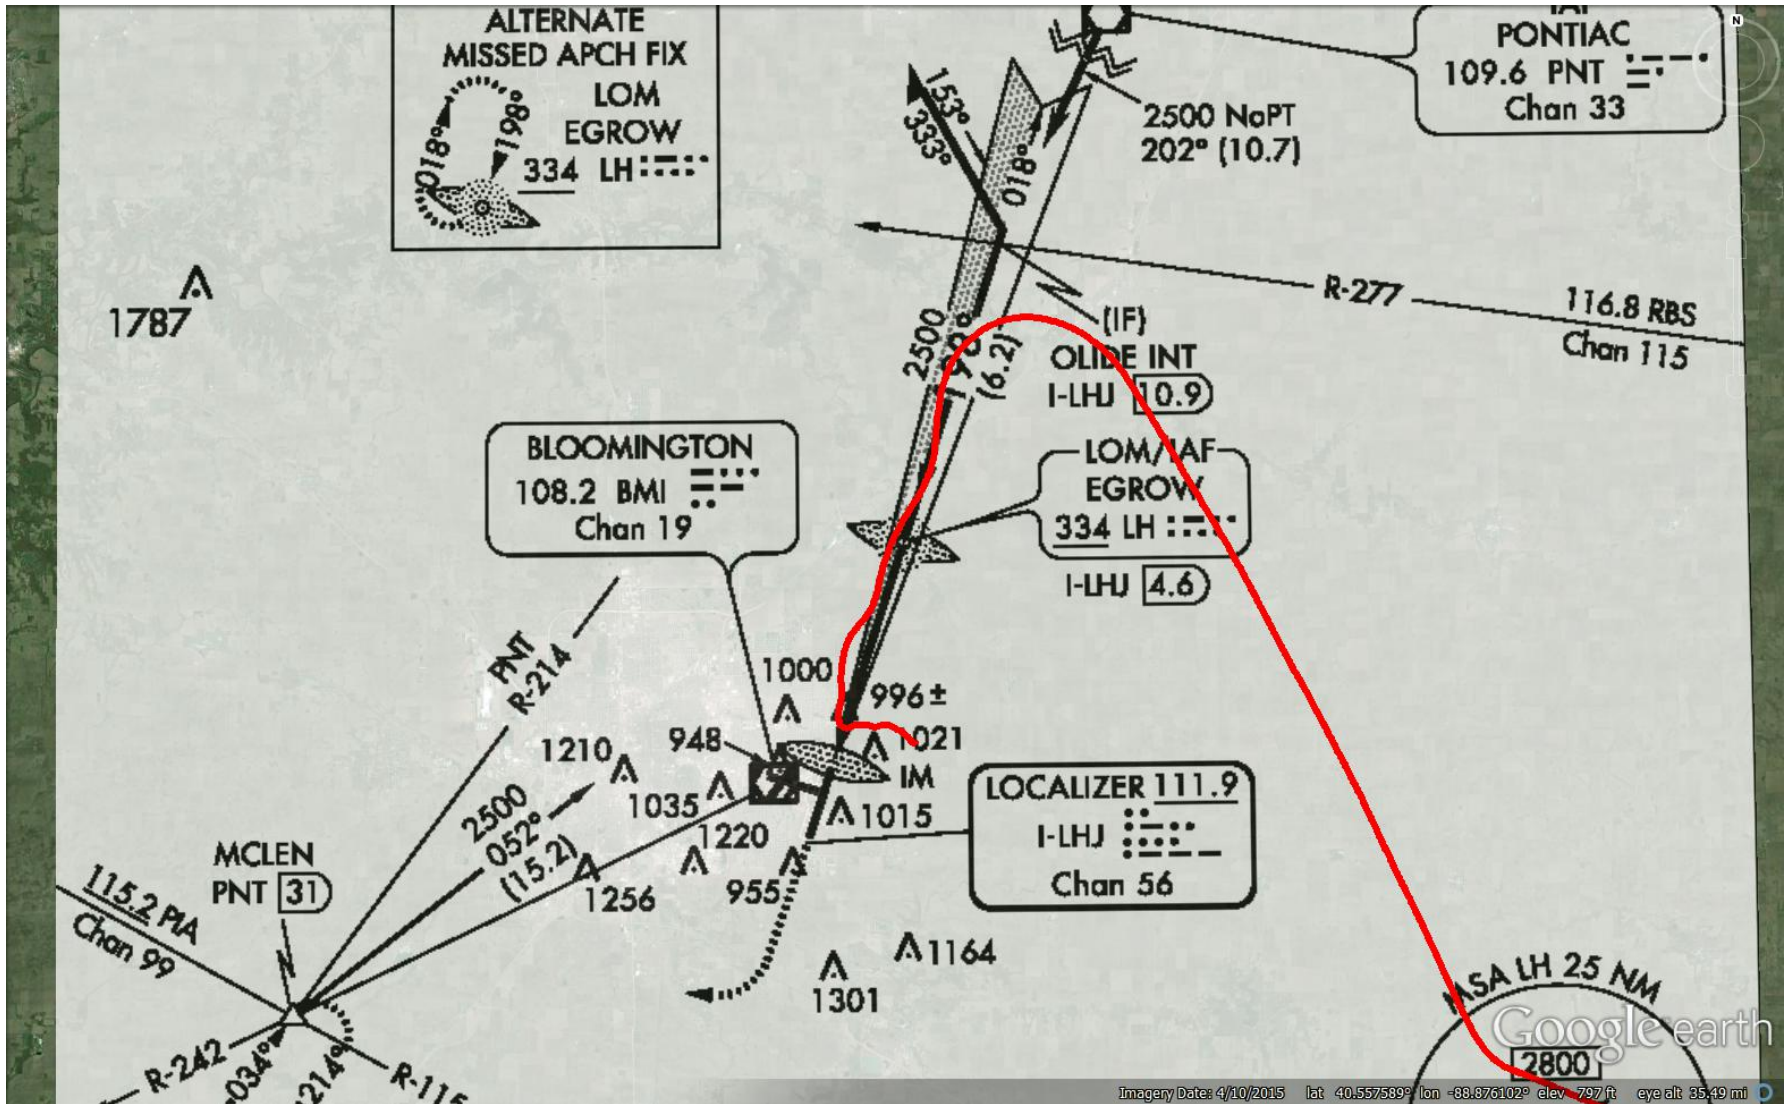
Figure 19. Accident flight path overlaid on the FAA BMI ILS Runway 20 approach chart (planview).

Figure 19 shows the flight path overlaid on the planview portion of the FAA ILS Runway 20 approach procedure. The aircraft intercepted the final approach course inside OLIDE intersection. By the outer marker (EGROW), the aircraft was slightly right of the approach course and continued on the right side until just before the inner marker, at which time the aircraft path deviated nearly 90 degrees to the left.

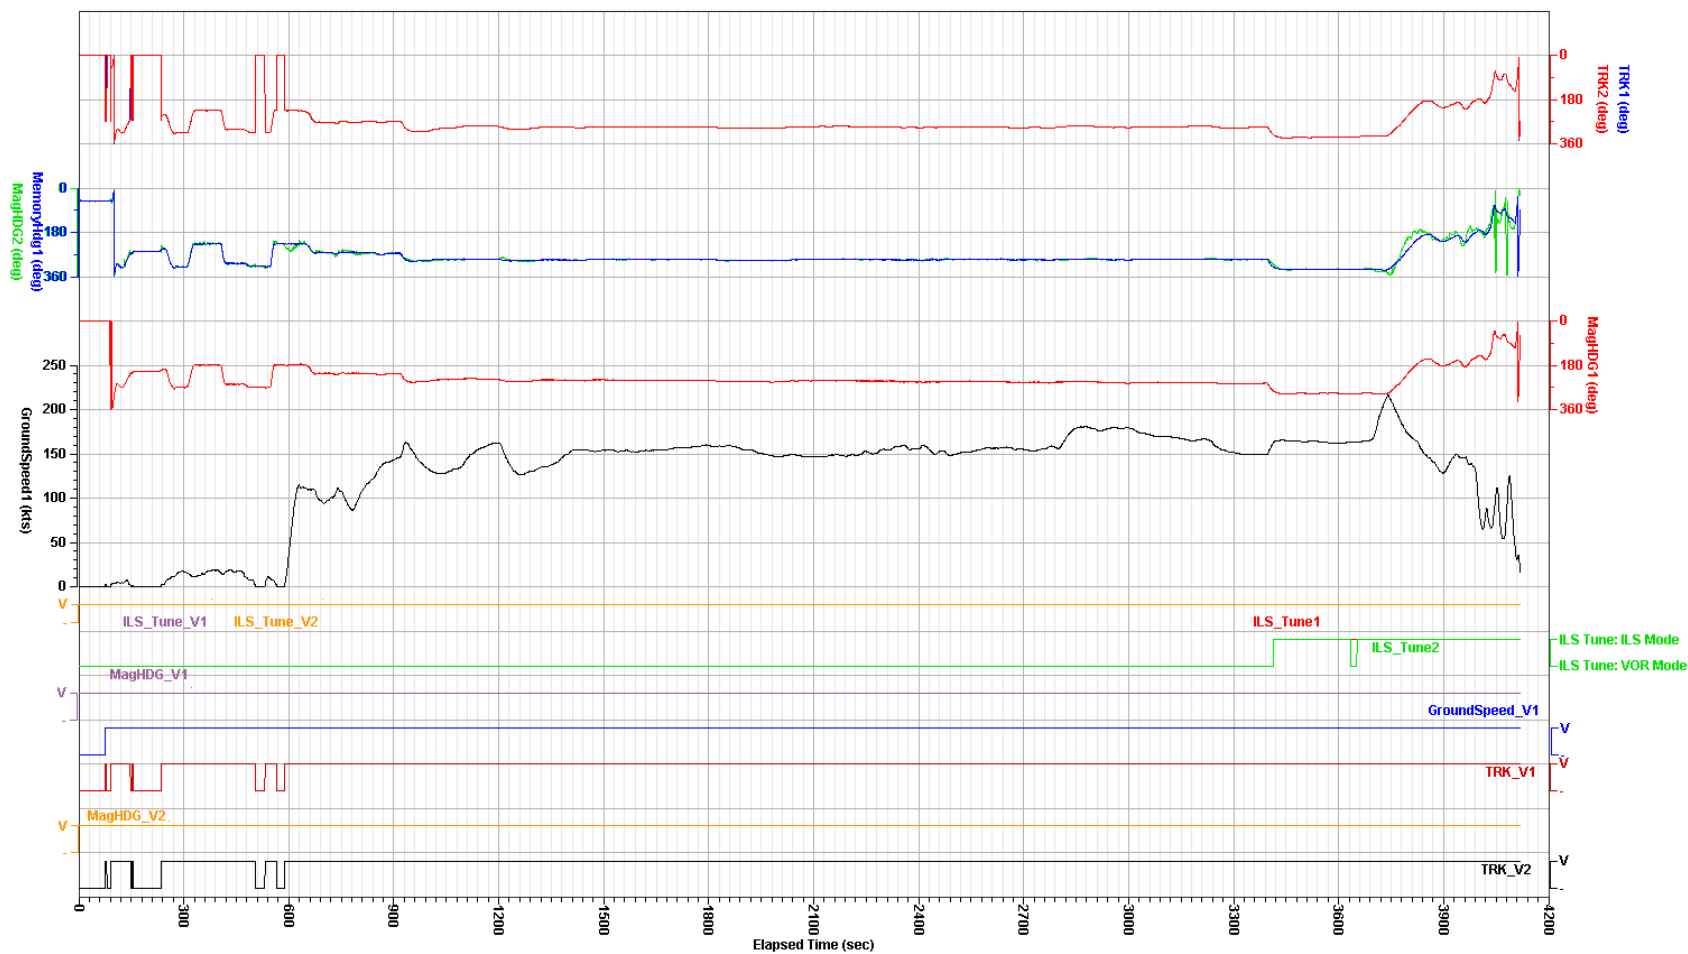
Figure 20. Accident flight parameters.

Figures 20 and 21 show plots of available parameters for the accident that were not already plotted previously. Figure 20 shows the aircraft departure and enroute portions, consistent with the ground track shown in figures 13 and 18. At about 3,990 elapsed time, the groundspeed began to decrease from about 130 kts to 65 kts in 22 seconds as MemoryHdg1 remained relatively constant at about 170 degrees.

From about 4,012 to 4,035 elapsed time, the ground speed once again fluctuated, and towards the end of this fluctuation, the MemoryHdg1 began to turn towards the left. By 4,046 elapsed time, MemoryHdg1 had reached 69 degrees.

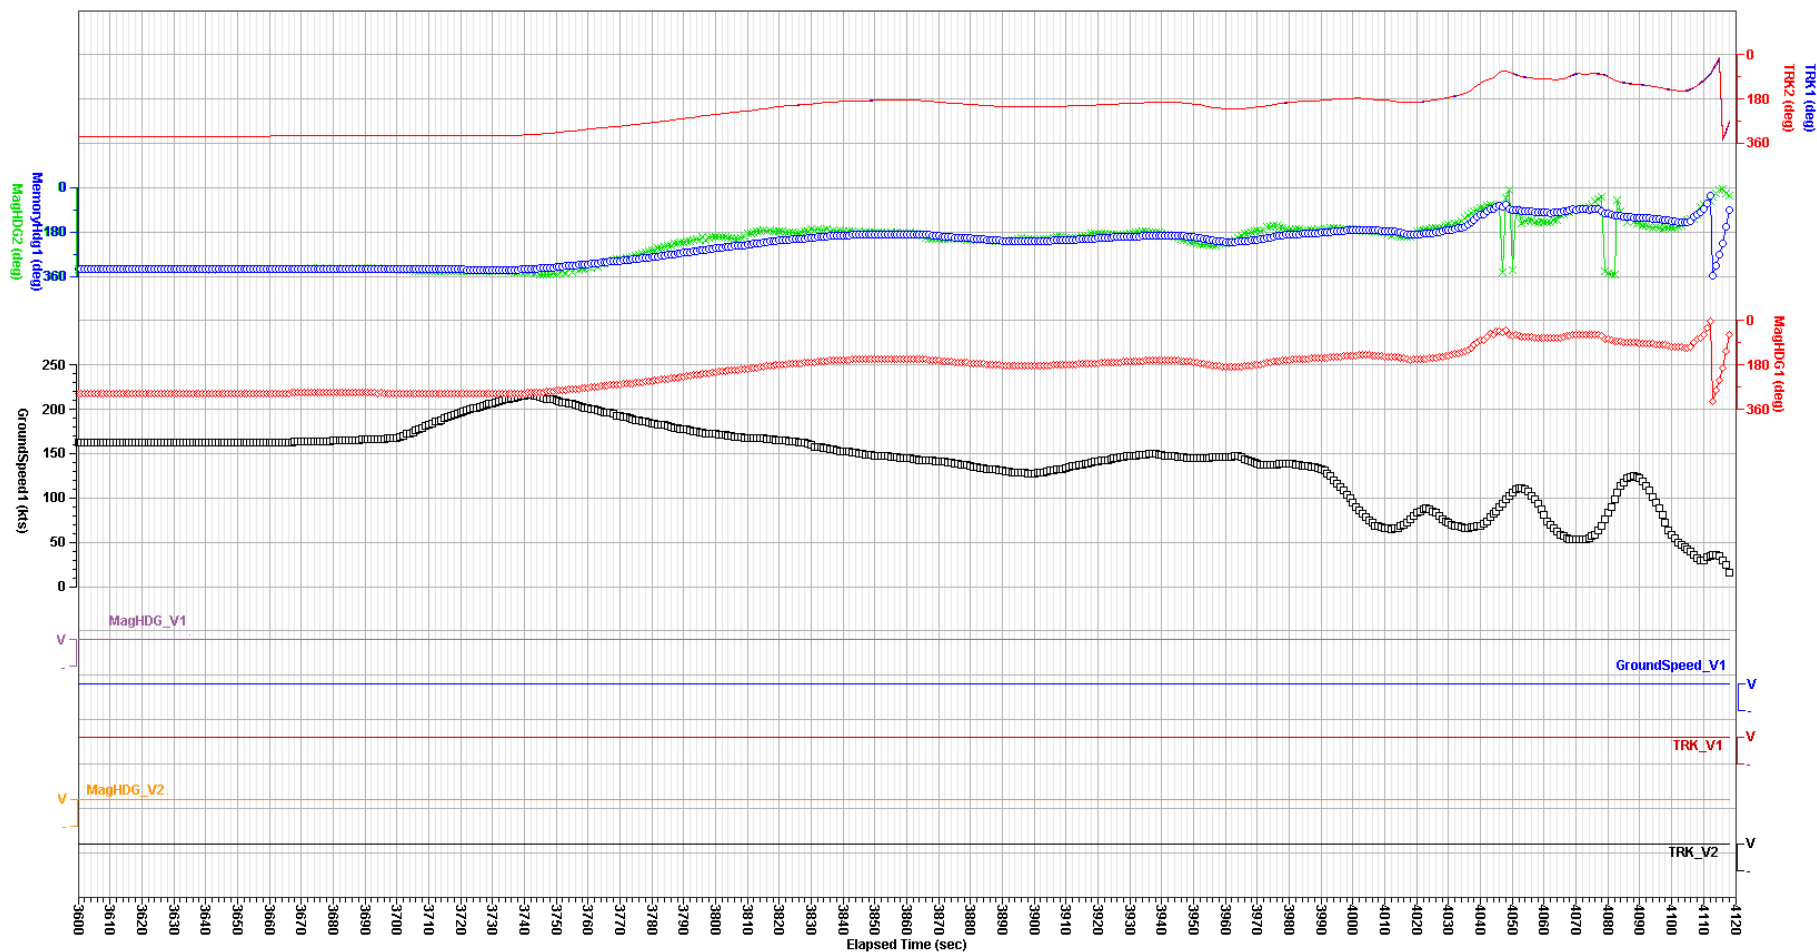
Figure 21. End of accident flight parameters.

From 4,046 until the end of the recording at 4,118, the groundspeed fluctuated from 110 kts, to 54 kts, then to 125 kts, followed by a final deceleration that continued until the end of the recording.

From 4,105 until the end of the recording, MemoryHdg1 continued in a left turn of more than 360 degrees.
