**NATIONAL TRANSPORTATION SAFETY BOARD**  
Vehicle Recorder Division  
Washington, D.C. 20594

## **Multiple Electronic Devices**

**Specialist's Factual Report**  
**by Bill Tuccio, Ph.D.**

Location:               Iola, Kansas  
Date:                    October 1, 2016  
Aircraft:               Lancair Evolution  
Registration:           N83DM  
Operator:               Aero Smart Solutions, Inc.  
NTSB Number:          CEN17LA009

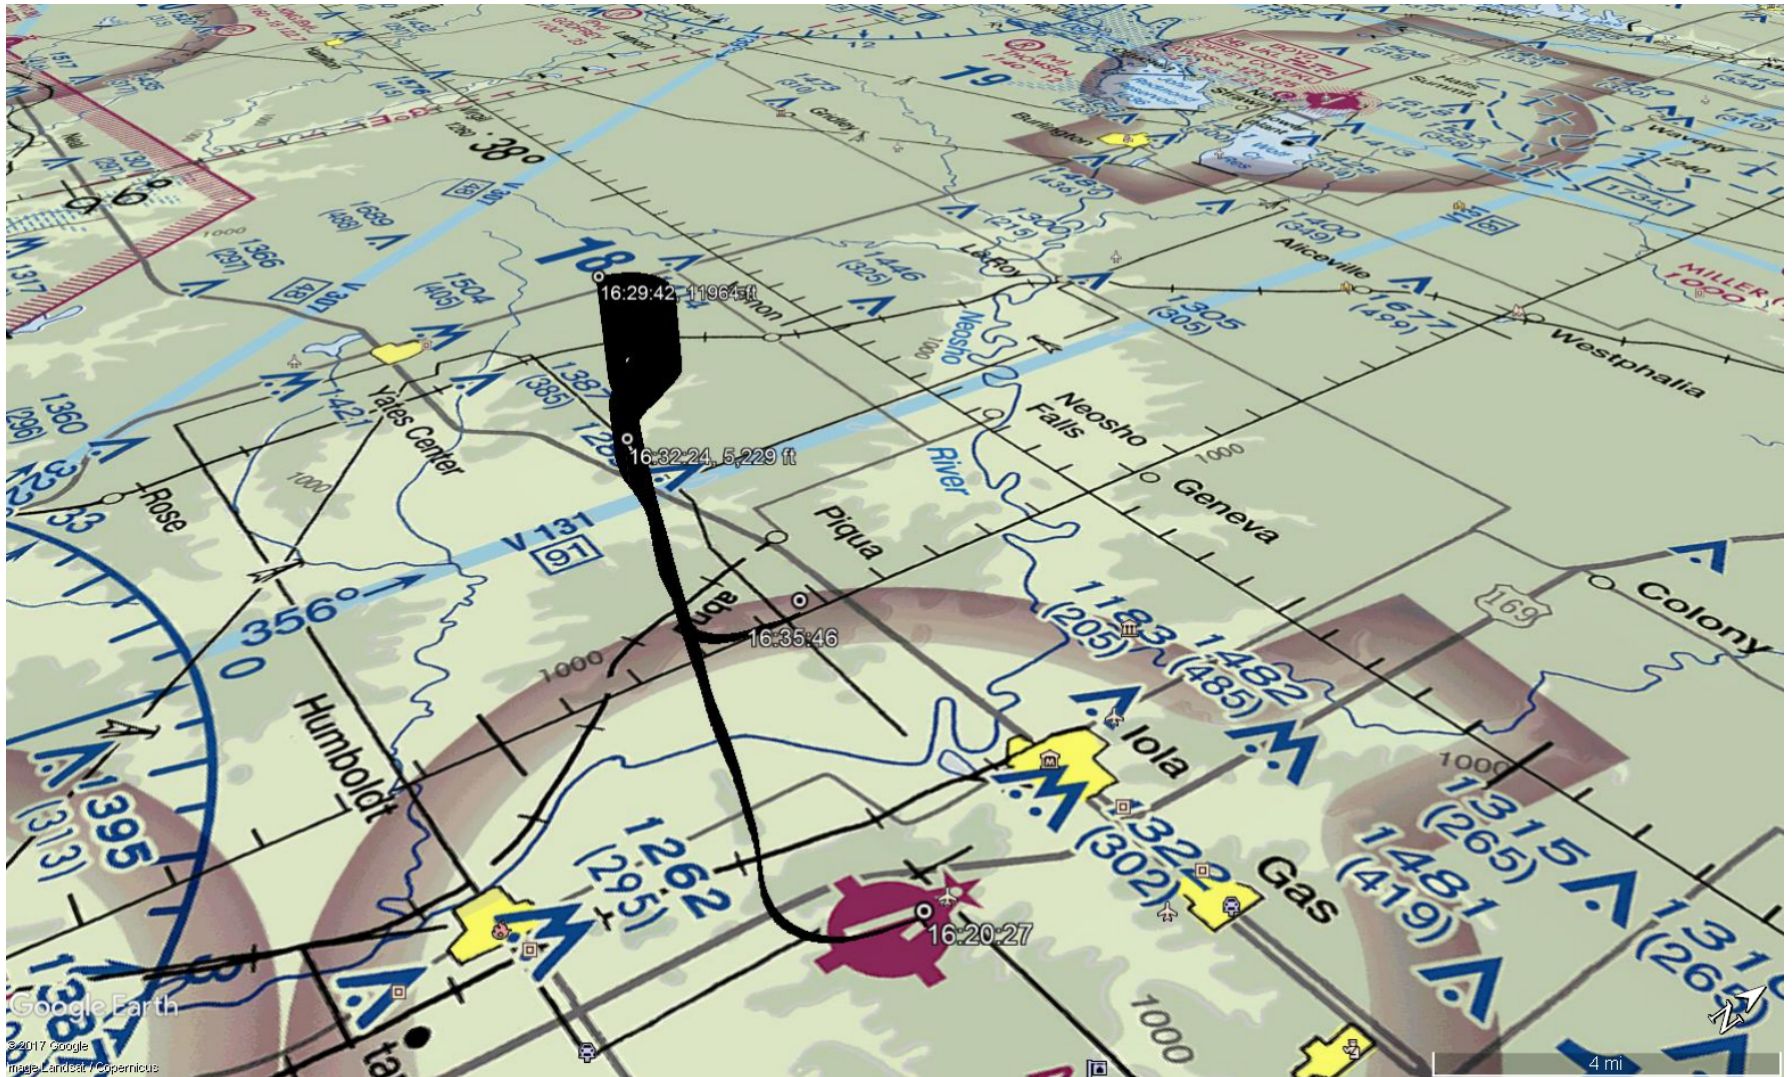
Figure 1. Overlay of accident flight.

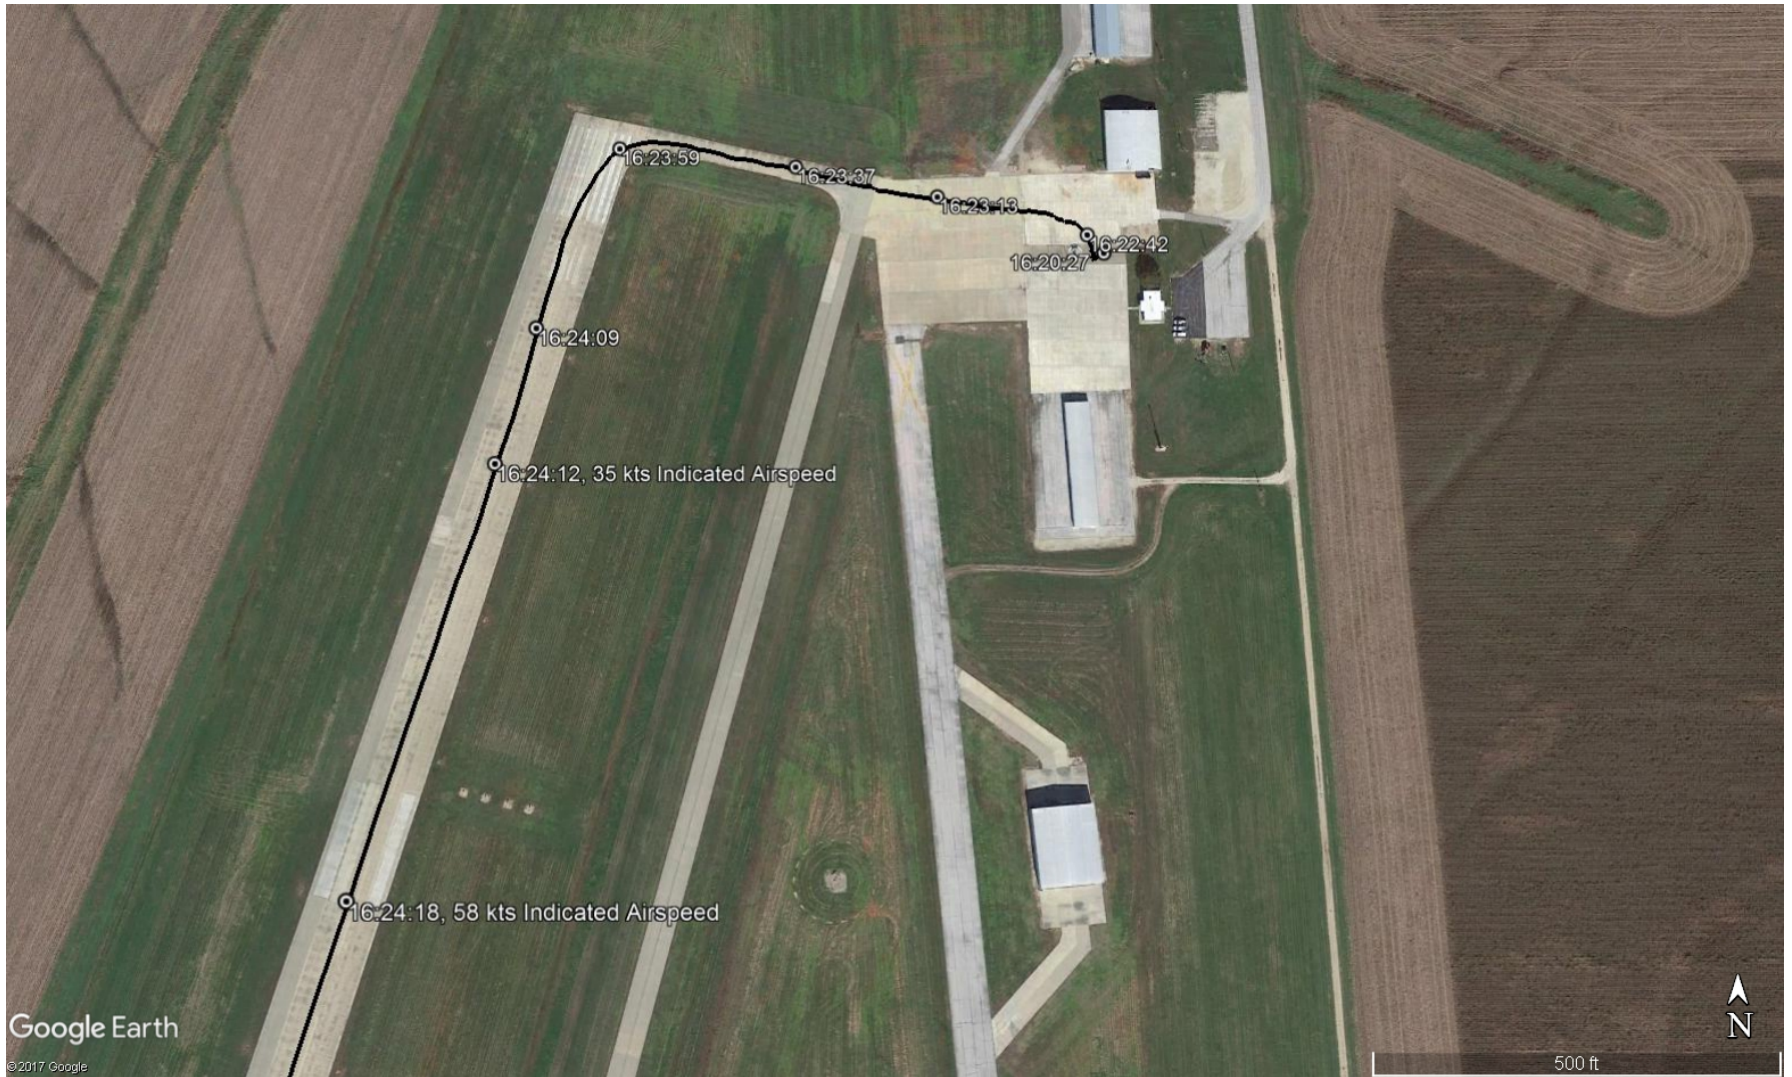
Figure 2. Overlay of start of accident recording.

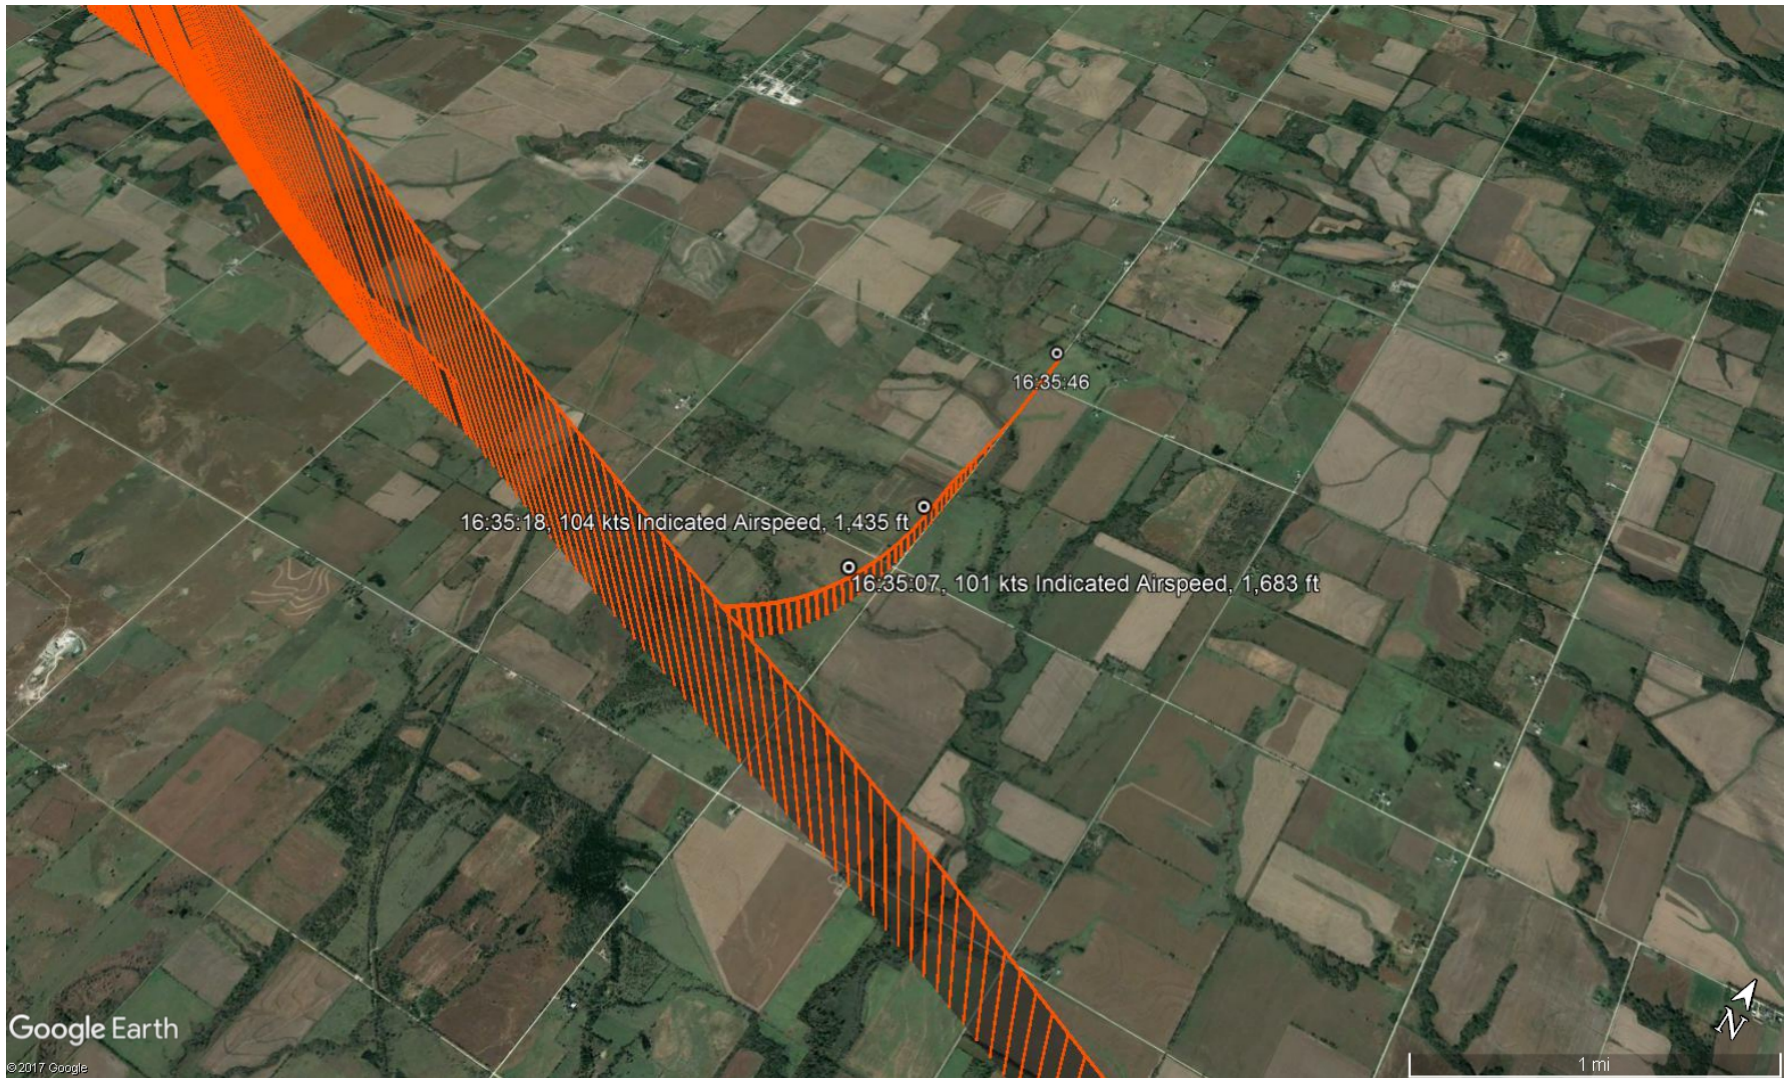
Figure 3. Overlay of end of accident recording.

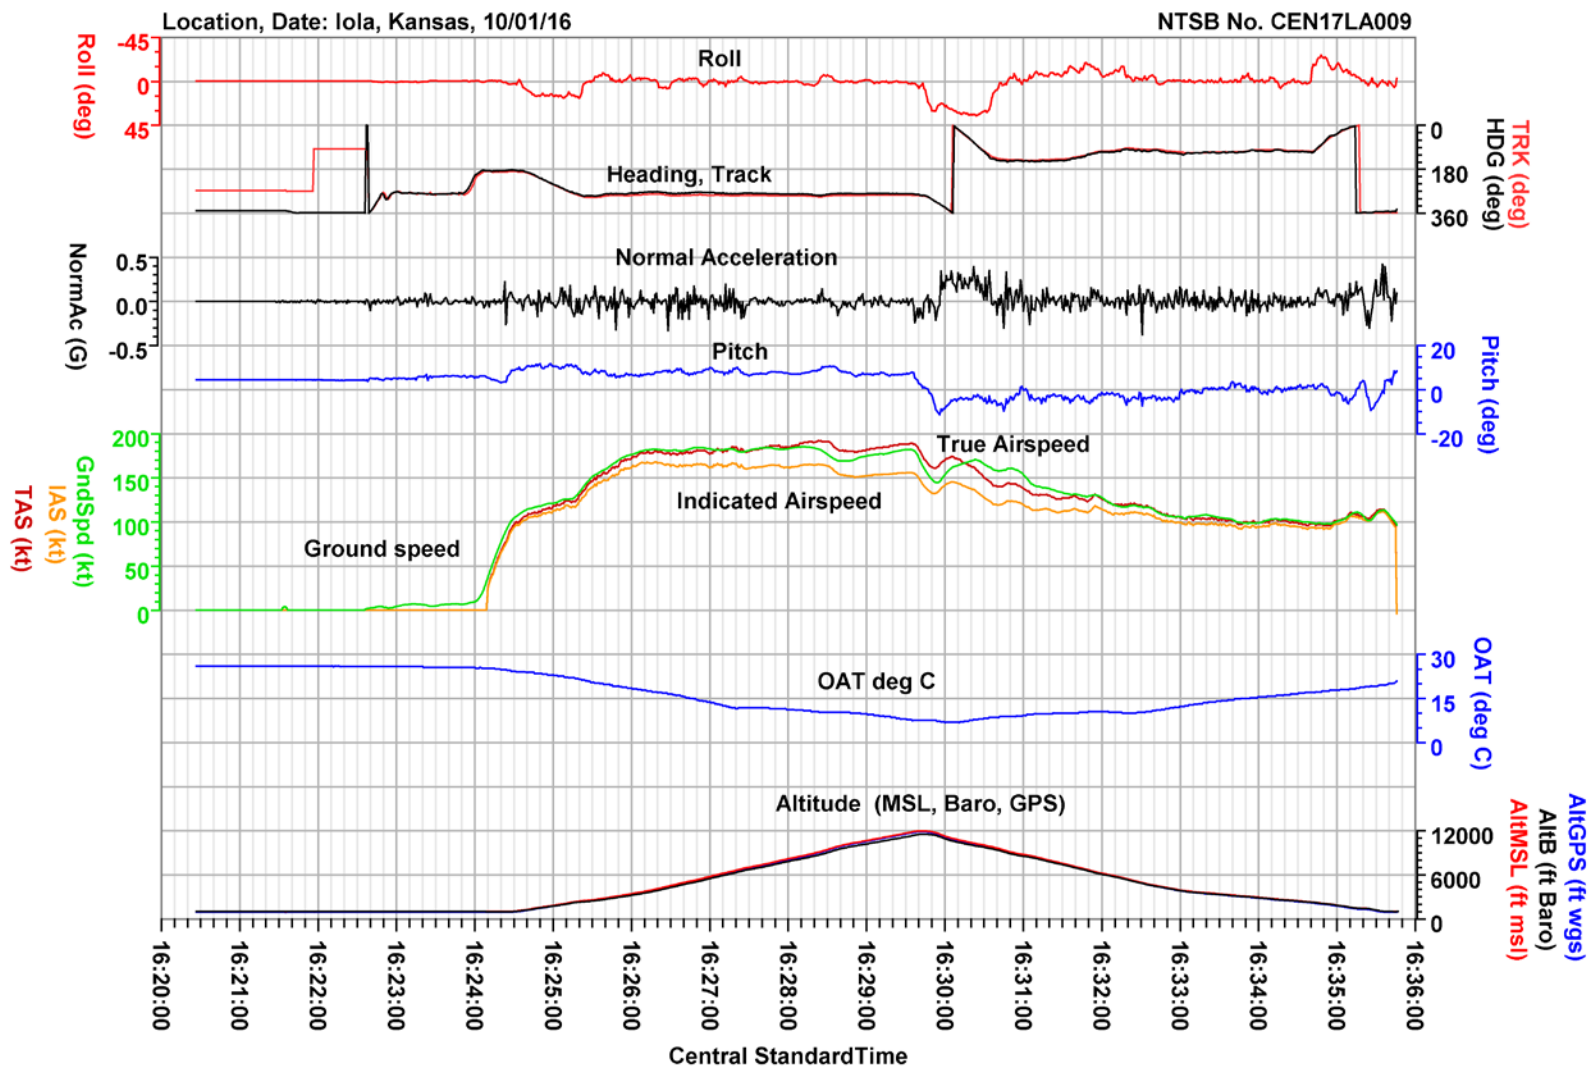
Figure 4. Plot of Garmin G900X data.

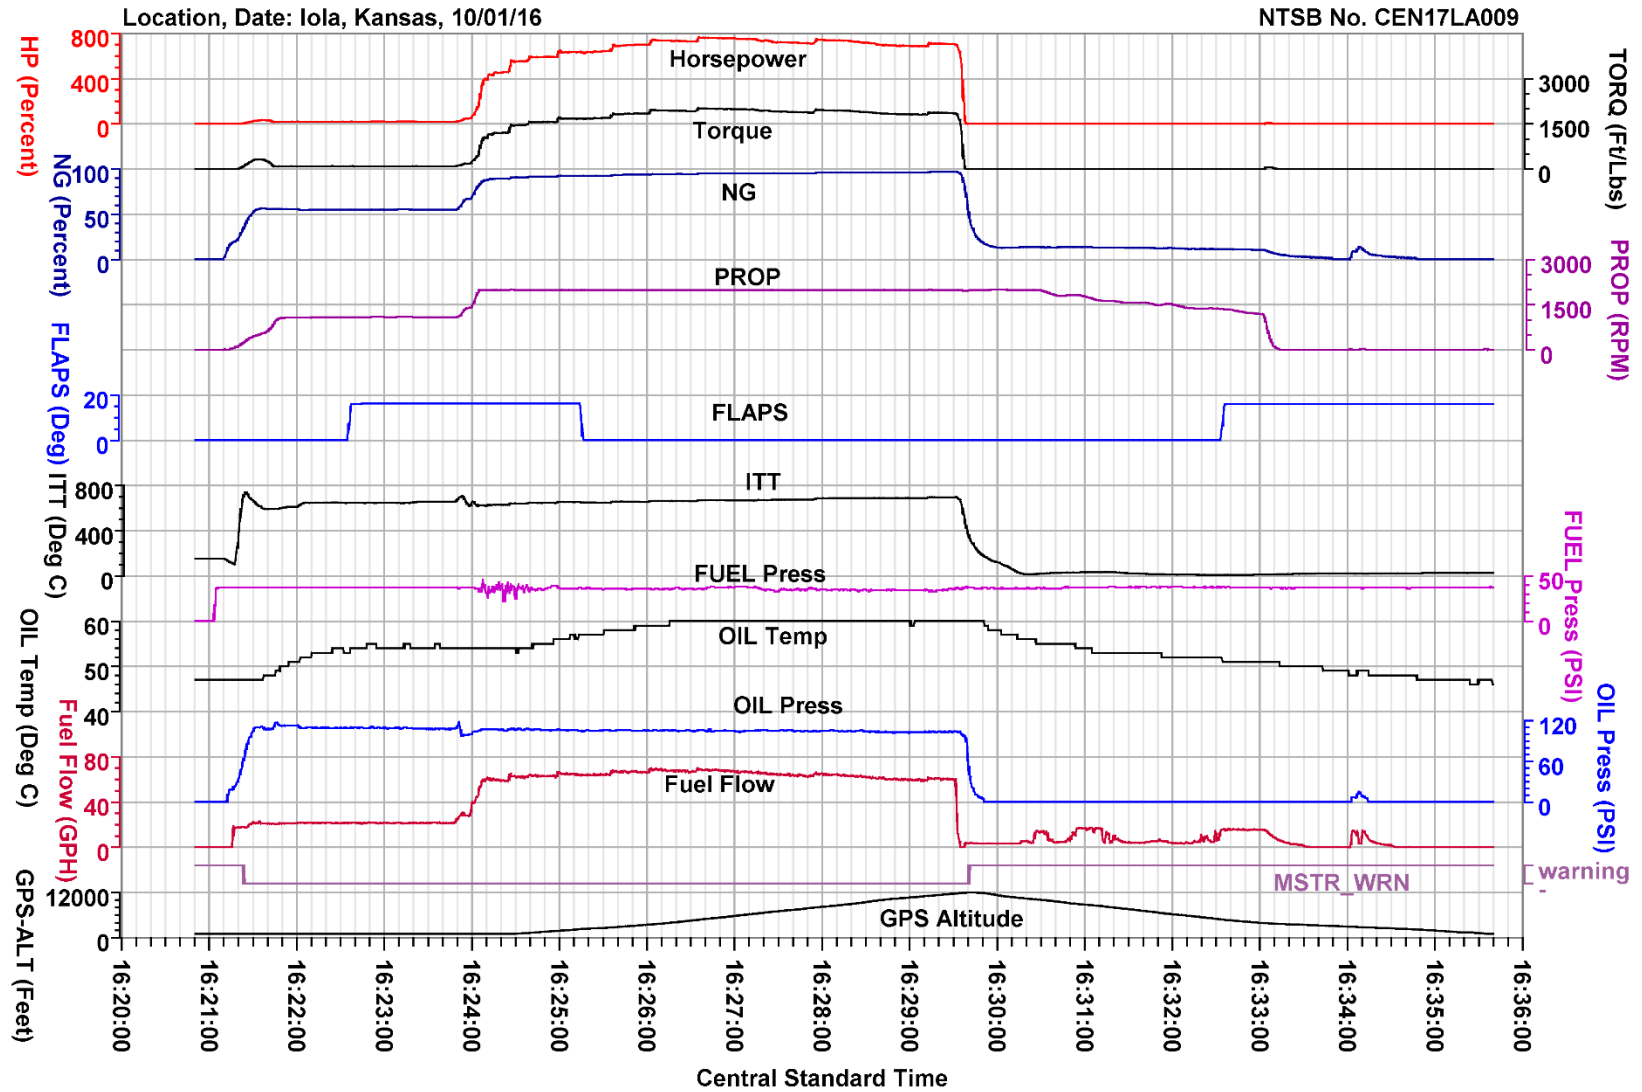
- The recording began on the ground at Allen County airport (K88) at 16:20:27 CST.
- By 16:24:09 CST, the aircraft began its takeoff run at K88.
- By 16:25:43 CST, the aircraft was climbing westerly.
- At 16:29:33 CST, fuel flow decreased.
- By 16:29:40 CST, oil pressure began to decrease.
- At 16:29:45 CST, the aircraft reached a maximum GPS altitude of 11,860 feet. At about this time, the aircraft started a right turn, and began to head easterly.
- Between 16:29:45 CST and the end of the recording at 16:35:45 CST, the aircraft descended, and then turned left towards the north.

Figure 5. Plot of EI MVP-50P data for entire accident recording.

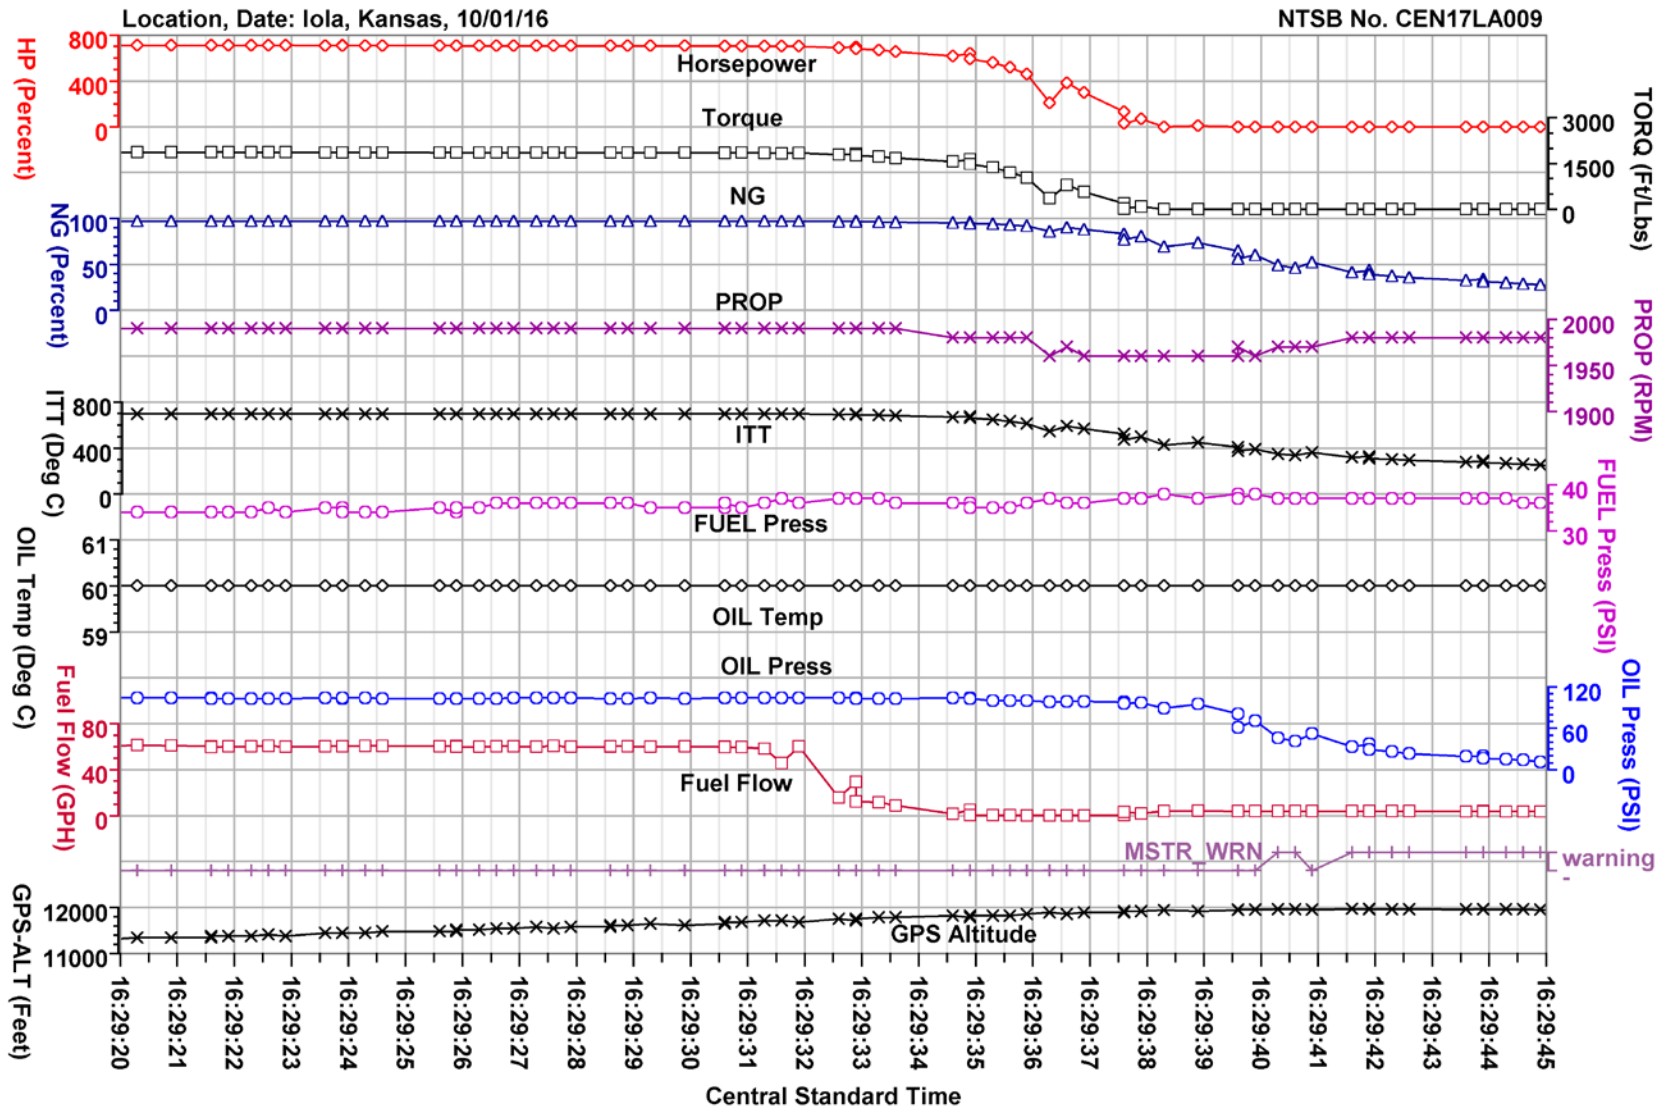
Figures 5 and 6 show plots of the EI MVP-50P engine data, with figure 6 showing a zoomed view near the time of the engine power loss.

Figure 6. Plot of EI MVP-50P data at time of power loss.

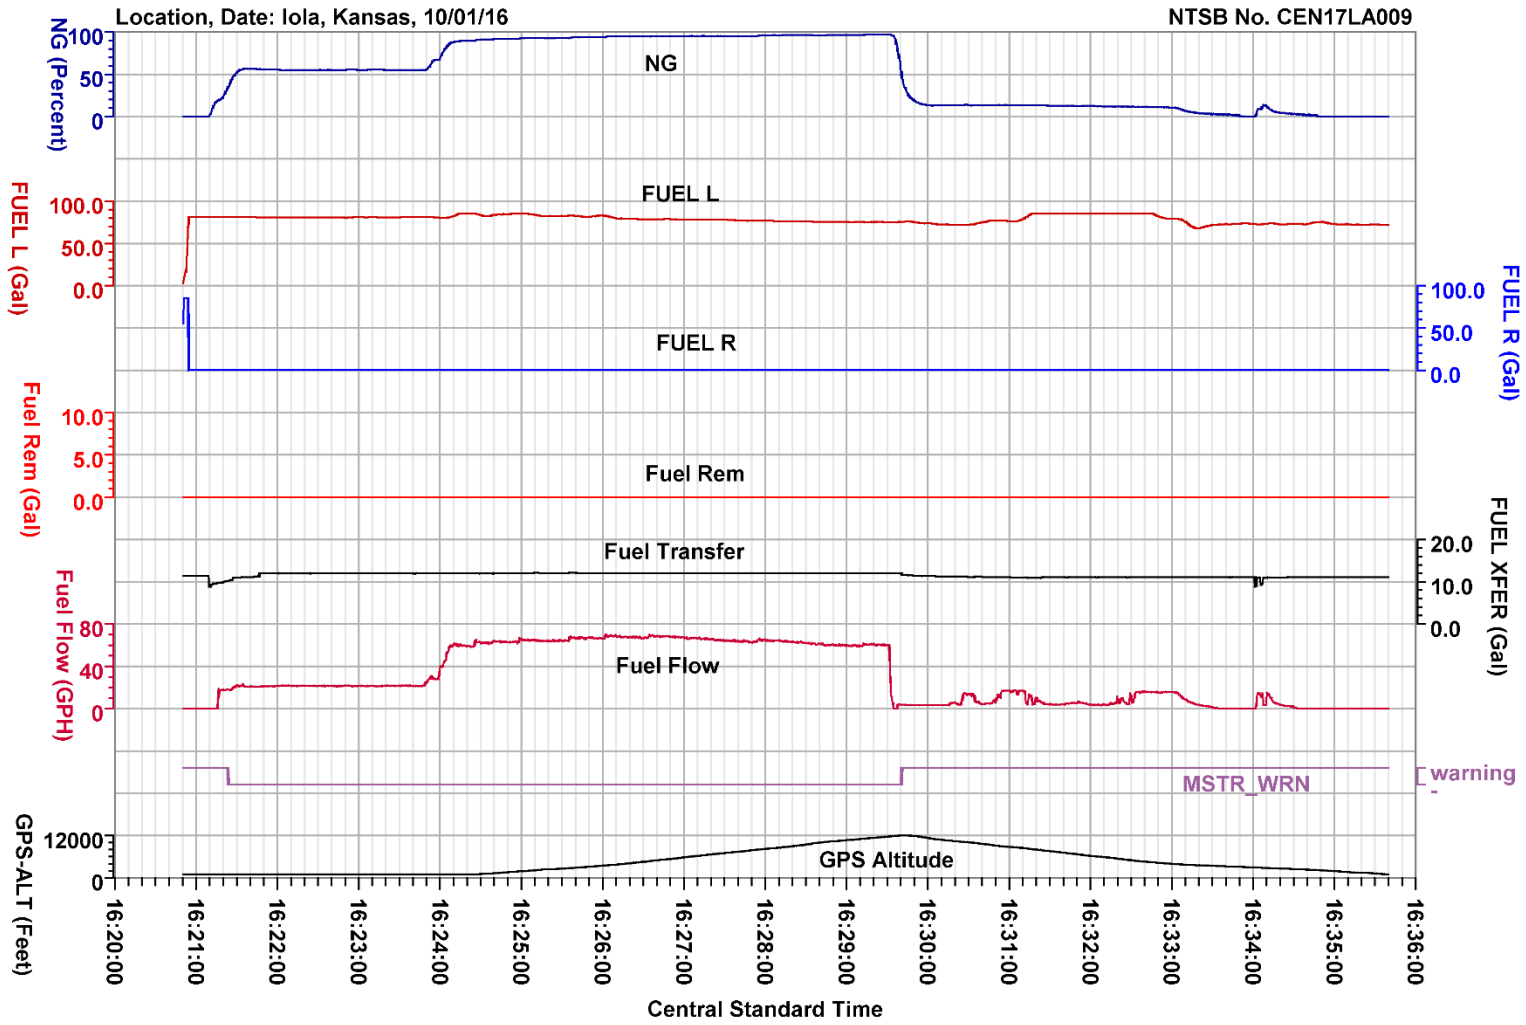
Note: The electromechanical source and accuracy of FUEL L, FUEL R, Fuel Rem, and FUEL XFER could not be verified for this report.

Figure 7. Plot of EI MVP-50P fuel-related data.
