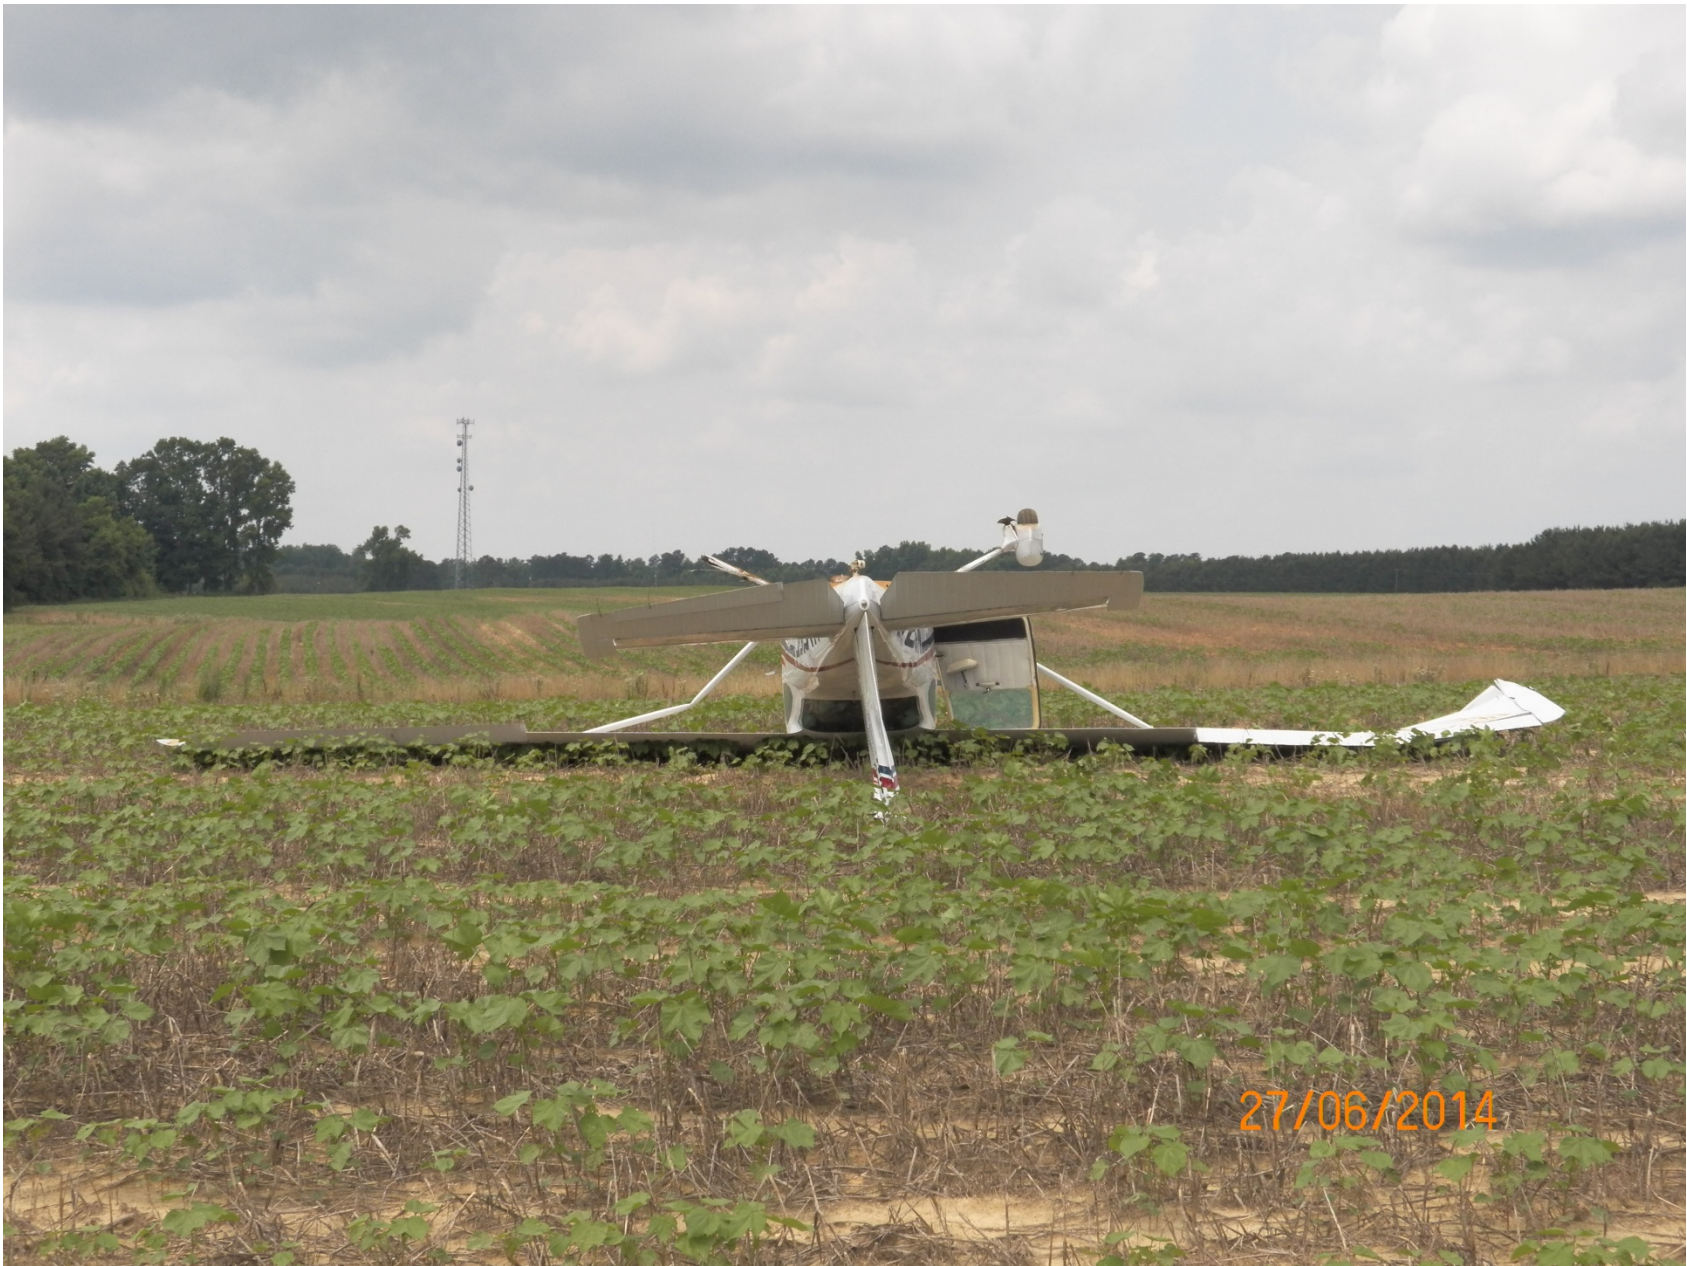
**Photo 1 – Rear view of airplane inverted**

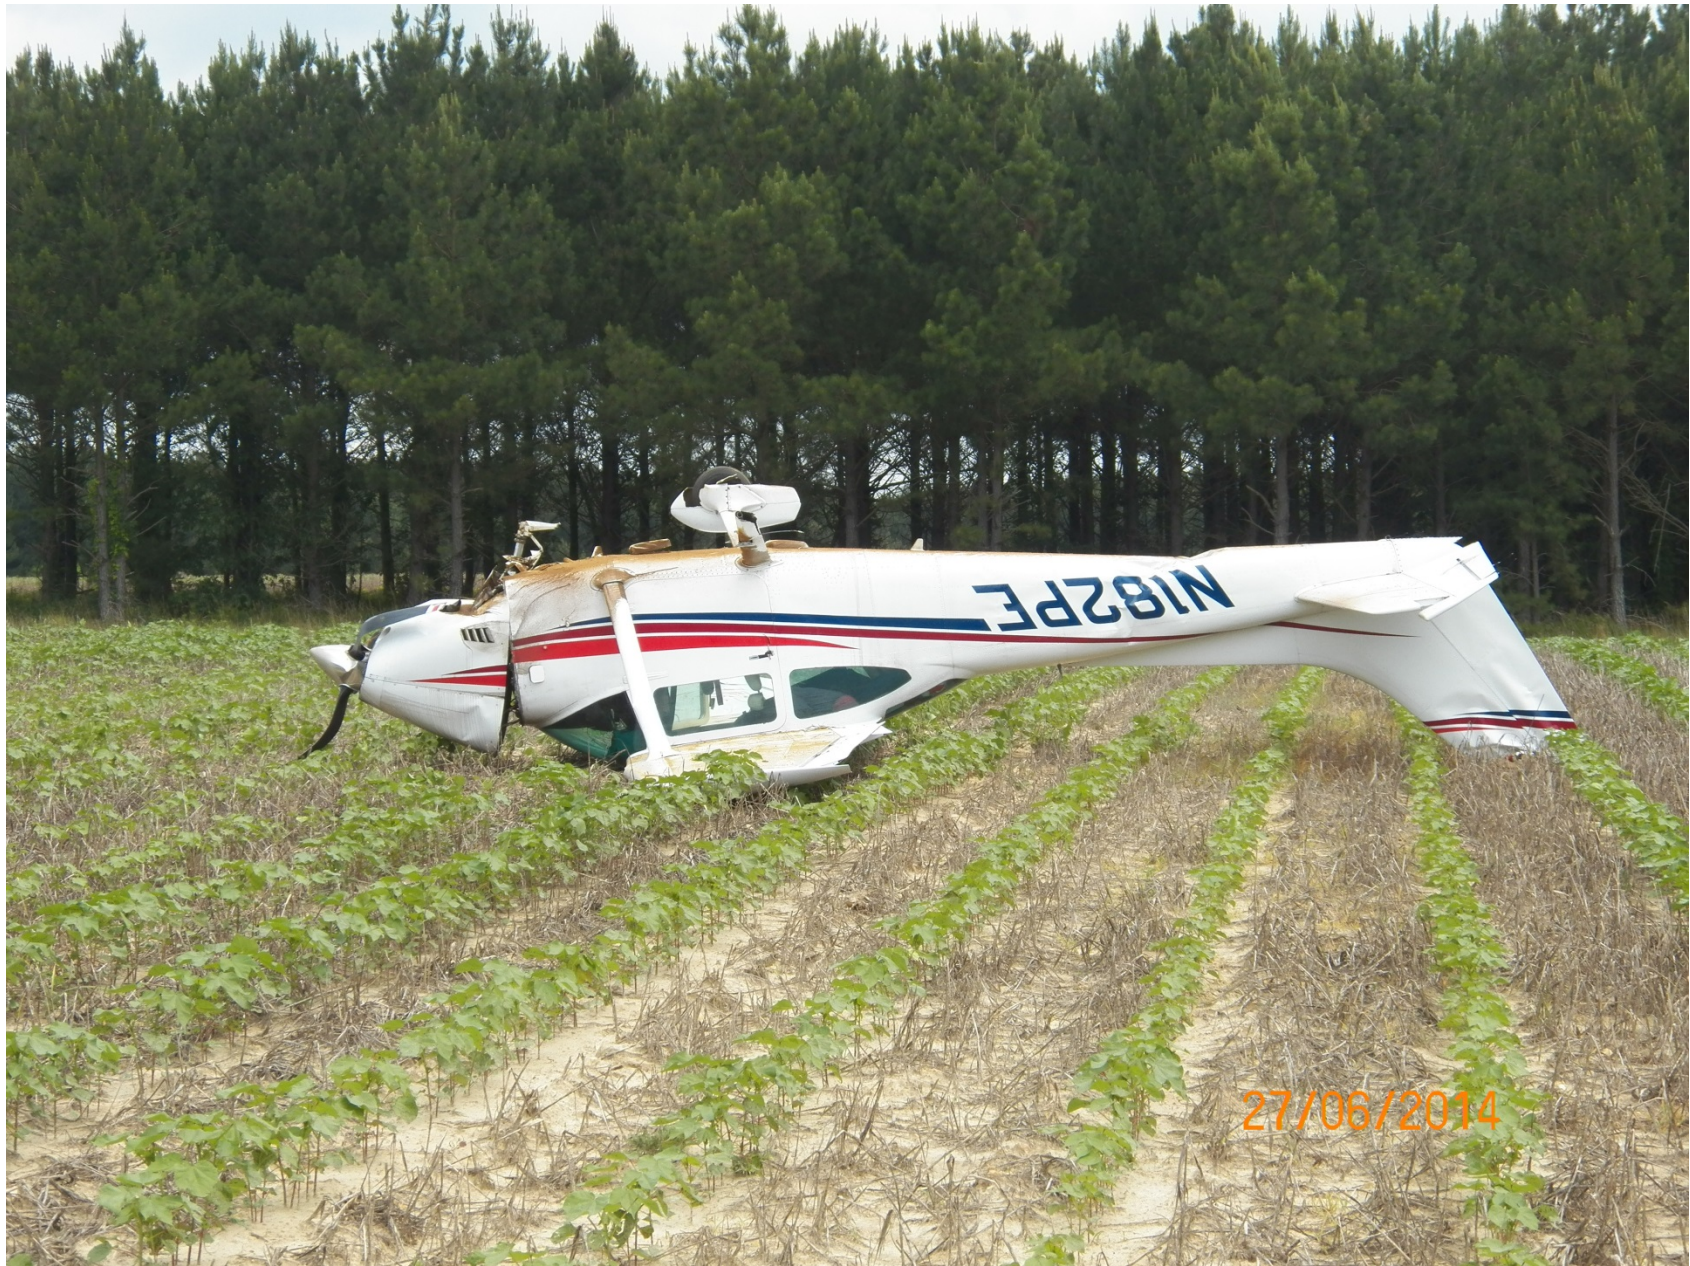
**Photo 2 - Right side of airplane inverted**

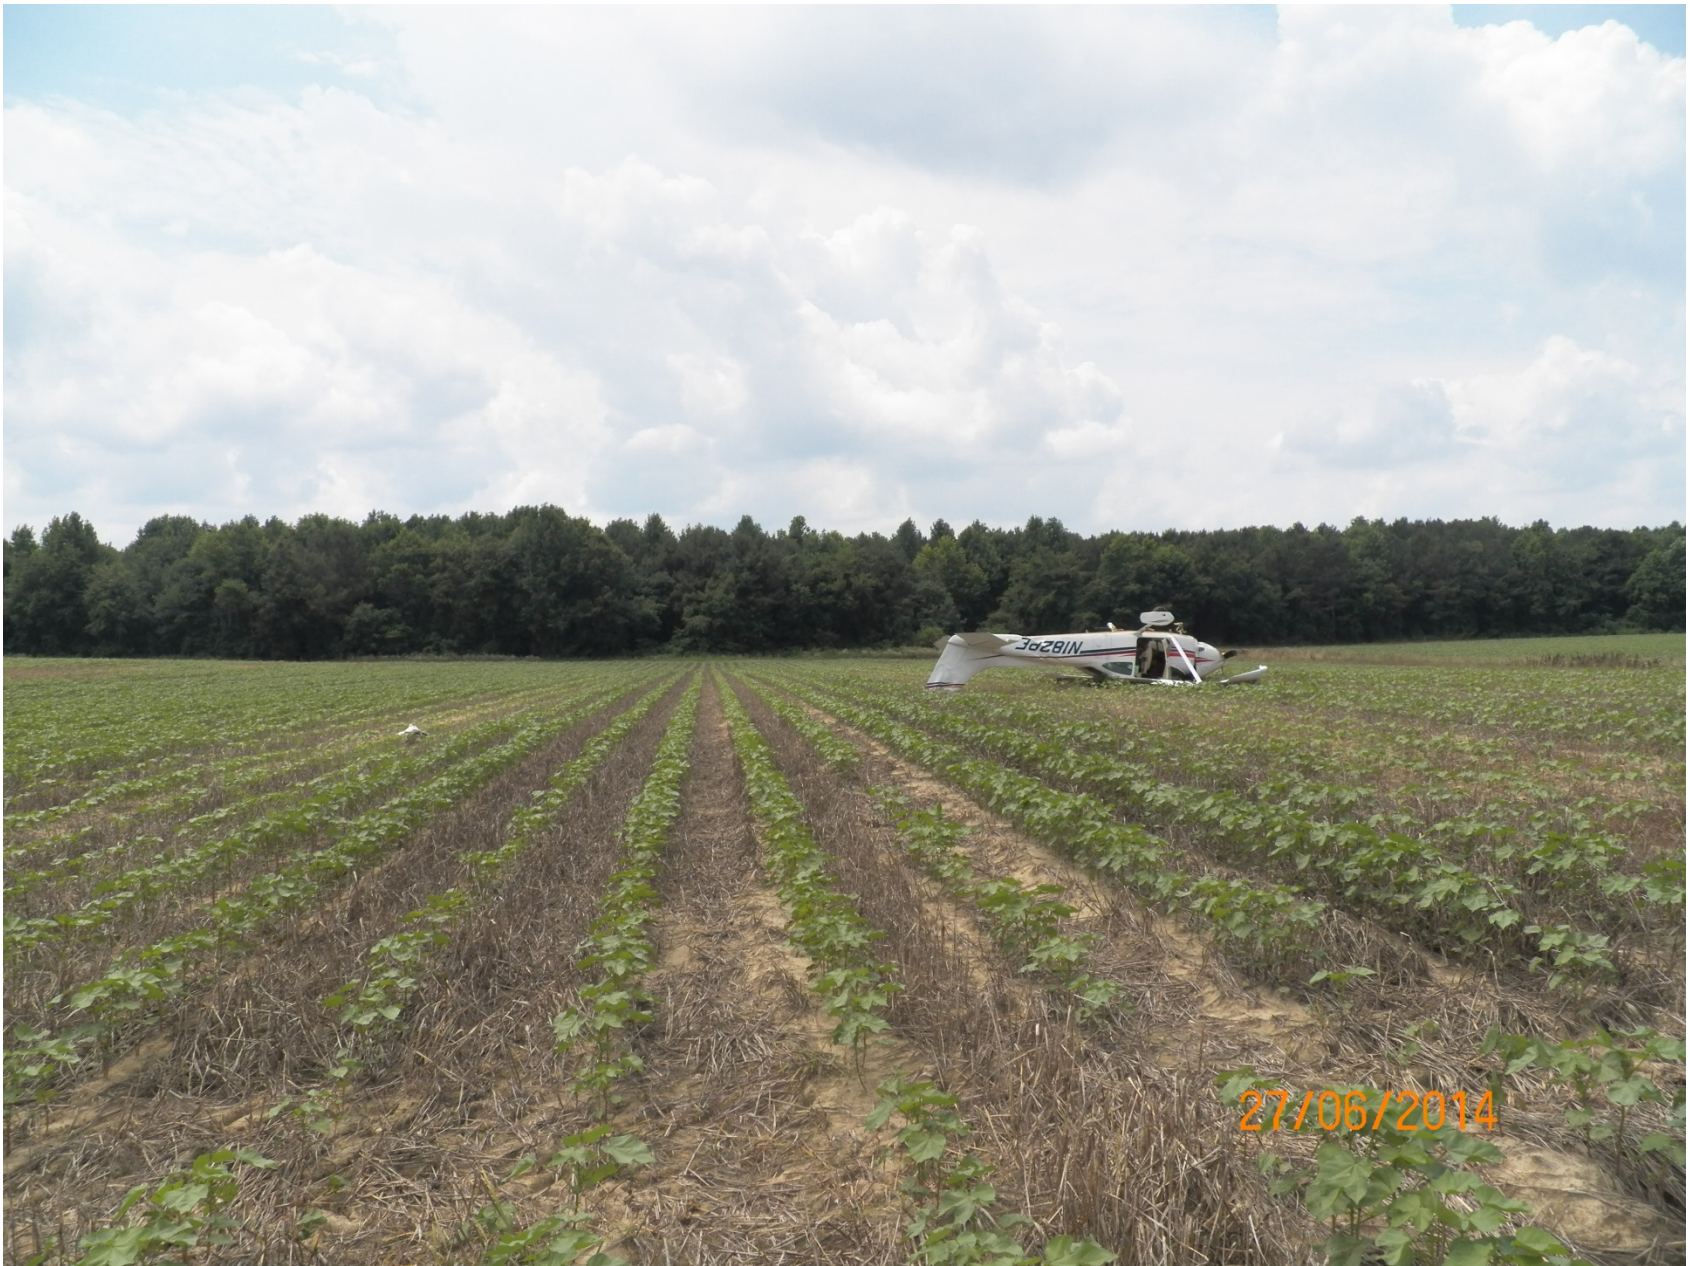
**Photo 3 - Left side of airplane inverted**

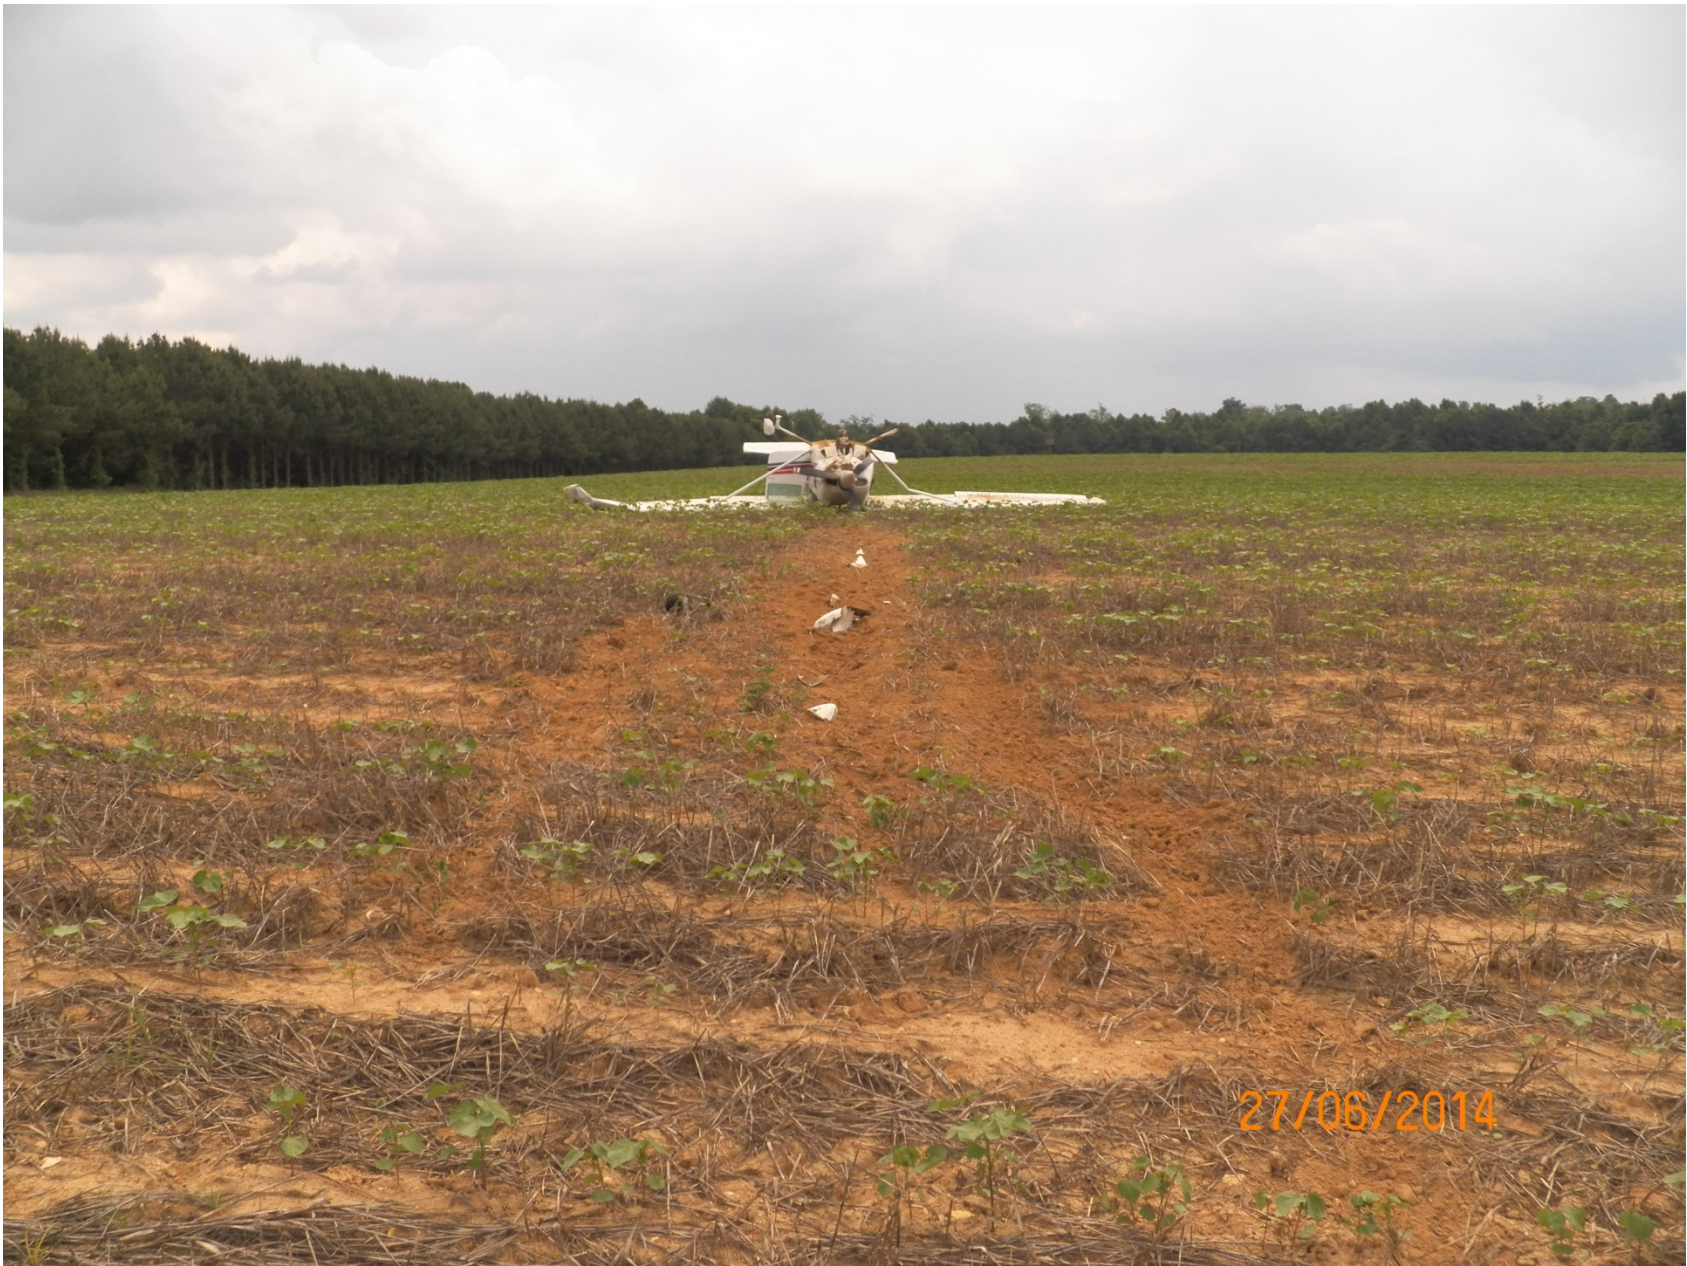
**Photo 4 - Front view of airplane inverted and ground scar**

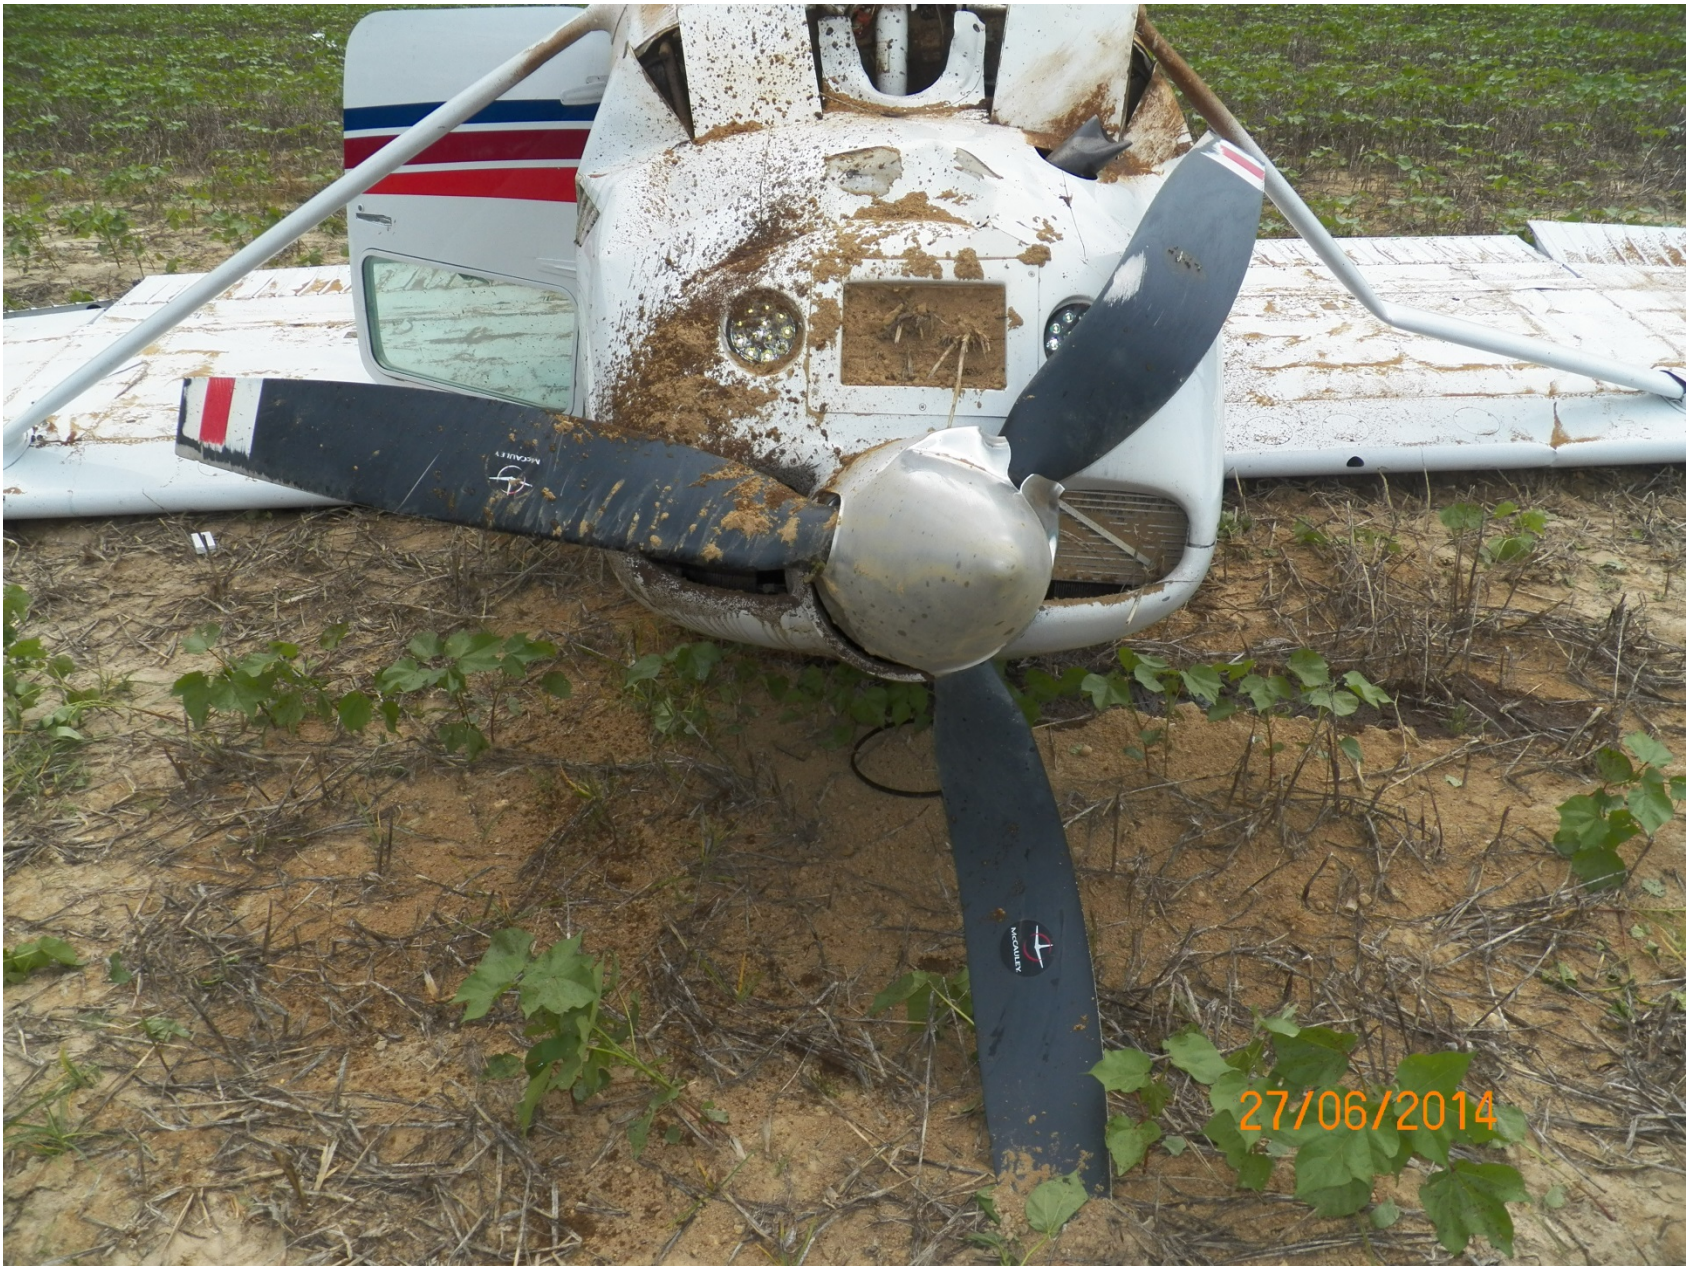
**Photo 5 - View of propeller**

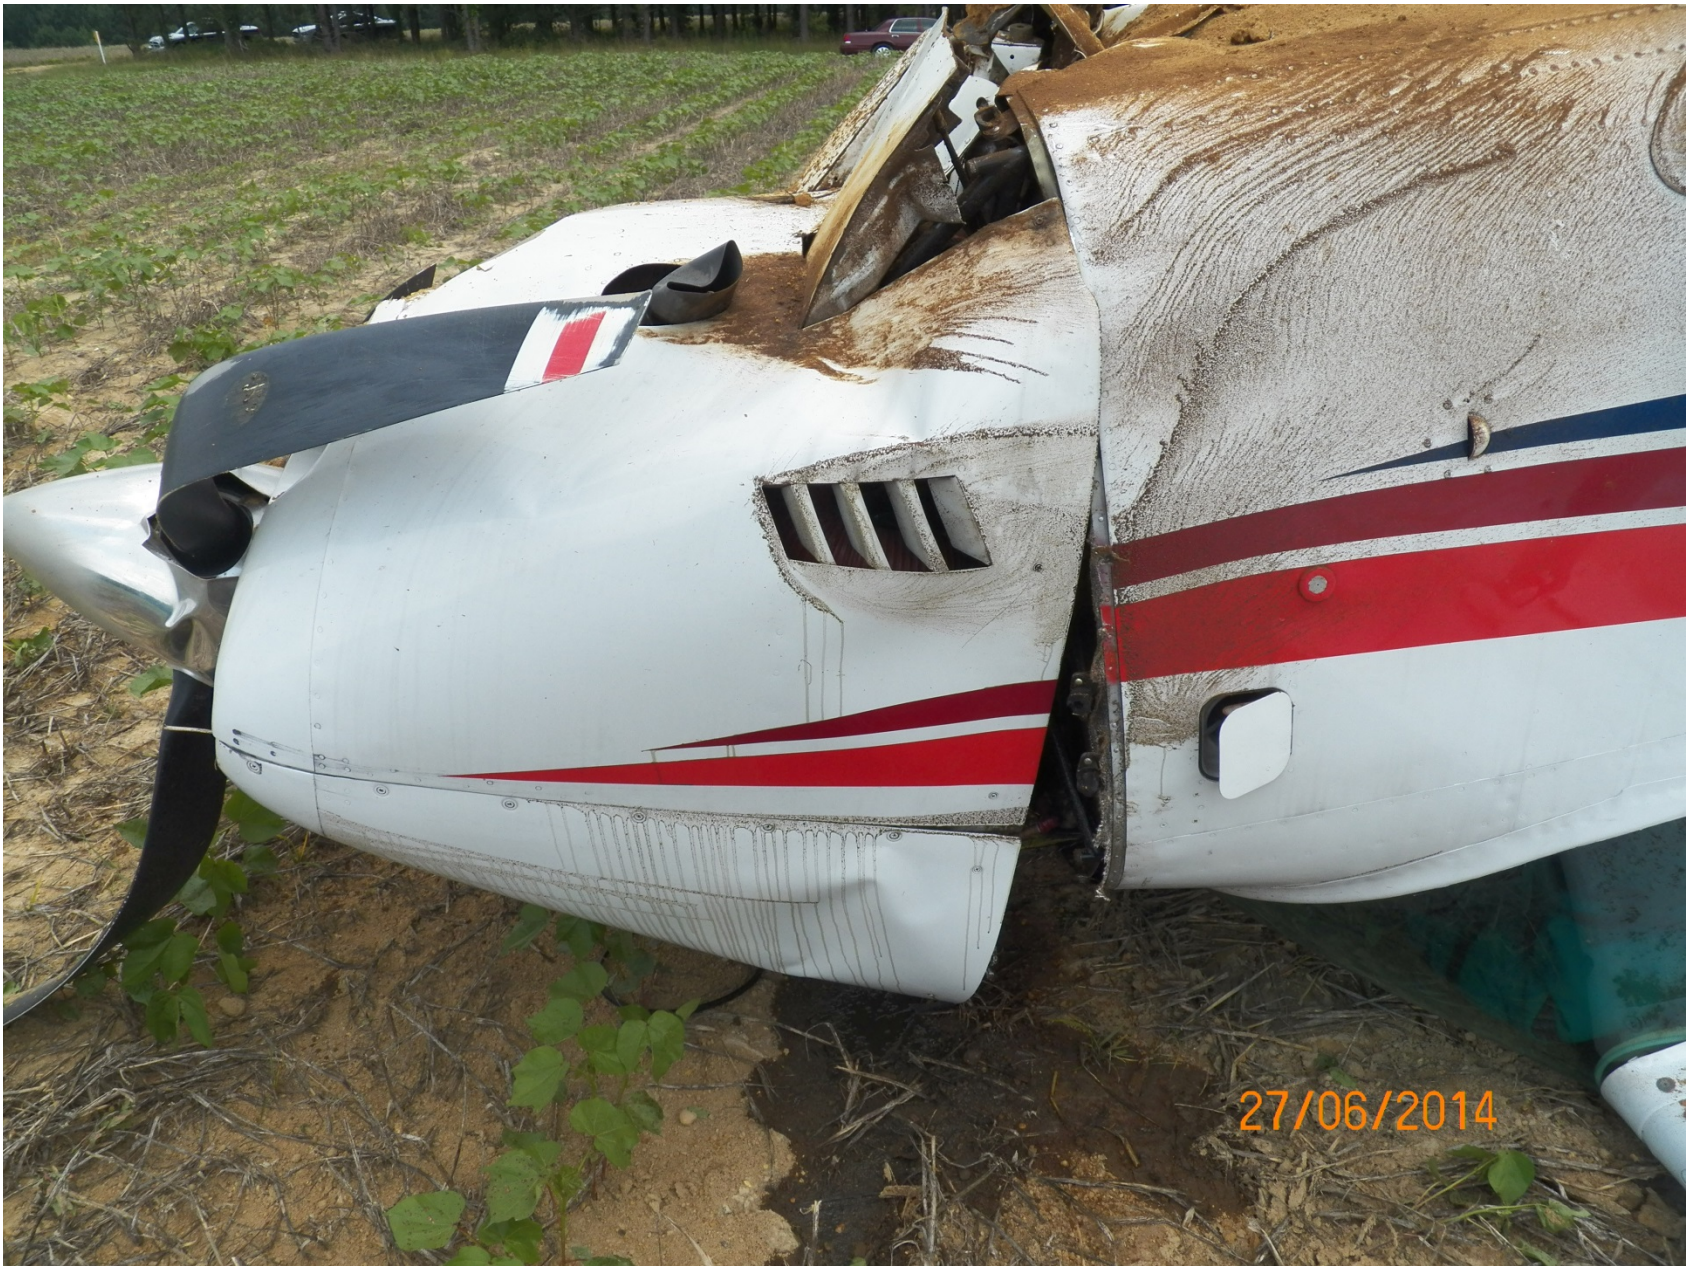
**Photo 6 - View of underside of airplane with oil streaks**

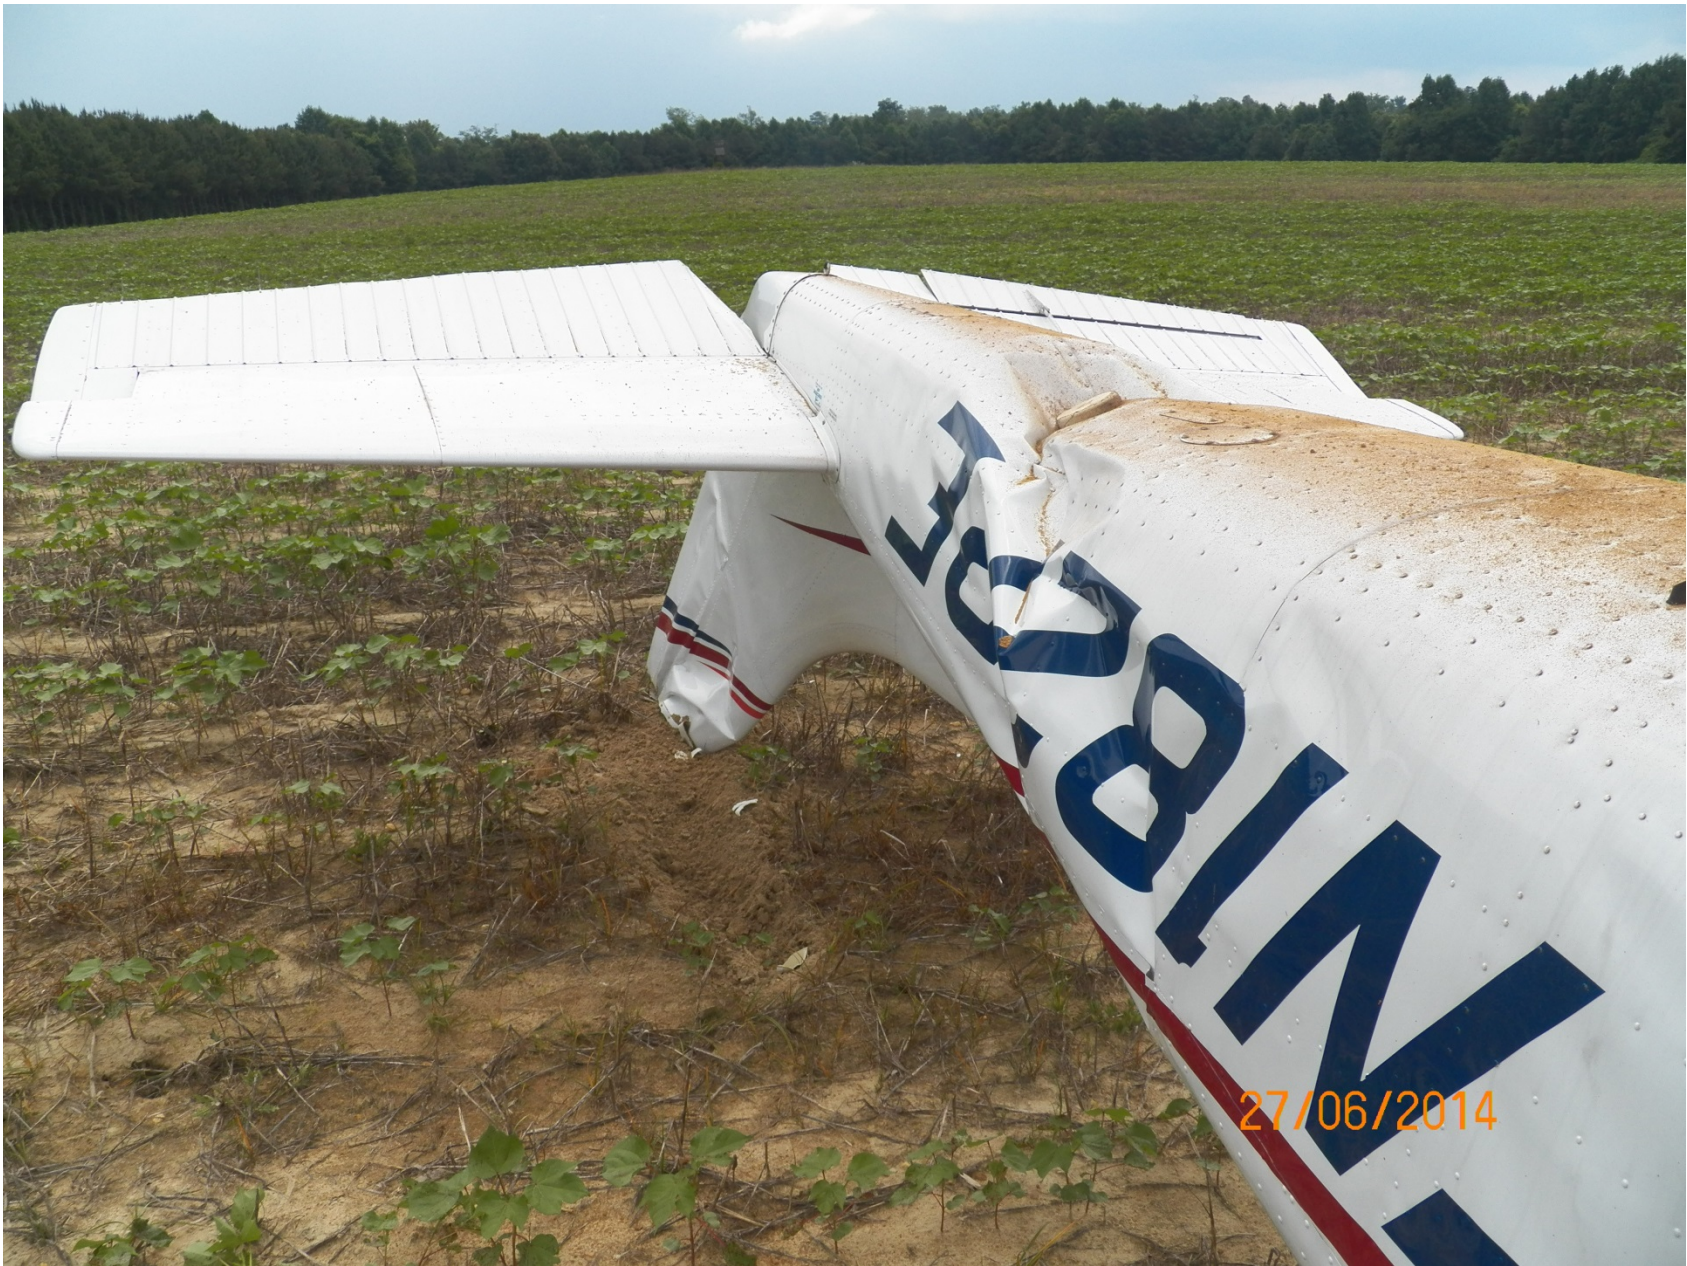
**Photo 7 - View of empennage crush damage**

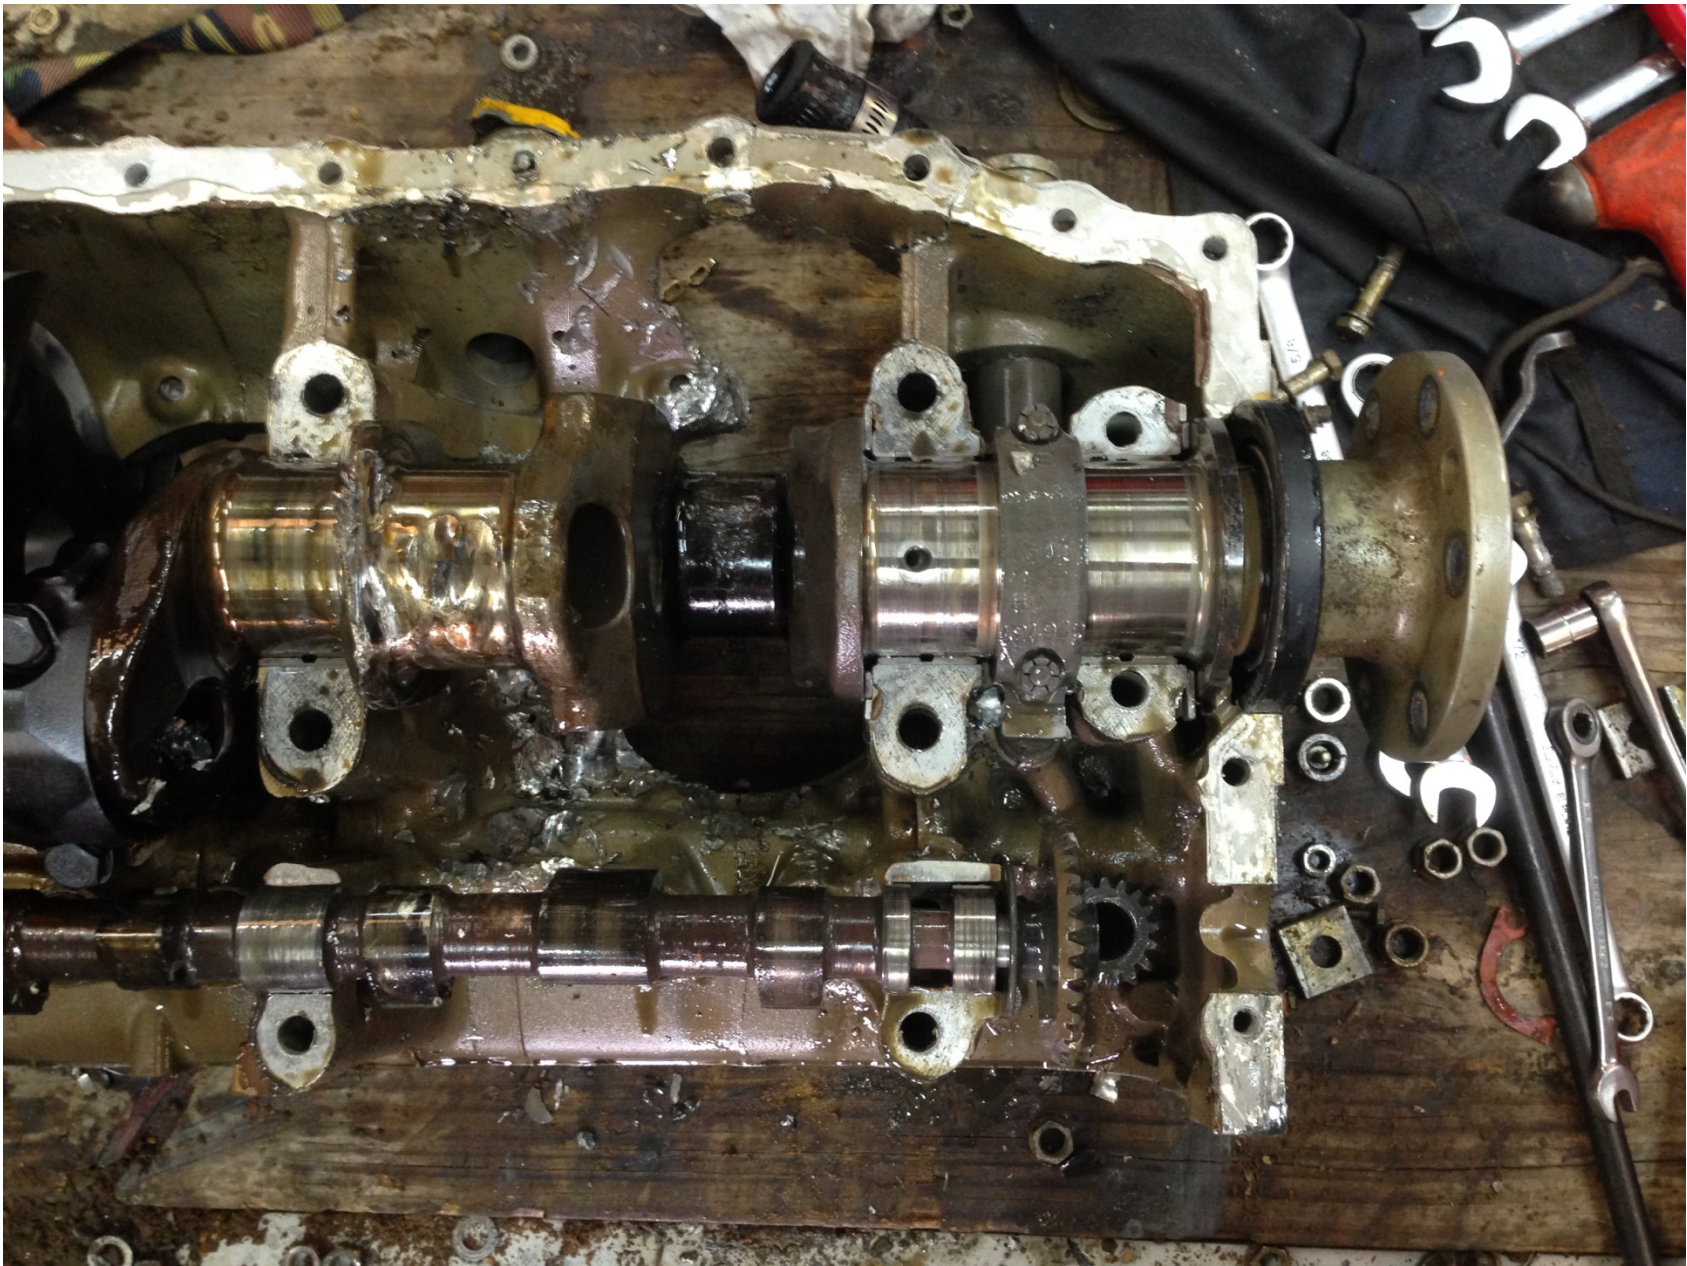
**Photo 8 - View of case halve and saddle mating surface forward propeller flange**

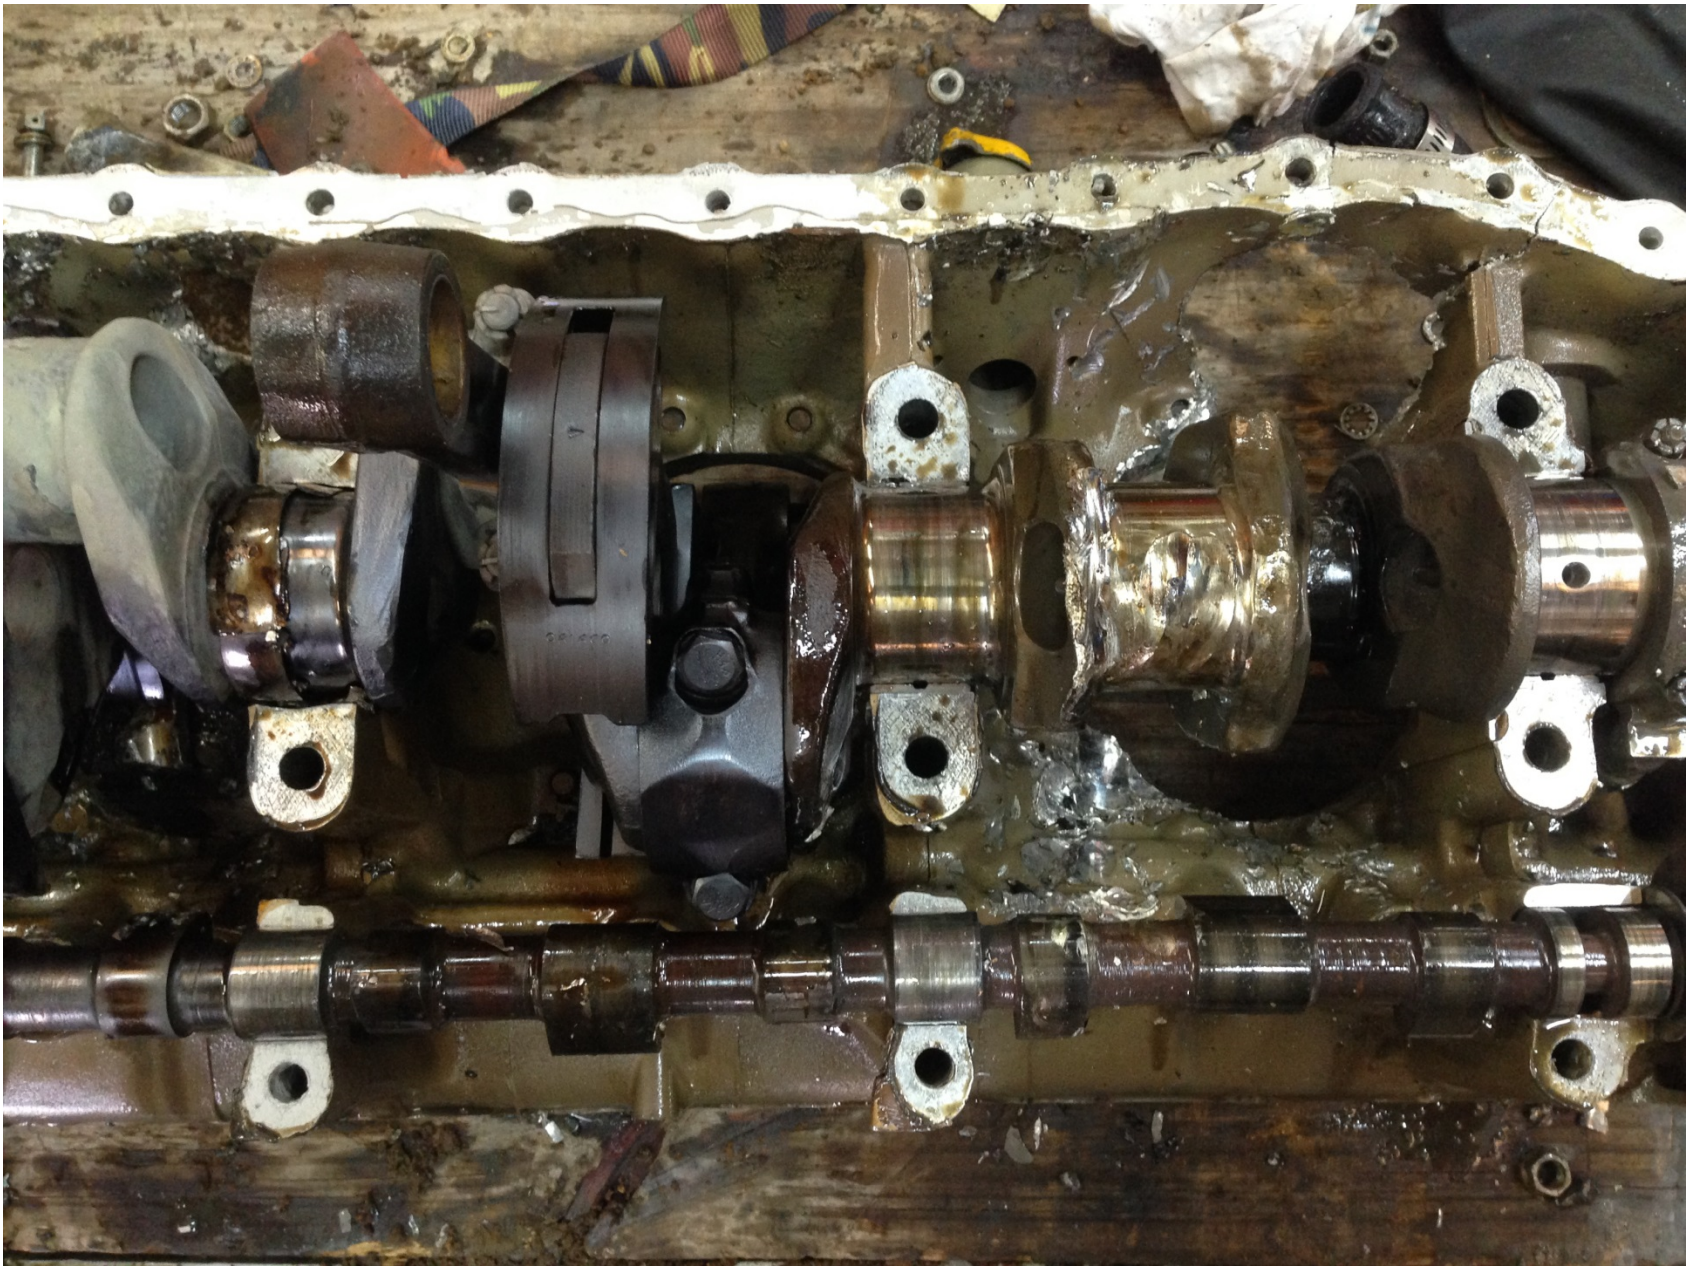
**Photo 9 - View of case halve hole extrusion from inside**

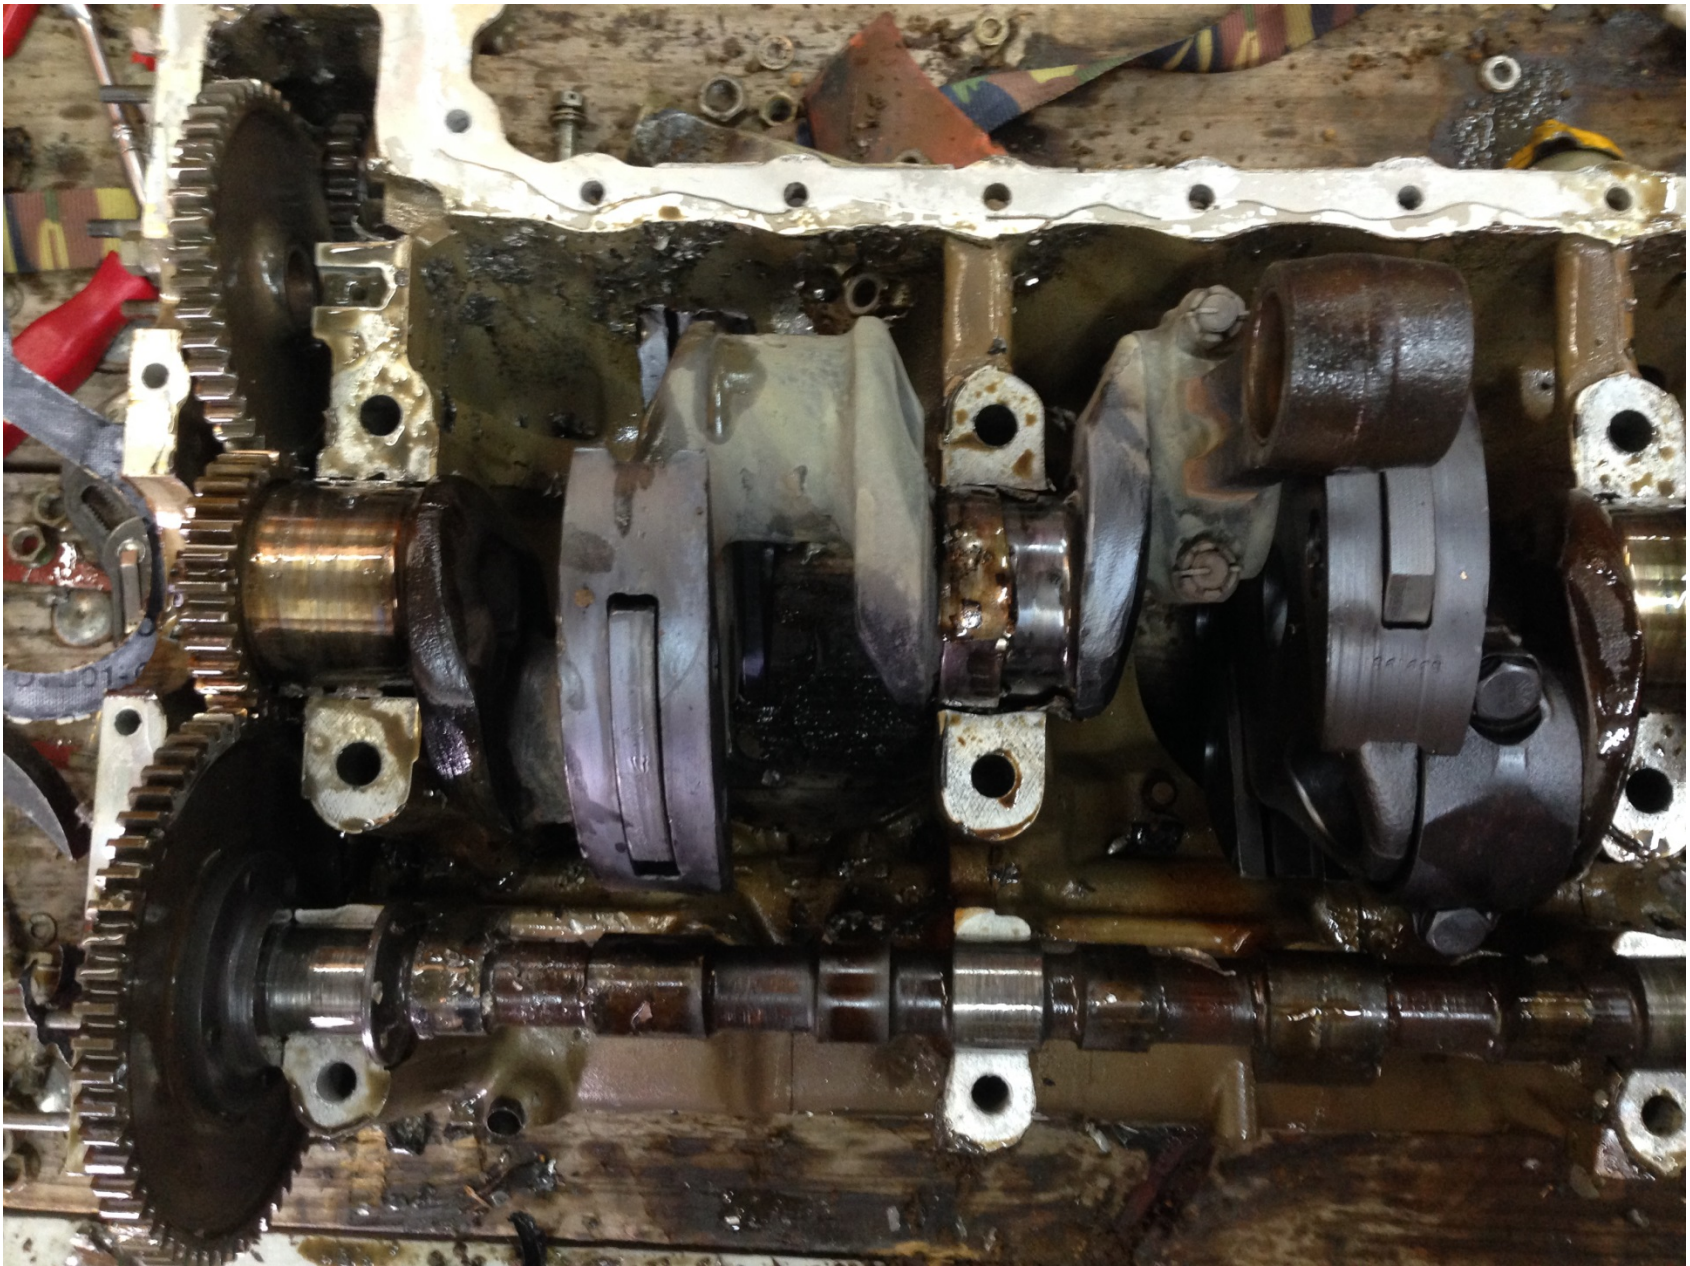
**Photo 10 - View of crankshaft rod journal excessive heat bluing**
