Taxiway Overflight  
Air Canada Flight 759  
Airbus A320-211, C-FKCK  
San Francisco, California  
July 7, 2017

NTSB/AIR-18/01  
PB2018-101561

# Aircraft Incident Report

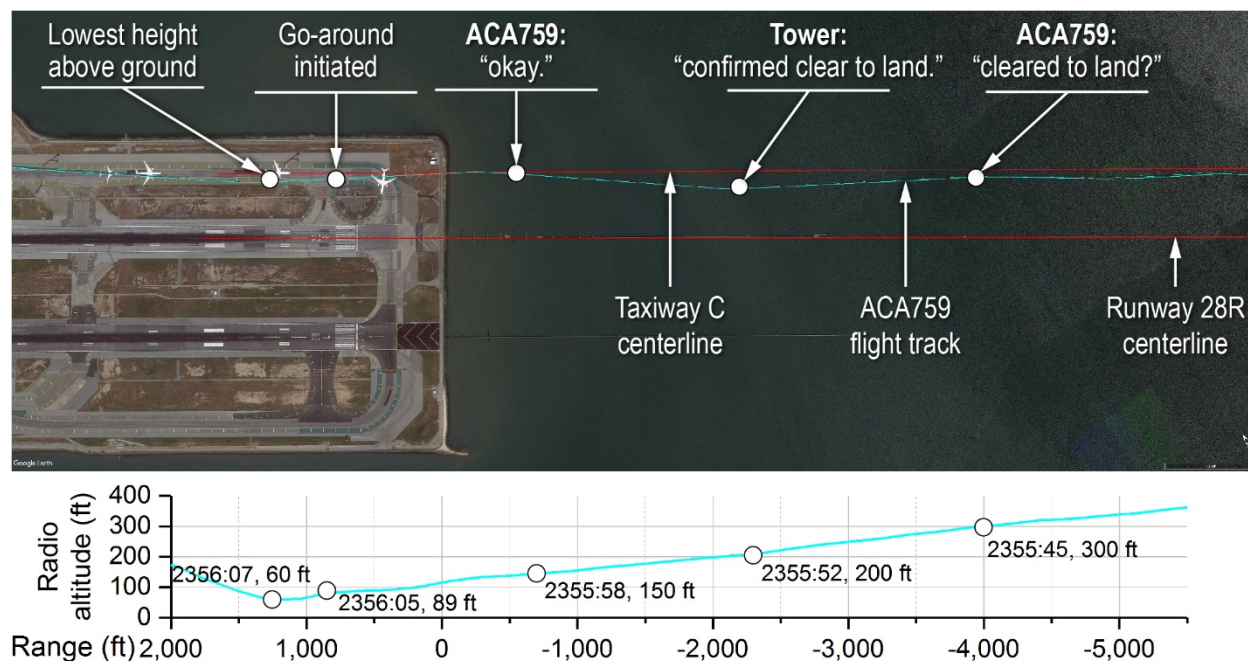
**Figure 1.** ACA759 track over SFO.

At 2355:52, 1 second after the flight crew completed its transmission, the controller replied, “Air Canada seven five nine confirmed cleared to land runway two eight right. There’s no one on runway two eight right but you.”<sup>25</sup> About that time, the airplane was passing through an altitude of 200 ft and was 2,300 ft (0.38 nautical mile [nm]) from the seawall that protected the airfield from San Francisco Bay.<sup>26</sup> At 2355:58, the flight crew acknowledged the transmission; about that time, the airplane was 500 ft (0.08 nm) from the seawall. Figure 1 shows ACA759’s track before reaching the seawall along with the extended centerlines for runway 28R and taxiway C.

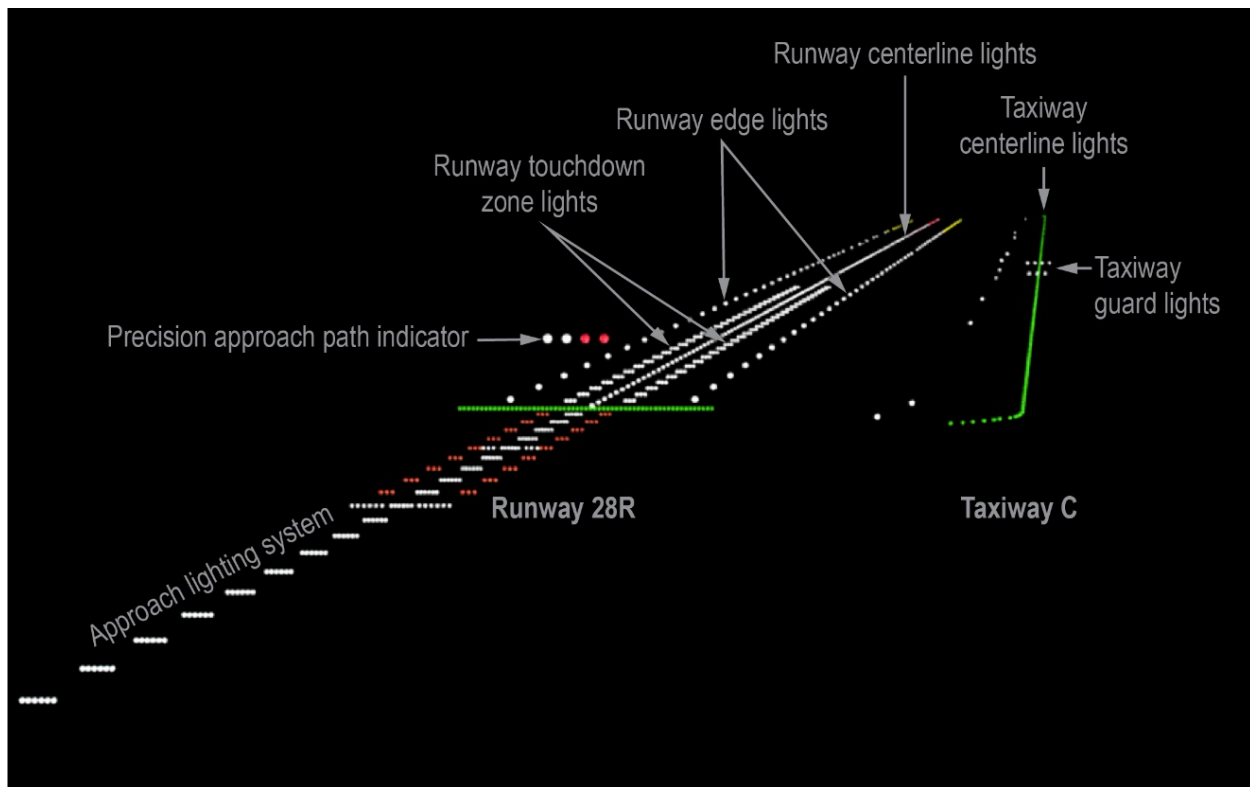
**Figure 4.** Illustration of SFO's lighting configuration.

The airport light status (on/off) and intensity were controlled from the ATCT. Runway 28R was equipped with white runway edge lights, white centerline lights, white touchdown zone lights, and an approach lighting system with white centerline sequenced flashing lights (ALSF-2).<sup>43</sup> Runway 28R was also equipped with a four-light precision approach path indicator with a 3° glidepath that was located on the left side of the runway. Taxiway C was equipped with green centerline lights that were spaced at 50-ft intervals ( $\pm 5$  ft), blue taxiway edge lights located at the intersections with runway 28R to highlight the edge of the intersections, and flashing yellow in-pavement guard lights located where taxiway C intersected runway 1R/19L (which ran perpendicularly to runways 28L and 28R and taxiway C).<sup>44</sup> Figure 4 shows an illustration of the lighting on runway 28R and taxiway C. On the night of the incident flight, the runway and taxiway centerline lights were set at step 1 (out of 5).

*Airport lighting.* Runway 28R (the intended landing runway for the flight) and parallel taxiway C at SFO met the requirements for lighting in 14 *CFR* Part 139. The runway 28R approach lights were on as the incident airplane approached SFO. Title 14 *CFR* 139.311 required taxiways to have one of four types of lighting systems, one of which was centerline lights, which were present and illuminated on taxiway C. The runway and taxiway centerline lights were set at step 1 (out of 5), which was appropriate for the weather conditions on the night of the incident.

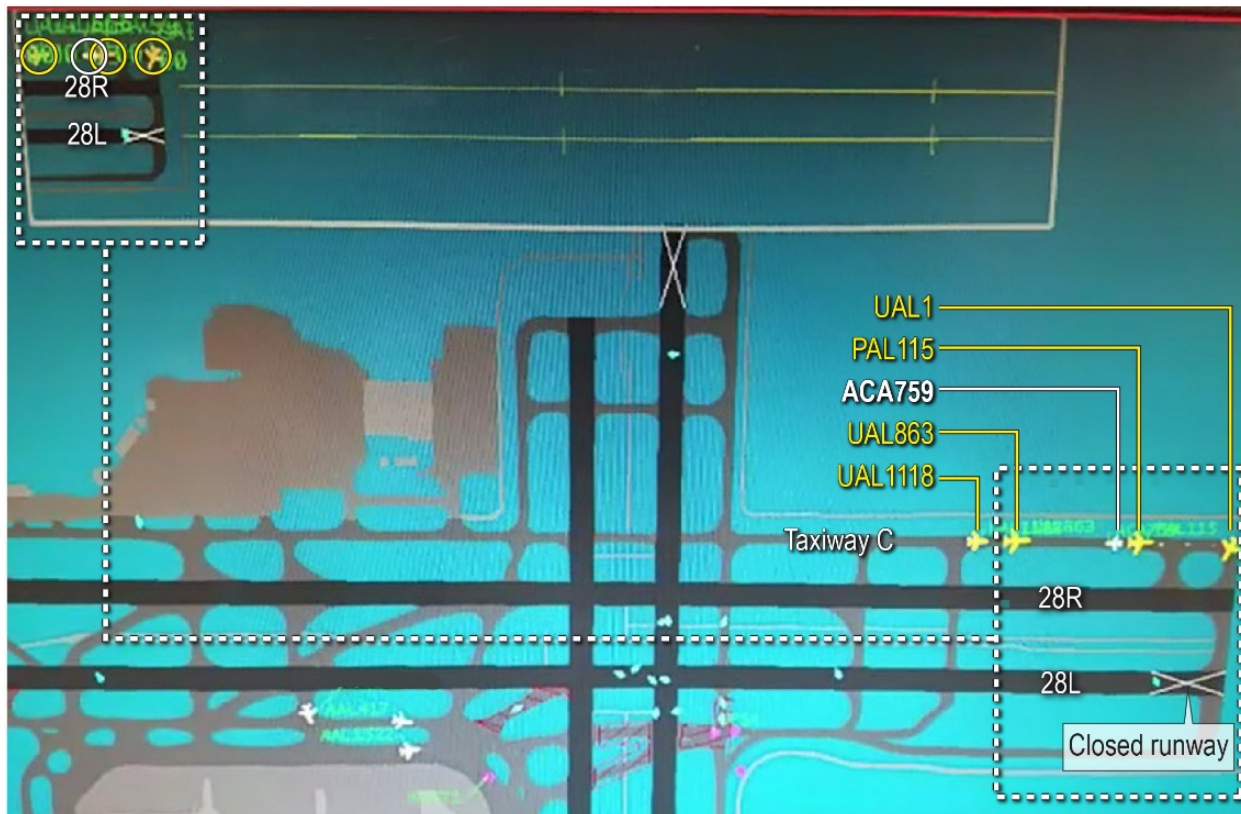
**Figure 5.** ASSC display at SFO.

the runway centerlines, which extended out to about 2.5 nm. Figure 5 shows the ASSC display at 2356:21 on the night of the incident.

tower cab windows.<sup>124</sup> The ACA759 data block reappeared on the ASSC display just before the flight crew initiated a go-around. Although the disappearance of the ACA759 data block from the ASSC display did not contribute to the incident, the current design of the ASSC system does not assist a tower controller in detecting potential taxiway landings. Such capability would be especially critical during nighttime and poor visibility conditions when a controller might not be able to visually observe an airplane lining up with a taxiway.

The NTSB concludes that, if an airplane were to align with a taxiway, an automated ASDE alert would assist controllers in identifying and preventing a potential taxiway landing as well as a potential collision with aircraft, vehicles, or objects that are positioned along taxiways. The taxiway arrival prediction capability that was implemented at SEA (and was scheduled to be evaluated and implemented at other feasible ASDE-X locations) could be expanded to other ASDE system models (ASDE-3 and ASSC). Therefore, the NTSB recommends that the FAA modify ASDE systems (ASDE-3, ASDE-X, and ASSC) at those locations where the system could detect potential taxiway landings and provide alerts to air traffic controllers about potential collision risks.

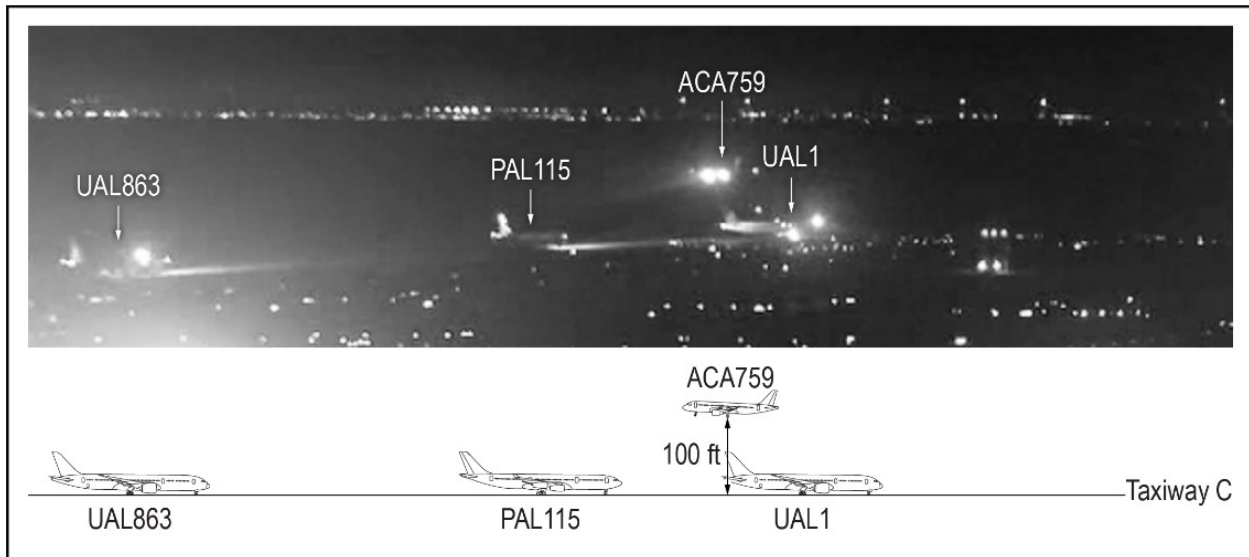
**Figure 7.** ACA759 passing over UAL1 (top) and relative locations of airplanes (bottom).

The security video also showed ACA759 passing over the airport seawall and then passing over UAL1 on taxiway C, as shown in figure 7. About this time, the PAL115 flight crew turned on that airplane's landing lights, which illuminated the taxiway between PAL115 and UAL1 as well as the tail and side of the UAL1 airplane. In addition, the security video showed the fuselage of PAL115, which was illuminated by the ACA759 landing lights, and ACA759 descending to its lowest altitude as the airplane passed over PAL115. At that point, the attitude of the ACA759 airplane changed from nose down to nose up, as shown in figure 8. Subsequent frames of the security video showed ACA759 gaining altitude over the taxiway and passing over UAL863 and UAL1118. (UAL863 is shown in figures 7 and 8, but UAL1118 is not shown in those figures).
