Impact with Power Lines  
Heart of Texas Hot Air Balloon Rides  
Balóny Kubíček BB85Z, N2469L  
Lockhart, Texas  
July 30, 2016

NTSB/AAR-17/03  
PB2018-100161

# Aircraft Accident Report

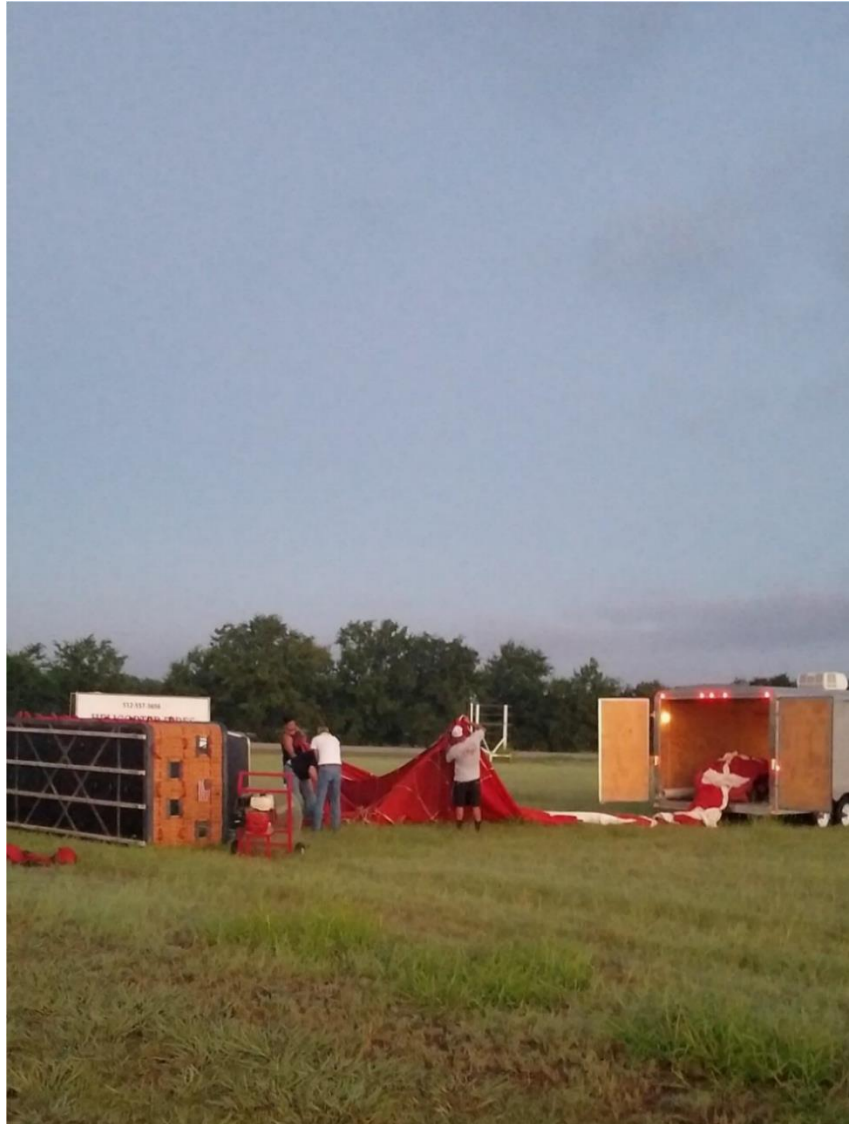
**Figure 1.** Weather conditions during launch preparation (about 0635).

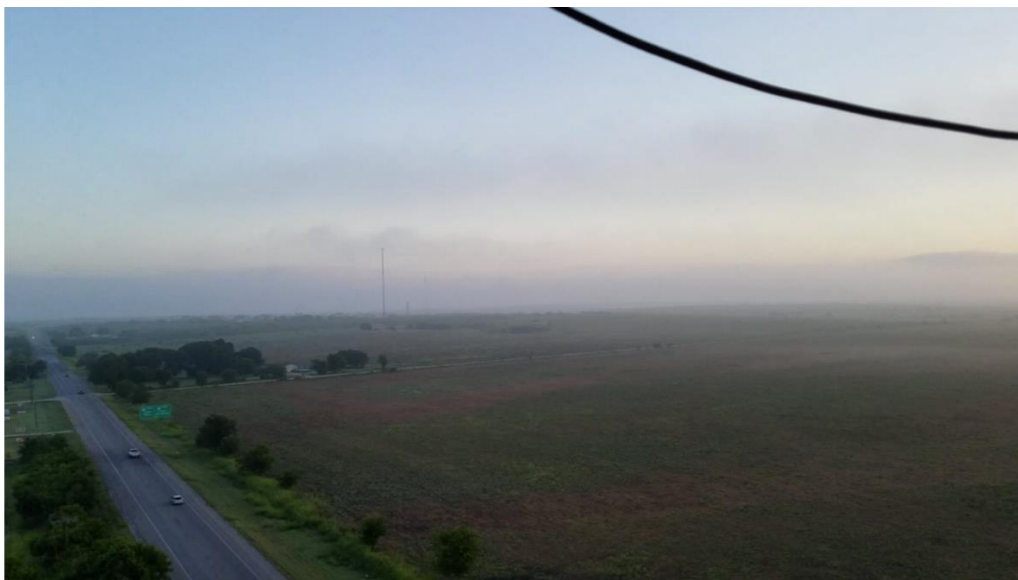
**Figure 2.** In-flight conditions 2 minutes after launch (about 0700).

Note: The photograph was taken facing north; fog and low-level clouds can be seen along the route of flight.

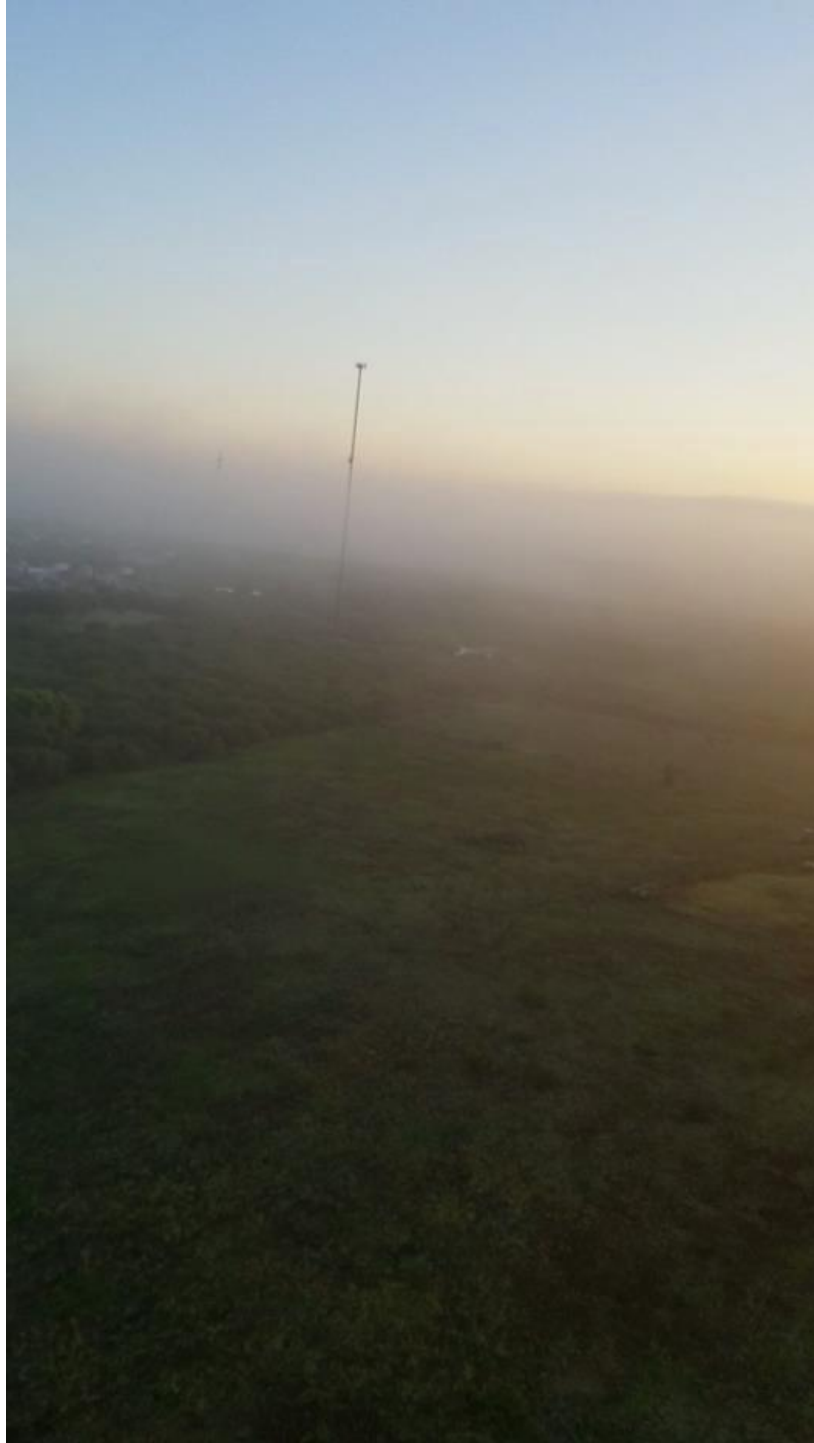
**Figure 3.** In-flight conditions 5 minutes after launch (about 0703).

Note: This photograph was taken 5 minutes after launch, facing north. The balloon was closer to the fog/clouds; however, the ground was visible.

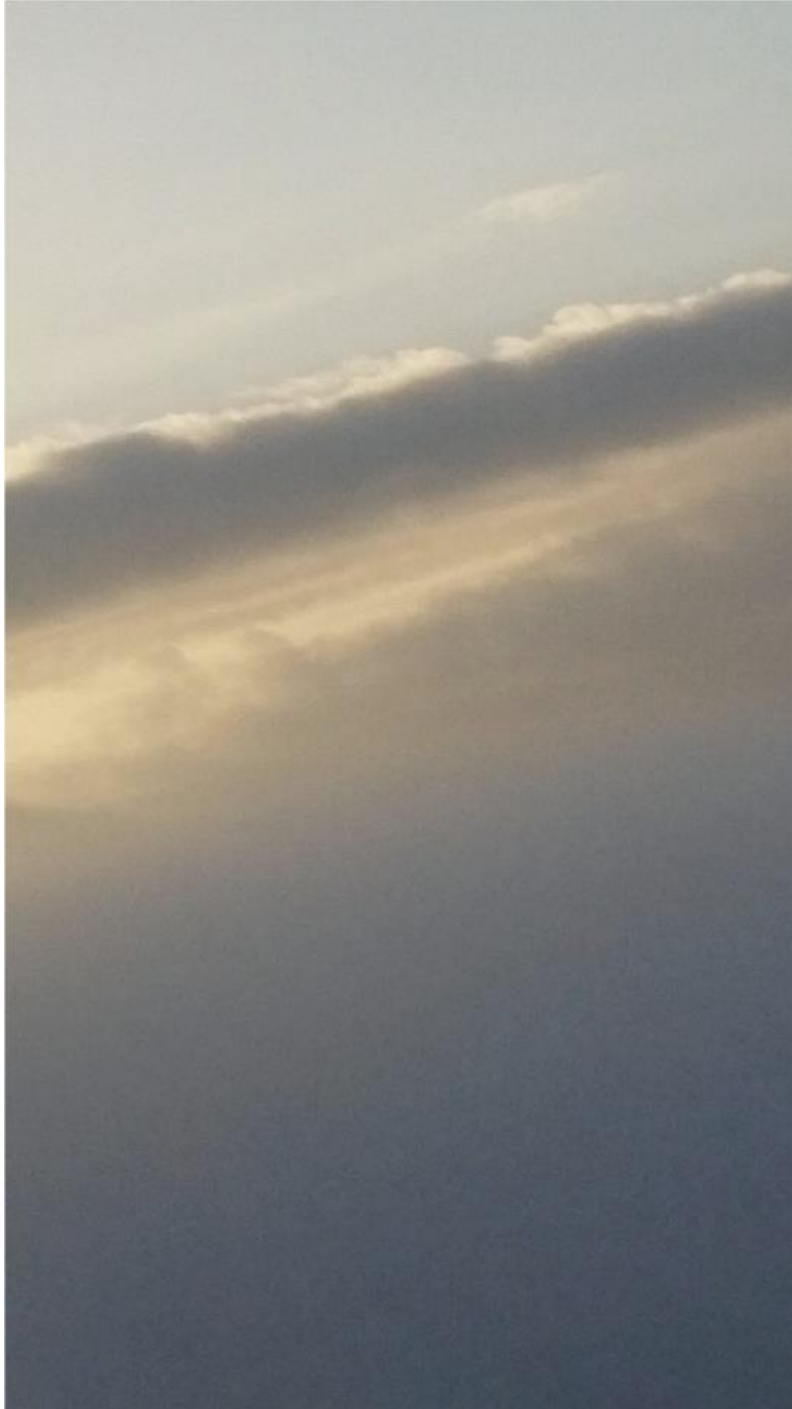
**Figure 4.** In-flight conditions 19 minutes after launch (about 0717).

Note: The balloon was in mist/fog/clouds; however, the ground was still visible. The direction from which the photograph was taken could not be determined.

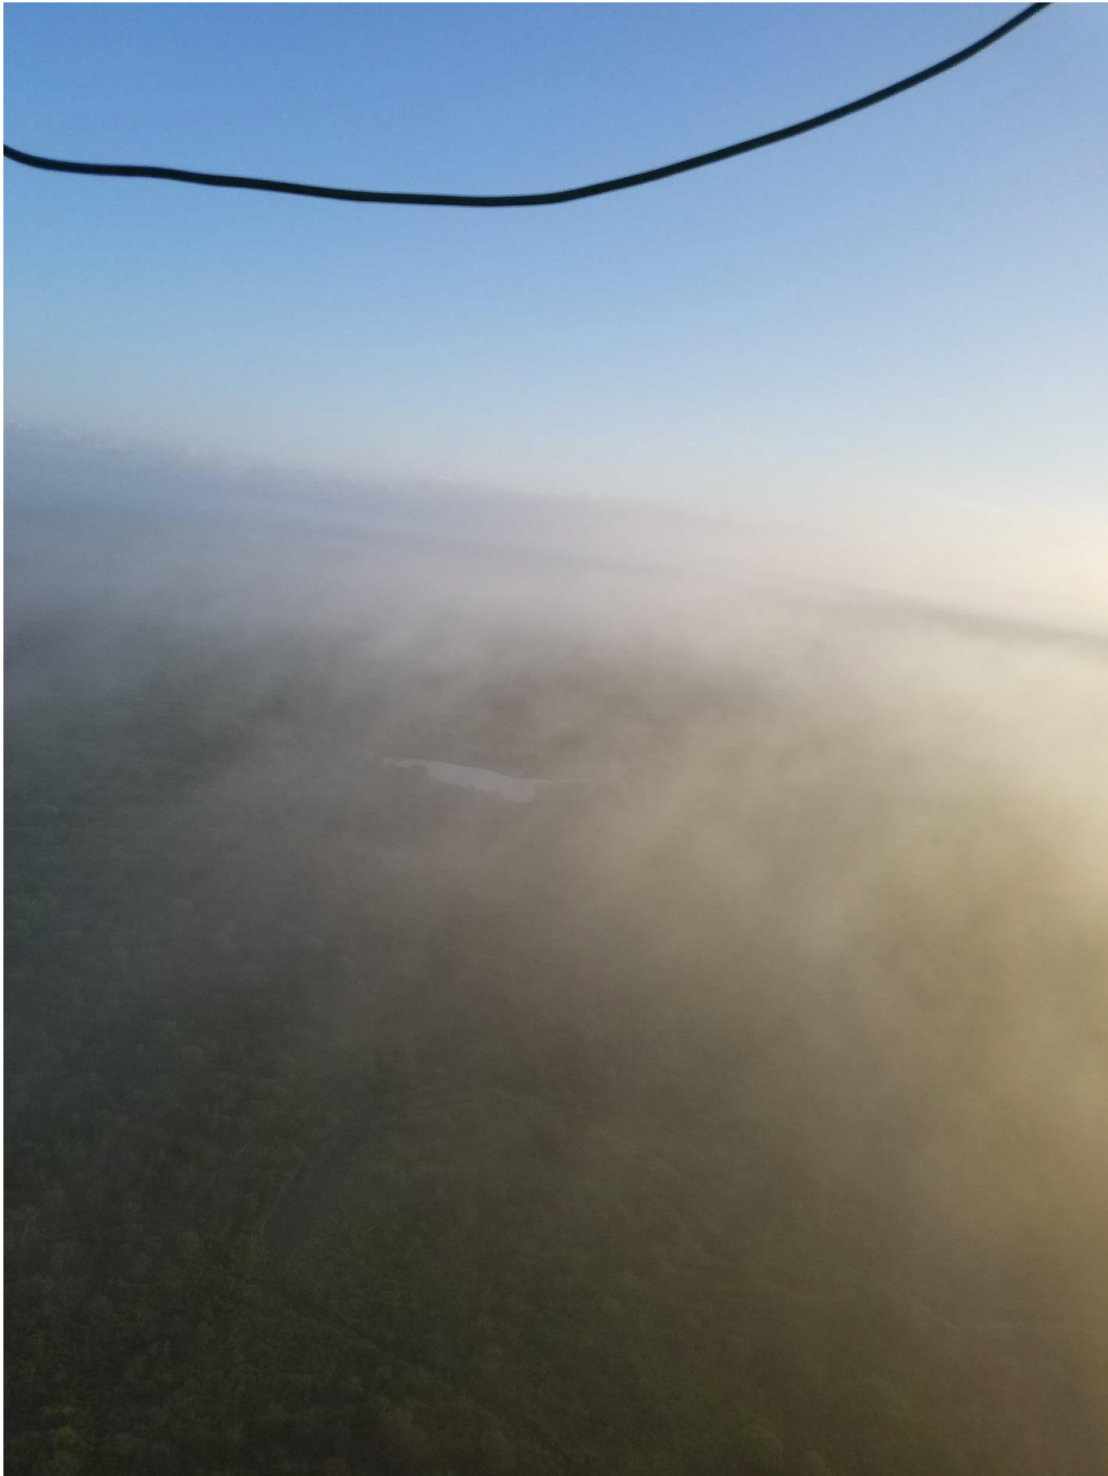
**Figure 5.** In-flight conditions 24 minutes after launch (about 0722).

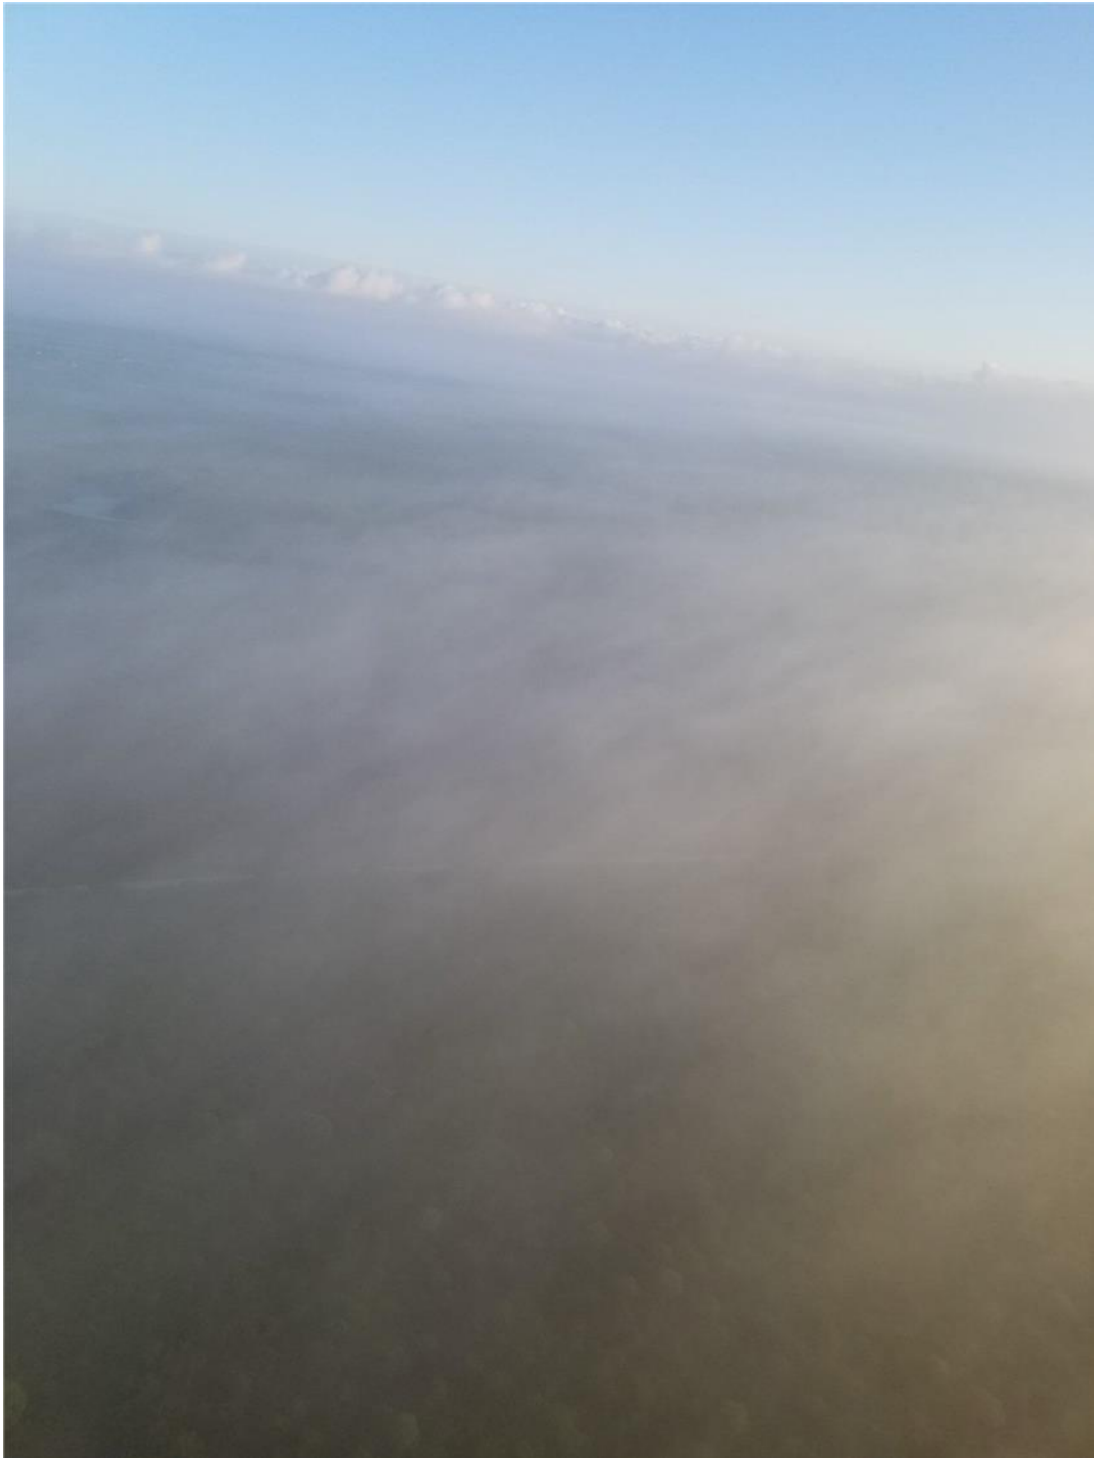
**Figure 6.** In-flight conditions 26 minutes after launch (about 0724).

Note: The ground is again visible through thin clouds.

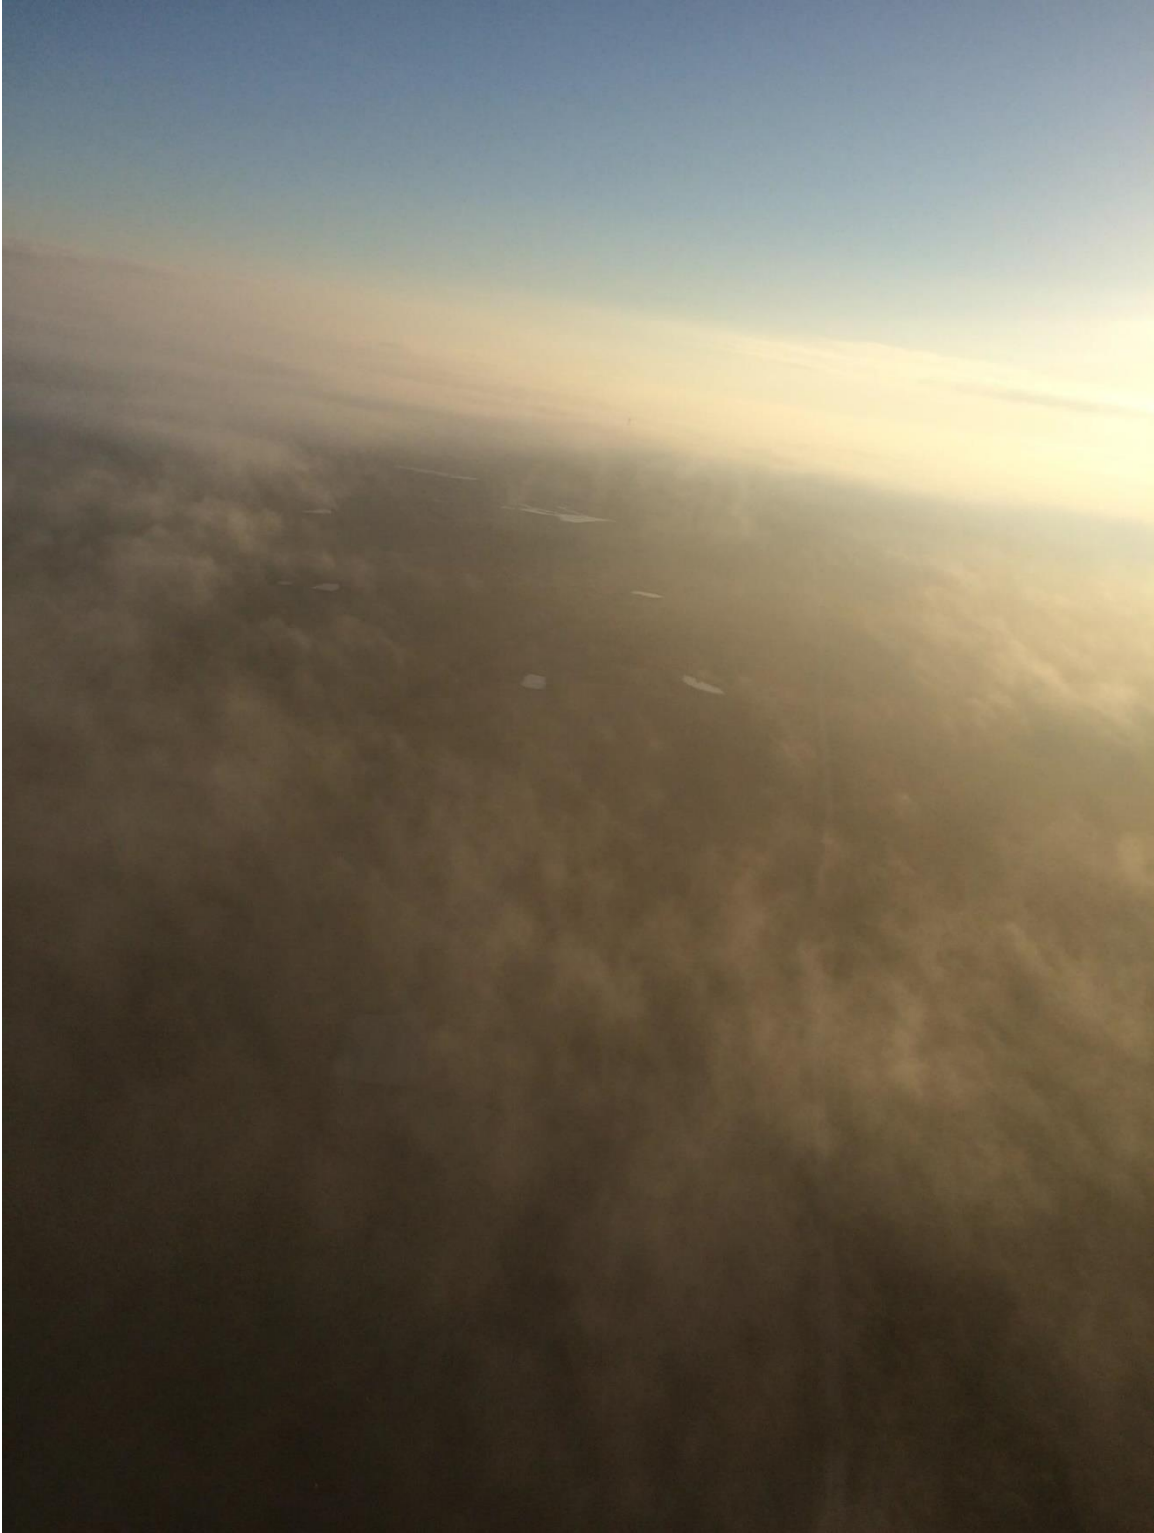
**Figure 7.** In-flight conditions 27 minutes after launch (about 0725).

Note: The ground remains visible through thin clouds.

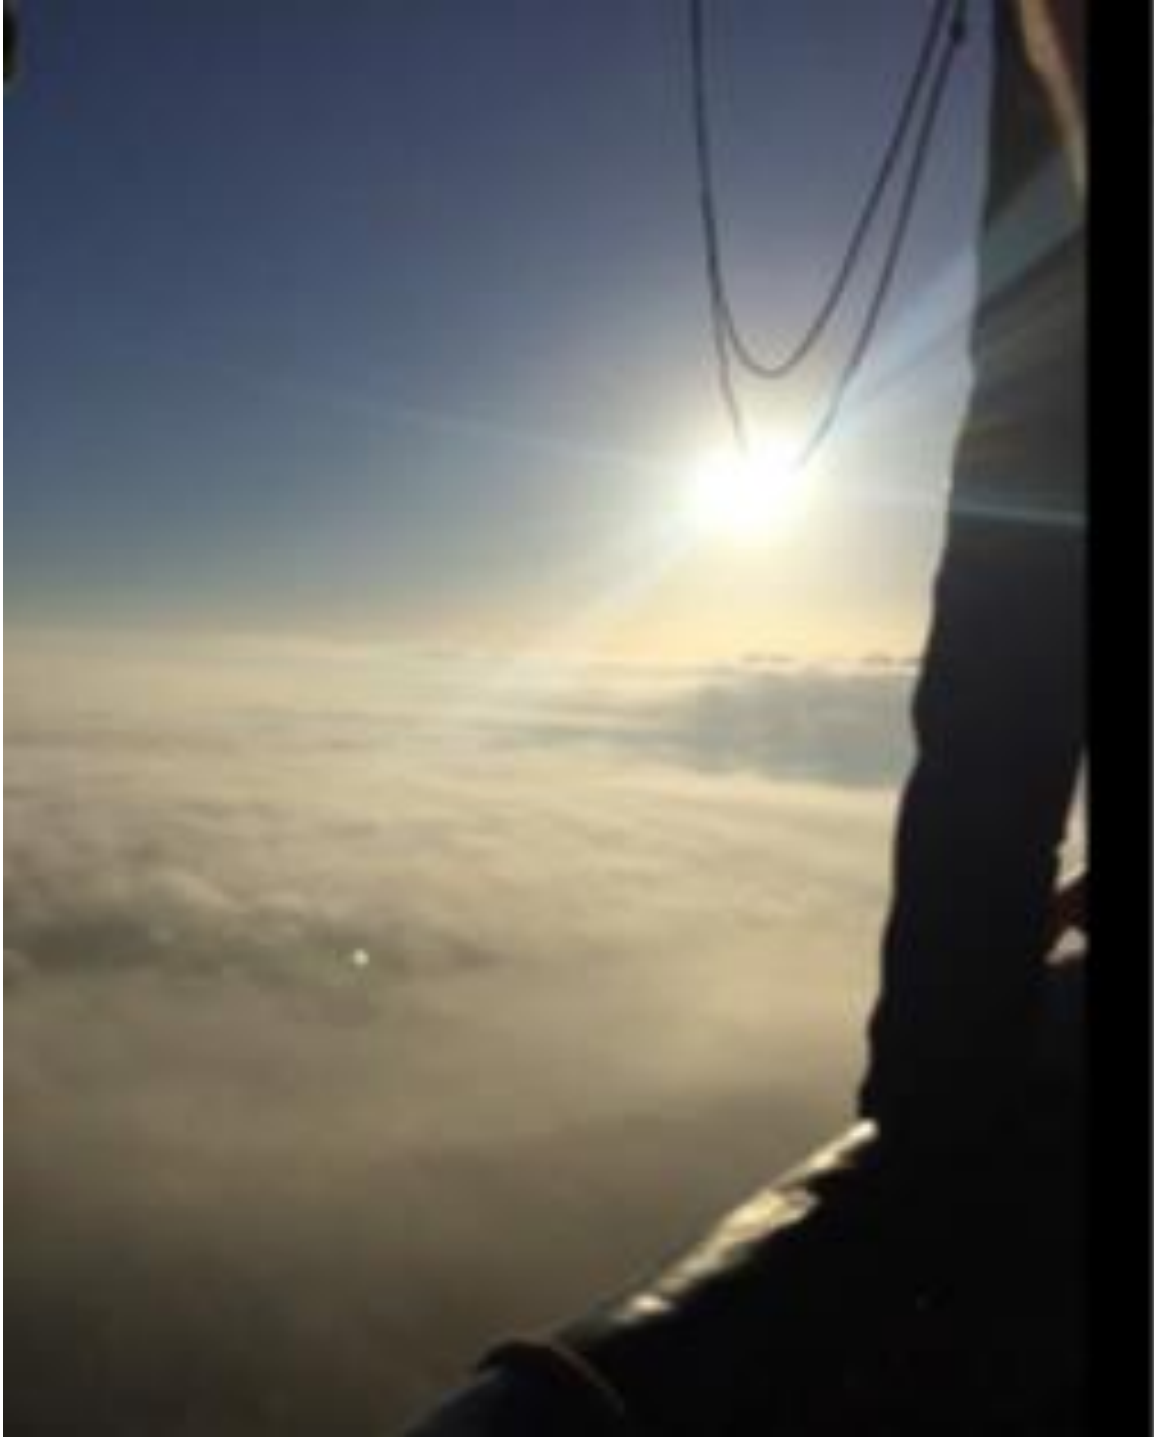
**Figure 8.** In-flight conditions 40 minutes after launch and 4 minutes before the accident (about 0738).

Note: This photograph was taken facing east; the balloon was tracking north. The cloud layer appears to extend to the horizon.

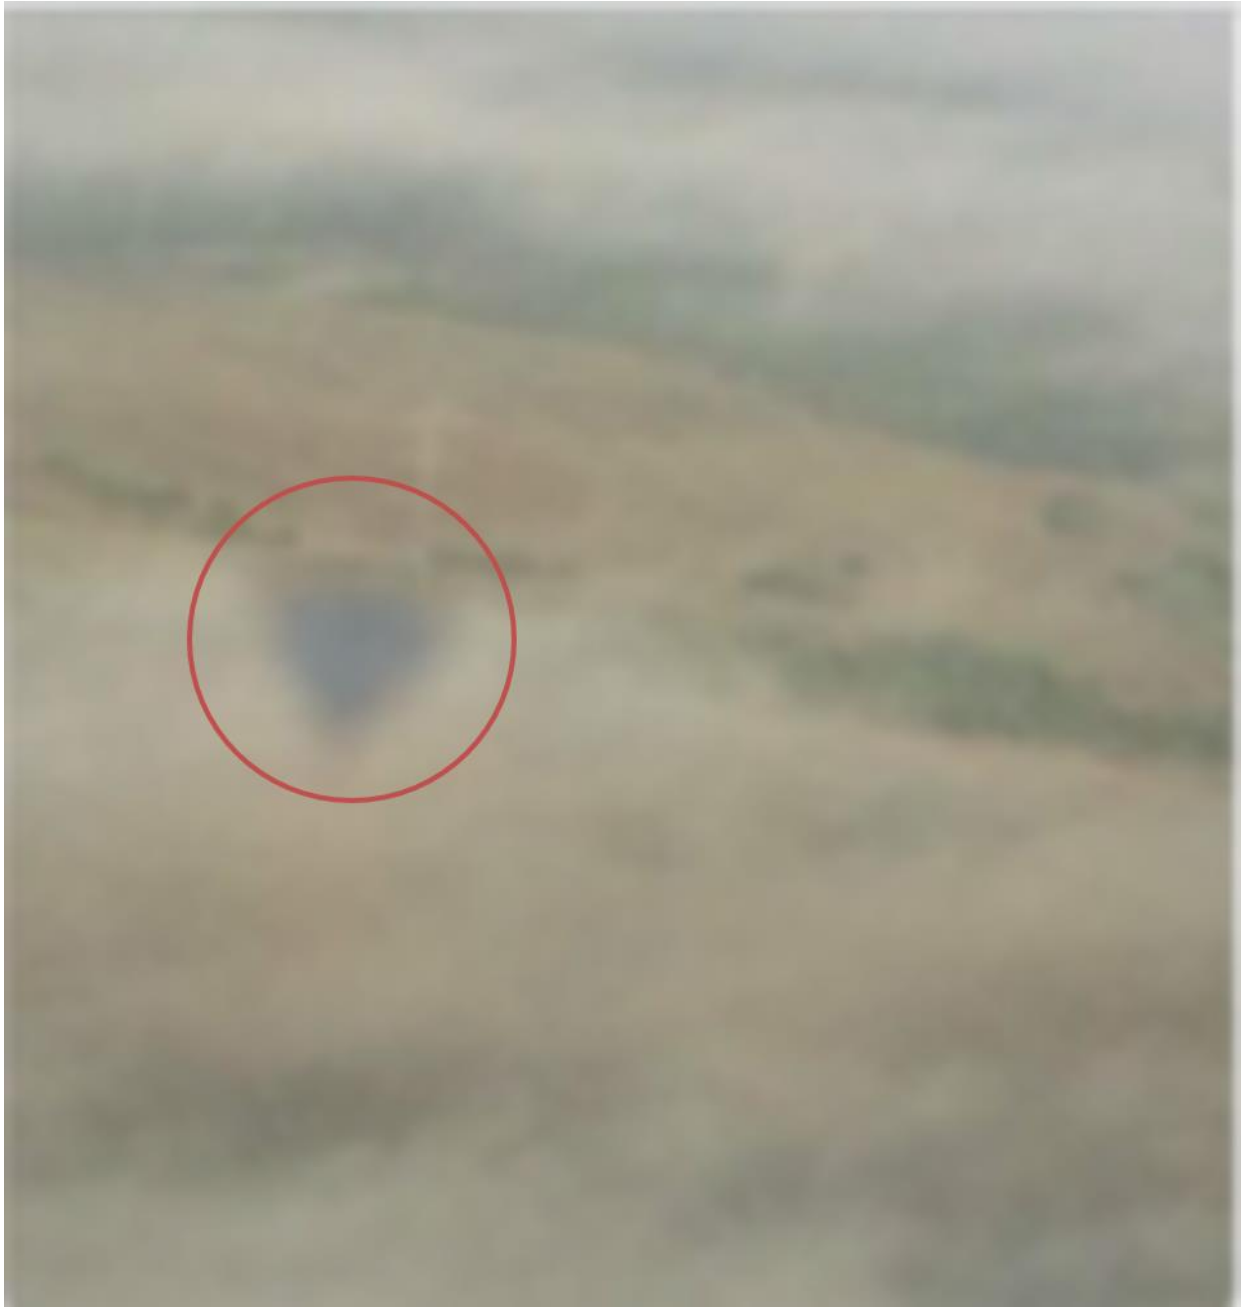
**Figure 9.** In-flight conditions 42 minutes after launch and 2 minutes before the accident (about 0740).

Note: This photograph was taken facing west. The balloon's shadow (circled) can be seen just below the break in the clouds. A power line tower is visible through the break in the clouds.

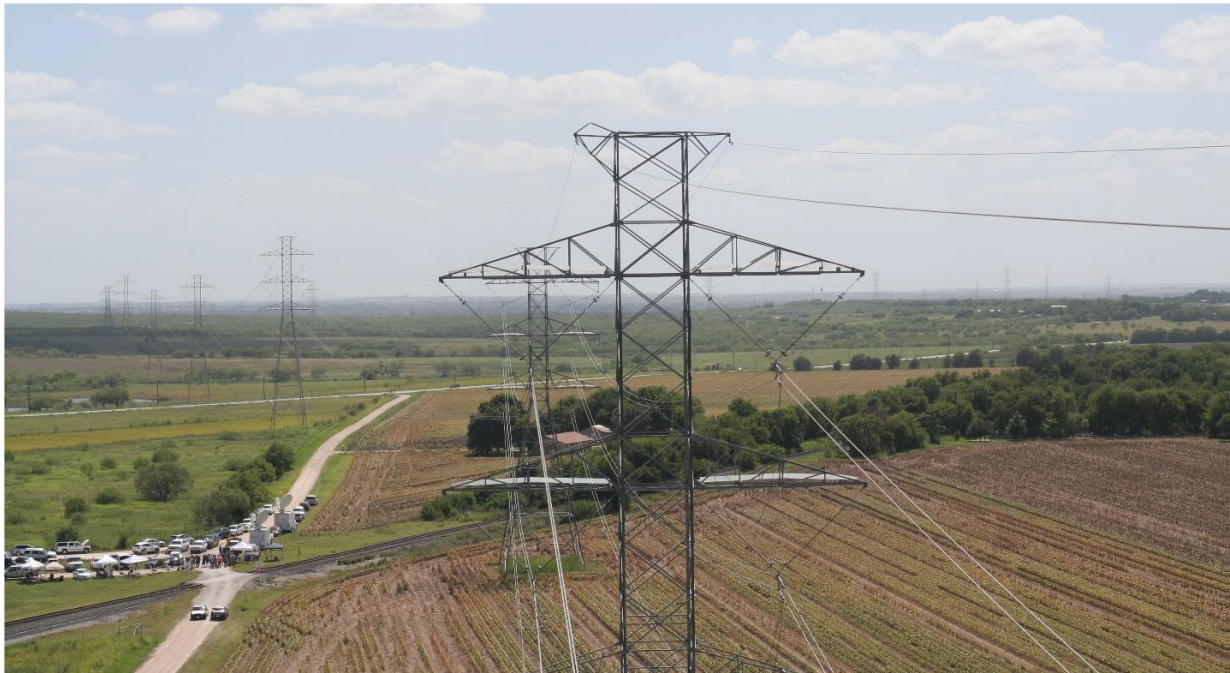
The crash site was located about 8 miles north of the launch site in an open field crossed by power lines. The power lines were oriented east/west, nearly perpendicular to the balloon’s flightpath. The lines were configured with a single, noncharged, grounded line on each side at the top with three phased pairs of charged lines below on each side (see figure 10). The balloon’s basket was located beneath the power lines. The balloon’s burner assembly and envelope were located about 0.5 mile downwind (north) of the basket (see section 1.6 for wreckage and impact information).

**Figure 10.** Power lines at the accident site.

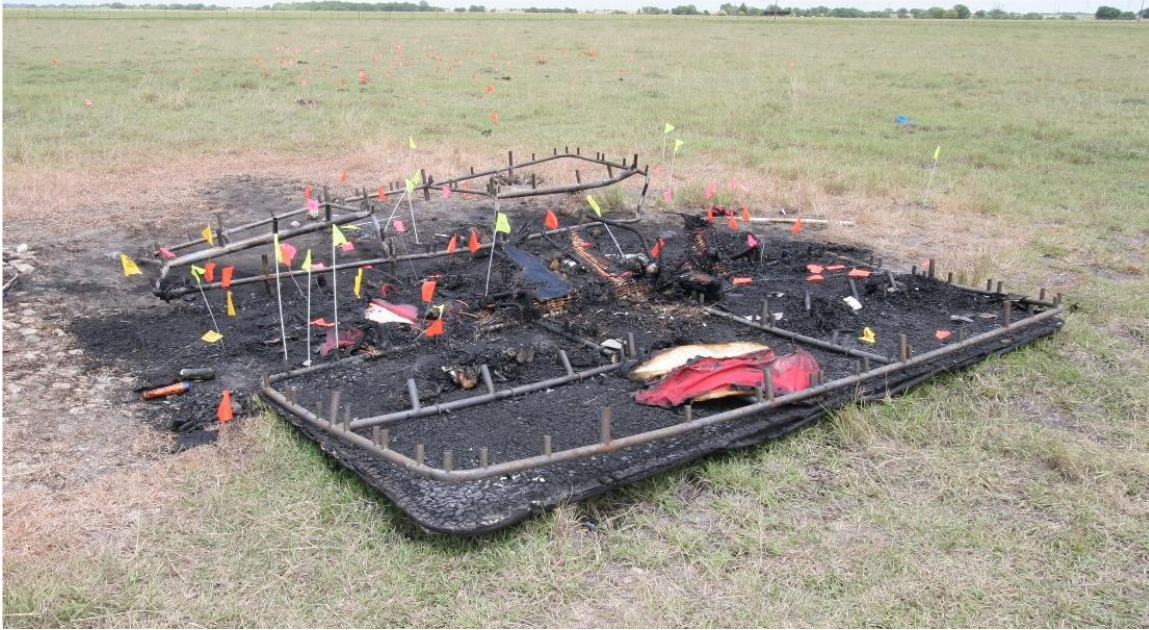
The basket was almost entirely consumed by fire; the upper and lower stainless-steel frames remained intact but were bent from ground impact (see figure 12). The basket support cables exhibited multiple severed ends with strand fusing. Evidence of electrical arcing was found on the carabiners that attached the basket support cables to the burner frame. Evidence of electrical arcing was also noted on the basket at the forward left corner of the upper and lower basket frames (see figure 13).

**Figure 12.** Postaccident photograph of the basket.

Note: All combustible basket components were completely burned; the remaining components were badly charred.

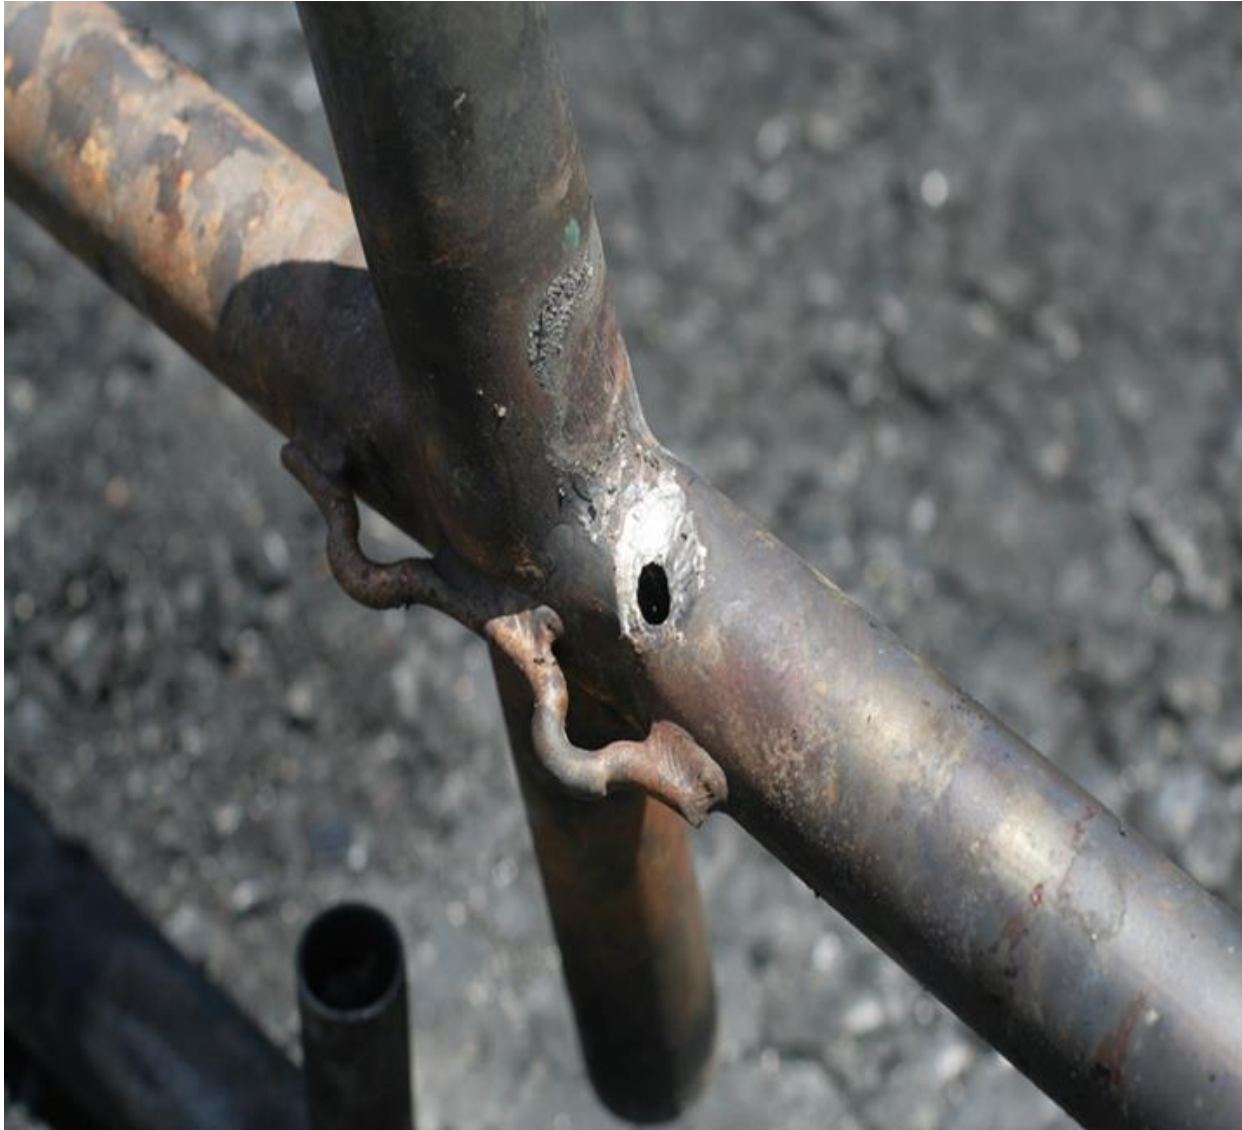
The NTSB's postaccident examination of the balloon found impact damage, fire damage, and electrical arcing damage. Arcing occurs when an object completes a circuit between two transmission lines or between a transmission line and a ground line. The power lines that were

**Figure 13.** Arcing damage on the basket frame.

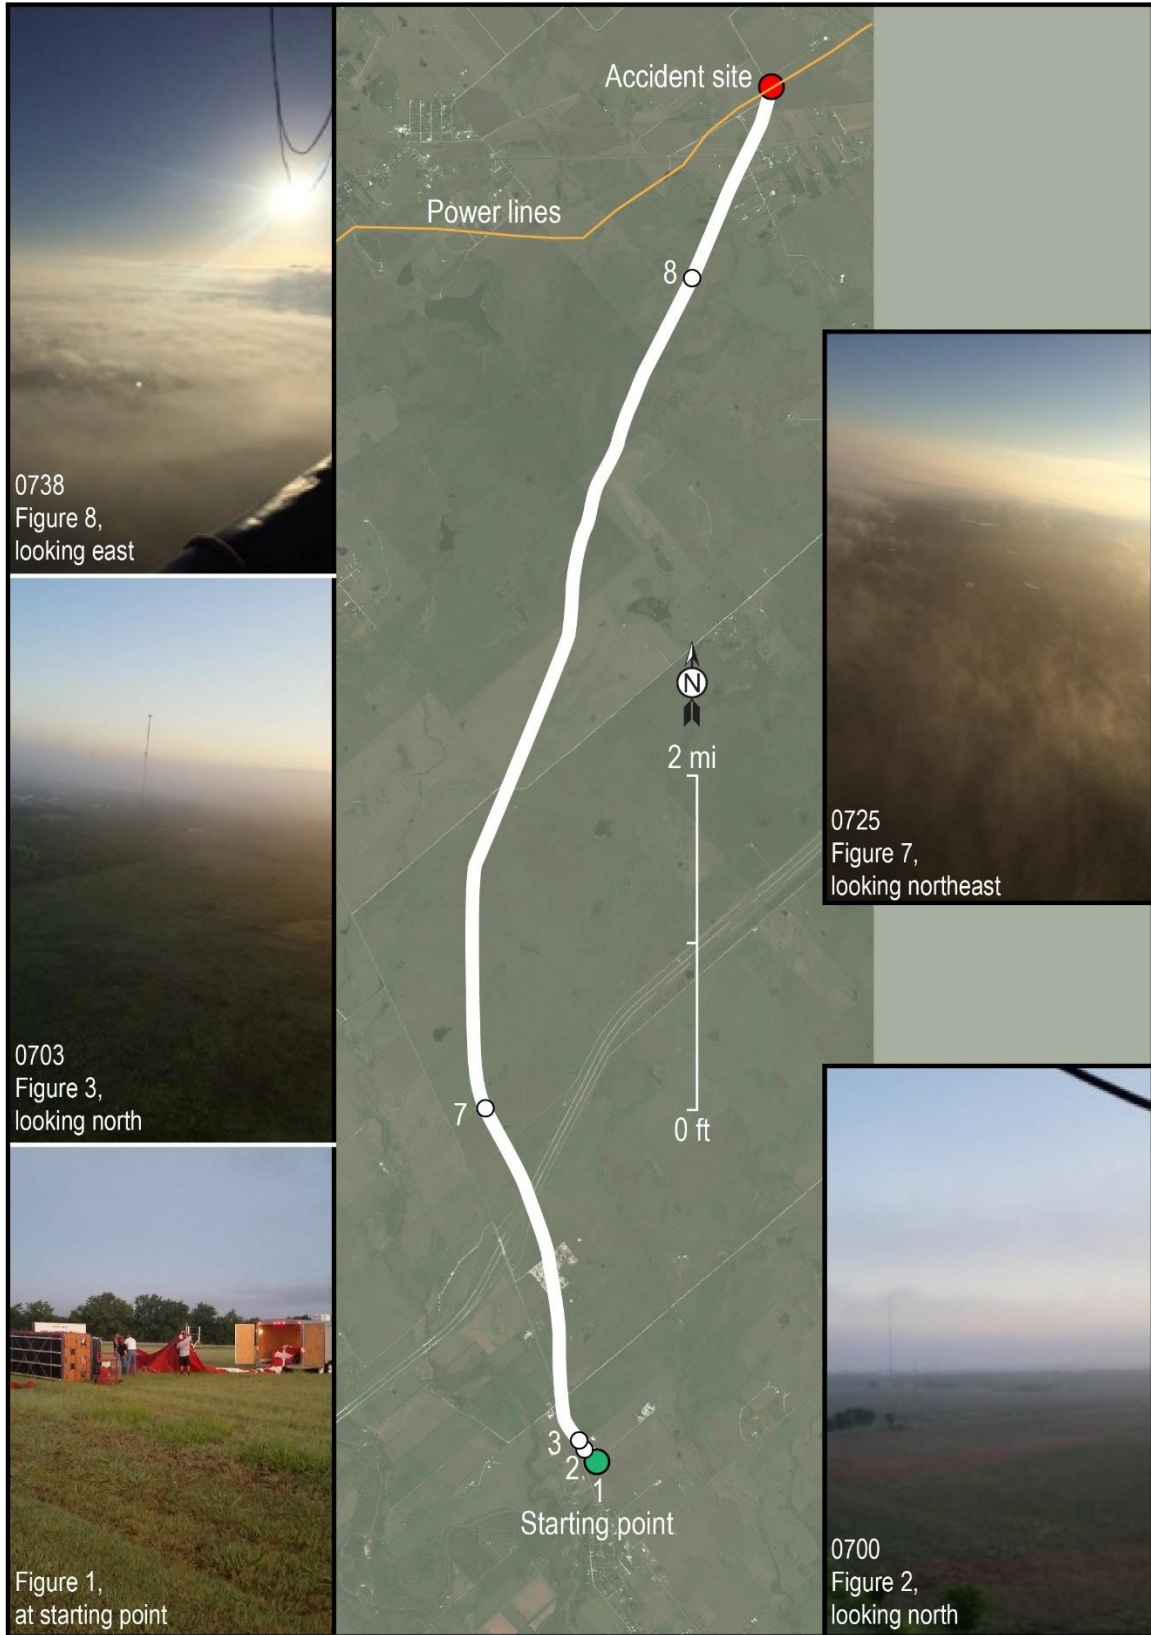
The accident pilot had the opportunity to make decisions based on the weather conditions at three points on the morning of the accident: prelaunch, en route, and end of flight. Figure 14 depicts locations (previously introduced as figures 1, 2, 3, 7, and 8) that show weather conditions along the flight route. Each of the pilot's decisions, related to these points, is discussed in the following sections.

Figure 14. Photographs and map overlay illustrating the pilot's weather-related decision points.
