Collision Between Freight Train and Charter Motorcoach at
High-Profile Highway–Railroad Grade Crossing
Biloxi, Mississippi
March 7, 2017

NTSB/HAR-18/01
PB2018-101328

Highway Accident Report

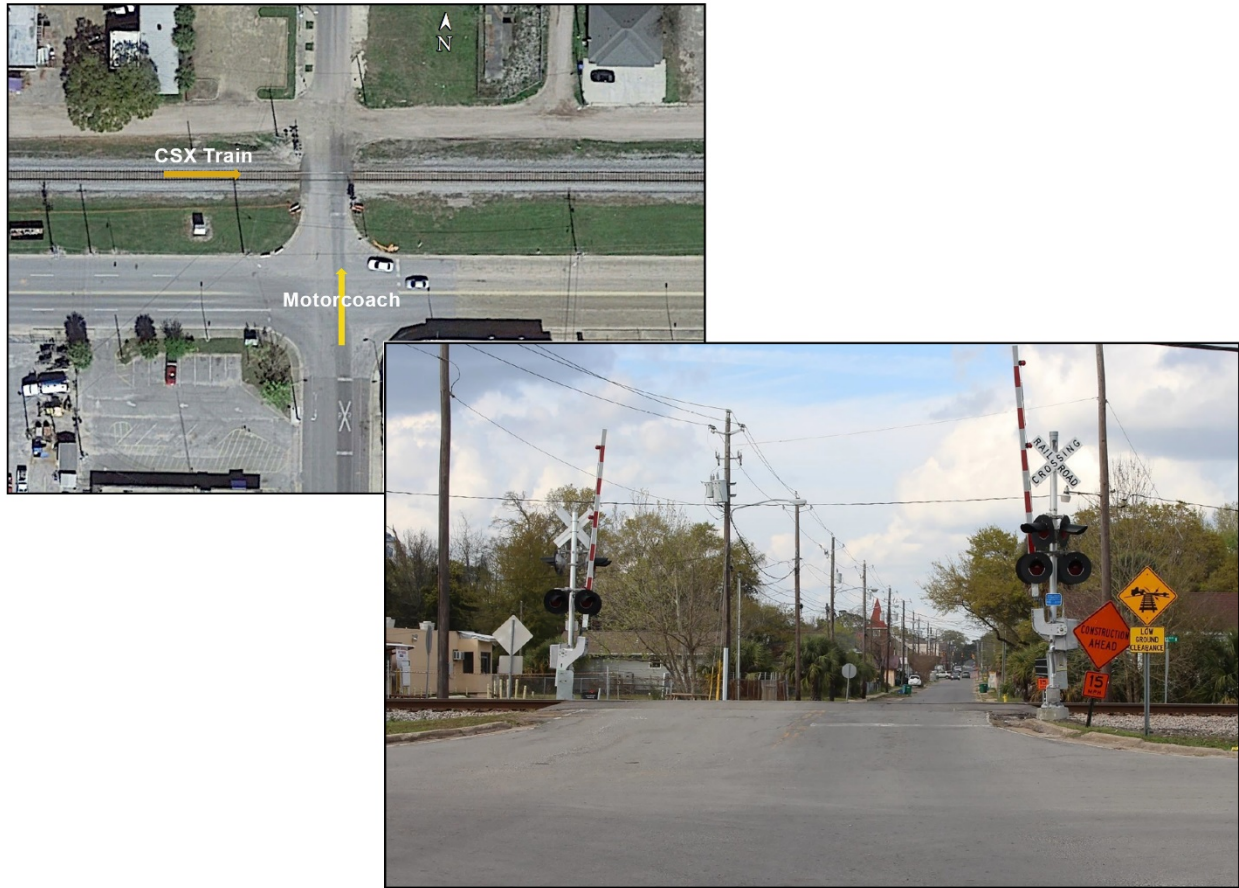
Figure 1. Overhead view of crash location (top) and forward view of northbound approach to Main Street grade crossing (bottom).

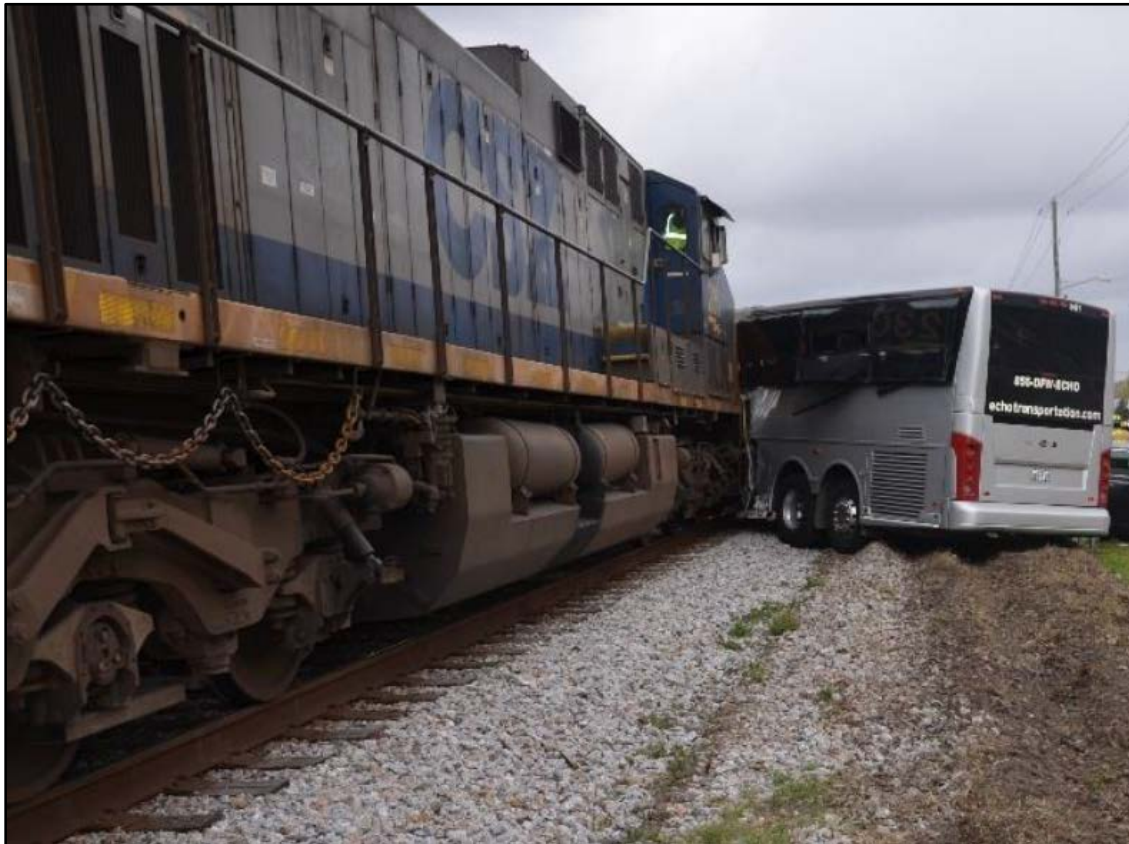
The train engineer later said that he had noticed the motorcoach on the tracks, but he expected it to clear the crossing before the train arrived there. As soon as the engineer realized that the motorcoach was not clearing the tracks, when the train was about 502 feet west of the crossing, he put the train into emergency braking. About 14 seconds later, by which time it had decelerated to about 19 mph, the train struck the left side of the motorcoach, pushing it 259 feet down the tracks before coming to a stop, with the motorcoach still in contact with the lead locomotive (see figure 2).⁷

Figure 2. Motorcoach and train final rest positions. (Source: Biloxi Police Department)

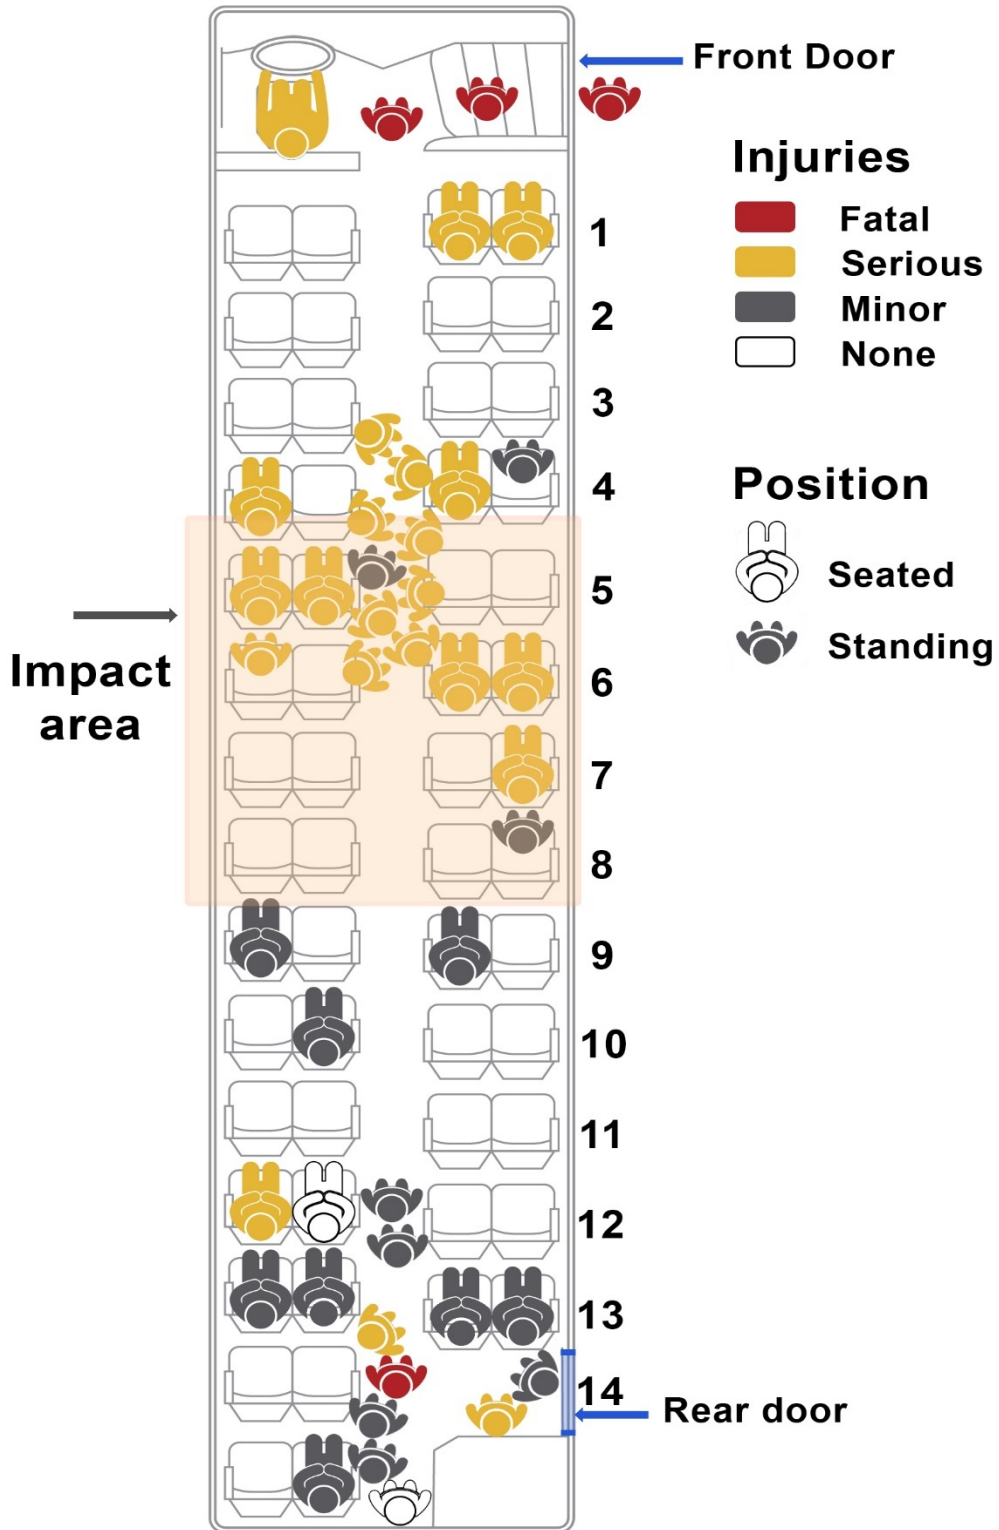
Figure 3. Motorcoach seating chart, showing the injury classifications and positions of the motorcoach driver and 43 passengers who were on or just outside the vehicle at the time of impact.

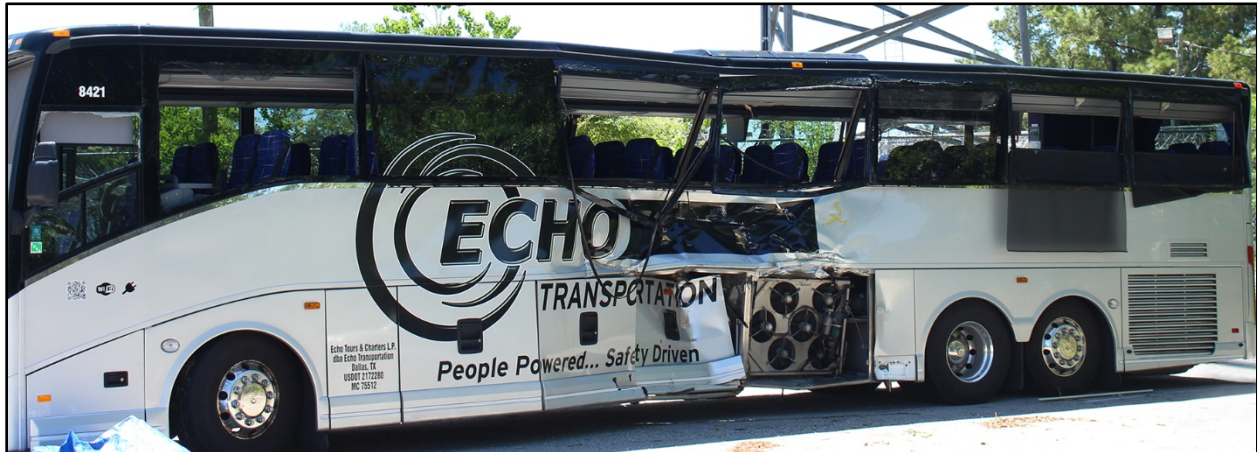
1.4.1.1 External. The motorcoach sustained significant contact damage on the left side, which began about 16.3 feet from the rear and extended forward about 9.3 feet (see figure 4). The maximum lateral displacement occurred about 22.7 feet from the rear, where the left sidewall intruded 27 inches. This maximum intrusion was in the region of rows 5 through 7. The luggage compartment door just forward of the rear axle was displaced and the compartment door to its left was folded toward the front of the motorcoach. The location of the impact damage on the left side indicated that the front of the motorcoach was about 20.4 feet past the north side of the rail tracks when the locomotive struck it. The front end sustained no crash damage.

Figure 4. Motorcoach postcrash, showing contact damage to the left side.

On the motorcoach's right side, the sidewall was bowed out in the area corresponding to the impact on the left side. The maximum lateral displacement occurred about 25.7 feet from the rear of the motorcoach, where the right sidewall bowed outward about 18 inches.

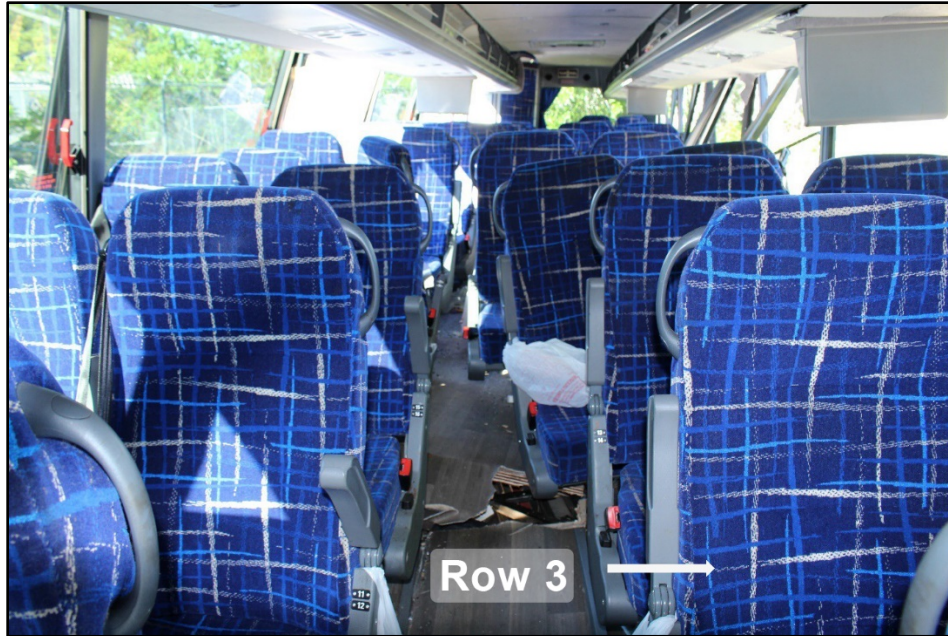
1.4.1.2 Interior. The driver seat was intact, and the steering wheel was undamaged. The front interior of the motorcoach, up to about row 4, was largely undamaged, and the aisleway in this area retained its original width of 17 inches. Extensive interior damage began at row 5 on the left side and extended to slightly beyond row 8 (see figure 5). The area of these four rows showed evidence of intrusion that reduced the overall interior width of the motorcoach, sidewall to sidewall, by 16 inches. The aisle in this area decreased in width from 17 inches to 8 inches. As a result of the impact, the motorcoach floor buckled, starting in the aisleway at row 4. The floor in front of the seats in row 5 on the right side had buckled and partially collapsed, creating an opening in the floor that extended into the row 6 seats on the right side. As a result of this floor collapse, the aisle seat in row 5 on the right side had dropped about 2 inches below the floor level, intruding into the luggage compartment. The upward buckling of the floor in row 5 raised the floor level at this location by about 12 inches.

Figure 5. Motorcoach interior, showing the buckling of the floor and the lateral displacement of the seats.

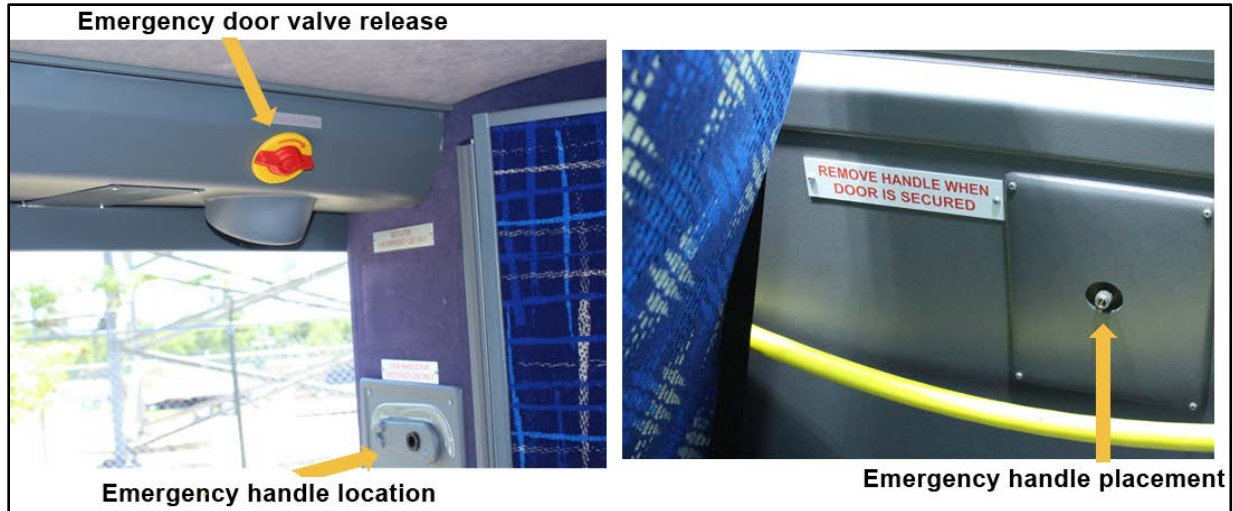
Figure 6. Interior of the motorcoach, showing the three assemblies necessary to open the rear door.

According to a passerby who entered the motorcoach after the crash but before the arrival of emergency responders, he attempted to open the rear door from inside the vehicle. He reported taking the handle that he saw mounted on the wall of the lavatory and placing it on the door in an attempt to open it, but he was unsuccessful.¹⁷

If the rear door is locked, it cannot be opened from outside the motorcoach. When the first responders attempted to open the rear door from the outside, they found it locked. Once inside the motorcoach, they were unable to locate the emergency door handle and could not open the door.¹⁸

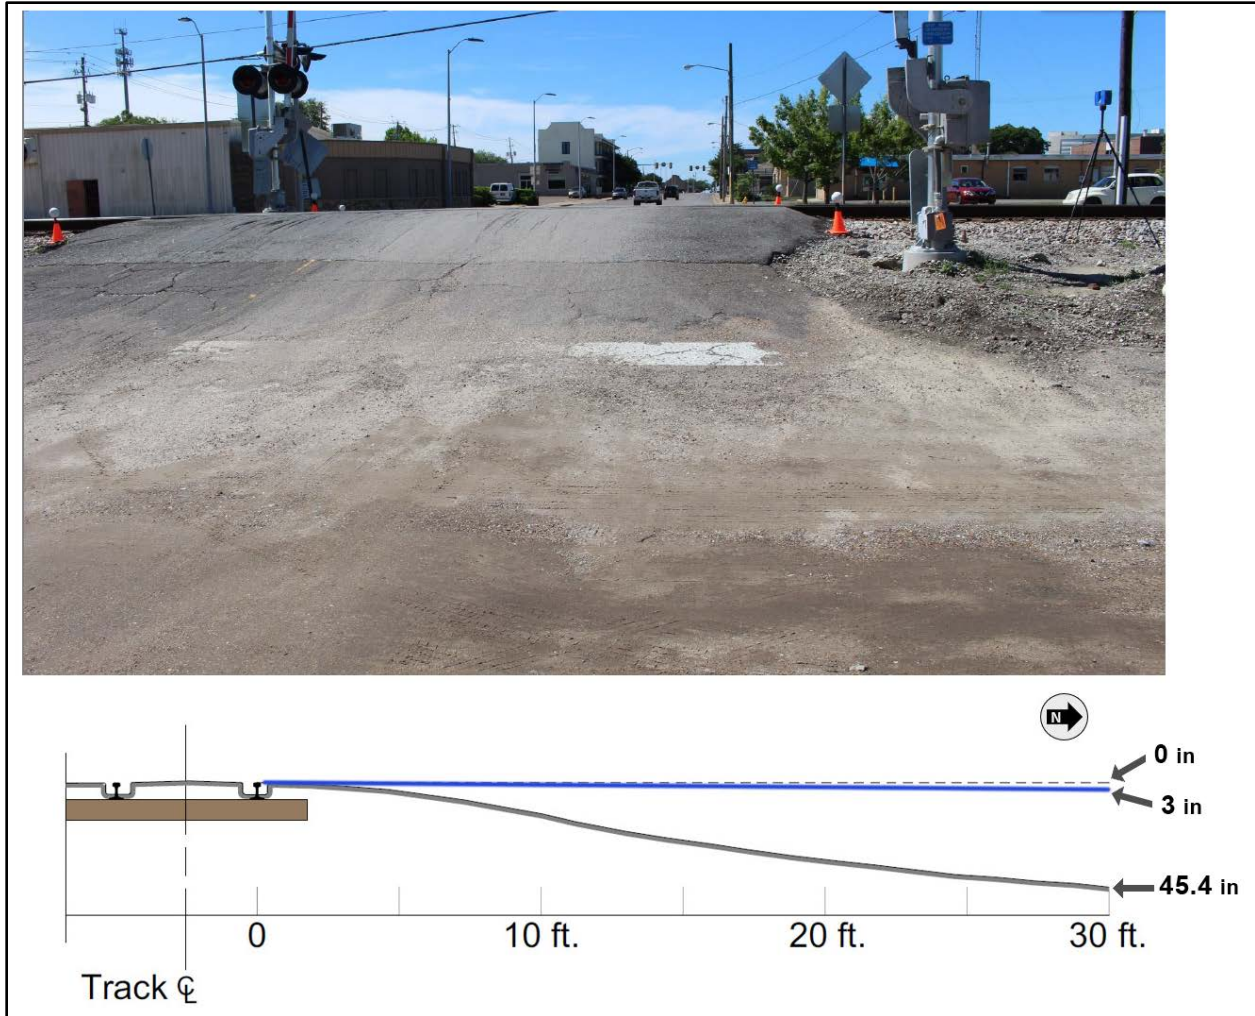
Figure 9. Photograph showing the southbound approach to the grade crossing (top) and cross-section diagram of the measured vertical profile of the approach's slope (bottom). The blue line in the diagram represents the maximum elevation difference between the crossing and the approach as recommended by the FHWA and AASHTO, and the gray line represents the actual elevation difference at the grade crossing.

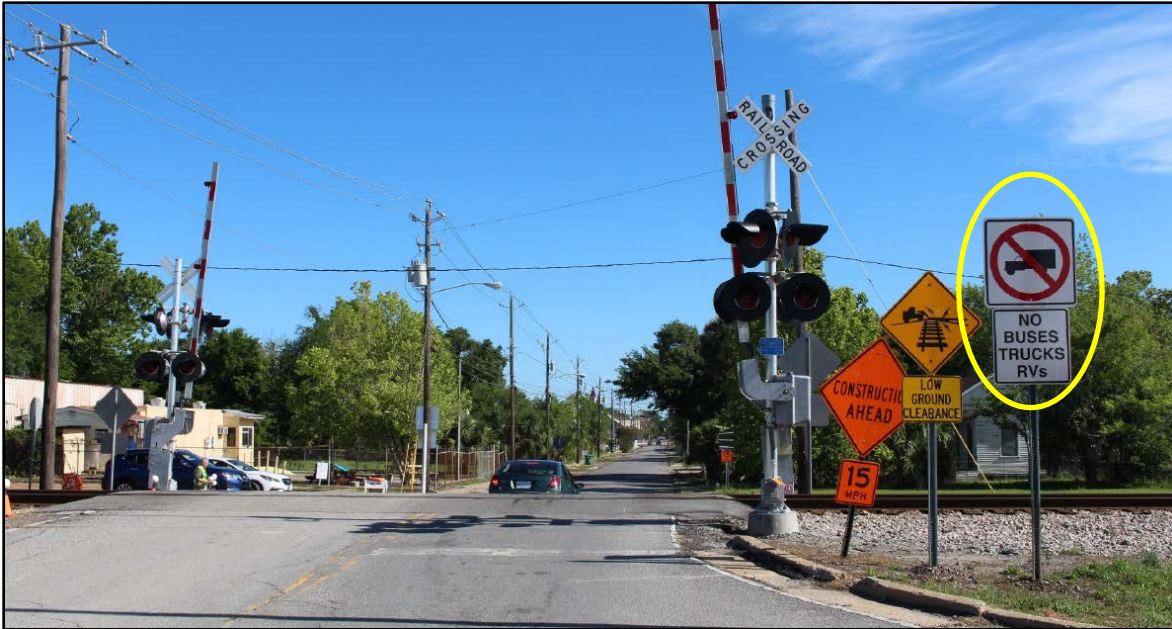
Figure 10. Postcrash view of the northbound approach to the Main Street crossing, showing the new vehicle exclusion sign and plaque (circled in yellow) posted by the City of Biloxi after the crash.

As a result of this crash, the MDOT Rails Division initiated a safety program in April 2017. As part of this program, MDOT met with local municipalities along the 74 miles of CSXT track in Mississippi and identified all grade crossings with vertical profiles exceeding the slope limits recommended in the FHWA/AASHTO design guidance. MDOT offered the local municipalities free access to LGC GC warning signs and accompanying “LOW GROUND CLEARANCE” plaques for installation at those crossings not meeting the design guidelines. As of July 2018, of the 12 entities eligible to receive the signs, 6 had requested them.
