School Bus Run-Off-Road and Fire
Oakland, Iowa
December 12, 2017

Highway Accident Report

NTSB/HAR-19/01
PB2019-100808

The National Transportation Safety Board (NTSB) determines that the probable cause of the fatal school bus run-off-road and fire in Oakland, Iowa, was (1) the driver's failure to control the bus, backing it into a roadside ditch for reasons that could not be established; and (2) the failure of the Riverside Community School District to provide adequate oversight by allowing a driver to operate a school bus with a known physical impairment that limited his ability to perform emergency duties. The probable cause of the fire was ignition of a fuel source on the exterior of the engine's turbocharger due to turbocharger overload and heat production, resulting from the blockage of the exhaust pipe by the bus's position in the ditch and the driver's attempts to accelerate out of the ditch. Contributing to the severity of the fire was the spread of flames, heat, and toxic gases from the engine into the passenger compartment through an incomplete firewall.

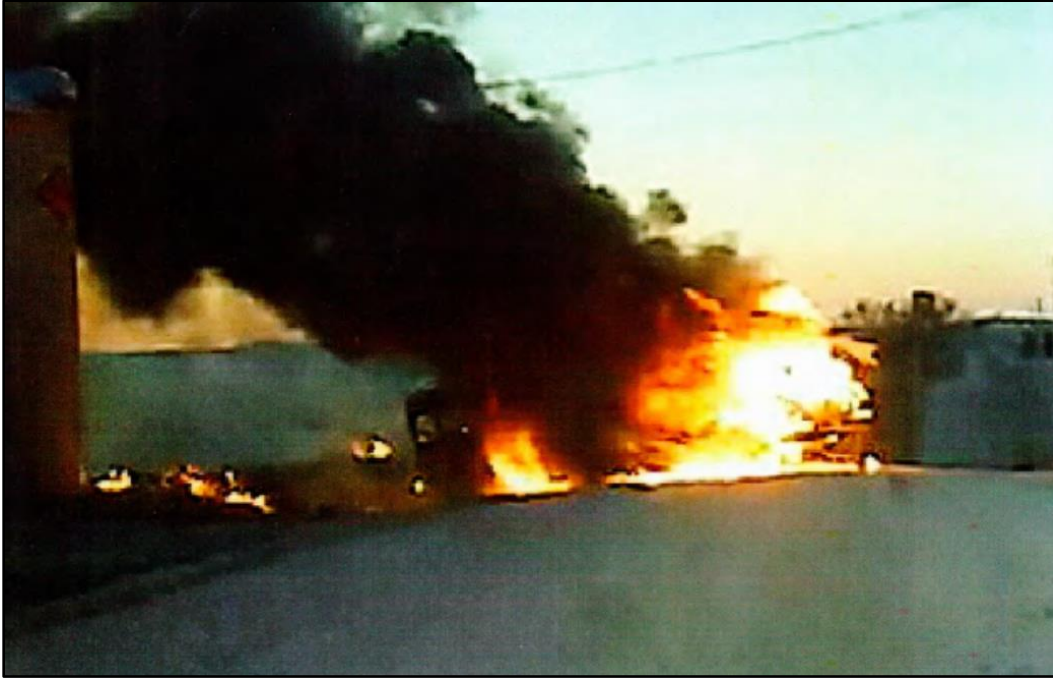
Figure 4. Burning school bus (right side) in still photograph captured from body camera video. (Source: Pottawattamie County Sheriff's Office)

The first county sheriff's deputy to arrive stated that the school bus was fully engulfed in fire when he arrived on scene (refer to figure 4). The deputy applied the fire extinguisher issued by the sheriff's department to the back of the bus, but it had no effect on the fire. He then tried to enter the school bus through the rear emergency exit door, but the flames and fire temperature stopped him. Members of the first fire department unit to arrive reported that when they approached the scene, the bus was on fire from front to rear. They immediately began fire suppression and extinguished the fire. The postcrash fire destroyed much of the school bus (figure 5).

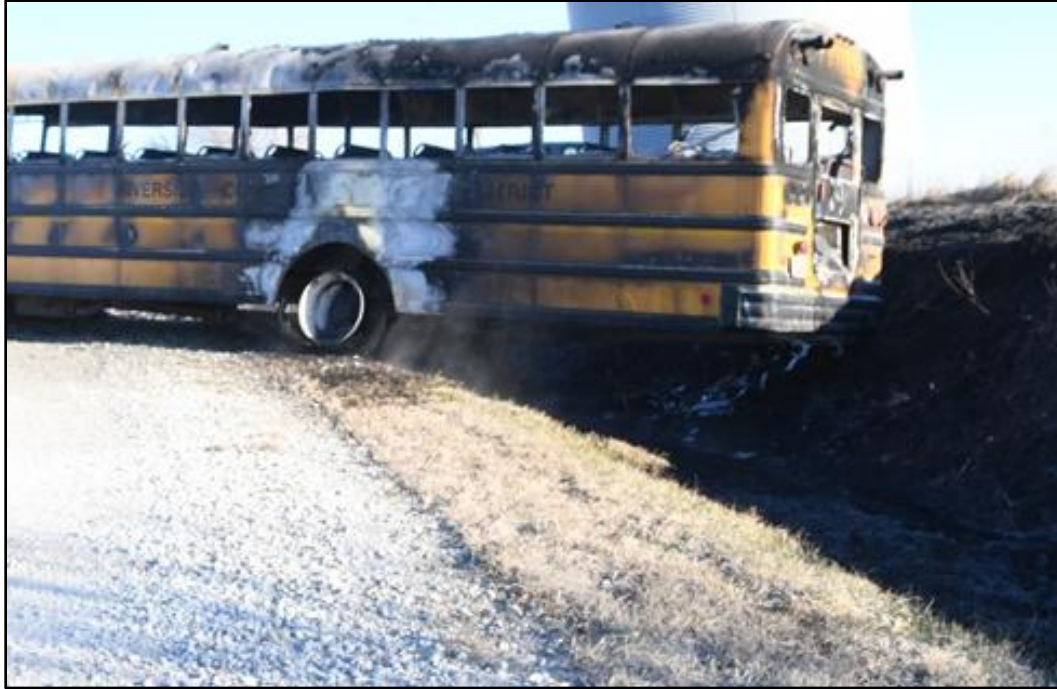
Figure 5. Burned school bus (left rear) at final rest in ditch. (Source: Pottawattamie County Sheriff's Office)

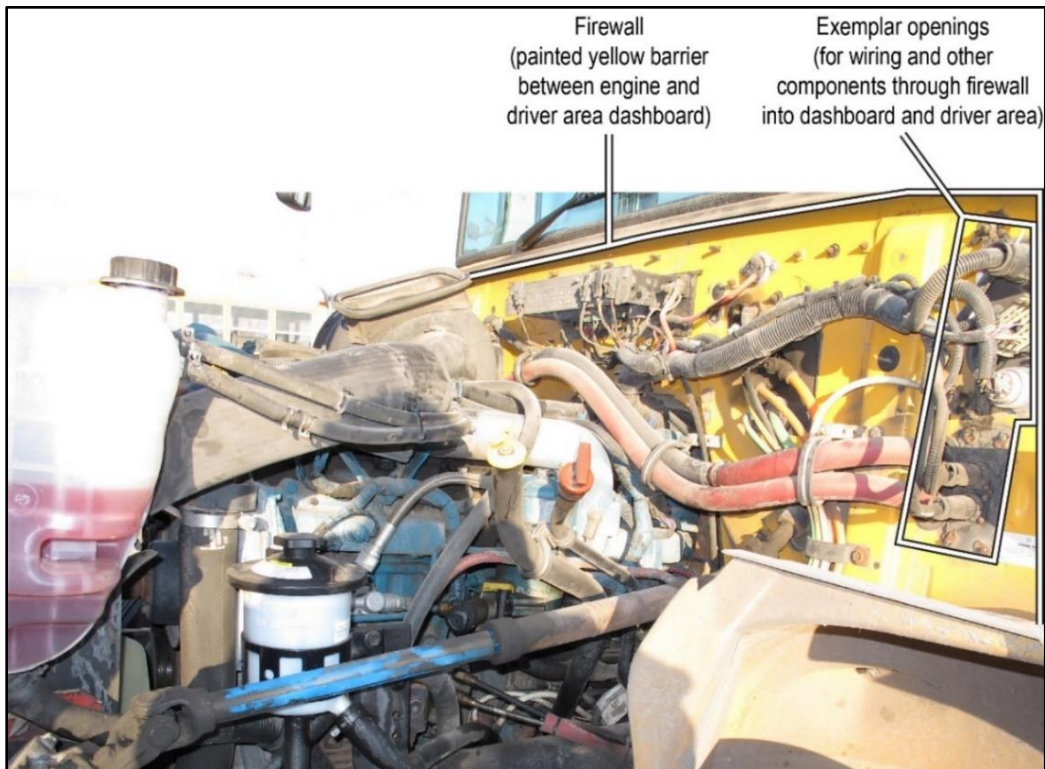
The engine block extended beyond the firewall into the driver area of the bus interior. The area was covered with a fiberglass cowling that was heavily damaged by the fire. Glass fibers were present, but a large amount of resin had burned out of the fiberglass. A hole was found on the upper right corner of the cowling. The engine block and components below the turbocharger and engine control board (forward from the firewall toward the front bumper) were intact and relatively undamaged. The blue paint on the lower part of the engine block was intact; the oil filter was also intact.⁴⁰ Between the engine block and the interior driver's area were several firewall penetrations for components such as wiring (figure 8). Components in the openings to the right of the vehicle's midline were destroyed by the fire. Electrical wiring was still present in the openings to the left of the midline, but the material used to seal the wiring inside the openings was missing and had most likely been destroyed by the fire.⁴¹

Figure 8. Engine compartment of exemplar bus showing firewall and openings into driver's area.

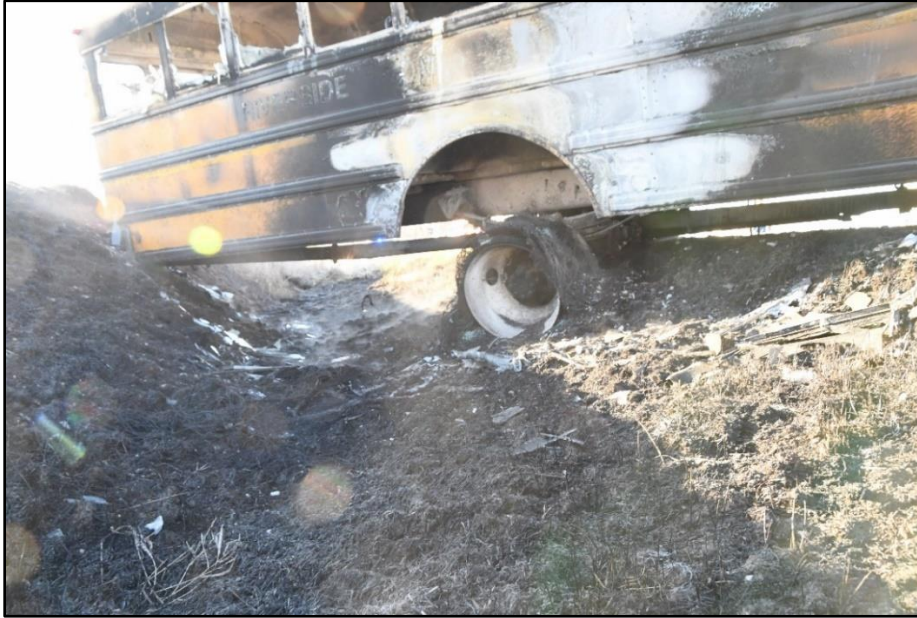
The rear emergency exit door did not show any damage from contact with the ditch or the embankment, and the door was found to be operational after the fire. From the rear left corner of the bus to the right rear tires and below the windows, the bus's body paint showed little thermal damage. Contact damage from the ditch embankment to the right rear bumper area was documented, and the obstructed exhaust tailpipe was photographed at the scene (see figure 9 and section 1.5.3, below).⁴²

Figure 9. Right rear bumper of bus embedded in drainage ditch embankment.

The right side of the bus's rear bumper was slightly deformed rearward and had pulled through the rivets that secured it to the bus body. The rear of the exhaust pipe was displaced upward (about 3 inches), as was the rearmost exhaust pipe support hanger (about 2 inches). The exhaust pipe had a split about 4 inches long and between 1/16 and 1/8 inch wide.

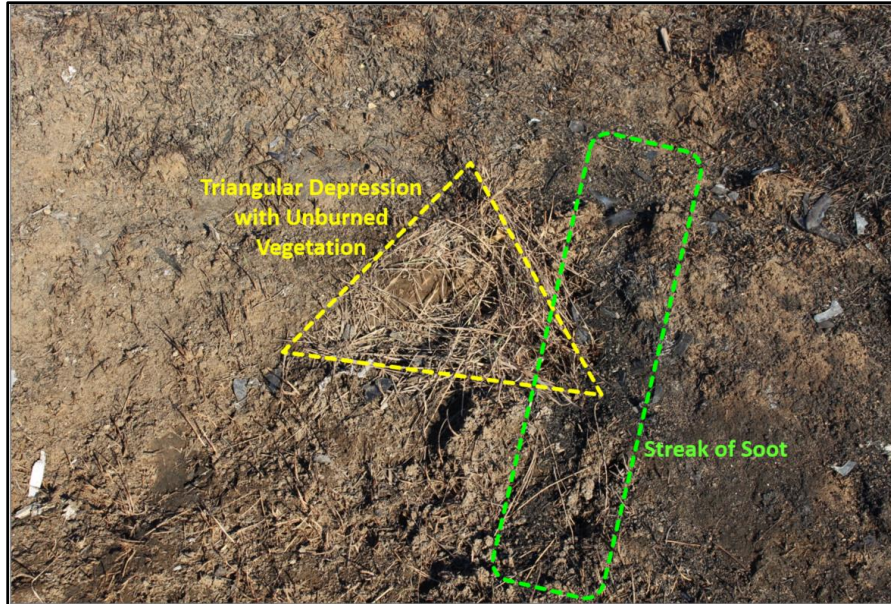
Figure 10. Streak consistent with soot deposit on drainage ditch backslope next to depression containing unburned vegetation.

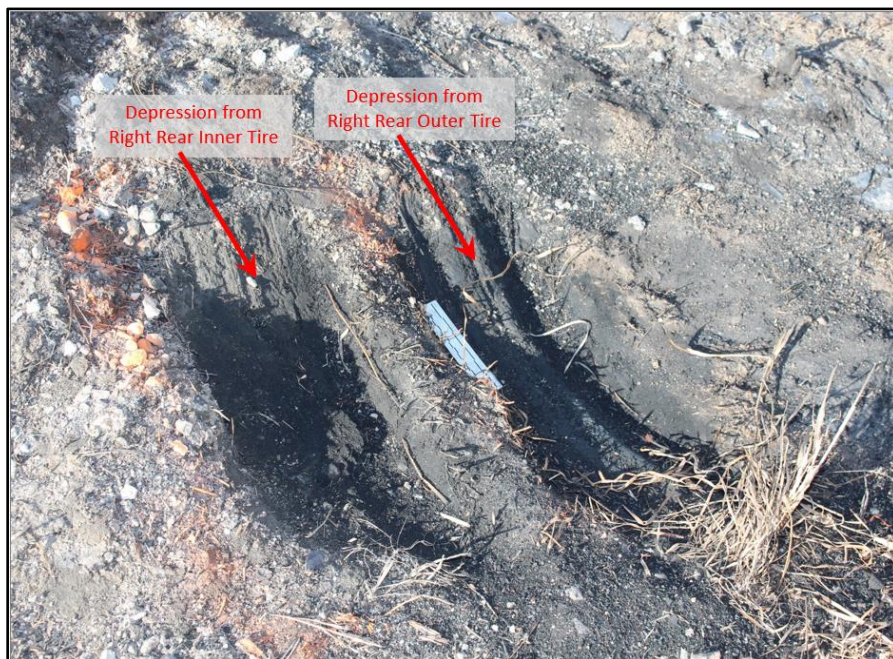
Two distinct depressions, consistent with impressions from the bus's right rear tires, were found in the soil near the bottom of the ditch foreslope. When investigators removed the fire debris, tire imprints in the depressions were exposed (figure 11). One imprint measured about 24 inches long, 9 inches wide, and 2 inches deep and was consistent with being formed by the right rear inner tire. The imprint formed by the right rear outer tire was about 27 inches long, 9 inches wide, and 2 inches deep. Large portions of partially burned and melted tire treads were found lining the bottoms of the depressions.

Figure 11. Soil depressions from rear tires on foreslope near ditch bottom.

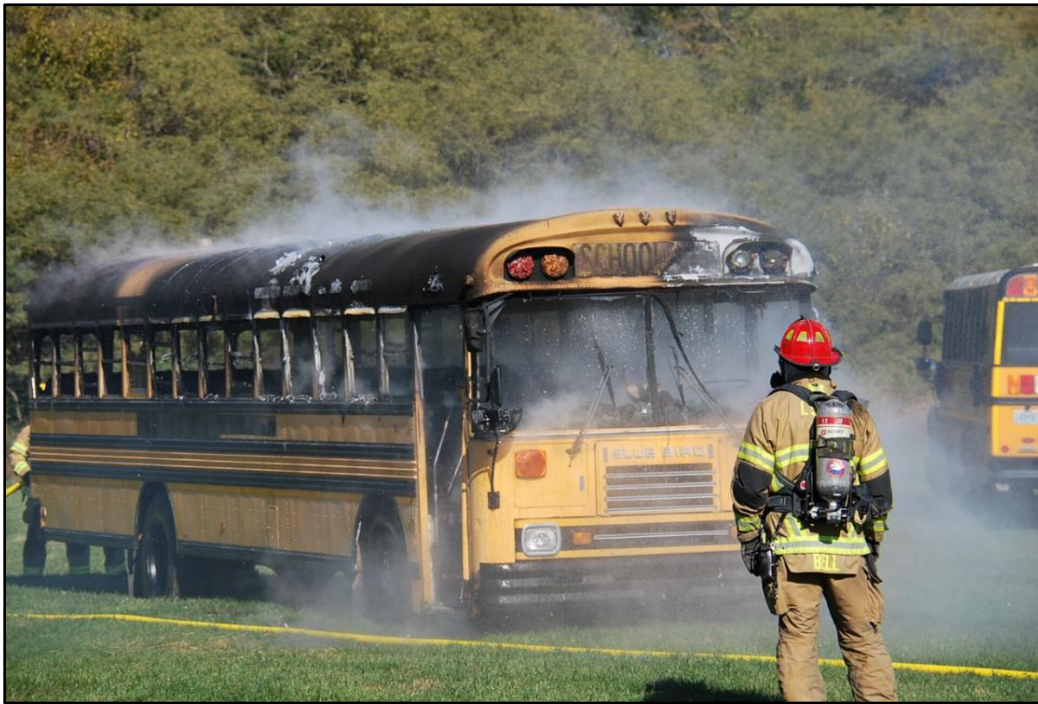
A bale of hay was set on fire inside the open front door of one bus, and by the 3-minute mark, the bus was filled with smoke, and temperatures had reached 900°F to 1,000°F (figure 16). Simultaneously, volunteers seated in another school bus (not set on fire) acted as passengers to demonstrate evacuation times. Without their seat belts, the volunteers evacuated the bus within 1 minute 16 seconds. When the demonstration was performed again, with the participants wearing seat belts, their evacuation time increased by 2 seconds. In a third demonstration, the same passengers wore their seat belts but also closed their eyes (to simulate reduced visibility due to smoke), which lengthened the evacuation time to 2 minutes 27 seconds.⁶¹

Figure 16. Extent of damage to school bus in Kansas City fire demonstration. (Source: NAPT)

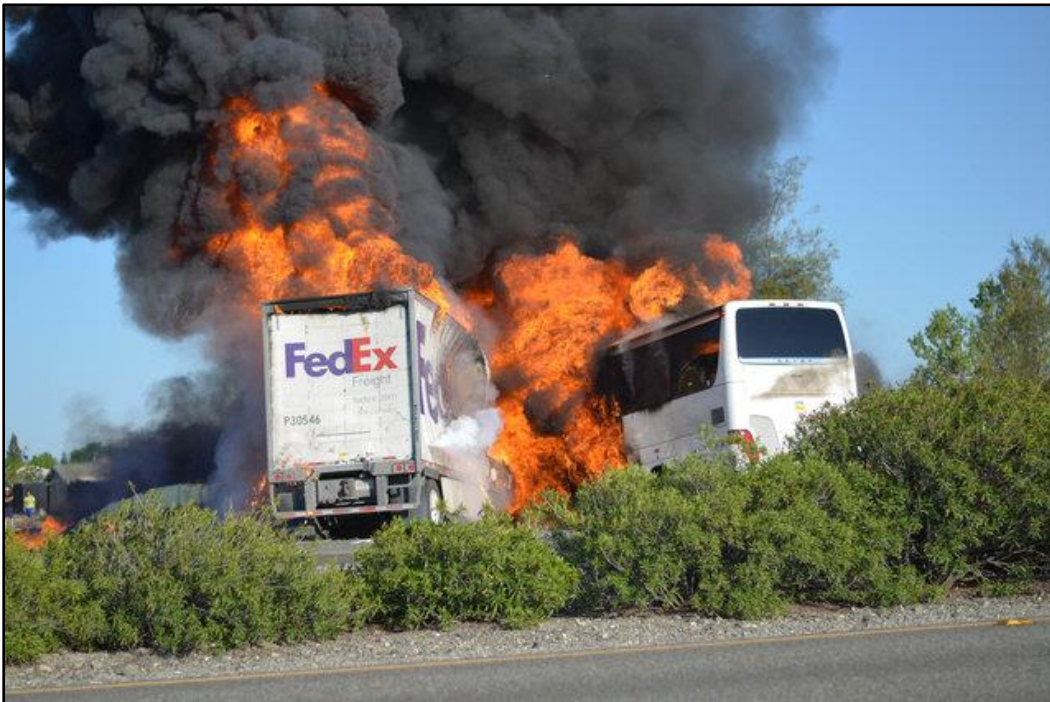
The truck-tractor collided with the front of the motorcoach, and both vehicles ran partially off the east side of I-5. A postcrash fire consumed the truck-tractor, significant portions of its trailers, and the motorcoach interior (figure 19). Both the truck and the motorcoach driver died, along with eight motorcoach passengers. Six passengers died of asphyxiation due to the inhalation of products of combustion; three were found inside the motorcoach. Two of the three did not exhibit antemortem (before death) traumatic injuries. The remaining 37 passengers received injuries of varying degrees. Ten seriously injured passengers sustained both fire-related injuries (inhalation injuries, acute respiratory failure, and second- or third-degree burns) and collision or egress injuries.

Figure 19. Truck-tractor double trailer and motorcoach burning after crash near Orland, California. (Source: J. Lockett)

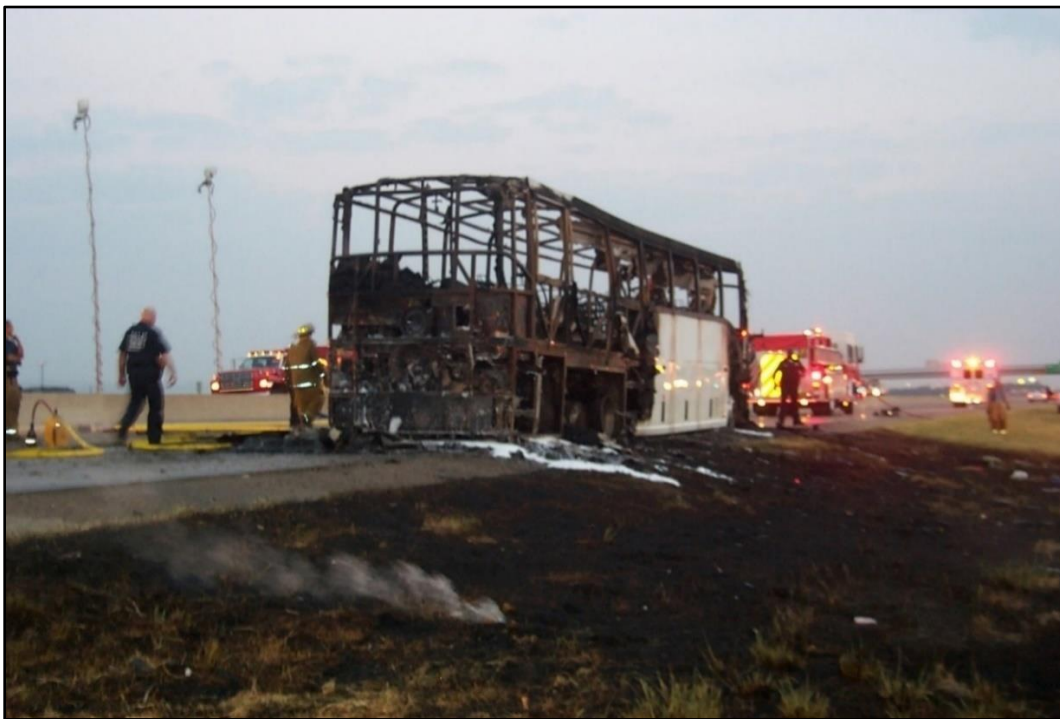
The driver and nursing staff exited the motorcoach and observed flames coming from the right-rear wheel well. As they began evacuating passengers from the motorcoach, with assistance from passersby, heavy smoke and fire quickly engulfed the vehicle (figure 20). Twenty-three passengers were fatally injured; their causes of death were smoke inhalation and thermal injuries. Of the 21 passengers who escaped, all received injuries, many due to smoke inhalation and burns.

Figure 20. Damaged motorcoach on I-45 after fire near Wilmer, Texas. (Source: Dallas County Sheriff's Office)

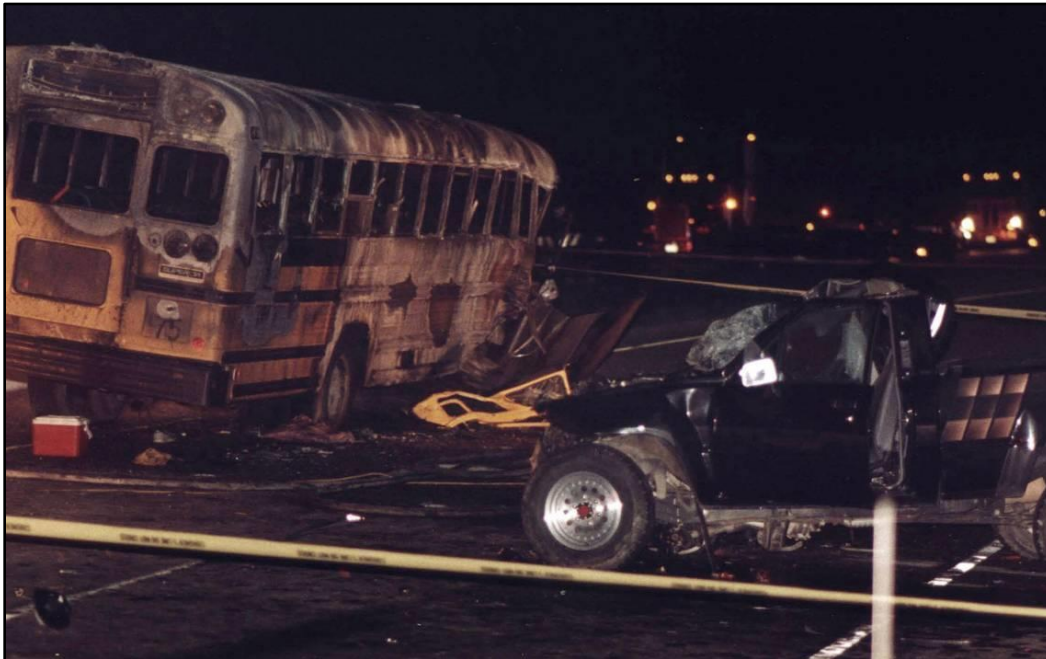
About 10:55 p.m. eastern daylight time on May 14, 1988, a pickup truck traveling north in the southbound lanes of Interstate 71 struck head-on a church activity bus traveling south in the left lane of the interstate near Carrollton, Kentucky (figure 21). As the pickup truck rotated during impact, it struck a car traveling south in the right lane near the church bus.

Figure 21. Scene of crash and fire near Carrollton, Kentucky, showing burned church bus and wreck of pickup truck that struck it. (Source: *Lexington Herald-Leader*)
