Motorcoach Collision With Combination Vehicle
After Traffic Break on Interstate 10
Palm Springs, California
October 23, 2016

NTSB/HAR-17/04
PB2018-100195

Highway Accident Report

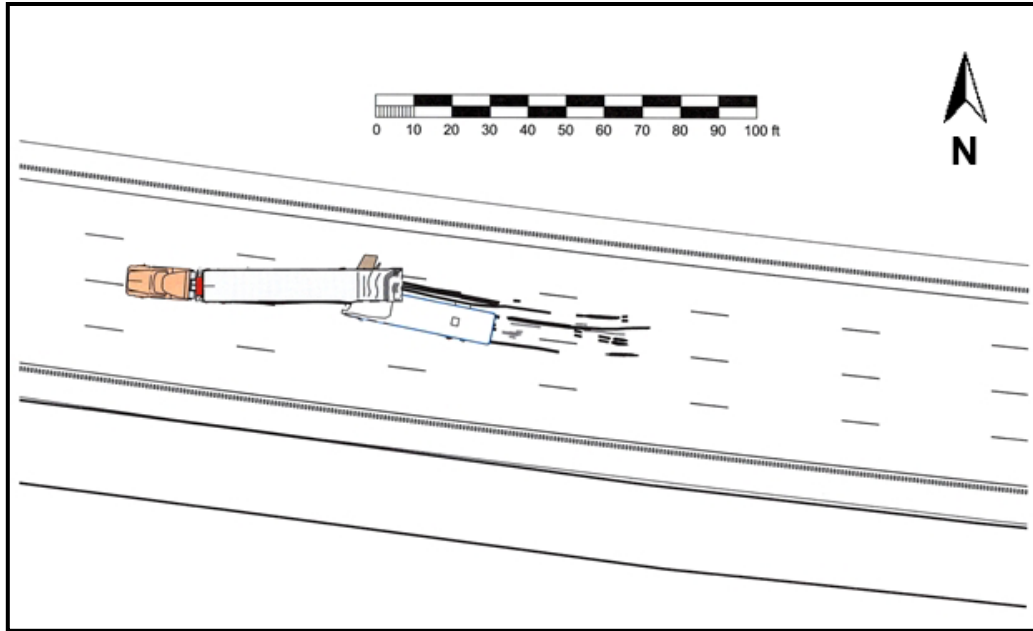
Figure 2. Postimpact positions of the combination vehicle and the bus, and the road friction marks created by the truck-tractor as it was being pushed by the bus.

Investigators found no precollision tire friction marks from the bus that could indicate an evasive braking maneuver. The impact by the bus moved the truck-tractor about 71 feet west, with friction marks terminating at the truck-tractor's drive axle. At rest, both vehicles partially occupied the left-center and right-center travel lanes (see figure 3).

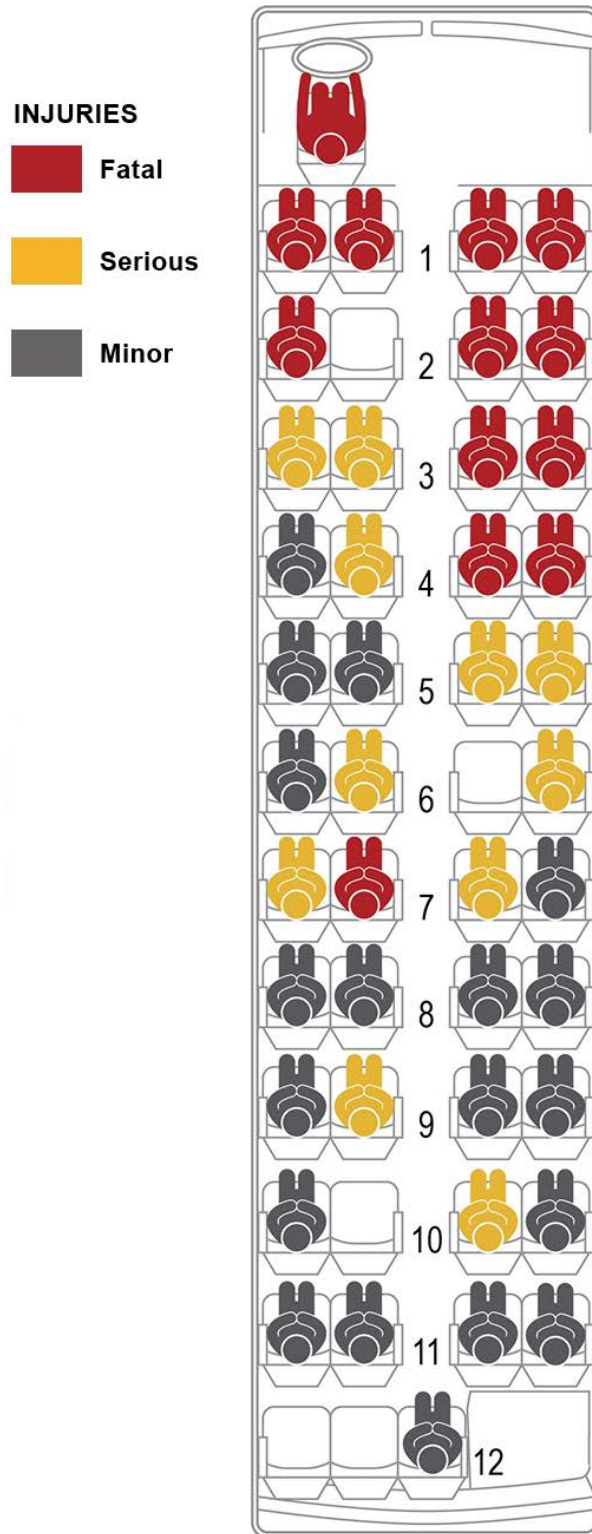
The distribution of injury severity shows that nearly all the bus passengers—9 of 11—who sustained serious injuries were seated in rows 3–7. Only two passengers in the rear half of the bus—those in rows 8–12—sustained serious injuries; the rest of those seated in the rear received minor injuries. Based on interviews with the surviving passengers, NTSB investigators determined the seating positions for all 42 passengers. Figure 4 shows the seating locations and injury classifications for the bus occupants.

Figure 4. Bus seating chart, showing the injury classifications for the driver and 42 bus passengers.

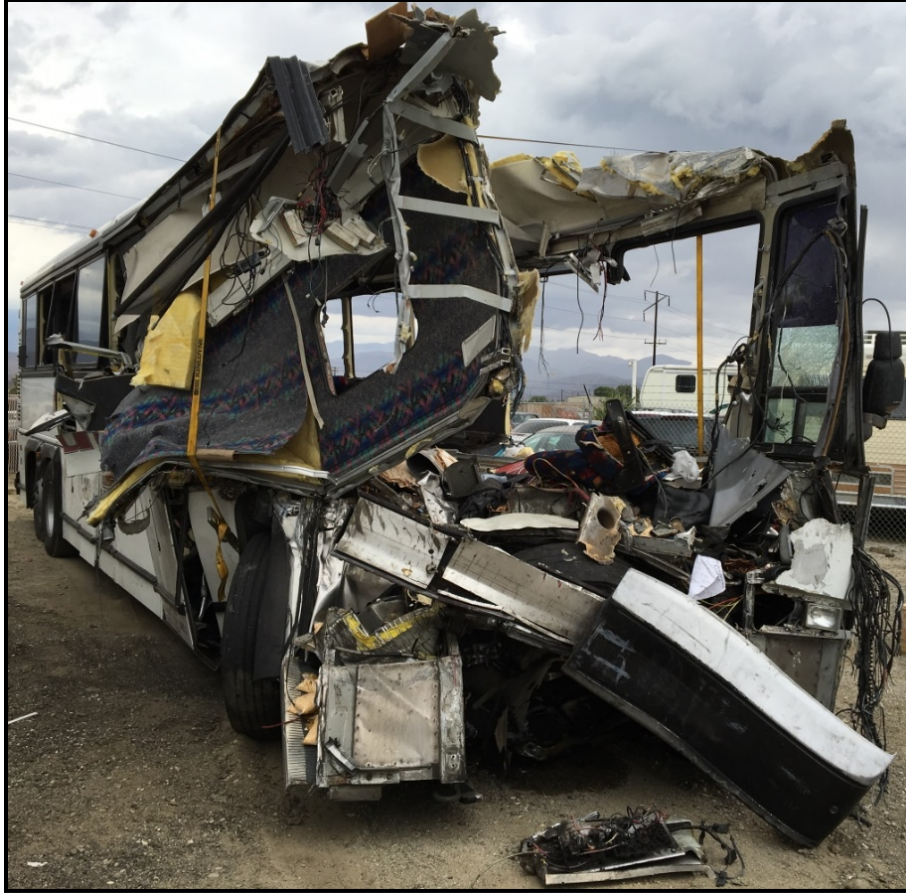
1.5.2.2 External Damage. The bus sustained catastrophic front-end damage (see figure 8). The entire windshield, with the right-side rearview mirror, was displaced and missing. The front body panels, the right-front headlamp, and left- and right-side turn signal assemblies were also displaced and missing. The left-side low- and high-beam headlights were damaged but remained in their mounting locations. The analysis of the low-beam filament by the NTSB Materials Laboratory could not conclusively determine whether the headlights were turned on at the time of the crash. Based on the video from the FedEx security cameras, the bus headlights were on in the moments before the crash.

Figure 8. Bus postcrash, showing extensive damage to the front of the vehicle.

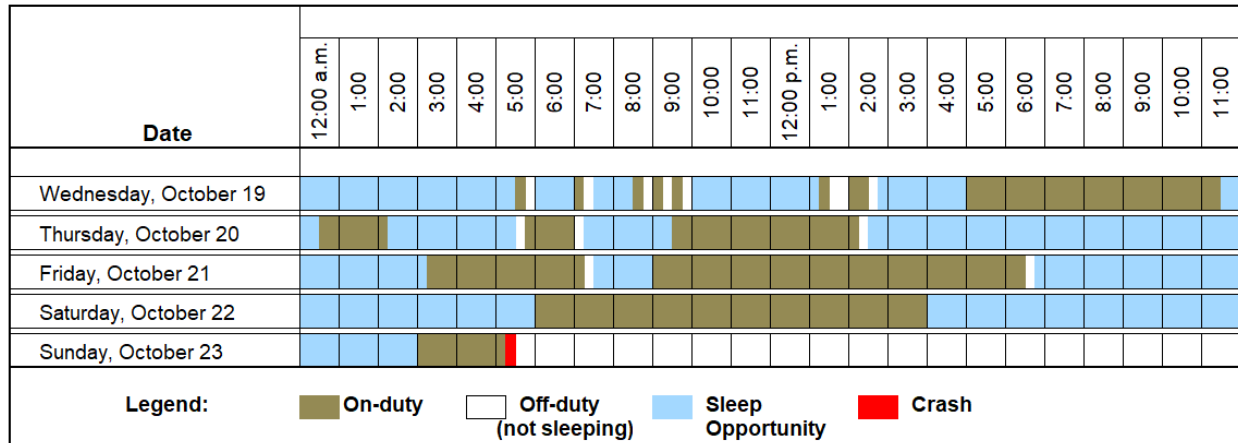
Figure 10. Precrash activities of the truck driver, October 19–23, 2016. (The shortest depicted interval is 15 minutes.)

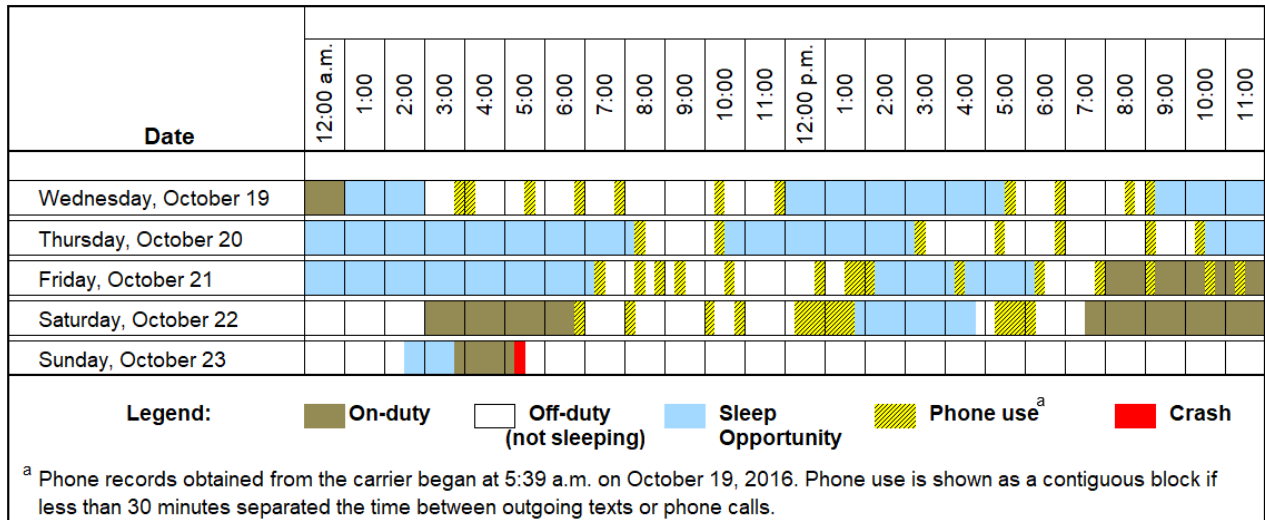
Figure 11. Precrash activities of the bus driver, October 19–23, 2016. (The shortest depicted interval is 15 minutes.)
