Collision of Tugboat/Barge *Caribbean Sea/The Resource*  
with Amphibious Passenger Vehicle *DUKW 34*  
Philadelphia, Pennsylvania  
July 7, 2010

**Accident Report**

NTSB/MAR-11/02  
PB2011-916402

**National  
Transportation  
Safety Board**

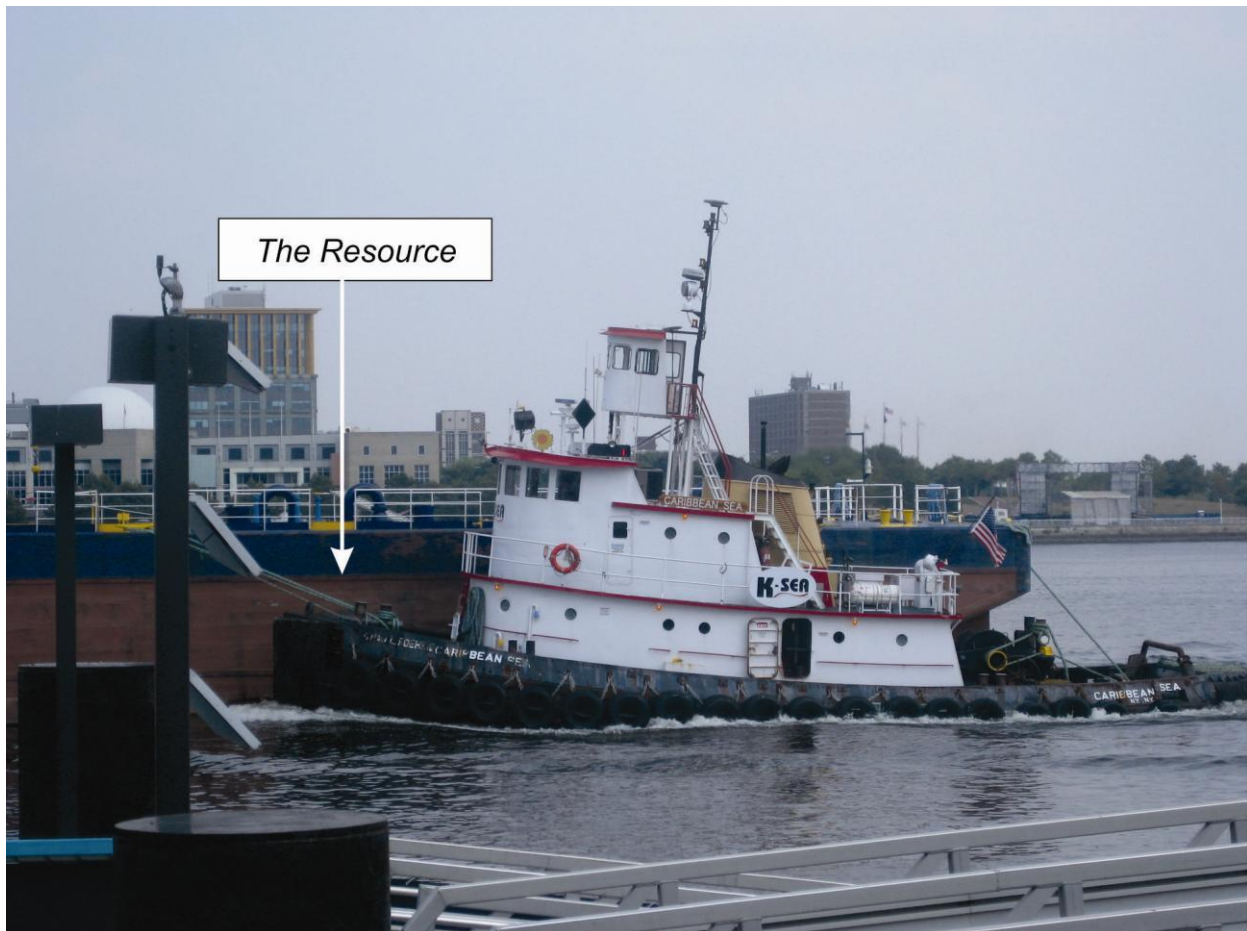
**Figure 3.** Tugboat *Caribbean Sea* with tank barge *The Resource* in a starboard hip tow as seen about 45 seconds before the accident. (Photo by Megan Scharpf)

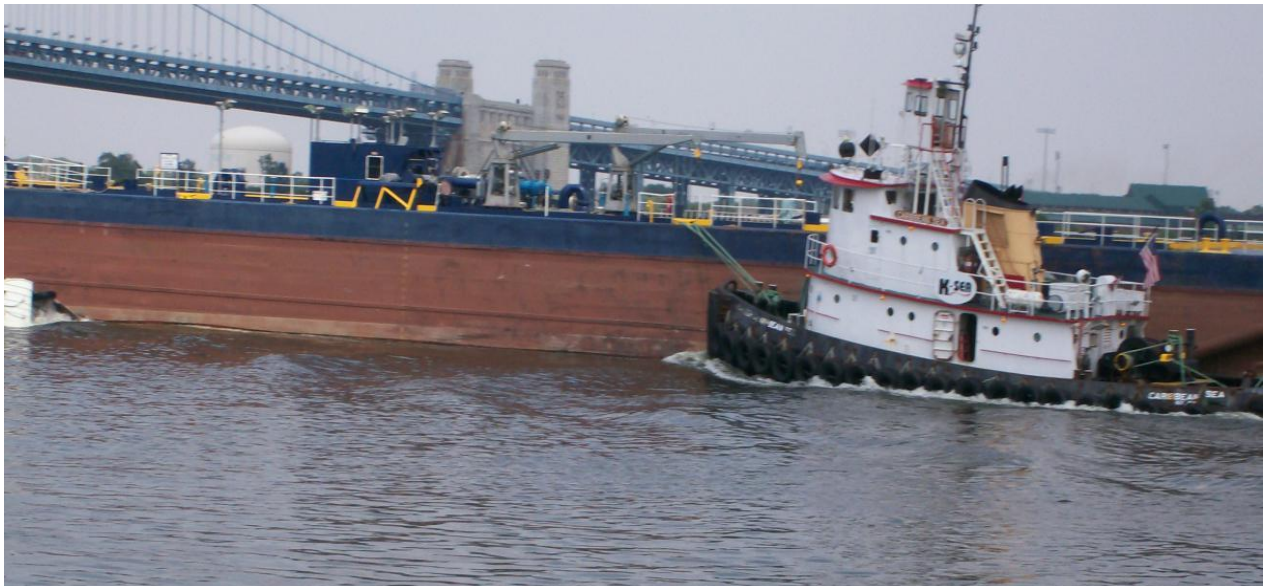
**Figure 4.** Tugboat *Caribbean Sea* and barge *The Resource* seconds after the bow of the barge made contact with *DUKW 34*, a portion of which is visible at far left. (Photo by Brian E. Stover)

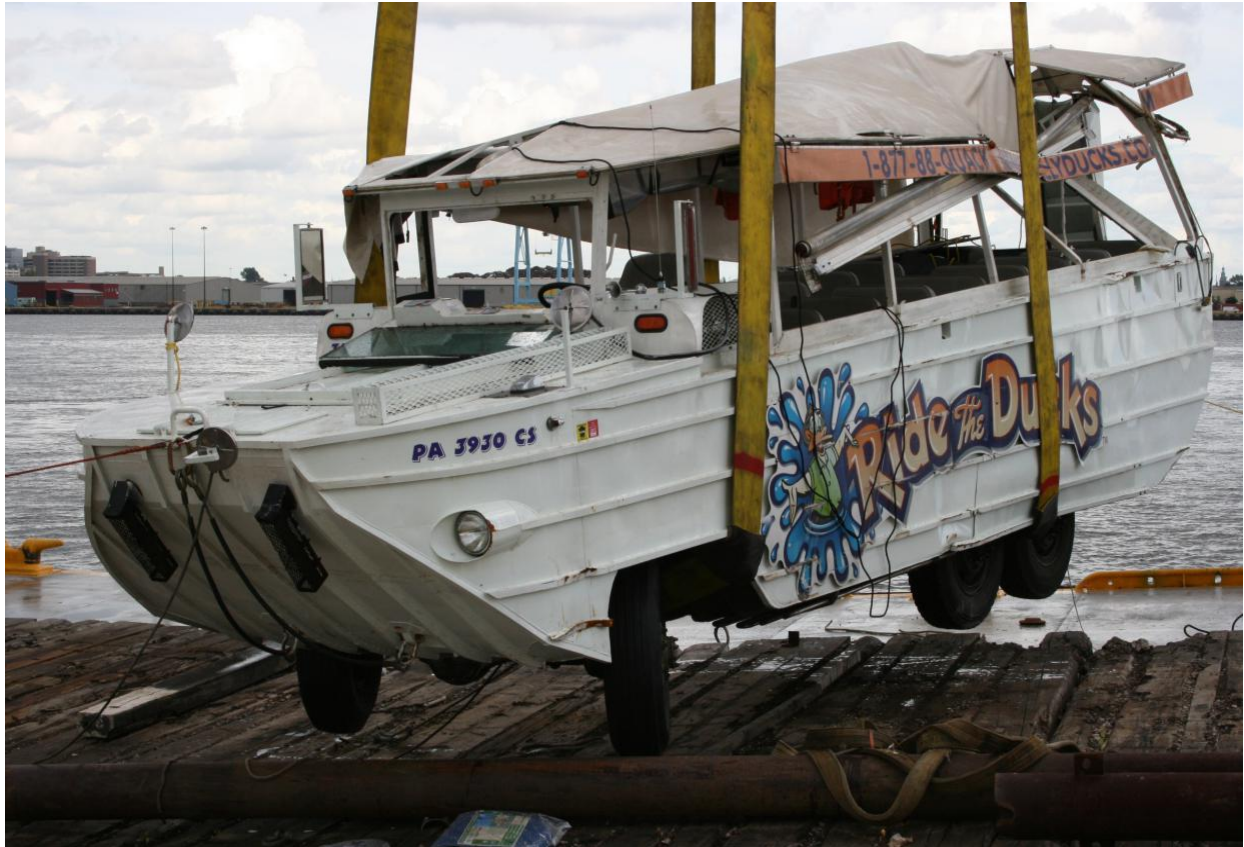
*DUKW 34* was raised from the river on July 9, 2010. Damage to the APV was principally to the port side of the hull and the aft portion of the port side of the canopy. The hull damage consisted of scrapes and indentations along the hull's external support members and hull shell, and to the "Ride The Ducks" sign attached to the side of the hull. The scrapes to the Ride The Ducks indicated the relative movement between the APV and the barge during their period of contact (figure 6).

**Figure 6.** *DUKW 34* after being raised from the river bottom.

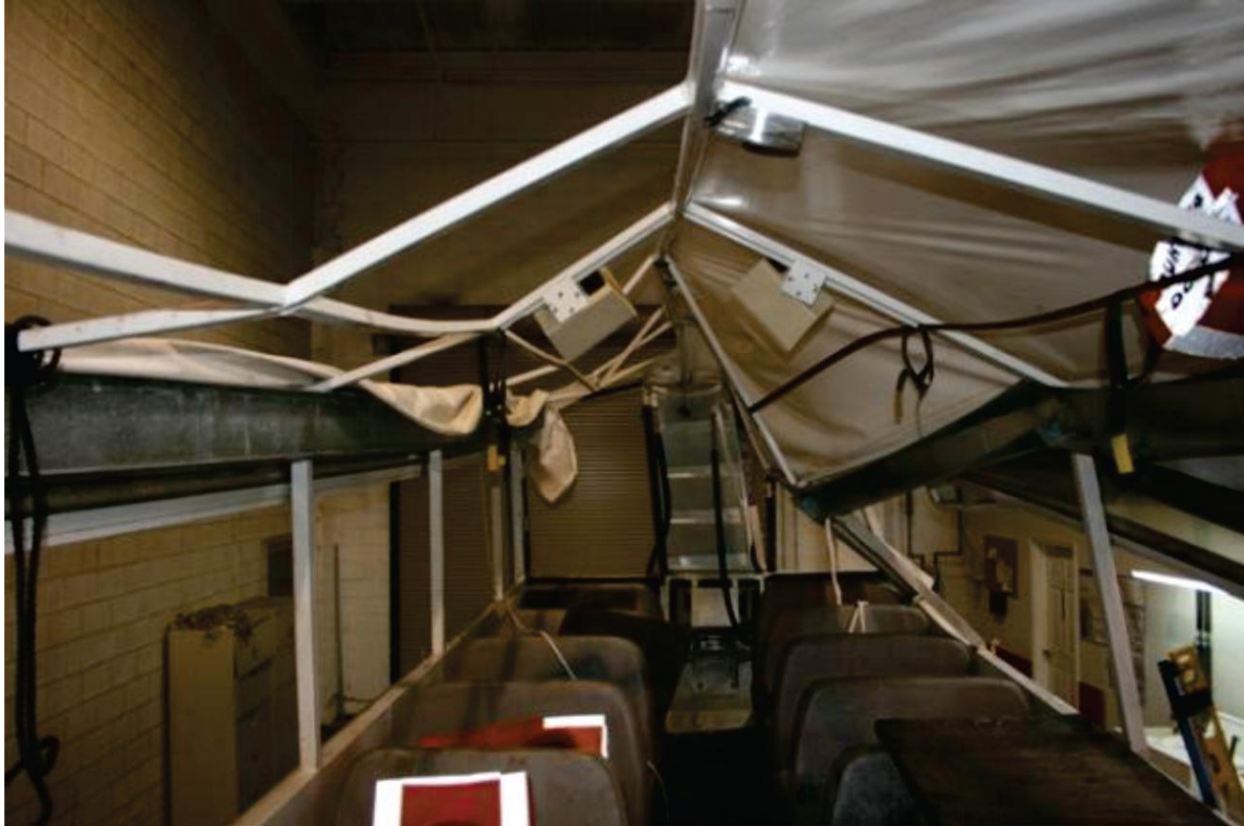
Damage to the canopy framing system (figure 7) consisted of bending and buckling of the square and rectangular steel tubing and some tearing of the canopy awning, principally at the aft portion. The two aftermost port side vertical frames of the canopy were bent over about 45°, and other support members were similarly damaged. The port-side roller curtain was damaged and detached from its mountings, and the passenger loading ladder indicated distortion and impact damage. The left front wheel was slightly displaced from its axis of rotation, and a subsequent tear-down examination showed that its drive axle was slightly bent.

**Figure 7.** View of *DUKW 34*'s damaged canopy, looking aft.

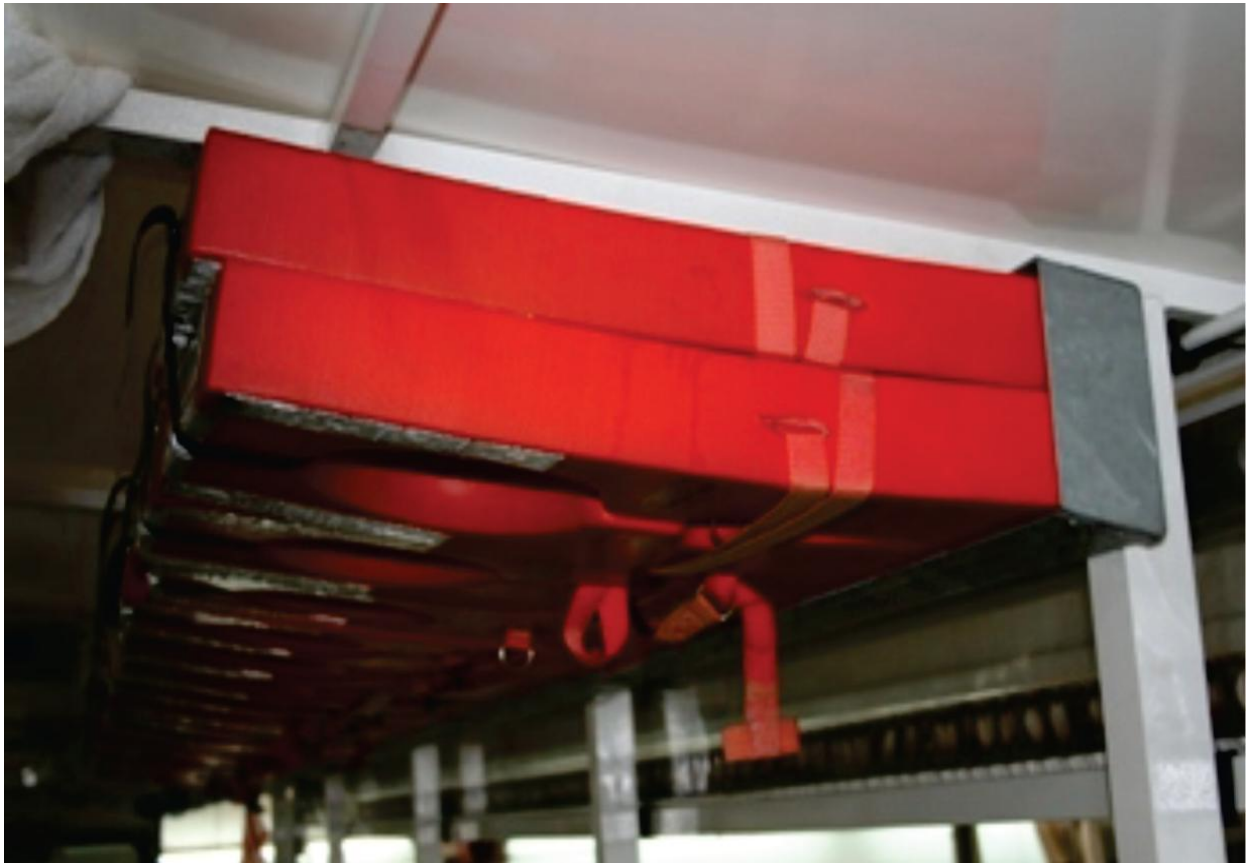
**Figure 8.** Lifejackets on Ride the Ducks APVs were stowed in stacks of two above each row of passenger seats. Adult jackets were on the starboard side; child jackets were on the port side.

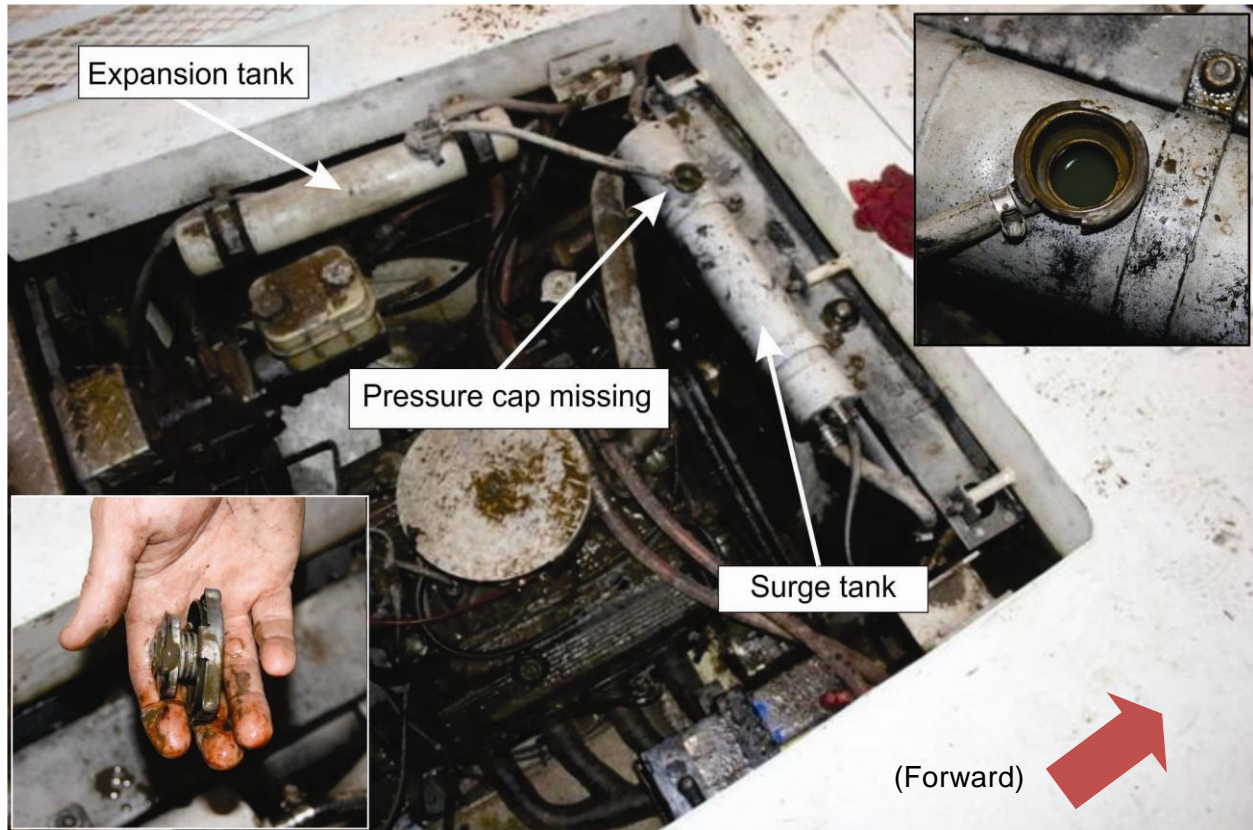
**Radiator.** Examination of the vessel's engine compartment revealed that the pressure cap normally fitted to the radiator surge tank was missing (figure 9). The pressure cap was subsequently found undamaged in the lower part of the engine compartment. The pressure cap was tested and was shown to open at 11 to 13 psi. The pressure cap was rated for 13 psi.

**Figure 9.** Engine compartment of the salvaged *DUKW 34*, with the surge tank pressure cap missing. The upper inset photo is a close-up of the uncapped tank; the lower inset photo shows the pressure cap recovered from the bottom of the engine bay.

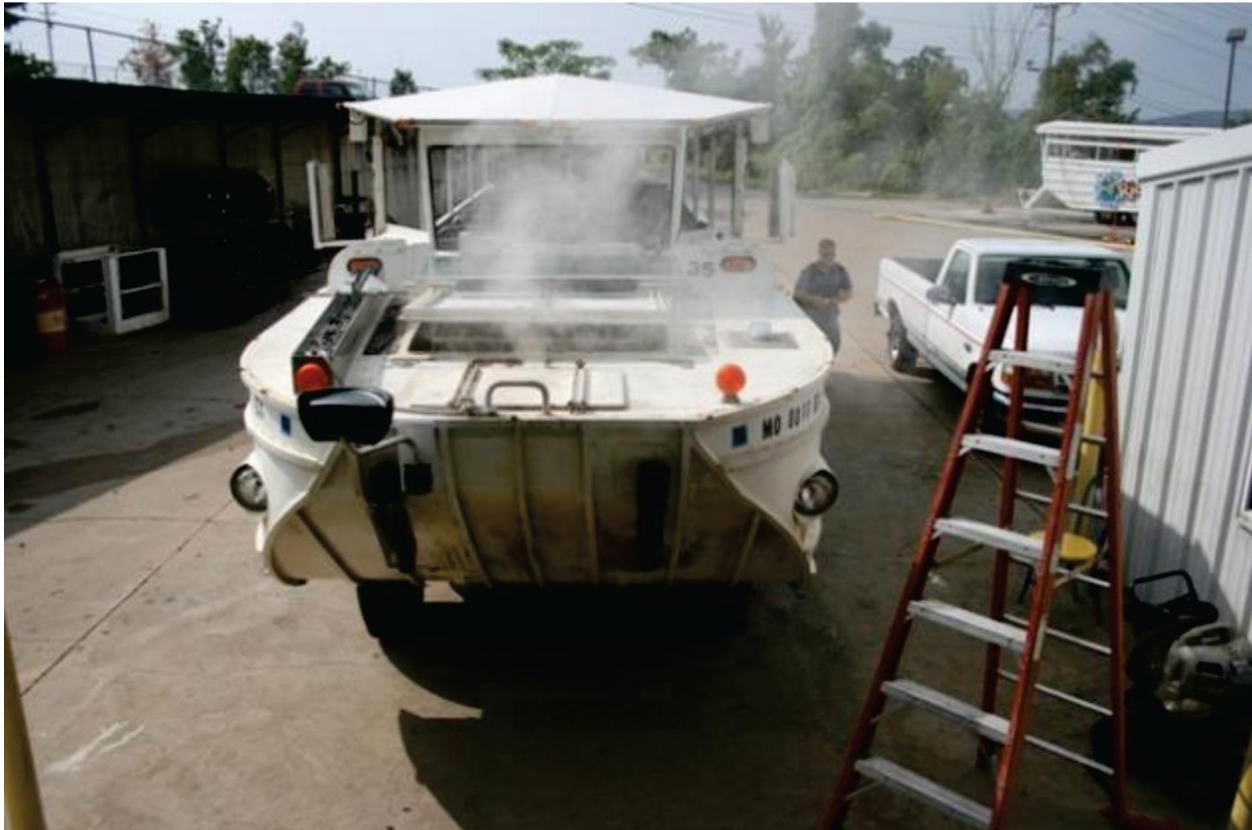
**Figure 10.** Steam from the engine compartment of a test APV, with cooling water temperature of about 220° F.

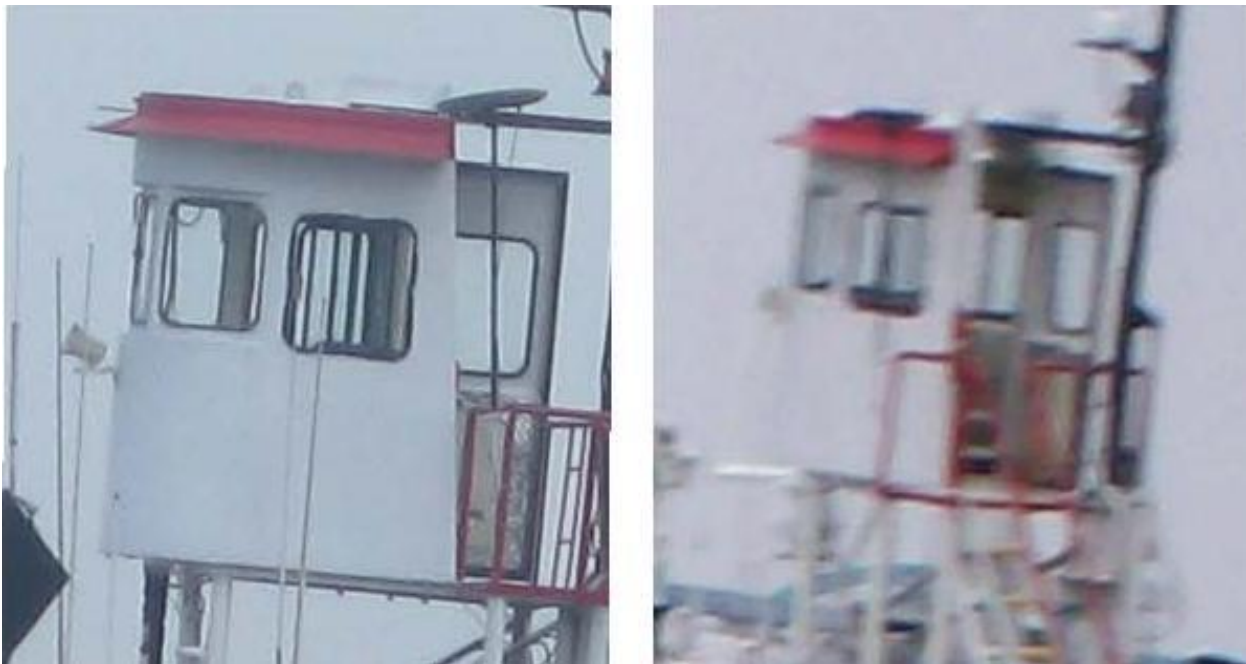
At least two of the still photographs (included as figures 3 and 4 in this report) provide fairly clear images of the upper wheelhouse of the *Caribbean Sea* just before and just as the barge struck the APV. Figure 11 shows enlargements from figures 3 and 4 that provide close-up views of the upper wheelhouse just before and after the accident. The enlargement from figure 3 shows the upper wheelhouse in a profile view. The door is open, and the wheelhouse appears to be empty. Anyone at the helm would have been visible through the un-tinted windows. The enlargement from figure 4, taken just after the bow of the barge *The Resource* struck the APV, shows the upper wheelhouse from almost a rear 3/4 view. A portion of the interior of the wheelhouse is visible through the open door. In this image, too, the upper wheelhouse appears to be empty.

**Figure 11.** (Left) Enlargement from figure 3, showing the *Caribbean Sea*'s upper wheelhouse about 45 seconds before the collision. (Right) Enlargement from figure 4, showing the *Caribbean Sea*'s upper wheelhouse just as the bow of the barge strikes *DUKW 34*.
