**National
Transportation
Safety Board**

NTSB/MAR-12/01
PB2012-916401

Allision of Passenger Ferry *Andrew J. Barberi*
With St. George Terminal, Staten Island, New York
May 8, 2010

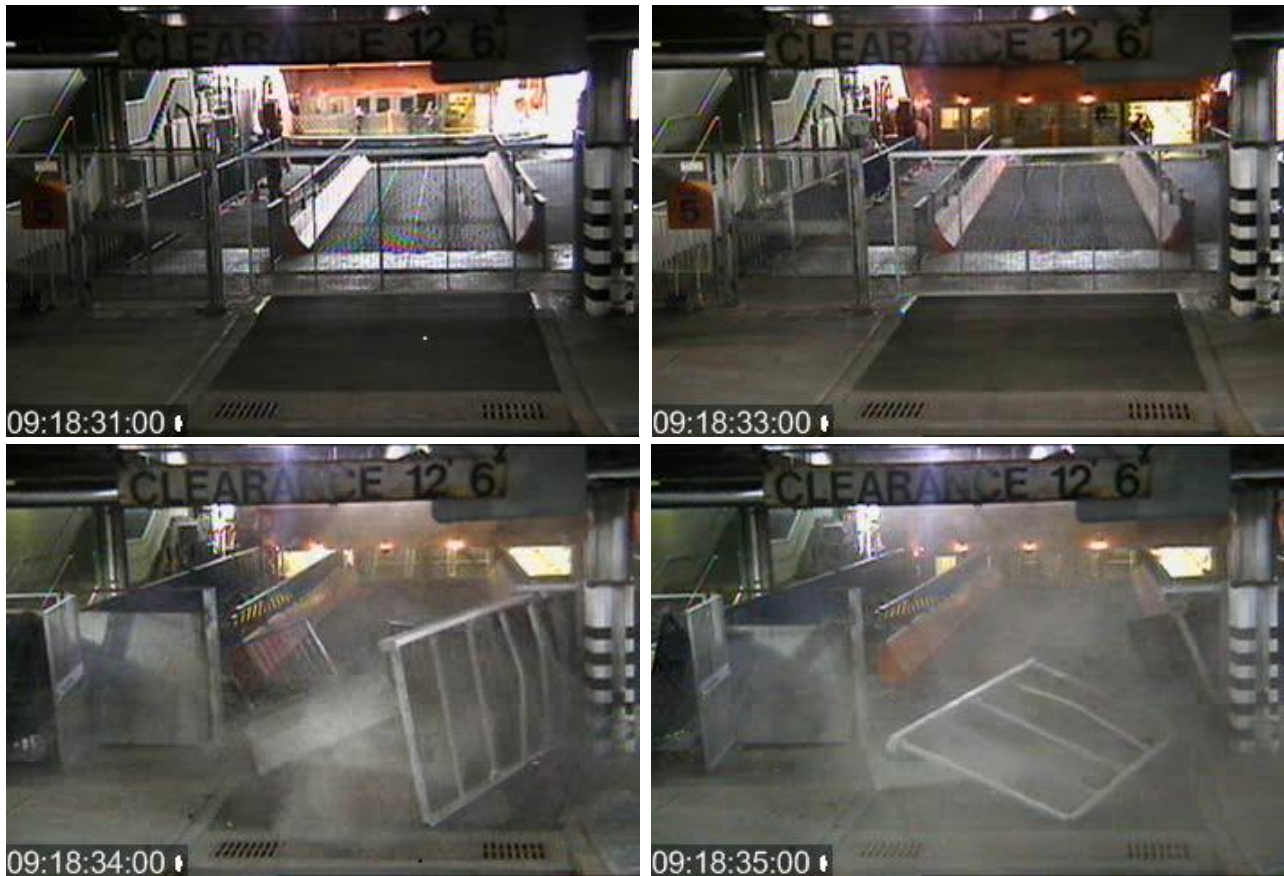
Figure 6. Video images of the impact.

The video footage also showed that, as a result of the allision, the shoreside transition bridge—which was designed to absorb some impact by being unfixed and able to float—was lifted up and displaced several yards into a security-perimeter fence. The bridge came to rest about 5 feet above the *Andrew J. Barberi*'s main deck, overlapping it by about 3 feet. The two aprons were lifted up and landed on the vessel's hurricane deck, two decks above their normal connecting level.

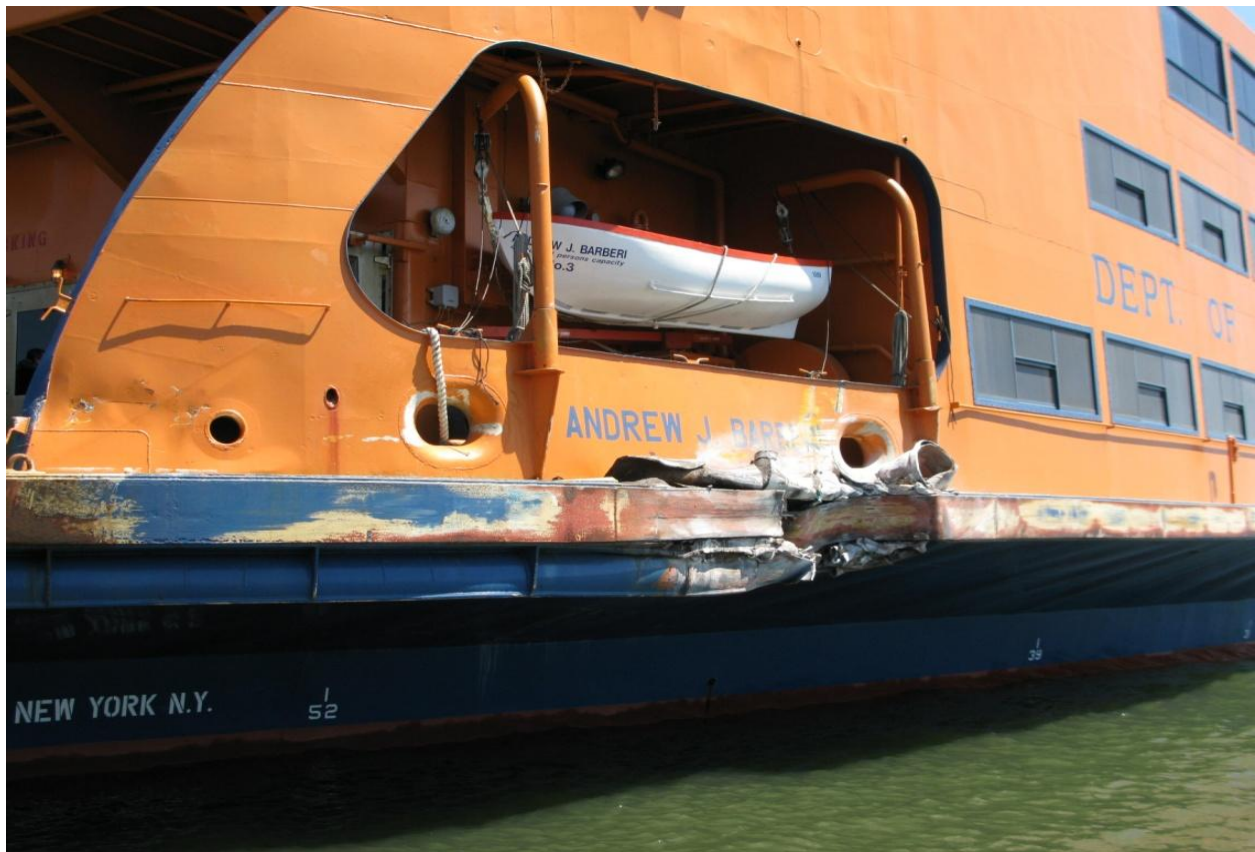
sides where the vessel impacted the rack pilings and concrete structure of the terminal (figures 7 and 8). On both sides, the hull was breached beneath the main deck, at the rub rail level,⁹ in the space that contained the cycloidal propulsion unit. The damage included about 15 feet of tearing and deformation to the port and starboard main deck plating and bulwarks,¹⁰ as well as tearing and deformation to the rub rails on both sides.

On the main deck, the portside mooring chock¹¹ was displaced. The watertight bulkhead separating the cycloidal propulsion space from the end-most ballast tank was buckled on both the port and starboard sides, and the immediate transverse web frames on each side of this watertight bulkhead were deformed. The survey also noted minor damage at the bridge deck, port and starboard of the pilohouse, resulting from the vessel striking the aprons.

Figure 7. Damage to the vessel's port side (Staten Island-end).

The cost to repair the *Andrew J. Barberi*'s allision damage was \$168,625, according to Ferry Division officials.

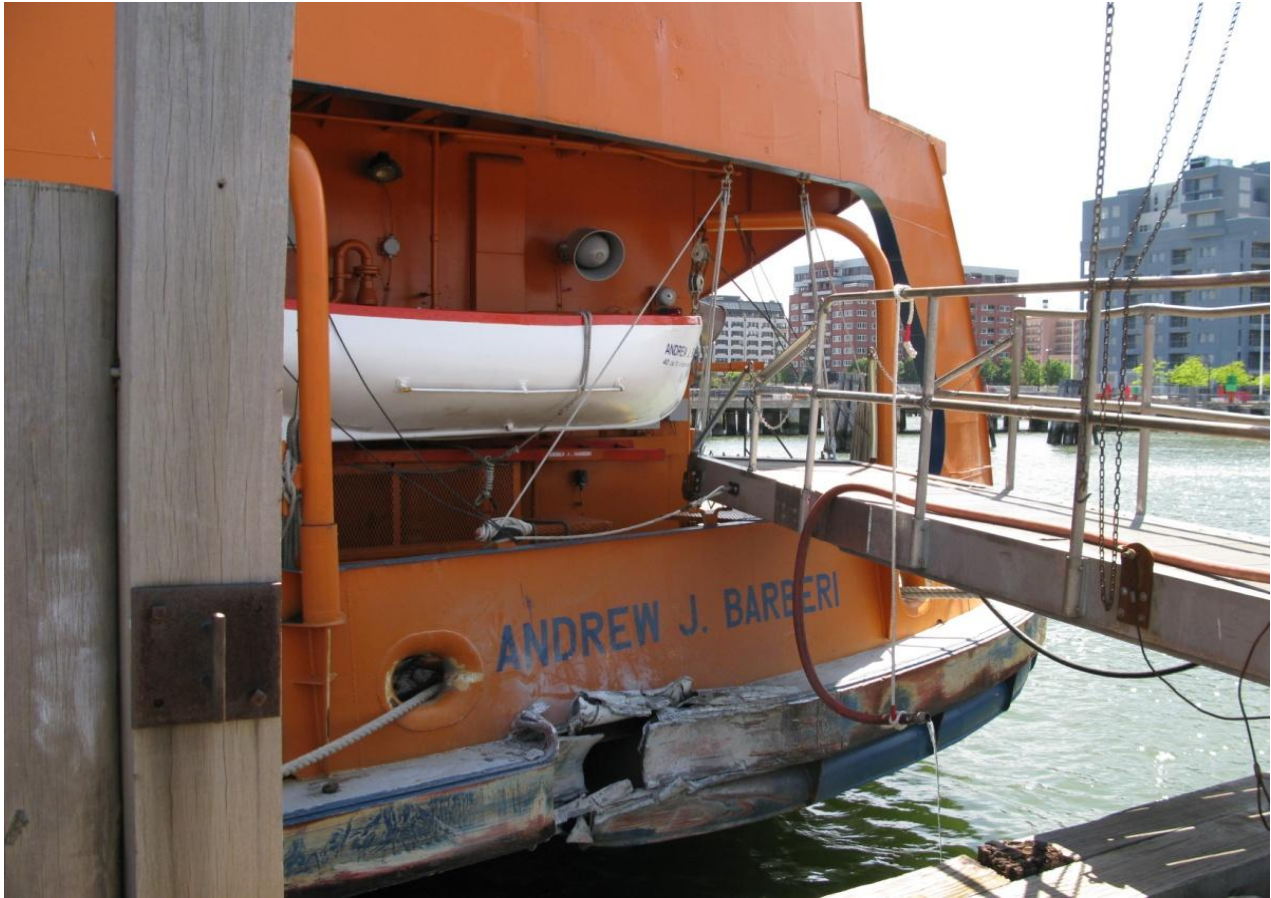
Figure 8. Damage to the vessel's starboard side (Staten Island-end).

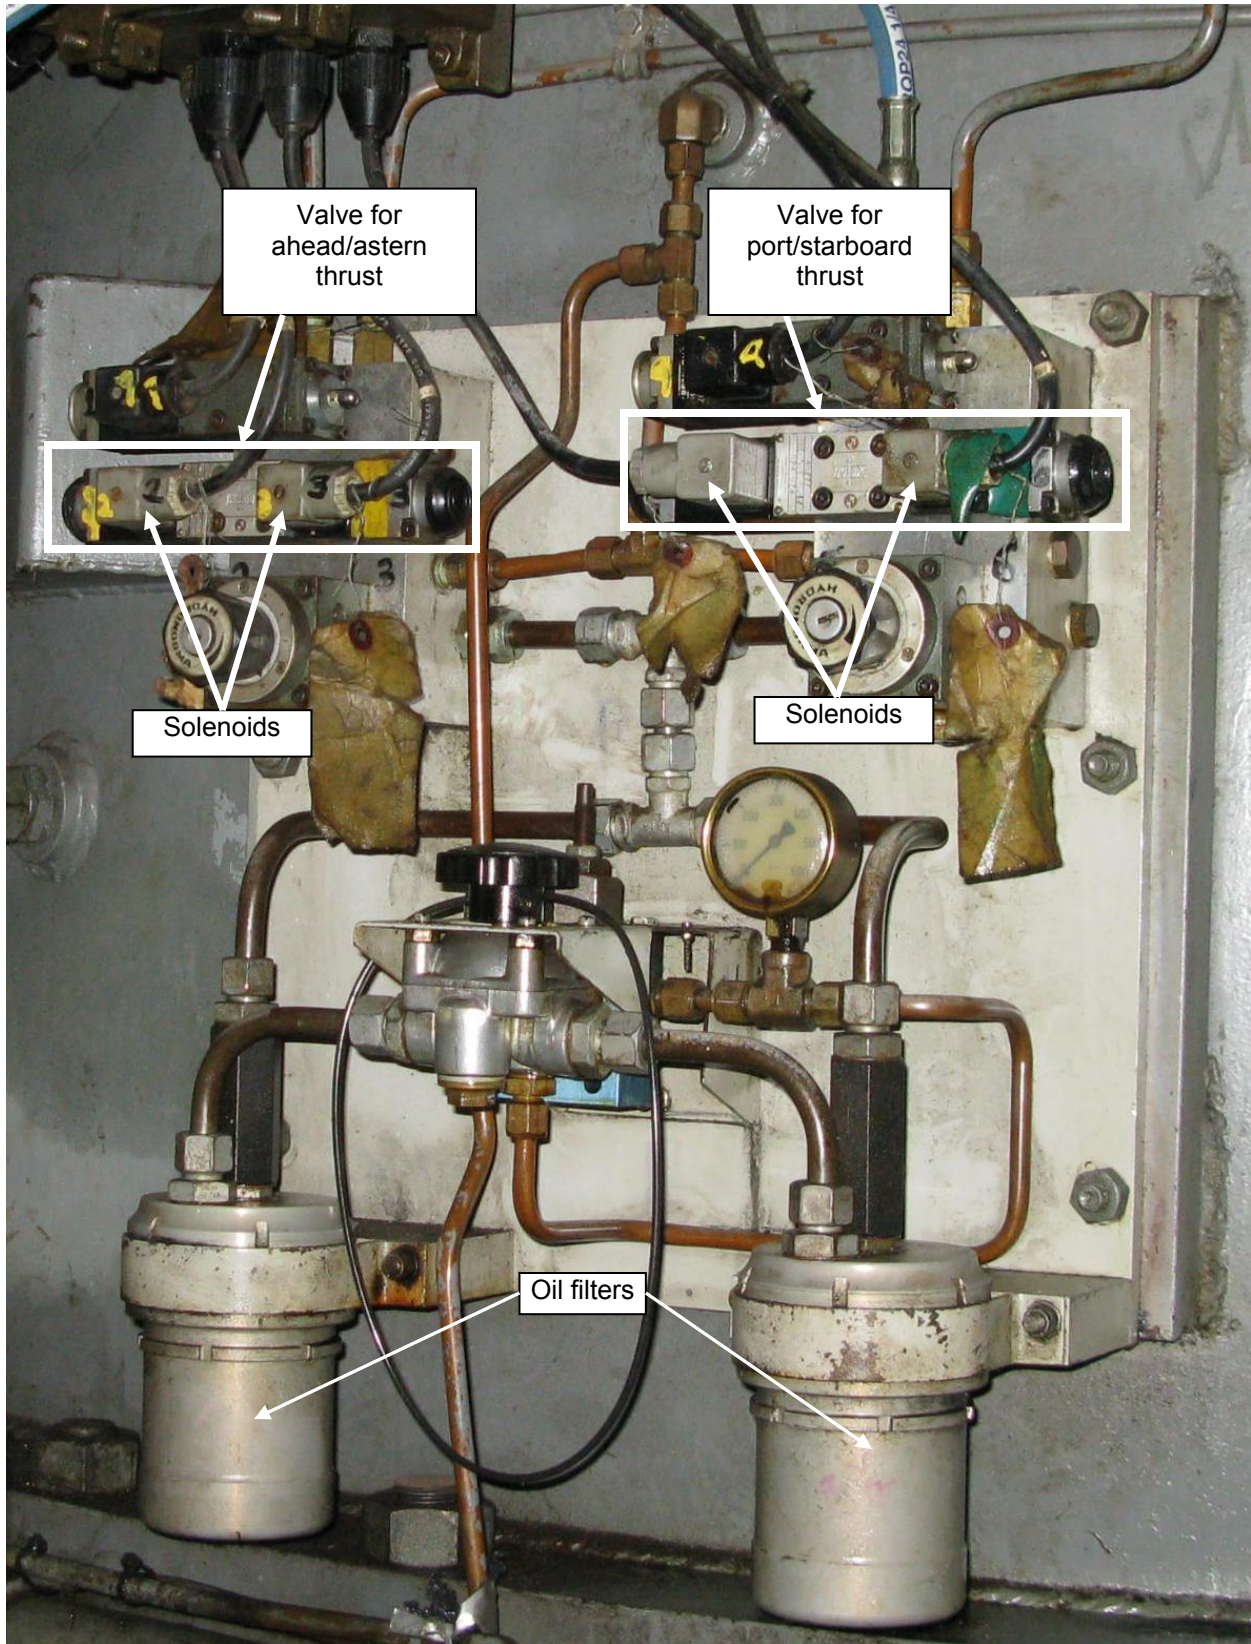
The engineering group then focused on the New York-end propulsion unit's control panel itself (figure 11) as the probable point of failure. The control panel transformed the electrical signal from the pilothouse to a hydraulic oil flow output, which controlled the pitch of the propeller blades and resultant thrust. The panel had two electro-hydraulic propulsion control valves (valves), one for controlling port/starboard thrust, the other for controlling ahead/astern thrust. Thrust control was achieved by using two electrically actuated solenoids, one located on each side of each valve, to mechanically move the valves between three positions (depending on the valve, either "ahead," "neutral," or "astern," or "port," "neutral," or "starboard").

Figure 11. The hydraulic control panel located at the vessel's New York-end propulsion unit.

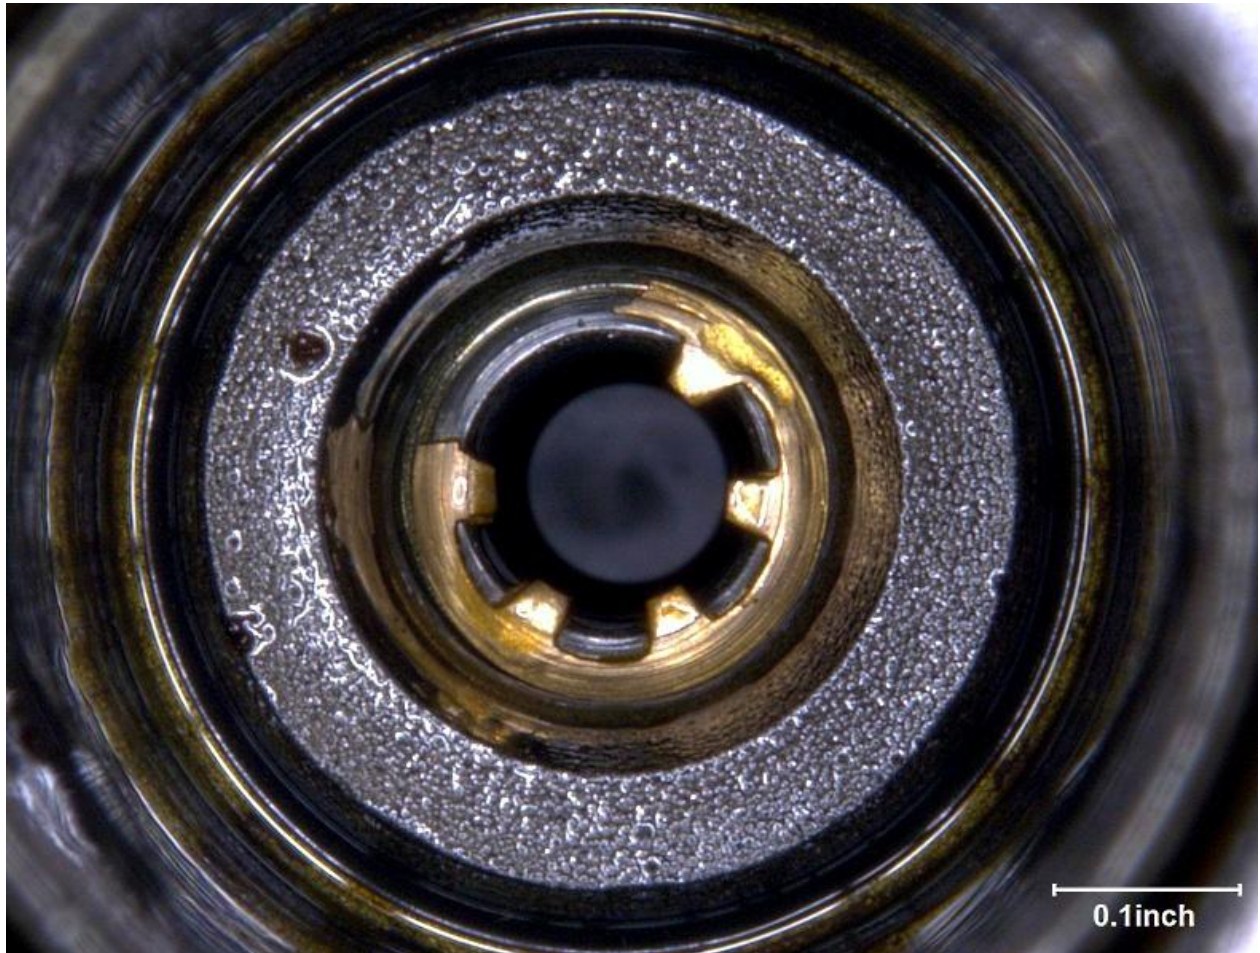
Figure 12. Fractured bronze ring in one of the two solenoids controlling ahead/astern thrust.

Investigators determined that the bronze rings in both of the solenoids controlling ahead/astern thrust had fractured, which allowed ring fragments to dislodge and interfere with the proper operation of the solenoids. The interference caused one of the solenoids to “stick” in a single position, which resulted in the inability of the New York-end propulsion unit to respond to pilothouse control. Investigators found no other anomalies.¹⁵

Although investigators examined the components to determine the mode of failure, damage to the fracture surfaces on the bronze ring fragments precluded investigators from determining the cause of the failure. Investigators noted that the rings in the ahead/astern-thrust solenoids—which had six tabs—were of a different design than the rings in the port/starboard-thrust solenoids, which had three tabs and were intact.¹⁶

¹⁶ The tabs of the fractured six-tab rings were 0.030 inches at their widest point. The tabs of the intact three-tab rings were 0.065 inches at their widest point. For further information, see the NTSB’s Materials Laboratory Factual Report No. 11-063, available in the NTSB public docket on this accident.

When the accident occurred, the Ferry Division was already in the process of replacing the control panels on its Barberi-class ferries with new and similar hydraulic control panels. The Ferry Division's senior port engineer told NTSB investigators that the control panels were not being replaced because they were problematic, but rather to simply "upgrade the system." To confirm this, NTSB investigators examined the maintenance records, engine logbooks, and Coast Guard incident report forms, and nothing in these documents indicated that the control panel replacement resulted from maintenance issues or failures. The control panels on the other vessel in the Barberi class, the *Samuel I. Newhouse*, had already been replaced during its previous scheduled maintenance period in spring 2010. The *Andrew J. Barberi* was scheduled to have its control panels replaced later that year during its maintenance period. However, because the vessel was taken out of service as a result of the allision, the Ferry Division replaced the control panels in the week following the accident. On May 13, after the new control panels were in place, the engineering group tested both end propulsion units for pilothouse command response, and both ends performed satisfactorily. The *Andrew J. Barberi* returned to service on June 23, 2010, following completion of all repairs.

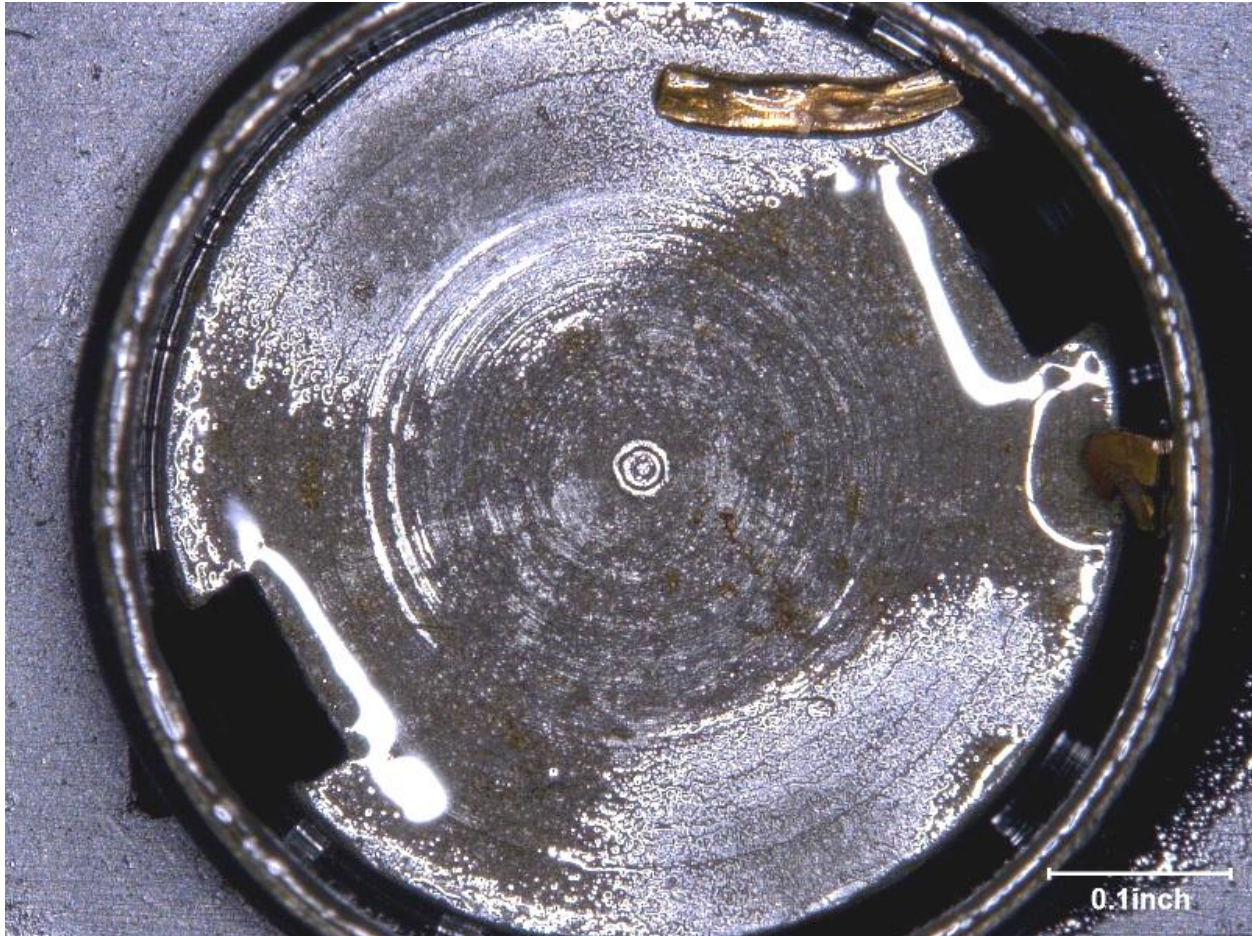
Figure 13. Bronze ring fragments in the second solenoid controlling ahead/astern thrust.
