Loss of Control at Takeoff
Air Methods Corporation
Airbus Helicopters AS350 B3e, N390LG
Frisco, Colorado
July 3, 2015

Accident Report

NTSB/AAR-17/01
PB2017-101425

NTSBAAR-17/01
PB2017-101425
Notation 56432
Adopted March 28, 2017

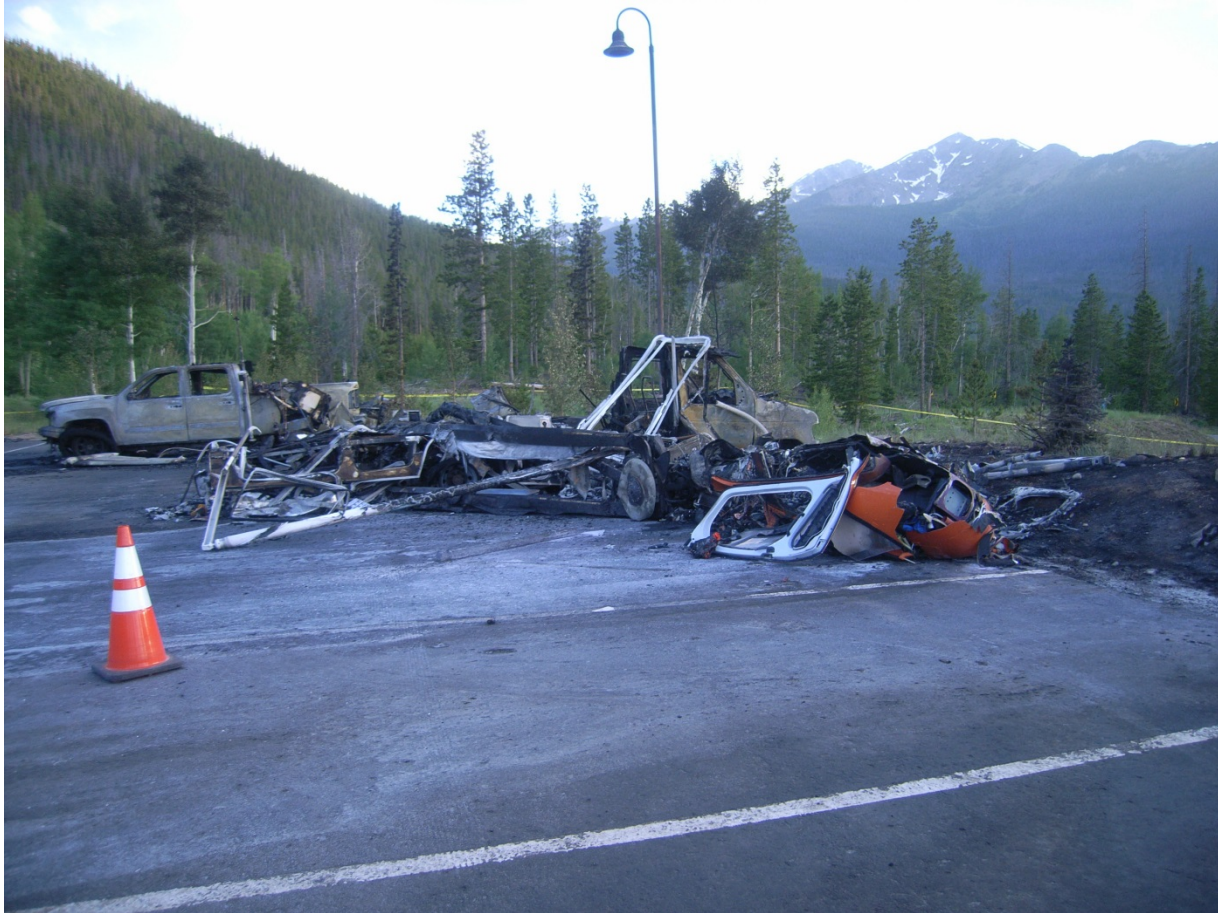
Figure 1. Main wreckage site.

The video capturing the ground impact (from the camera in the medical center parking lot) showed fuel flowing from the wreckage and the onset of a postcrash fire 3 seconds after impact. The postcrash fire spread and consumed or severely damaged most of the helicopter wreckage, including the main fuselage and tailboom (as further explained in section 1.3). Table 1 lists events that the video captured regarding the helicopter's flight and impact with the ground, and figure 1 shows the main wreckage site.

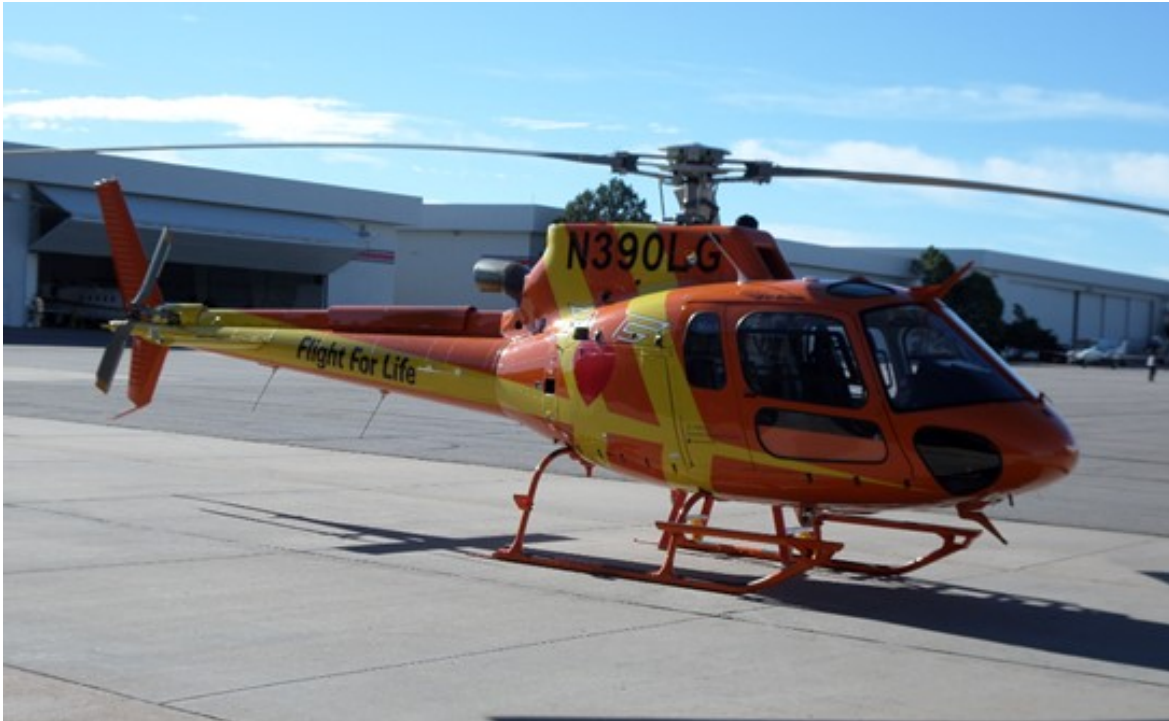
Figure 2. N390LG upon delivery to Air Methods.

The accident helicopter, serial number 7595, was manufactured in March 2013. Figure 2 shows the helicopter at the time of delivery to Air Methods.¹⁵ At the time of the accident, the helicopter had a total time of about 487 flight hours. The helicopter was equipped with a Turbomeca Arriel 2D turboshaft engine, which had a total time of about 481 hours. (See section 1.3.2 for more information about the engine.) The helicopter’s weight at the time of the accident was about 4,717 pounds, which was based on the operating conditions that day and included the weights of the occupants, fuel, and medical equipment.

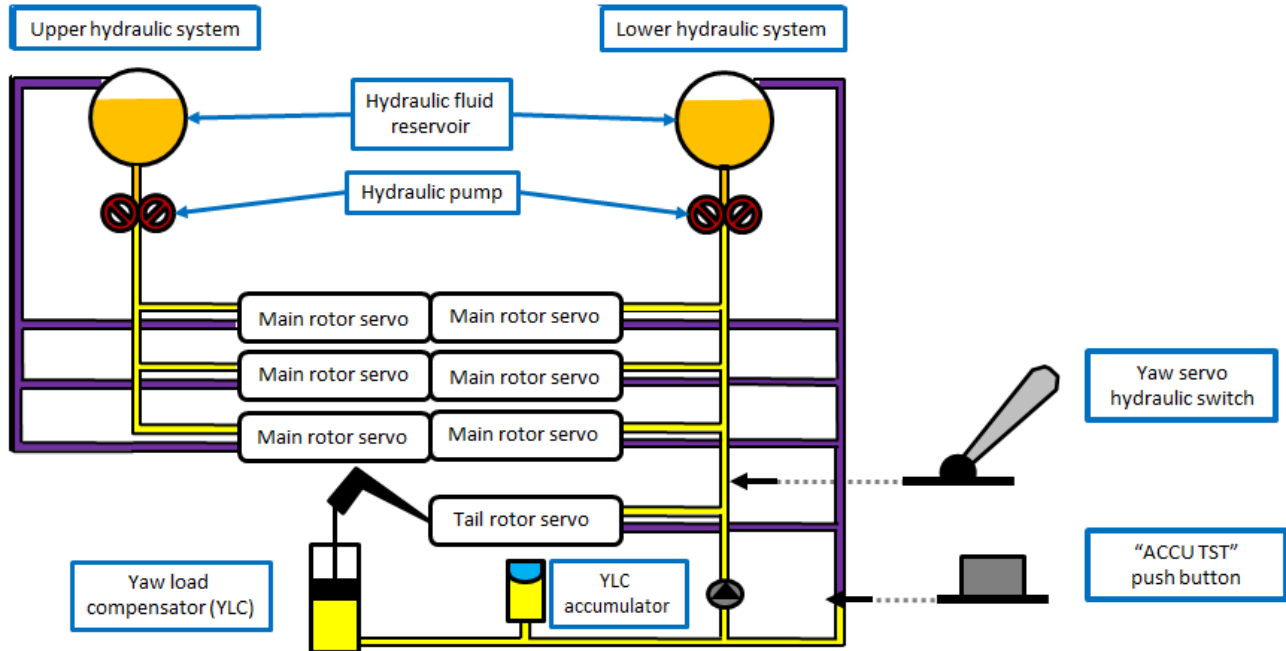
Figure 3. AS350 B3e dual hydraulic system.

As previously stated, the AS350 B3e is equipped with an upper and a lower hydraulic system.²³ The dual hydraulic setup provides hydraulic assistance redundancy to the main rotor servo controls in case one of the hydraulic systems were to fail.²⁴ The tail rotor servo control, yaw load compensator, and its accumulator are powered only by the lower hydraulic system. The yaw load compensator and its accumulator comprise a closed-loop system that would provide continuous hydraulic power assistance to the pedal controls in the event of a depressurization of the lower hydraulic system.²⁵ (The yaw load compensator is biased toward the right pedal because a right pedal input is needed to counteract the main rotor torque effect.) Figure 3 shows the hydraulic system configuration of the accident helicopter.

The hydraulic isolation electrovalve, installed on the transmission deck, provides a means to isolate the tail rotor hydraulic circuit from the lower hydraulic system in the event of a tail rotor servo control malfunction. Actuation of the hydraulic isolation electrovalve is controlled by a yaw servo hydraulic switch located on a control block installed at the forward end of the collective stick (see figure 4 in section 1.3.5.1). During normal operation, the hydraulic isolation electrovalve is in the open position, and the yaw servo hydraulic switch is on.

Because the hydraulic isolation electrovalve was not recovered in the wreckage (it had likely been destroyed by the postcrash fire), the NTSB could not determine if the valve had malfunctioned. However, even with a hydraulic isolation electrovalve malfunction, a correctly configured tail rotor hydraulic circuit, with a functioning yaw load compensator, could provide partial hydraulic assistance to the pedals.²⁸ Although the yaw servo hydraulic switch was found in the forward position, the position of the internal switch mechanism at the time of impact could not be determined due to thermal damage. In addition, because of damage from impact forces and the postcrash fire, the internal switch position of the “ACCU TST” push button at the time of impact could not be determined.

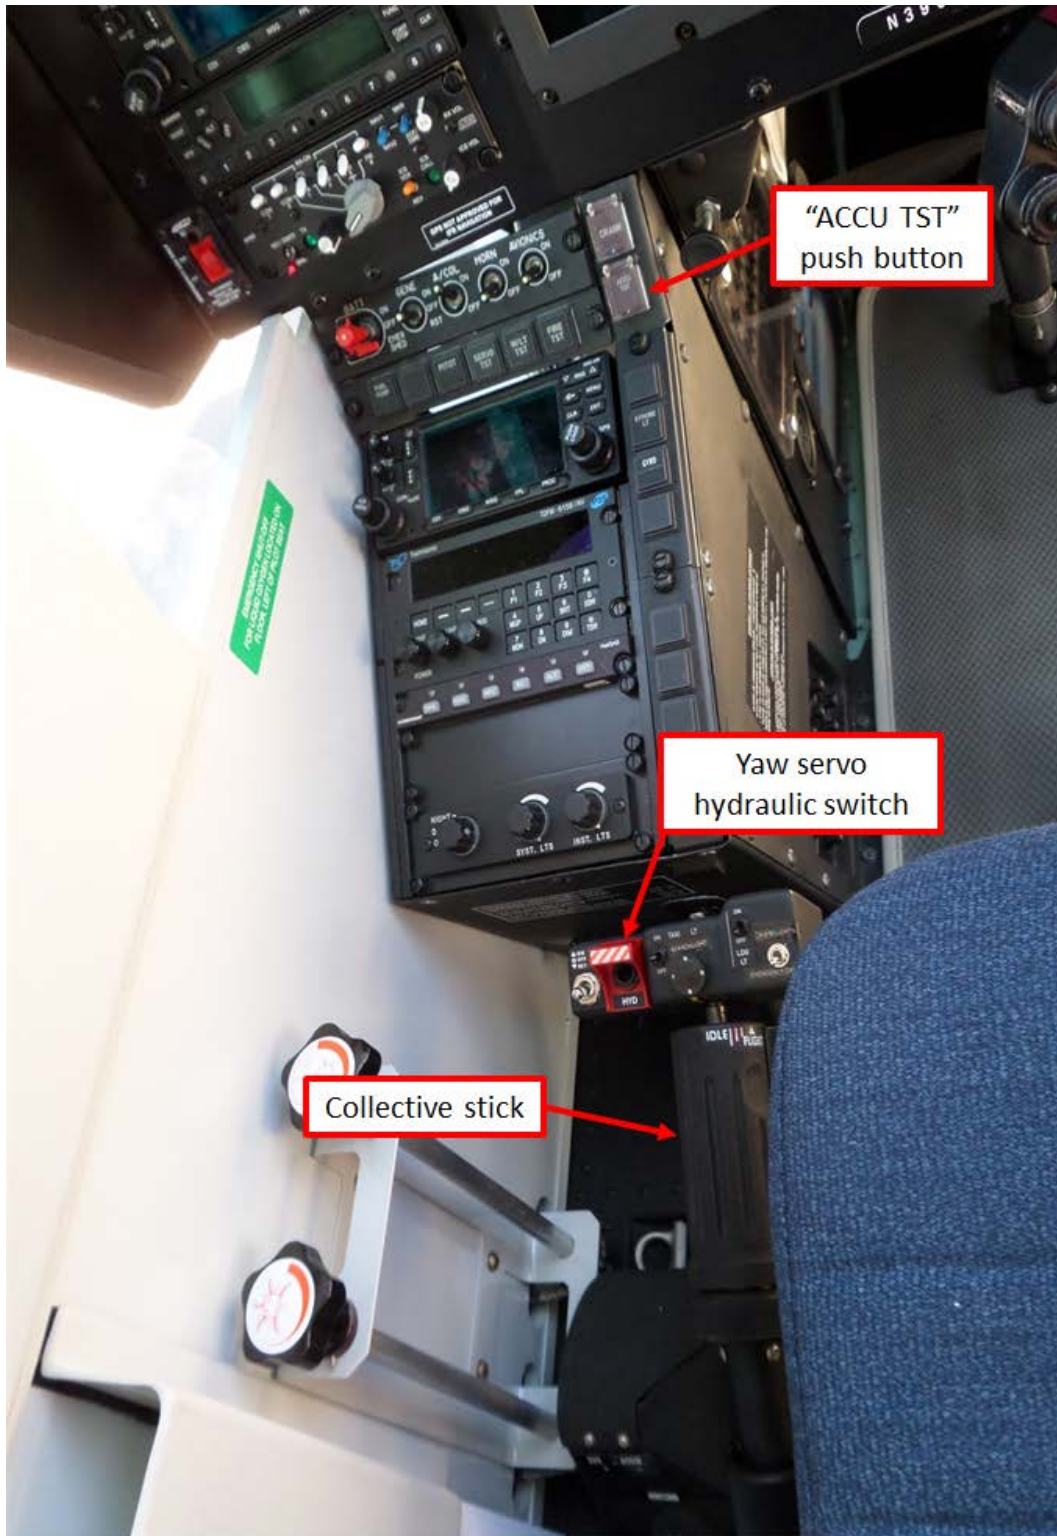
Figure 4. Yaw servo hydraulic switch and "ACCU TST" push button.

The yaw load compensator assembly contains an accumulator test electrovalve that allows hydraulic pressure to discharge from the yaw load compensator and accumulator when the “ACCU TST” push button, located on the cockpit center console, is depressed. Operating procedures for the AS350 B3e at the time of the accident indicated that the “ACCU TST” push button should be depressed during a ground check of the yaw load compensator accumulator (see section 1.3.5.1) or as part of emergency procedures for a tail rotor control failure. During normal operations, the accumulator test electrovalve is in the closed position, and the “ACCU TST” push button is raised.

X-ray scans of the remaining collective stick control block and the “ACCU TST” push button were performed at the NTSB’s Materials Laboratory in Washington, DC. The position of collective stick control block switches (including the yaw servo hydraulic switch) and the “ACCU TST” push button switch could not be determined because of the damage to the components resulting from the accident.

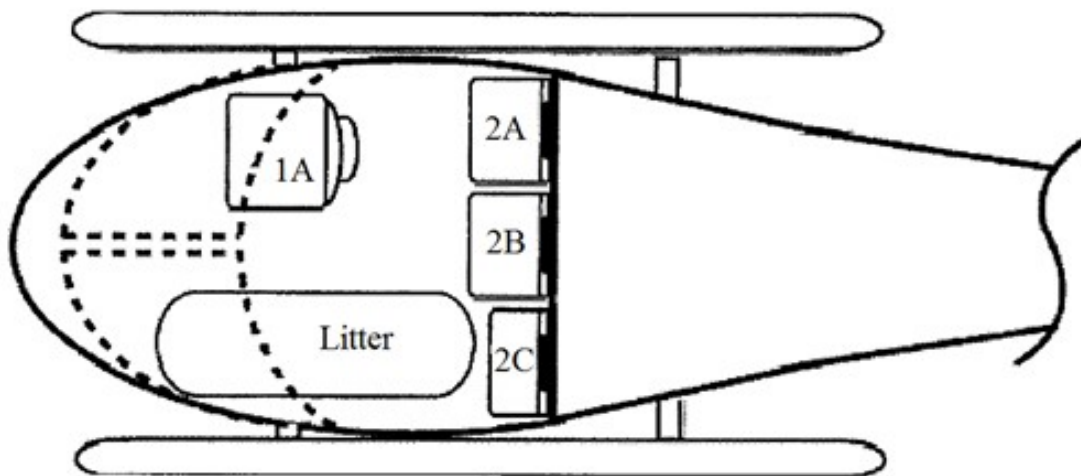
Figure 5. Occupant seating positions on N390LG.

The helicopter was equipped with four occupant seats and one patient litter, as shown in figure 5. The pilot's seat was located at the front of the cabin on the right side. The litter was adjacent to the pilot's seat on the left side of the helicopter next to an emergency exit door. The three forward-facing medical crewmember seats were mounted to the aft bulkhead.

Note: The pilot was in seat 1A, the flight nurse who sustained blunt force injuries only was in seat 2A, and the flight nurse who sustained blunt force and thermal injuries was in seat 2C.

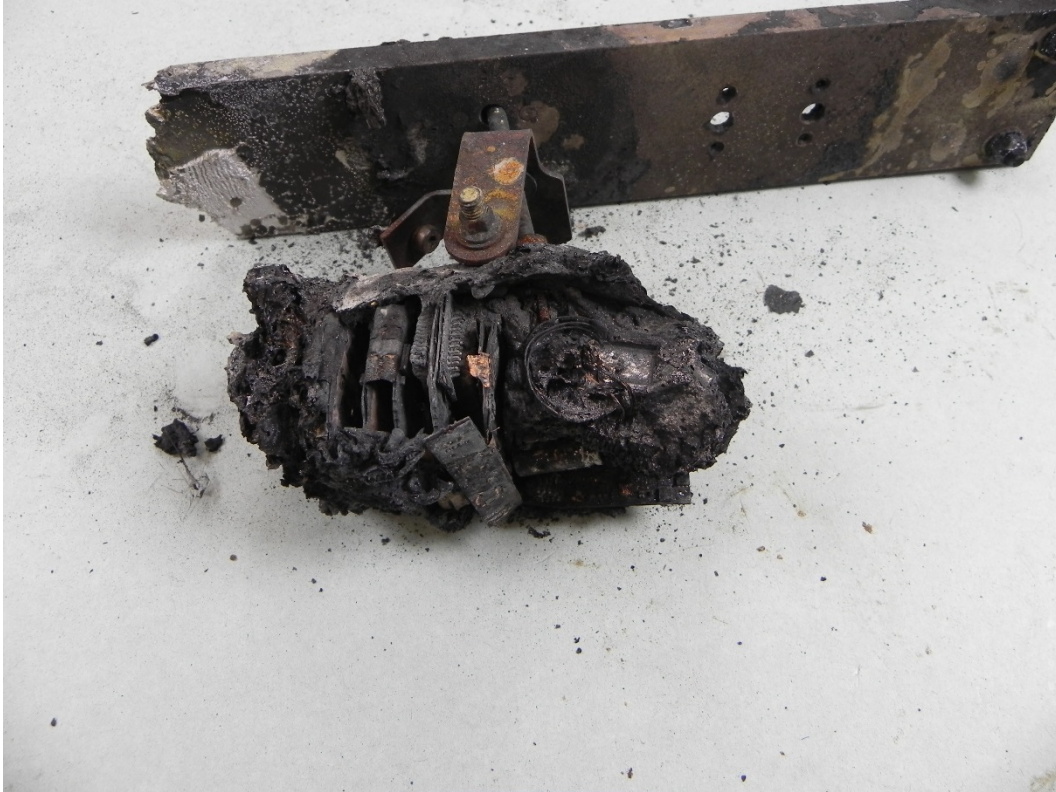
Figure 6a. Postaccident condition of onboard image recorder.

Postaccident examination of the helicopter's Appareo device showed that the device sustained extensive heat damage. Figure 6a shows the condition of the Appareo device upon arrival at the NTSB's vehicle recorders laboratory, and figure 6b shows an exemplar Appareo Vision 1000 onboard image recorder for comparison purposes. The SD memory card was removed from the Appareo device. The silicon memory device (internal to the SD card) was cracked and fractured throughout, so data recovery from the SD card was not possible. The Appareo device's internal NVM module was then removed, and the two NVM chips were removed from the internal memory device chassis. One chip (referred to as NVM chip 1) exhibited bubbling on, and cracking along, its plastic packaging surface. The other chip (referred to as NVM chip 2) exhibited heavy bubbling on its plastic packaging surface. The bubbling and cracking were indicative of high-temperature heat damage.

X-ray images of both NVM chips revealed a region of broken bond wires in the upper left portion of NVM chip 1 and no visible defects in NVM chip 2. A binary readout attempt of NVM chip 2 was performed but failed; an error message that is typically associated with failures due to internal damage to the chip was displayed. No further attempts were made to read out either NVM chip.
