Collision between US Navy Destroyer *John S McCain* and Tanker *Alnic MC*
Singapore Strait, 5 Miles Northeast of Horsburgh Lighthouse
August 21, 2017

Marine Accident Report

NTSB/MAR-19/01
PB2019-100970

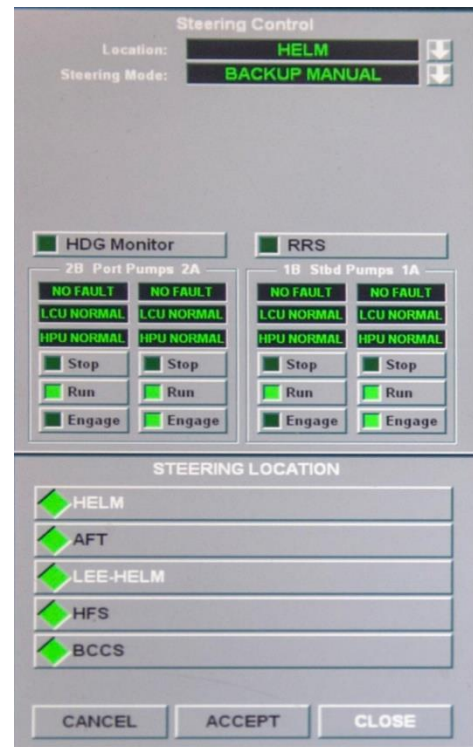
Figure 5. Steering control region of IBNS GUI display, with opened steering location menu. (From US Navy photo)

The GUI display was divided into regions. In one region of the display, readouts showed the location of the station in control of steering and the mode of steering that was in use. Selecting a button next to the location readout opened a menu on the display that was used to transfer the location of steering control. Selecting a button next to the mode readout activated a menu that was used to change the steering mode.

Per the technical manual and as demonstrated to National Transportation Safety Board (NTSB) investigators on another Navy destroyer equipped with the IBNS, at any time that steering was in backup manual mode, a watchstander at any of the other stations could unilaterally take steering control. When this occurred, the steering mode automatically shifted to the computer-assisted manual mode, and control shifted to that station. This type of transfer was noted in the IBNS technical manual, but it was not provided as a standard procedure.

After the accident, the Navy issued an advisory message to IBNS-equipped ships providing a "recommended action" that mitigates the risk of unintended transfers in backup manual mode. However, given that the steering control directive is provided as a "recommended action" only, the NTSB recommends that the Navy issue permanent guidance directing destroyers equipped with the IBNS to operate in computer-assisted steering modes, except during an emergency.

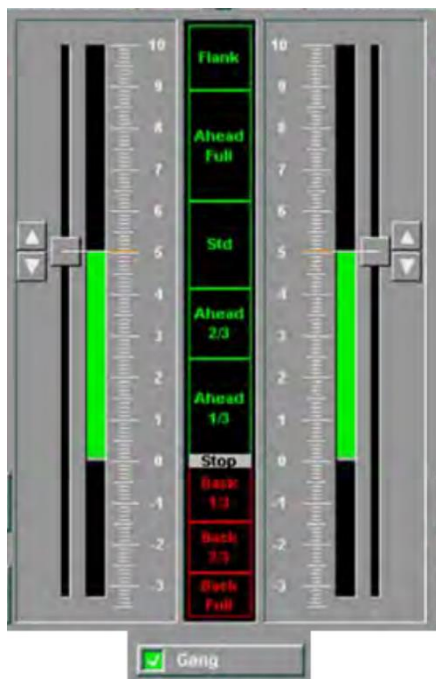
Figure 6. Port and starboard throttles and gang button on IBNS GUI display. (Image from IBNS technical manual)

The thrust for each shaft and the speed of the vessel could be controlled by moving a graphical depiction of a throttle on the GUI display. The throttle for each shaft was independent of the other, but the display allowed the throttles to be linked, or “ganged.” When ganged, the movement of one throttle would also move the other throttle by the same amount (both propellers thrust equally).

In addition to the control stations, the *John S McCain* had numerous displays on the bridge and on the bridge wings that showed the propeller pitch and turns. When NTSB investigators visited a similarly equipped Navy destroyer, they noted that the displays were visible from almost anywhere on the bridge. During the accident sequence, the throttles remained mismatched for over a minute, but the CO, OOD, conning officer, and other bridge watchstanders did not recognize the lee helmsman's error, and, consequently, no actions were taken to correct it. The NTSB concludes that the *John S McCain* bridge team was not monitoring the lee helmsman's response to orders and therefore did not recognize that the throttles were mismatched.

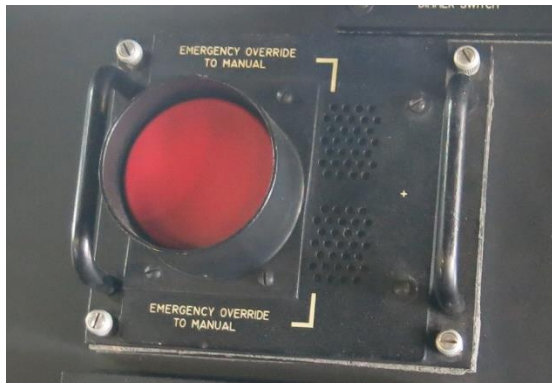
Figure 7. *John S McCain* emergency-override-to-manual button on the SCC.

Separate from the touch screen display controls, the SCC helm station and the ASU each had a steering *emergency-override-to-manual* button (also called the “big red button” by Navy crewmembers). When the button was pressed at the SCC helm or ASU station, steering control would immediately transfer to that station and the steering mode would simultaneously change to backup manual.

mode. However, the helmsman told investigators that, during the accident, he did not press the emergency-override-to-manual button because he believed that this sent steering control to aft steering (an opinion shared by other bridge watchstanders interviewed by investigators). The OOD told investigators that she did not order the helmsman to press the emergency-override-to-manual button because the steering system was already in the backup manual mode. Instead, she ordered the conn, who in turn ordered the helmsman, to switch hydraulic power units (HPUs).¹⁸ The helmsman told investigators that he tried to switch HPUs from the SCC helm station, but he “could not gain control of them.” The steering log showed that steering control remained at the lee helm station in computer-assisted mode for over 2 minutes, until 05:23:02.

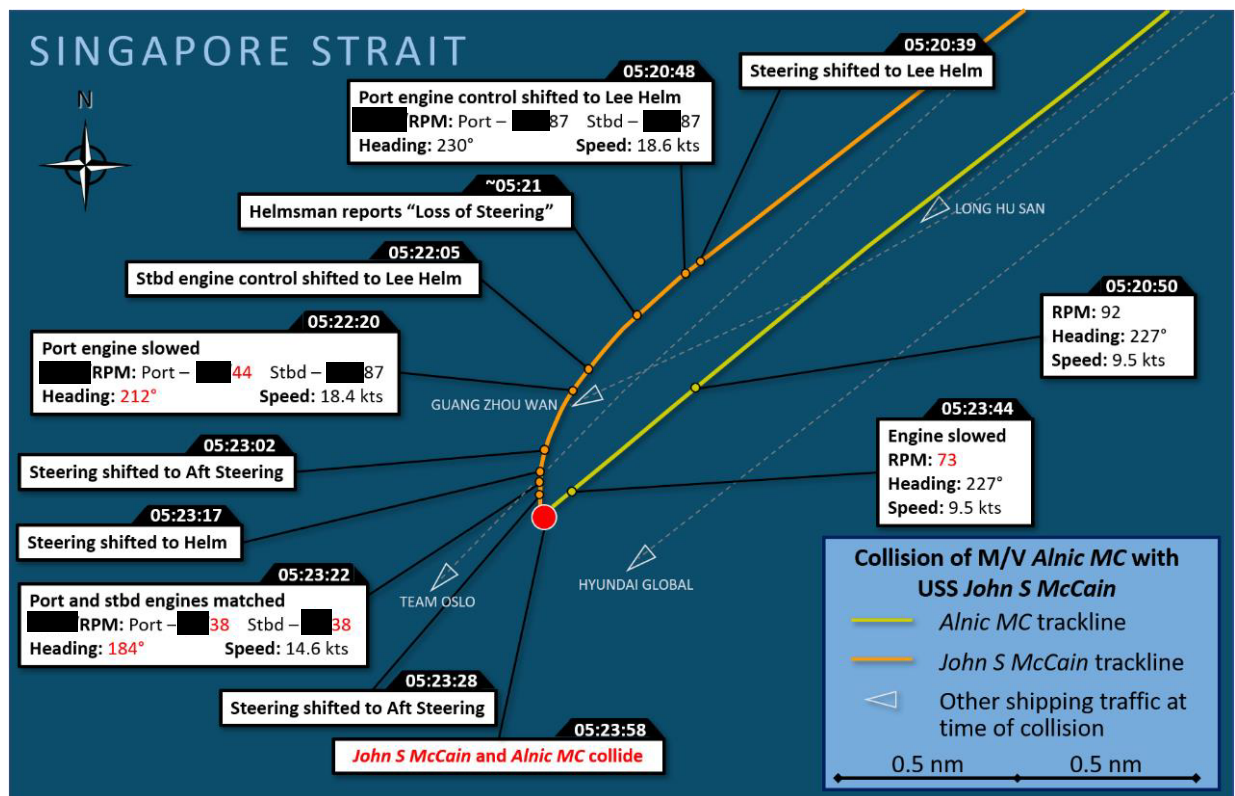
Figure 11. Vessel tracks and accident events.

In the 1-minute time span from 05:21:19.5 to 05:22:19.5, the *John S McCain*'s heading changed 13.3 degrees to port, toward the *Alnic MC*. The destroyer's rudder angle remained at 0 degrees during this time. According to radar pictures downloaded from the *Alnic MC*'s VDR, the destroyer was nearly abeam of the *Alnic MC* when it began to move toward the tanker.

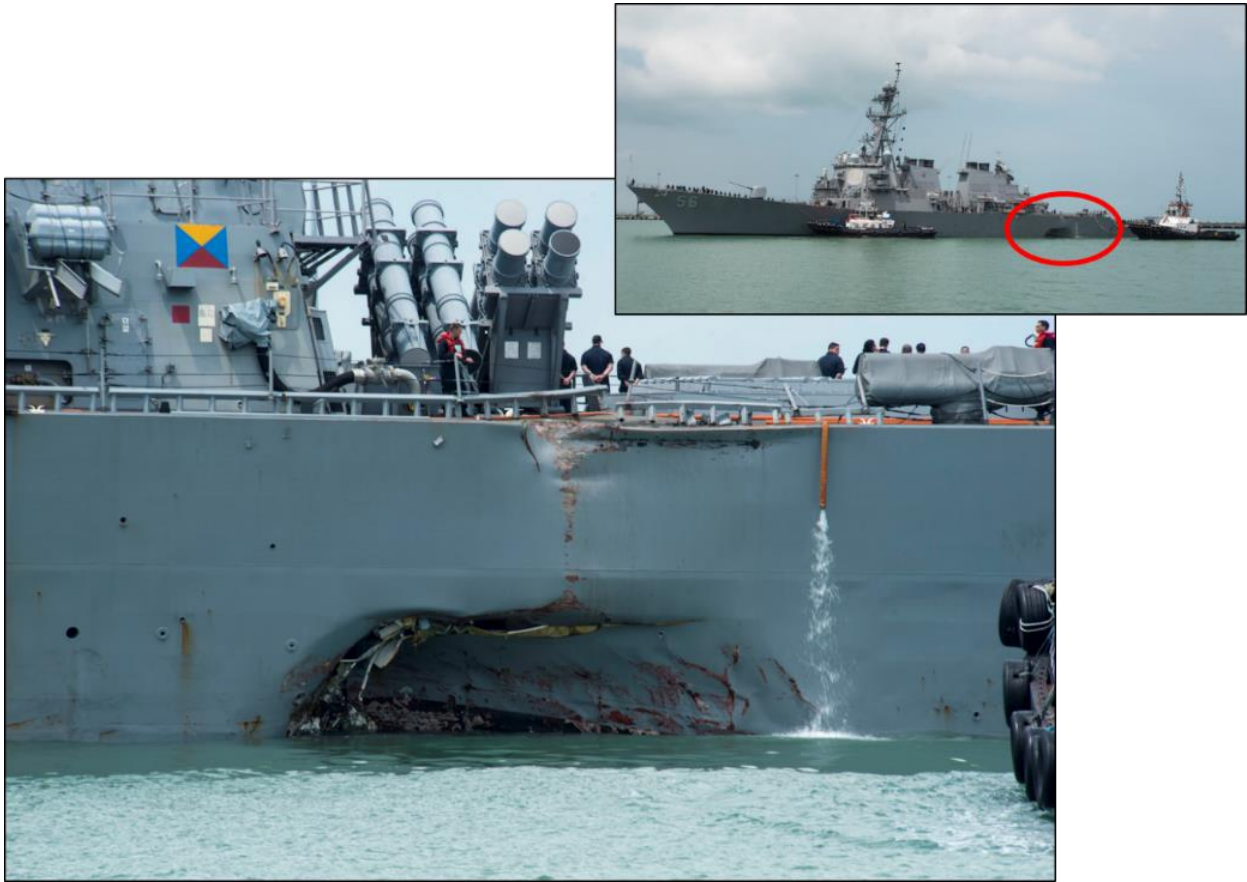
Figure 12. Hull damage to *John S McCain*. (Photos by Navy Mass Communication Specialist 2nd Class Joshua Fulton)

When the vessels collided, the *Alnic MC*'s bulbous bow opened a 28-foot-diameter hole in the *John S McCain*'s hull, above and below the waterline, resulting in significant structural and flooding damage to several spaces, including crew berthing. Repairs to the hull, internal structures, and equipment were estimated at over \$100 million.

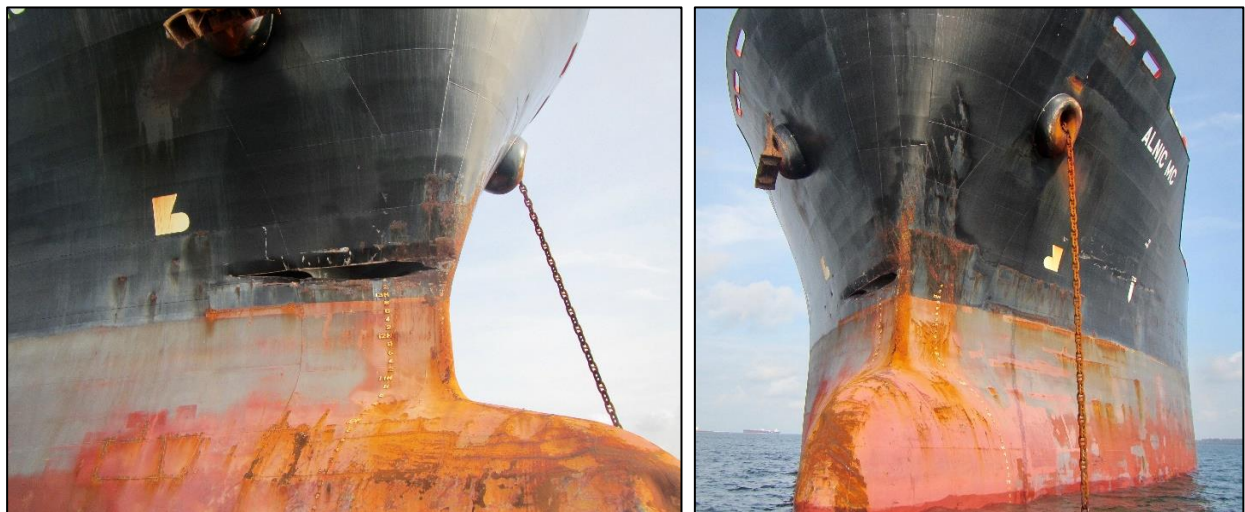
Figure 13. Hull damage to *Alnic MC*. (Photos by Coast Guard)

Damage to the *Alnic MC* included a breach of the hull, about 8 feet long, on the starboard bow about 20 feet above the waterline and indentation in the plating on the bulbous bow, bow stem, and just aft of the bow stem on the port and starboard sides. Repair costs totaled about \$225,000.
