Highway Accident Brief

Fatal Pedestrian Collision with Pickup Truck Lewiston, Maine, November 3, 2016

Accident Number: HWY17SH008

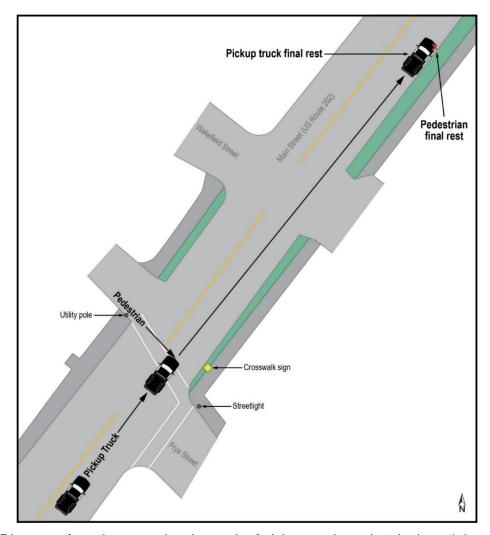
walking northeast bound on the sidewalk. [The pedestrian] positions himself in the crosswalk (western side) on the side of the road. He appears to wait until traffic continues by. When there is a lull in traffic he proceeds to walk across Main St still in the crosswalk. As he passes the centerline he stops briefly and appears to look right to see . . . the vehicle heading towards him. [The pedestrian] attempts to get out of the way by running east bound.. [He] was not able to get out of the way of [the] vehicle. [He] is struck just beyond the crosswalk.

The driver stated that she did not see the pedestrian until just before her vehicle struck him, and investigators found no evidence that she braked before the impact. The pedestrian first struck the pickup's hood and grille, then became stuck underneath, near the right front wheel. The pickup dragged the pedestrian along the pavement for 176 feet before coming to rest. A passerby called 911. Emergency crews responded and pronounced the pedestrian dead at the scene.

Figure 1. Diagram of crash scene showing path of pickup truck, pedestrian's path in crosswalk to point of impact, and final rest positions of pickup and pedestrian.

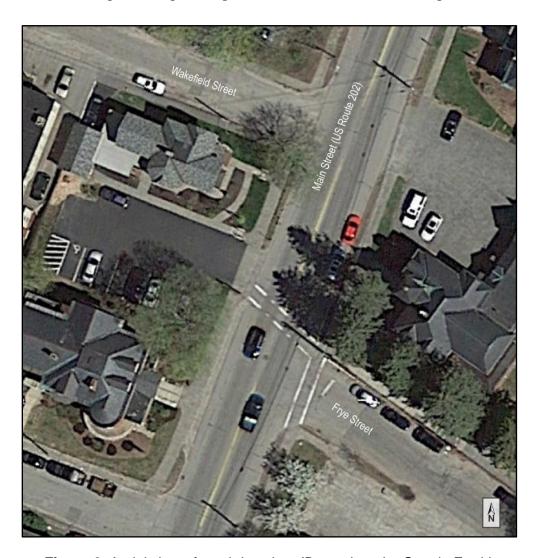
Main Street is classified as an urban arterial roadway. It runs northeast to southwest and in the area of the crash has two lanes separated by a double yellow line. The neighborhood contains a mix of residences and office complexes (figure 2). A hospital is situated just south of the crash site. Traffic in the area is moderate to heavy during the time the crash occurred, according to the police reconstruction report. The posted speed limit on Main Street is 25 mph.

Figure 2. Aerial view of crash location. (Base photo by Google Earth)

The crash intersection has no traffic signals. Traffic entering Main Street from Frye Street is regulated by a stop sign. The area around the intersection includes sidewalks, and a marked pedestrian crosswalk on Main Street goes from the northeast corner of Frye Street to the southeast corner of a driveway. A pedestrian crossing sign is located on Main Street next to the crosswalk, visible to vehicles traveling northeast. A streetlight stands at the northeast corner of the intersection. No other pedestrian crashes have occurred at the intersection, according to its crash history.

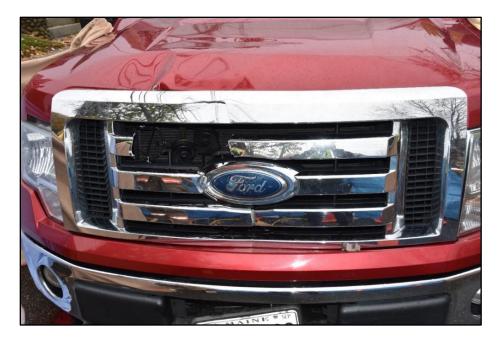
The driver reported that the pickup truck was in working order before the crash. The air bags for the driver and front-seat passenger did not deploy in the crash.³ Damage to the pickup, which was examined at the impound site, included a broken grille and dents on the leading edge of the hood on the right (passenger) side (figure 3). There were no indications beyond the damage to the hood that the pedestrian rode onto the pickup. Police found no mechanical defects during the postcrash examination of the vehicle.

Figure 3. Closeup of crash vehicle showing damage to hood and grille. (Source: Lewiston Police Department)
