# National Transportation Safety Board

## Marine Accident Brief

### Capsizing and Sinking of Fishing Vessel *Destination*

<b>Accident no.</b>	DCA17FM006
<b>Vessel name</b>	<i>Destination</i>
<b>Accident type</b>	Capsizing and sinking
<b>Location</b>	Bering Sea, 2.6 miles northwest of St. George Island, Alaska 56°39' N, 169°49.8' W
<b>Date</b>	February 11, 2017
<b>Time</b>	0610 Alaska standard time (coordinated universal time – 9 hours)
<b>Injuries</b>	6 fatalities
<b>Property damage</b>	\$2.5 million est.
<b>Environmental damage</b>	Oil sheen
<b>Weather</b>	Visibility 9 miles, light snow, cloudy skies, winds northeast at 23 knots with gusts up to 34 knots, seas northeast at 13 feet, surface current south at 0.78 knots, air temperature 18°F, water temperature 37°F, morning twilight 0915, sunrise 0955
<b>Waterway information</b>	The Bering Sea covers 885,000 square miles in the north Pacific Ocean, bordered by the following areas: Russia (Siberia), Bering Strait, mainland Alaska, Alaska Peninsula, and Aleutian Islands. The average depth of the sea is approximately 5,000 feet. The area around St. George and St. Paul Islands (Pribilof Islands) is much shallower, measuring 180–300 fe

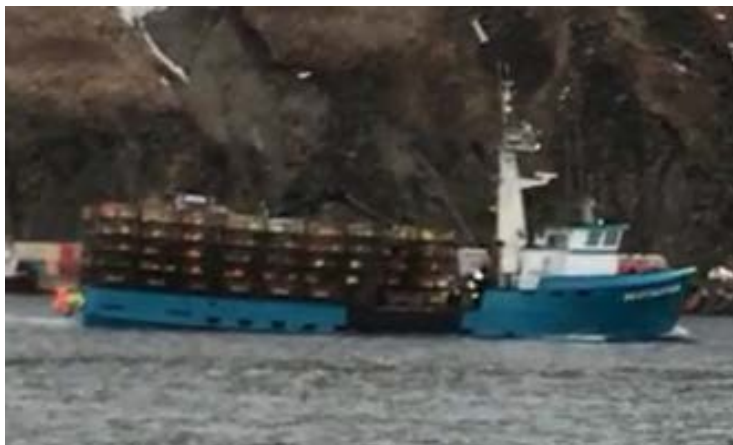
**A screenshot from video of the *Destination* as it arrived in Dutch Harbor carrying 200 crab pots on February 9, two days before the accident. (Video courtesy of *April Lane* crewmember)**

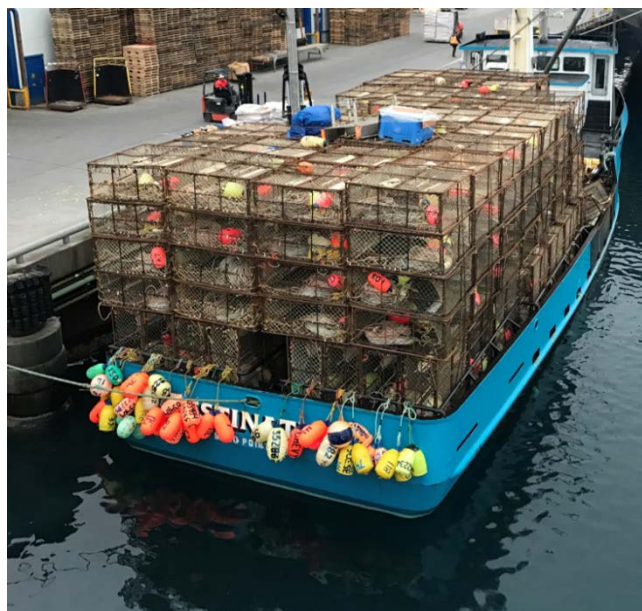
Although the *Destination* could carry a maximum of 224 pots per its stability instructions booklet, former crewmembers said that the captain nearly always carried 200 pots. The pots were stacked in five tiers: those in the first tier were stored on their sides, which left space for a 3-foot-wide-by-7-foot-high tunnel down the centerline of the vessel; the other pots in the four tiers were stacked horizontally, four across and approximately seven lengthwise. The tunnel allowed the crew access to the following: the manhole covers for wet-well fish hold nos. 1, 2, and 3 located on the centerline; the steering room, through a watertight door from fish hold no. 3; and the mooring cleats on deck at the stern. Two former crewmembers said that fish hold nos. 1 and 2 were typically full, “pressed” with seawater, and that hold no. 3 was empty and uncovered. “We always left the hatch off,” one of them added, in reference to the manhole for hold no. 3. The *Destination*'s stability instructions booklet that investigators reviewed required that the no. 3 hold be empty for the departure condition that most resembled the vessel's actual departure condition on the accident voyage and advised that “precautions shall be taken to ensure that the tank is completely empty.”

Crab pots that the *Destination* was carrying during its stopover at Dutch Harbor. (Photo courtesy of *Ocean Rover* crewmember)

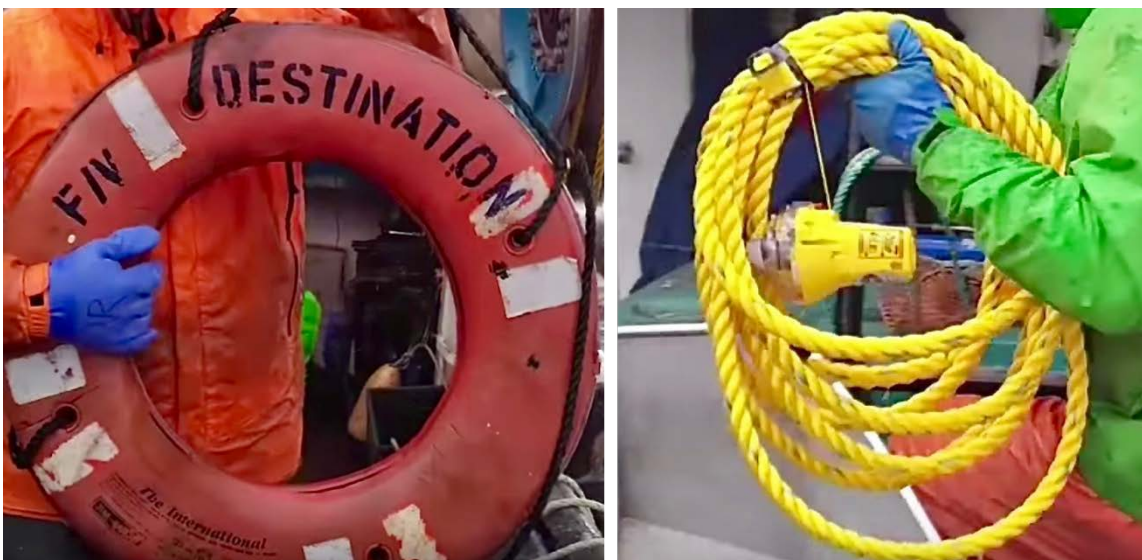
Screenshots from video captured by the *Silver Spray* crew of items recovered from the *Destination*: a life ring (at left), along with a line and the vessel’s EPIRB (at right).

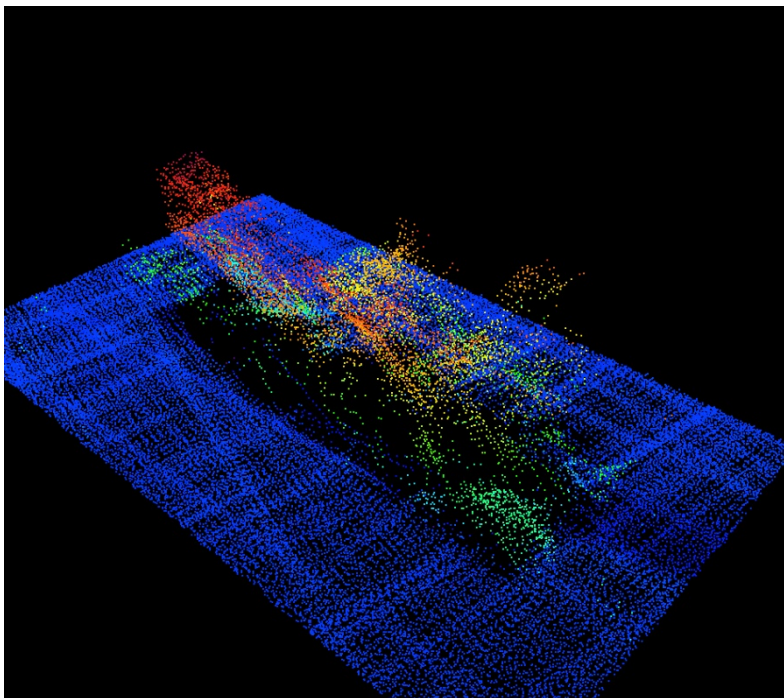
Following the accident, the Coast Guard Marine Board of Investigation requested assistance from the National Oceanic and Atmospheric Administration (NOAA) to locate and examine the *Destination* on the seafloor. About 5 months after the accident, on July 8, the crew of the NOAA vessel *Fairweather* began surveying the area near the *Destination*’s last known position using side-scan sonar.<sup>8</sup> A target matching the description of the *Destination* was located approximately 7 miles north of Dalnoi Point. The commanding officer of the *Fairweather* told the marine board that the sonar imagery showed the vessel resting on its port side facing southwest in 256 feet of water and a scour line extending 330 feet southwest from the vessel.<sup>9</sup>

Side-scan sonar image of the *Destination* on its port side. (Image courtesy of NOAA)

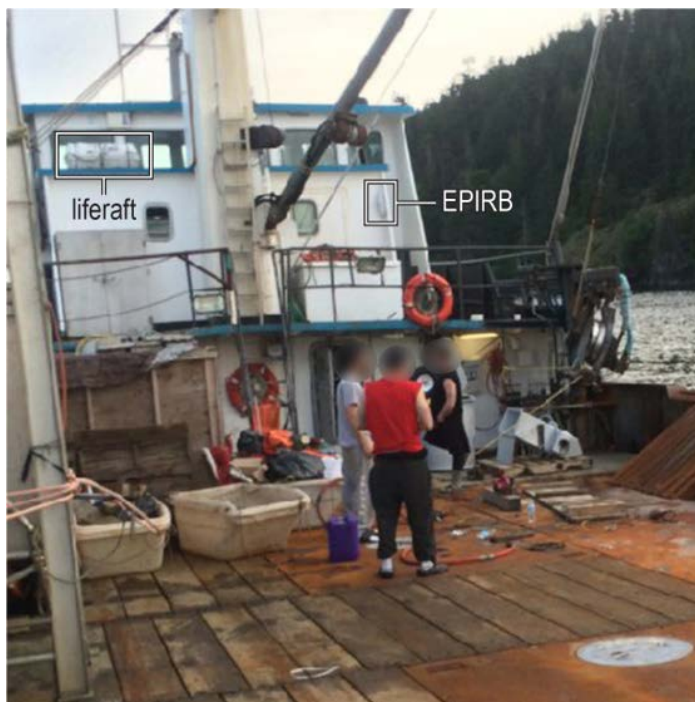
An undated photo of the *Destination* taken by a former crewmember reveals the locations of the liferaft (at left) and EPIRB (at right) that were on board the vessel aft of the wheelhouse.

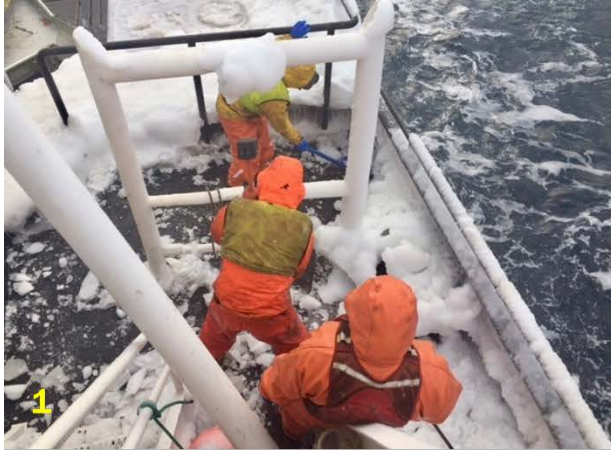
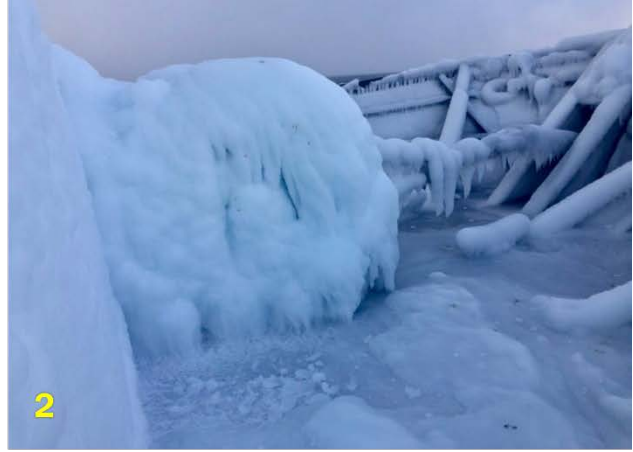
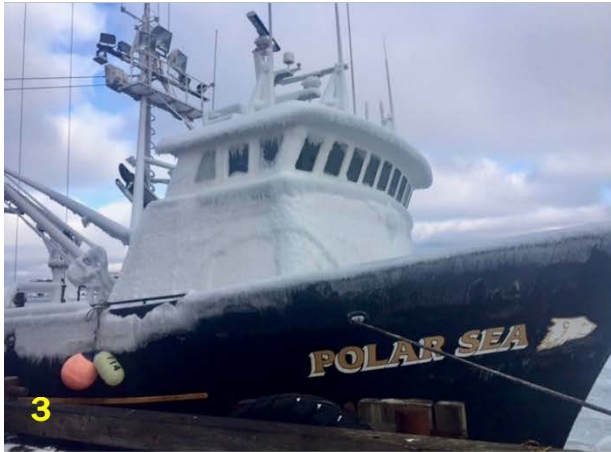
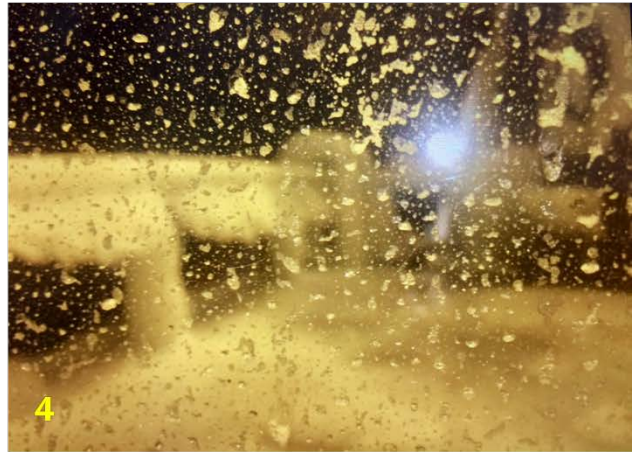
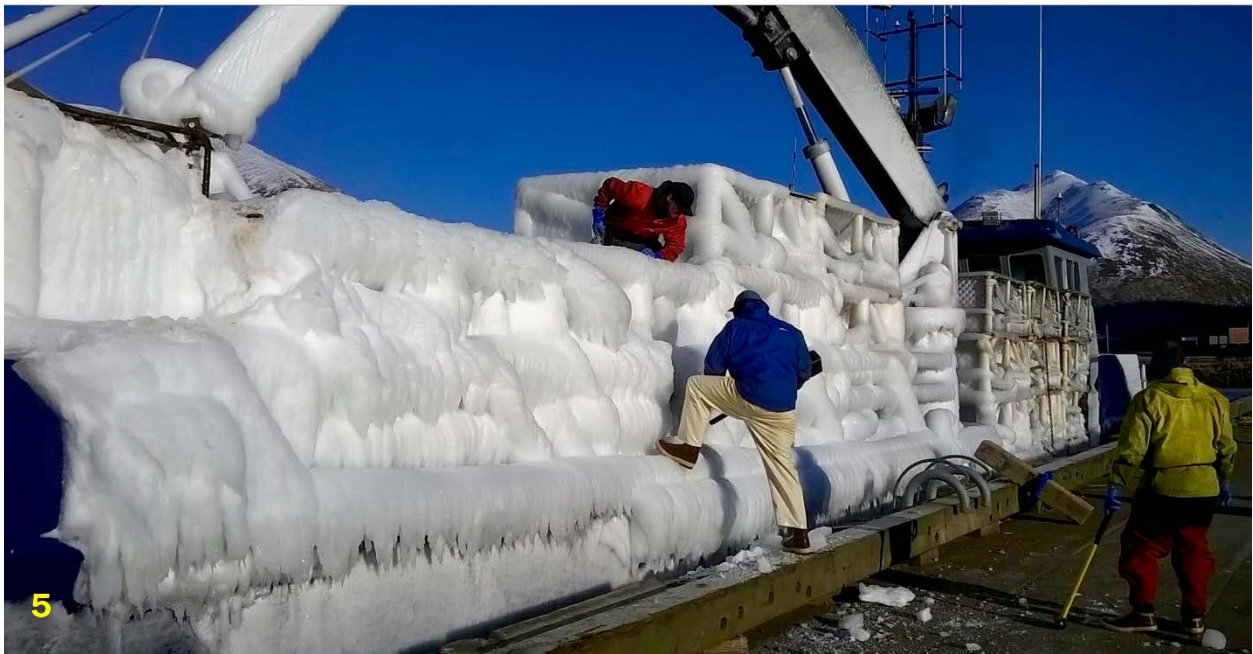
(1, 2, and 3) *Polar Sea*: ice covers the decks and anchor chain during the vessel's transit to St. Paul Island on February 10 and remains on the wheelhouse while it was docked there the following day. (4) *Bering Rose*: accumulation of ice on deck aft of the wheelhouse during the early hours of February 11. (5) *Sandra Five*: while in King Cove on February 12, crewmembers examine the ice that accumulated during their transit from St. Paul Island.

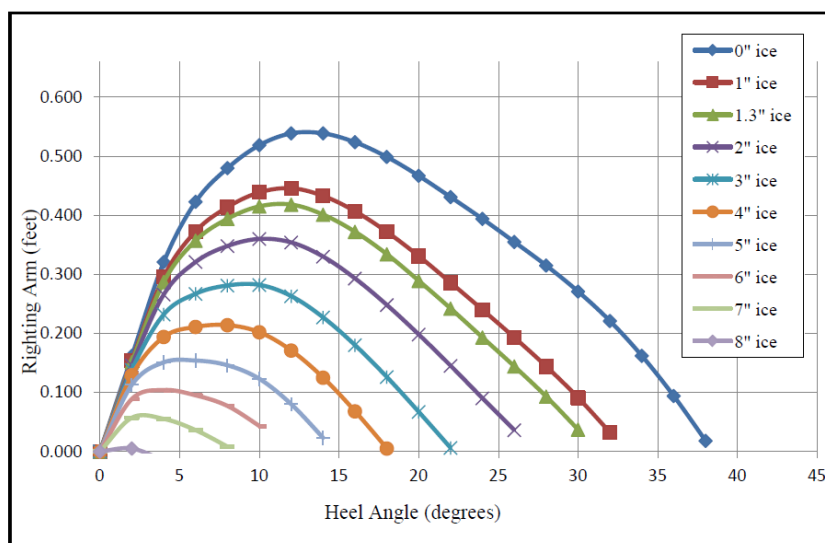
The righting arm curves were based on ice accumulating on the vessel as it was loaded when the vessel departed Dutch Harbor. The curves were developed using crab pot weights of 840 pounds, which was based on an actual weight of a *Destination* crab pot recovered after the accident, rather than the weight of 700 pounds referenced in the vessel's stability instructions booklet (the difference was an additional 28,000 pounds for 200 pots). The MSC also included a total of 19,706 pounds of bait (some of which were stored on deck) based on payment receipts, rather than the 6,048 pounds referenced in the stability instructions booklet (the difference was an additional 13,658 pounds). The analysis also included the 3,366 pounds of steel plate added to the bulwark, the bulbous bow, and other items not found in the stability instructions booklet that reflected the actual loading condition determined by investigators. As stated, vessels have negative stability when their righting arm is less than zero. For example, with 4 inches of ice, the

The MSC concluded that the vessel likely capsized in the large seas and winds as it came out of the lee of St. George Island due to prolonged icing conditions adding weight high on the vessel, leaving it with a lower freeboard and a decreased righting arm (lower stability). The AIS position data that indicated a rapid heading change as the vessel left the island’s lee support this capsizing scenario.

**Righting arm curves for incremental ice loads calculated by the Coast Guard’s Marine Safety Center for its stability analysis of the *Destination*.**
