National Transportation Safety Board

Highway Accident Brief

Low-Speed Collision Between Truck-Tractor and Autonomous Shuttle, Las Vegas, Nevada, November 8, 2017

Accident Number:	HWY18FH001
Accident Type:	Collision involving automated test vehicle on public road
Location:	South 6th Street, Las Vegas, Nevada
Date and Time:	November 8, 2017, 12:07 p.m. Pacific standard time
Vehicle 1:	2006 International truck-tractor in combination with 2010 Utility refrigerated trailer
Vehicle 2:	2017 Navya Arma autonomous shuttle
Fatalities:	0
Injuries:	0

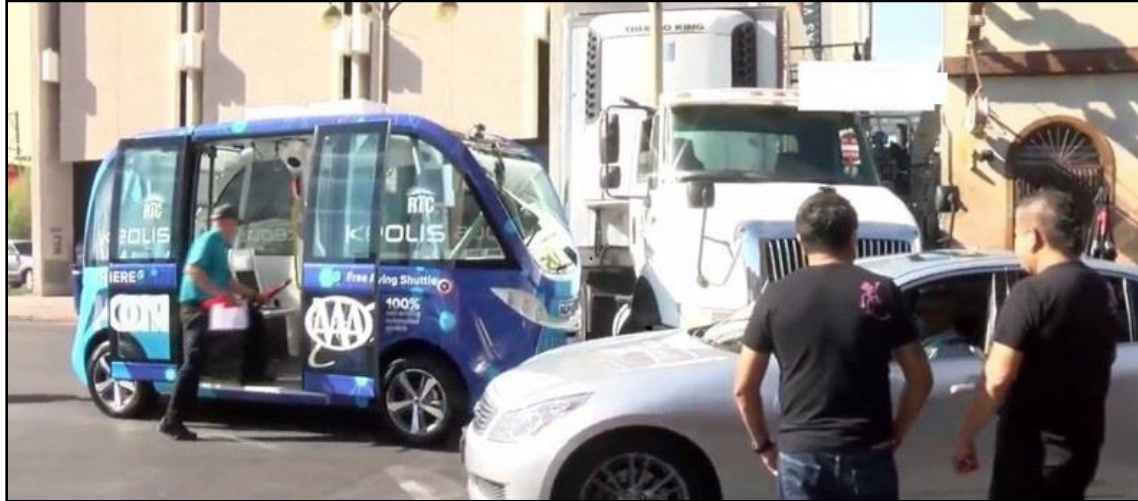
About 12:07 p.m. on Wednesday, November 8, 2017, a minor collision (figure 1) occurred on South 6th Street in downtown Las Vegas, Clark County, Nevada, between a truck-tractor combination vehicle, operated by a 48-year-old driver, and a 2017 Navya Arma autonomous shuttle, carrying 7 passengers and a 38-year-old attendant. The shuttle, manufactured by Navya and operated by Keolis North America, was on a 0.6-mile designated loop beginning and ending at a downtown shopping center known as Container Park (the buildings are repurposed shipping containers or modular cubes).¹ The combination vehicle, a 2006 International truck-tractor pulling a 2010 Utility refrigerated trailer, was backing into an alley west of South 6th Street while on a delivery route for US Foods when it struck the shuttle.²

Figure 1. Scene of minor collision between truck-tractor and autonomous shuttle in downtown Las Vegas (white car in foreground was not involved). (Source: KSNV News 3 Las Vegas)

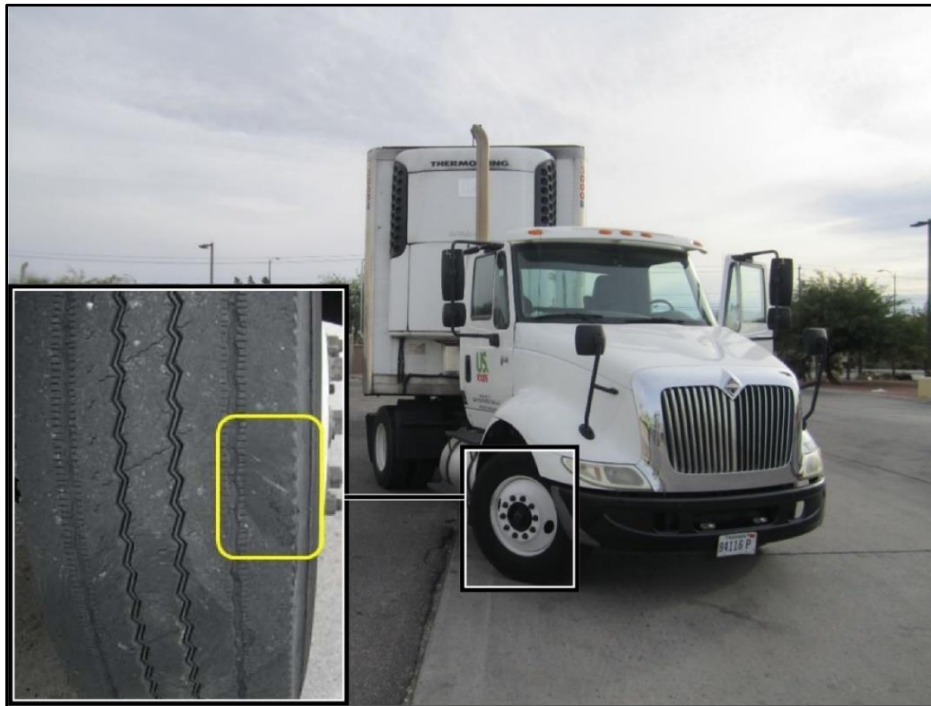
The collision caused minor damage to the lower left front of the shuttle’s body and a minor abrasion to the truck’s tire (see photos later in this report, in “Truck” and “Autonomous Shuttle” sections). The shuttle passengers, the attendant, and the truck driver were uninjured. The shuttle and the combination vehicle remained in service after the collision.

For the inspection, the truck-tractor and trailer were placed in their approximate postcrash positions (figure 3). The truck's steering wheel was turned to the left. The offset distance from the right fender to the outboard tire shoulder on the truck's steer axle measured about 6 inches. The abrasion on the truck's right front tire extended inboard 1.75 inches from the outboard shoulder.

Figure 3. Truck-tractor after collision, with inset showing damage to right front tire (photo taken 4 days after collision).

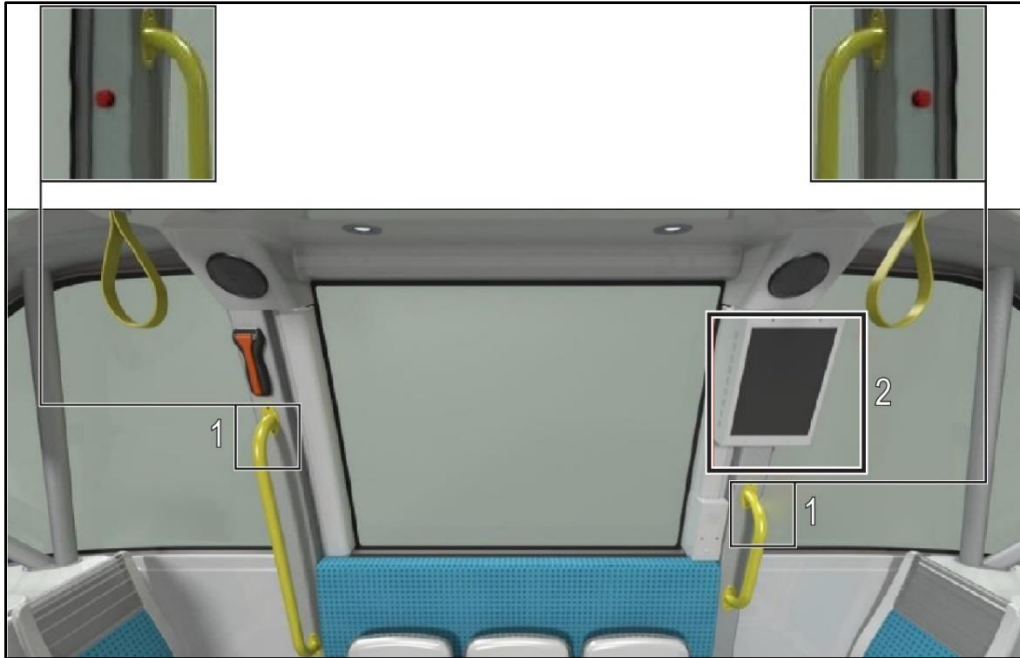
When the shuttle was 3.1 meters (10.2 feet) from the truck and at nearly a complete stop, the attendant pressed one of the emergency stop buttons on the wall opposite the loading doors.⁴ Cameras inside the shuttle showed the attendant and passengers waving to the truck driver. The truck driver continued in reverse. Eleven seconds after the shuttle stopped, according to Navya’s incident report, it was struck by the right front tire of the slow-moving truck.

Two emergency stop buttons were installed on either side of the central window opposite the loading doors (figure 5). Pushing an emergency stop button would turn off the motor, activate three types of brakes, and turn on flashing hazard signals. The loading doors were equipped with emergency release handles. If the doors could not be used to evacuate the shuttle in case of emergency, a hammer could be used to break the central window, marked “emergency exit.” A fire extinguisher and first aid kit were stored under the seats opposite the doors.

Figure 5. Rendering of shuttle interior showing locations of (1) emergency stop buttons (detailed in inset drawings) and (2) navigation touch screen. Emergency hammer (red) is shown in upper left. (Adapted from Navya owner’s manual)

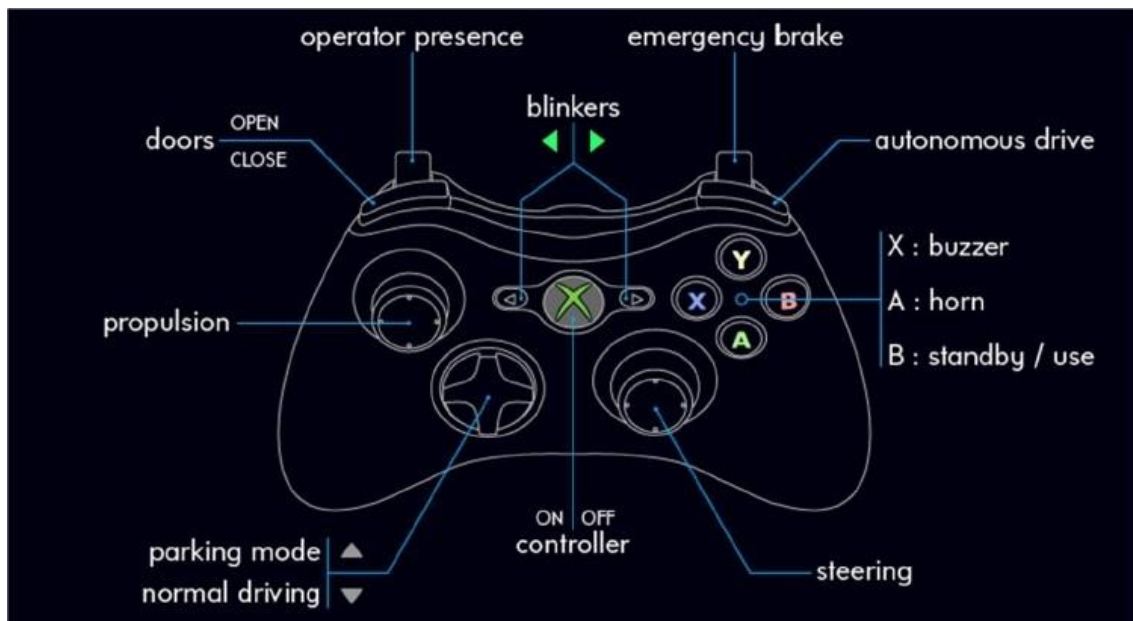
Figure 7. Schematic of controller used to operate shuttle in manual mode or return it to autonomous mode. (Source: Navya operator training booklet)

Before the crash, the controller was stored in an enclosed space at one end of the passenger compartment. The attendant did not retrieve the controller during the event. After the crash, Keolis put in place a new company policy to make the controller more accessible. Attendants were now to remove the controller from its storage space at the beginning of a trip and keep it available throughout the trip.

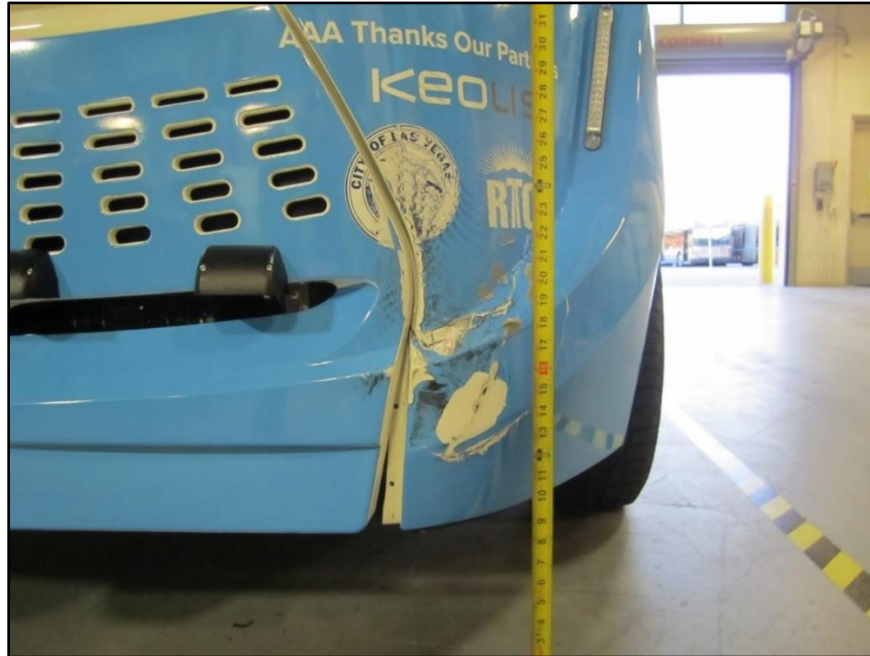
NTSB investigators examined the shuttle 3 days after the collision. The left front fiberglass panel on the body was displaced to the left, creating a gap (measuring from 1.375 inches at the bottom to 1.125 inches at the top) between the panel and the access door at one end of the shuttle (figure 8).¹⁸ Investigators also observed black transfer marks on the fiberglass.

Figure 8. Closeup of damage to lower left front of shuttle (photo taken 3 days after collision).
