National Transportation Safety Board

Highway Accident Brief

Intersection Collision Involving Motorcoach and Transit Bus, Flushing, New York, September 18, 2017

Accident Number:	HWY17MH015
Accident Type:	Intersection collision
Location:	Northern Boulevard (New York State Route 25A) and Main Street, Flushing, New York
Date and Time:	September 18, 2017, 6:16 a.m.
Vehicle 1:	2015 MCI motorcoach operated by Dahlia Group Inc.
Vehicle 2:	2015 New Flyer XD40 bus operated by New York City Transit Authority
Fatalities:	3
Injuries:	Multiple

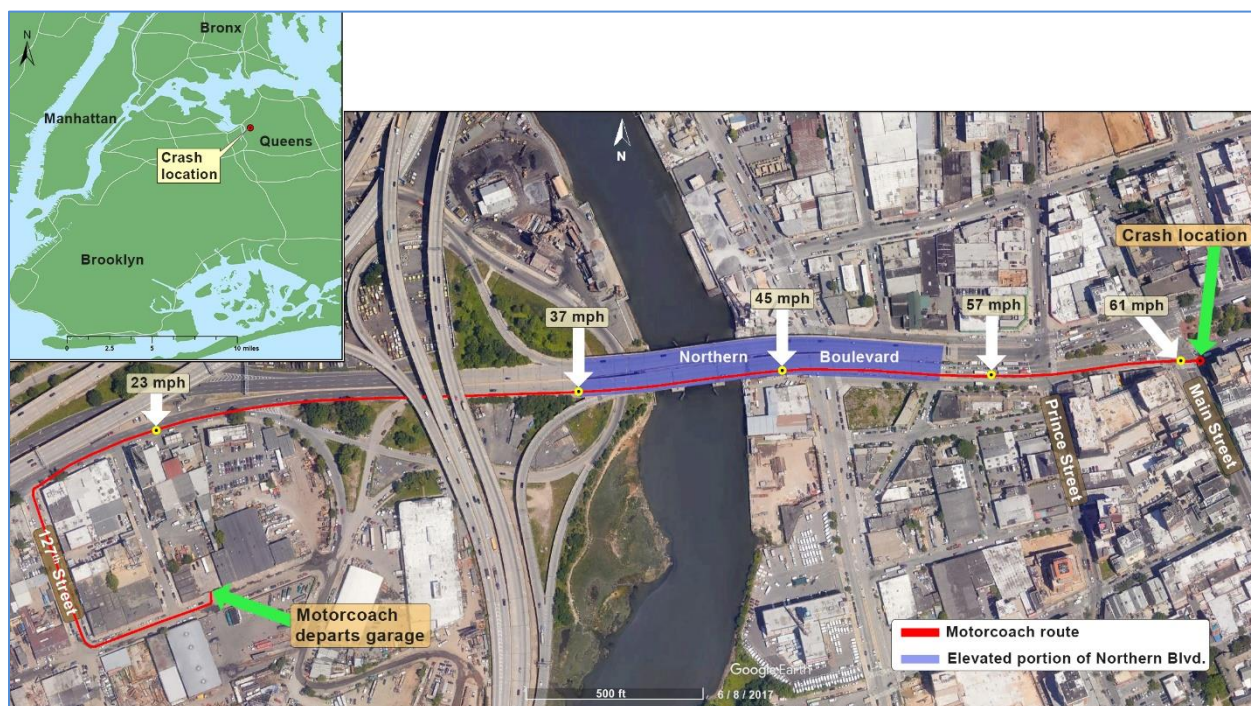
The motorcoach—occupied only by the driver—was traveling east on Northern Boulevard and failed to stop for a red traffic signal at the intersection with Main Street (figure 1). Meanwhile, the transit bus—occupied by the driver and 16 passengers—was executing a right turn on a green right-turn traffic signal from northbound Main Street onto eastbound Northern Boulevard. The motorcoach was traveling 60–61 mph when it struck the left rear side of the transit bus, causing the transit bus to rotate 120 degrees counterclockwise and then strike two cars parked along the right curb of Northern Boulevard.² One of the parked vehicles—a 2009 Honda—was unoccupied; the other—a 2002 Toyota—was occupied by a driver and a front passenger. The motorcoach then departed the south side of Northern Boulevard; crossed over the sidewalk; and struck a building

Figure 1. Path of motorcoach from beginning of trip to crash location, highlighting elevated portion of Northern Boulevard over Flushing River and motorcoach speeds increasing from 23 to 61 mph.

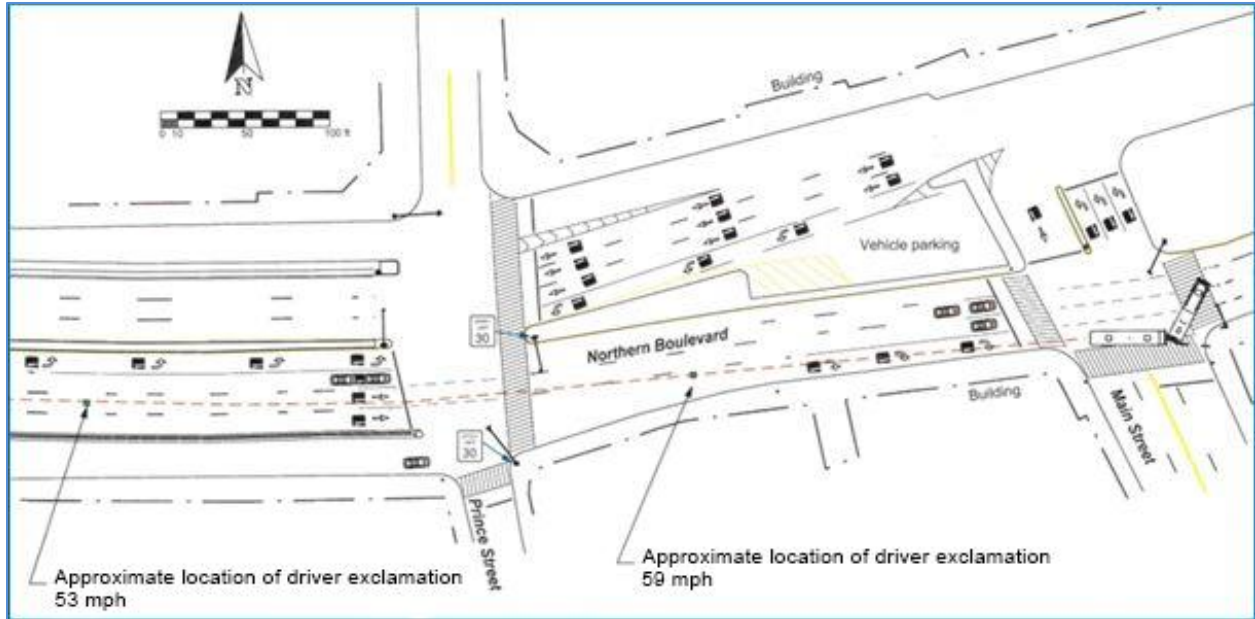
The Garmin video shows the traffic signal visible at the Prince Street intersection. At 6:16:03 a.m., a driver exclamation is recorded as the motorcoach is traveling 53 mph. The motorcoach continues travel in lane 3 and enters the Prince Street intersection at 57 mph through a red traffic signal; the signal turns green as the motorcoach is in the middle of the intersection (figure 2).

Figure 2. Depiction of motorcoach path of travel through Prince Street and Main Street intersections, with approximate location of driver exclamations noted.

At 6:16:06 a.m.—3 seconds after the first exclamation—the driver exclaims a second time as he approaches the Main Street intersection and moves to the right (from lane 3 to lane 4) in response to stopped vehicles in lanes 2 and 3. This steering maneuver is the only known action the driver takes after experiencing unintended vehicle acceleration. Vehicle data show no brake application. The motorcoach enters the Main Street intersection at 60 mph.

The Garmin video ends as the motorcoach enters the Main Street intersection, estimated to be about 0.6 second before the collision with the transit bus. As noted earlier, the transit bus had entered the intersection and was progressing through its right turn onto Northern Boulevard (figure 2). The video and onboard telematics system indicate a final vehicle speed of 60–61 mph. The motorcoach driver makes an unintelligible remark prior to the end of the video. Table 1 summarizes the motorcoach trip events.

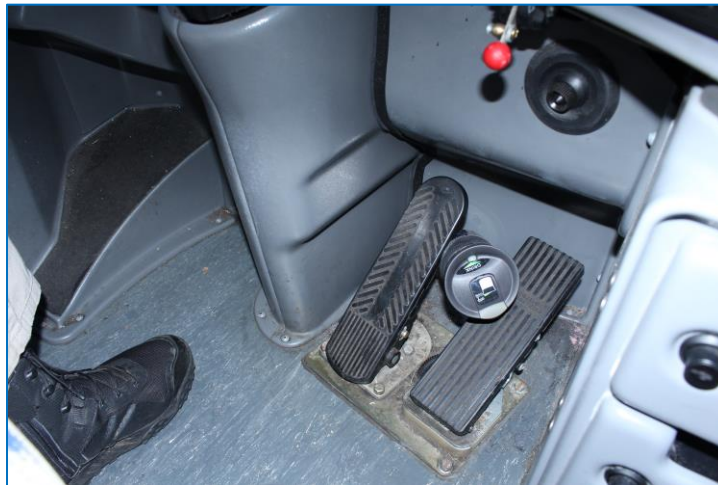
NTSB investigators considered the possibility that an object became lodged beneath or between both the brake and the accelerator pedals, resulting in uncontrolled acceleration and the inability to apply the brakes (figure 3). At the scene of the crash, investigators found a metal thermos near the control pedals. When interviewed, the driver's wife stated that he had taken his thermos for the trip. The thermos could potentially explain the metal rattling heard on the Garmin audio just before the driver's first remark.

Figure 3: Pedal obstruction test using exemplar motorcoach and metal thermos, showing one lodging position among several possible thermos and pedal combination scenarios.

Investigators examined the audio recording to determine if a dropped thermos could have created the sound, but the results were inconclusive. Metallurgists from the NTSB Office of Research and Engineering examined marks on the thermos to determine if they could have been caused by contact with the vehicle control pedals; no physical evidence was present to indicate this type of interference. Investigators also obtained a similar thermos and attempted to lodge it in the pedals of an exemplar motorcoach. They found that it was possible to position the thermos

beneath and between the pedal controls such that it prevented brake application while depressing the throttle.

The surveillance video that captured the motorcoach colliding with the bus does not show any brake lights from the motorcoach until it comes to rest.¹³ Likewise, the engine control module data provide no indication of a hard brake application. It is possible that an engine control module would not record a brake attempt if the pedal was obstructed, thus preventing the driver from fully depressing it. Results of exemplar brake testing indicate that only a small brake application is required to register on the brake application gauge (about 1 degree movement of the brake pedal to the floorboard). With less than 1 degree of pedal movement, the data might not indicate braking even if a driver attempted to apply the brakes. The NTSB concludes that though an obstructed brake pedal could not be discounted as a factor in the crash, it also could not be determined as causal to the crash.
