NATIONAL TRANSPORTATION SAFETY BOARD

WRECKAGE EXAMINATION SUMMARY

WPR15MA243AB

Location: San Diego, California
Date: August 16, 2015
Aircraft A: Cessna 172M, N1285U
Aircraft B: Sabreliner NA-265-605C, N442RM

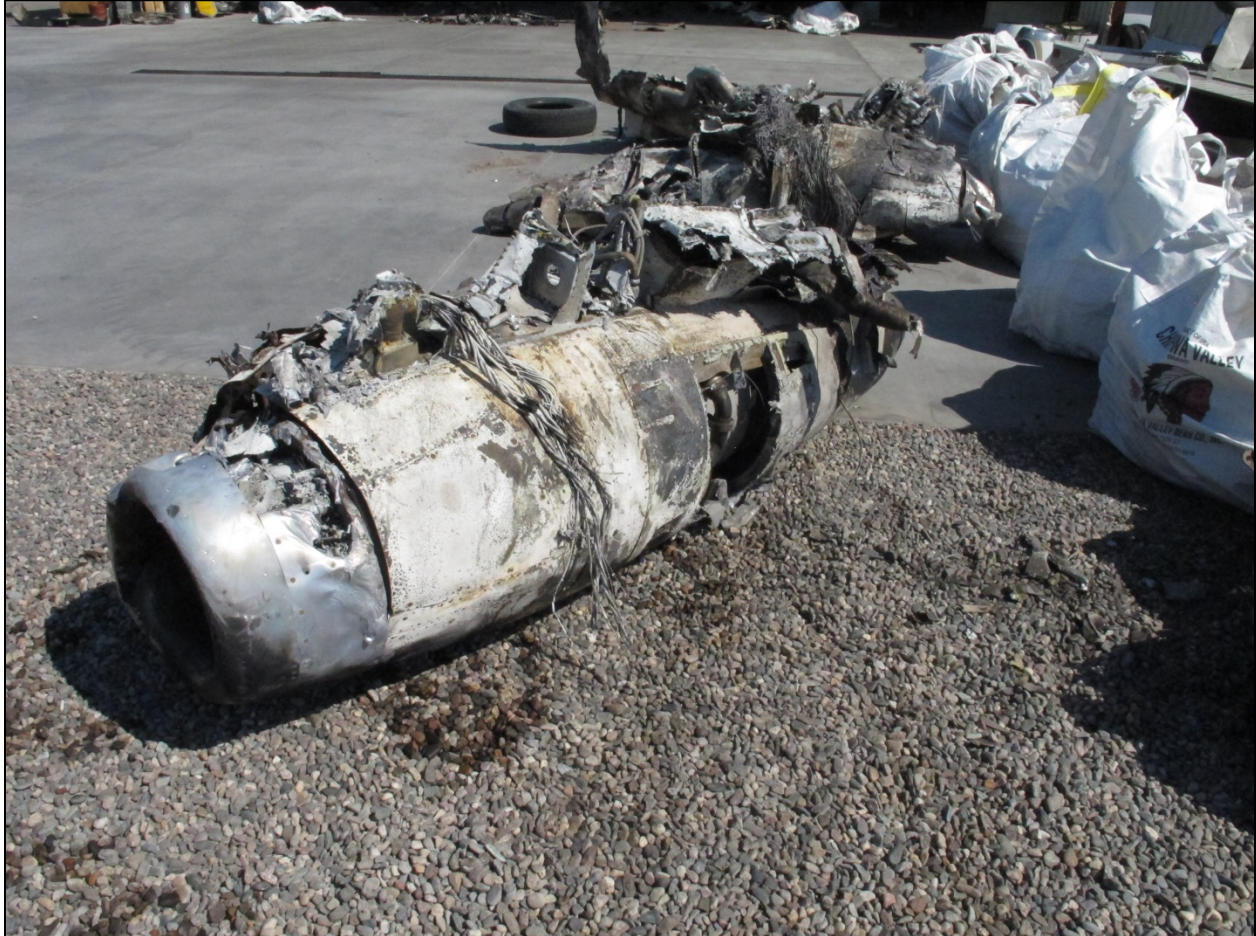
Figure 1-Sabreliner No. 1 (Left) Engine

The engines had separated from the fuselage, and both had impact and thermal damage at the nacelles.

The left engine was crushed lengthwise. The left engine's first stage compressor blades had leading edge damage that was consistent with rotation during the accident sequence.

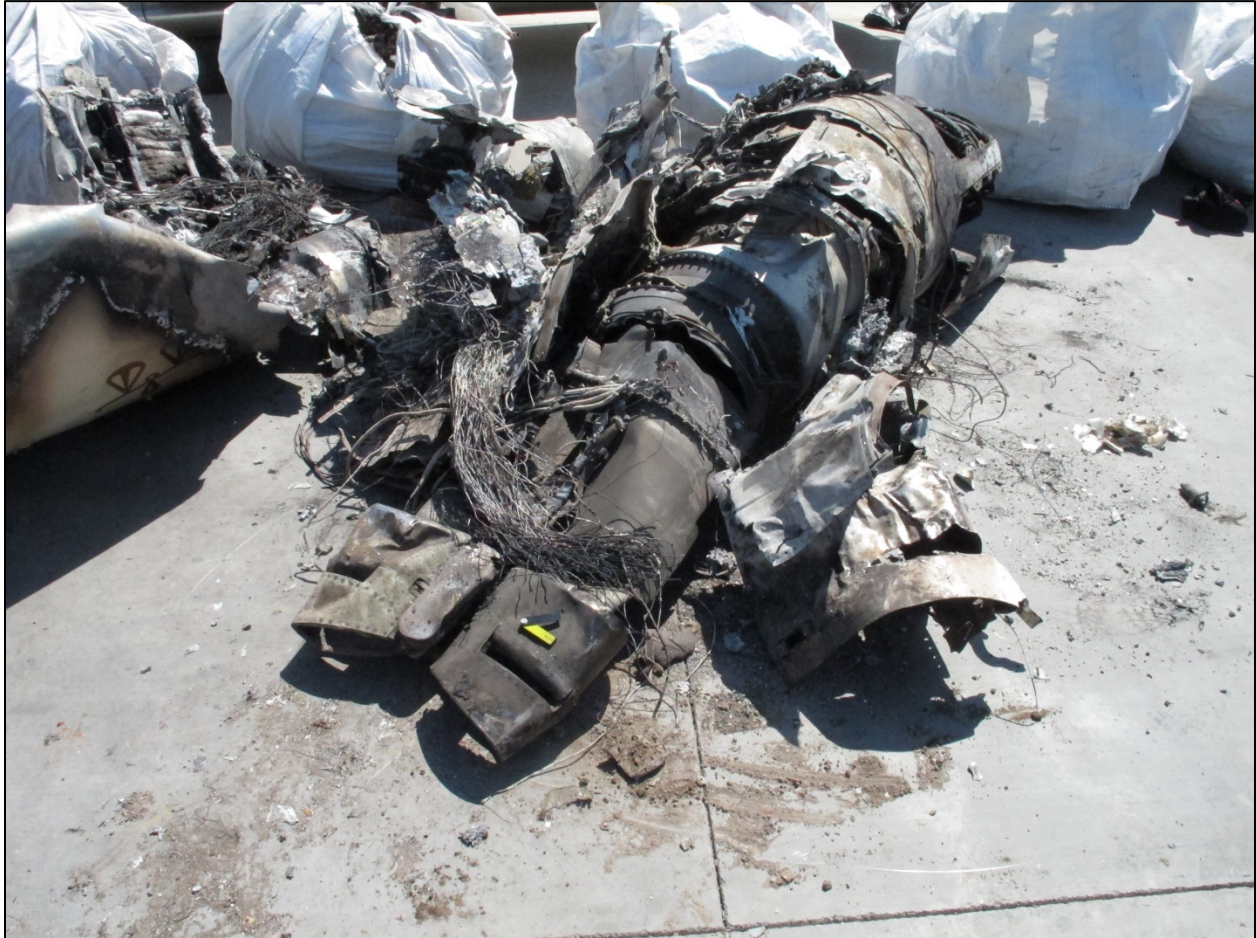
Figure 2-Sabreliner No. 2 (Right) Engine

The right engine was crushed from its side, leaving the thrust reverser assembly vertically flat. The turbine section revealed damage consistent with ground impact. Internal components were identified through openings in the turbine case section. Damaged and loose turbine blades were found in the turbine case section.

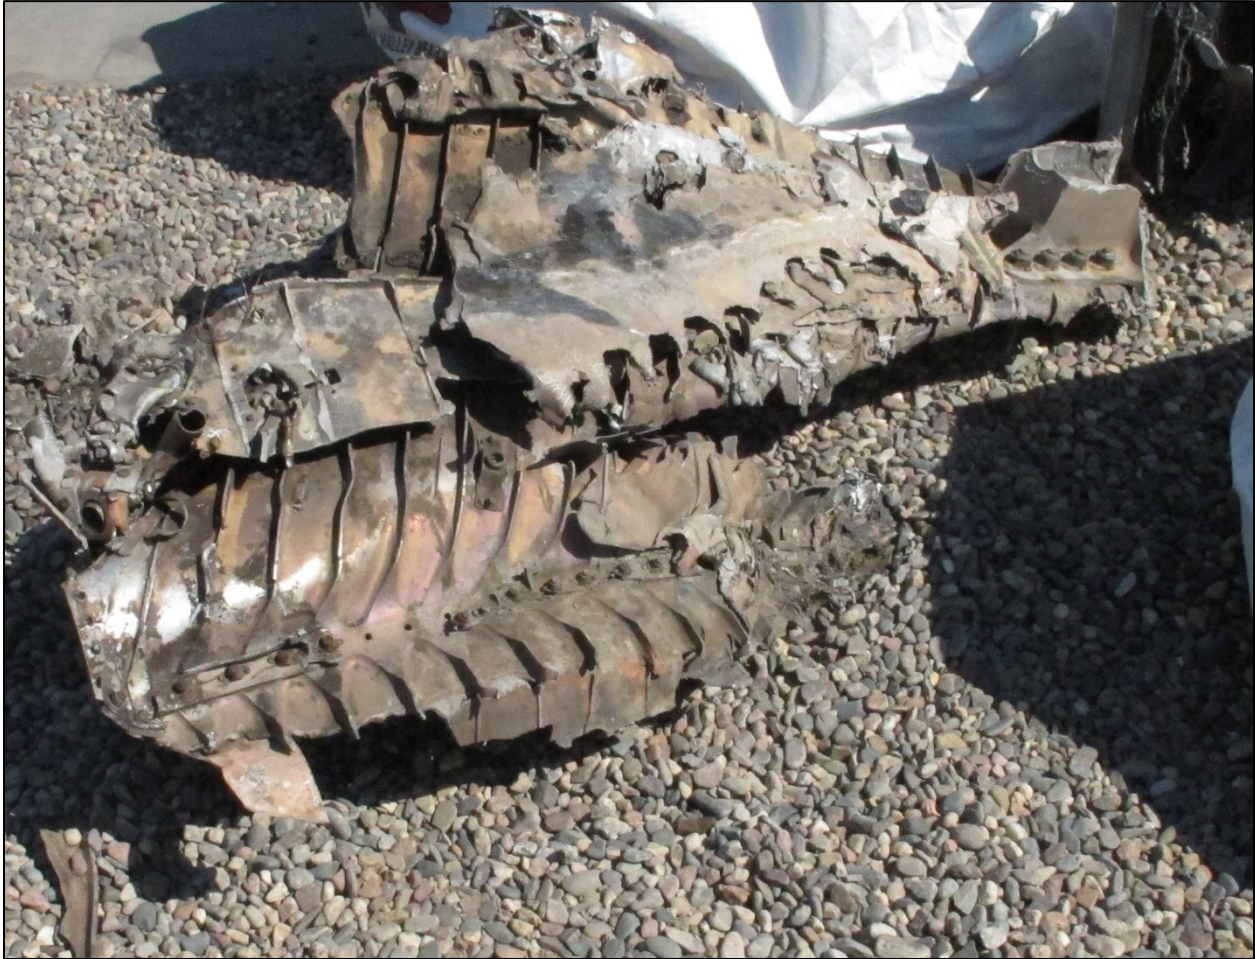
Figure 3-Sabreliner Right Wing Inboard Root Section

The fracture-separated right wing root section displayed thermal discoloration and impact damage.

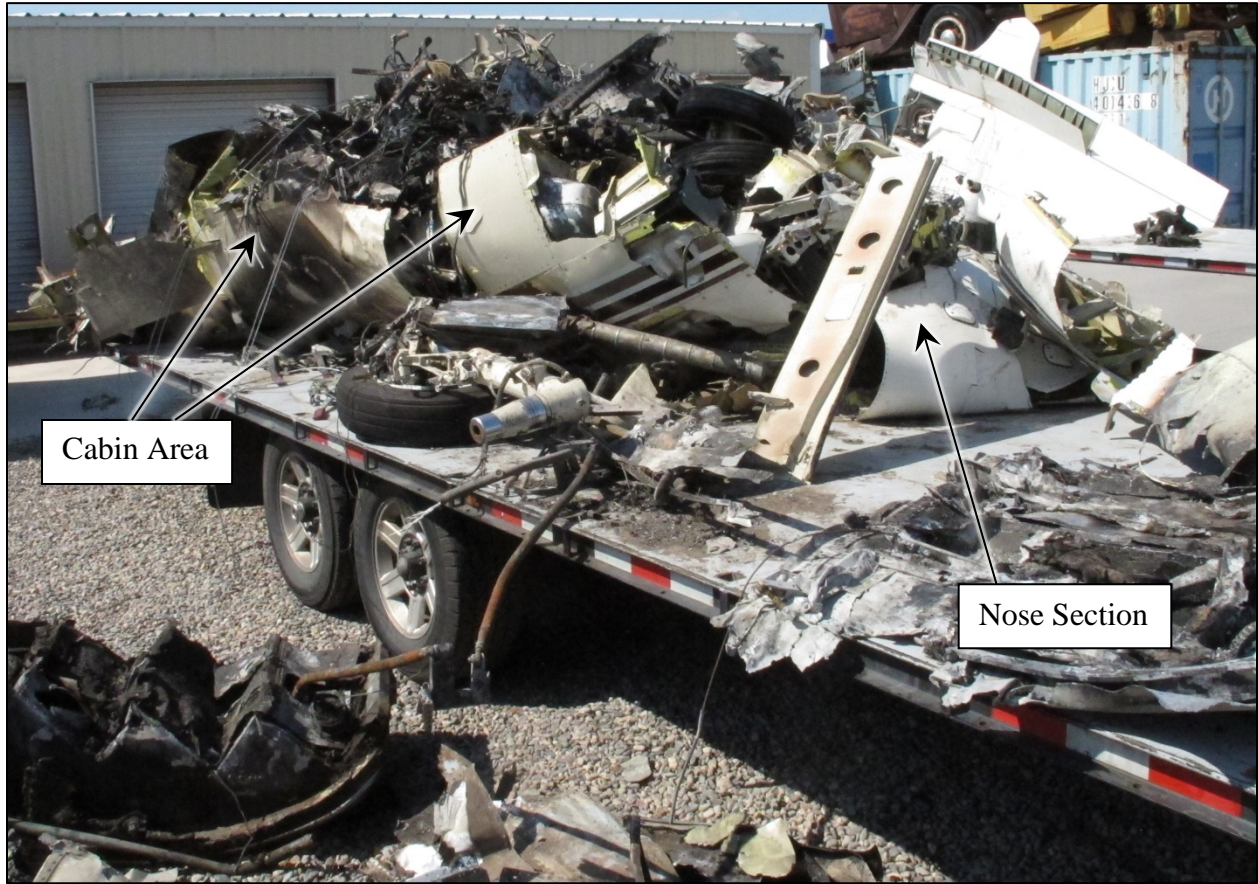
Figure 4-Sabreliner Main Fuselage and Cabin Area

The main fuselage and forward cabin area were crushed laterally, consistent with ground impact. The right side of the fuselage, including the right aft side of the cabin area, was substantially damaged by postimpact fire. The forward nose section revealed impact damage consistent with ground impact.

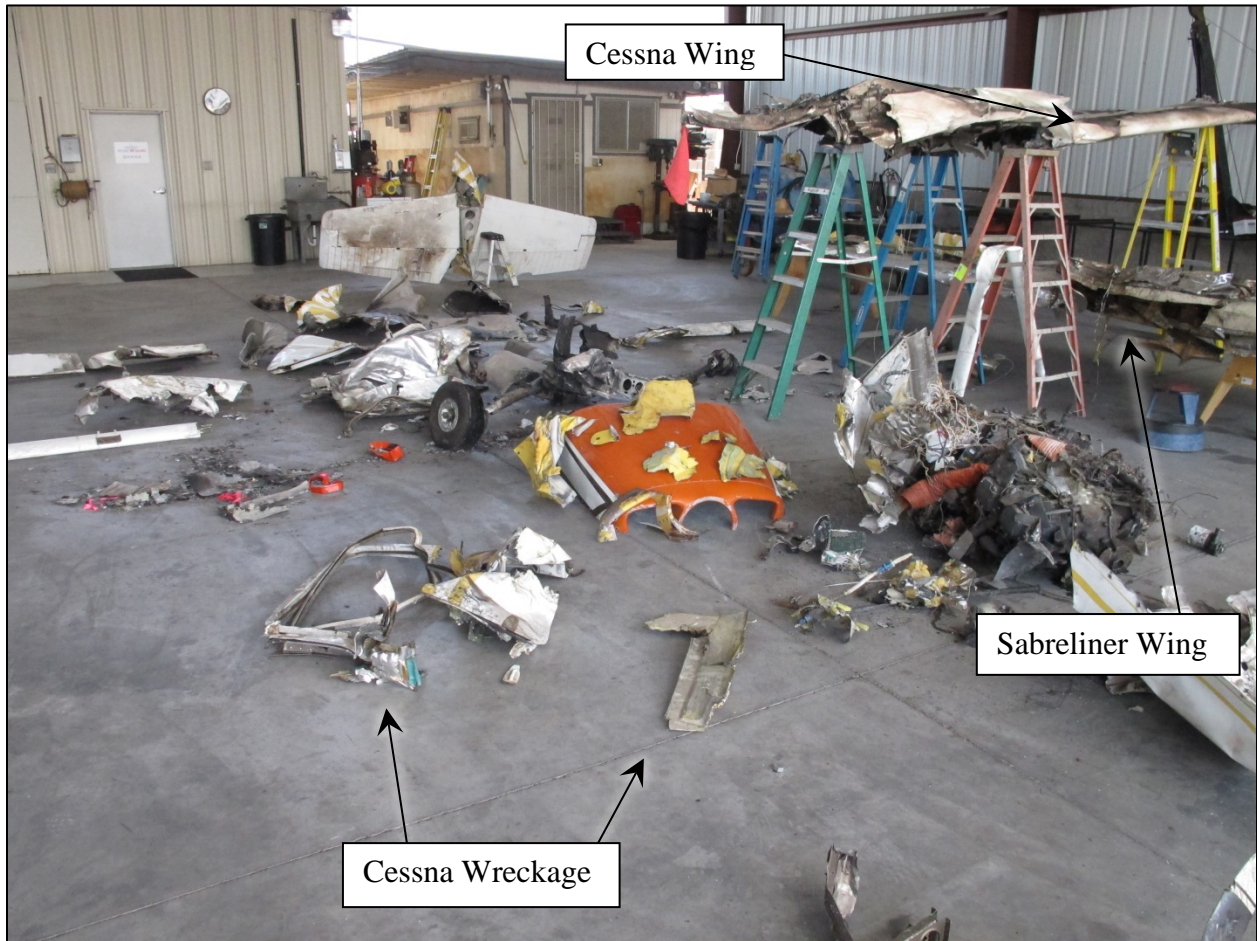
Figure 5-Cessna Wreckage and Sabreliner Right Wing Layout

The Cessna wreckage was laid out on the floor of an examination area. The Cessna left wing and cabin roof section, and the Sabreliner right wing were supported off the floor for visualization purposes. An exemplar orange-colored upper cowling was used during the examination to identify fragmented cowling sections.

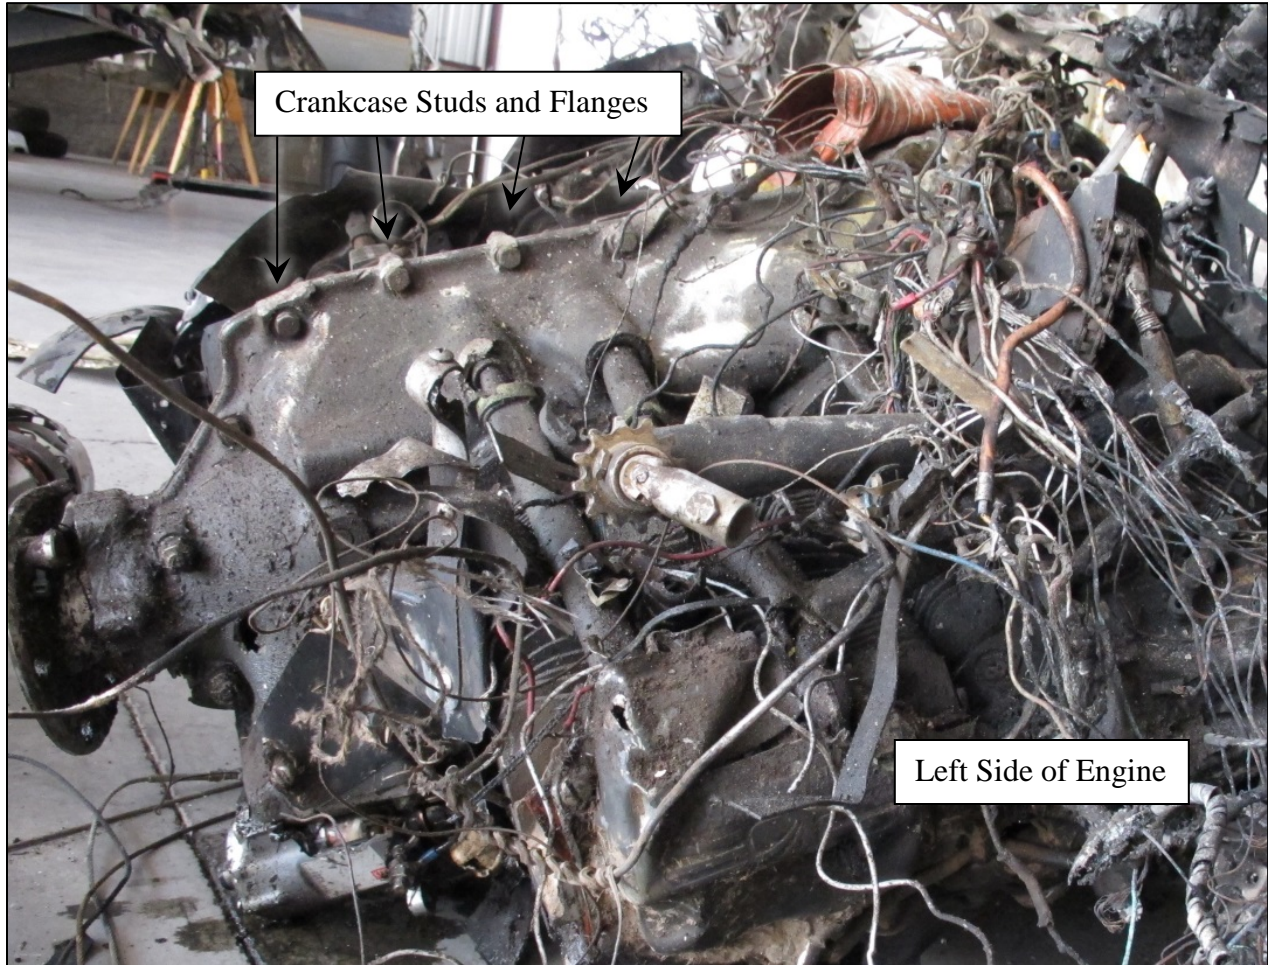
Figure 6-Cessna Engine (Left Side View)

The engine crankcase had impact damage consistent with being impacted from the left side. The upper crankcase support stud flanges were distorted and flattened on the top side. The stud spacing was measured to be about 2 1/2 inches from center to center. The spacing was consistent with marks identified on the lower inboard side of the Sabreliner right wing. The valve covers on the left bank of cylinders exhibited crush damage. The upper engine cowling had separated from the lower engine cowling, and was fragmented.

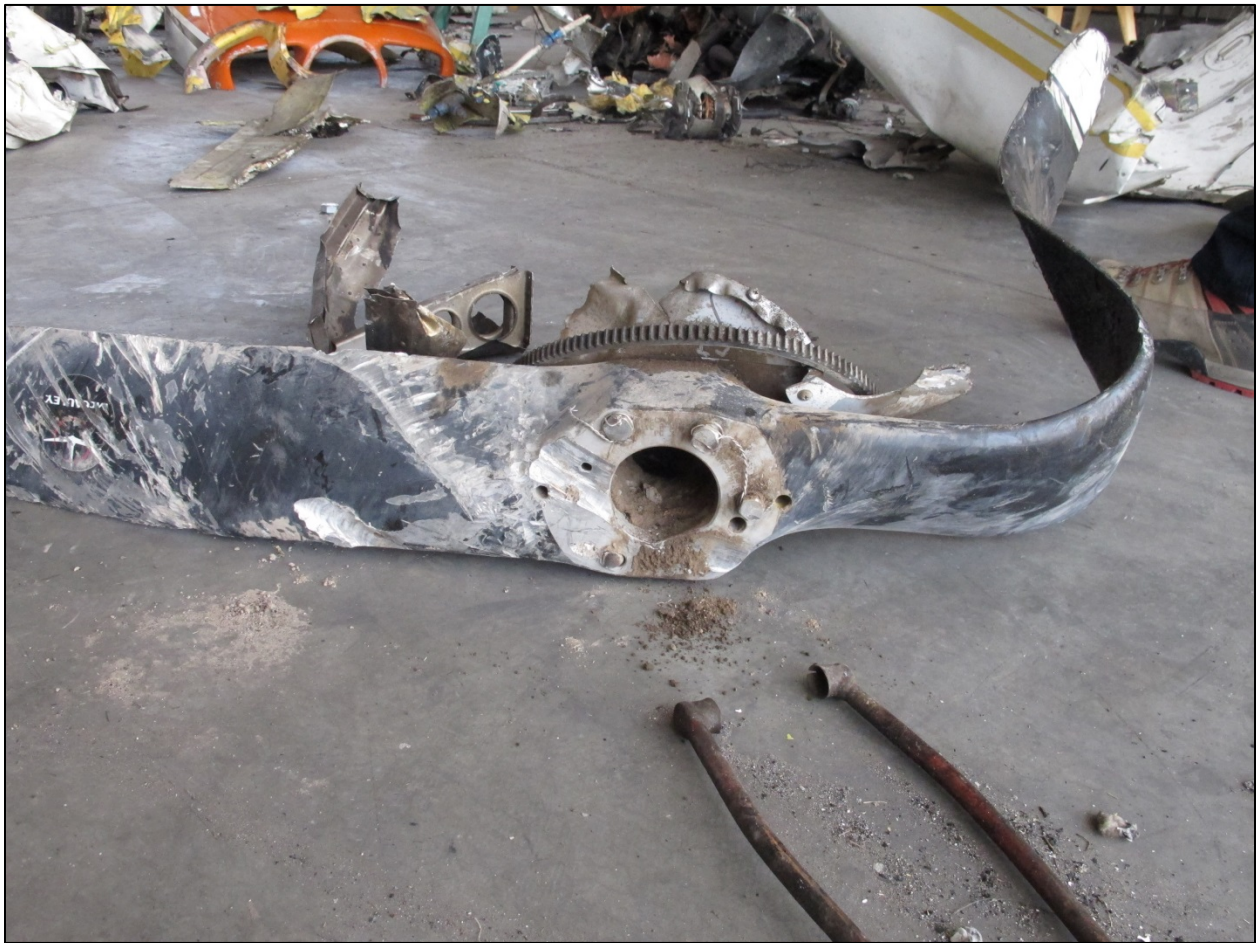
Figure 7-Cessna Propeller

The propeller was fracture-separated from the engine. For examination purposes, the blades were arbitrarily marked “A” and “B”. Blade A was bent aft with an S-type bend, and exhibited leading edge gouging and chordwise scratches. Large gouges were present through the hub of the blade and continuing diagonally through blade B. Blade B exhibited leading edge and diagonal gouges. Blade B was fracture-separated near the tip.

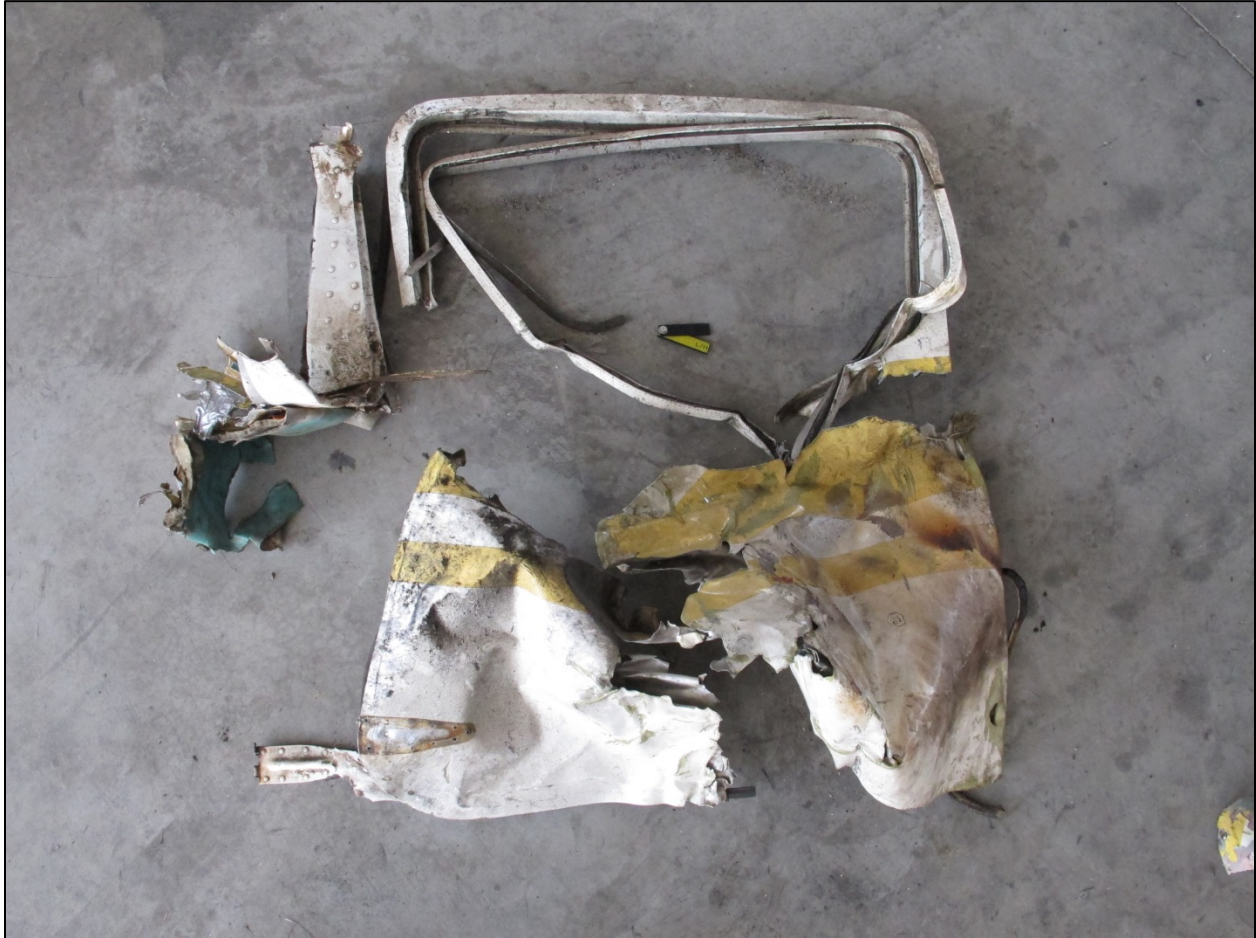
Figure 8-Cessna's Left Entry Door

The Cessna left entry door was fractured into three major portions. The left door window frame had separated from the lower door structure, which separated into two additional pieces. The main separation between the left door window frame and lower door structure exhibited inboard deformation. The forward portion of the left door frame was deformed in the inboard direction, consistent with a wing striking the frame.

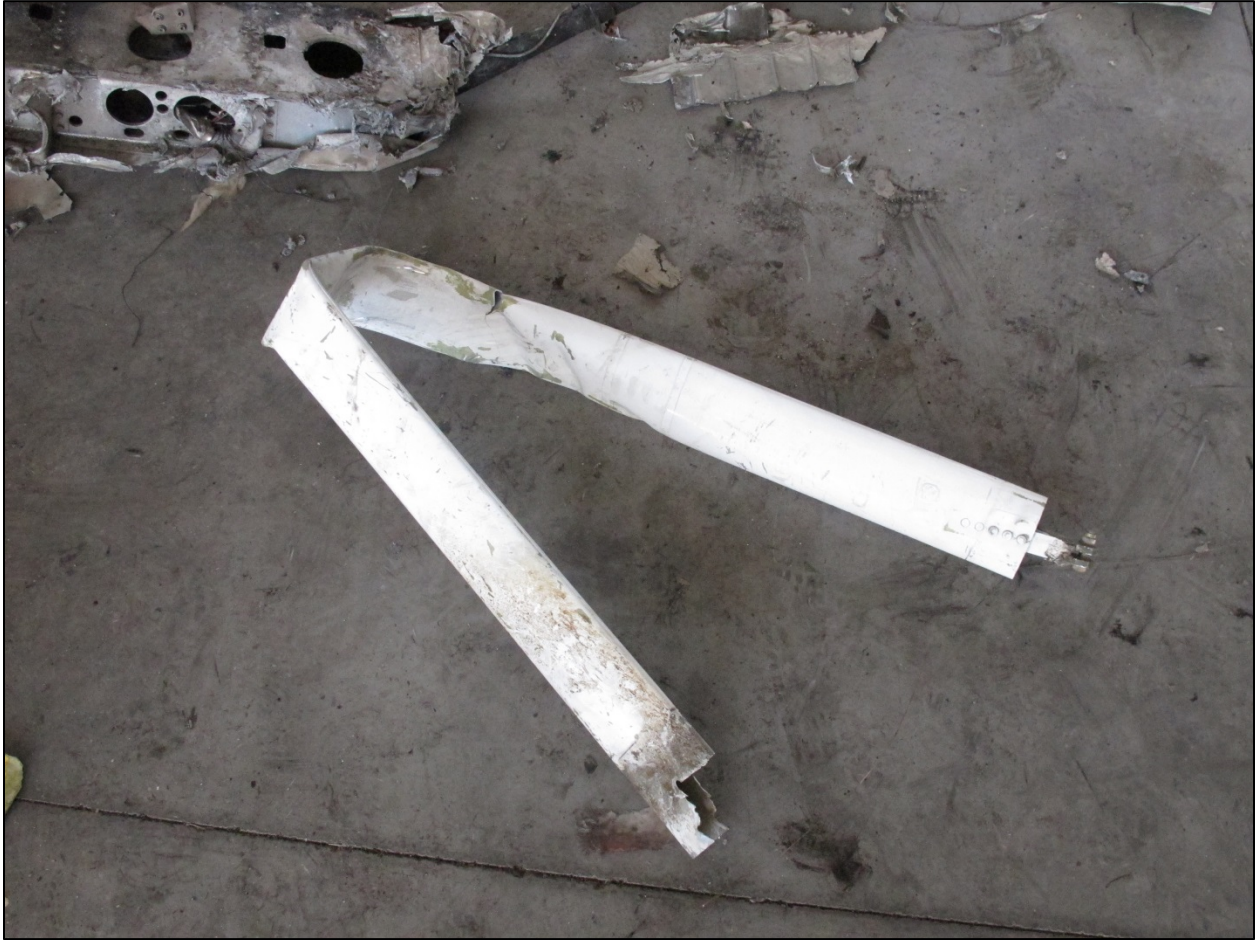
Figure 9-Cessna Left Wing Side Strut

The Cessna left wing strut was bent inboard approximately 3.5 feet from the top of the strut, and fracture-separated from the left wing and fuselage. The radius of the left wing strut bend was consistent with the profile of the Sabreliner right wing leading edge.

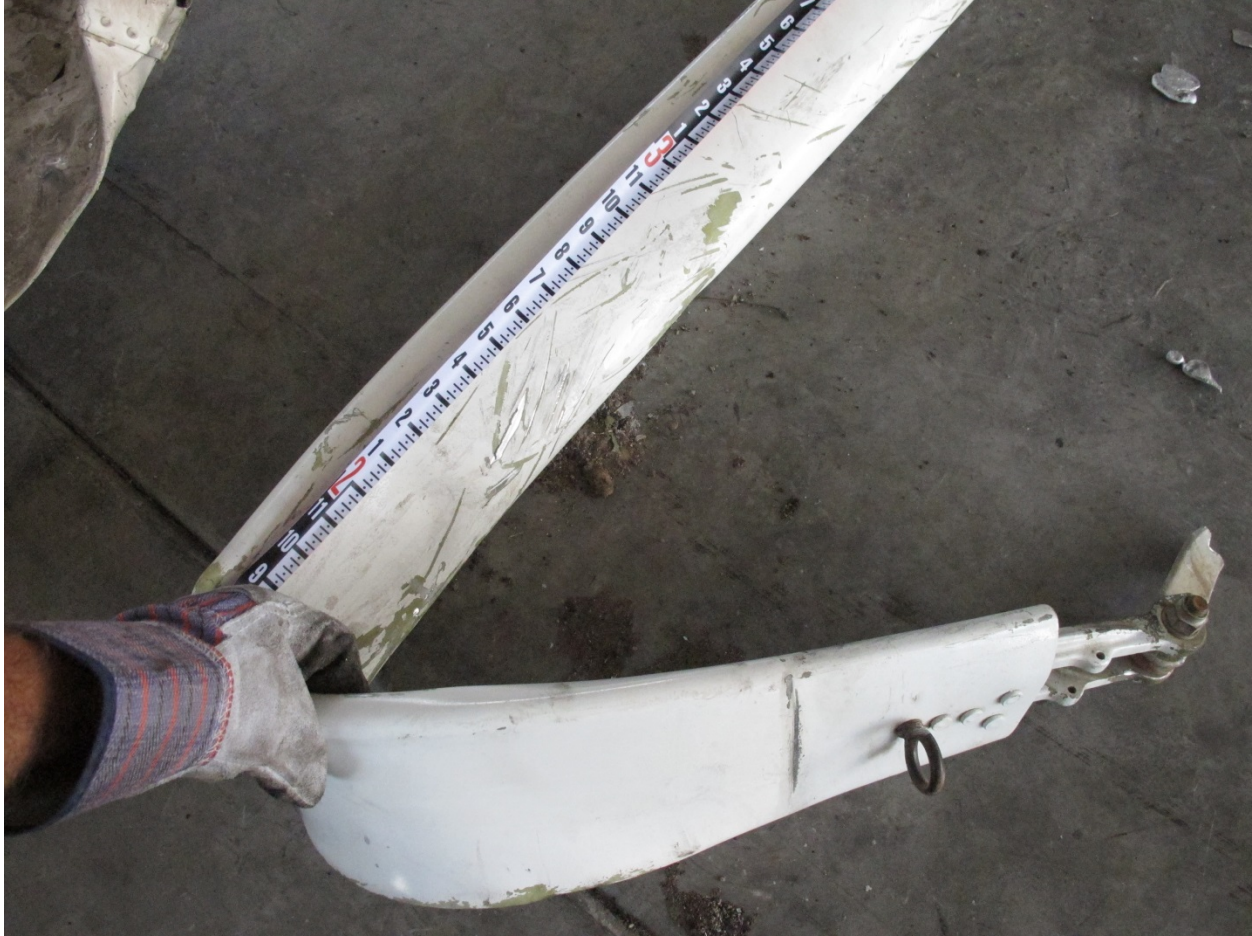
Figure 10-Cessna Right Wing Side Strut

The right wing strut was bent outboard approximately 1 1/2 feet from the top of the strut, and separated from the right wing and fuselage. The radius of the right wing strut bend was consistent with the radius of the Sabreliner main landing gear strut.

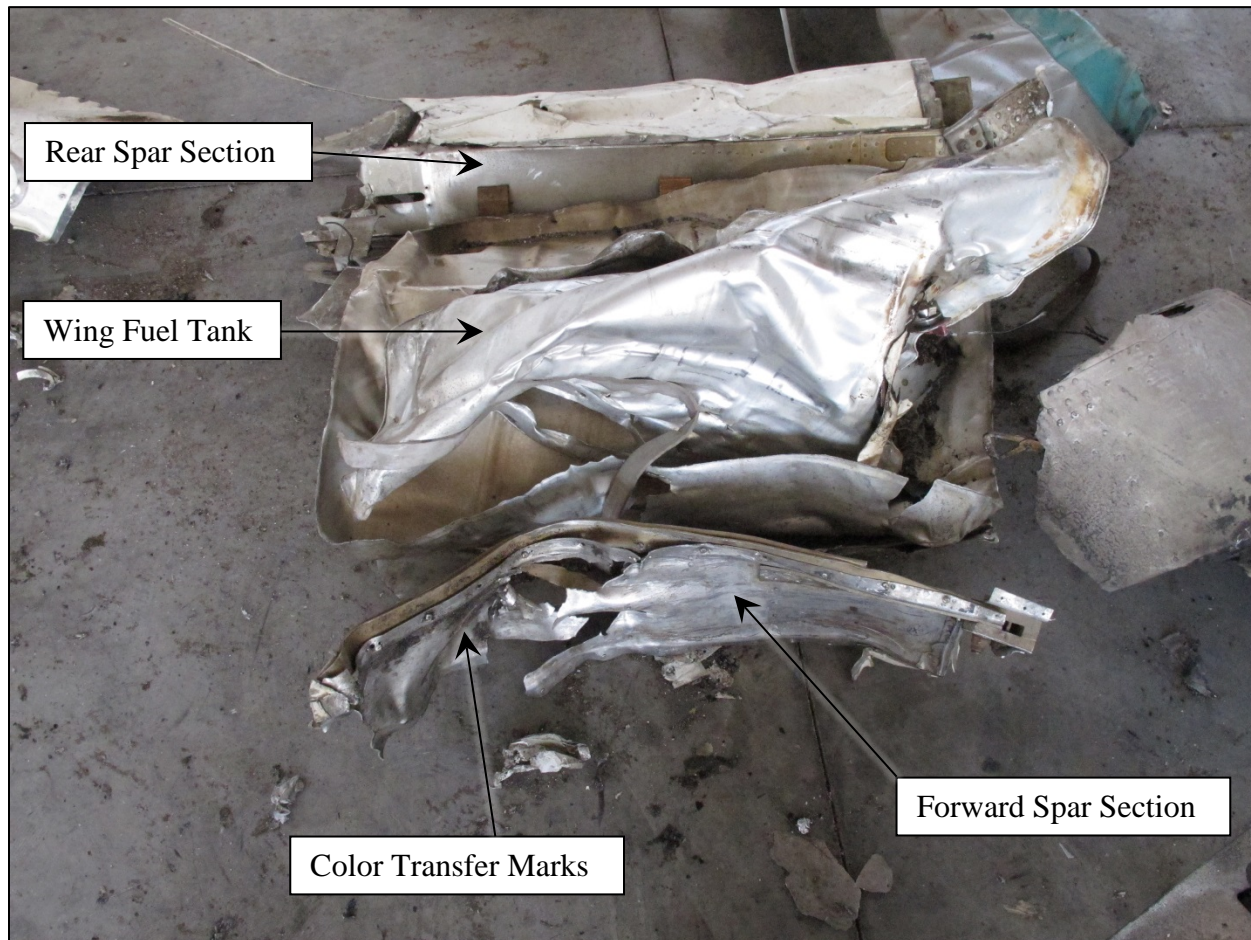
Figure 11-Cessna Right Wing Section and Fuel Tank

A separated inboard portion of the Cessna right wing forward spar exhibited lateral scratches and orange colored material transfer marks, and was bent consistent with contact with the Sabreliner right wing leading edge. See figure 12. The fuel tank, located behind the forward spar portion, was hydraulically deformed with the upper and lower halves of the tank separated at the welds.

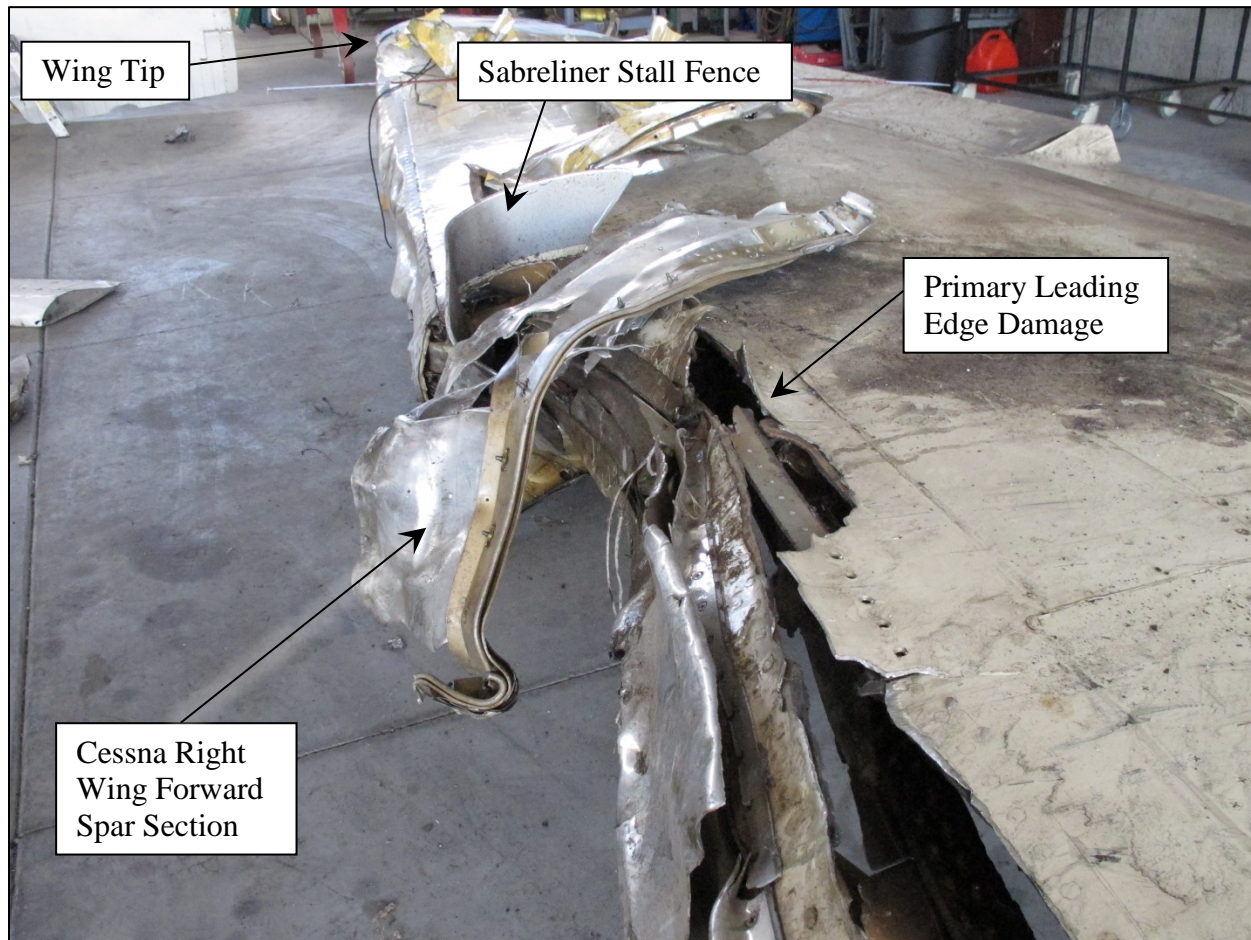
Figure 12-Sabreliner Right Wing and Cessna Right Wing Forward Spar Section

The Cessna right wing forward spar section was laid on the Sabreliner wing for reconstruction purposes. The Cessna right wing forward spar section exhibited signatures consistent with the impact of portions of the Sabreliner right wing leading edge.

Orange colored material transfer marks were present on the Cessna left wing leading edge, and the color was consistent with that of a material found inside the leading edge of the Sabreliner right wing.

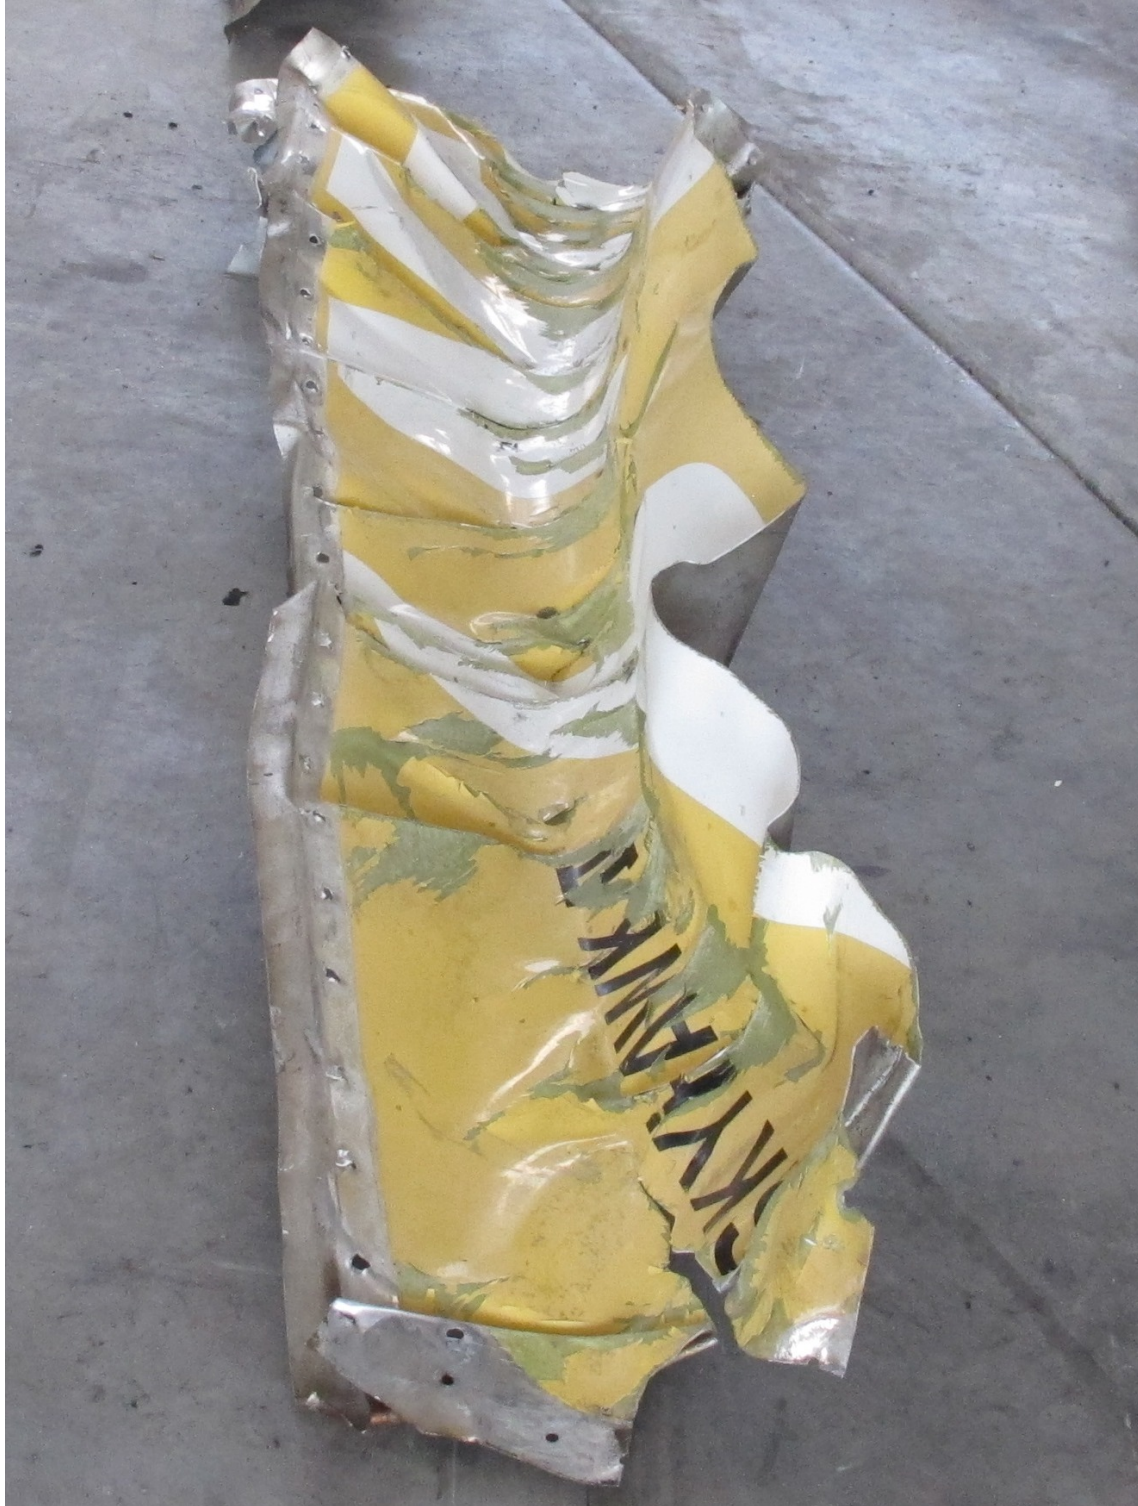
Figure 13-Cessna Left Side Fuselage Skin Section

The Cessna left fuselage side skin section, including the painted registration number, was fracture-separated from the fuselage.

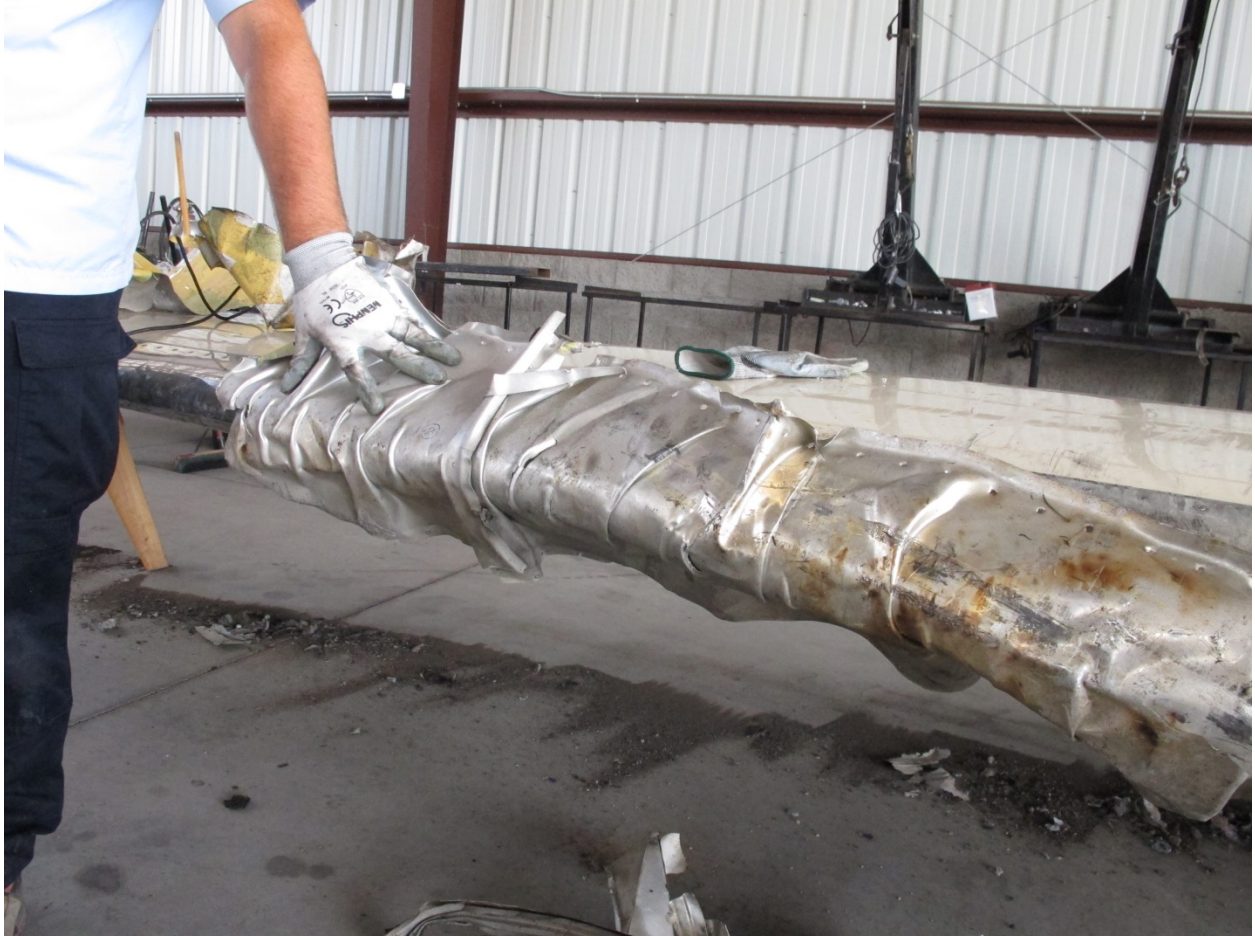
Figure 14-Cessna Left Side Fuselage Skin Section and Sabreliner Right Wing Leading Edge

The Cessna left fuselage side skin section was laid on the Sabreliner wing for reconstruction purposes. The section conformed to the leading edge of the Sabreliner wing, and revealed multiple folds consistent with forward to aft movement of the skin during impact.

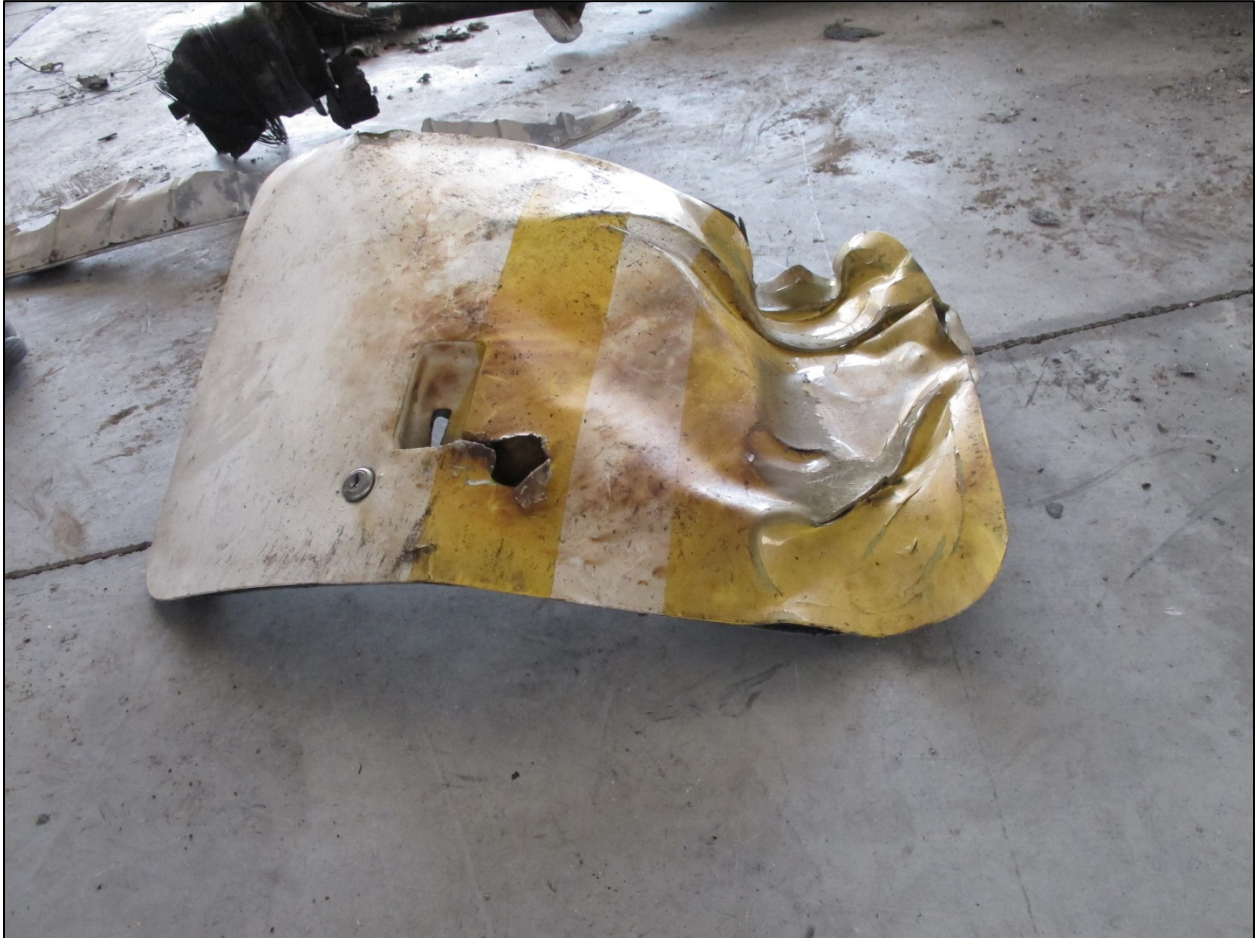
Figure 15-Cessna Baggage Door

The upper portion of the baggage door on the left side of the fuselage was also deformed inboard, consistent to the shape of the leading edge of the Sabreliner wing. The door skin also exhibited lapped folds consistent with forward to aft movement during impact.

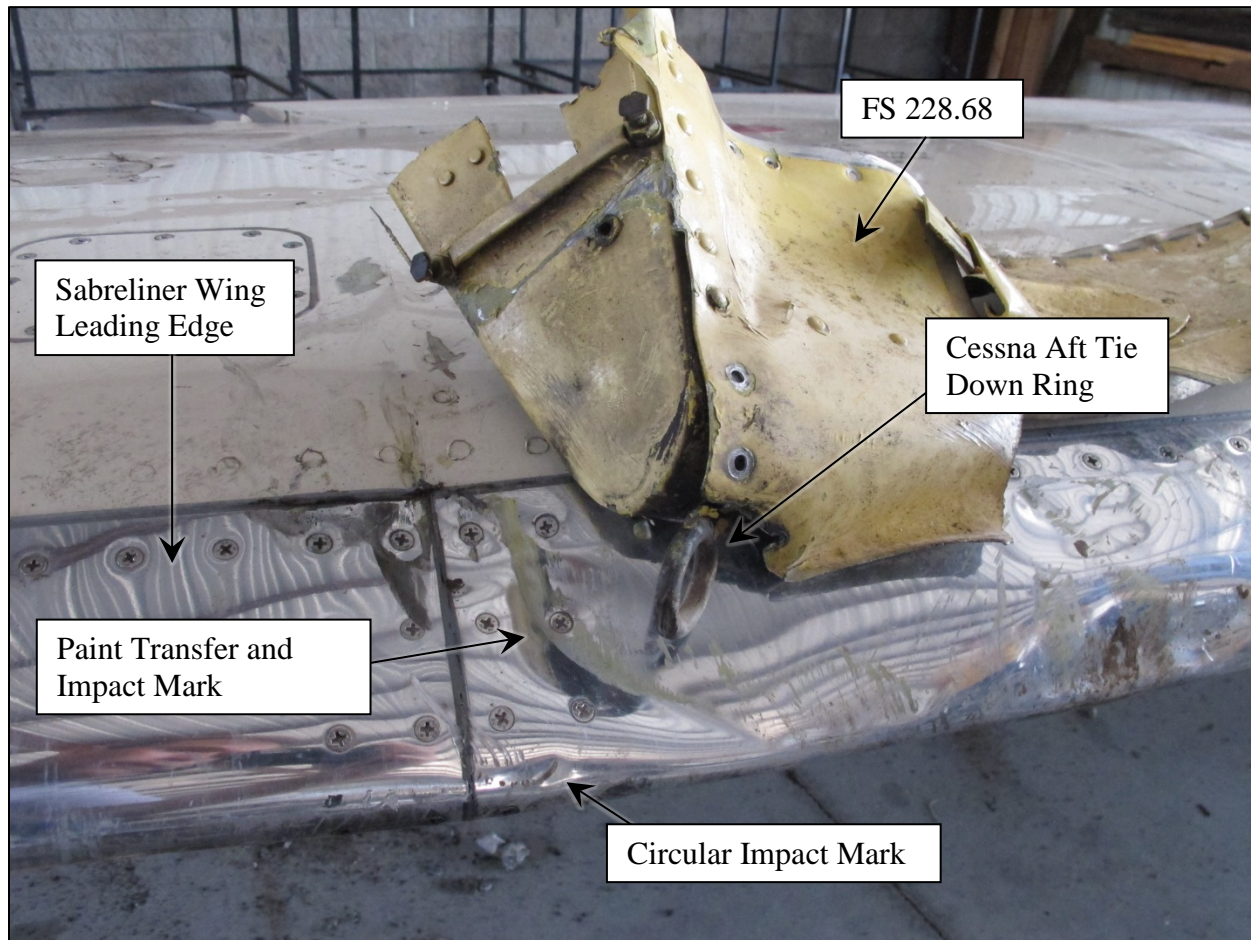
Figure 16-Cessna Aft Tiedown Ring and Supporting Structure and Sabreliner Right Wing Leading Edge

The lower portion of the Cessna bulkhead at FS 228.68 was separated from the fuselage structure. Impact signatures consistent with the FS 228.68 bulkhead and aft tiedown ring were present on the Sabreliner right wing at approximately WS 254. The upper portion of the Cessna FS 228.68 bulkhead remained attached to the Cessna empennage.

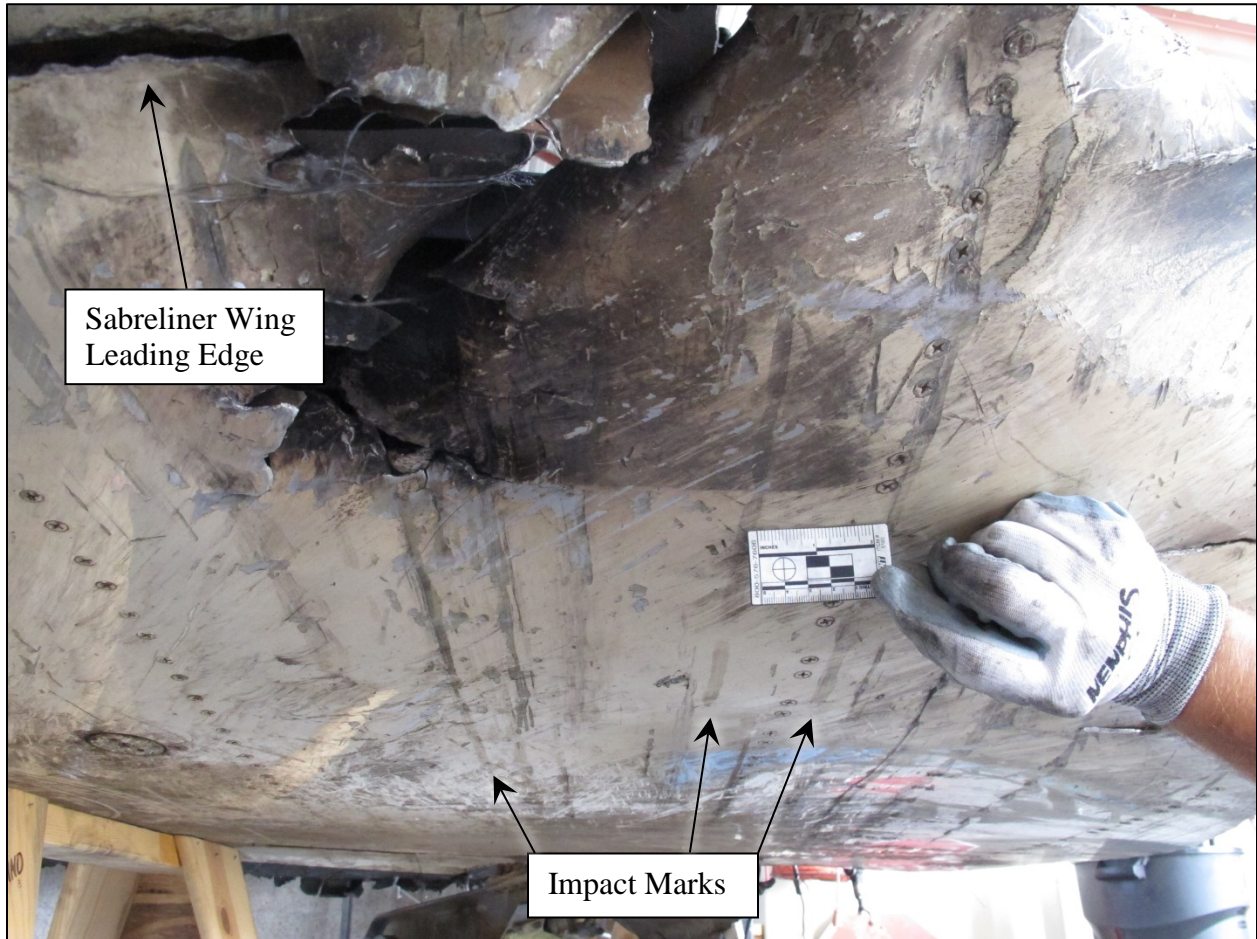
Figure 17-Sabreliner Right Wing Lower Surface

The right wing of the Sabreliner was positioned with the Cessna wreckage, and an examination for contact signature evidence between the airplanes was accomplished. Evidence was observed in the form of impact marks found on the Sabreliner. The Sabreliner right wing had intrusions that are consistent with impact of the Cessna engine continuing through the Cessna left entry door post and the aft fuselage.

The spacing of the impact marks on the Sabreliner right wing inboard lower surface were consistent with the spacing of the Cessna engine crankcase upper studs and flanges and engine lifting eye. The angle of the marks was about 30 degrees, as measured from the Sabreliner's longitudinal axis. The damage on the crankcase upper studs and flanges and engine lifting eye was consistent with impact from its left side. Based upon the orientation of the evidence, the respective collision and convergence angles were calculated.
