NATIONAL TRANSPORTATION SAFETY BOARD

WRECKAGE EXAMINATION SUMMARY

WPR15MA243AB

Location: San Diego, California
Date: August 16, 2015
Aircraft A: Cessna 172M, N1285U
Aircraft B: Sabreliner NA-265-605C, N442RM

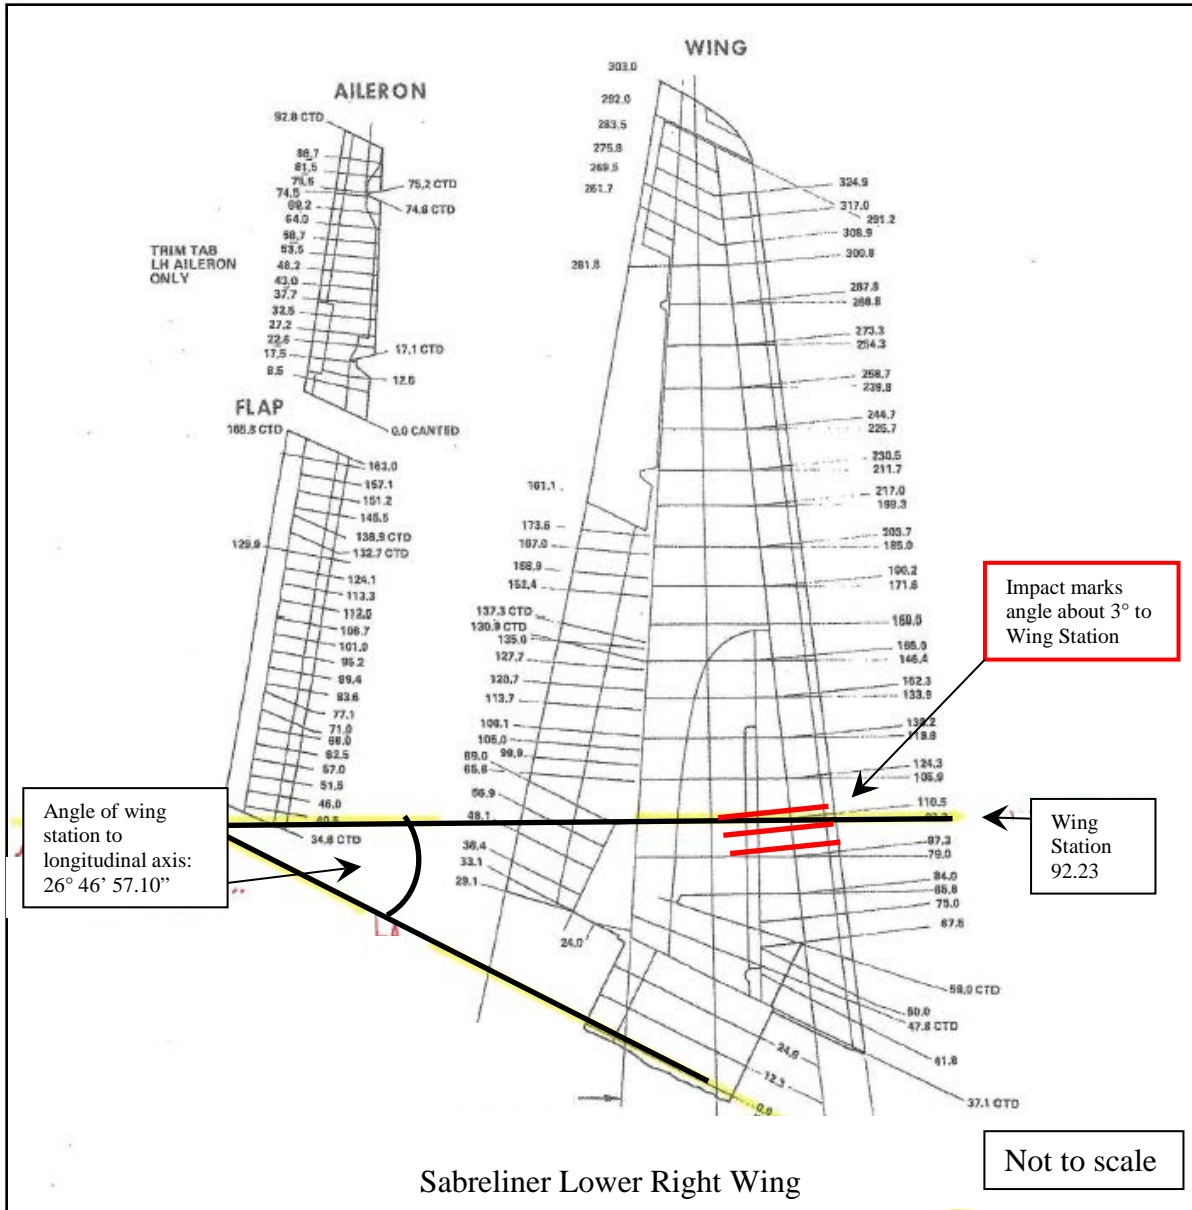
Figure 18 – The diagram used to determine the convergence angle discussed above.

Evidence of the convergence angle between the airplanes was provided by the parallel marks left on the Sabreliner right wing inboard lower surface. The marks were about 30 degrees to the right of the Sabreliner centerline, as shown in Figure 18. In addition, the conformity between the Sabreliner structure and damage to the Cessna fuselage, wing struts, and wing spar described above indicates that the Sabreliner right wing impacted the Cessna as depicted in Figure 19. Based on this evidence, the positions of the airplanes relative to each other at the time of collision would have been as depicted in Figures 20-22.

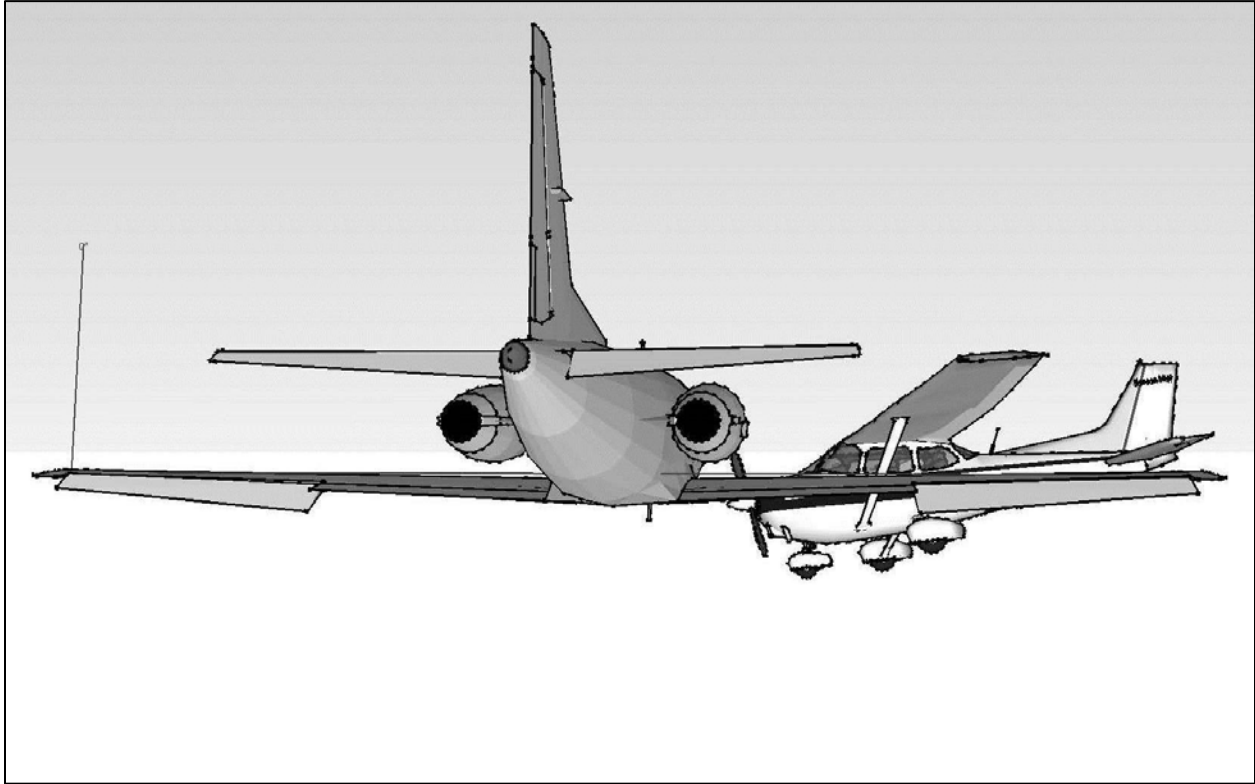
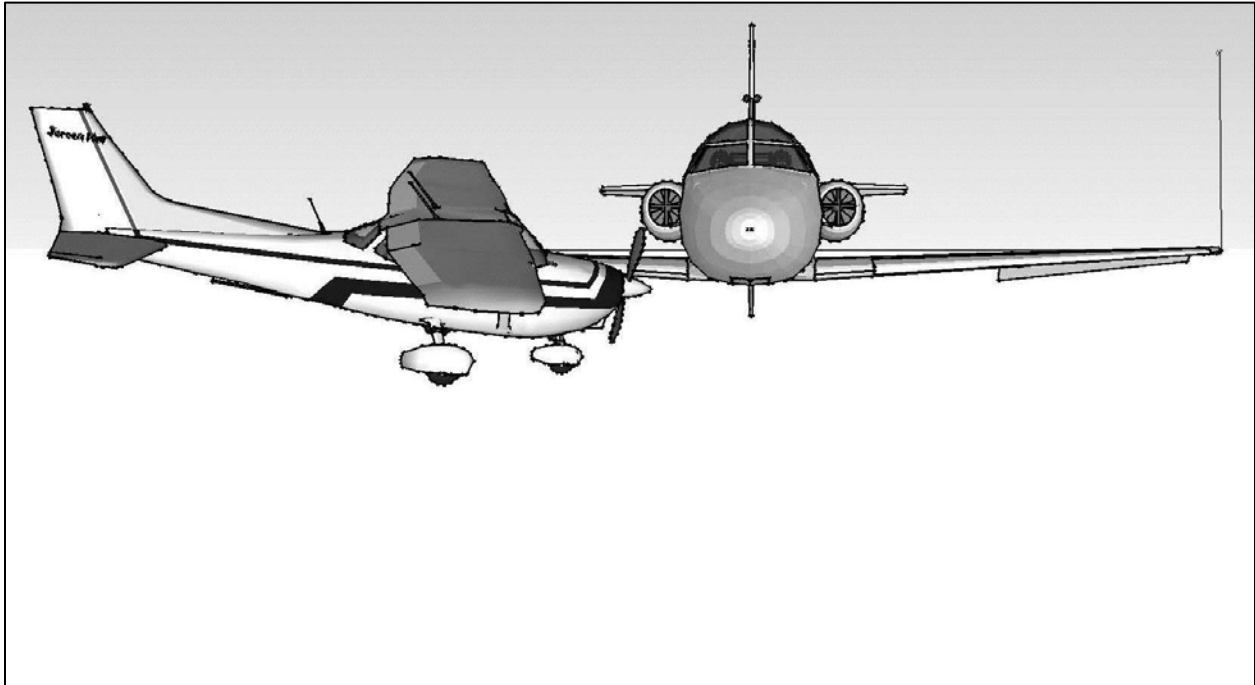
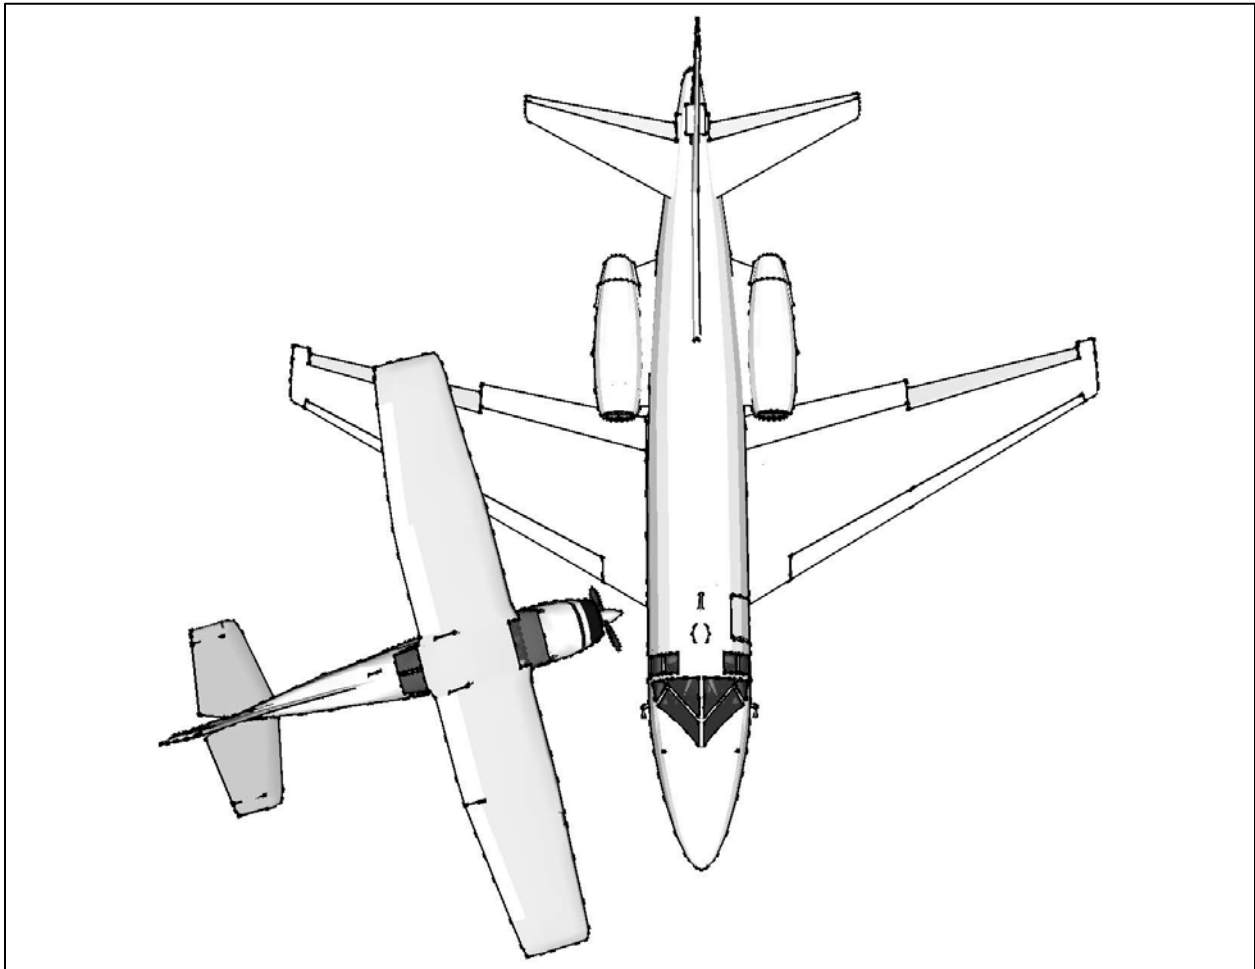
The reconstruction of the airplanes' flight paths, based on radar data, is described in the Aircraft Performance Study for this accident. The collision geometry resulting from the reconstruction is consistent with that depicted in Figures 20-22.
